# Reclamation Inspection

10/21/2016

Operator: Magpie Operating

Location ID: 401718

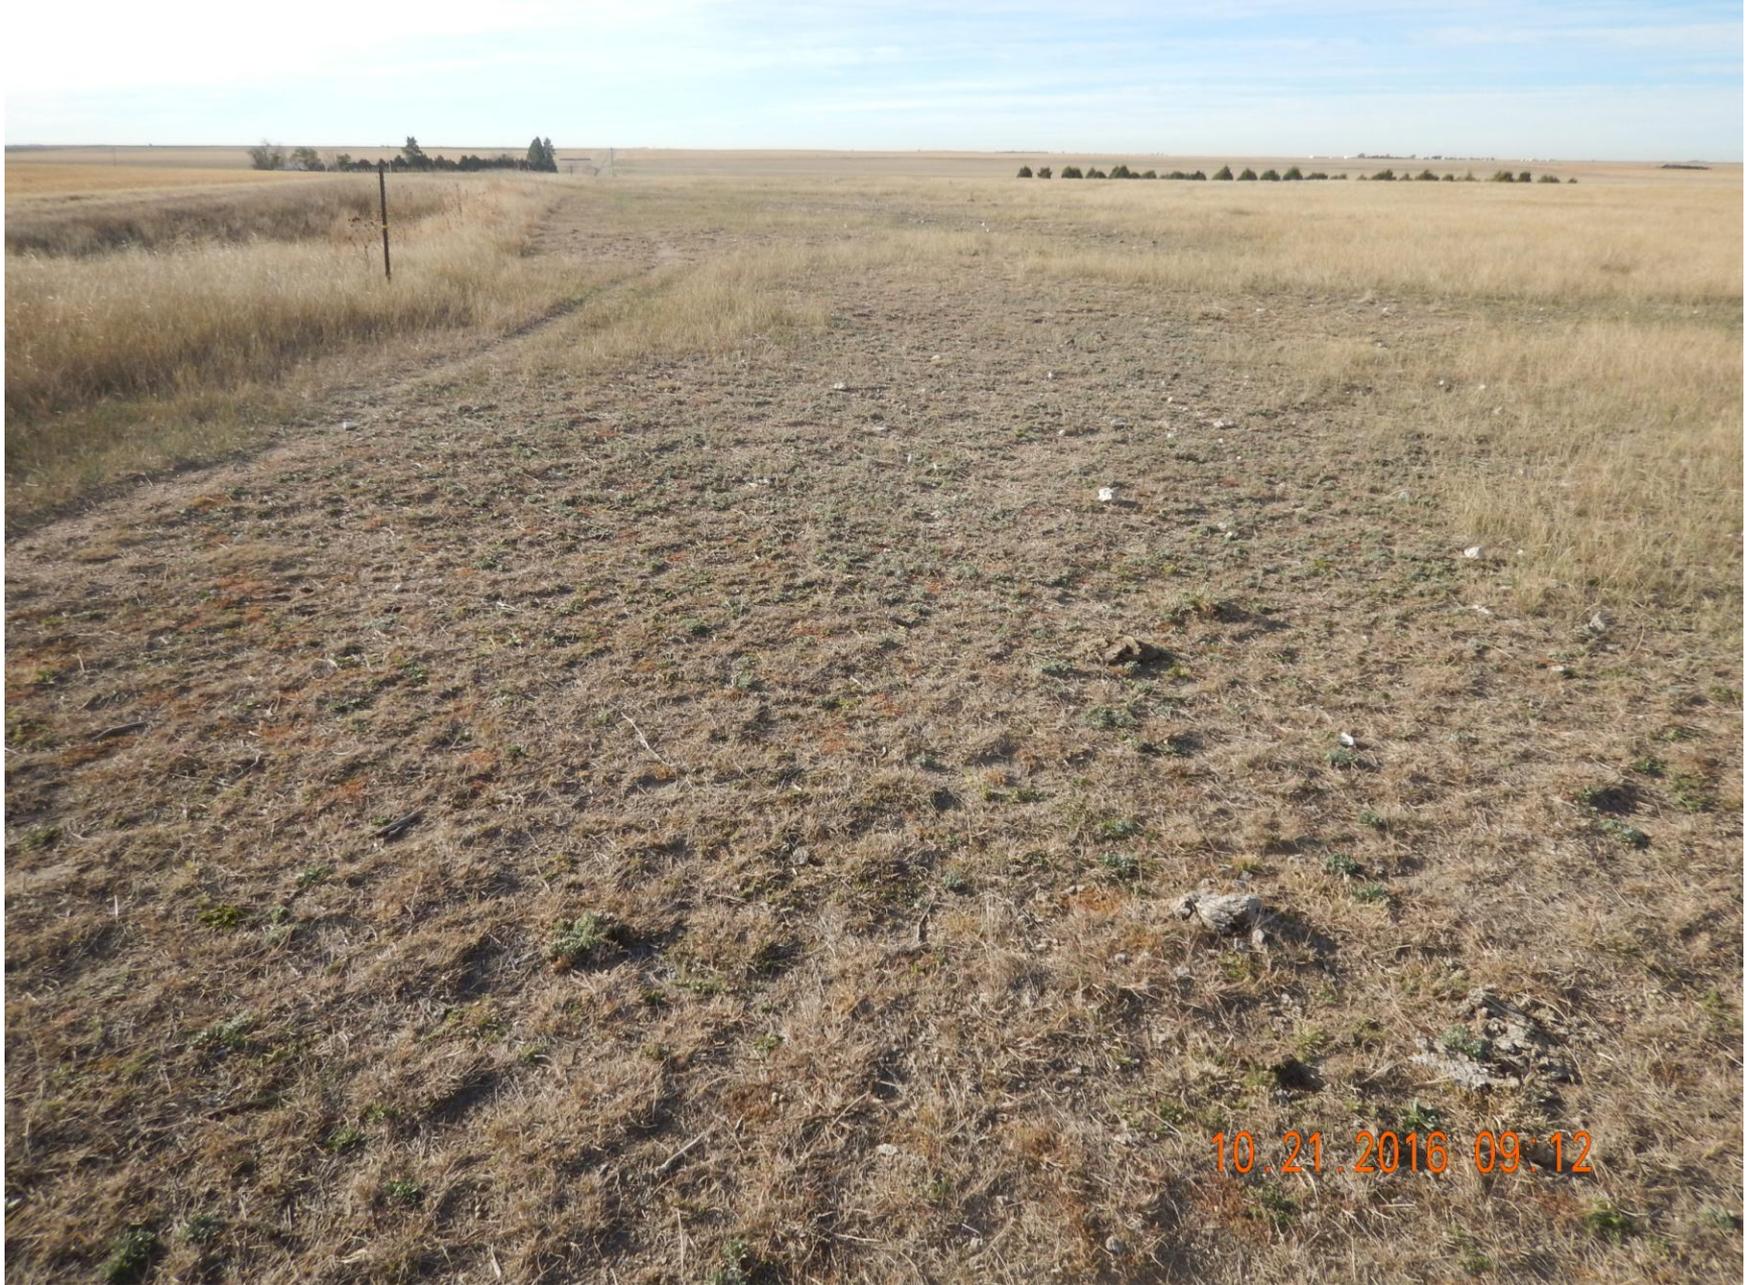
**Figure 1:** Photo taken from the northeast end of the pit location, facing south. Photo shows the vegetation over the reclamation area.

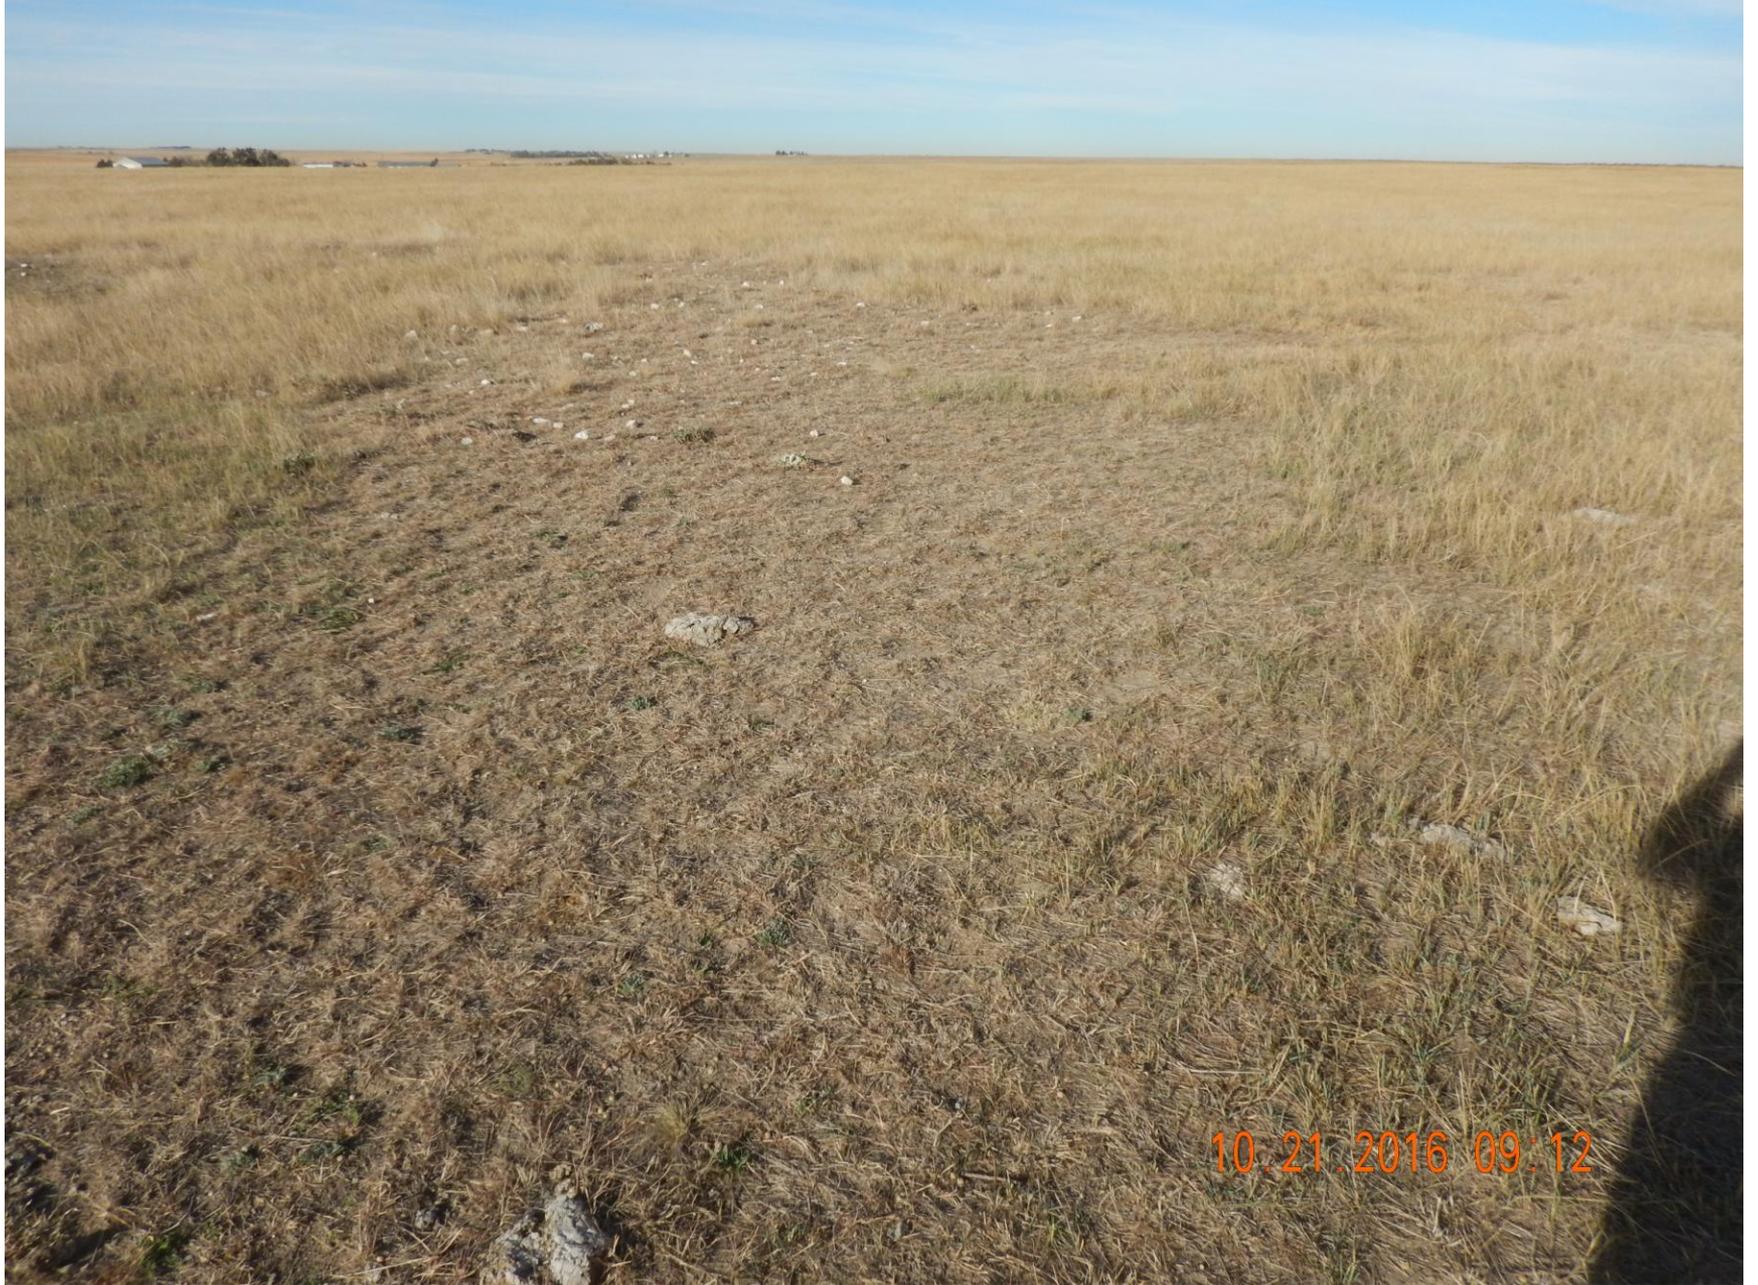
**Figure 2:** Photo taken from the northeast end of the pit location, facing west. Photo shows the vegetation over the reclamation area.

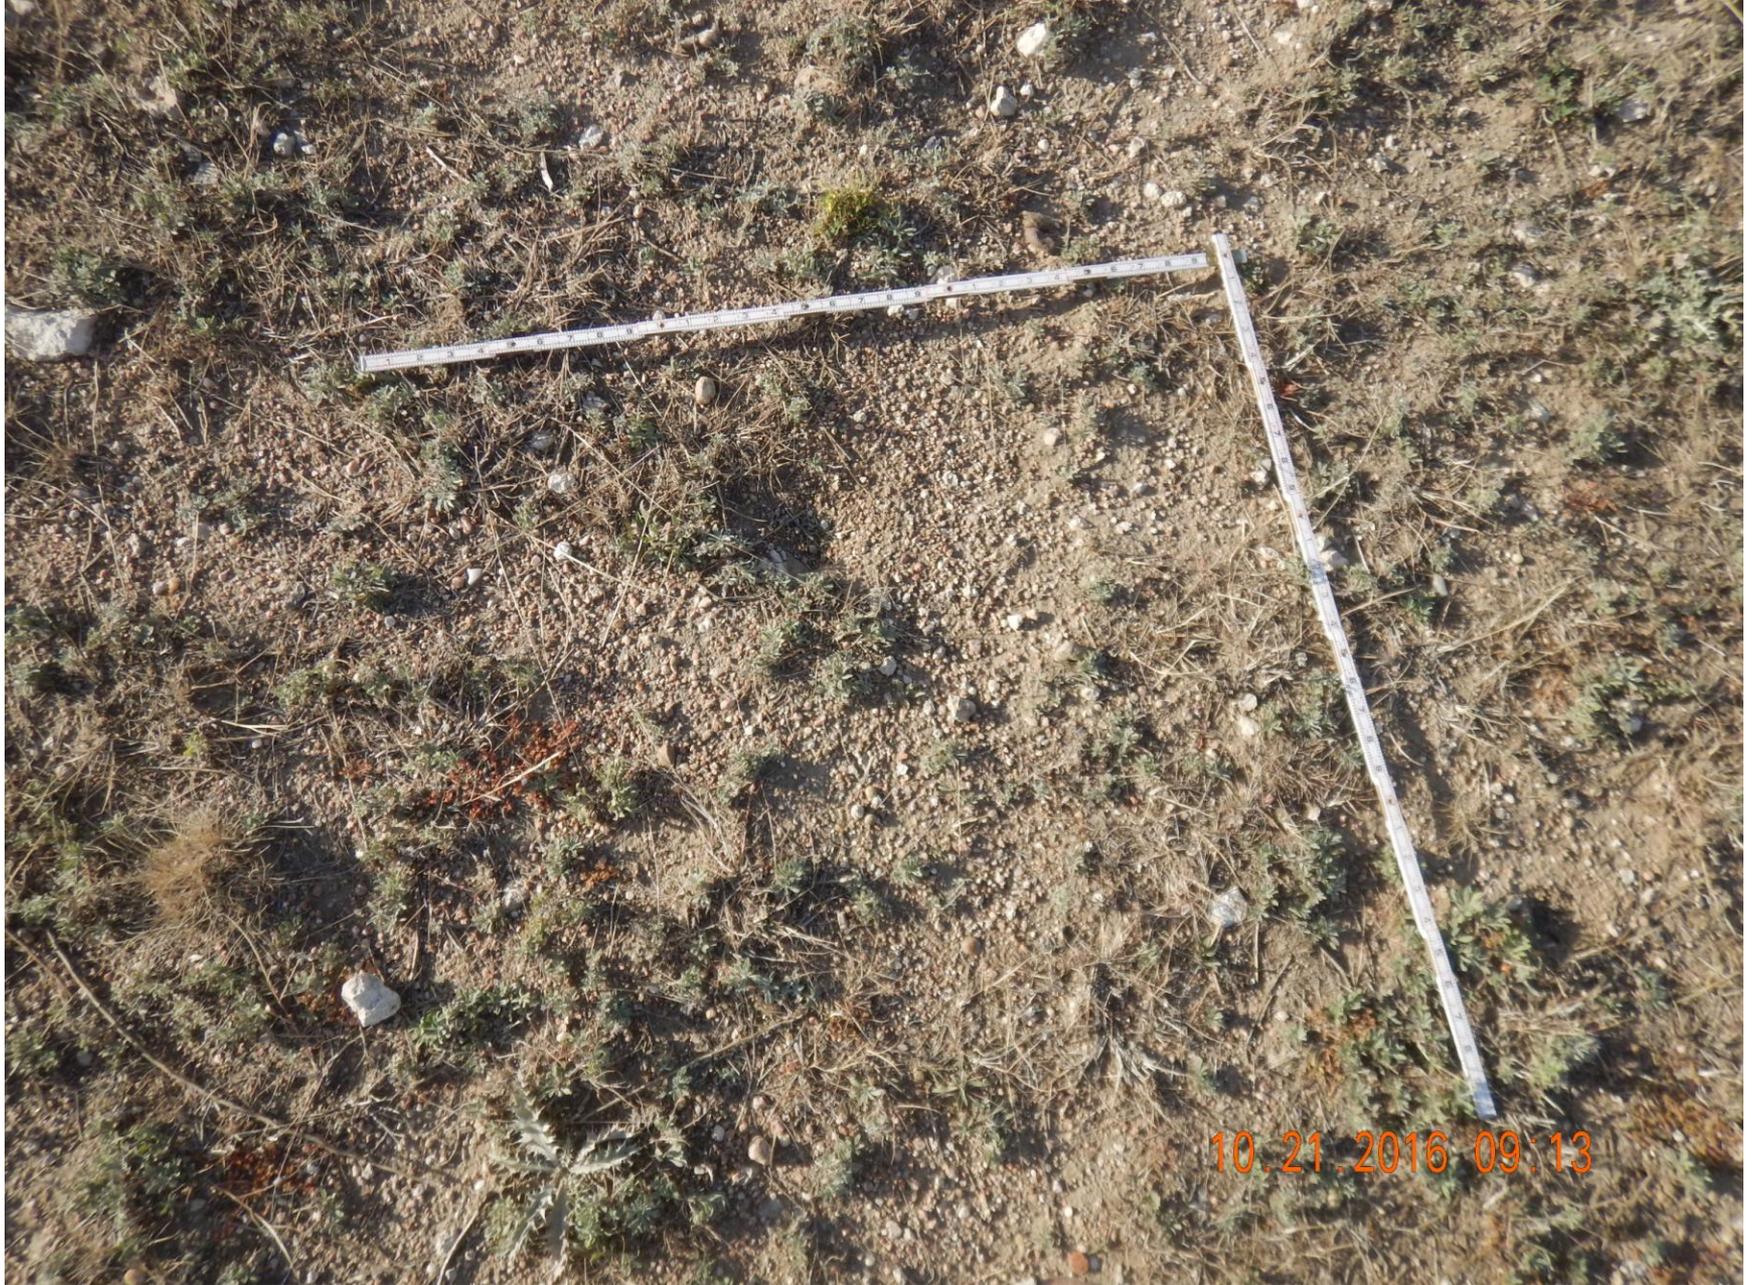
**Figure 3:** Photo taken from the north end of the pit location. Photo shows areas over the reclamation area that remain unvegetated.

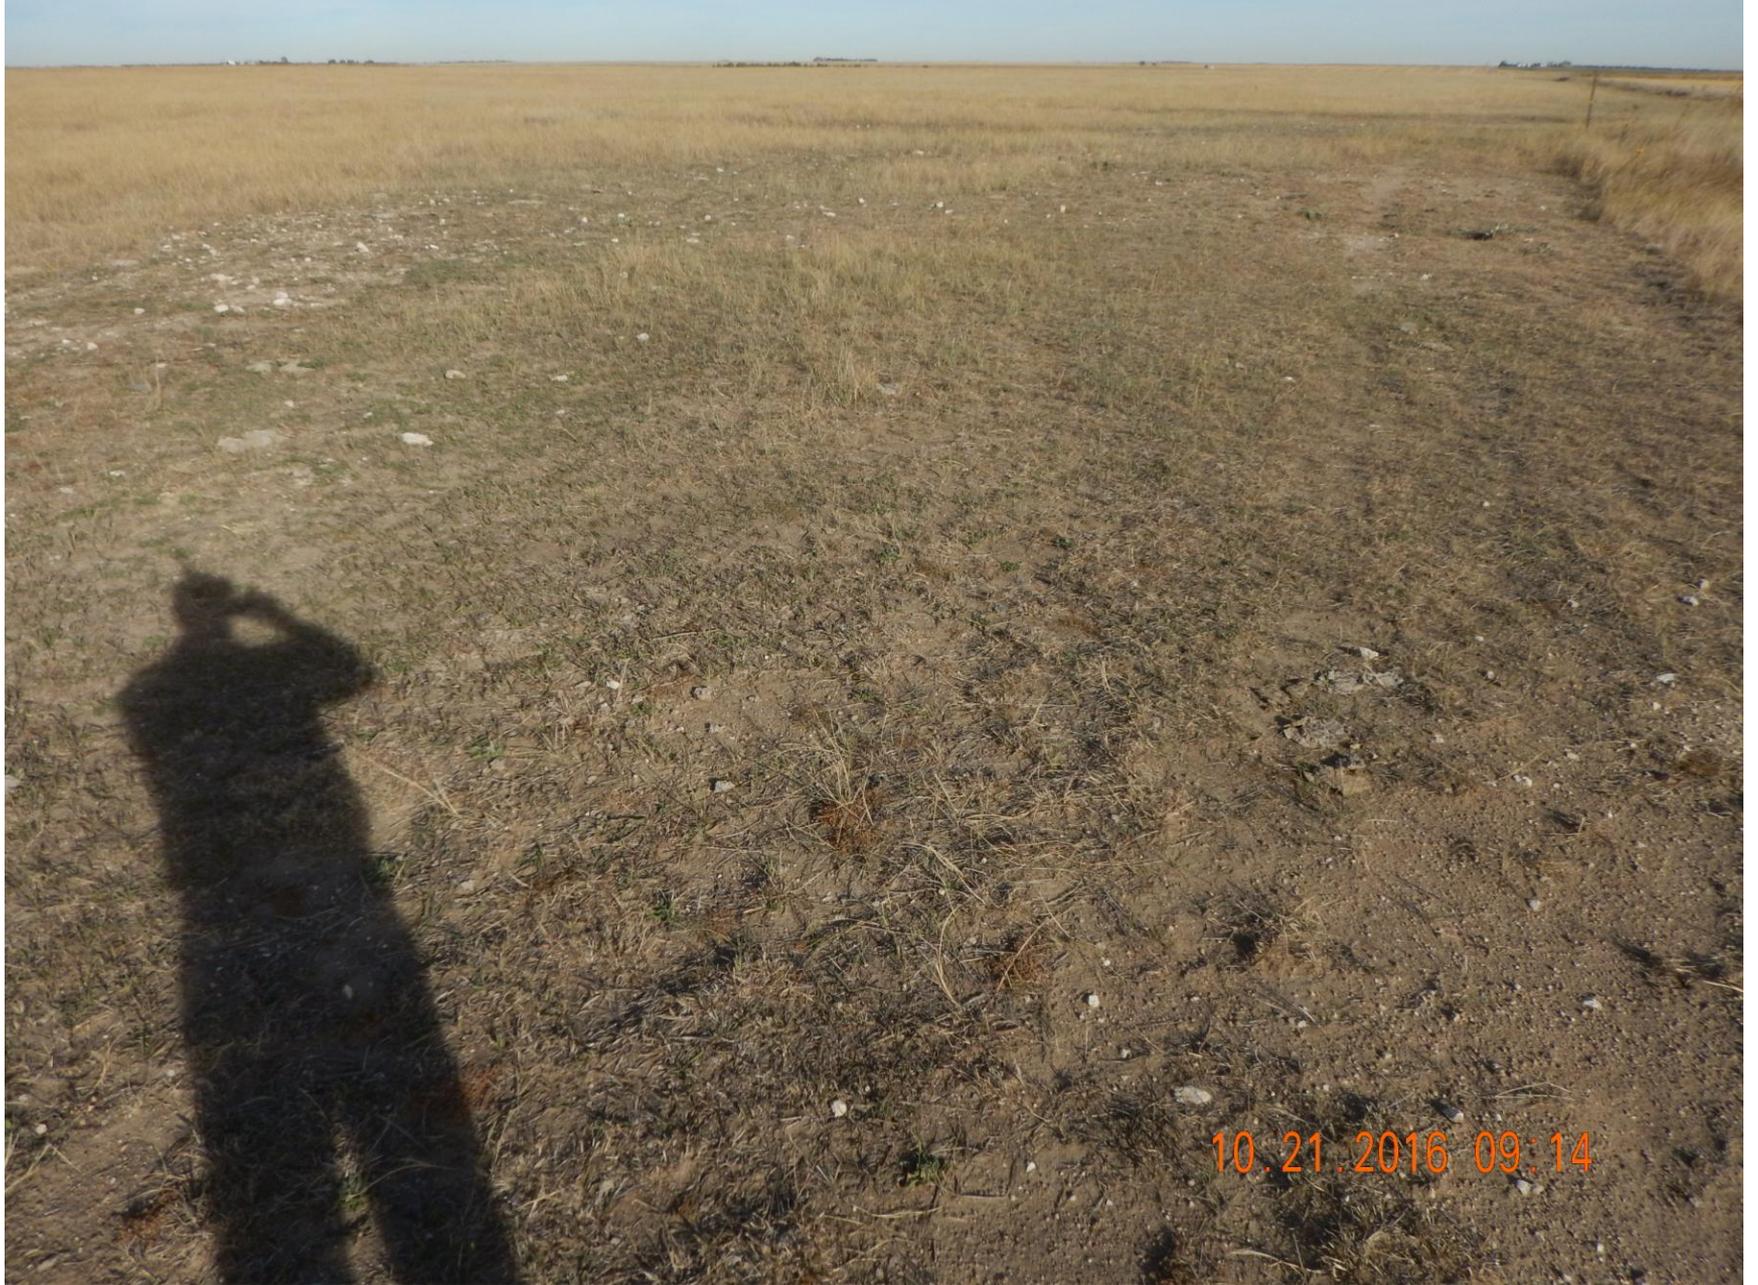
**Figure 4:** Photo taken from the east end of the pit location, facing north. Photo shows the vegetation over the reclamation area.

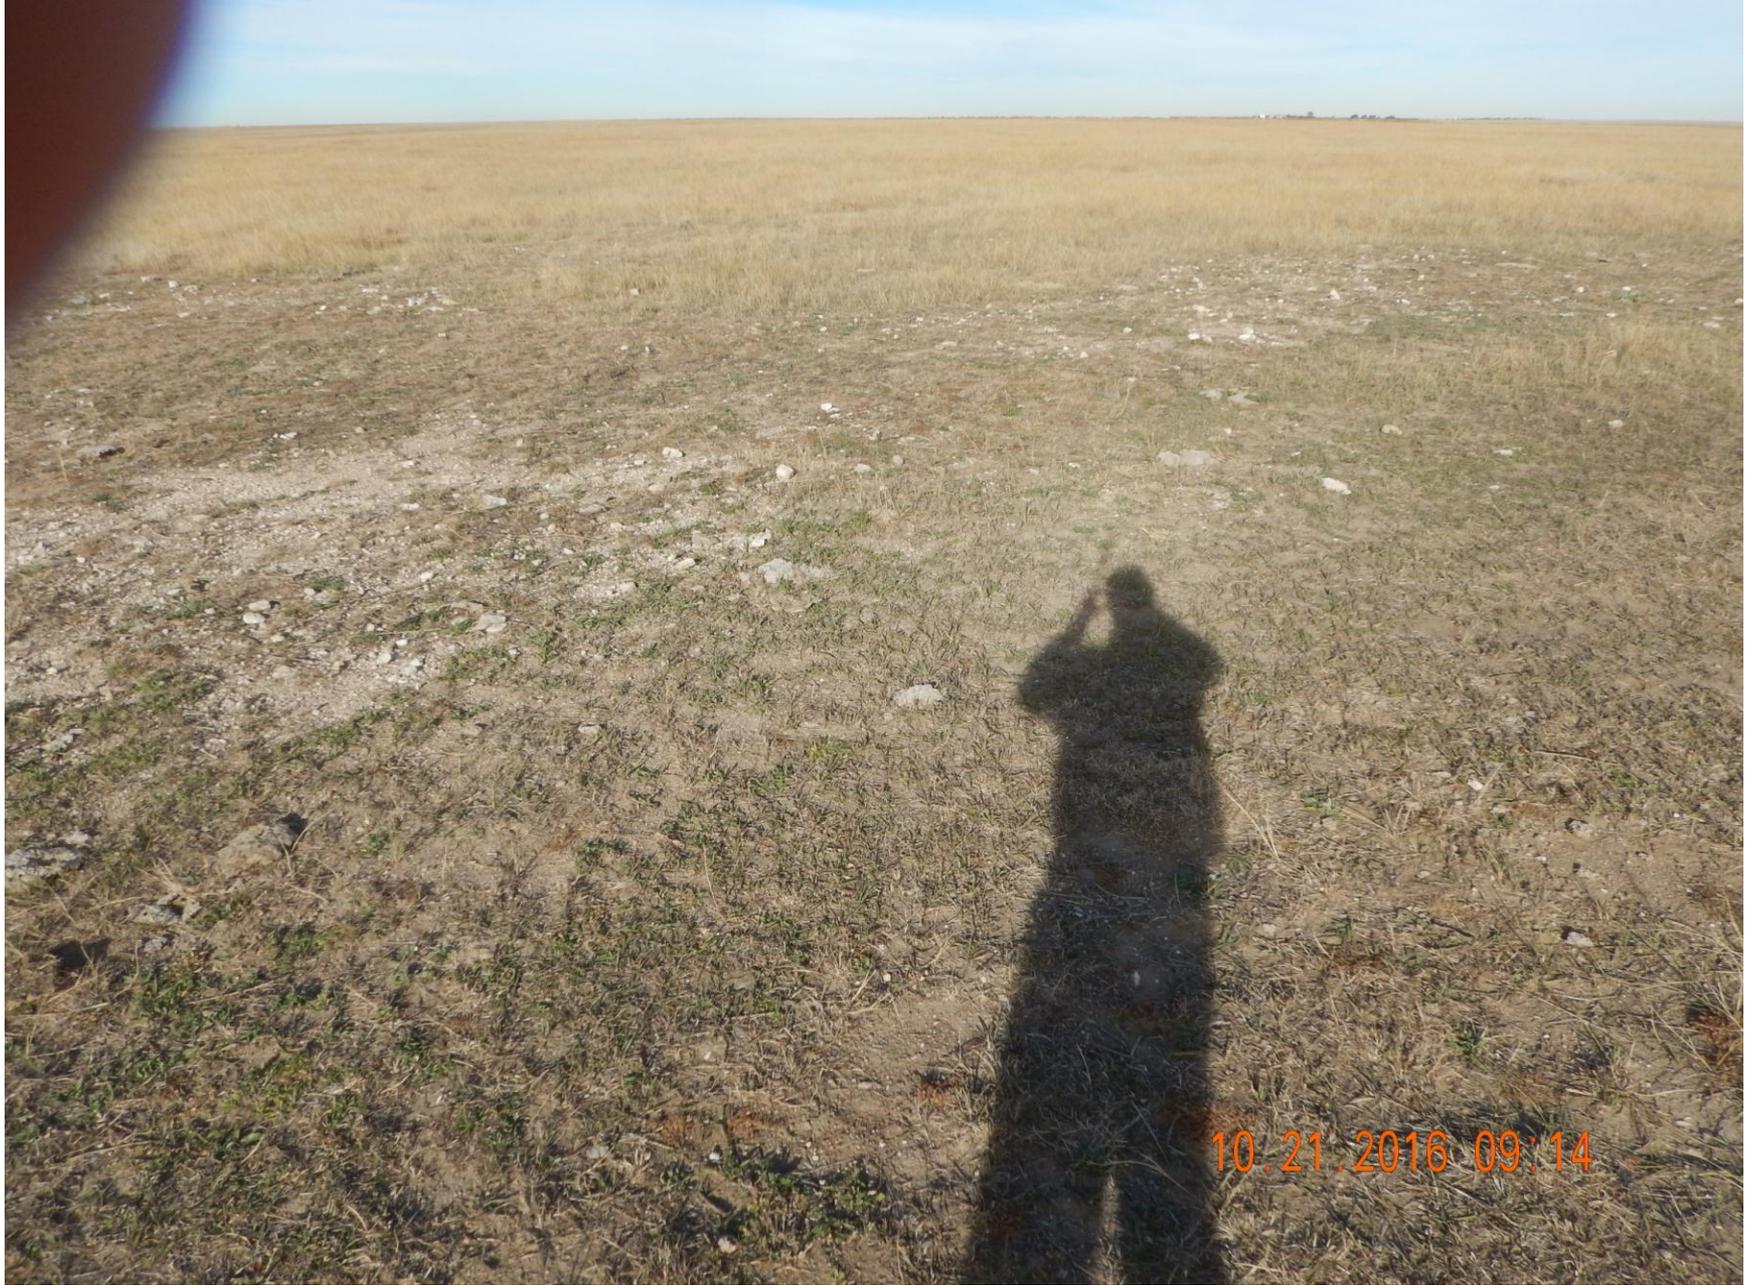
**Figure 5:** Photo taken from the east end of the pit location, facing northwest. Photo shows the vegetation over the reclamation area.

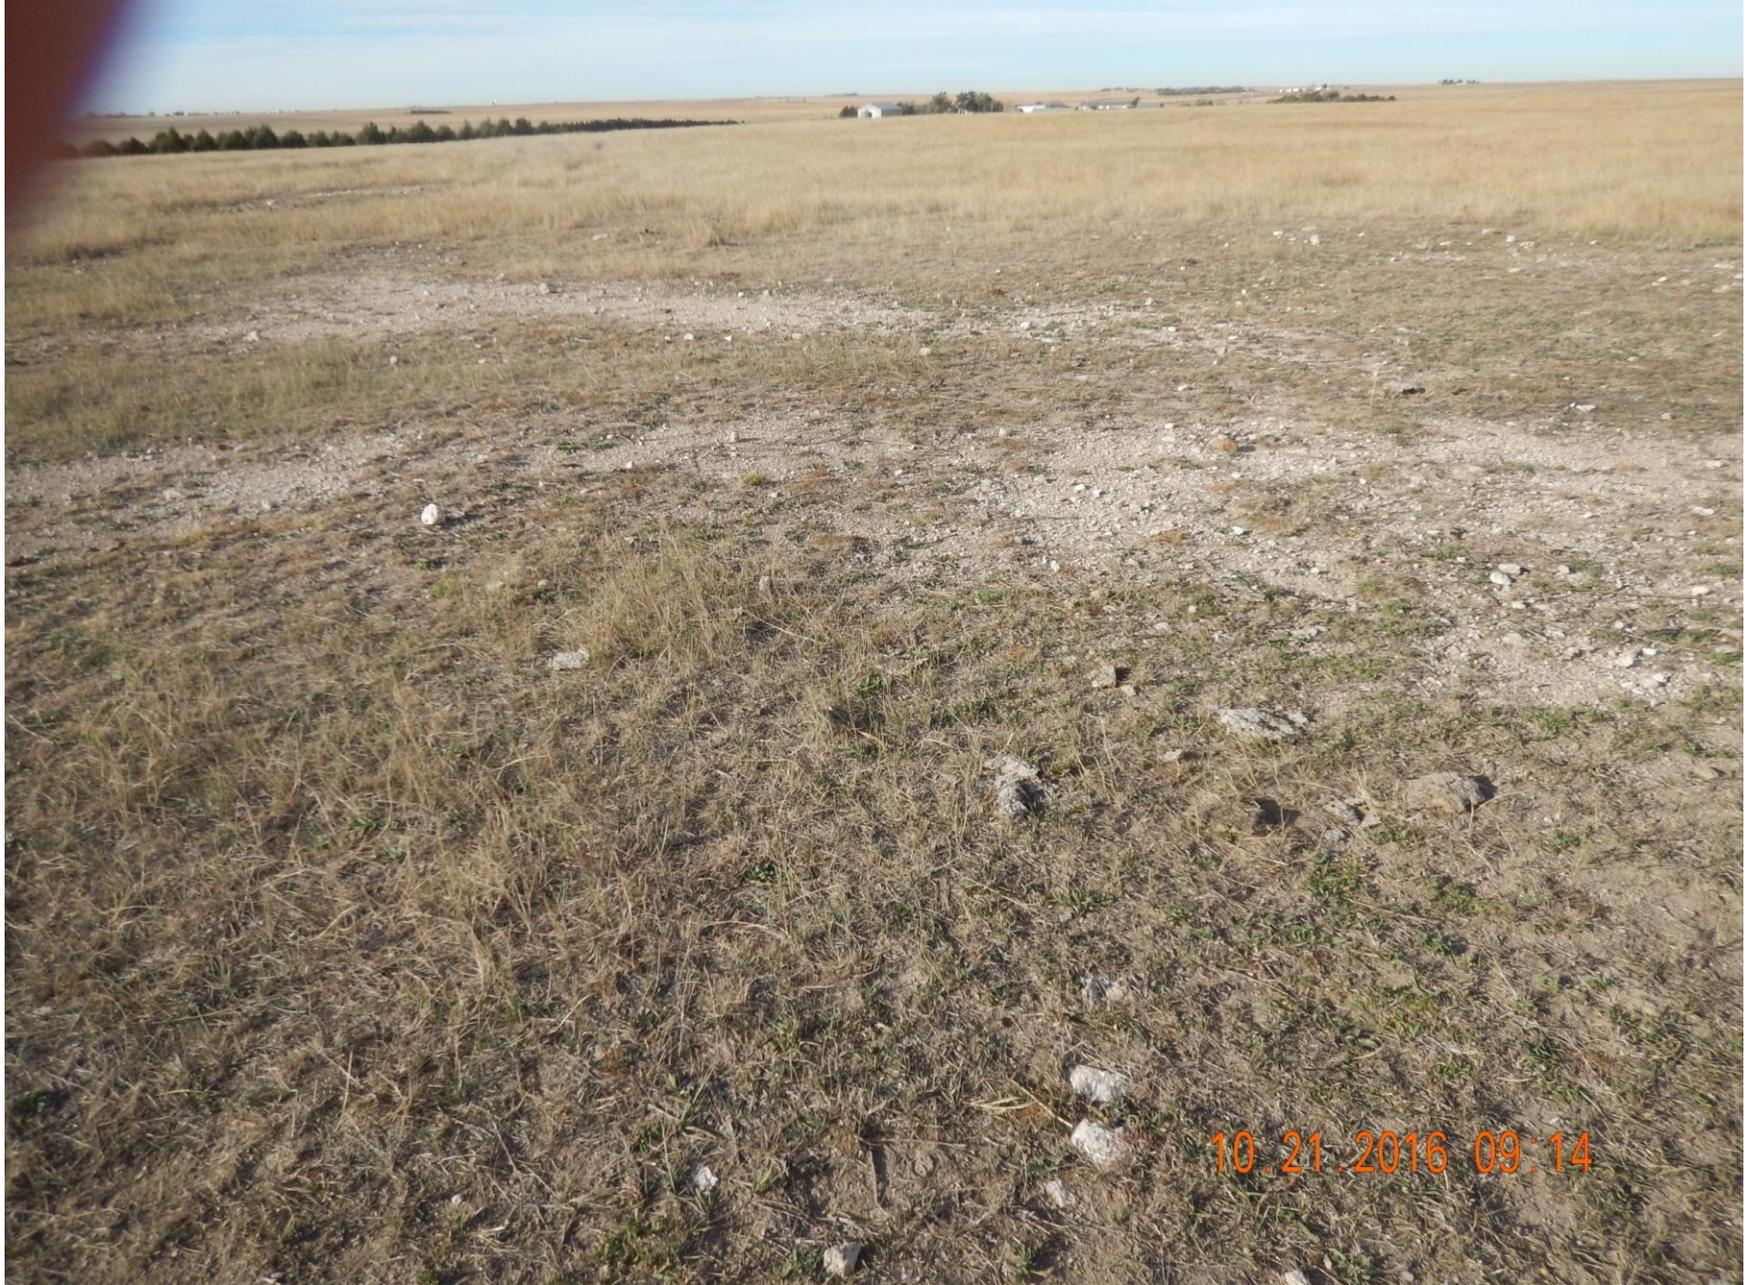
**Figure 6:** Photo taken from the east end of the pit location, facing southwest. Photo shows the vegetation over the reclamation area.

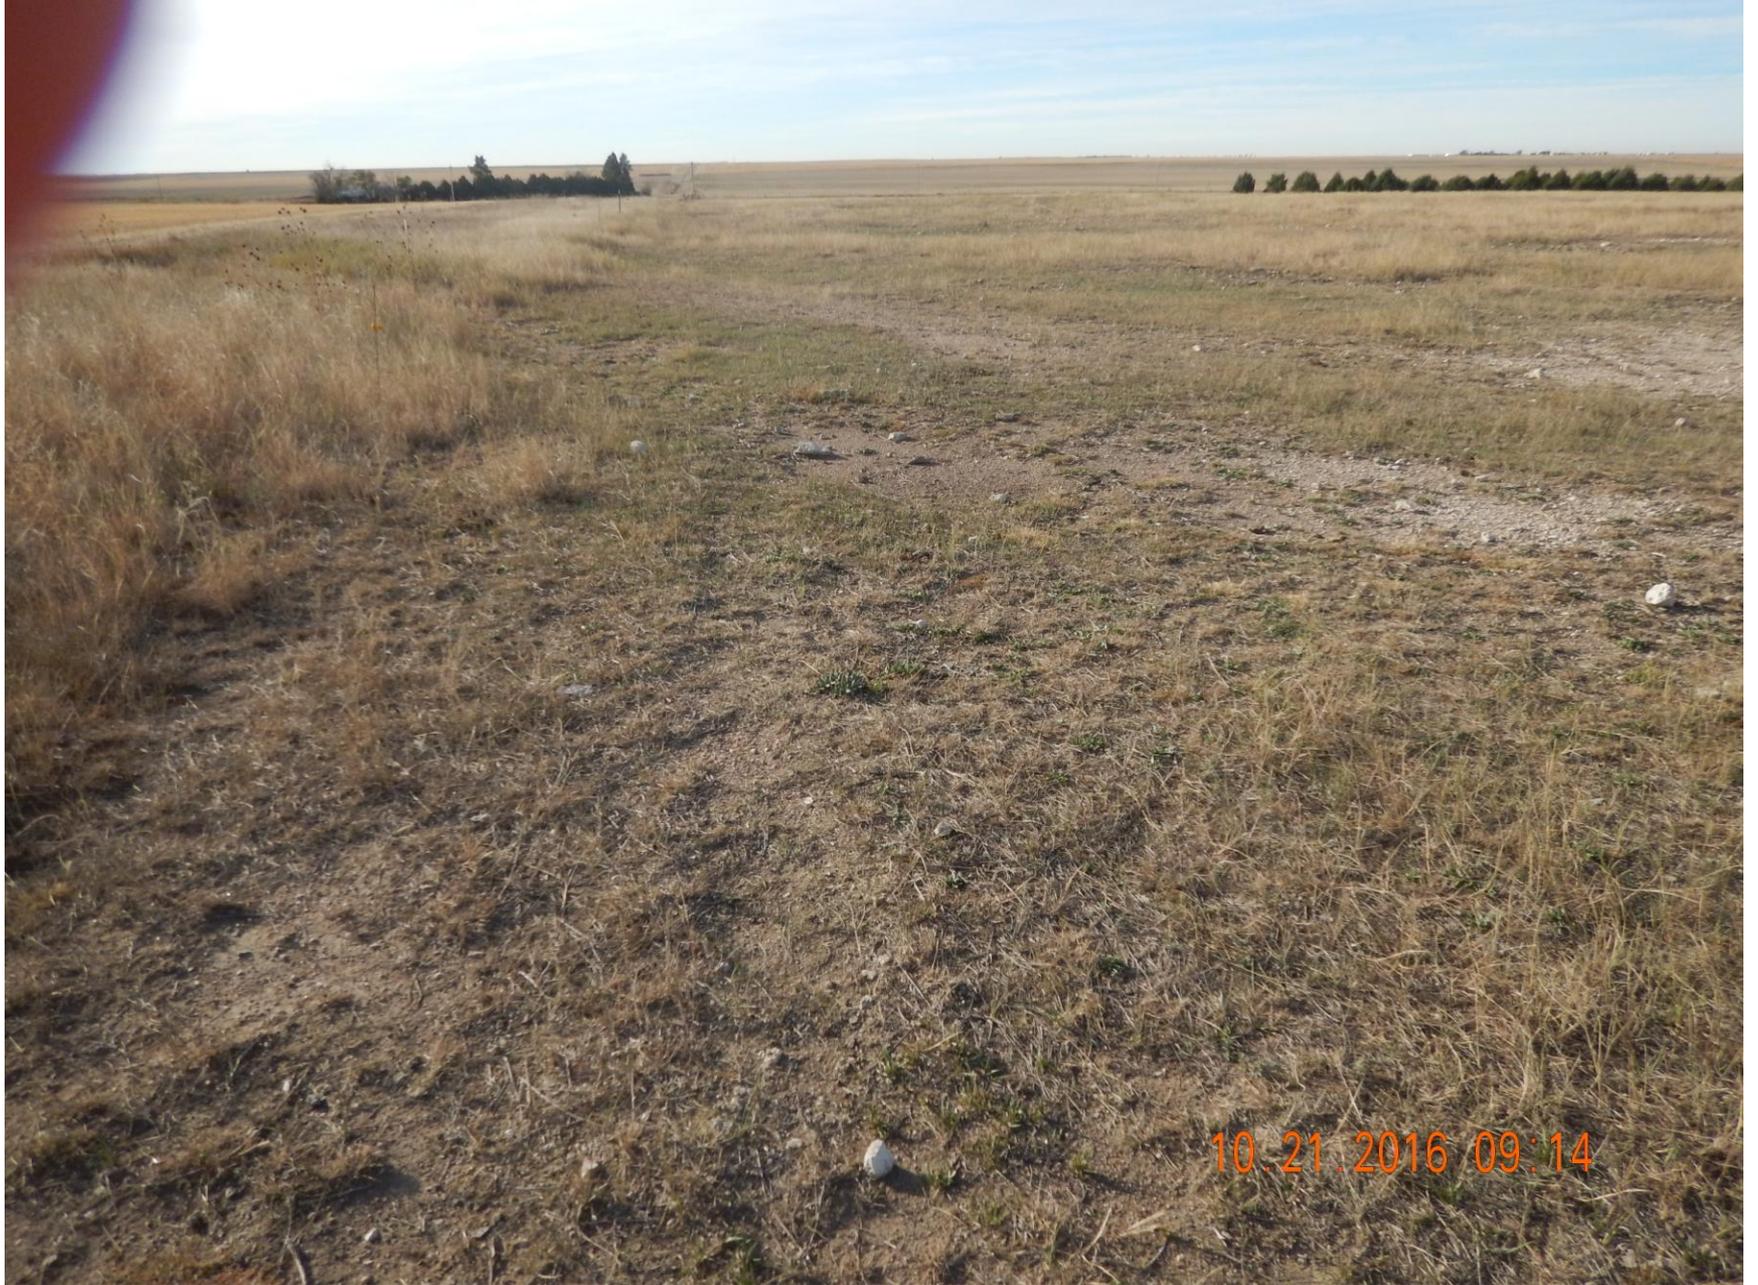
**Figure 7:** Photo taken from the east end of the pit location, facing south. Photo shows the vegetation over the reclamation area.

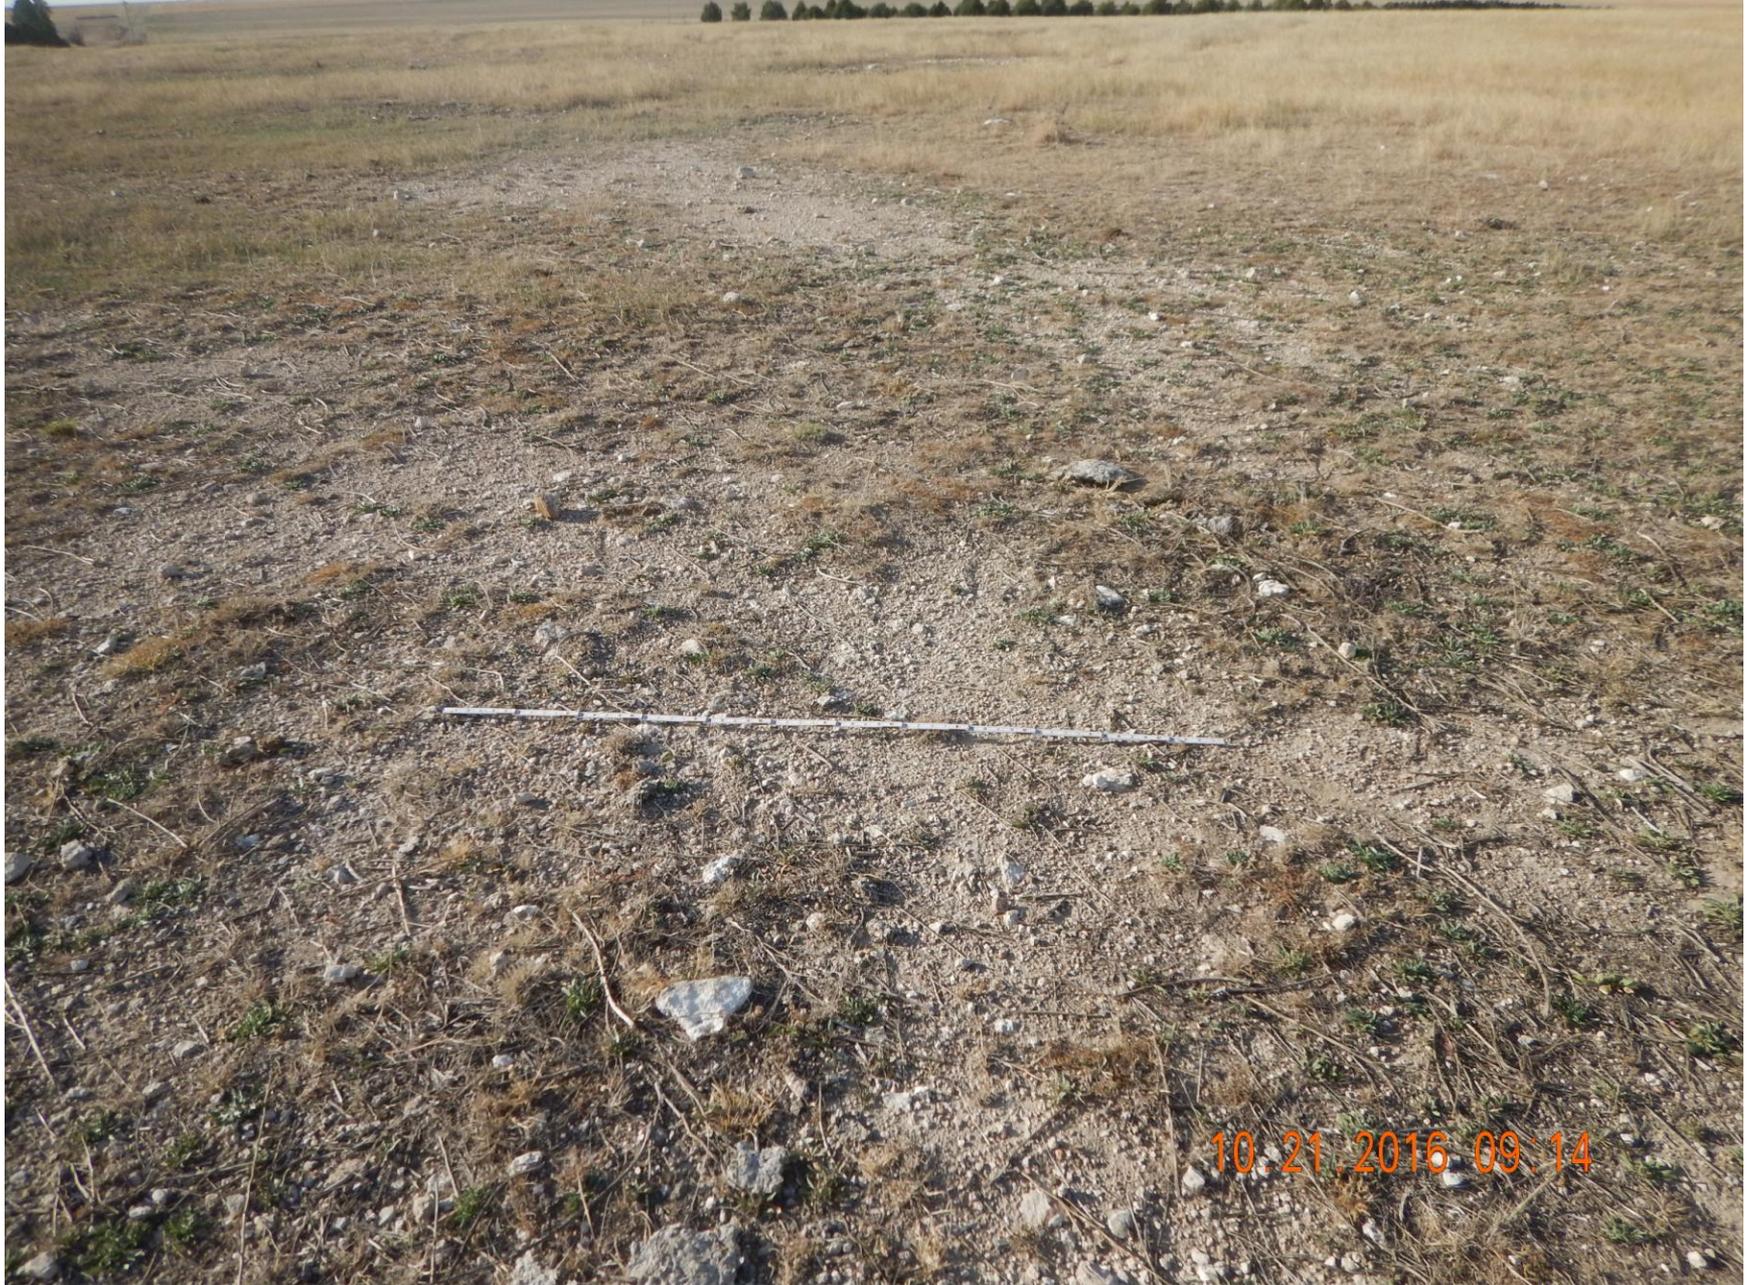
**Figure 8:** Photo taken from the pit location, facing southwest. Photo shows large portions of the reclamation area have not achieved uniform, desirable perennial vegetative cover.

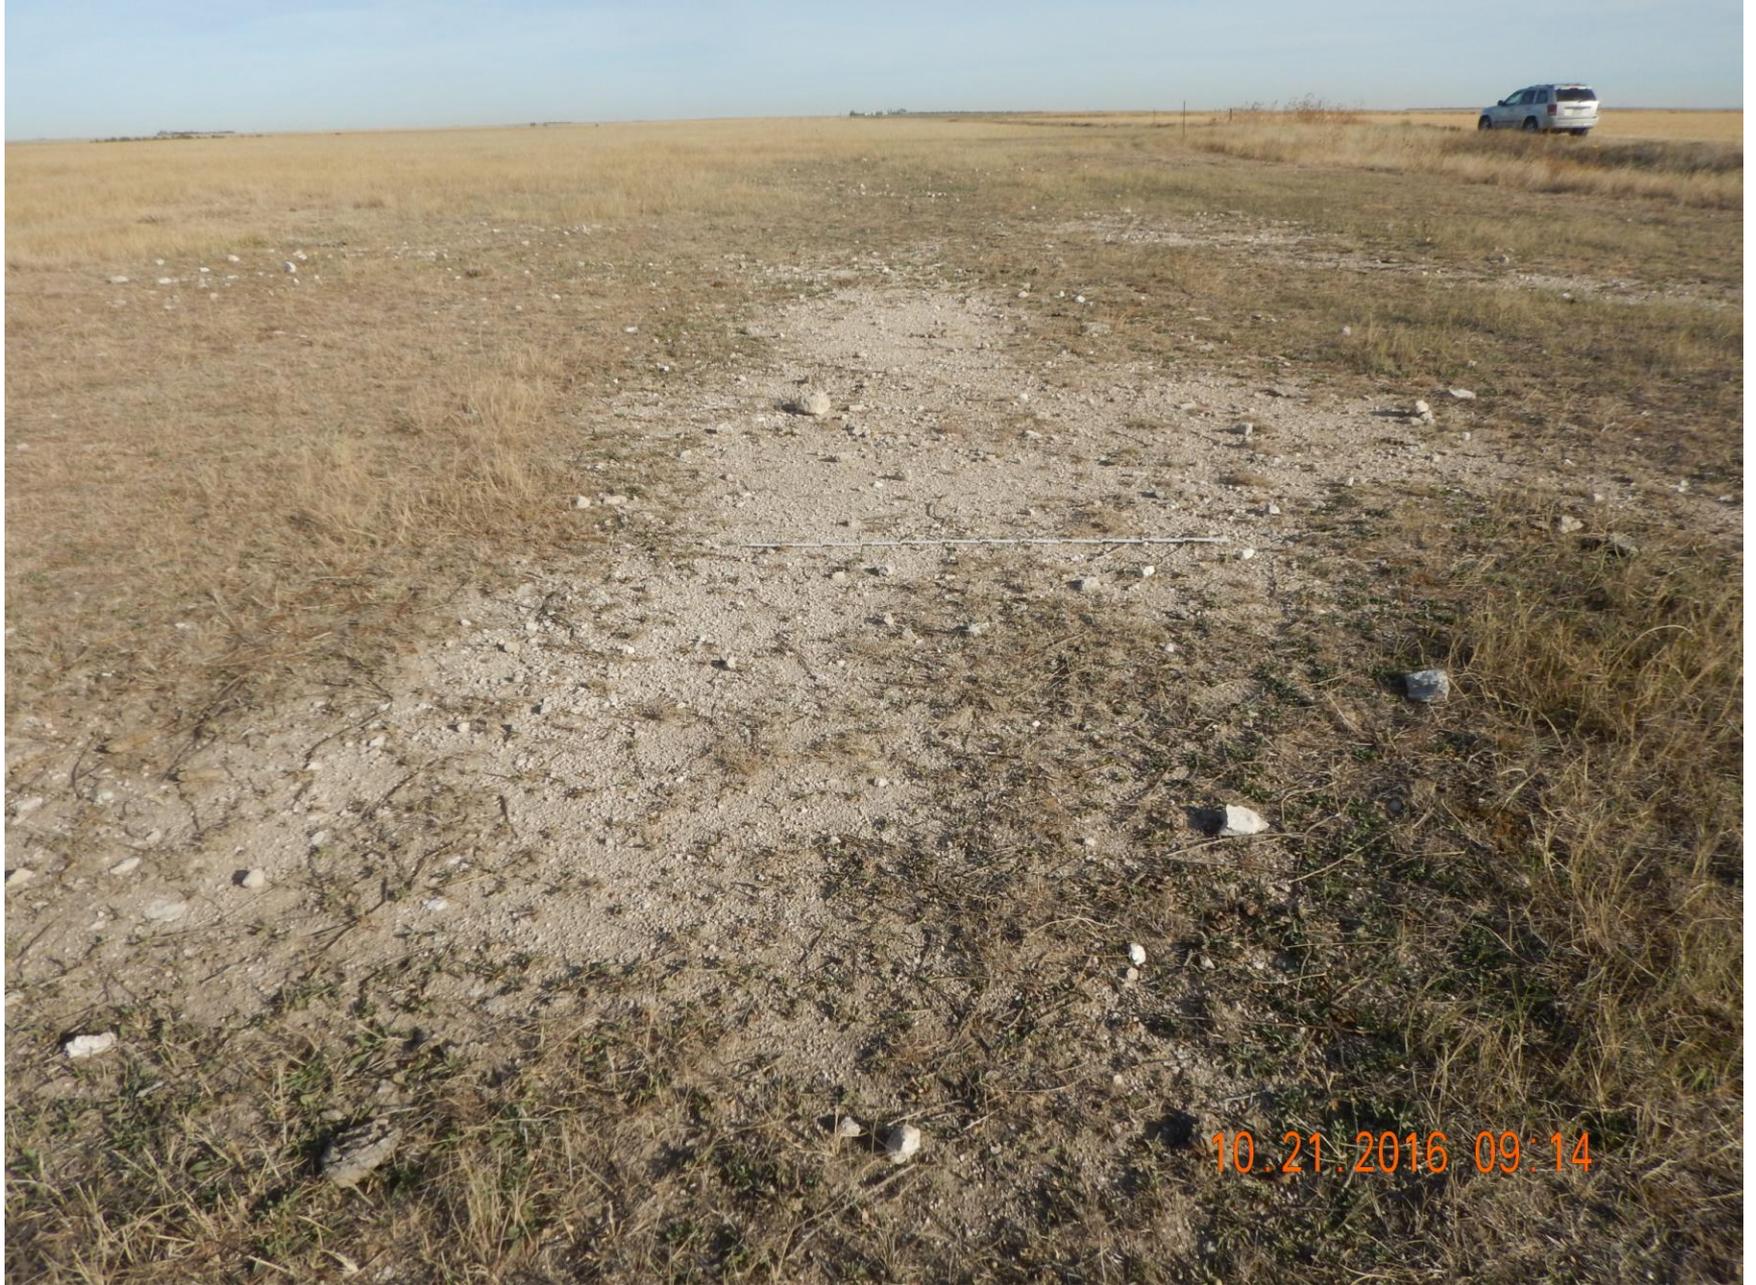
**Figure 9:** Photo taken from the south end of the pit location, facing north. Photo shows large portions of the reclamation area have not achieved uniform, desirable perennial vegetative cover.

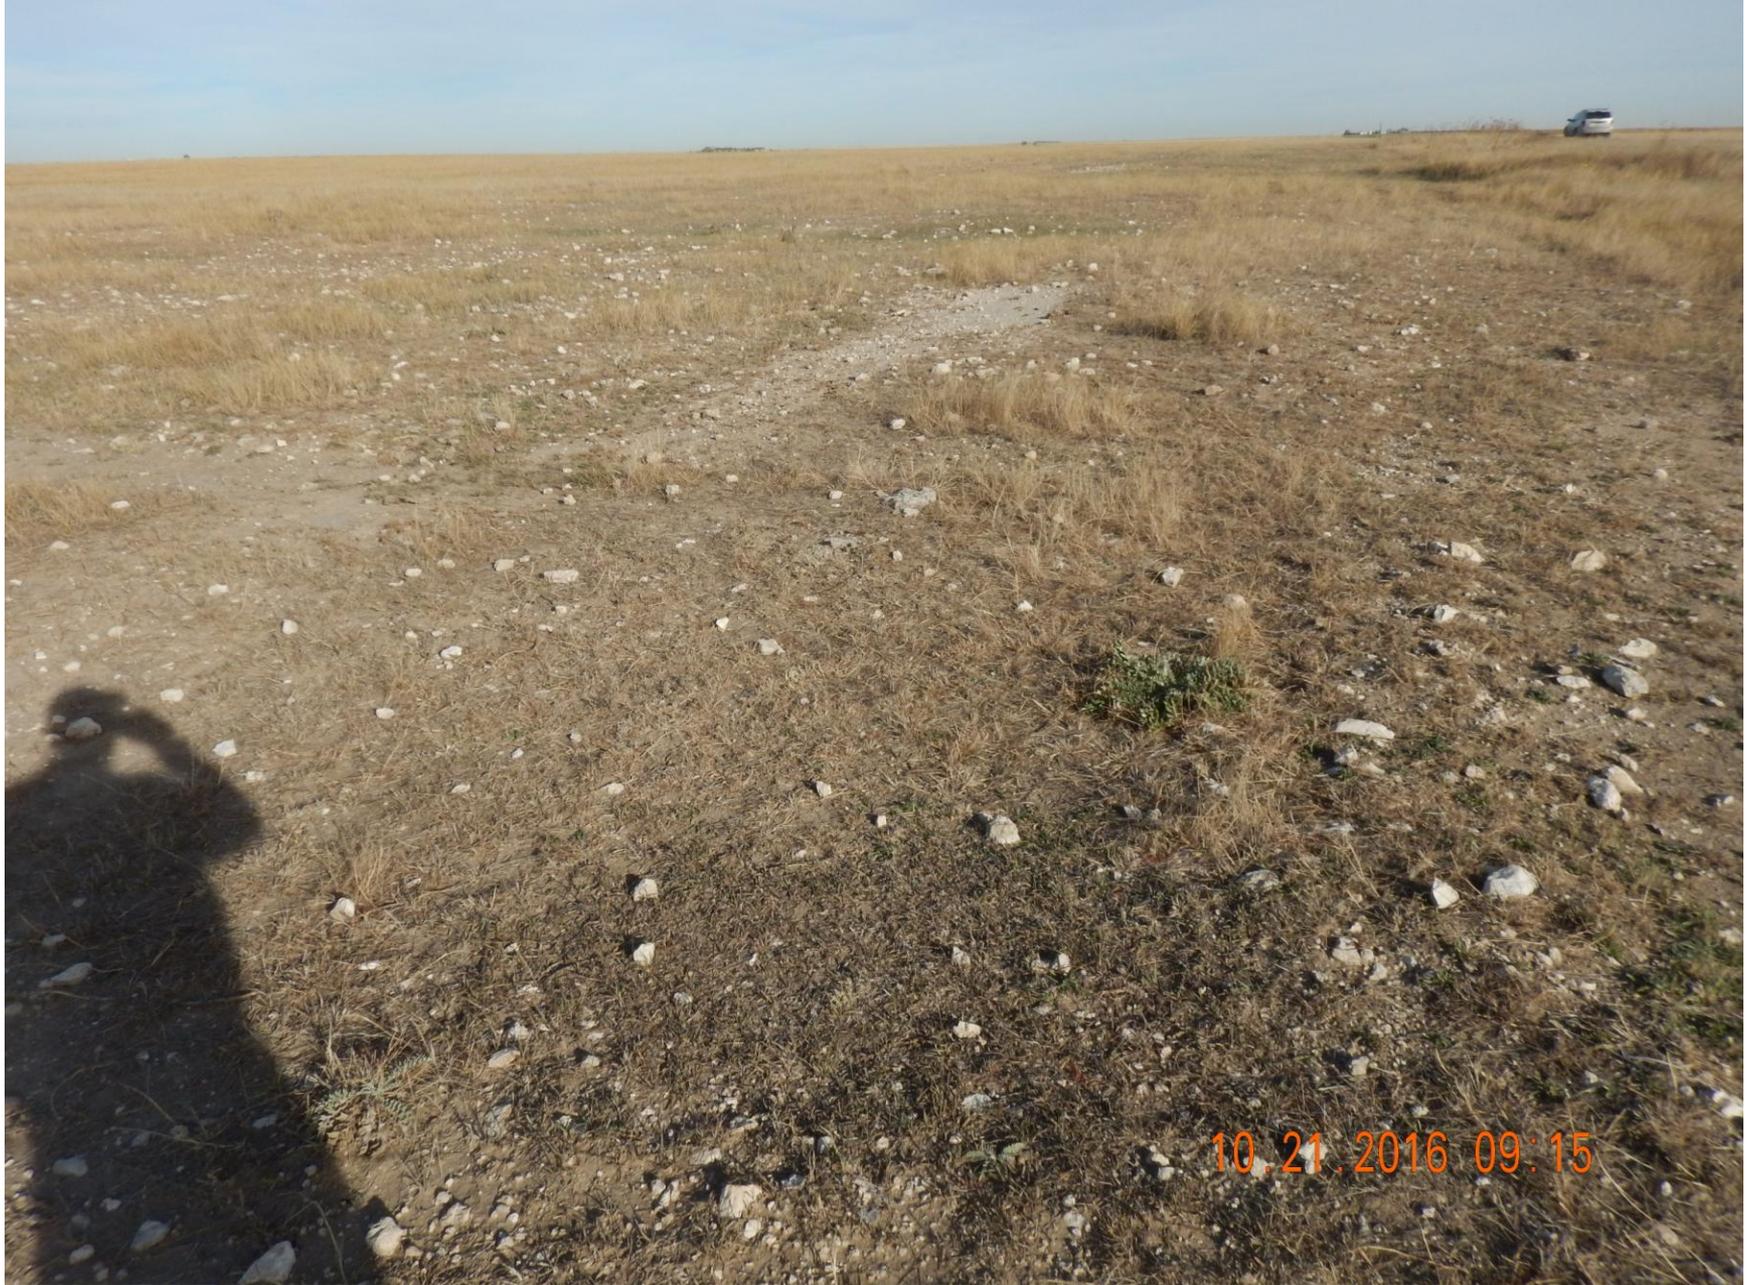
**Figure 10:** Photo taken from the south end of the pit location, facing north. Photo shows large portions of the reclamation area have not achieved uniform, desirable perennial vegetative cover.
