# Reclamation Inspection

10/21/2016

Operator: Magpie Operating

Location ID: 401718

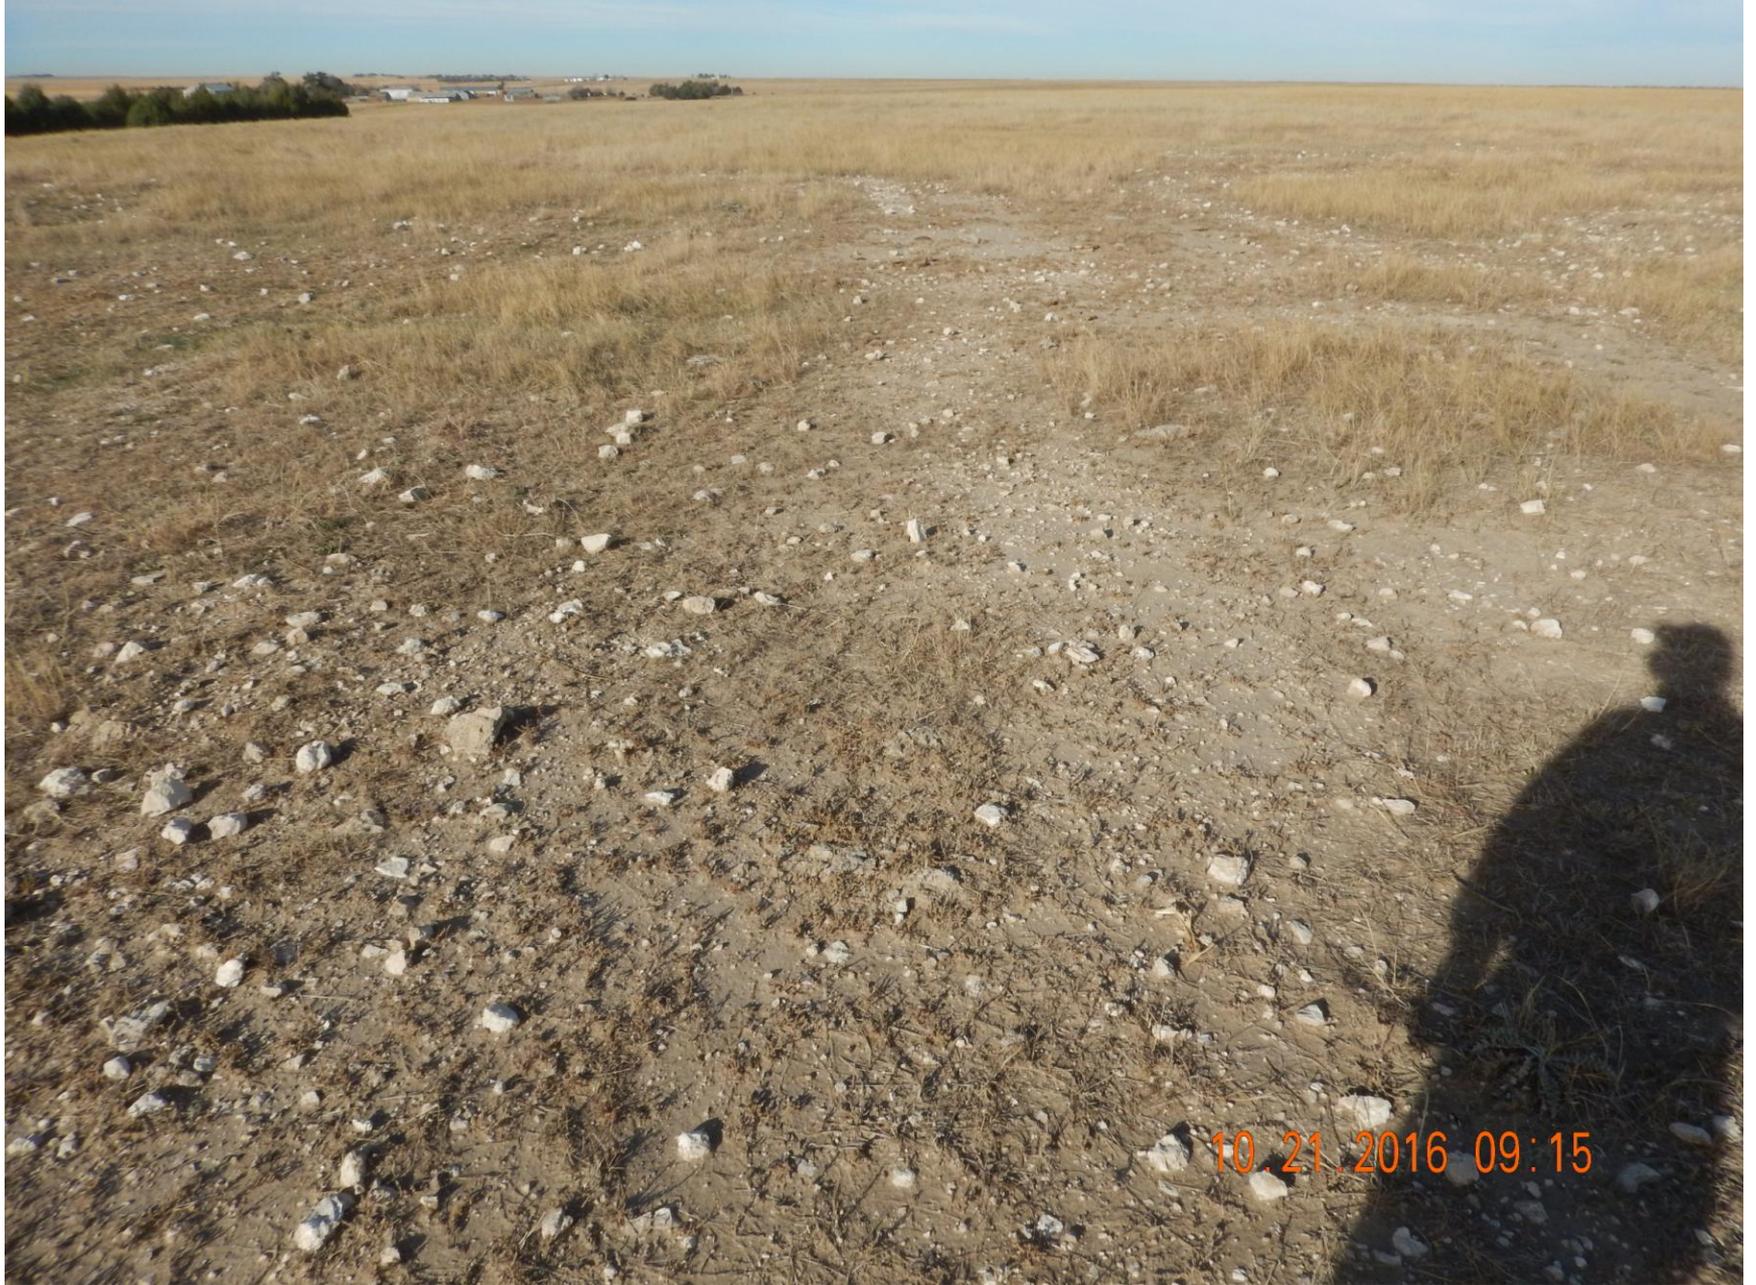
**Figure 11:** Photo taken from the southeast end of the pit location, facing west. Photo shows large portions of the reclamation area have not achieved uniform, desirable perennial vegetative cover.

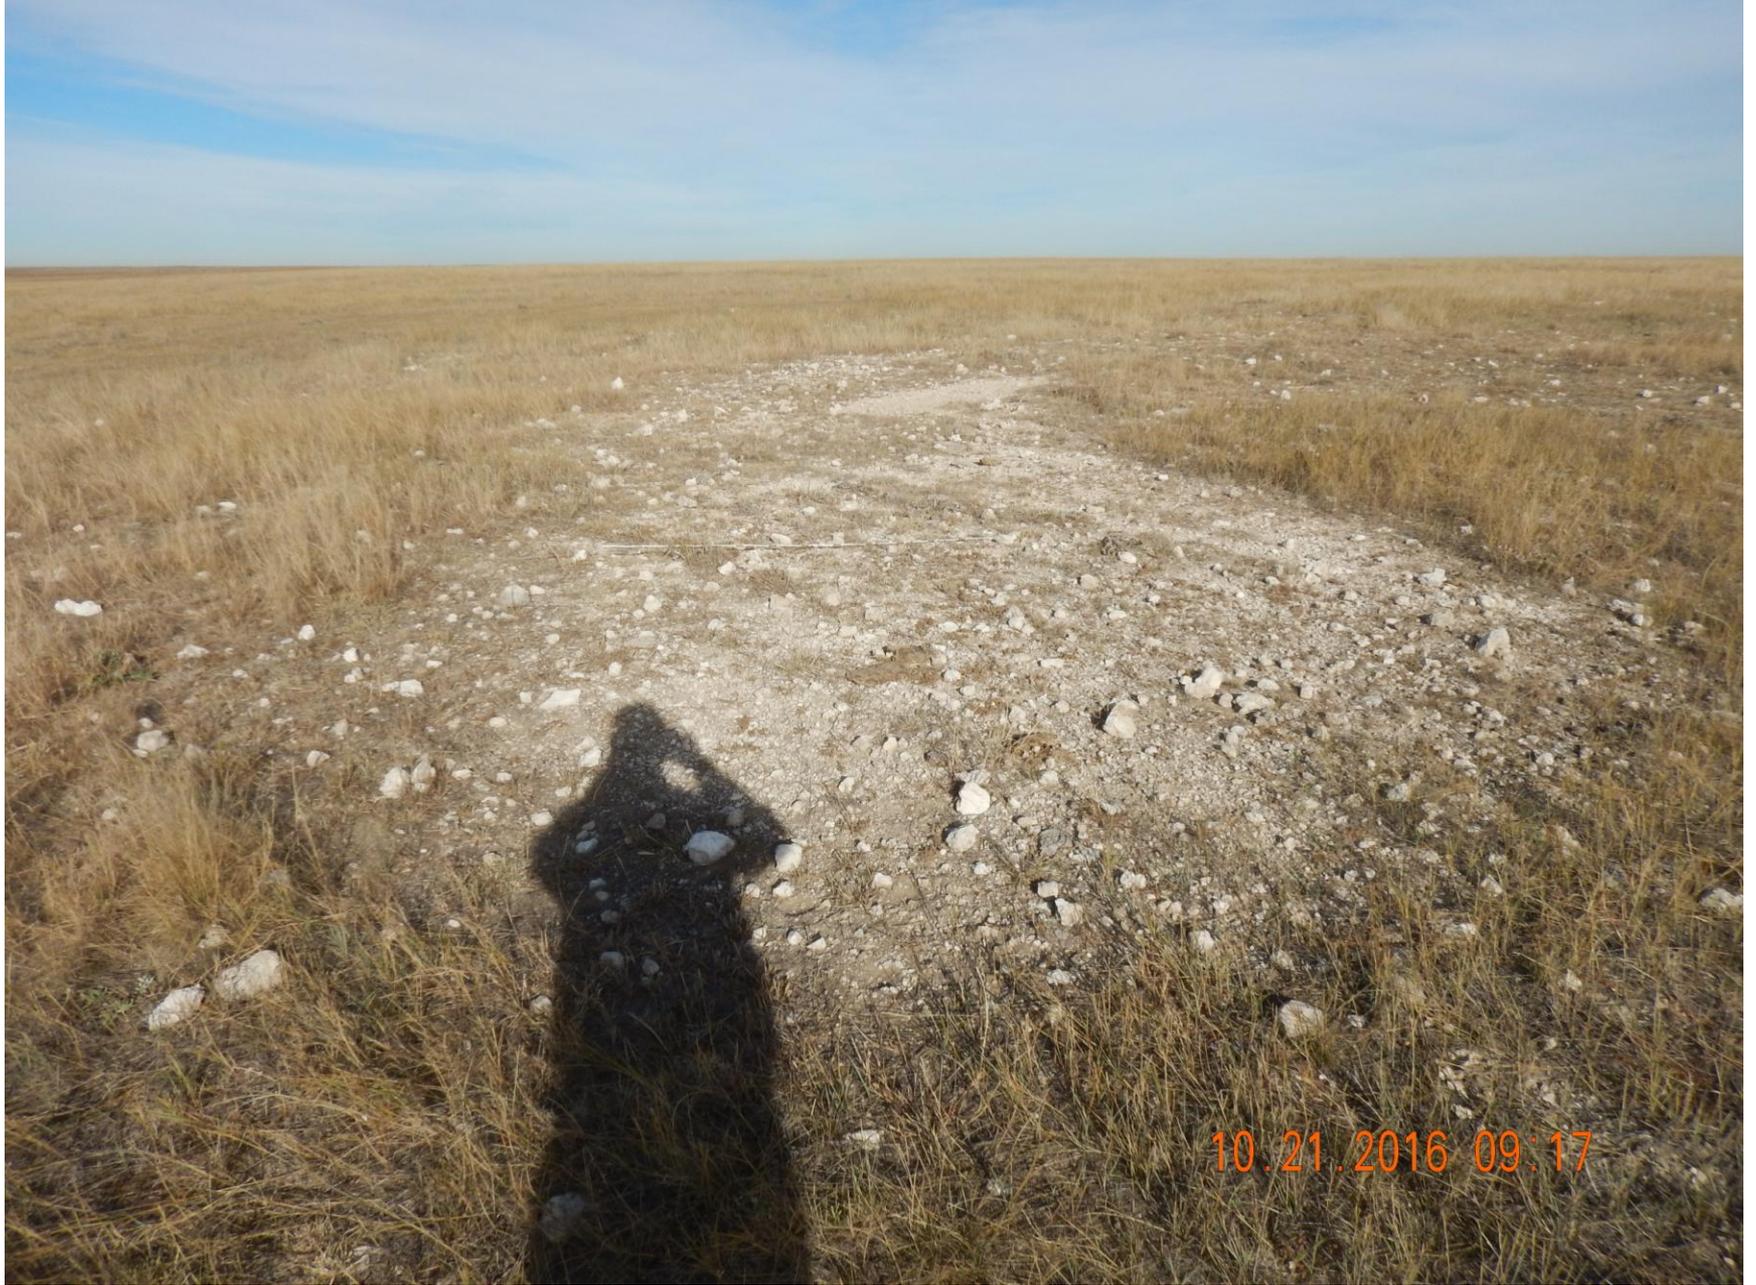
**Figure 12:** Photo taken from the southwest end of the pit location, facing north. Photo shows large portions of the reclamation area have not achieved uniform, desirable perennial vegetative cover.

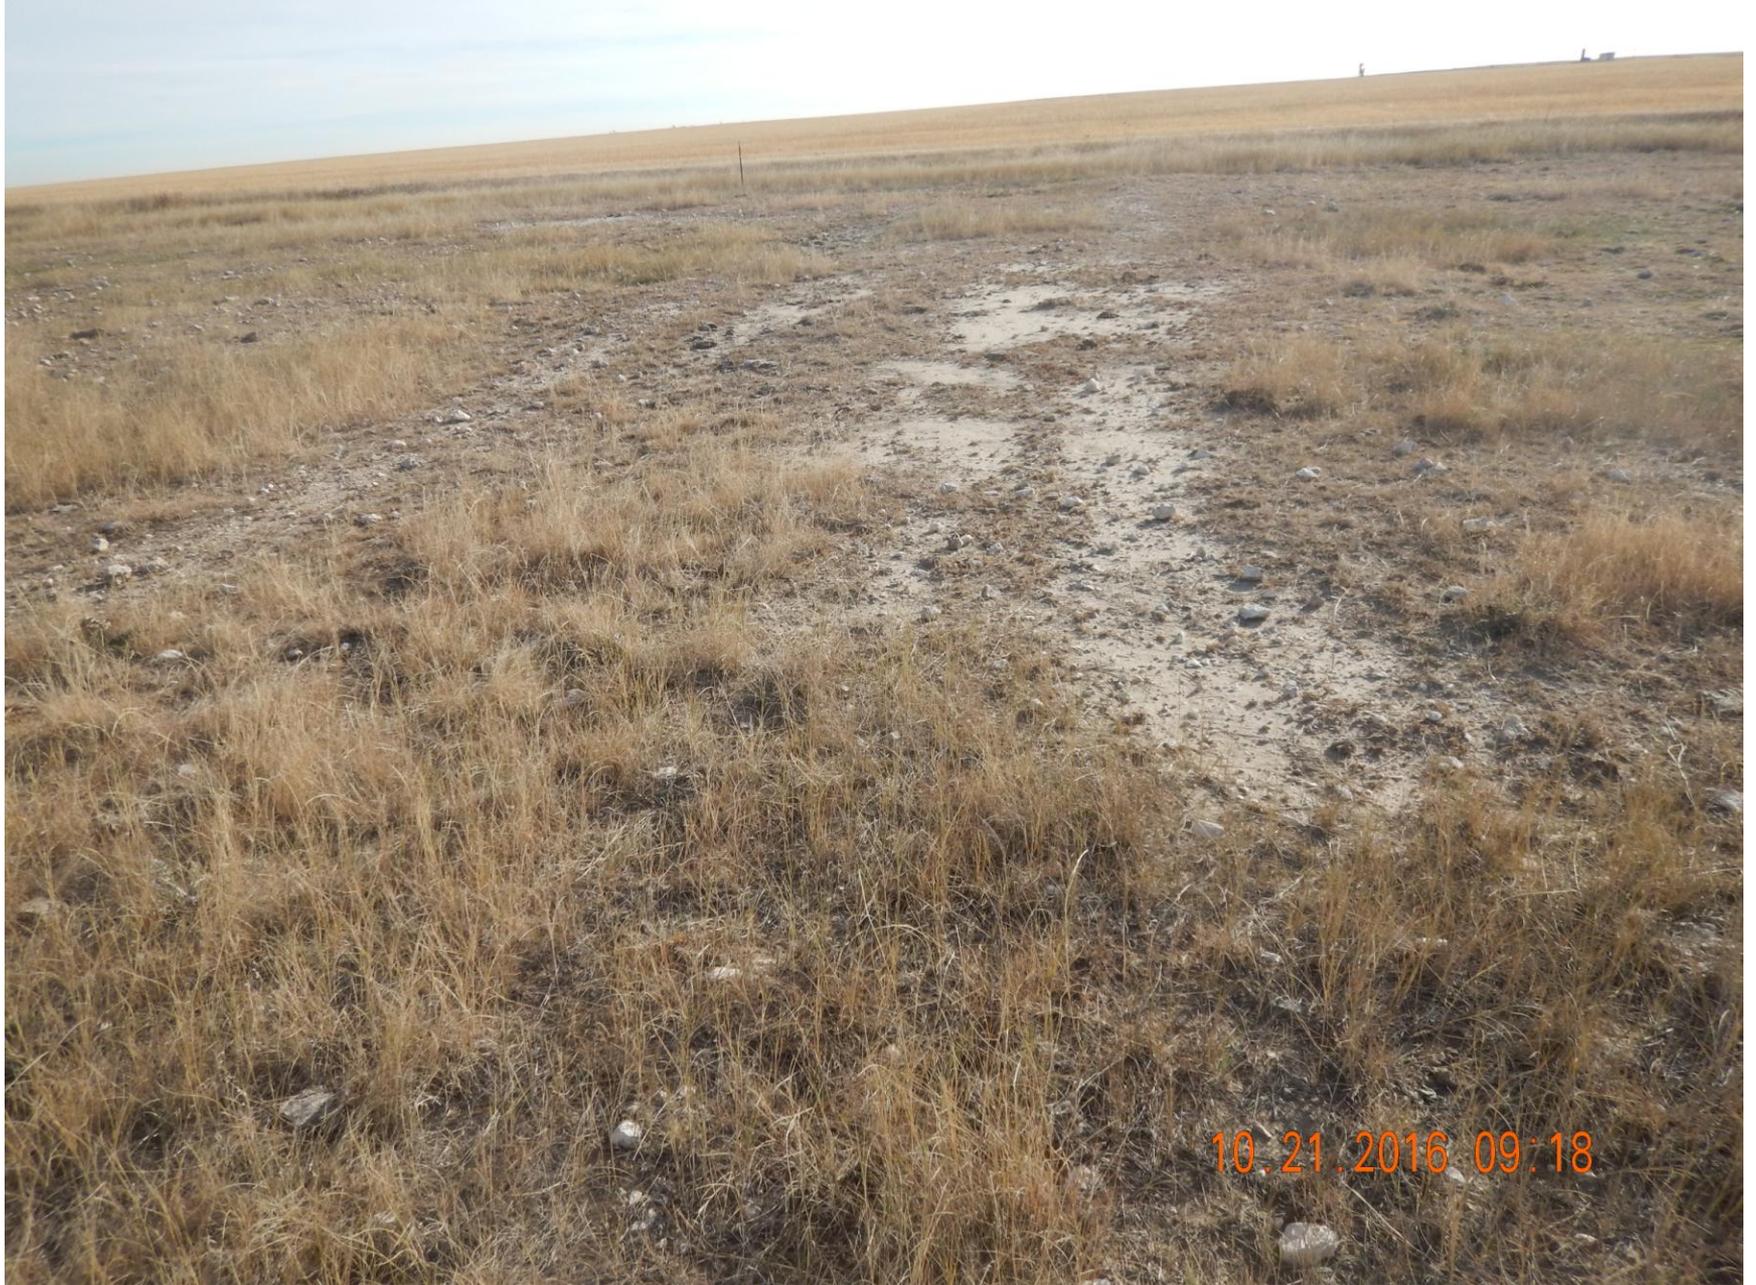
**Figure 13:** Photo taken from the west end of the pit location, facing east. Photo shows large portions of the reclamation area have not achieved uniform, desirable perennial vegetative cover.

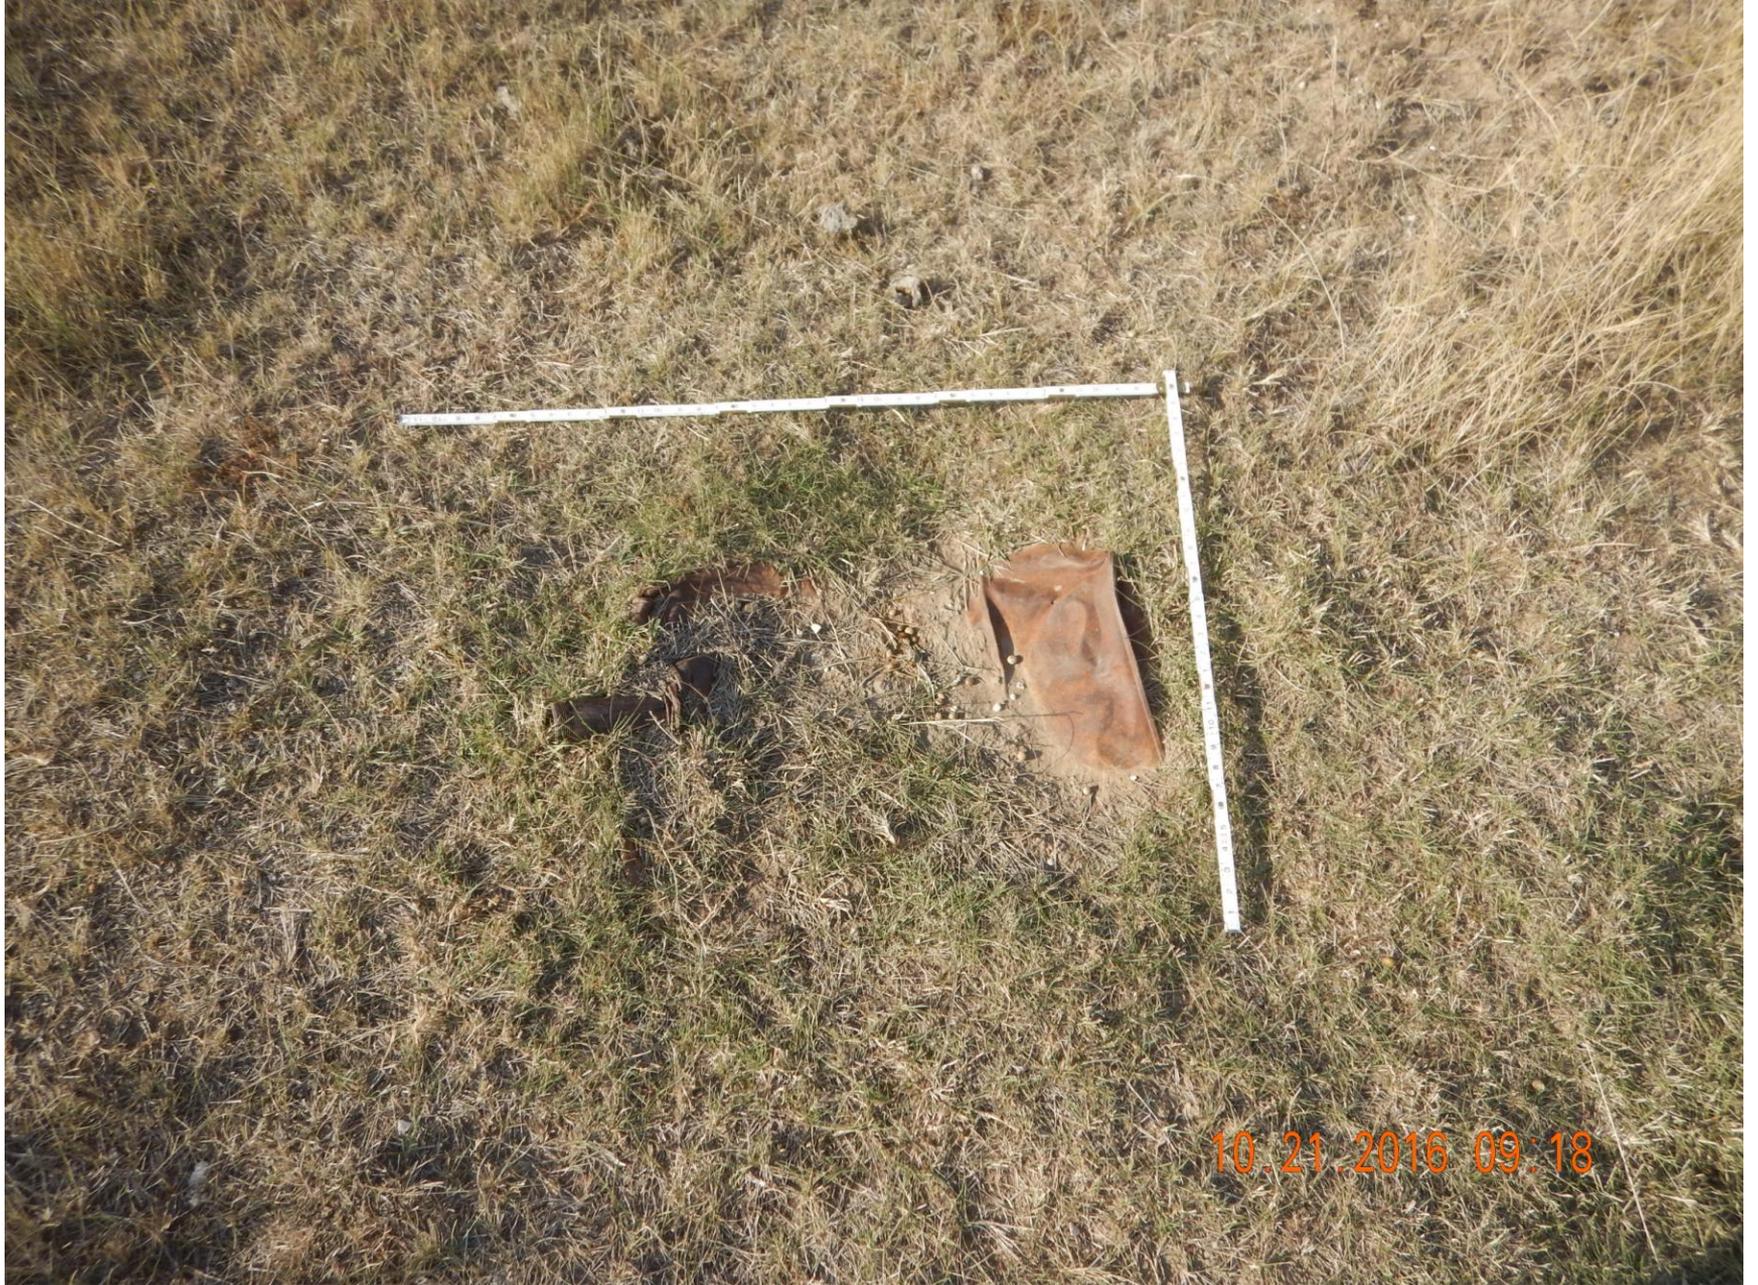
**Figure 14:** Photo taken from the west end of the pit location. Photo shows debris still remaining on location. Debris will need to be removed and properly disposed. 3.5'x2.3' measuring stick for reference.

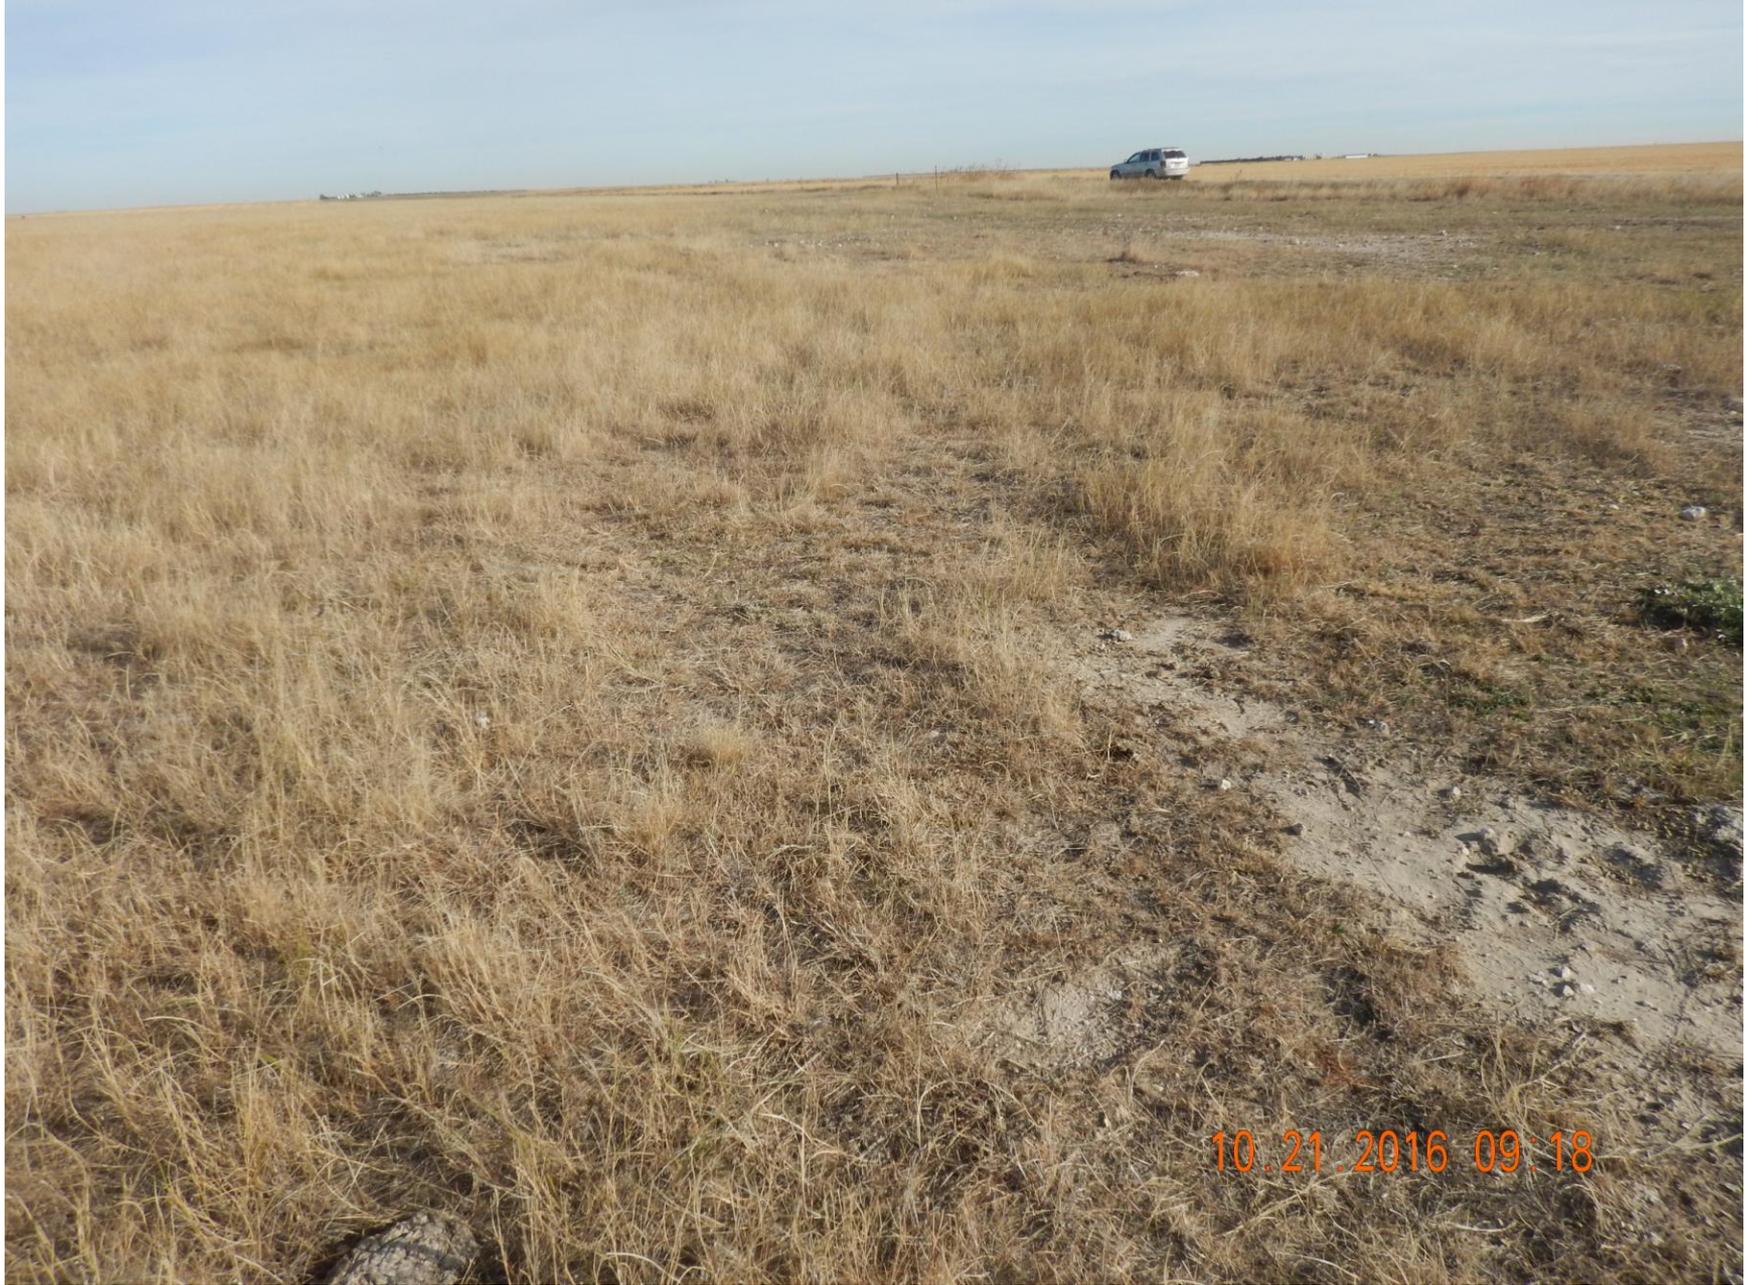
**Figure 15:** Photo taken from the west end of the pit location, facing northeast. Photo shows the vegetation over the reclamation area.

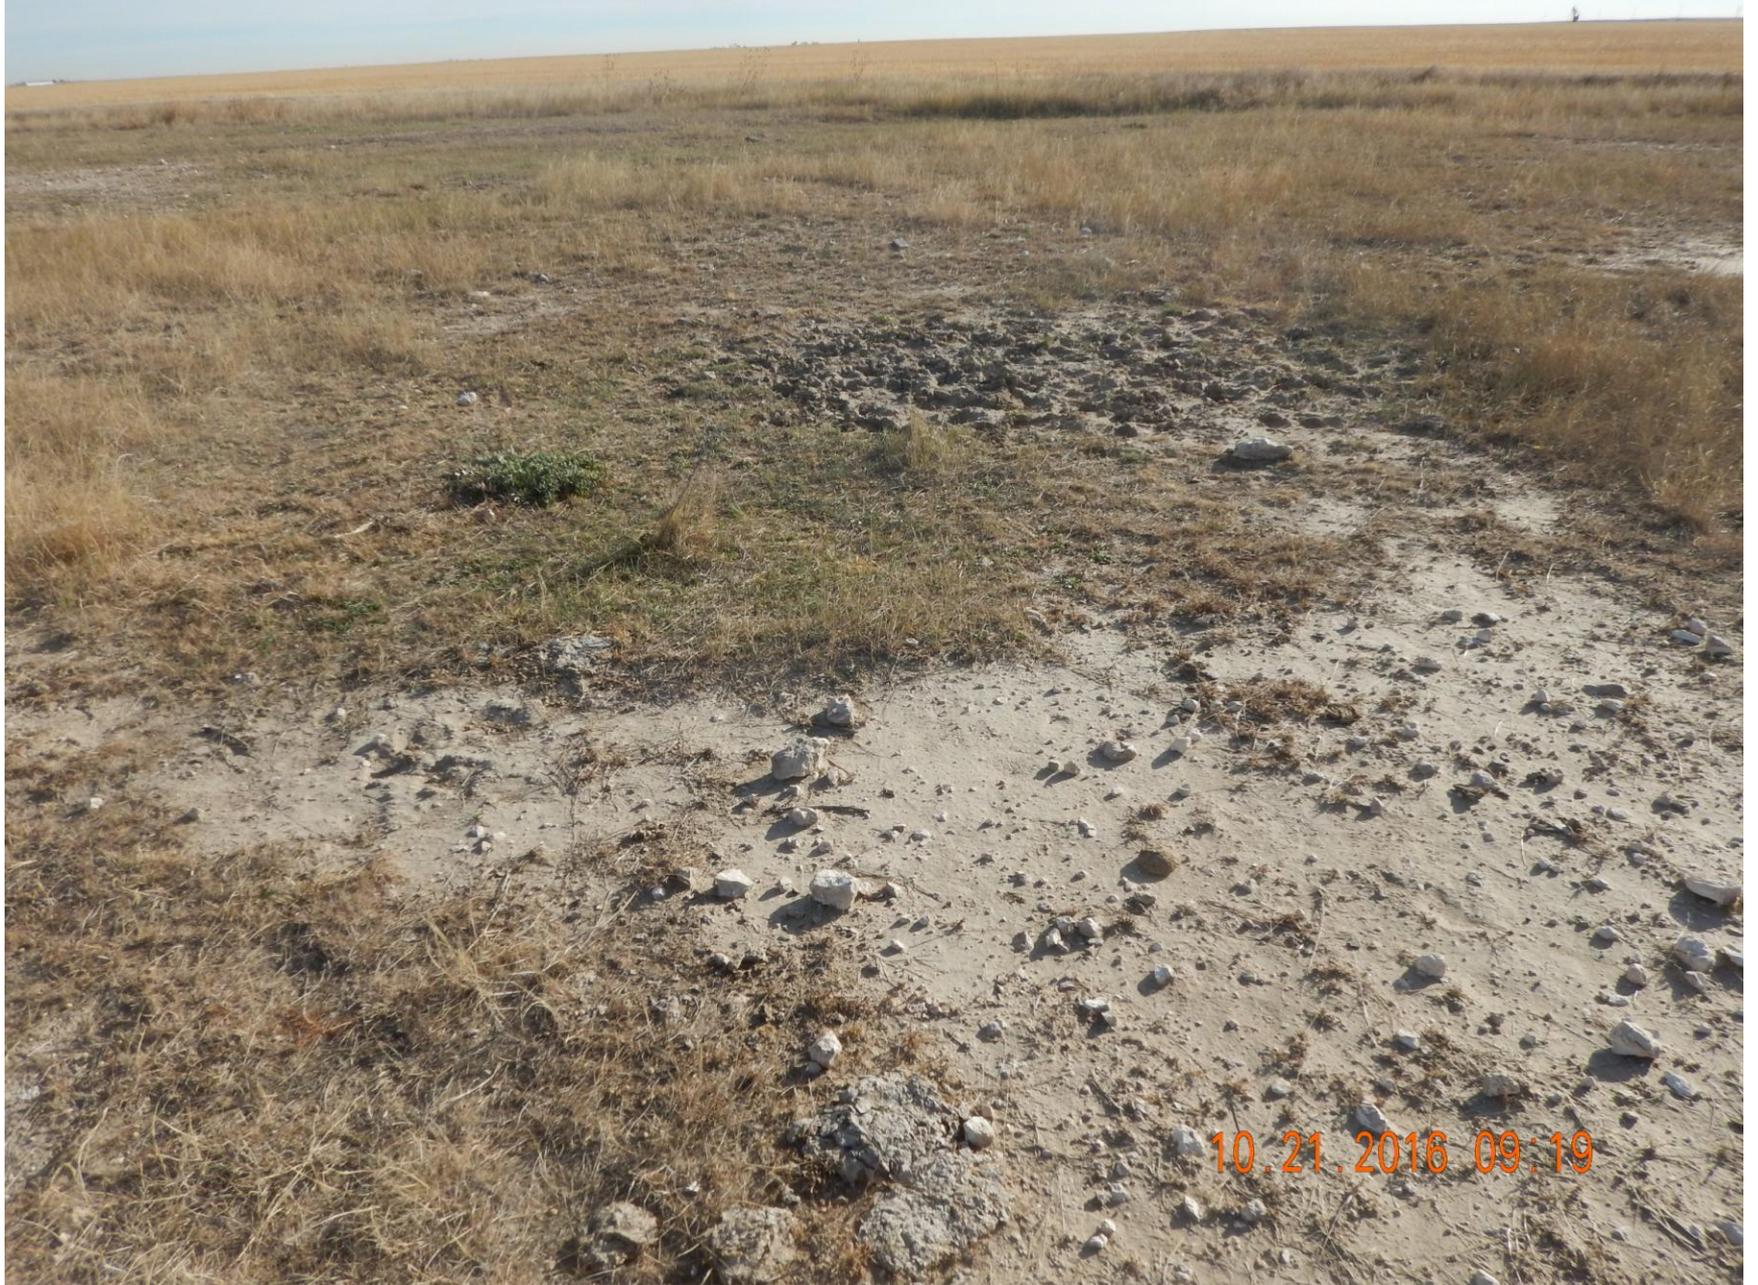
**Figure 16:** Photo taken from the west end of the pit location, facing east. Photo shows the vegetation over the reclamation area.

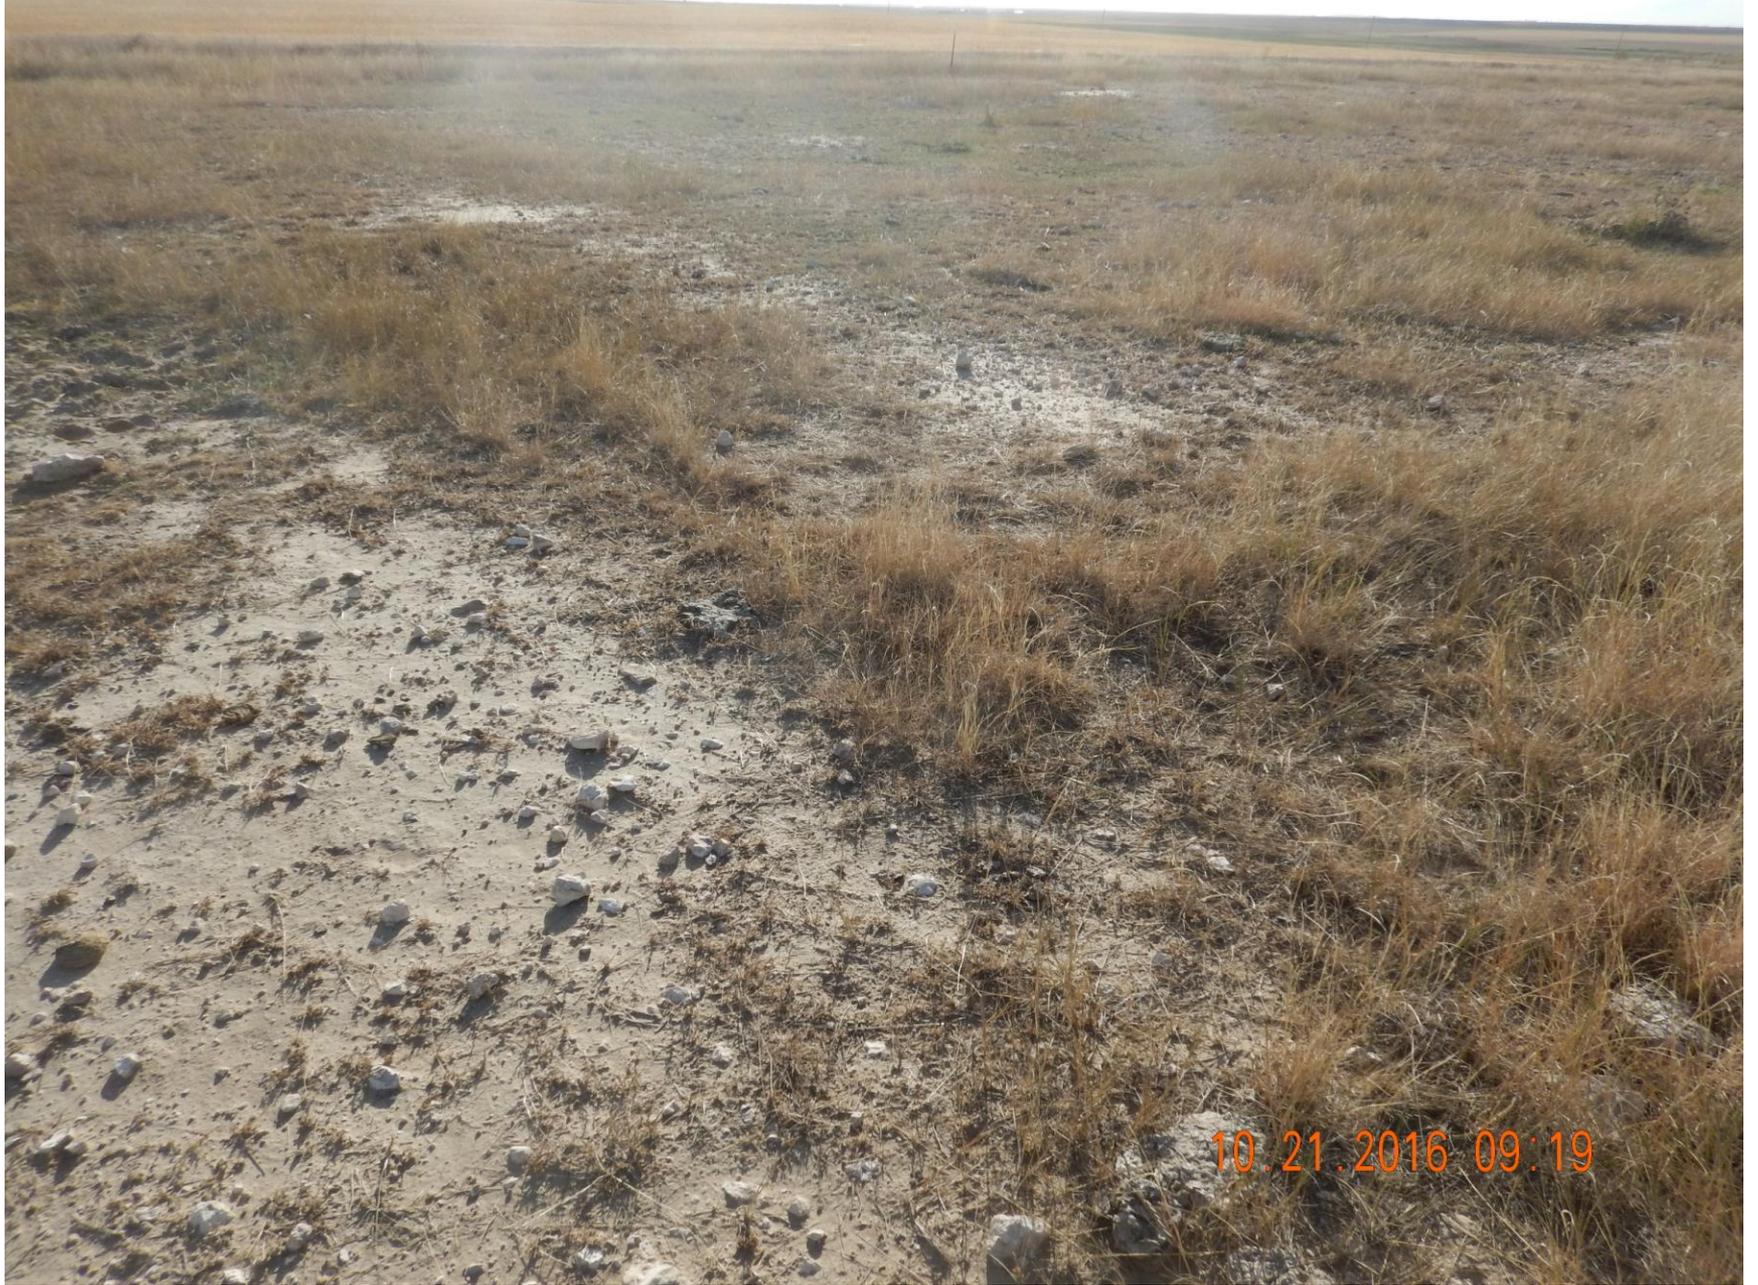
**Figure 17:** Photo taken from the west end of the pit location, facing southeast. Photo shows the vegetation over the reclamation area.

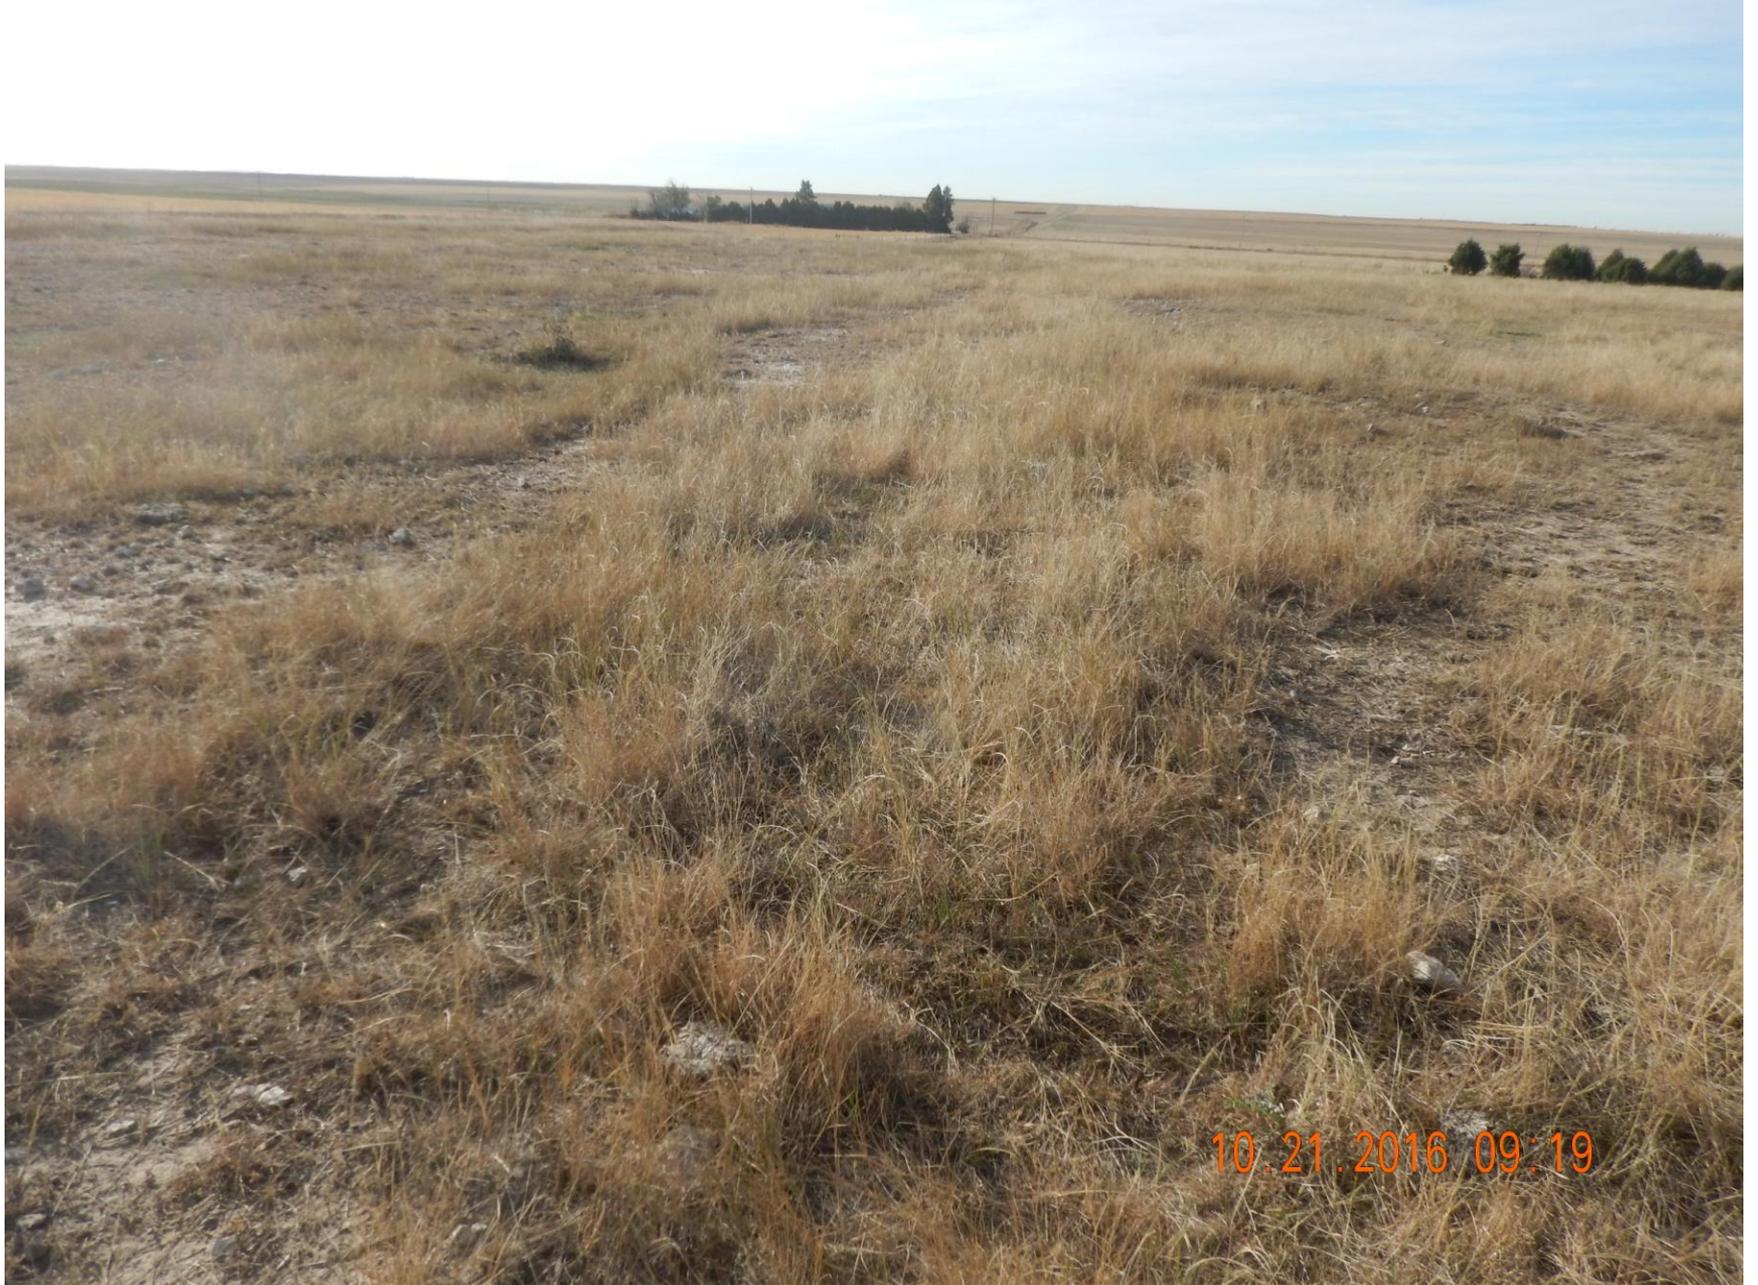
**Figure 18:** Photo taken from the west end of the pit location, facing south. Photo shows the vegetation over the reclamation area.
