Final Reclamation Inspection

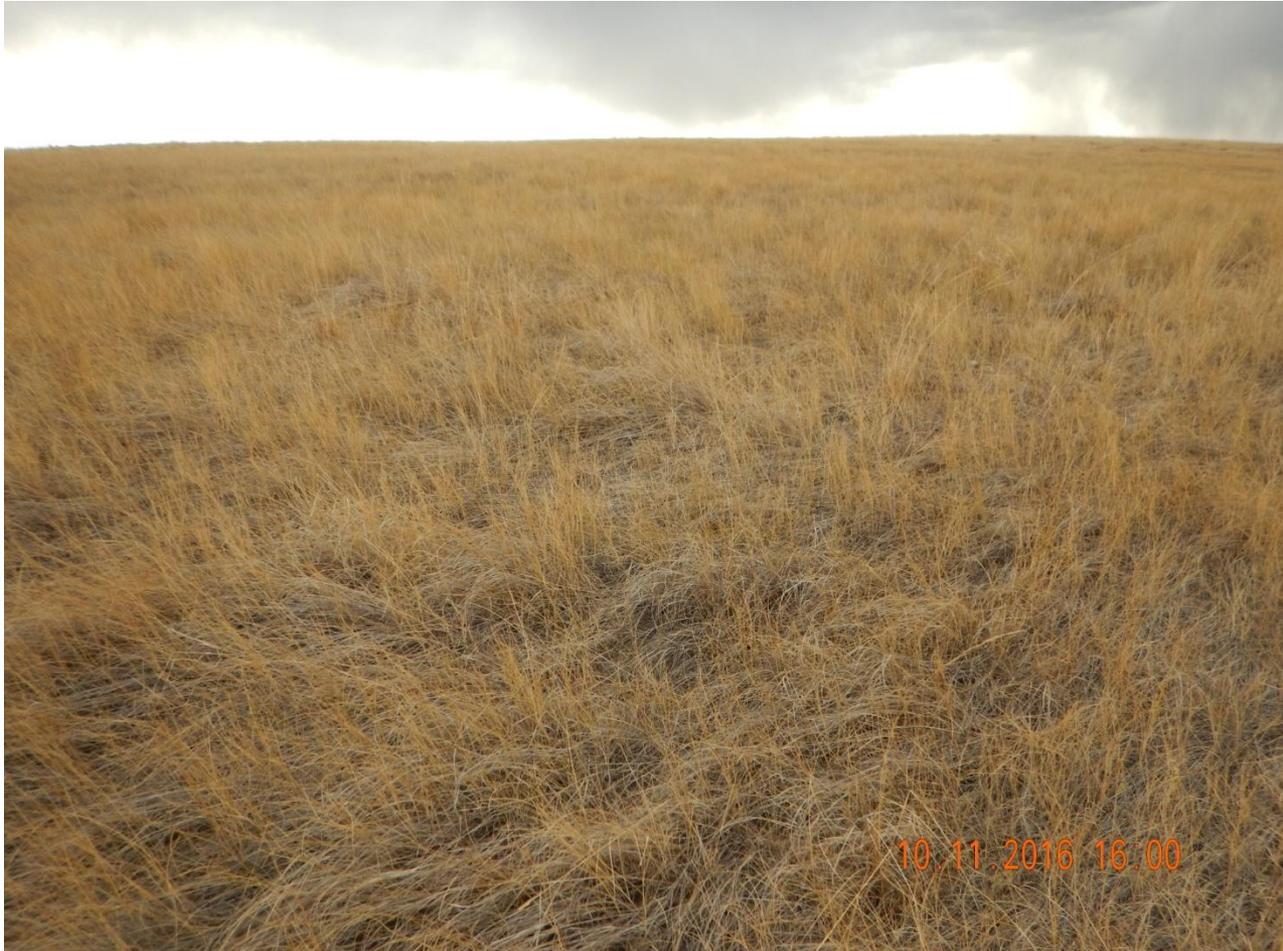
Photo 1. Photo taken from center of location, facing West. No evidence of disturbance. Uniform vegetative growth throughout location.

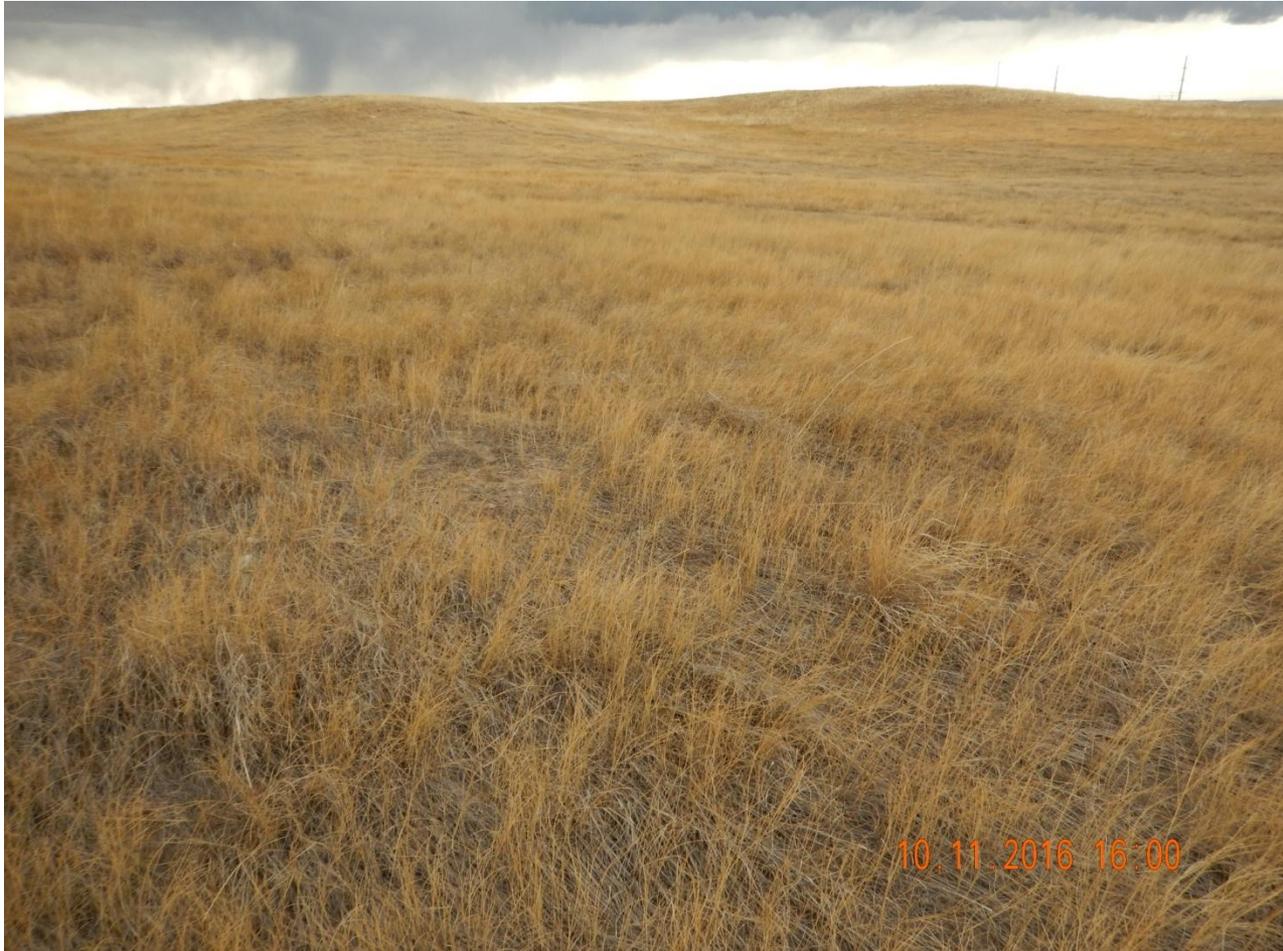
Photo 2. Photo taken from center of location, facing North. No evidence of disturbance. Uniform vegetative growth throughout location.

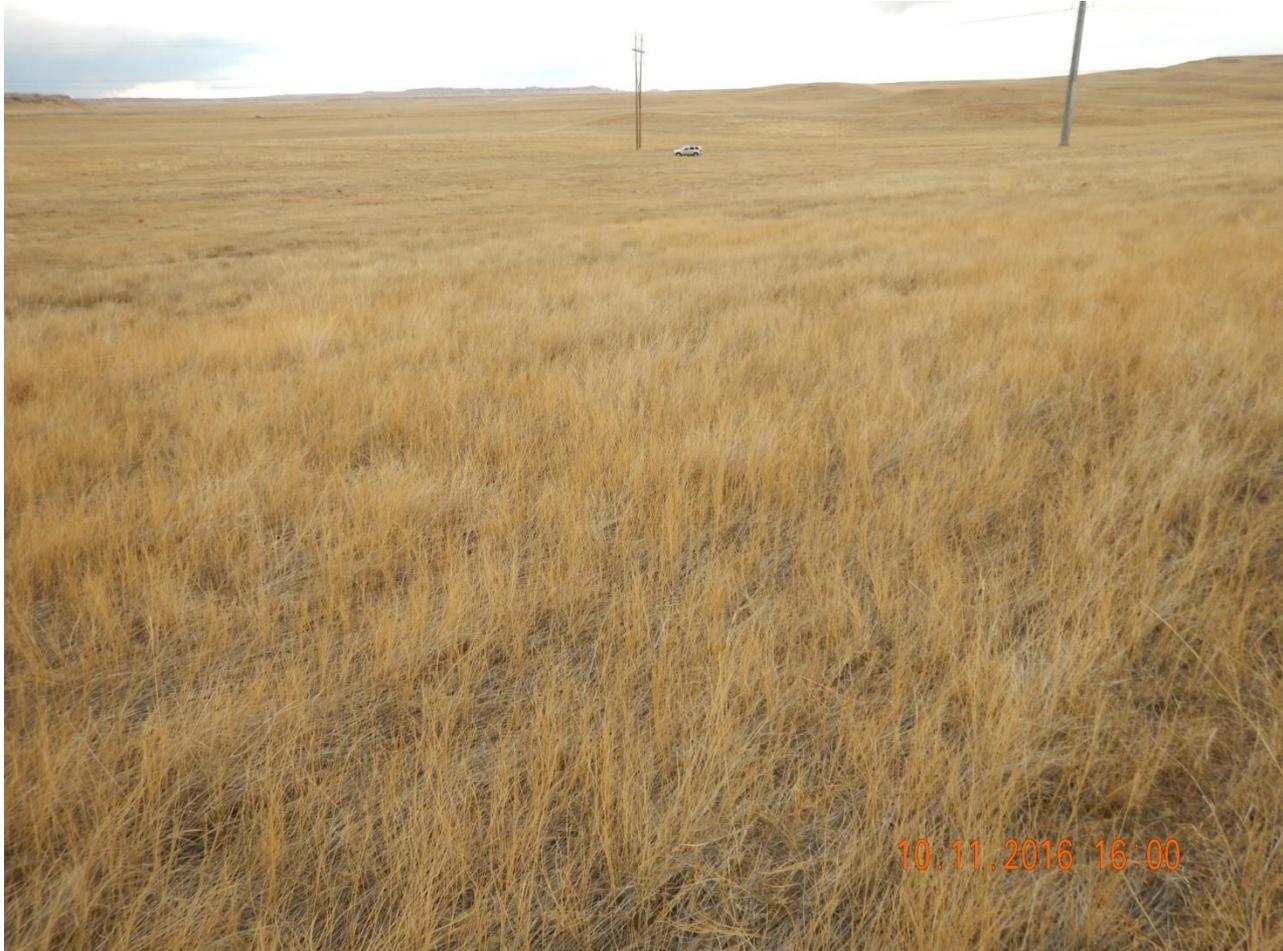
Photo 3. Photo taken from center of location, facing East. No evidence of disturbance. Uniform vegetative growth throughout location.

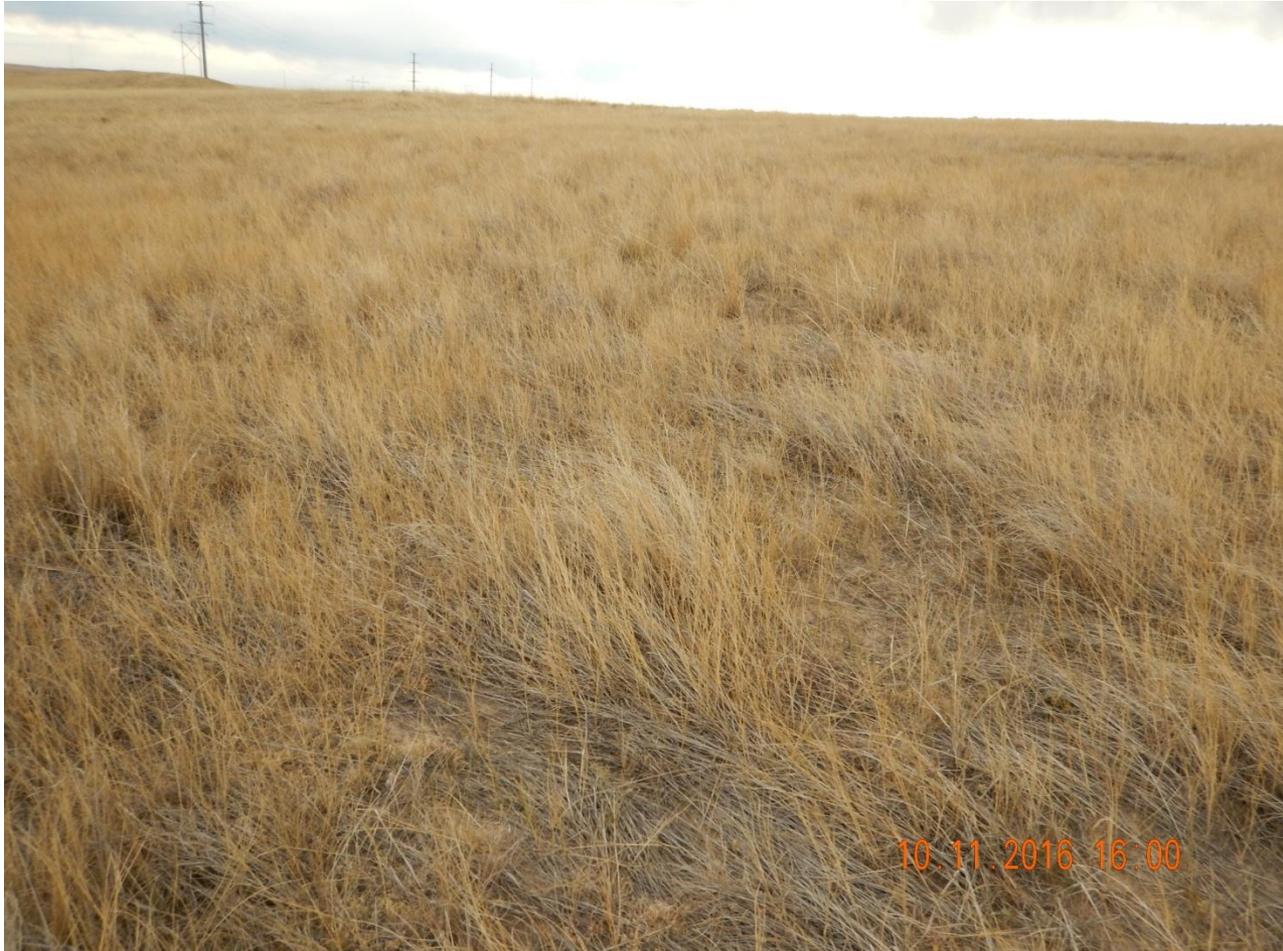
Photo 4. Photo taken from center of location, facing South. No evidence of disturbance. Uniform vegetative growth throughout location.

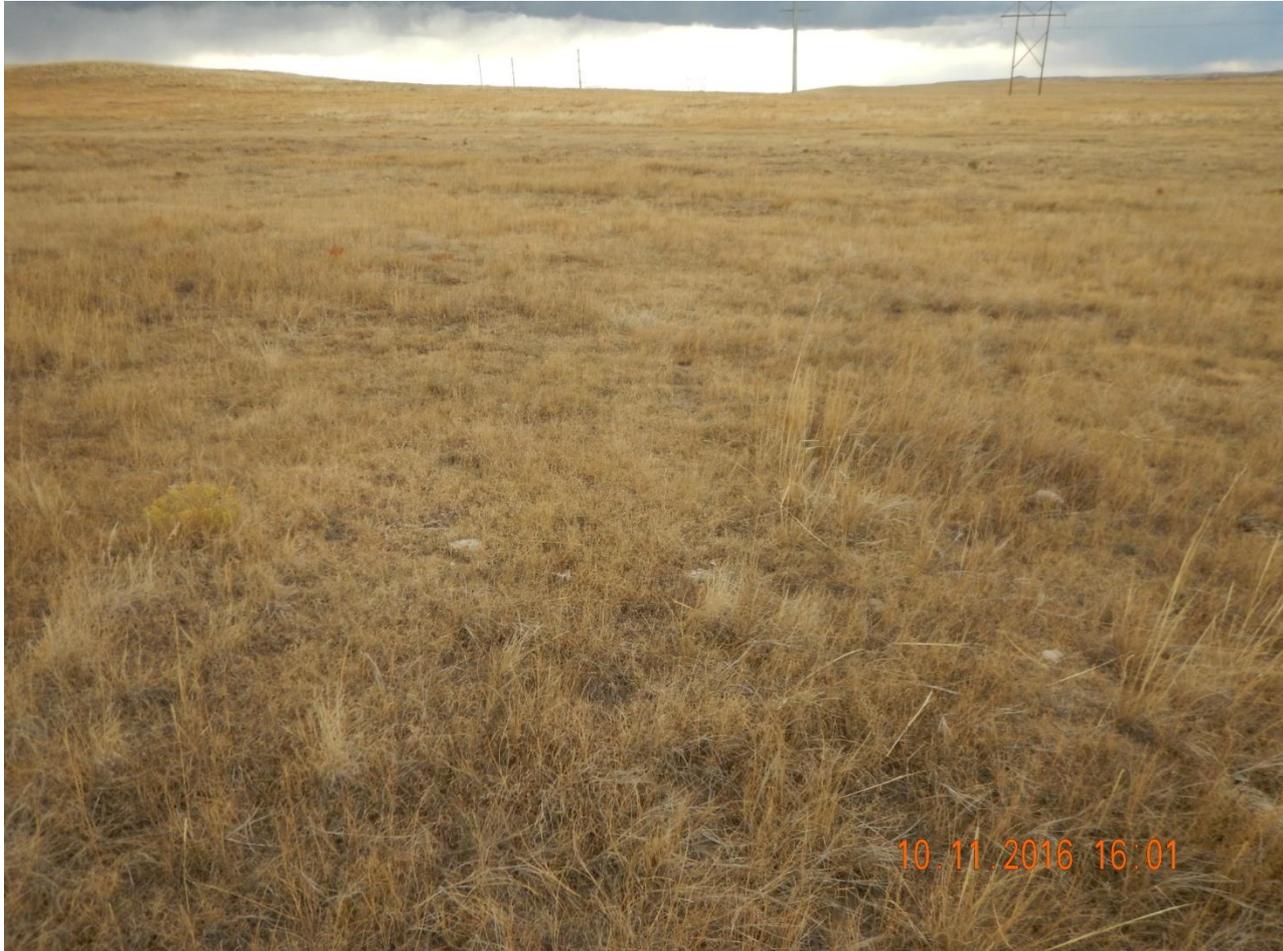
Photo 5. Reference photo taken northeast of location, facing North. Location appears to be reflective of the reference areas.
