Final Reclamation Inspection

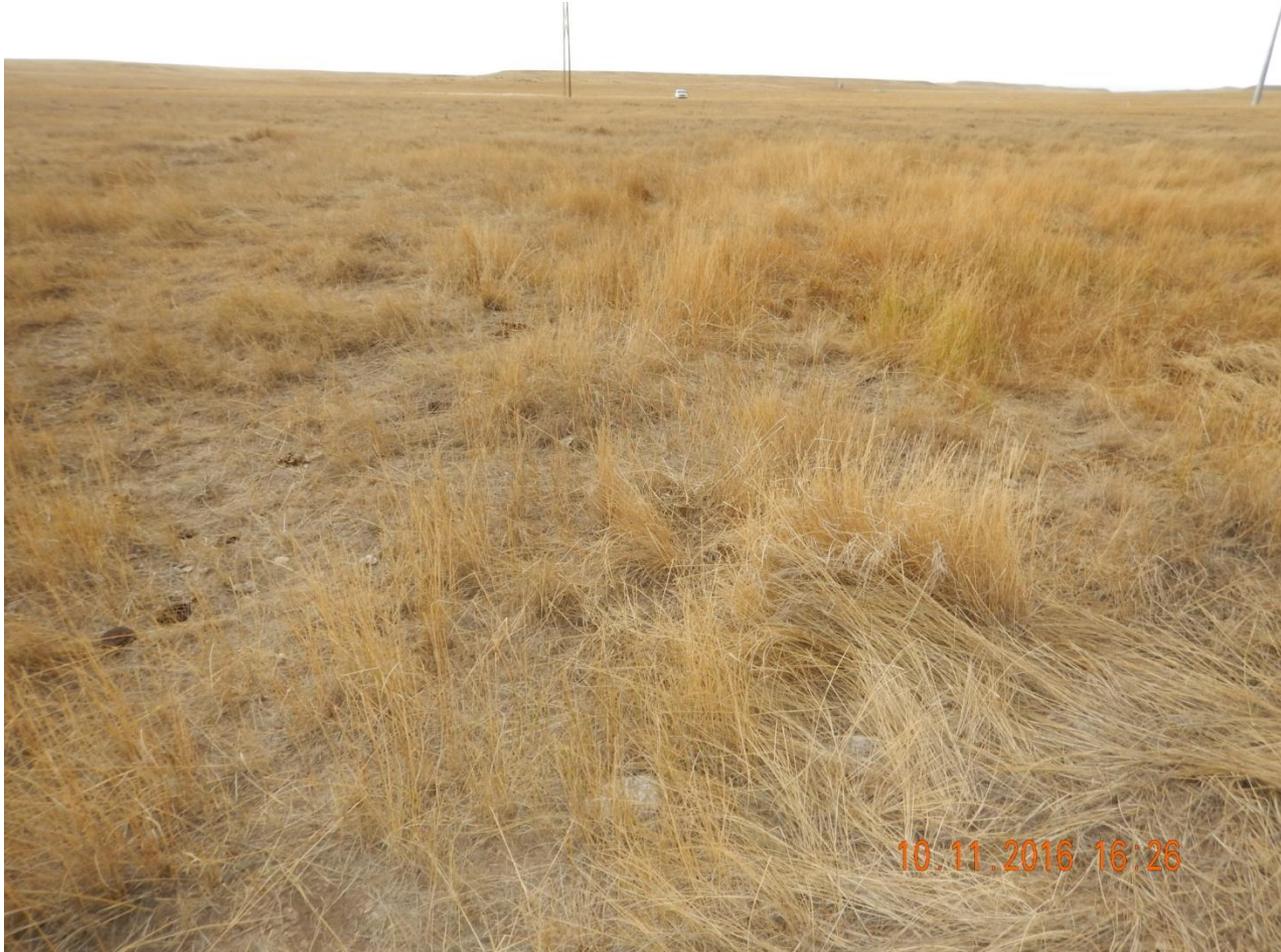
Photo 1. Photo taken from center of location, facing West. No evidence of disturbance. Uniform vegetative growth throughout location.

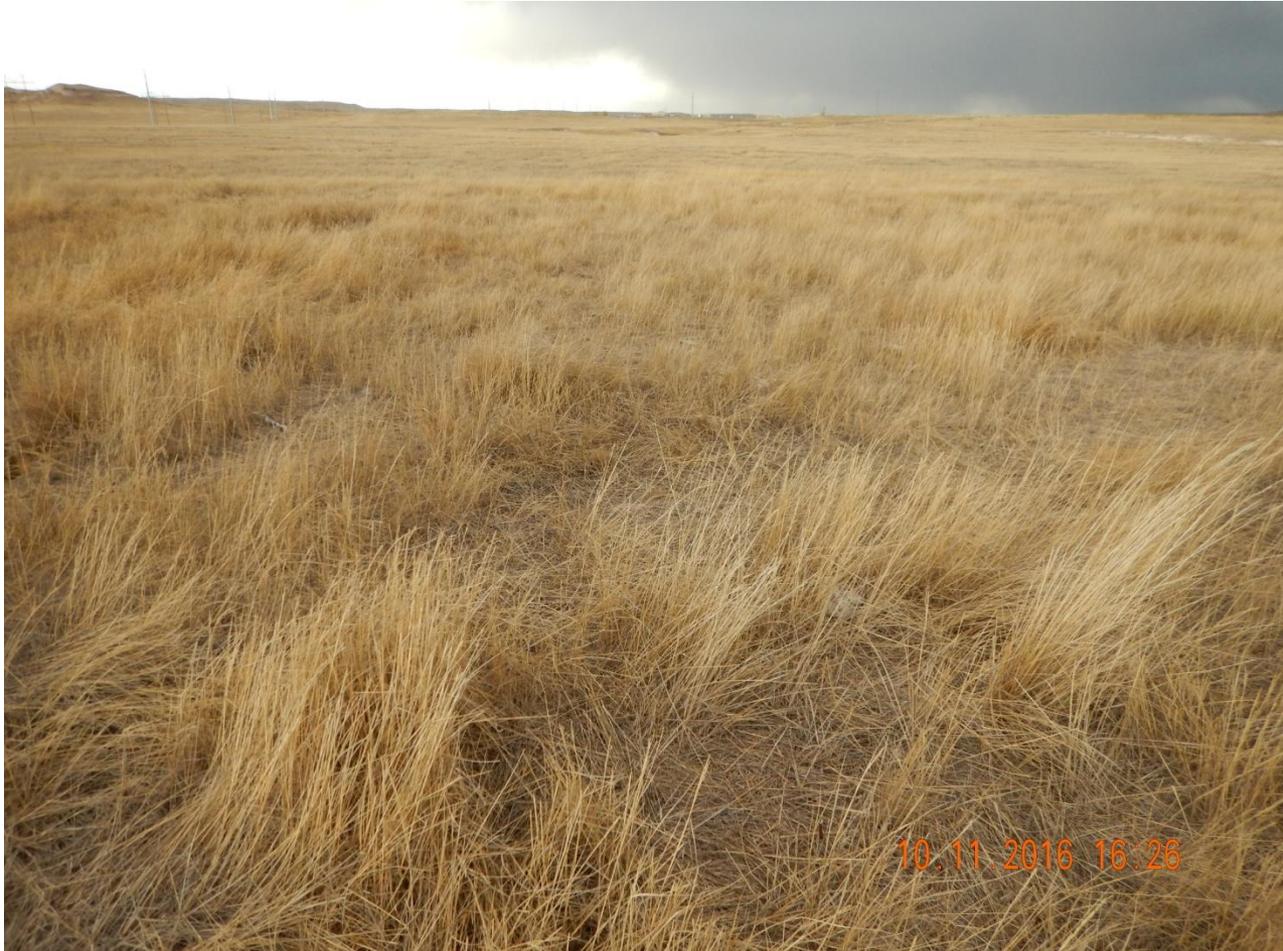
Photo 2. Photo taken from center of location, facing North. No evidence of disturbance. Uniform vegetative growth throughout location.

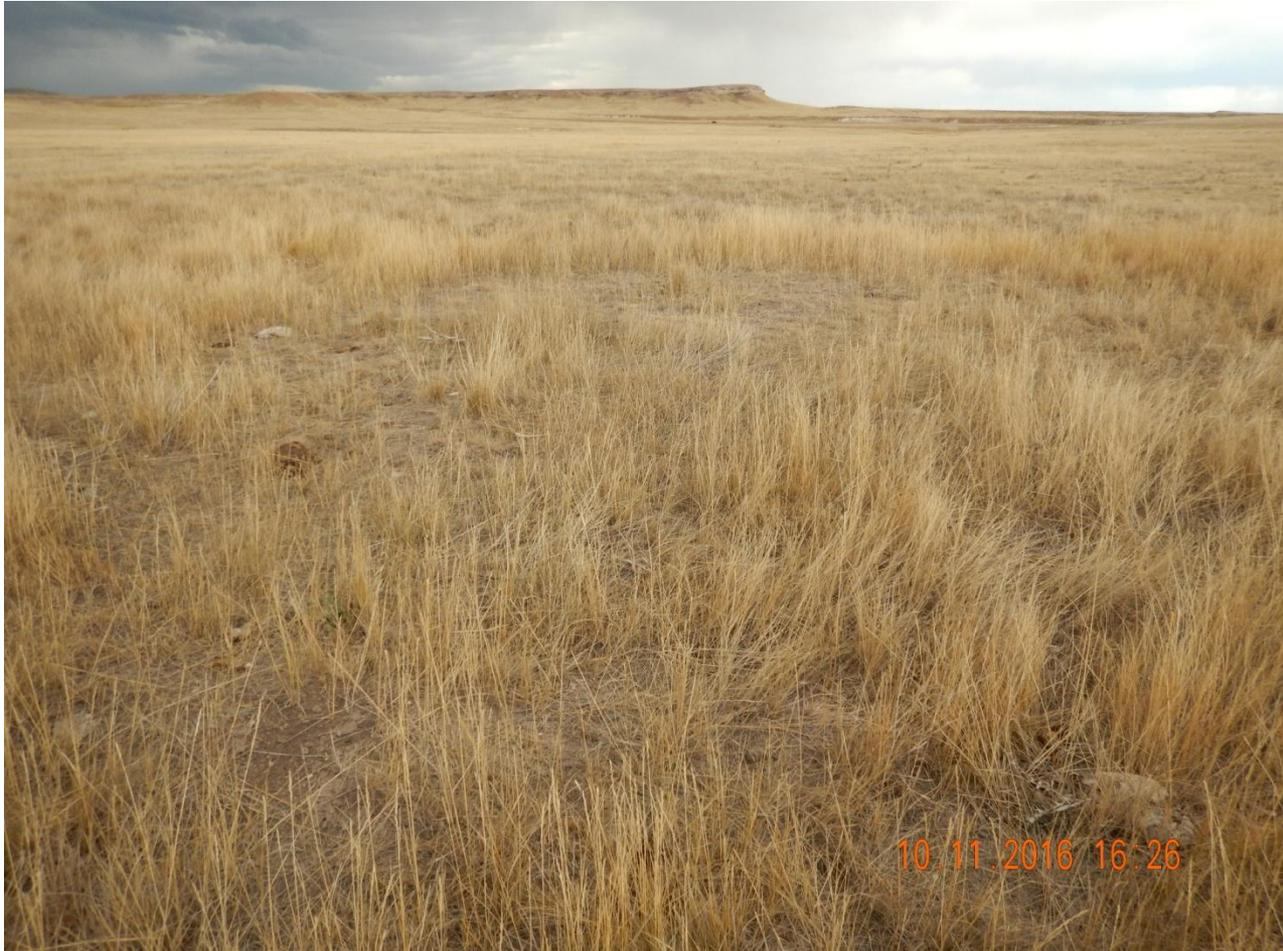
Photo 3. Photo taken from center of location, facing East. No evidence of disturbance. Uniform vegetative growth throughout location.

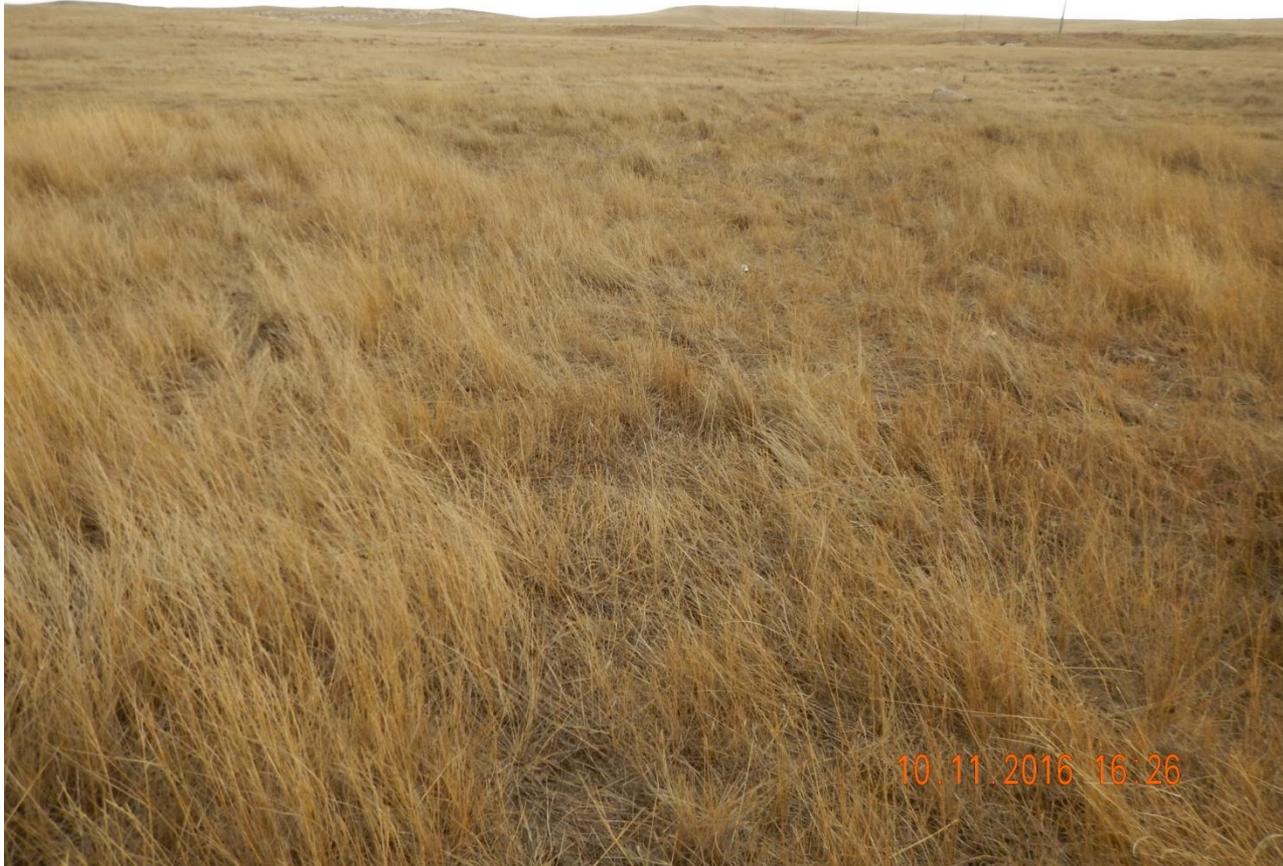
Photo 4. Photo taken from center of location, facing South. No evidence of disturbance. Uniform vegetative growth throughout location.

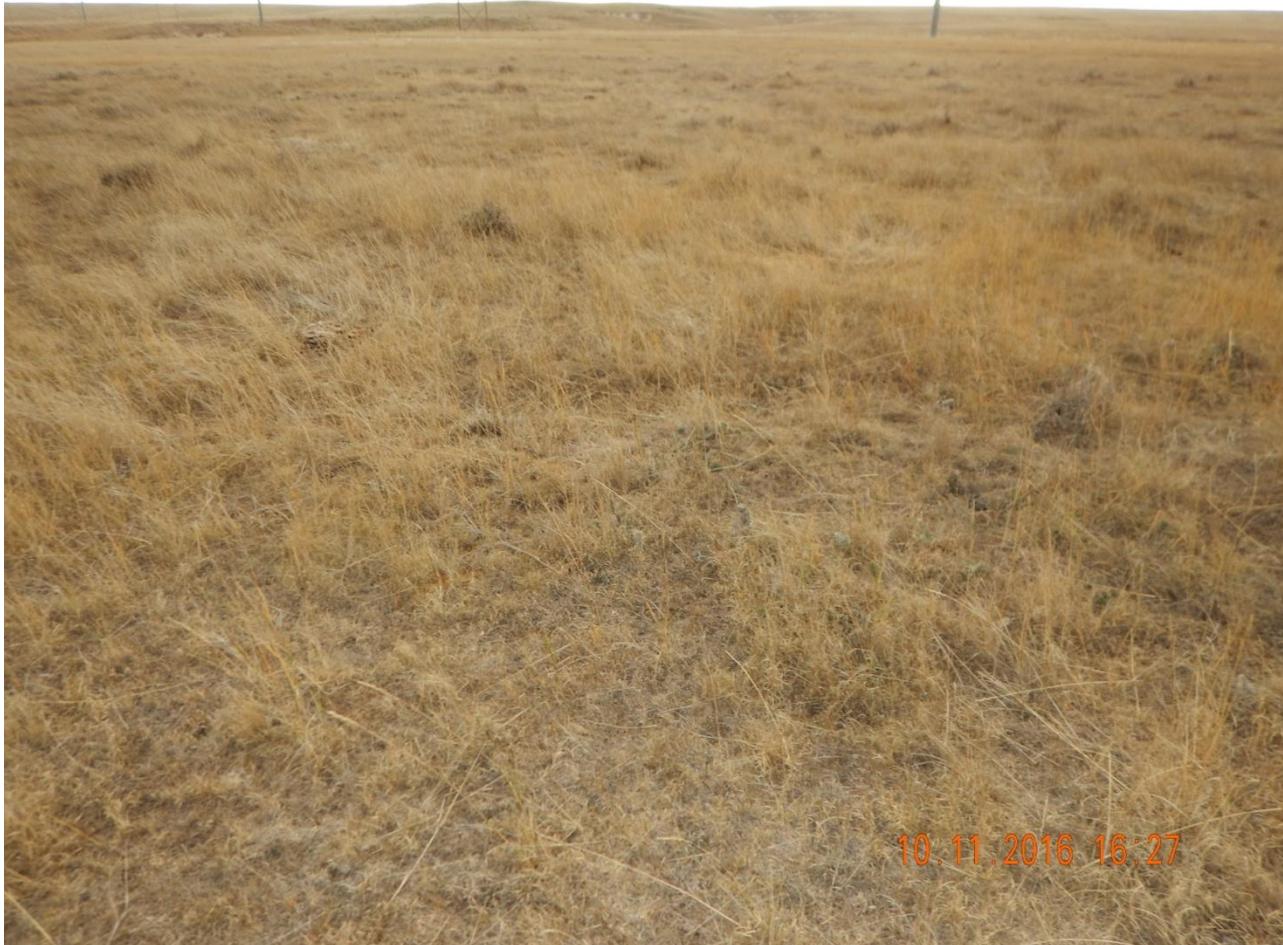
Photo 5. Reference photo taken west of location, facing North. Location appears to be reflective of the reference areas.
