Construction Inspection

10/21/2016

Operator: Grand Mesa Operating Co

Location ID: 442964

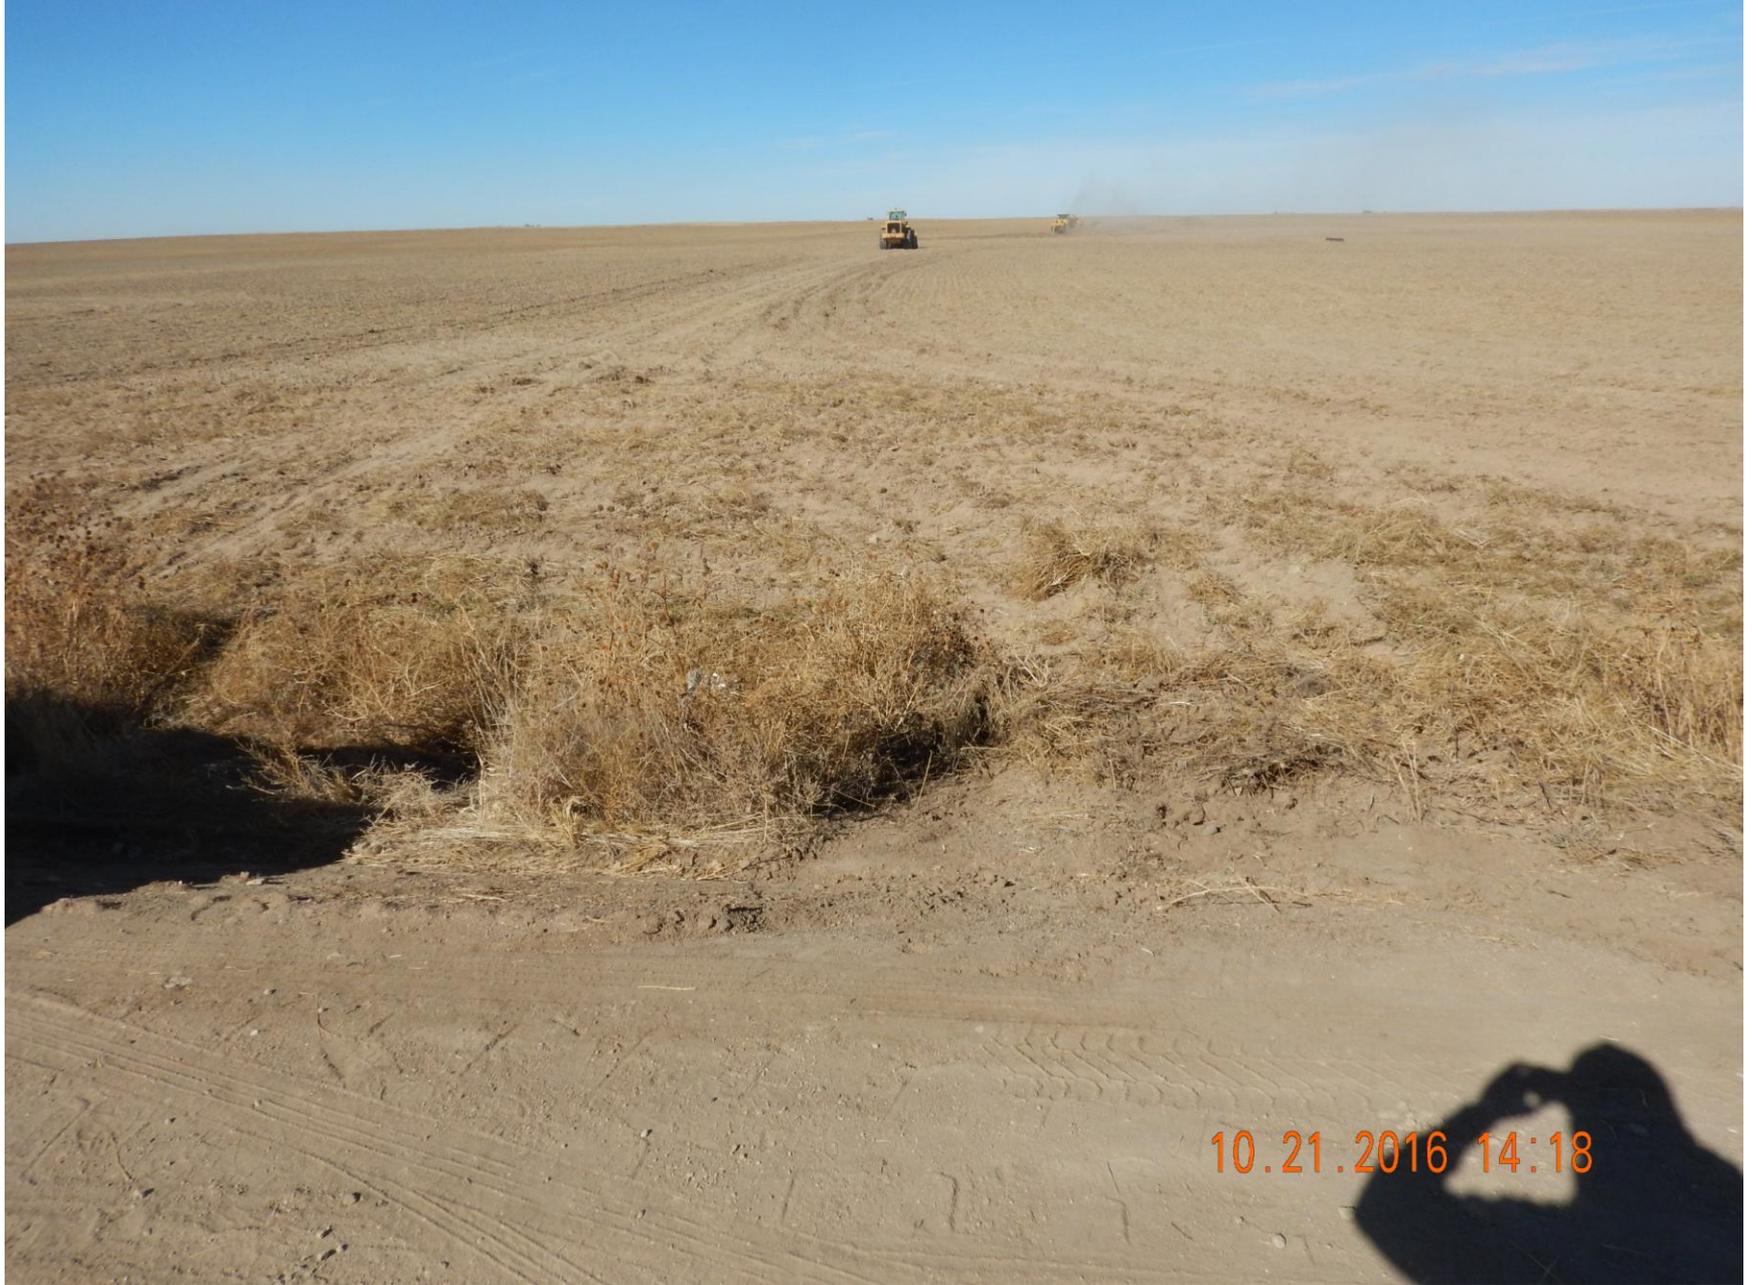
Figure 1: Photo taken from Washington County Road 2, facing north. Photo shows approximate area where access road will be constructed.

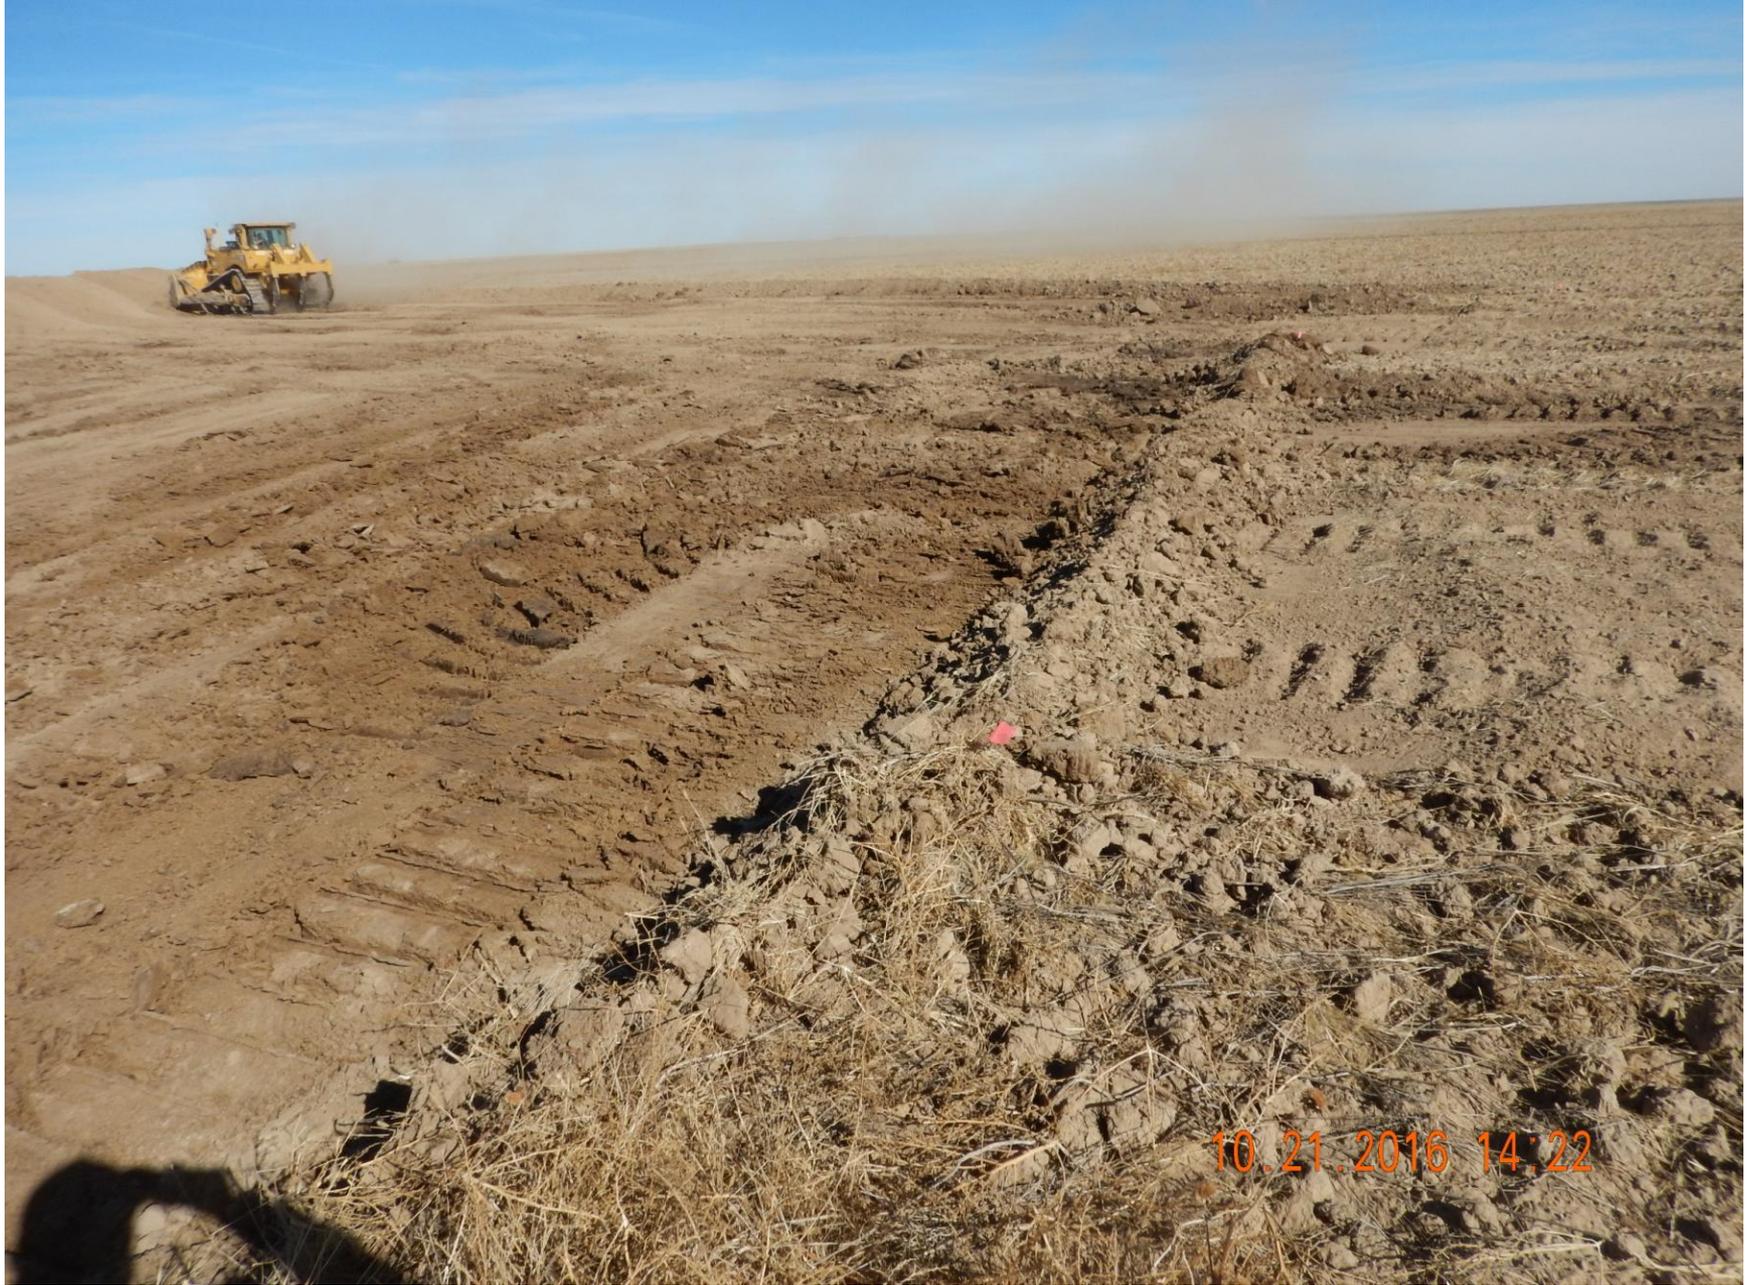
Figure 2: Photo taken from south end of the location, facing east. Photo shows construction in process.

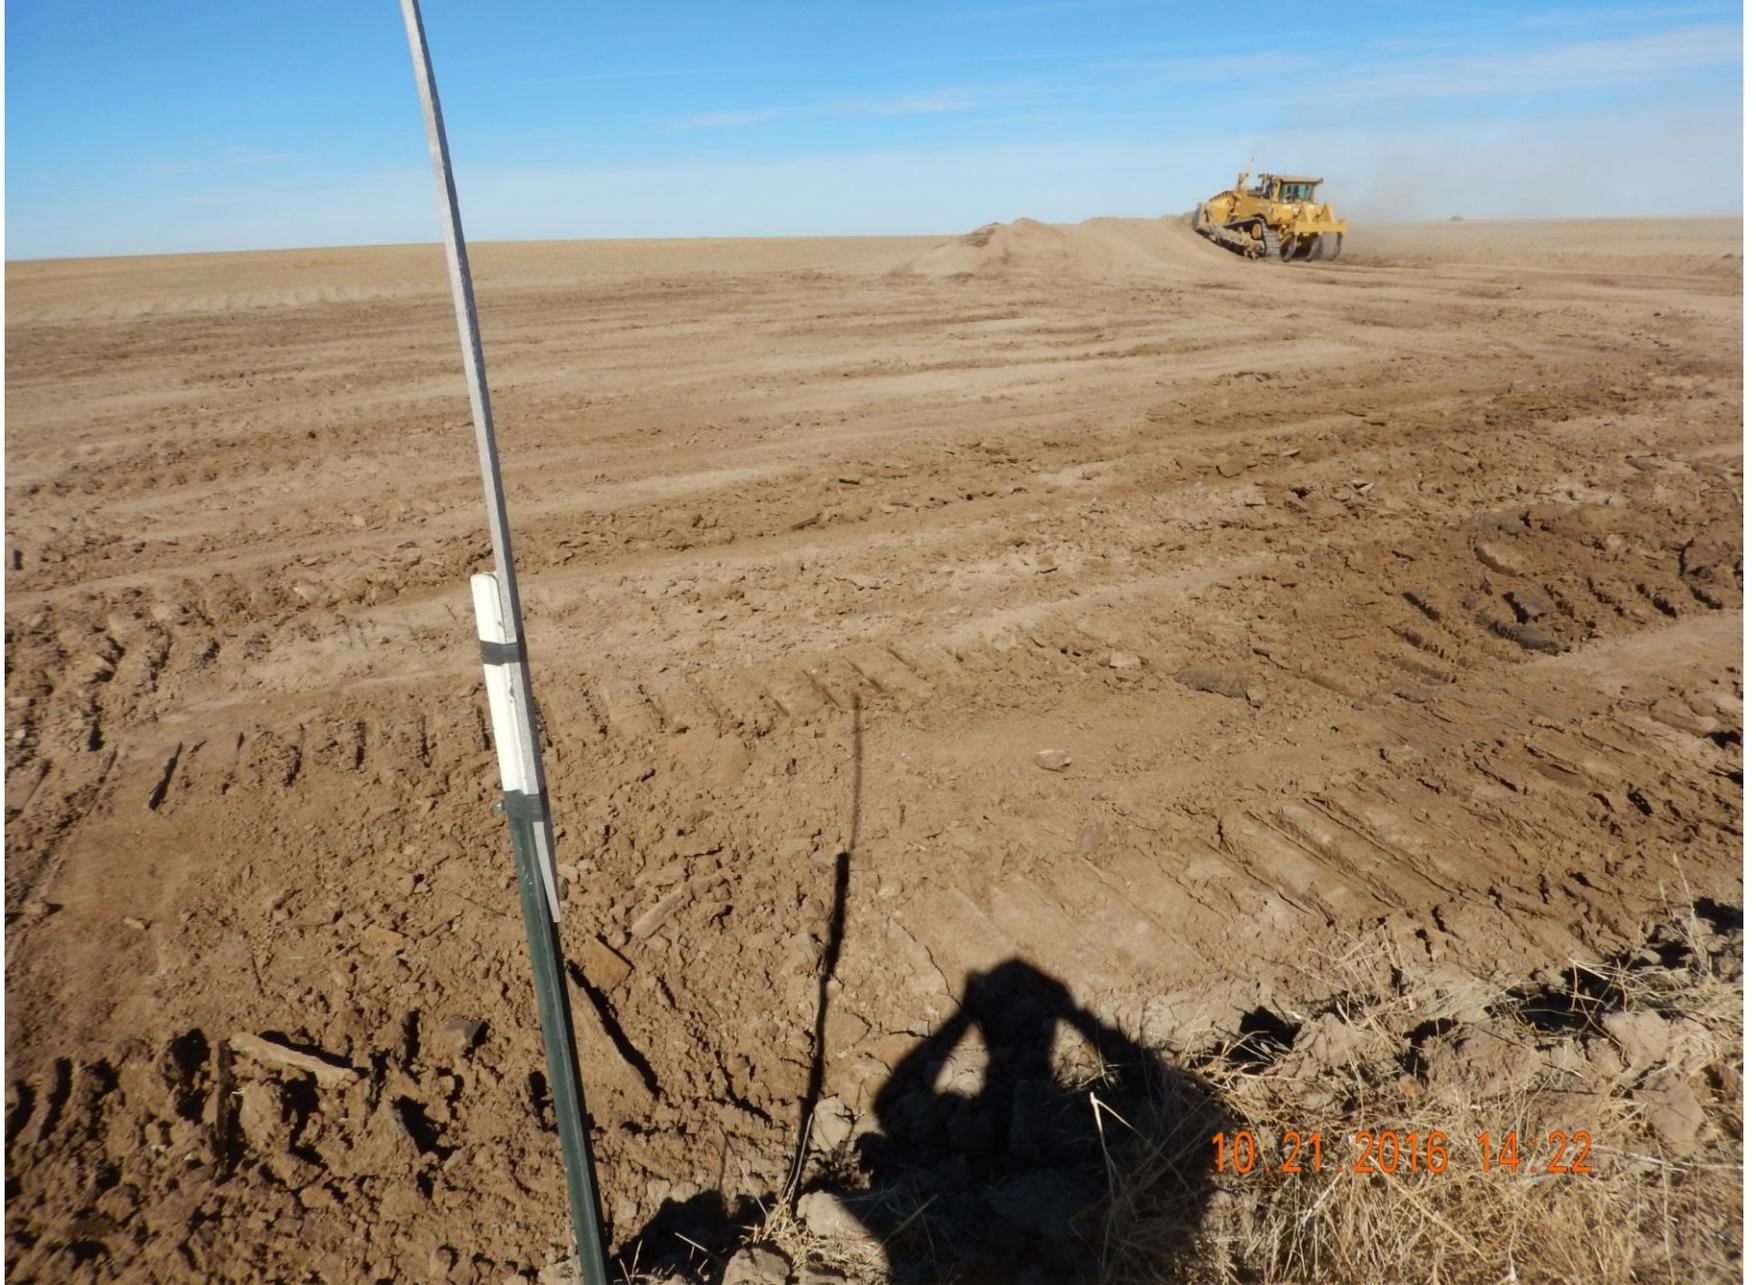
Figure 3: Photo taken from south end of the location, facing northeast. Photo shows construction in process.

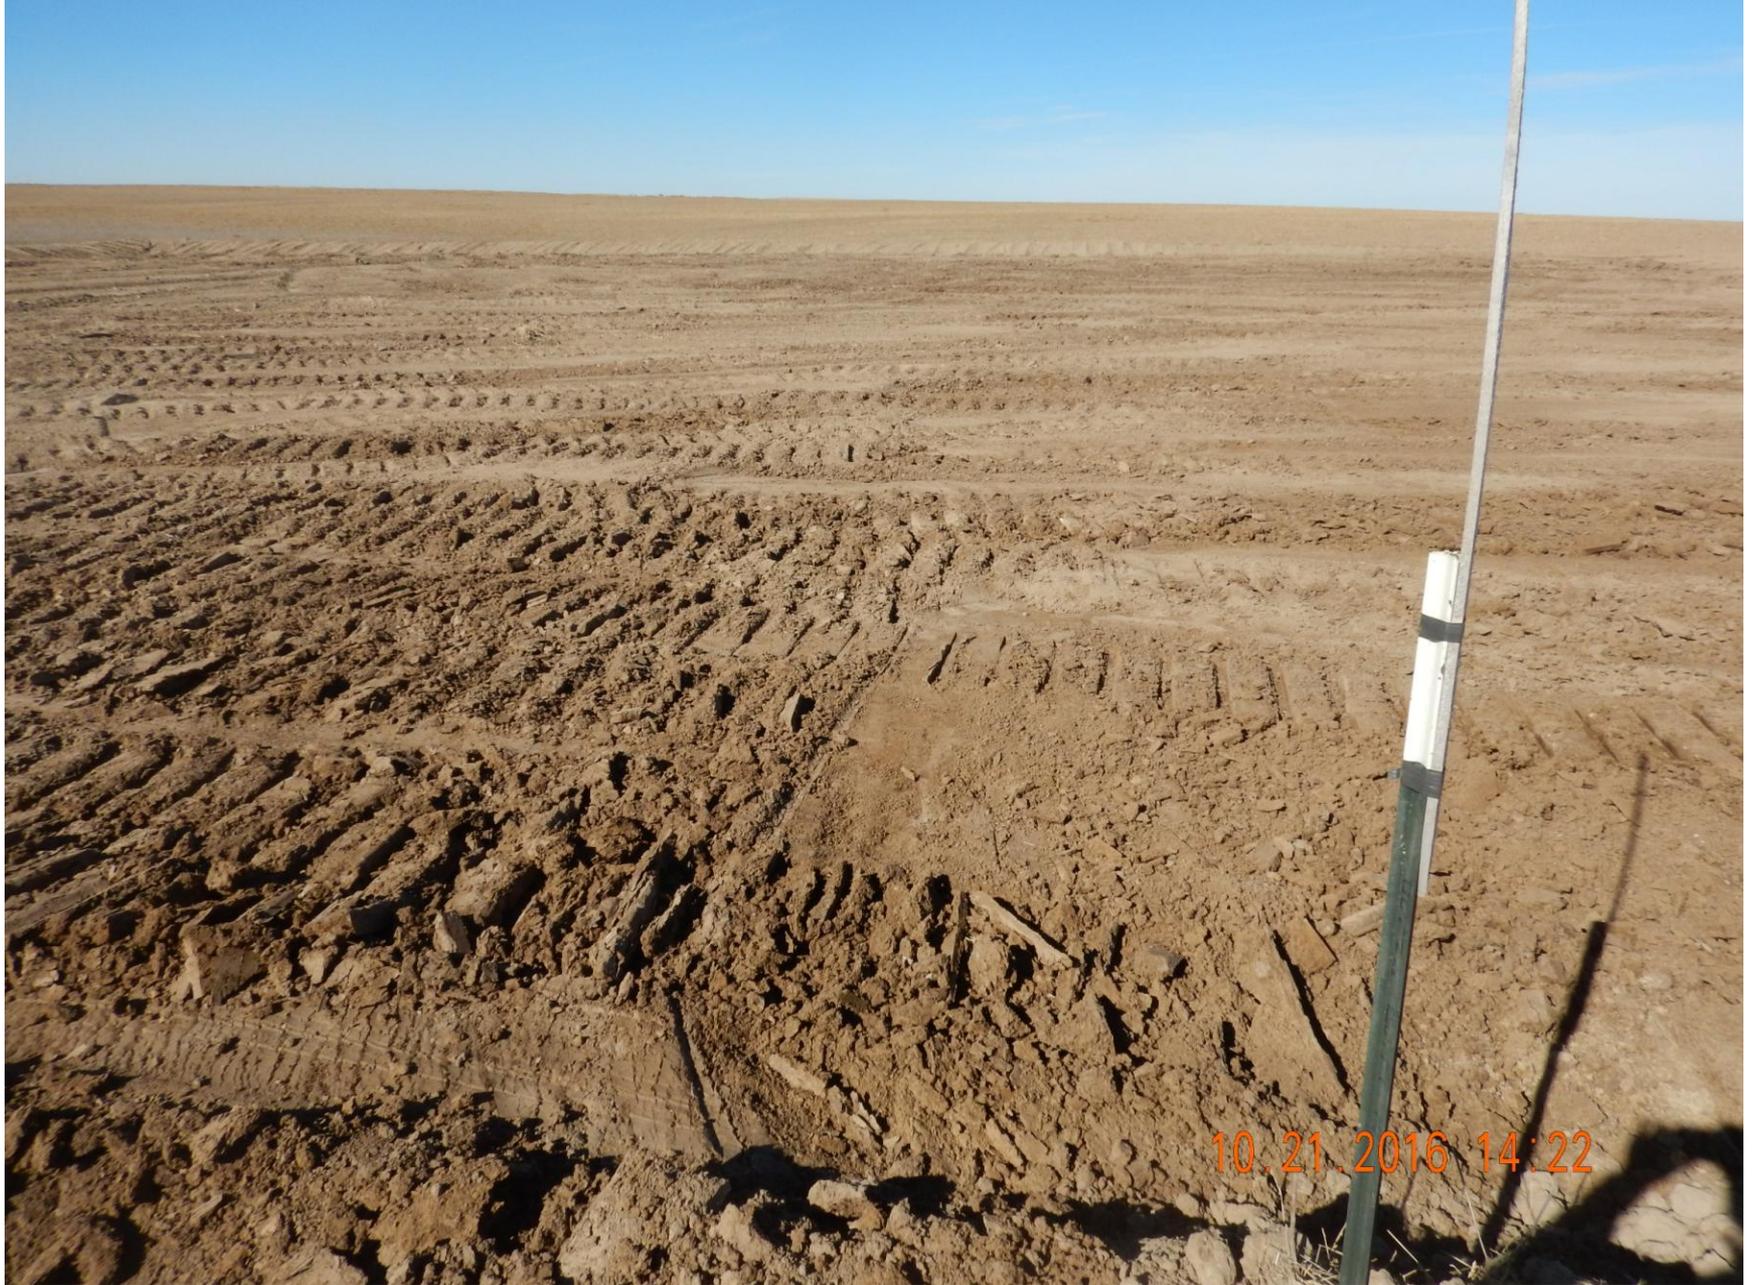
Figure 4: Photo taken from south end of the location, facing north. Photo shows construction in process.

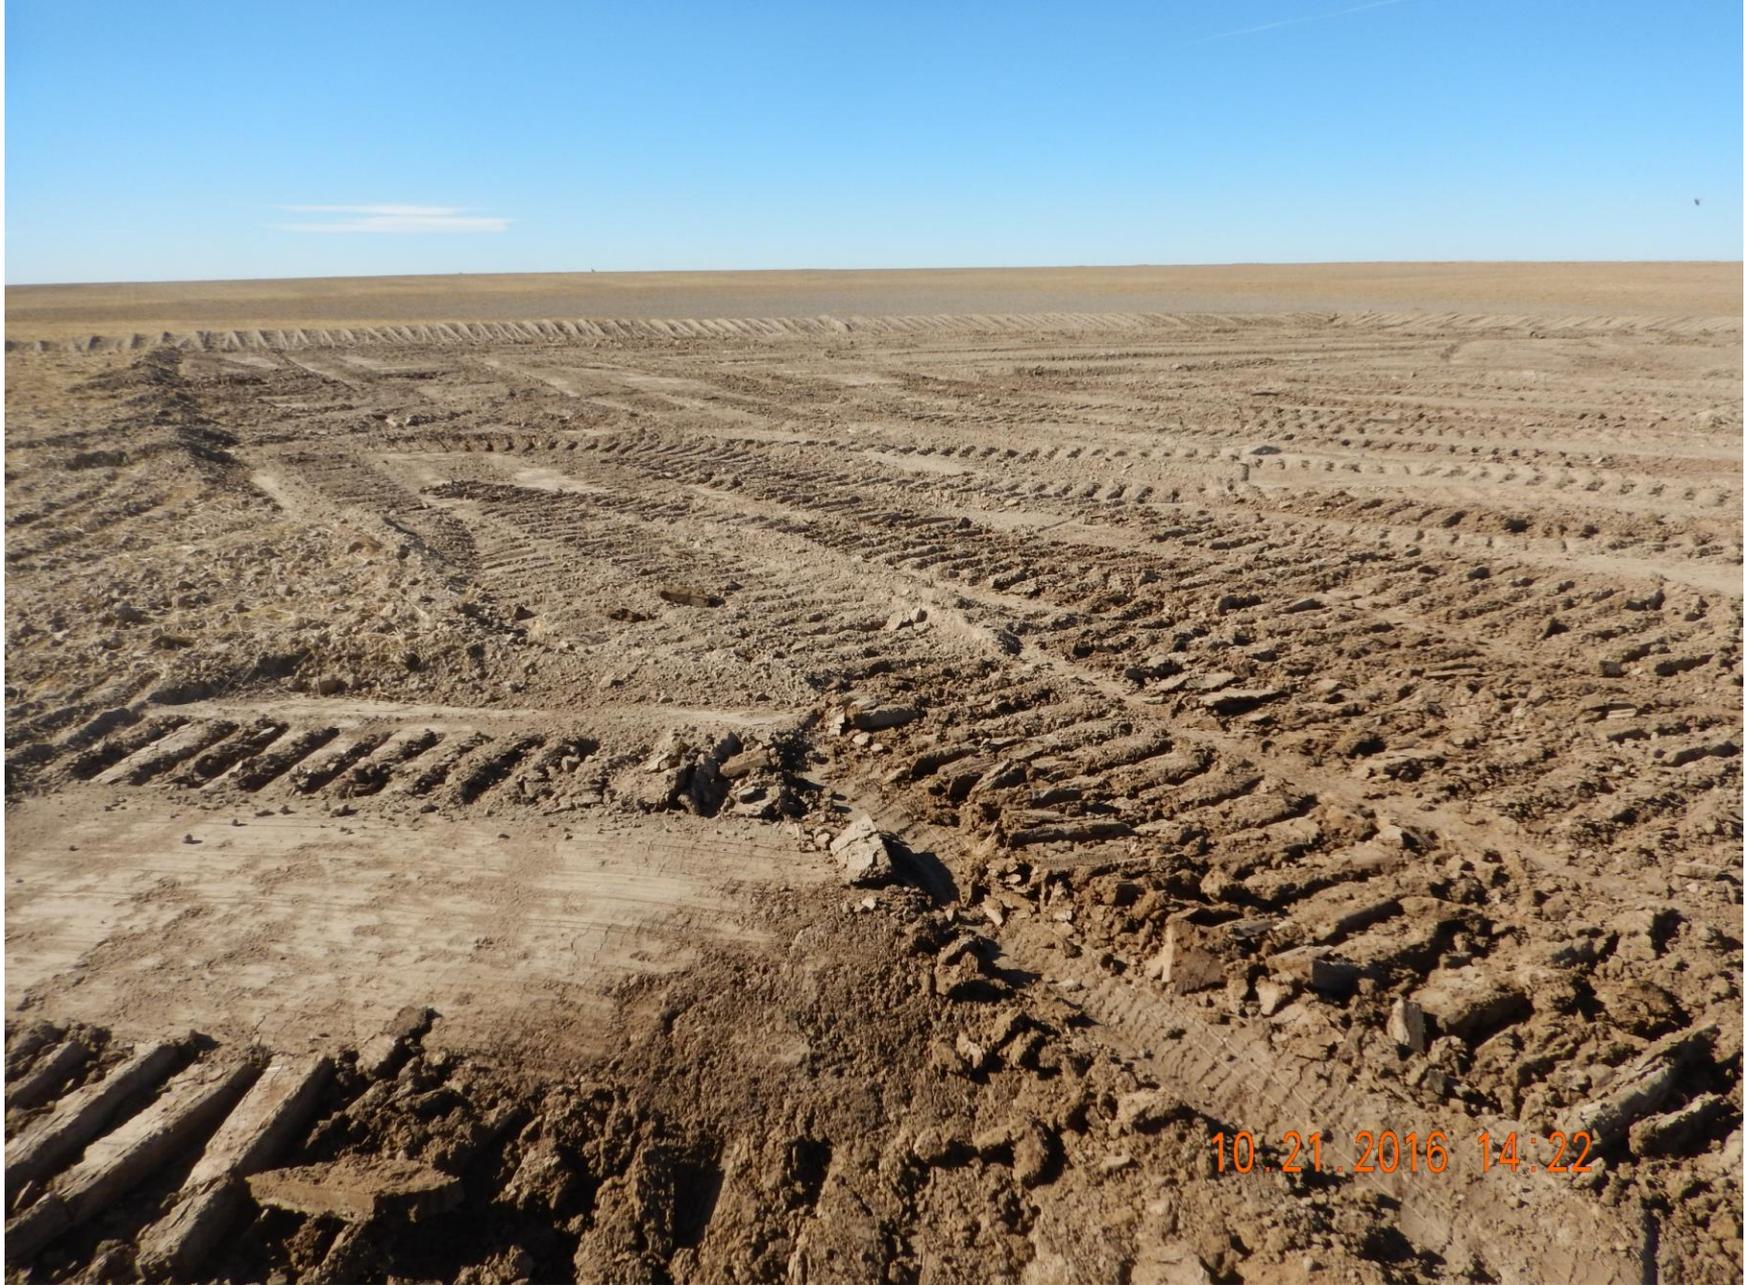
Figure 5: Photo taken from south end of the location, facing northwest. Photo shows construction in process.

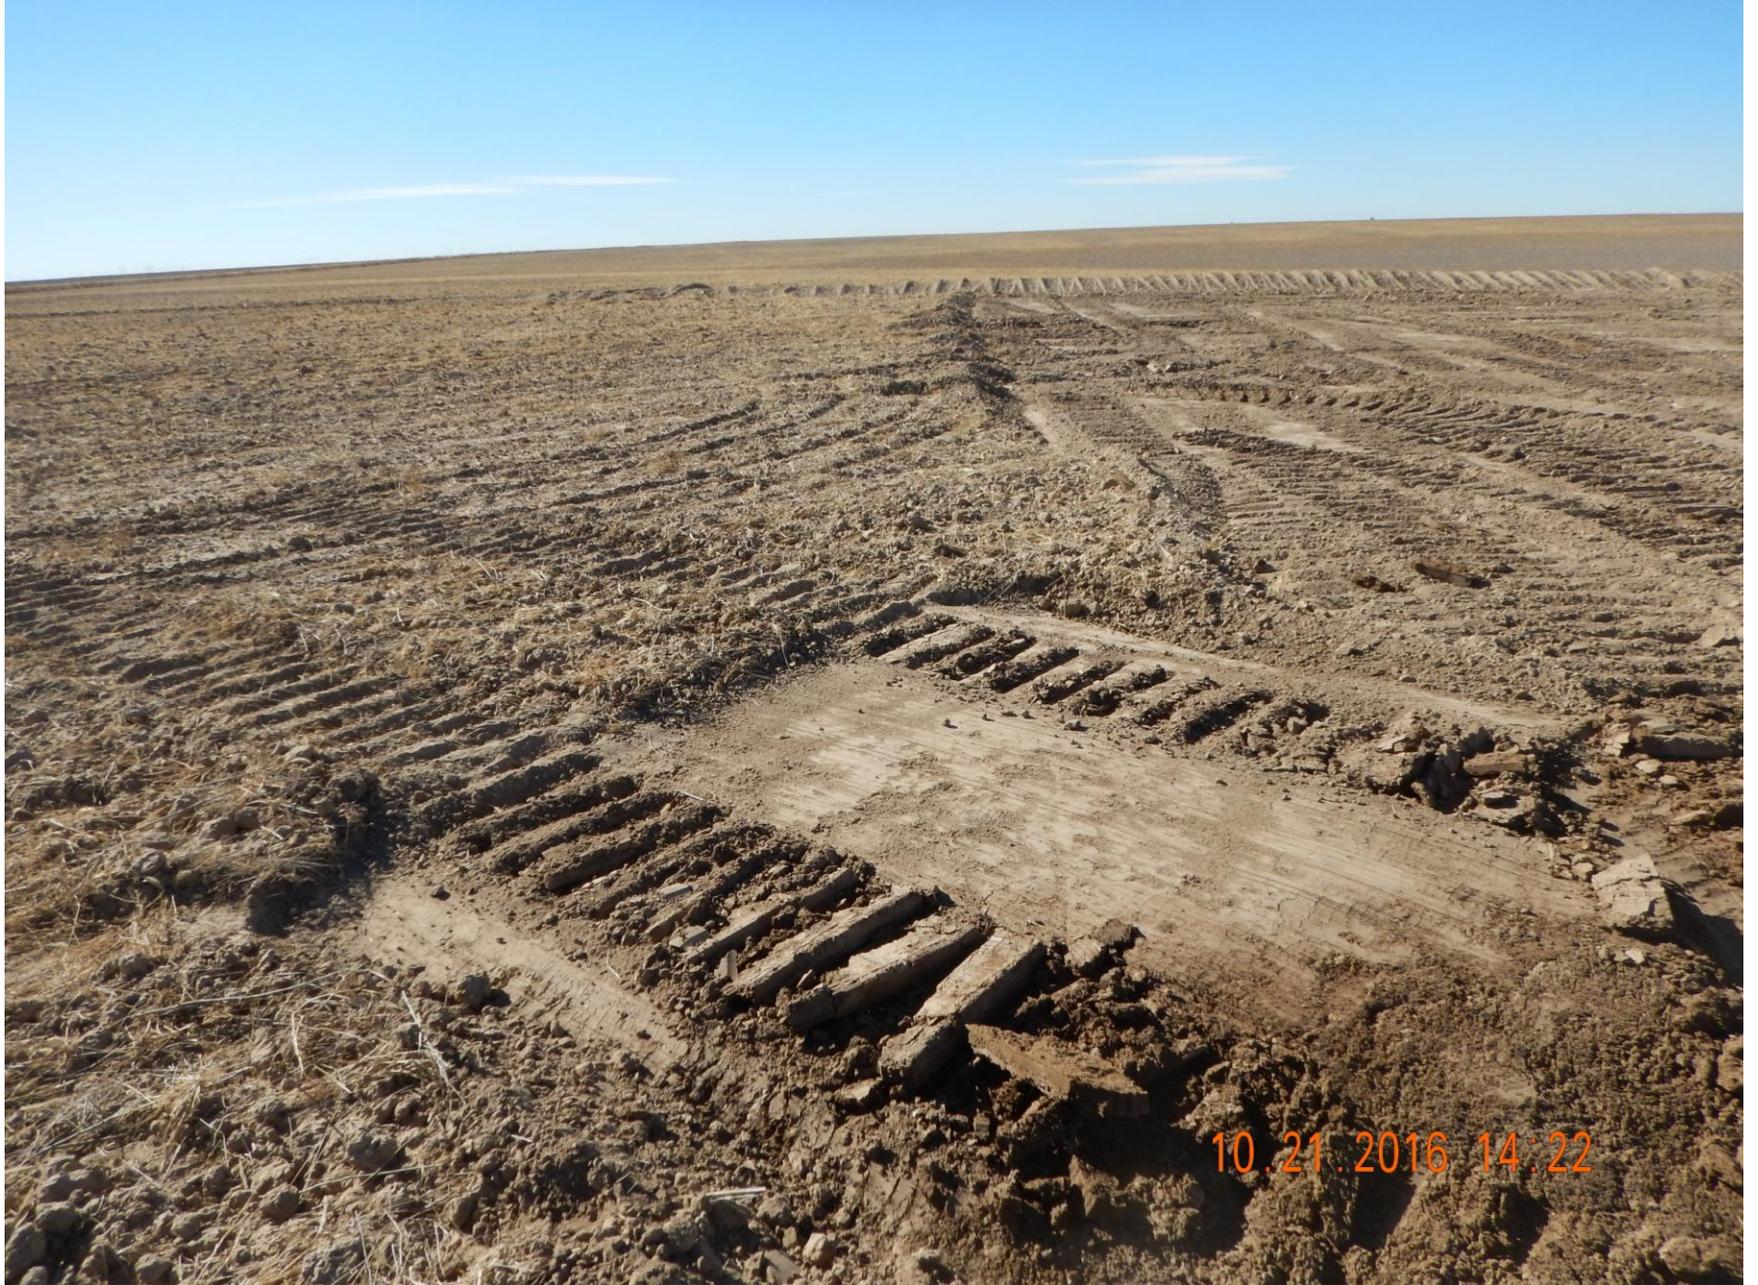
Figure 6: Photo taken from south end of the location, facing west. Photo shows construction in process.

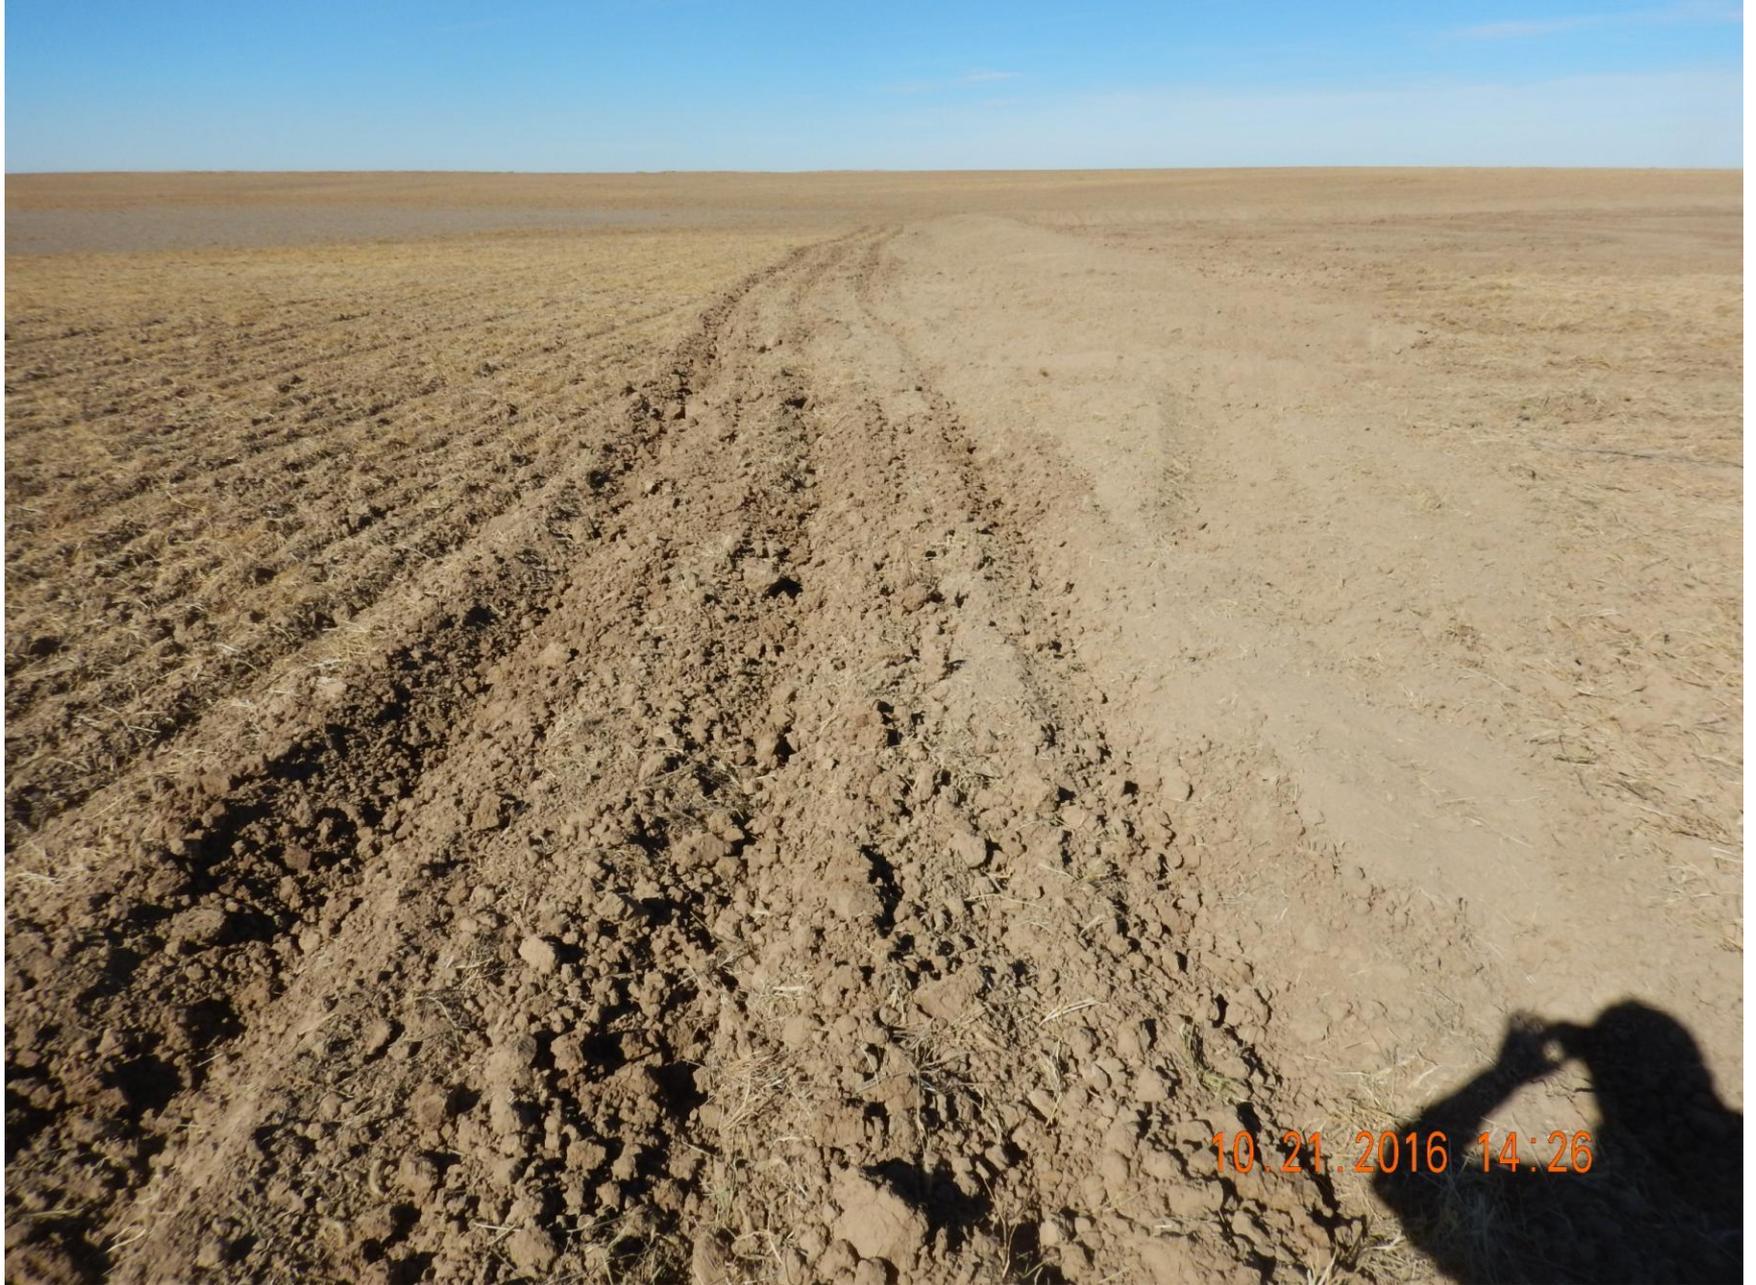
Figure 7: Photo taken from the west end of the location, facing north. Photo shows surface roughening has been constructed in conjunction with berms as a stormwater and sediment control BMP

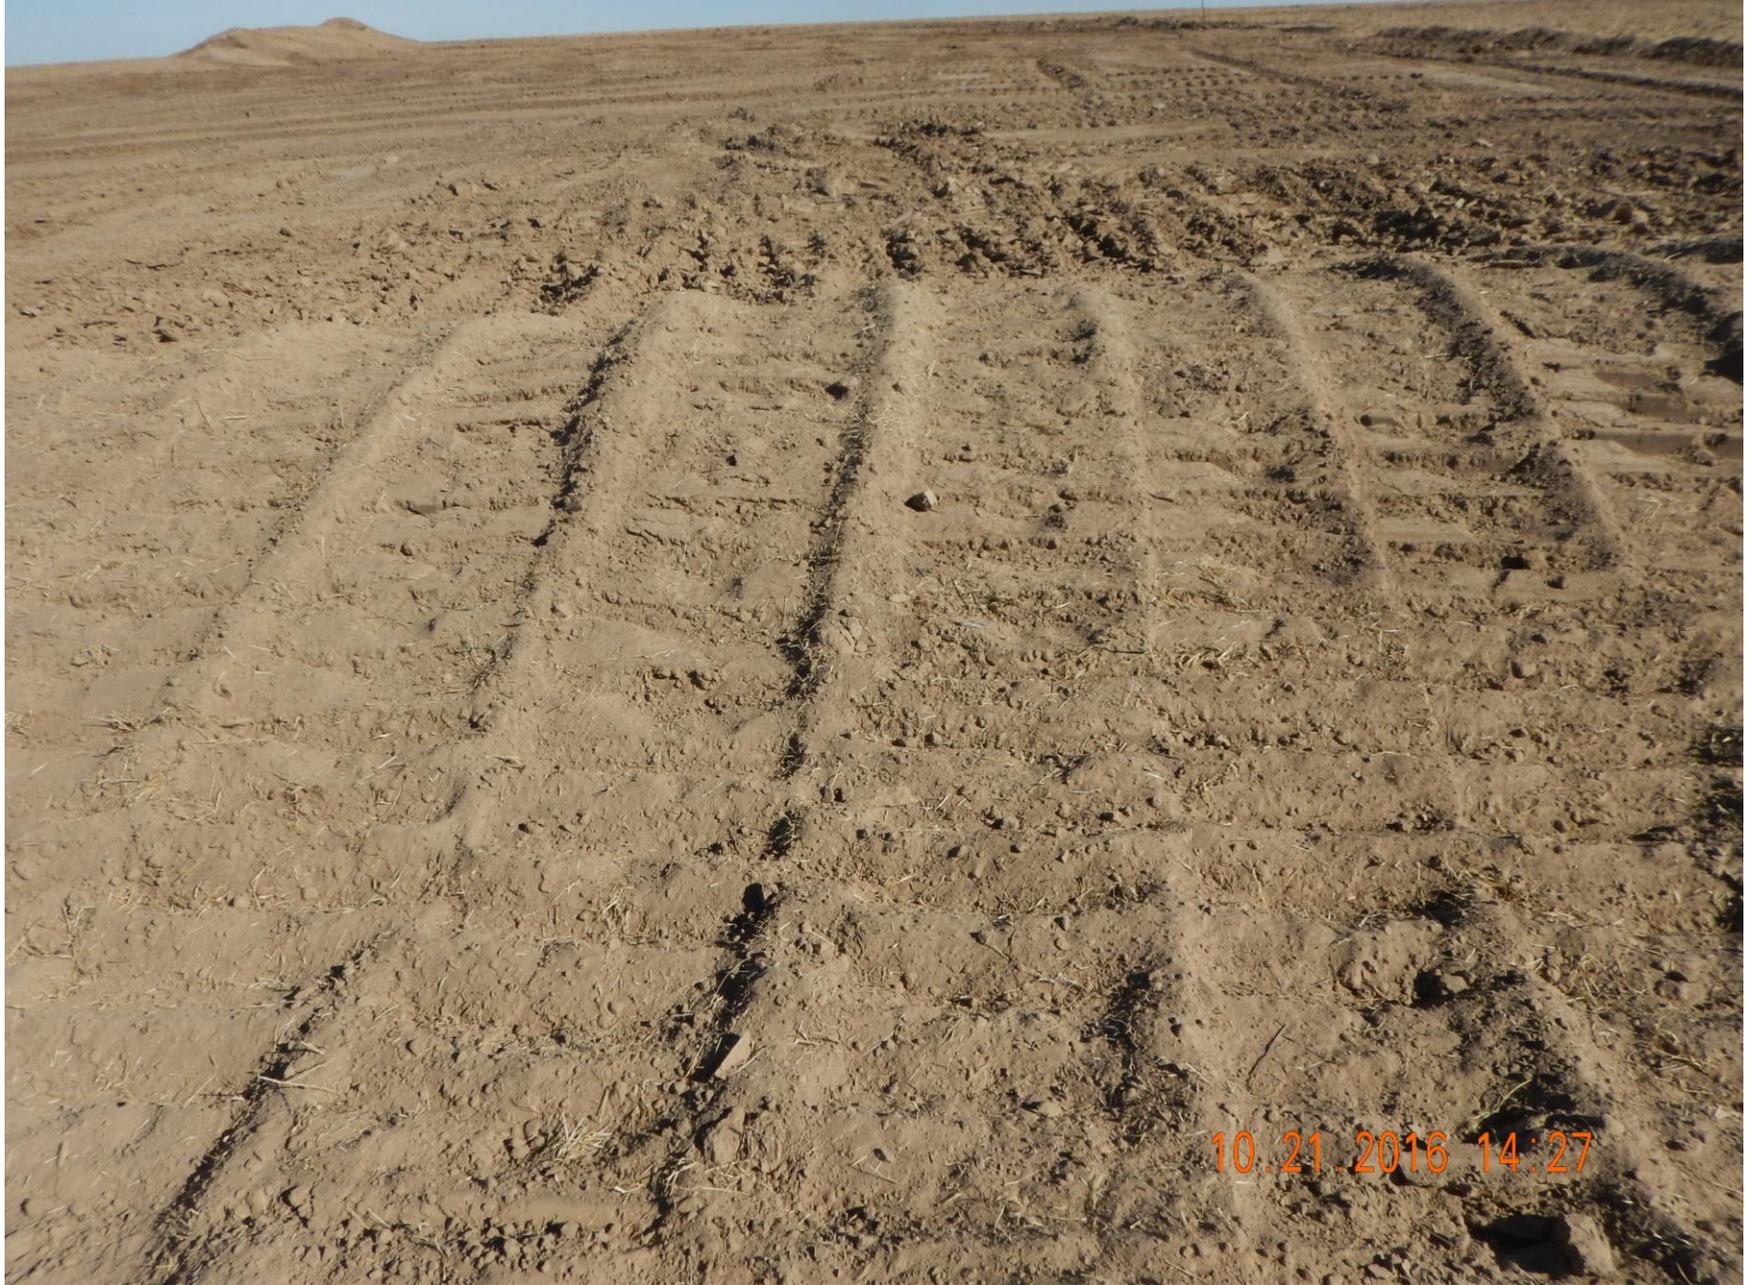
Figure 8: Photo taken from the west end of the location, facing north. Photo shows berms along the western and northern perimeter of the location have been adequately tracked.

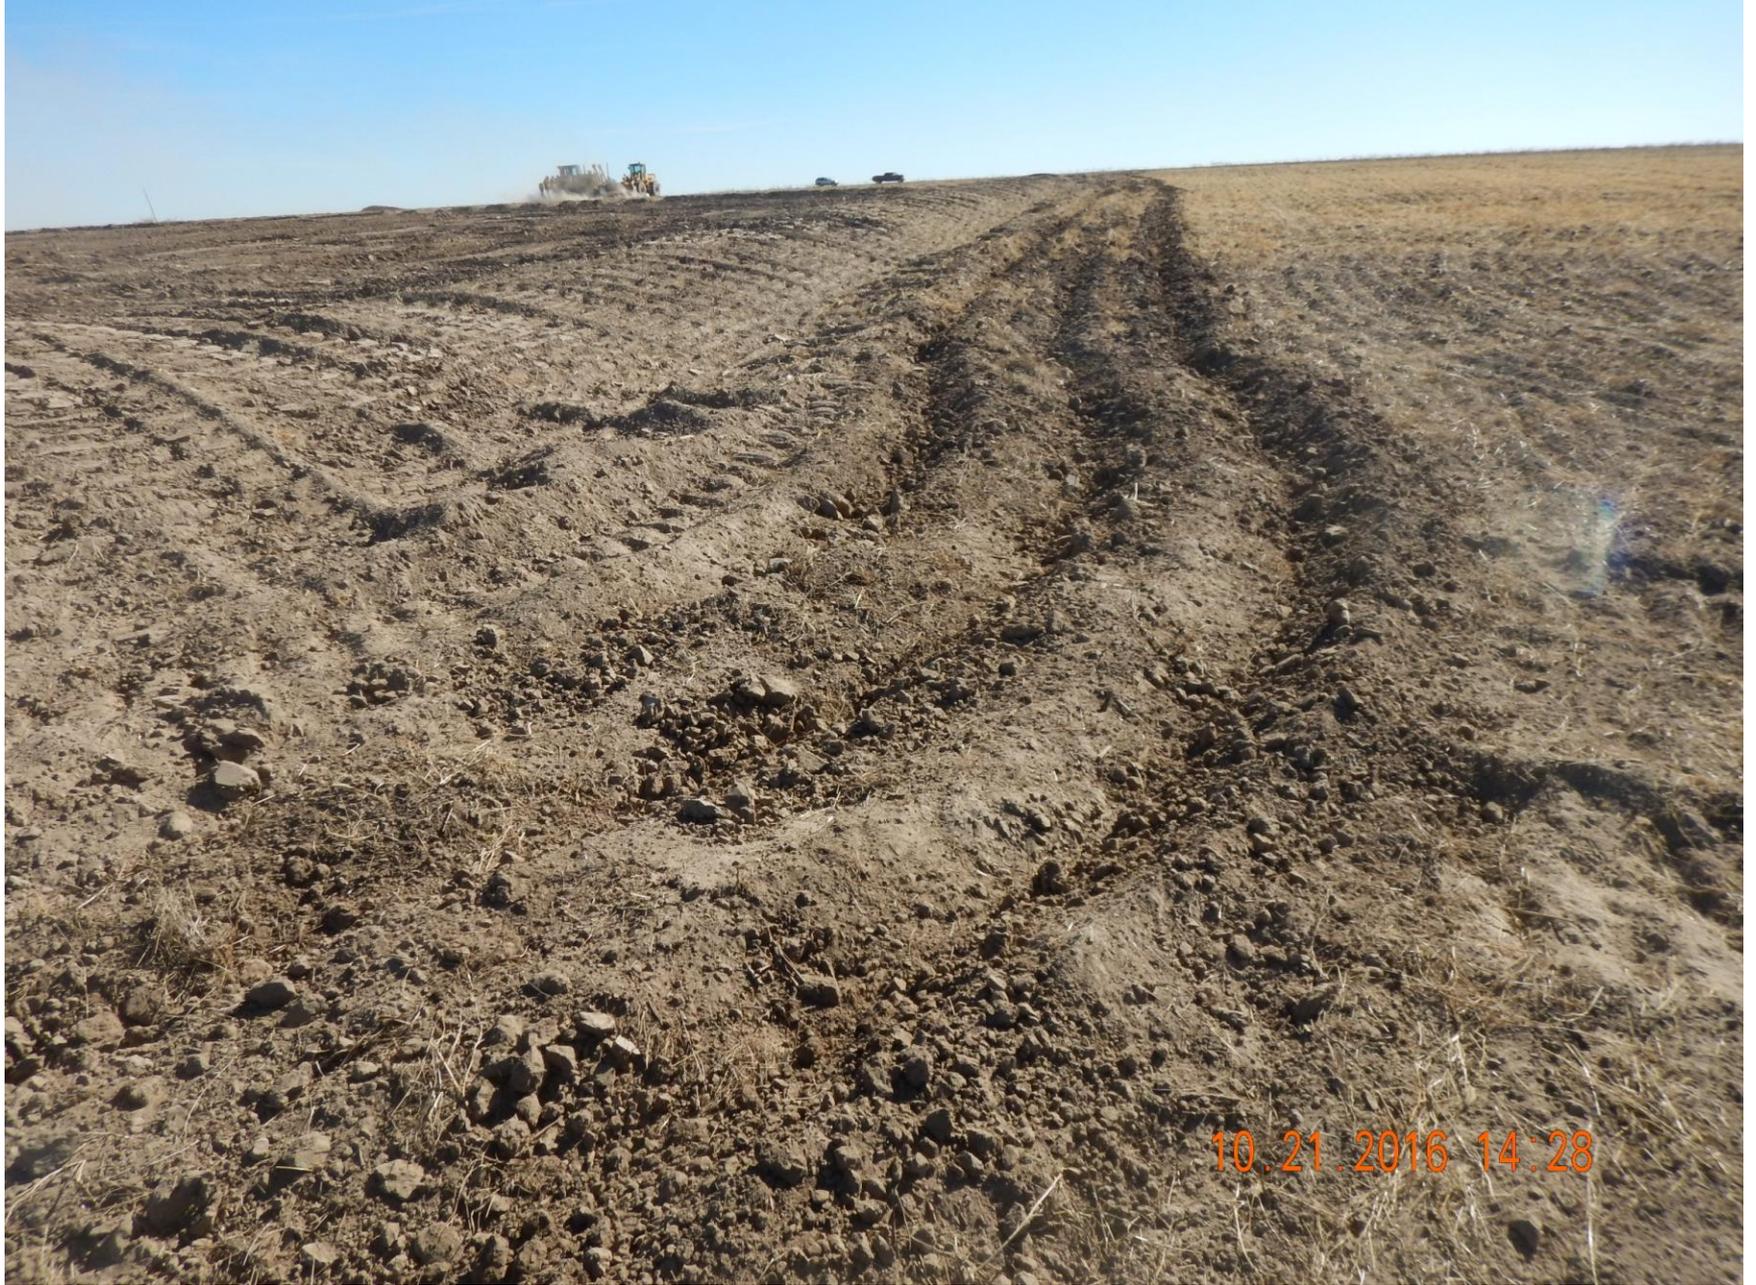
Figure 9: Photo taken from the northwest corner of the location, facing south. Photo shows surface roughening used in conjunction with berms as a stormwater and sediment control BMP.

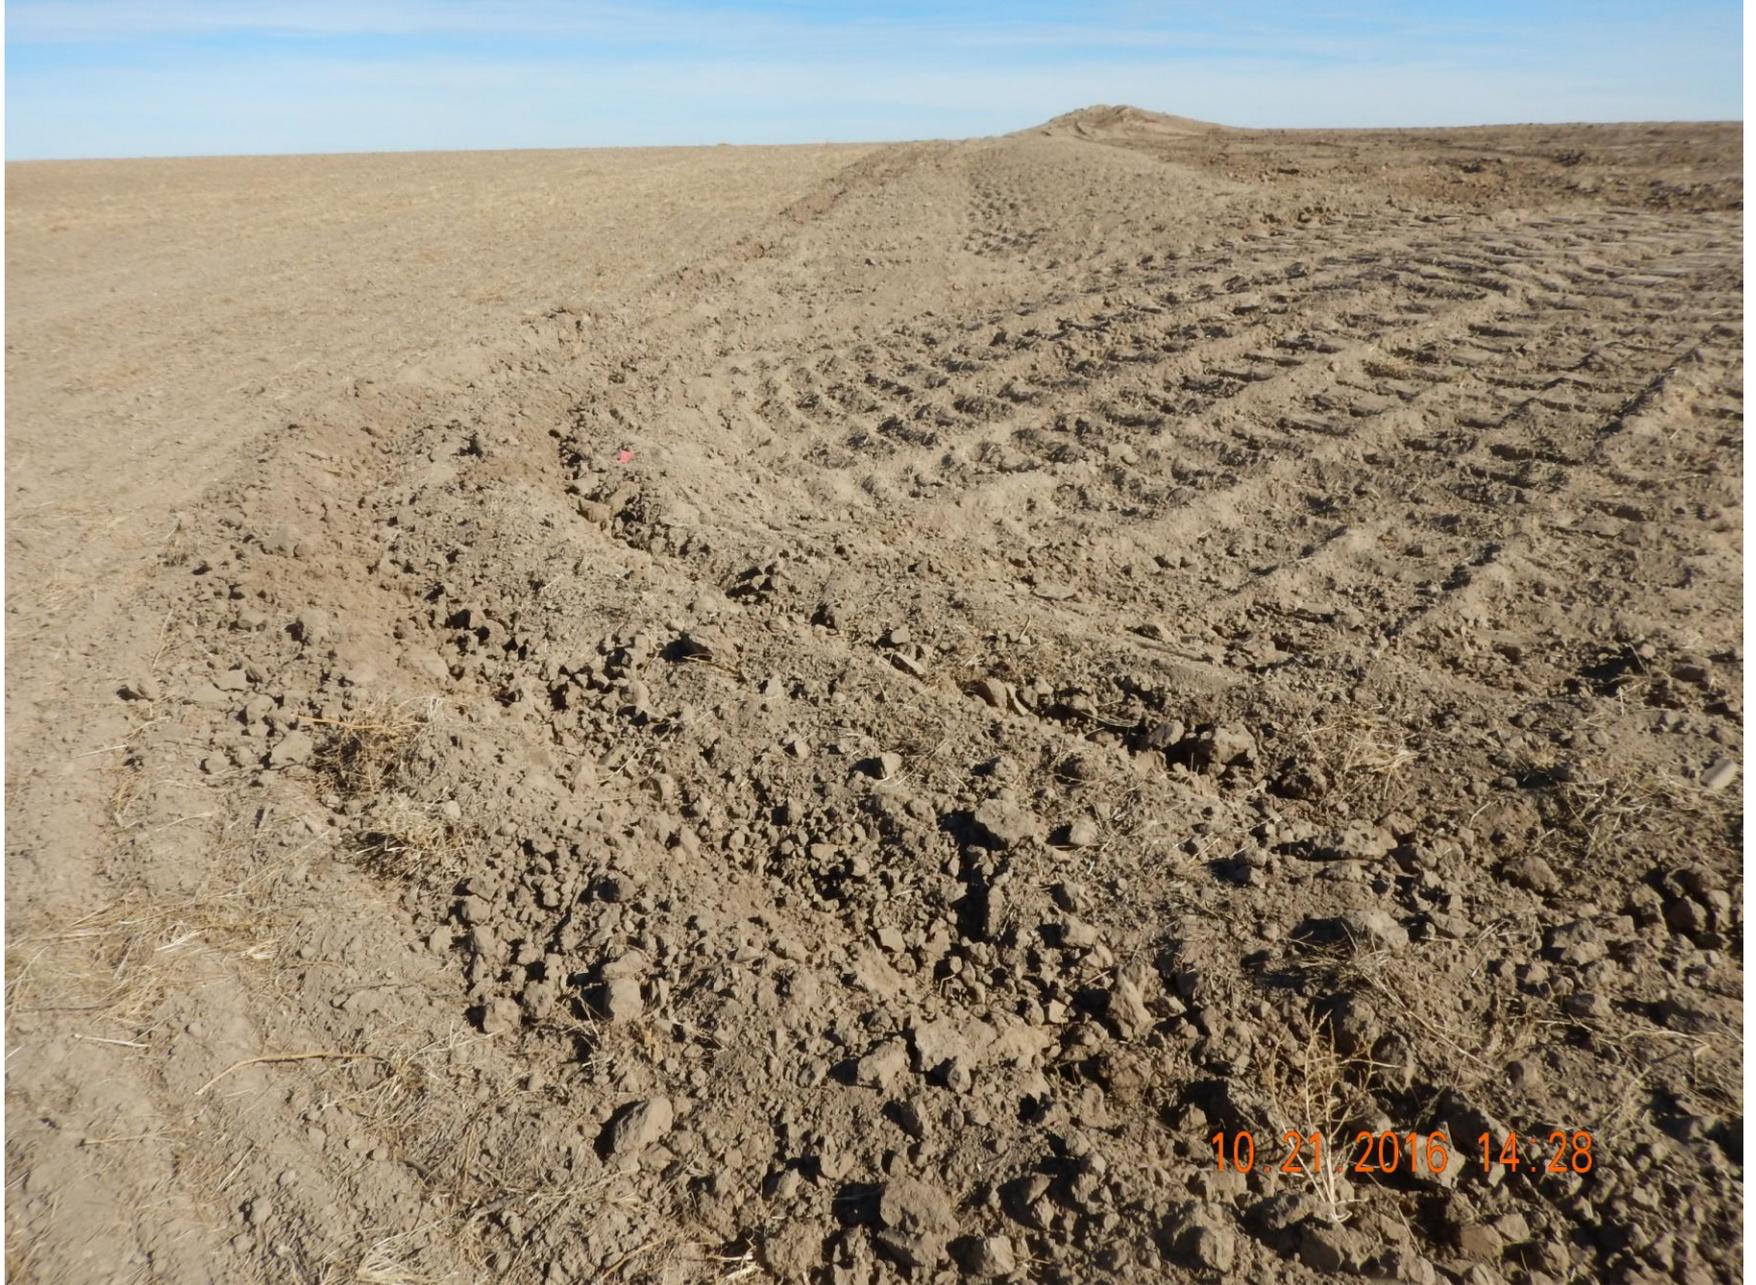
Figure 10: Photo taken from the northwest corner of the location, facing east. Photo shows surface roughening used in conjunction with berms as a stormwater and sediment control BMP.
