Construction Inspection

10/21/2016

Operator: Grand Mesa Operating Co

Location ID: 442964

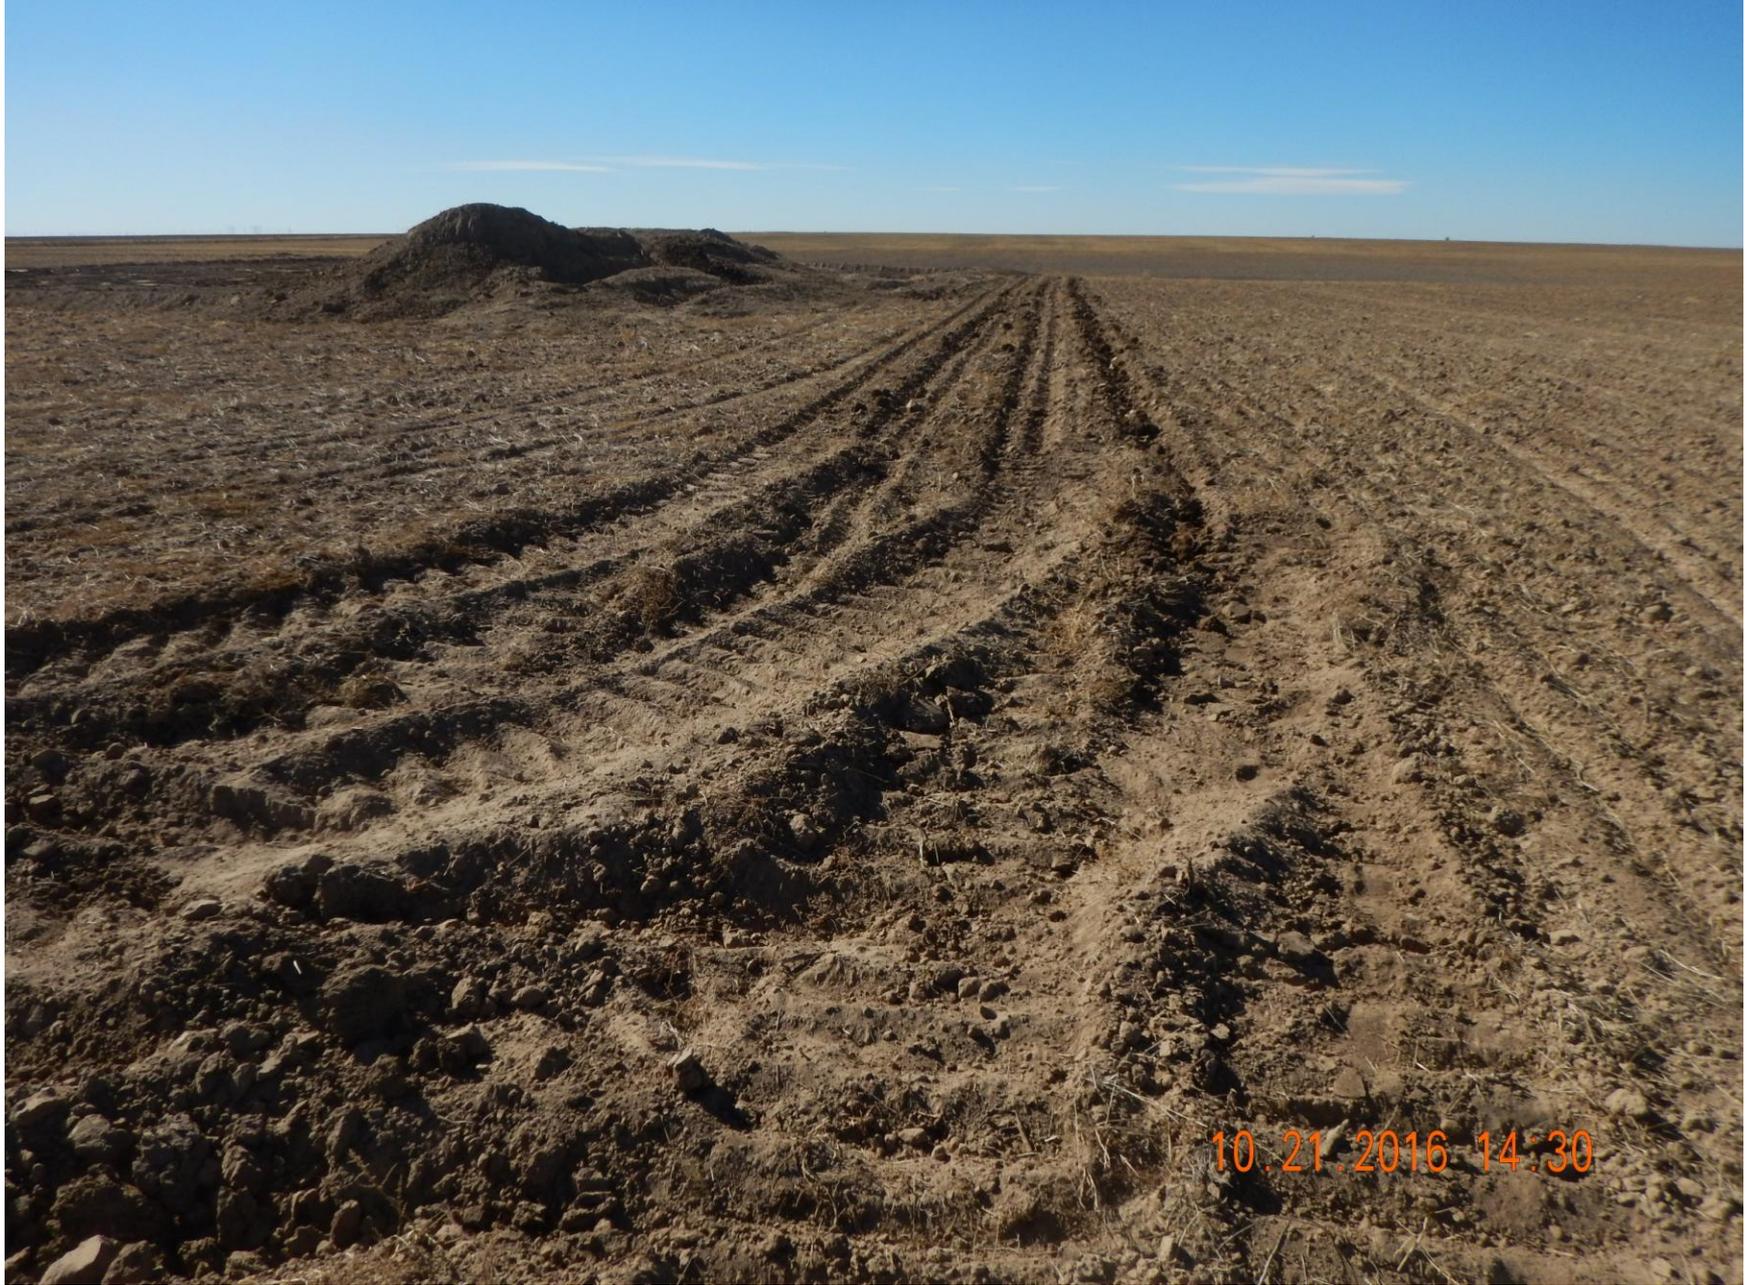
Figure 11: Photo taken from the northeast corner of the location, facing west. Photo shows surface roughening implemented around perimeter of location. Topsoil stockpile to the top right of the photo.

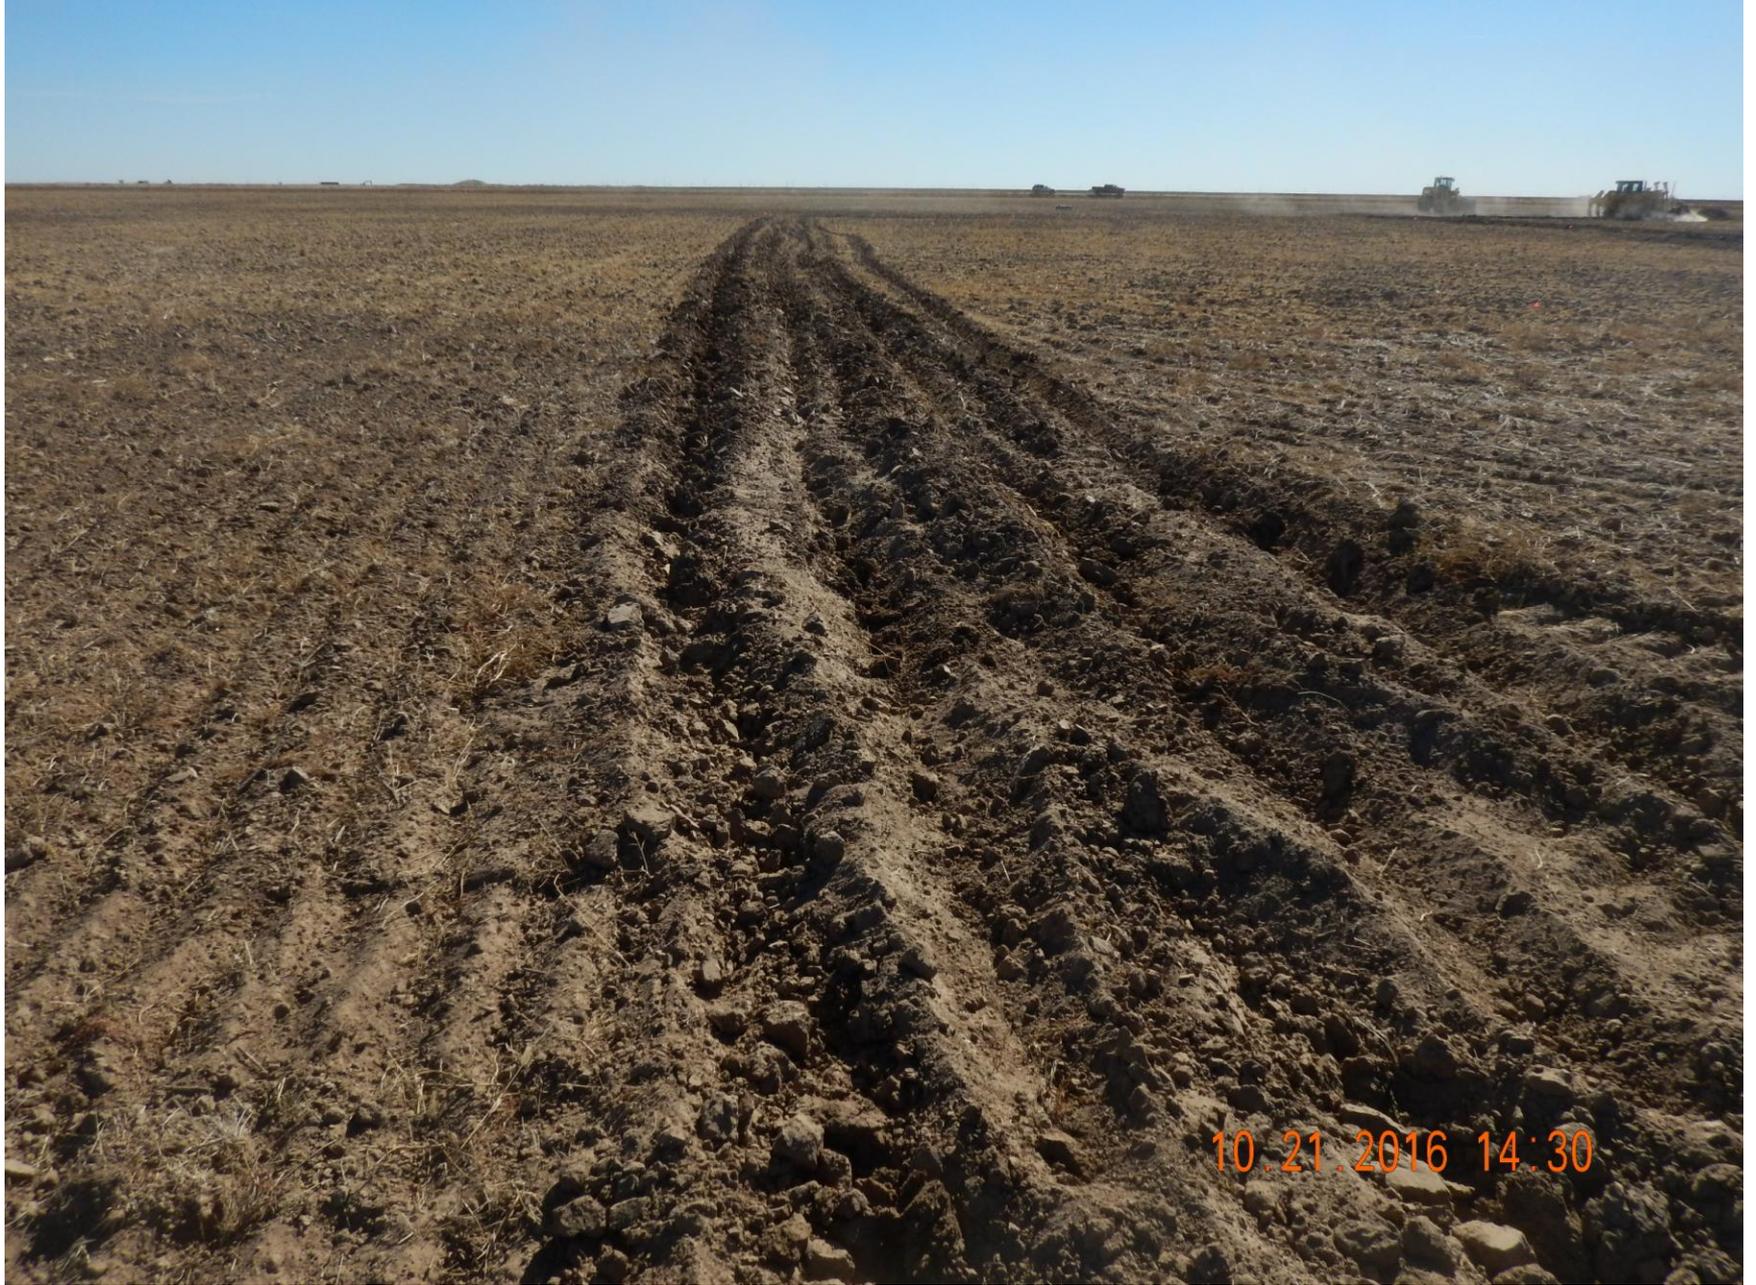
Figure 12: Photo taken from the northeast corner of the location, facing south. Photo shows surface roughening implemented around perimeter of location.

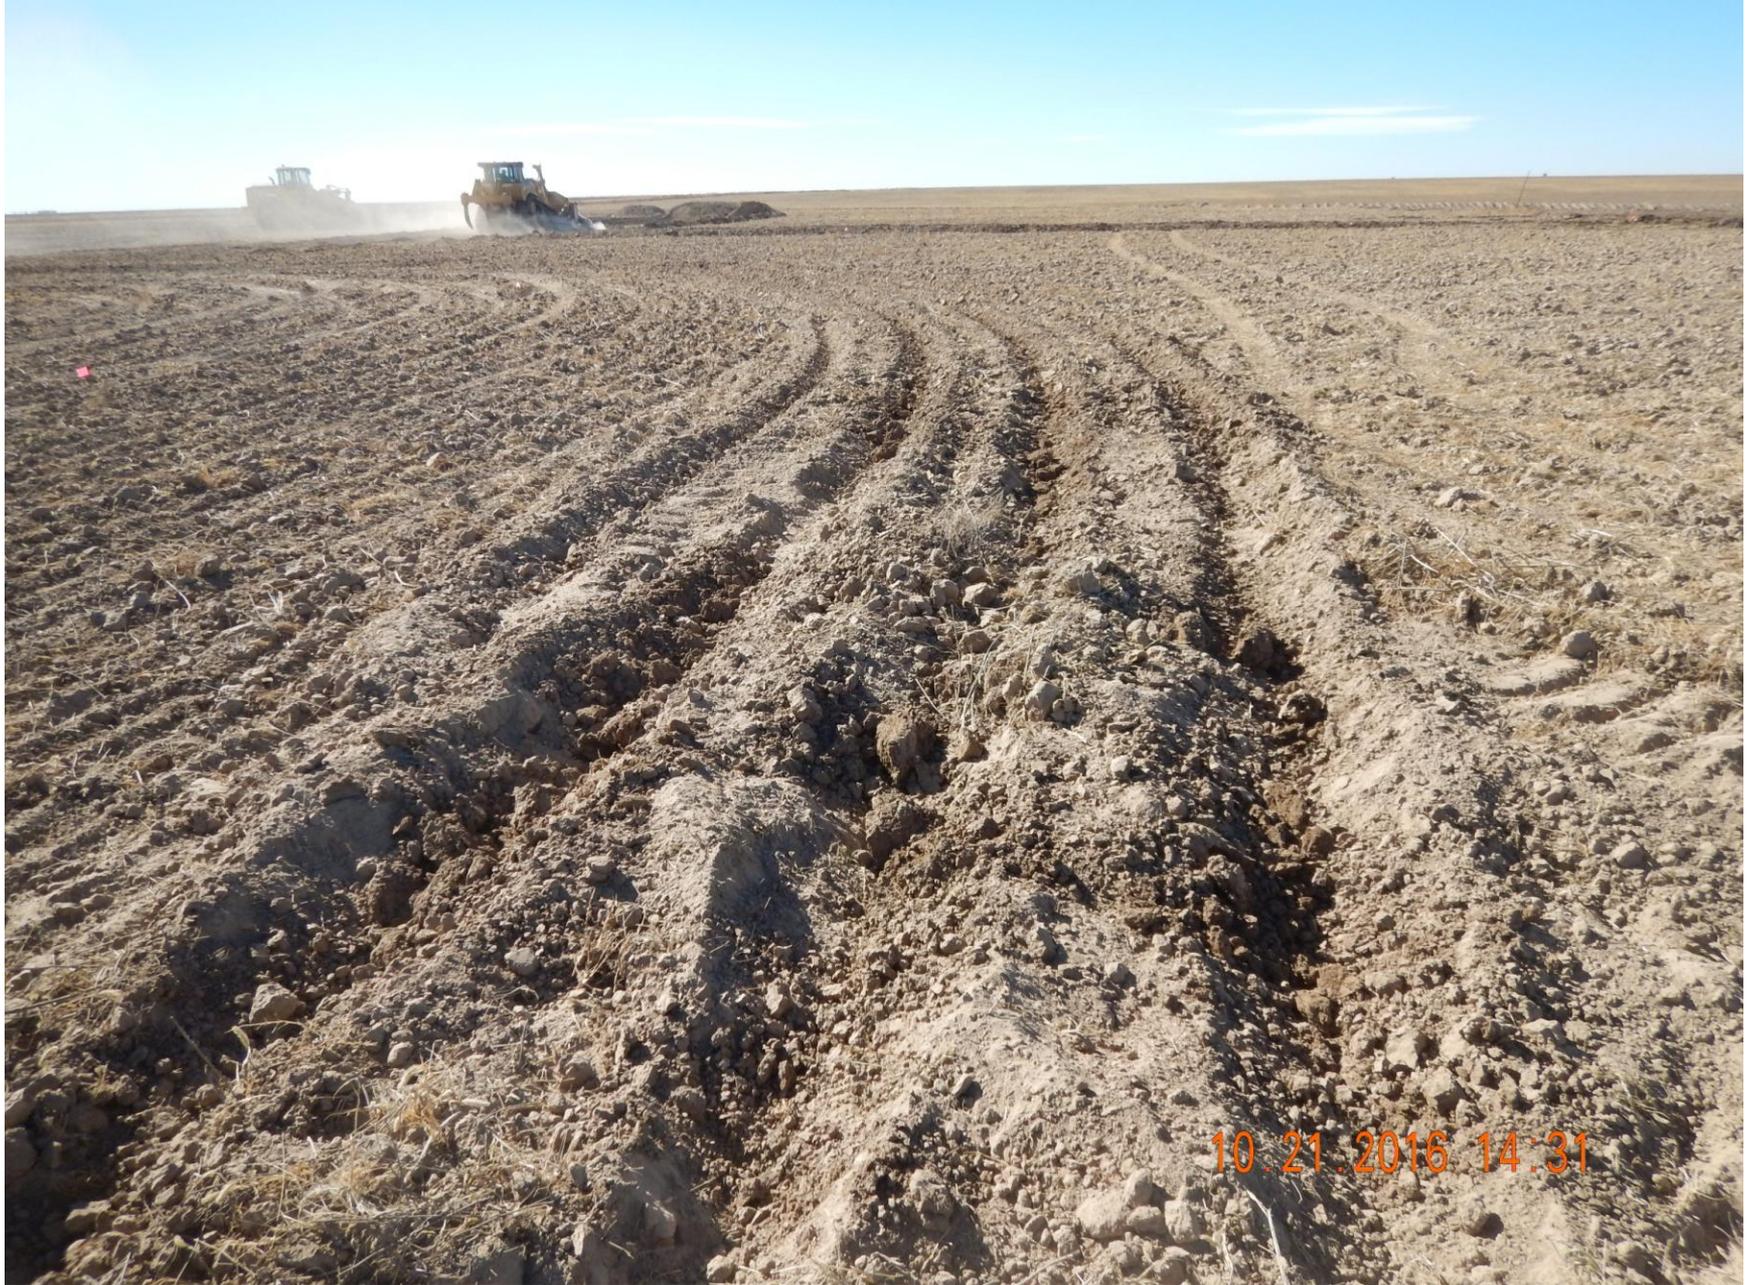
Figure 13: Photo taken from the southeast corner of the location, facing west. Photo shows surface roughening implemented around perimeter of location.

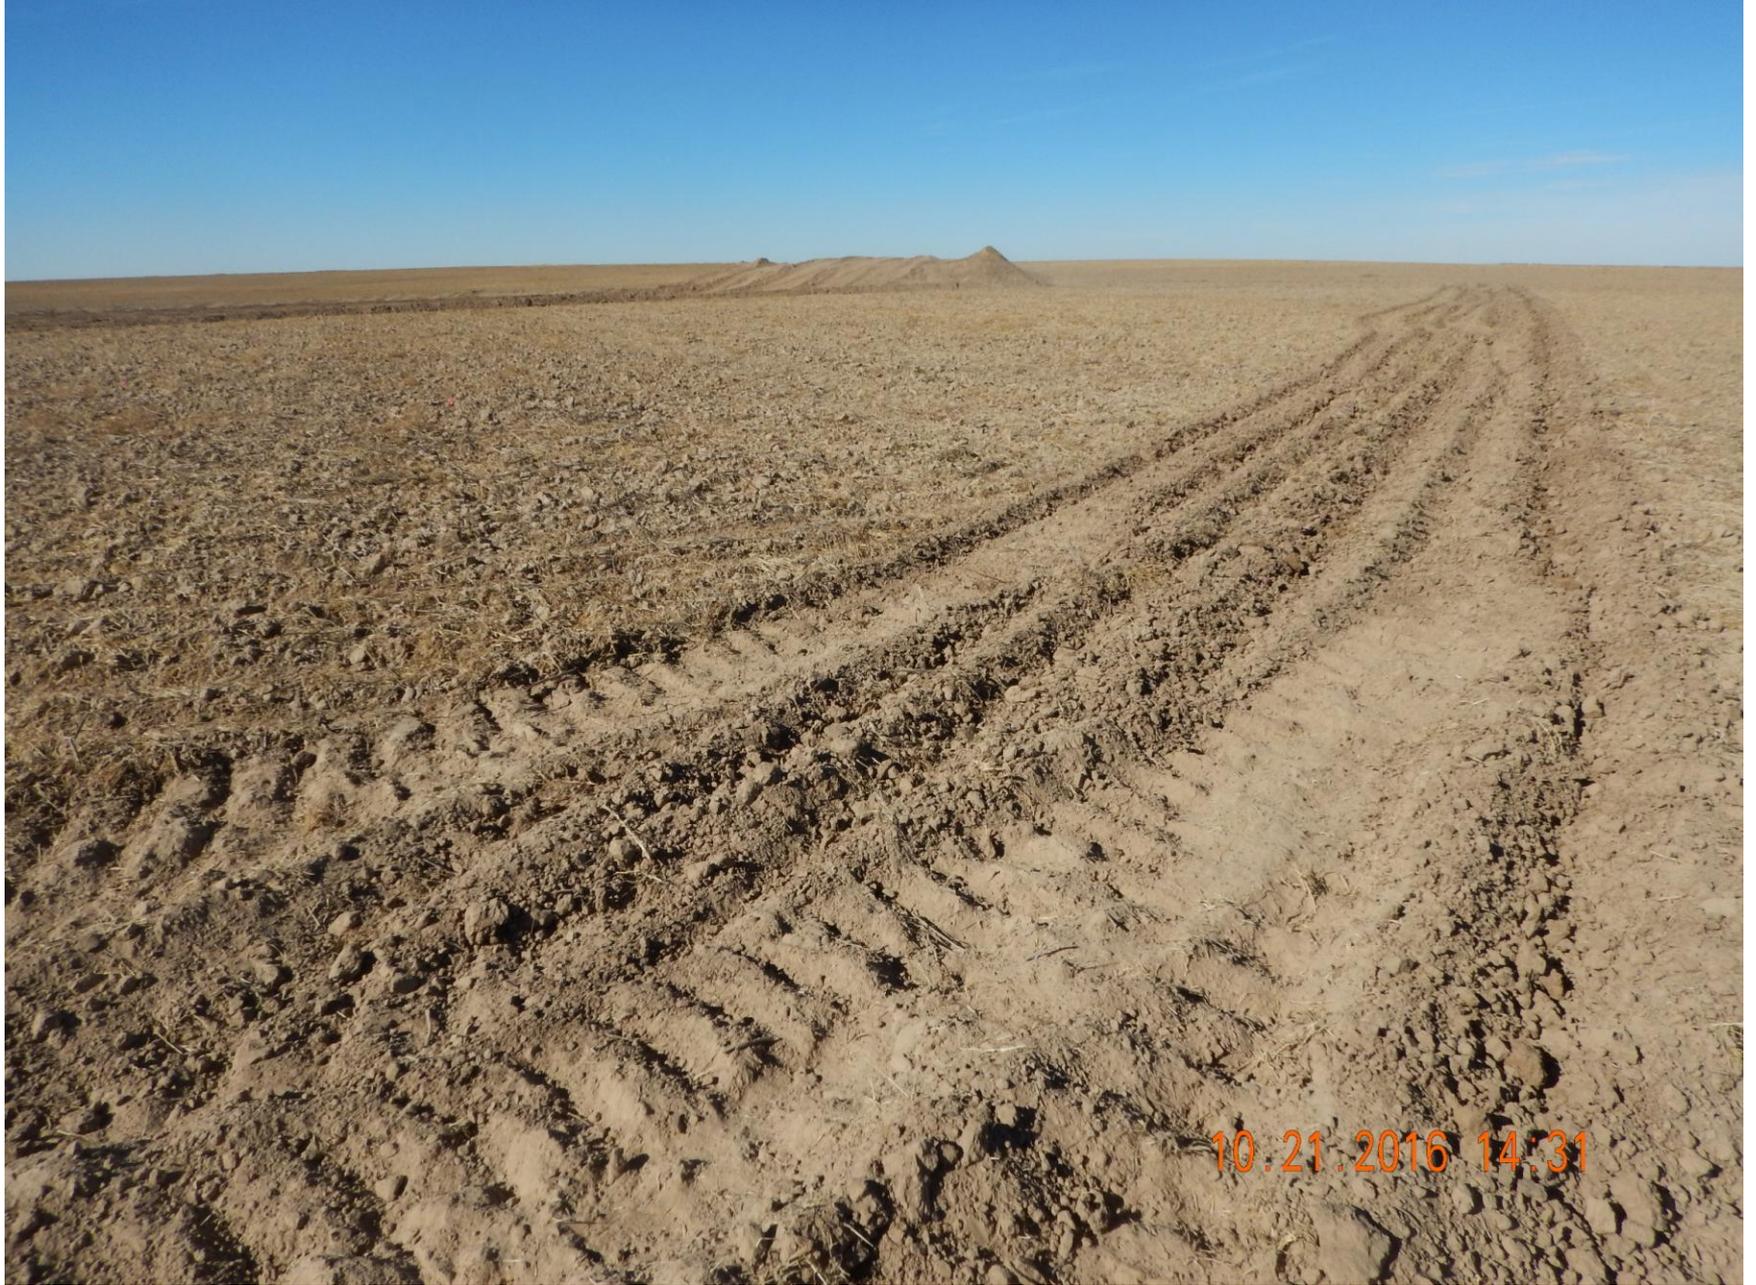
Figure 14: Photo taken from the southeast corner of the location, facing north. Photo shows surface roughening implemented around perimeter of location

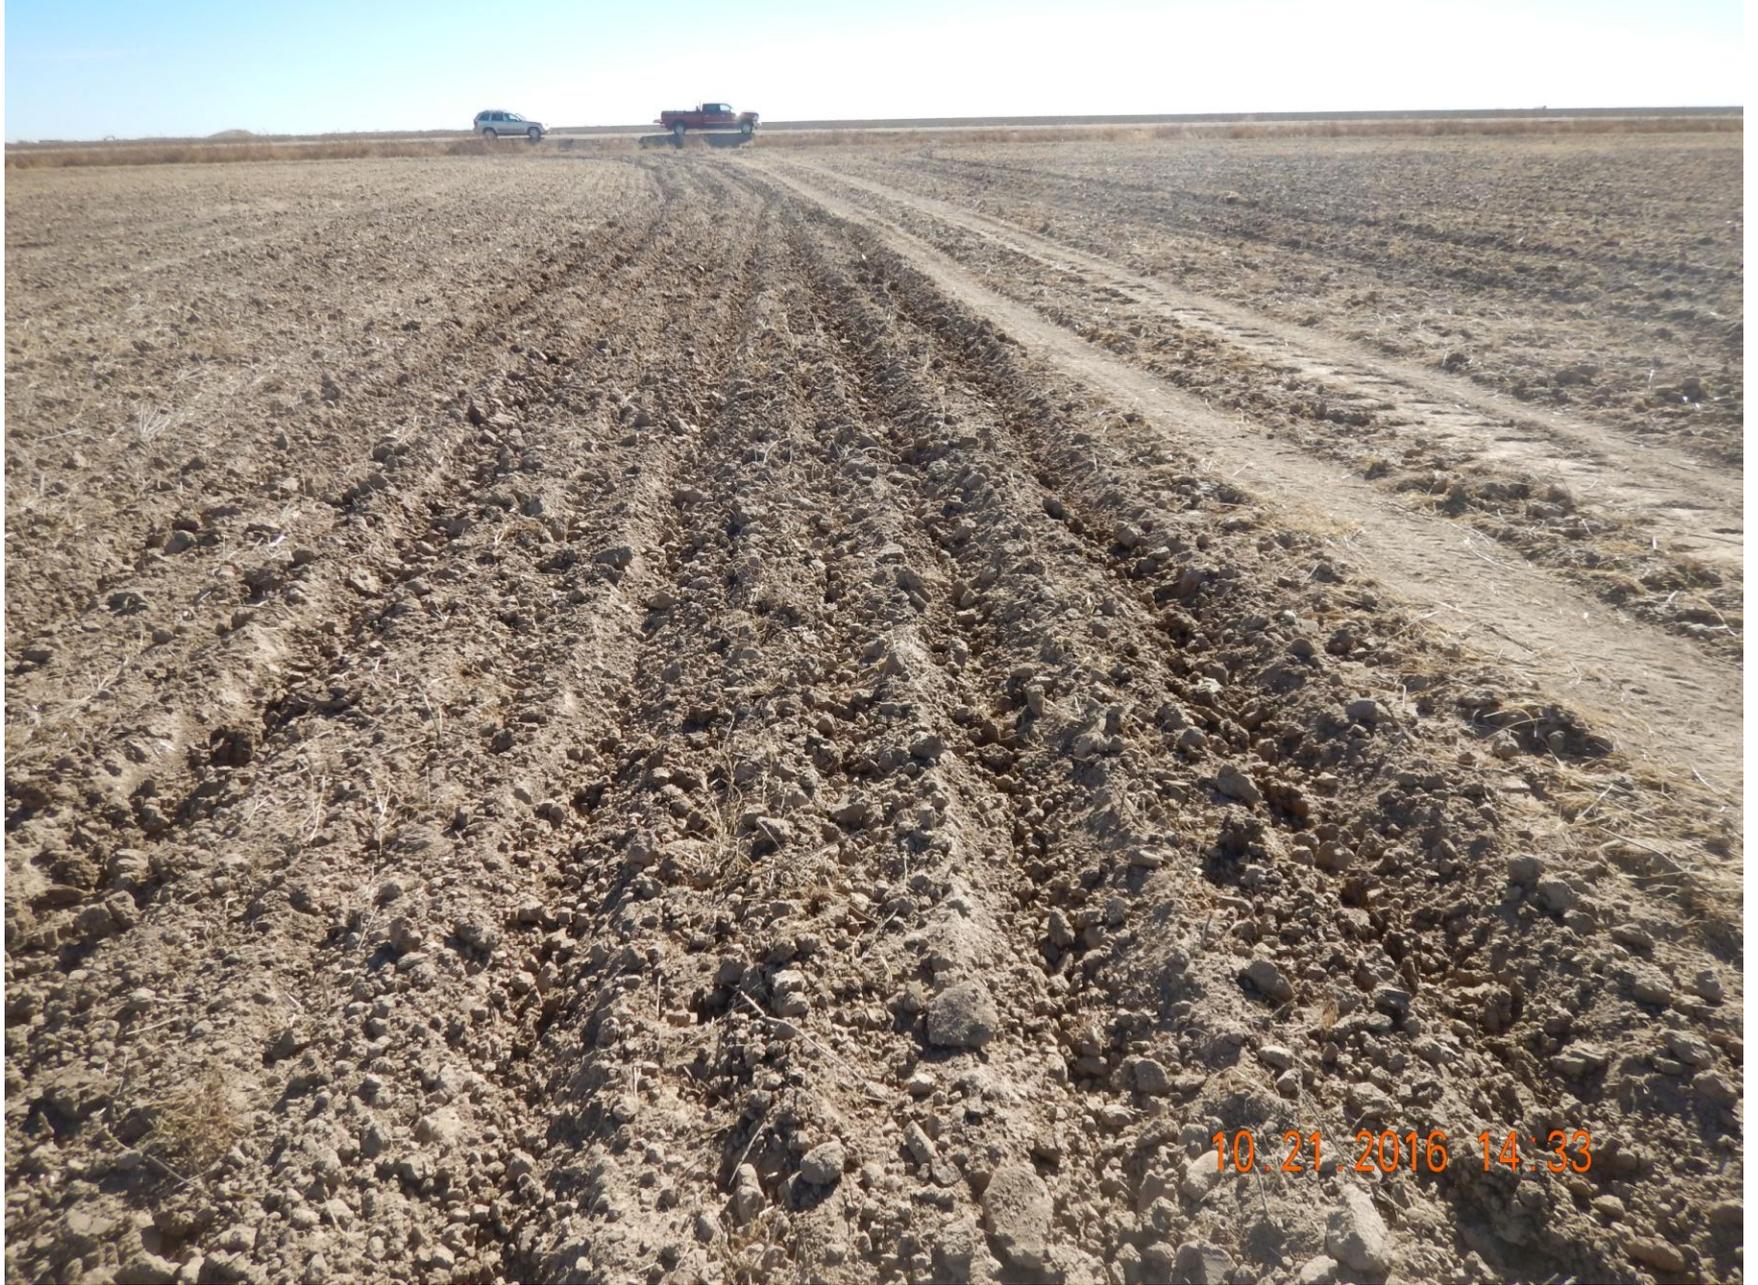
Figure 15: Photo taken from the south end of the location, facing south. Photo shows surface roughening implemented around perimeter of location
