## Final Reclamation Inspection

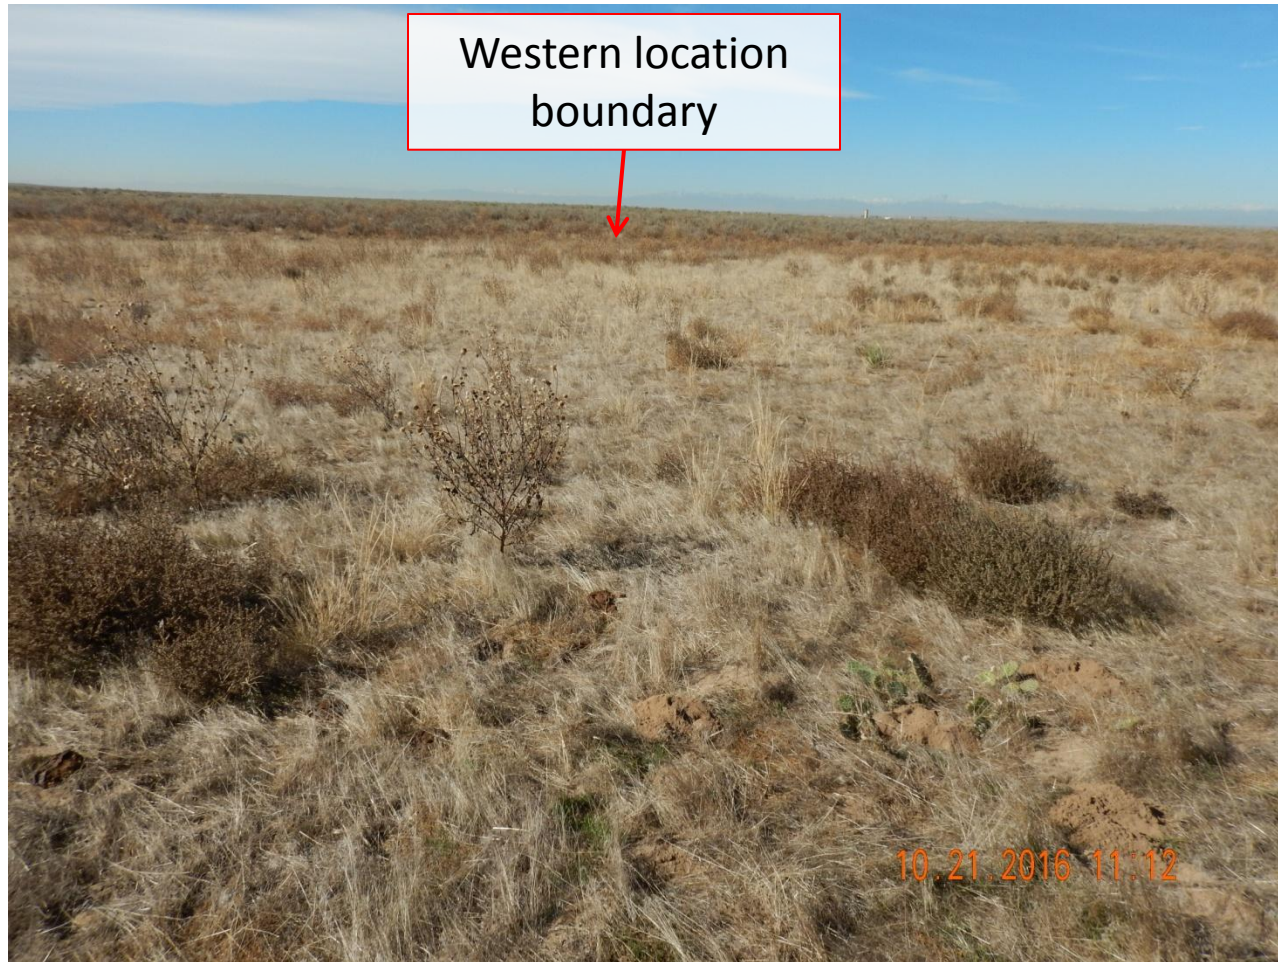
**Photo 1.** Photo taken from center of location, facing West. Native, perennial grass has established on the western half of the location but lacks on the eastern half of the location. Native, perennial shrubs have not established at location which is not reflective of reference areas.

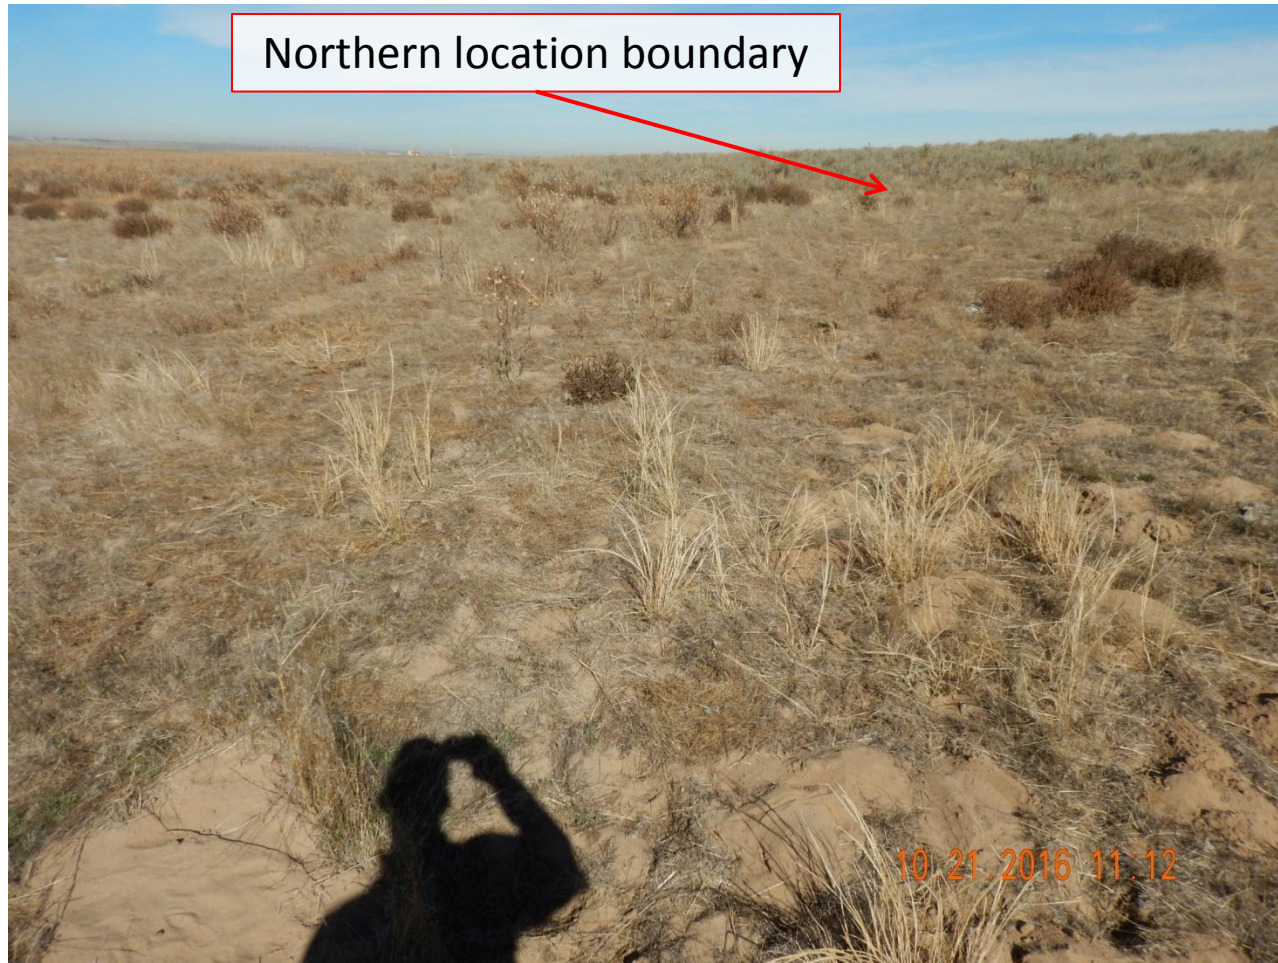
**Photo 2.** Photo taken from center of location, facing North. Native, perennial grass has established on the western half of the location but lacks on the eastern half of the location. Native, perennial shrubs have not established at location which is not reflective of reference areas.

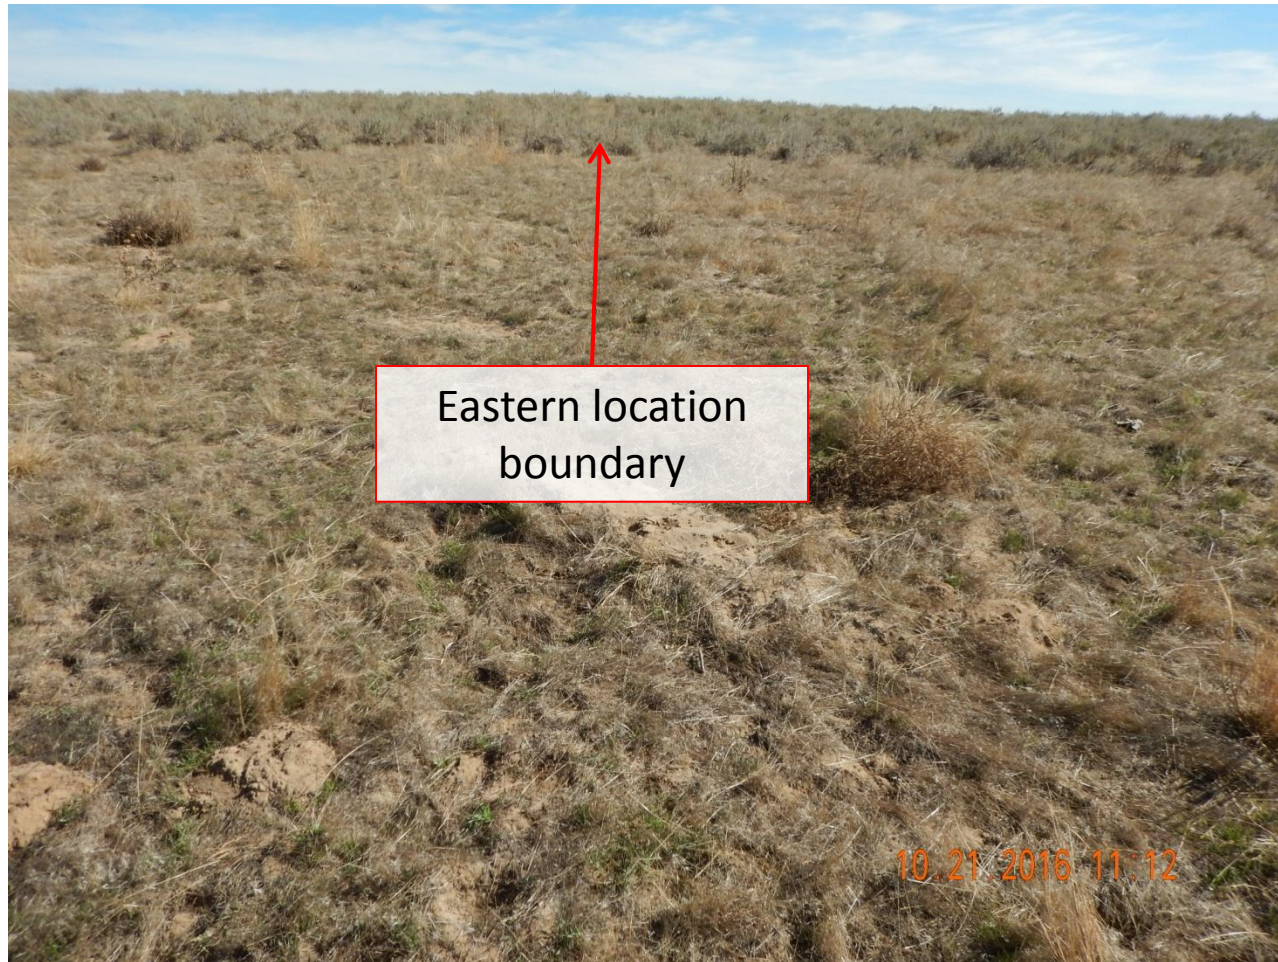
**Photo 3.** Photo taken from center of location, facing East. Native, perennial grass has established on the western half of the location but lacks on the eastern half of the location. Native, perennial shrubs have not established at location which is not reflective of reference areas.

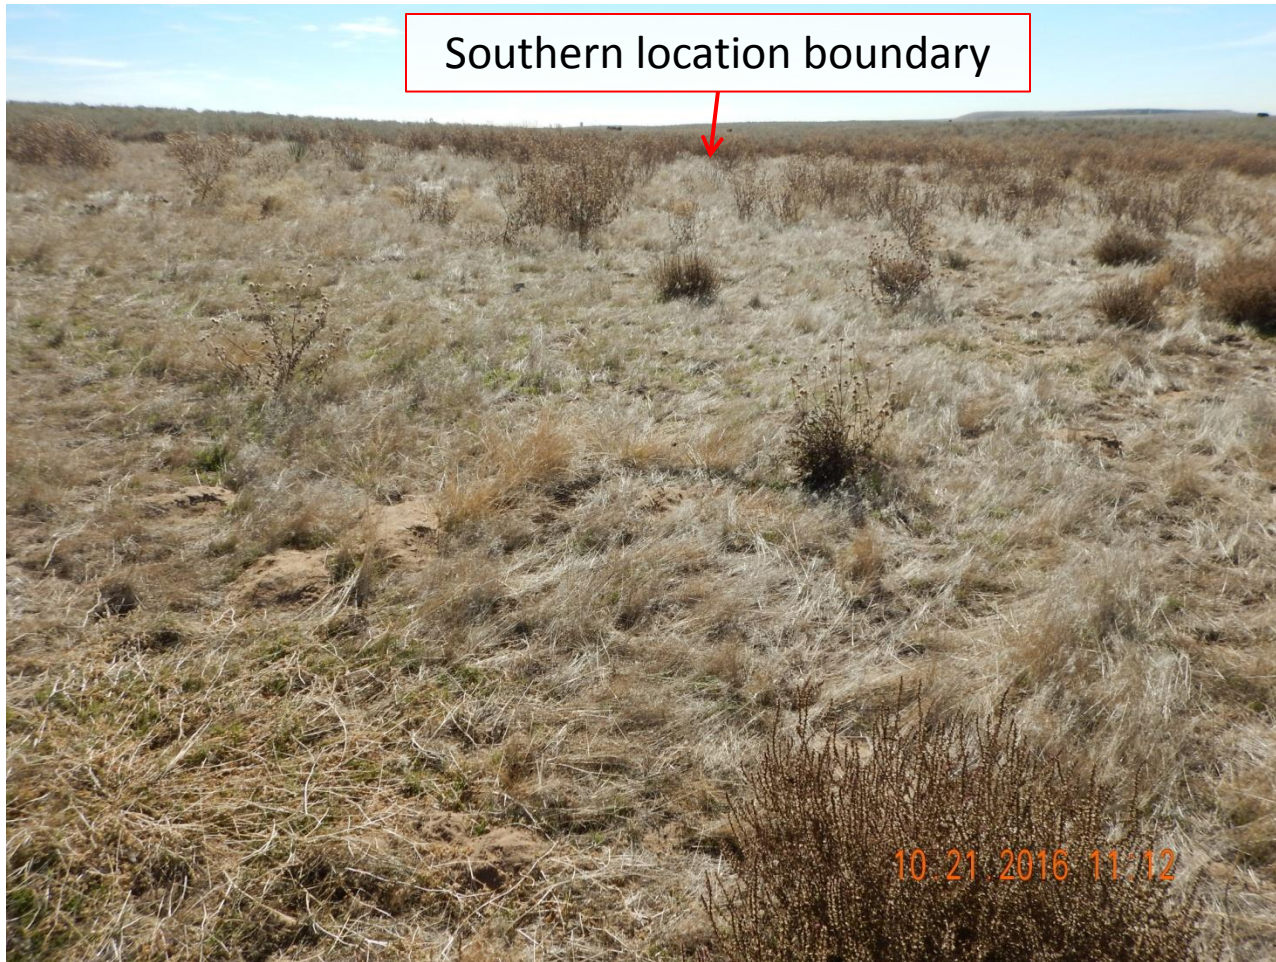
**Photo 4.** Photo taken from center of location, facing South. Native, perennial grass has established on the western half of the location but lacks on the eastern half of the location. Native, perennial shrubs have not established at location which is not reflective of reference areas.

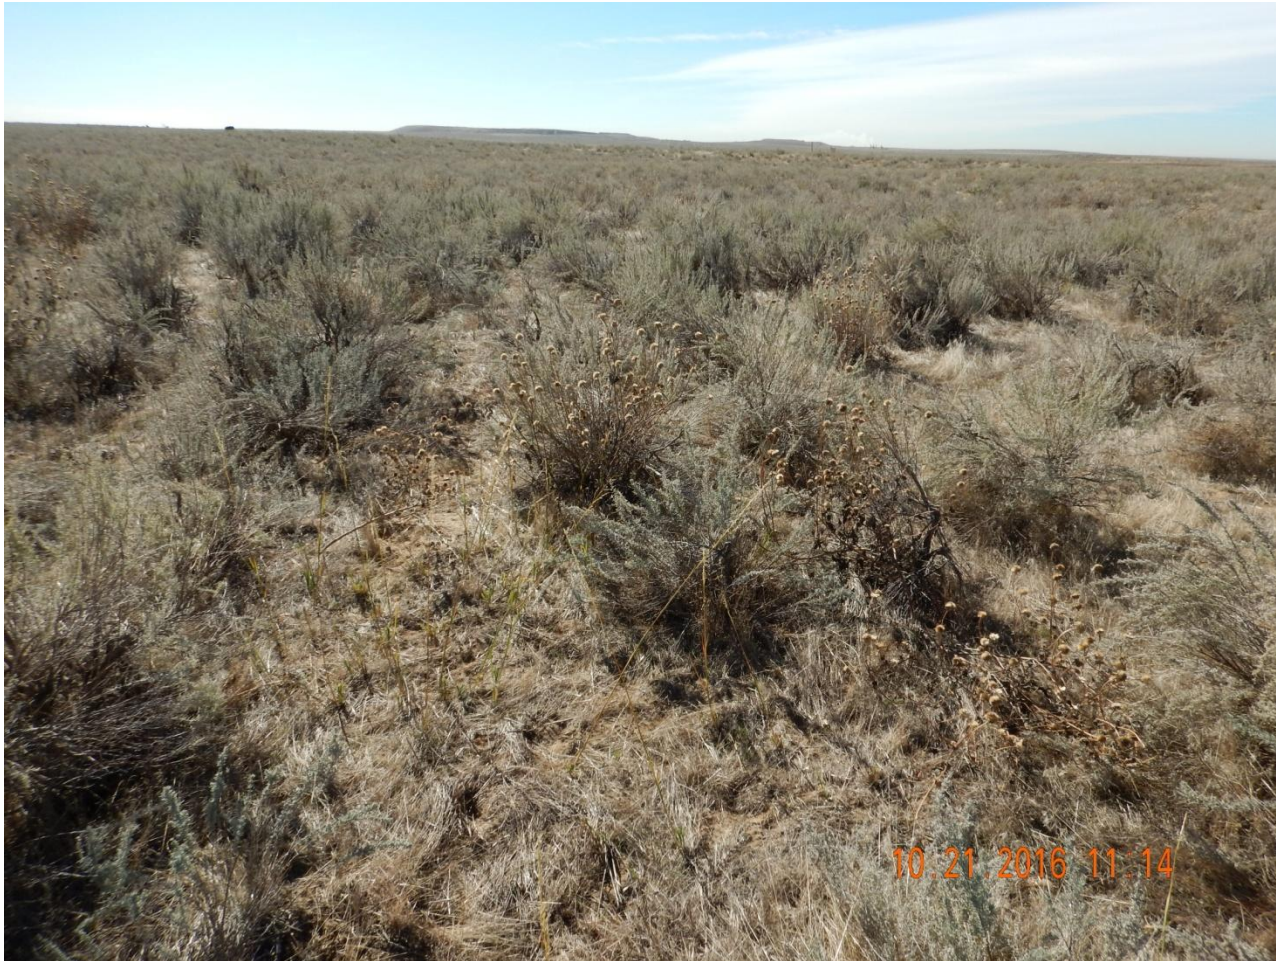
**Photo 5.** Reference photo taken west of location, facing South. Location is still IN-PROCESS. Location is not reflective of reference areas as illustrated with this photo.
