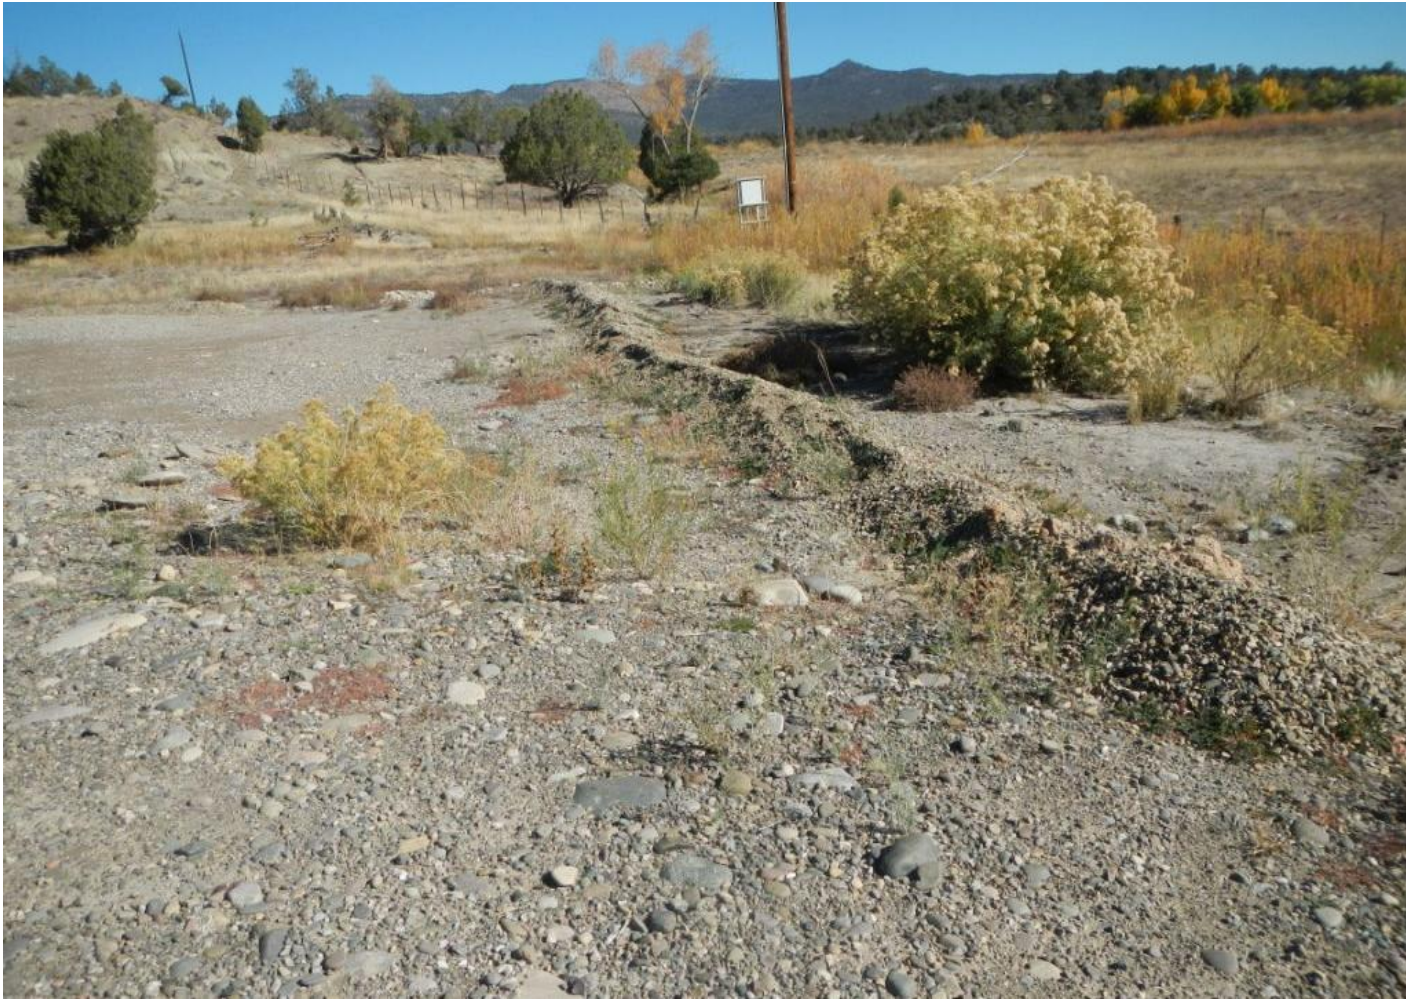
Photo 1. View of the eastern portion of the project area where a new berm was installed, from southeastern corner facing northward.

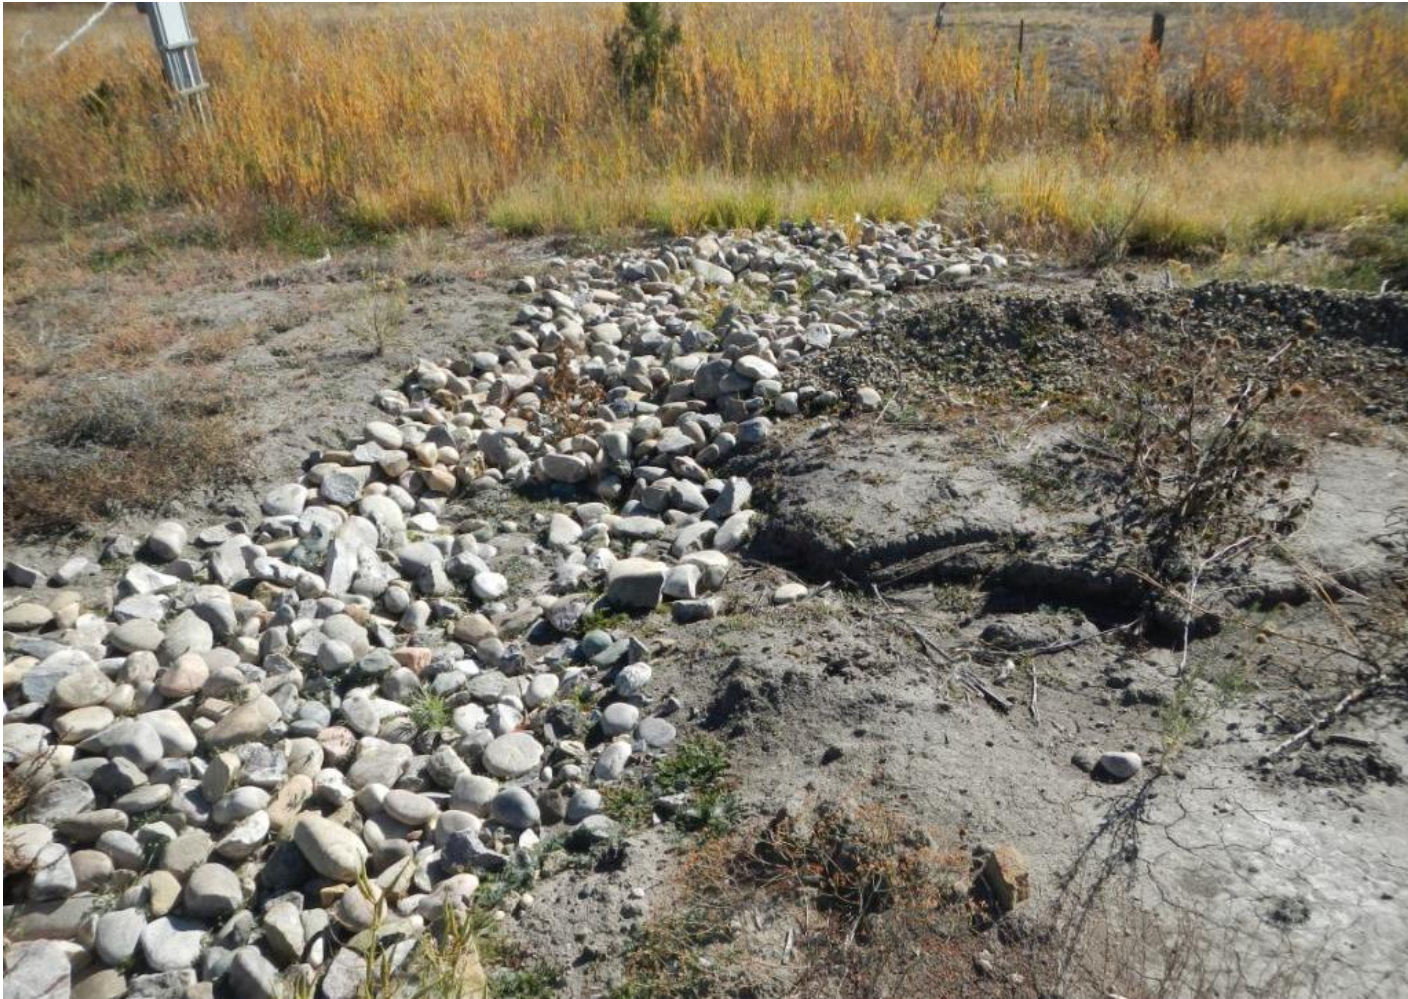
Photo 2. View of new cobble run-down in the northeastern corner of the project area.

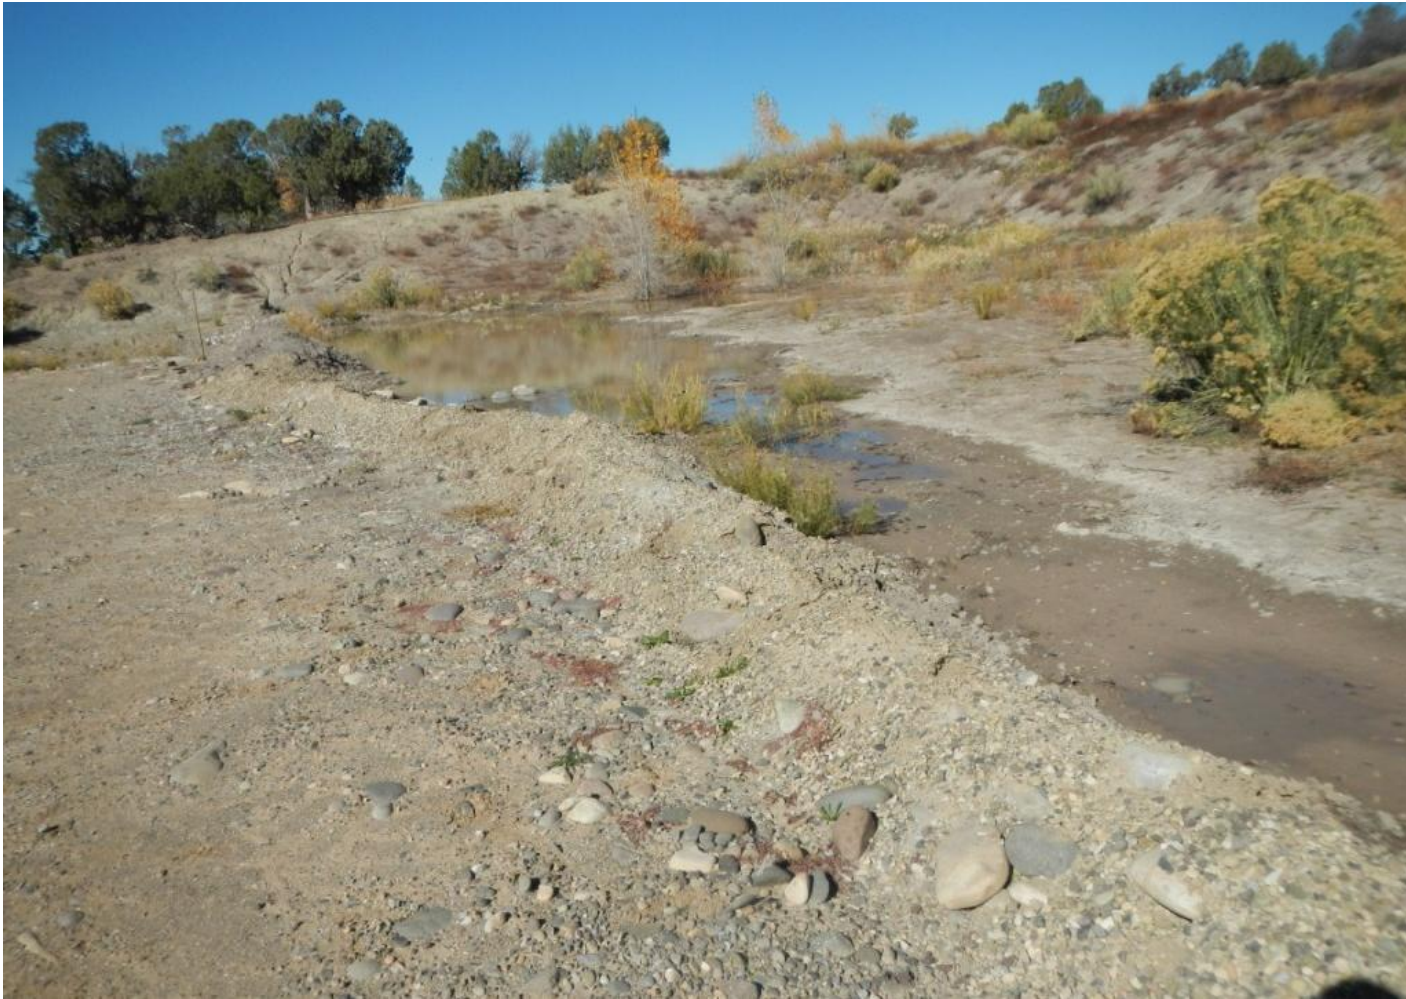
Photo 3. View of new berm on the northern edge of the working area, appears to be functioning.

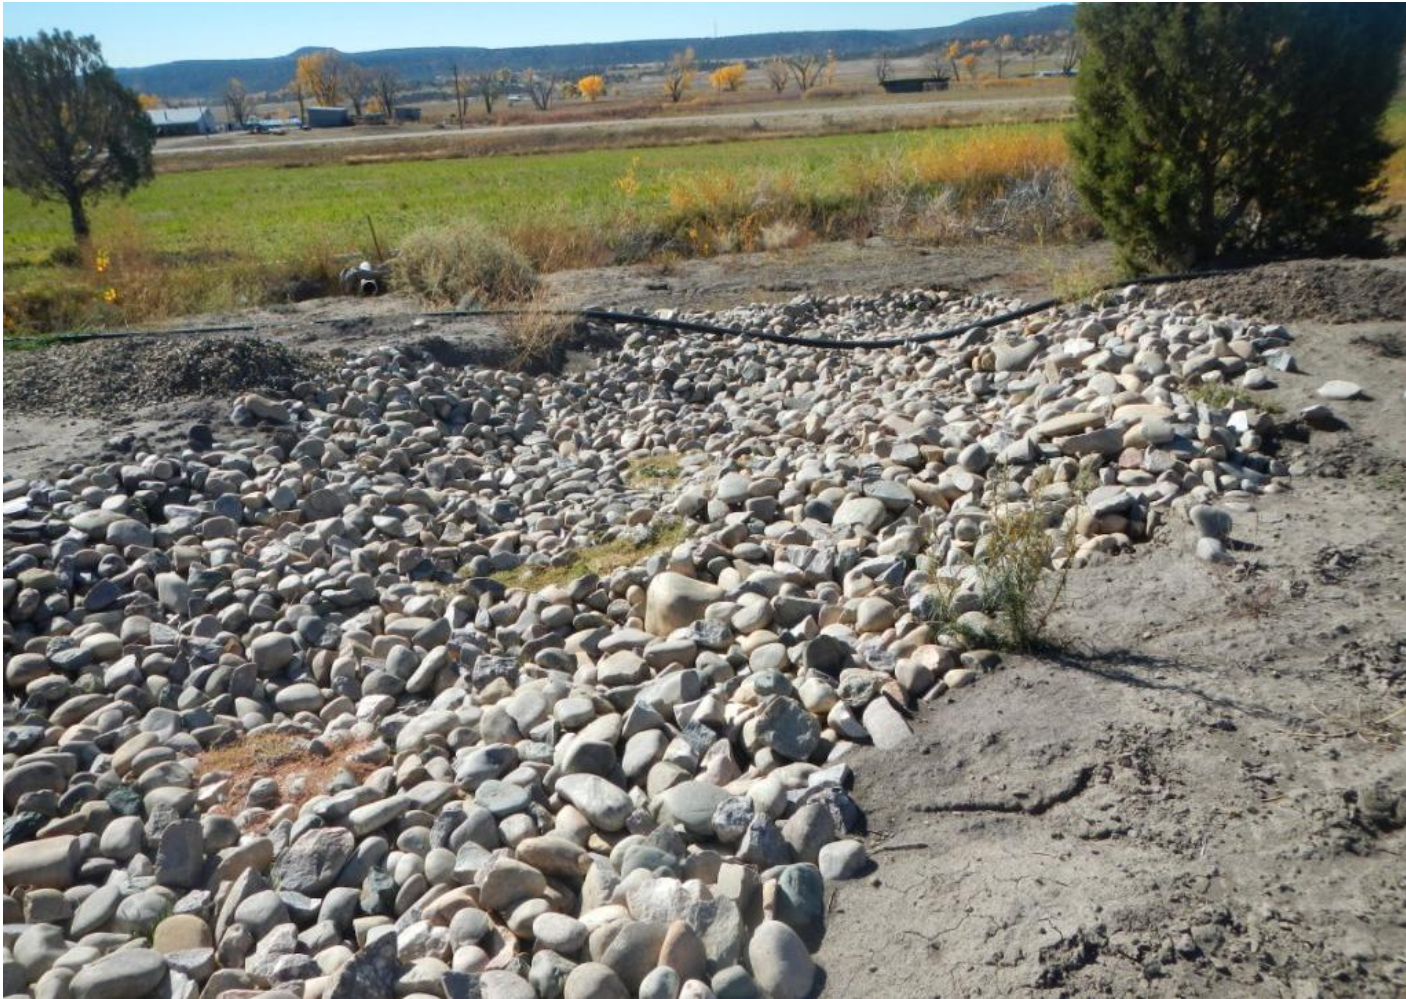
Photo 4. View cobble run-down in the southwestern corner of the project area, appears to be functioning.

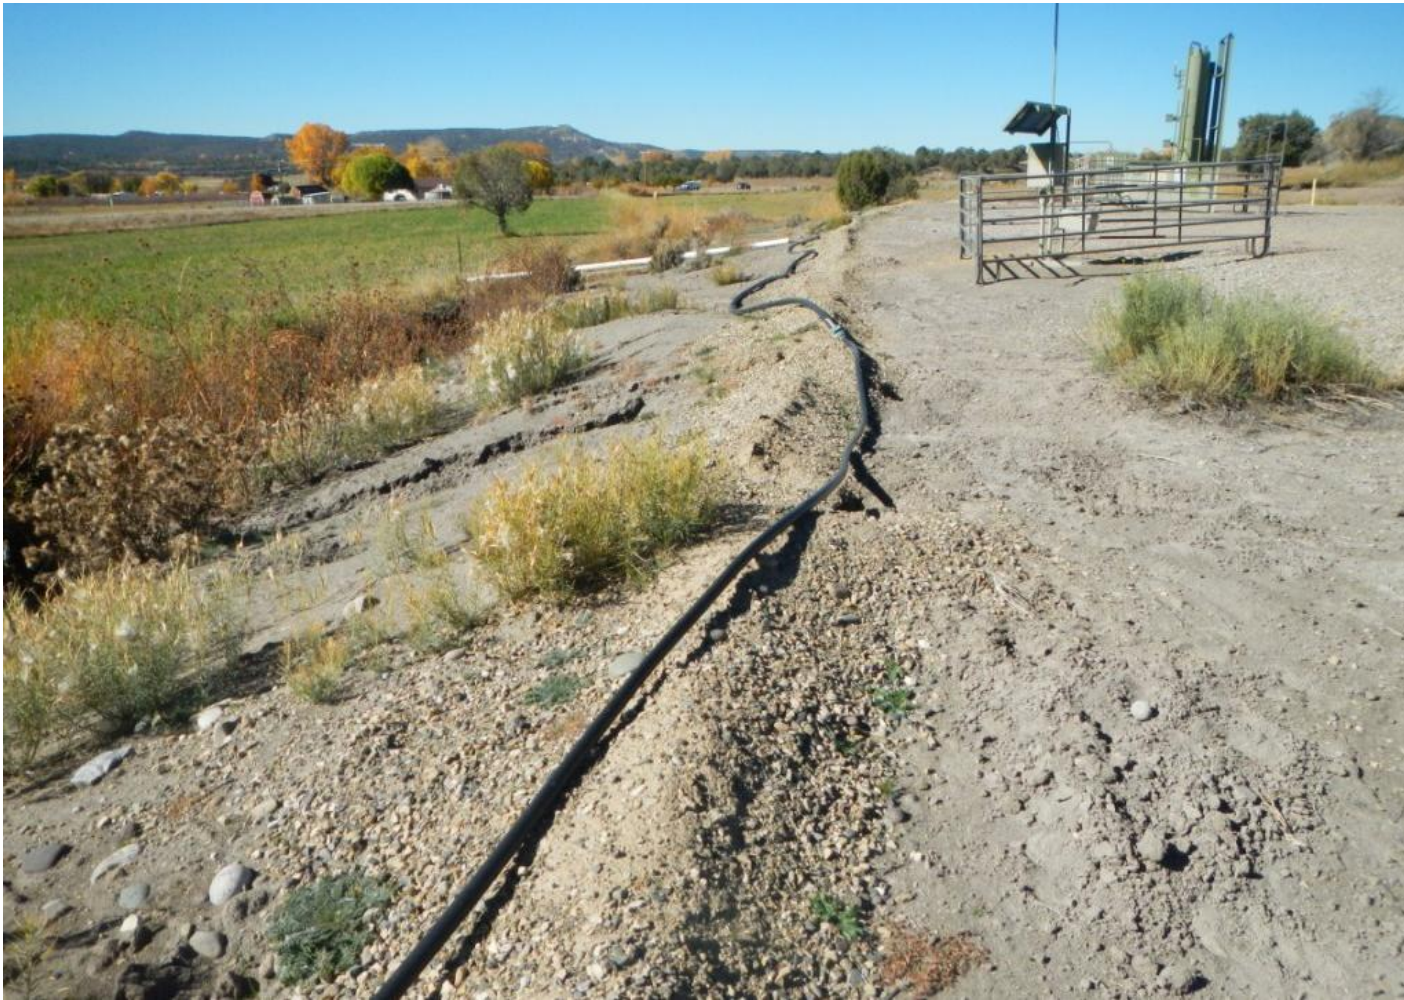
Photo 5. View of new berm along the southern edge of the working area. This berm is not sufficient at controlling stormwater erosion along the southern fill slope where significant erosion is occurring from exposed soils eroding into adjacent irrigation ditch.

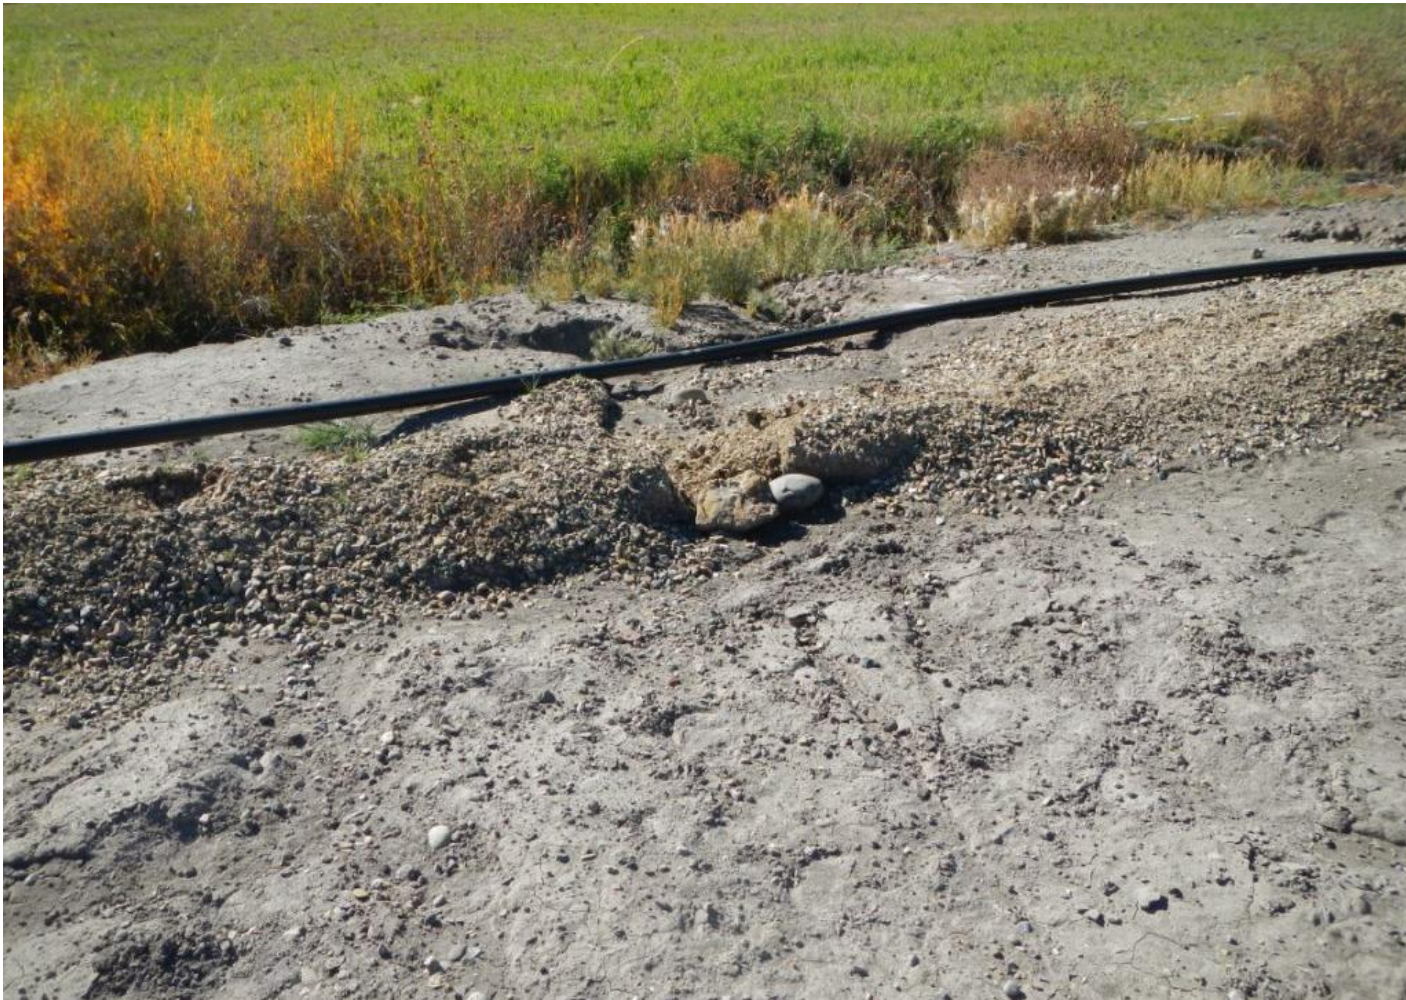
Photo 6. View of area on southern edge of well pad where new berm is eroding (facing downslope toward ditch).

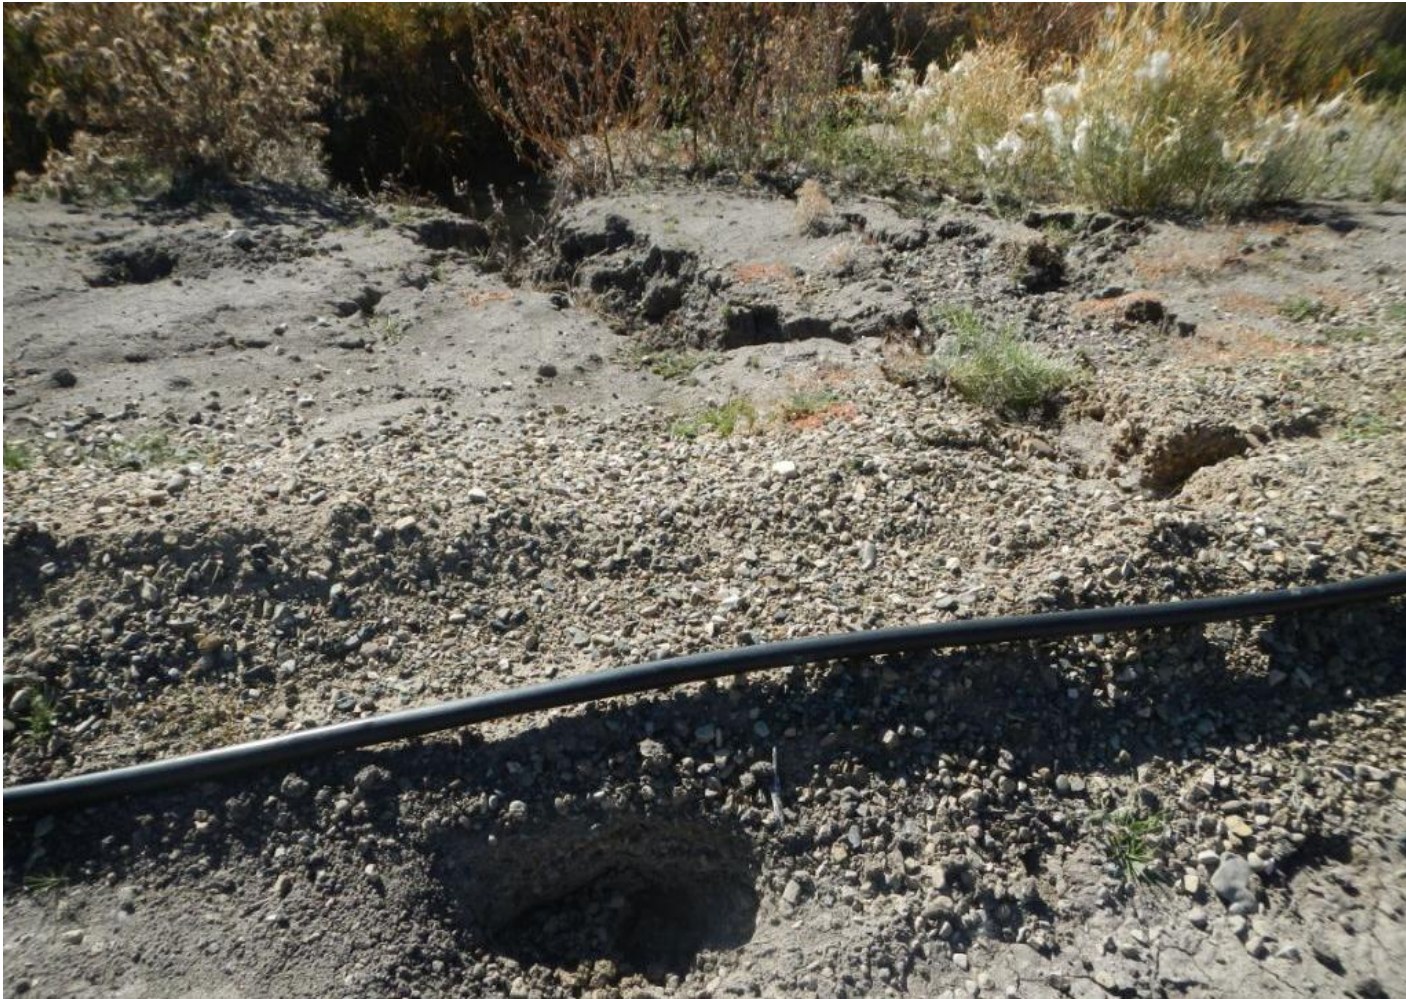
Photo 7. Another area along southern edge where berm is eroding (facing downslope).

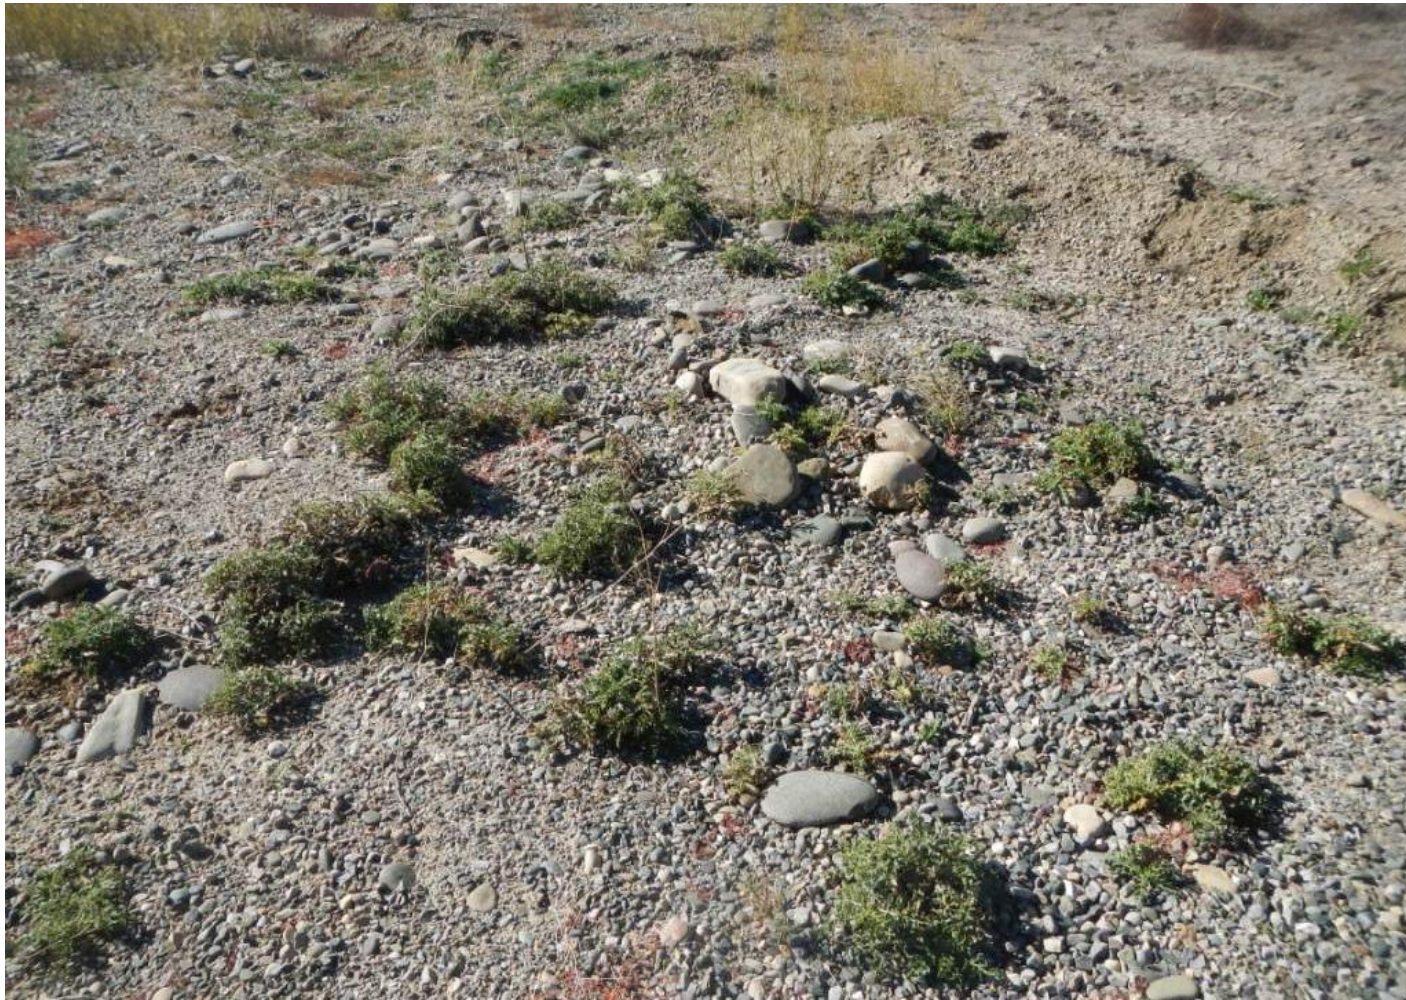
Photo 8. Canada thistles (*Cirsium arvense*) growing in the western portion of the well pad.
