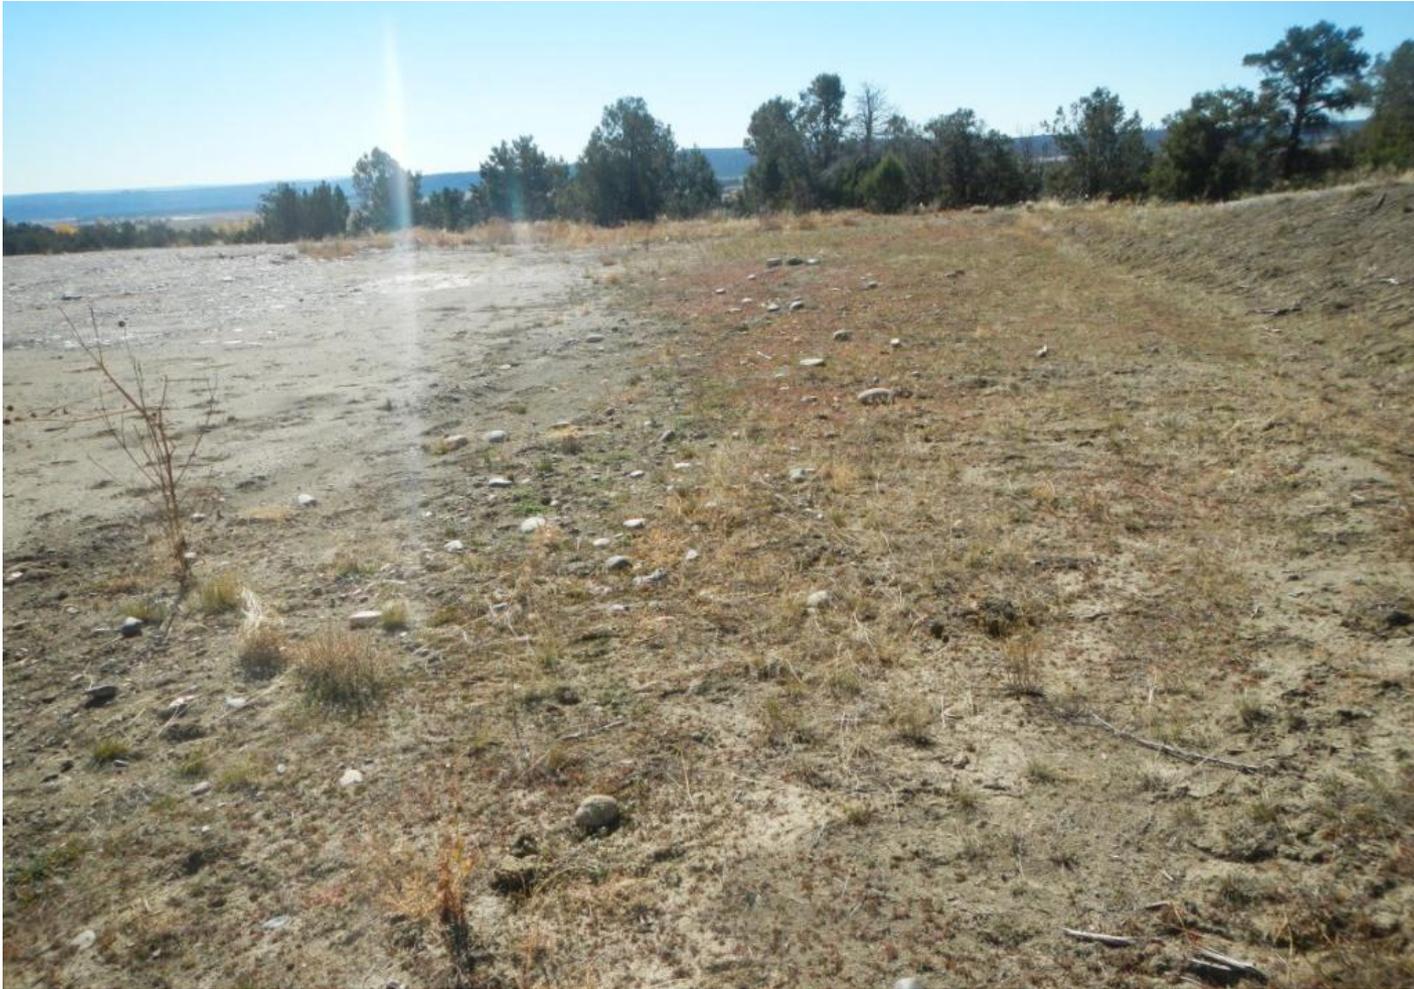
Photo 1. View of the western portion of the project from the northwestern corner facing southward. It appears western portion was seeded since last inspection.

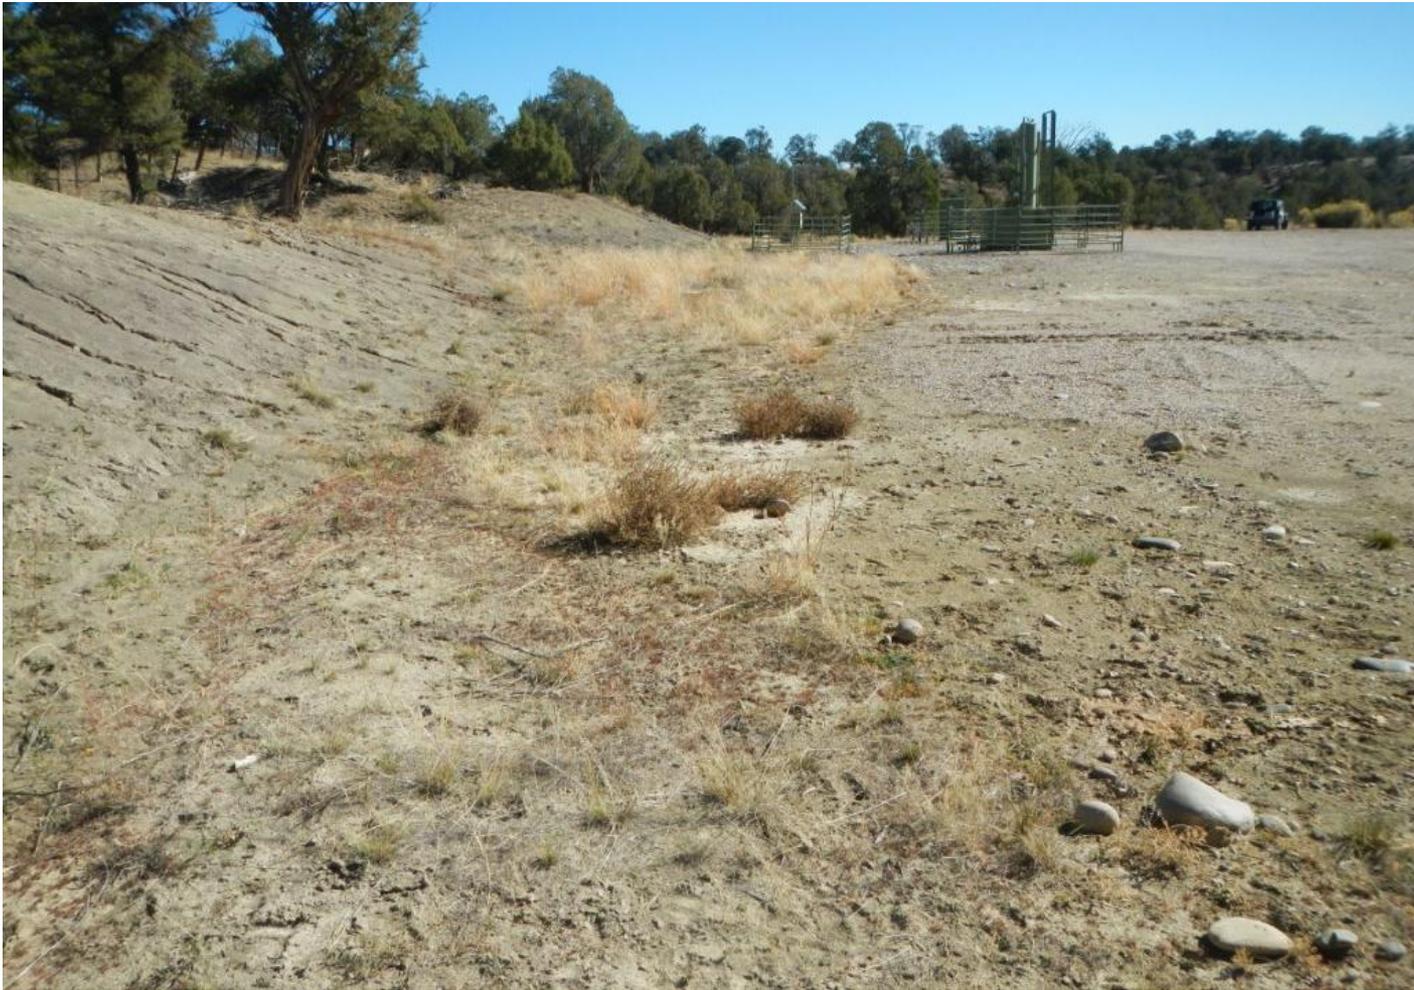
Photo 2. View of the northern portion of the project area from the northwestern corner facing eastward.

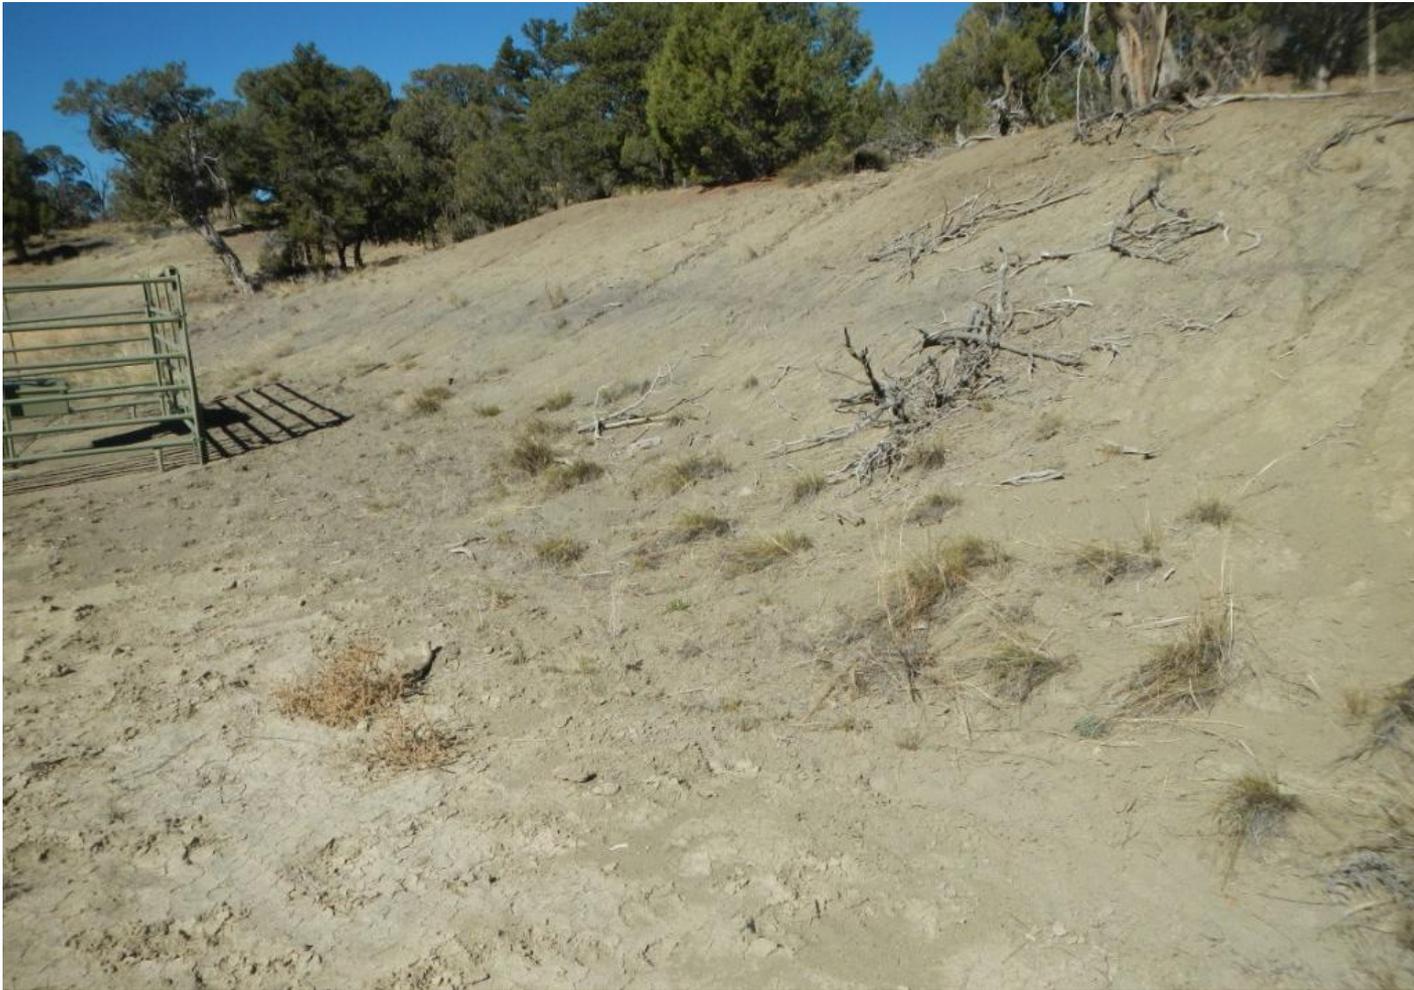
Photo 3. View of northern cut-slope with sparse revegetation.

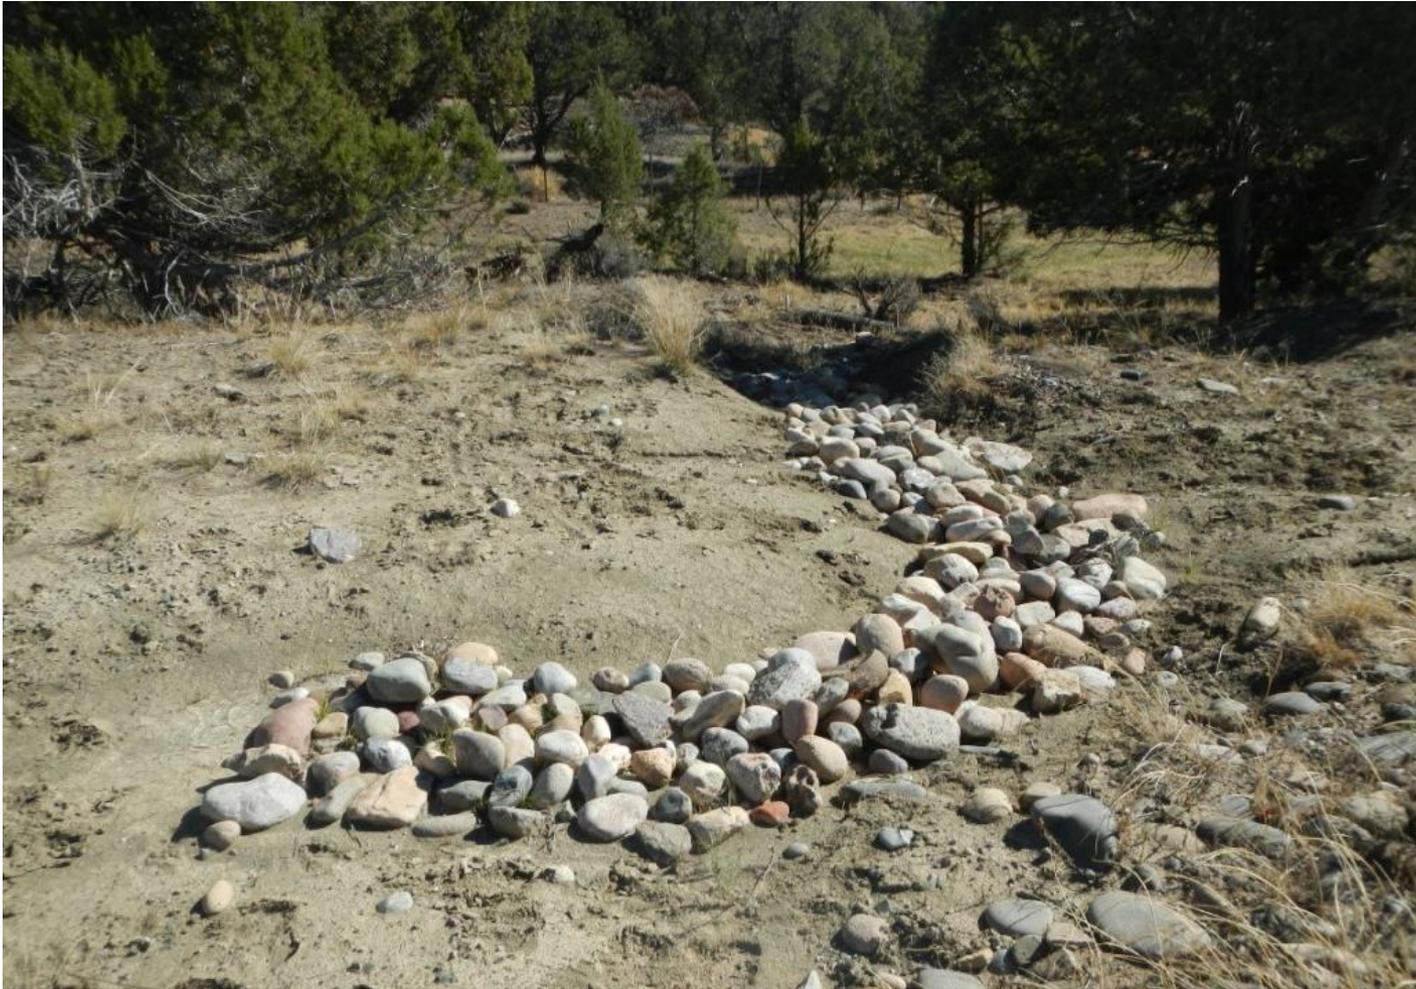
Photo 4. View of cobble run-down placed to stabilize erosional channel in the northeastern portion of the project area.

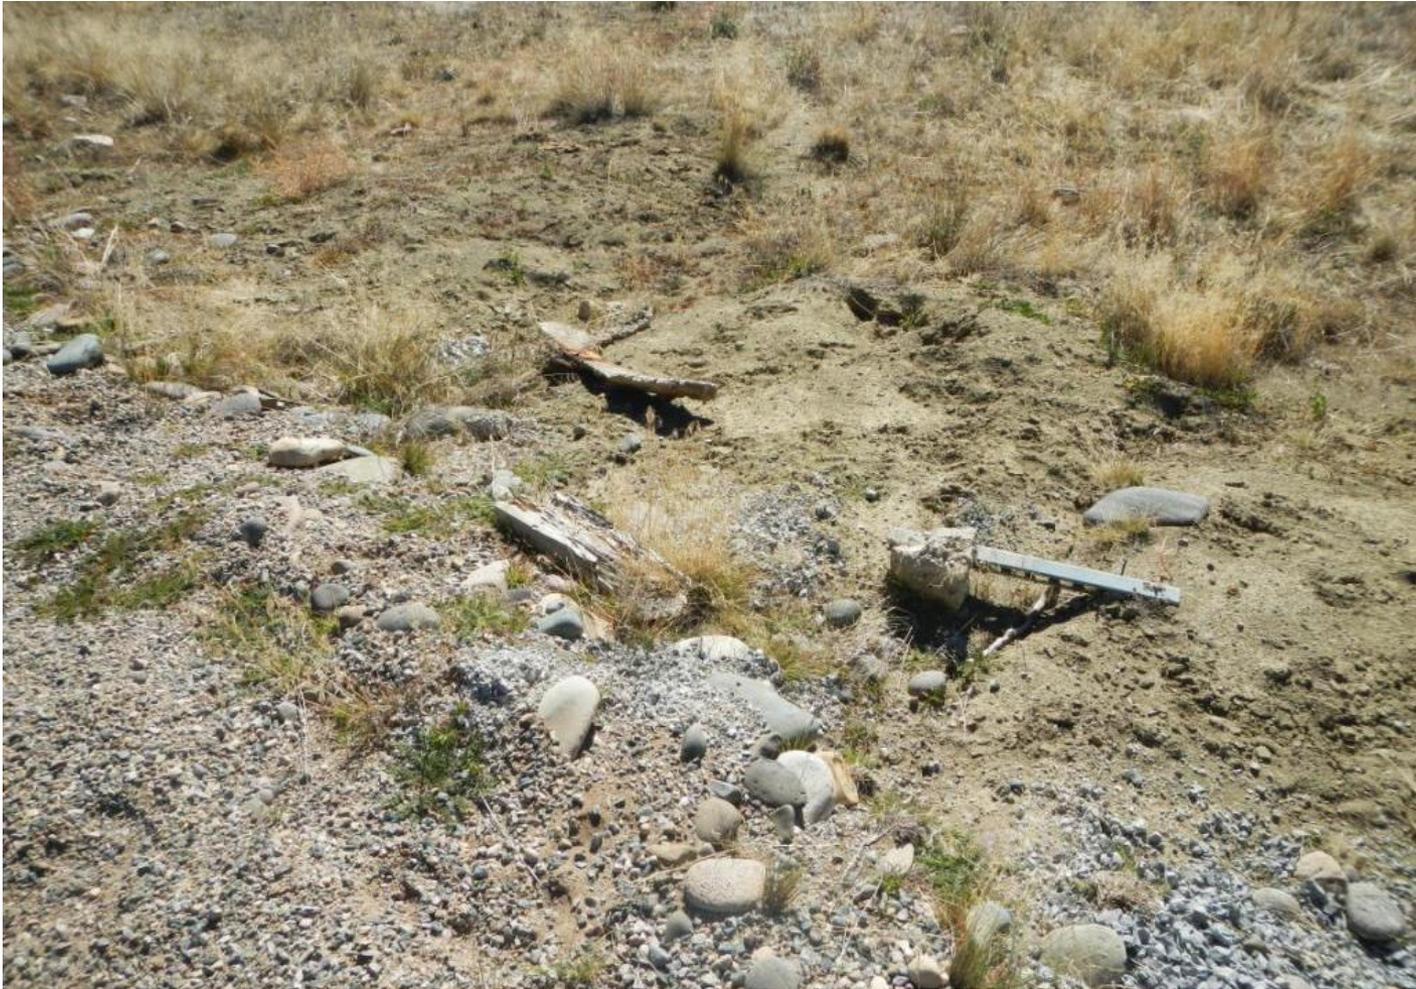
Photo 5. View of small pieces of debris in the southern portion of the interim reclamation area.
