Final Reclamation Inspection- Overview

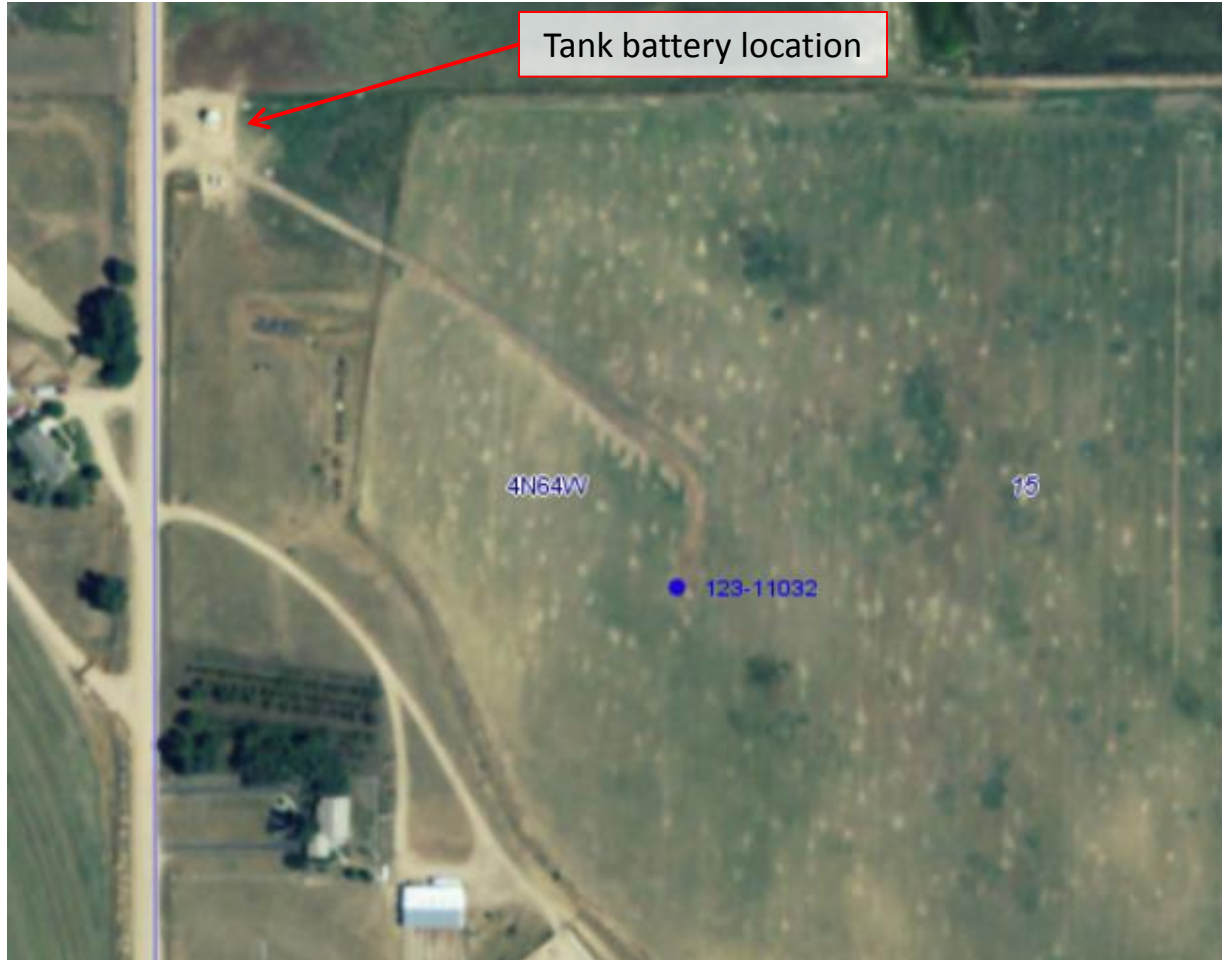
Aerial imagery taken 2011 using COGCC GISOnline database. Tank battery location still has pipeline risers. Need to remove risers per Rule 1004.

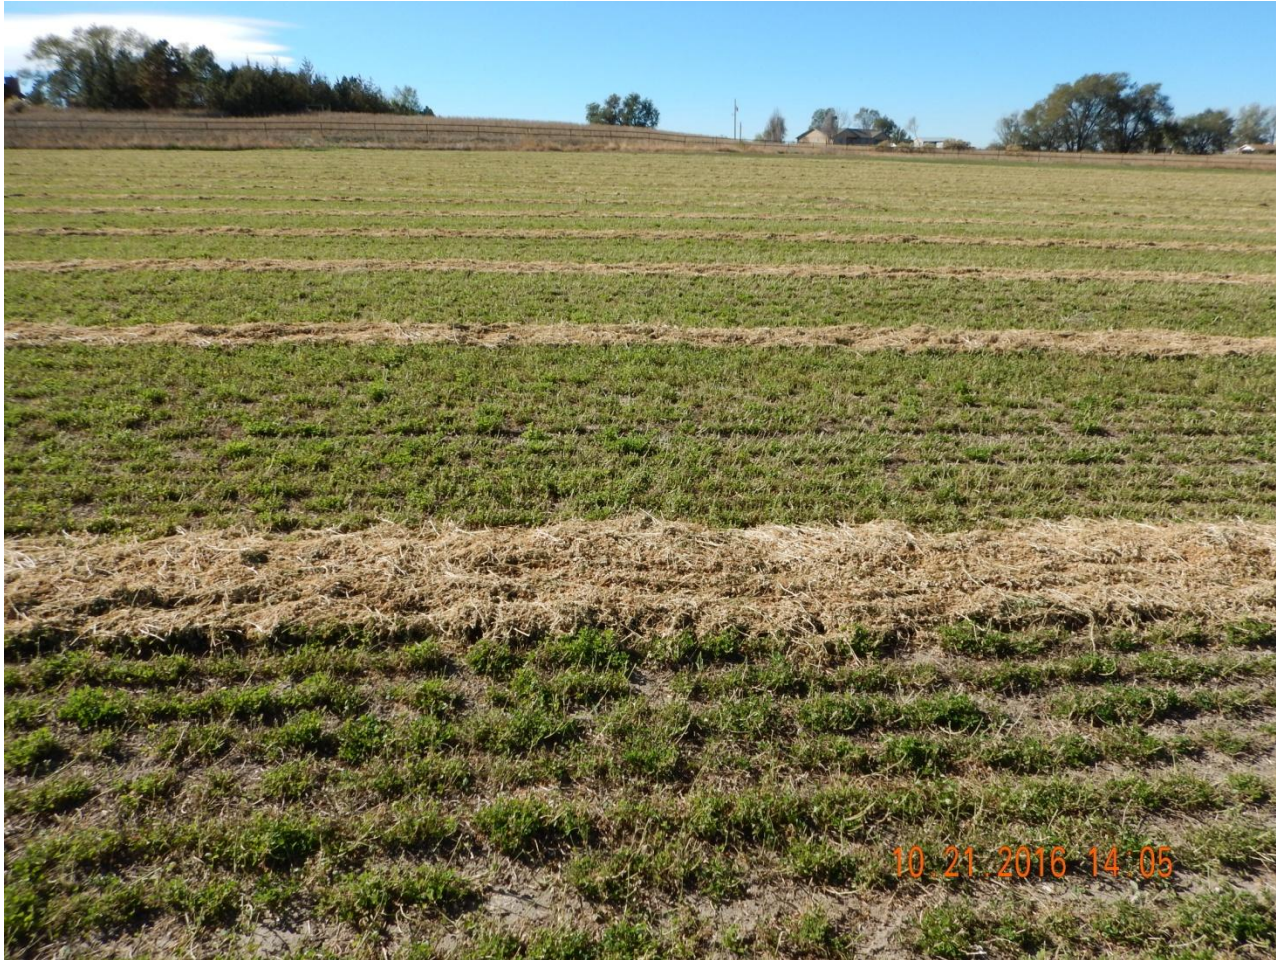
Photo 1. Photo taken from center of well location, facing West. No evidence of disturbance. Uniform vegetative crop growth and density throughout location.

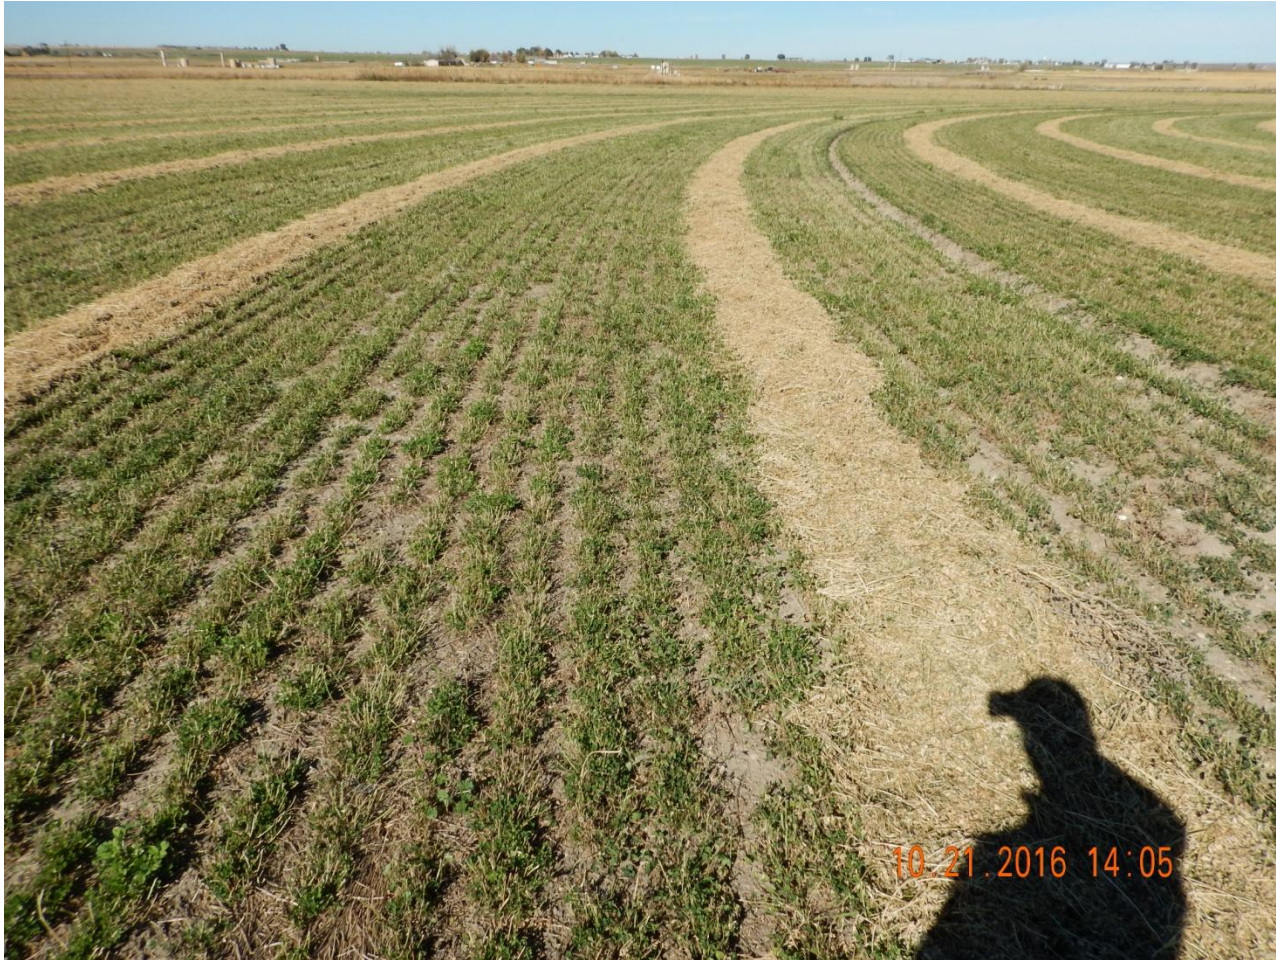
Photo 2. Photo taken from center of well location, facing North. No evidence of disturbance. Uniform vegetative crop growth and density throughout location.

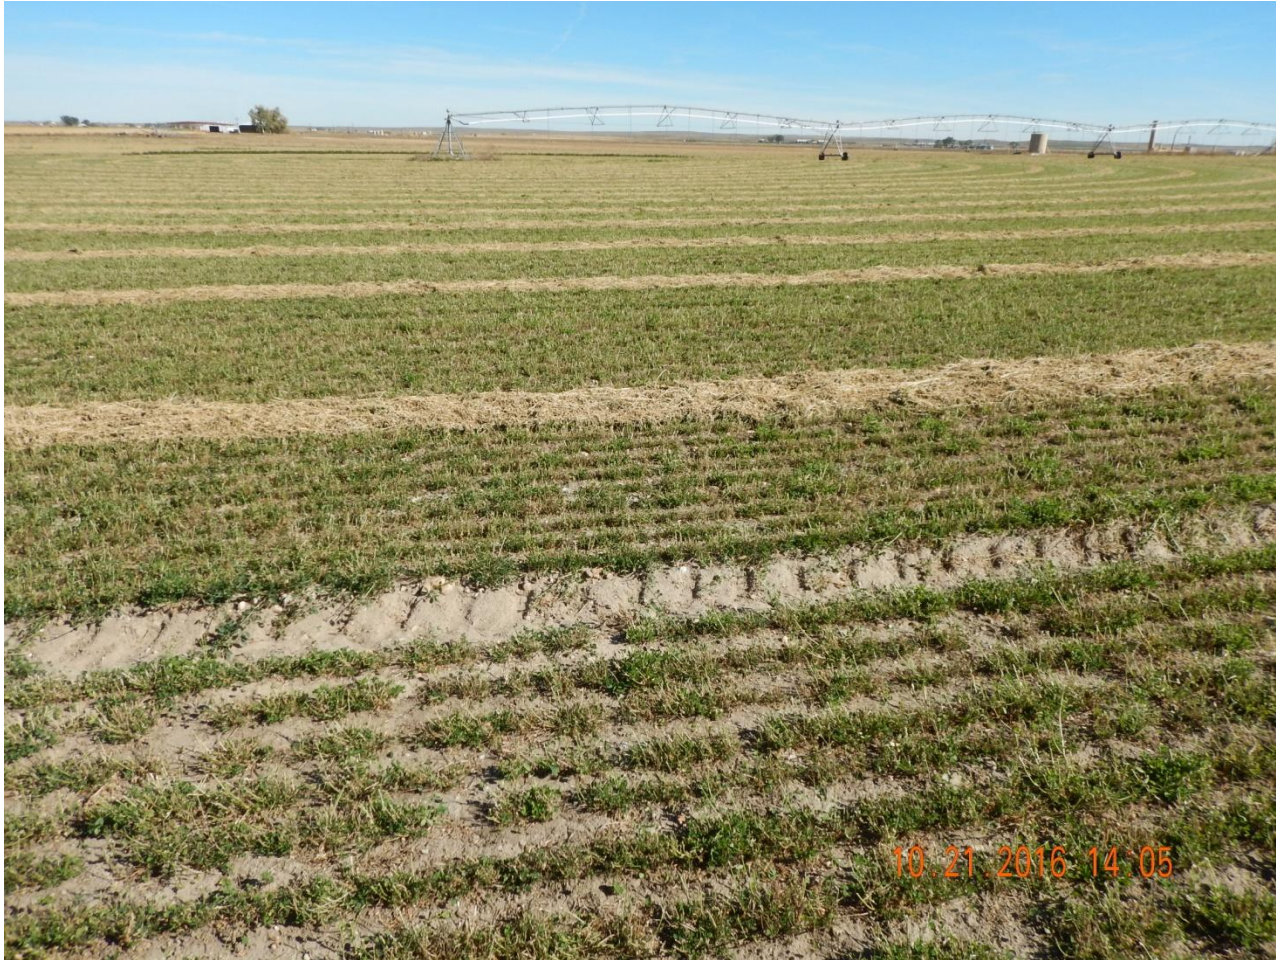
Photo 3. Photo taken from center of well location, facing East. No evidence of disturbance. Uniform vegetative crop growth and density throughout location.

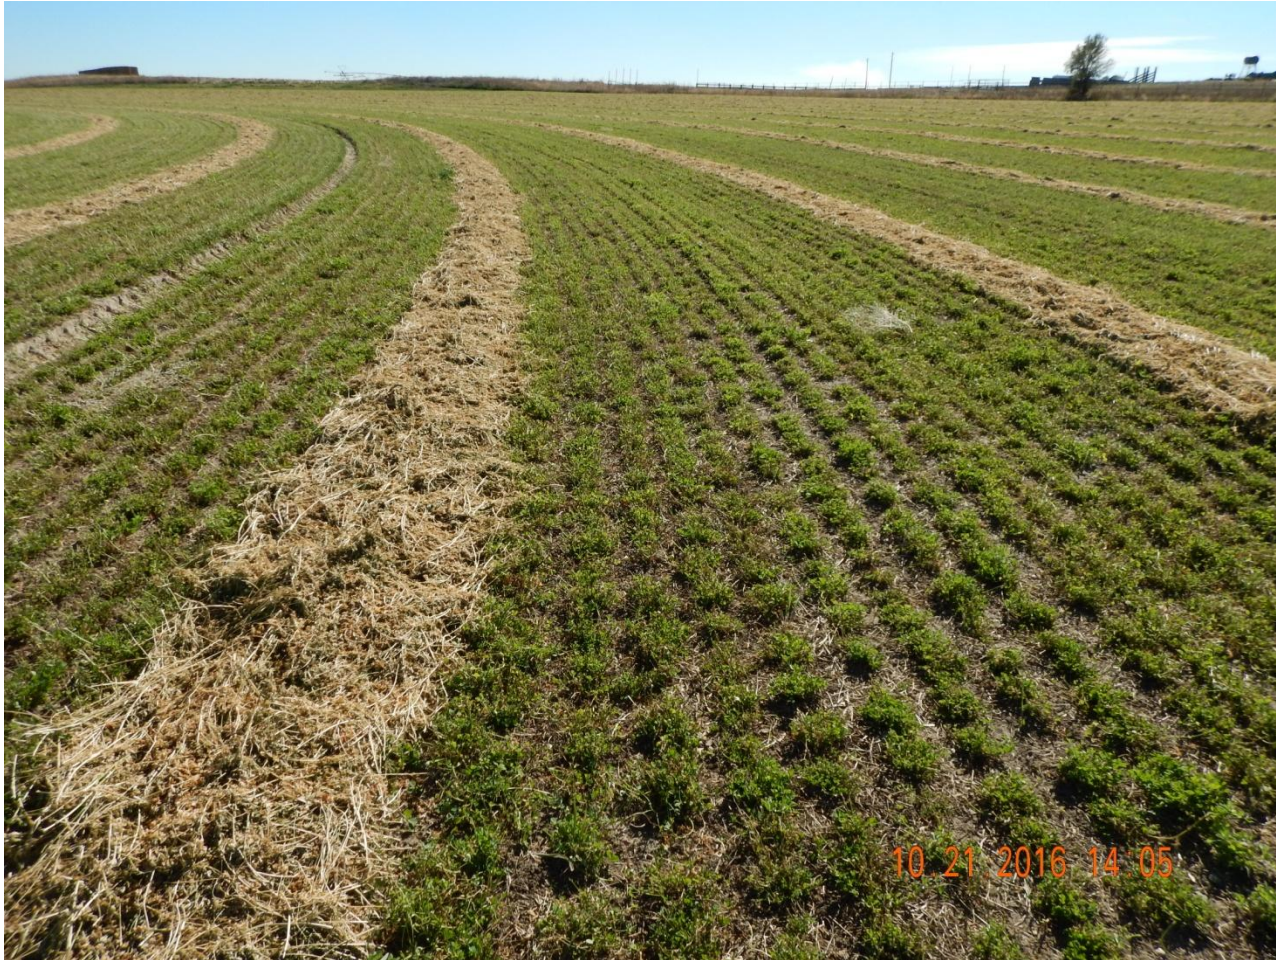
Photo 4. Photo taken from center of well location, facing South. No evidence of disturbance. Uniform vegetative crop growth and density throughout location.

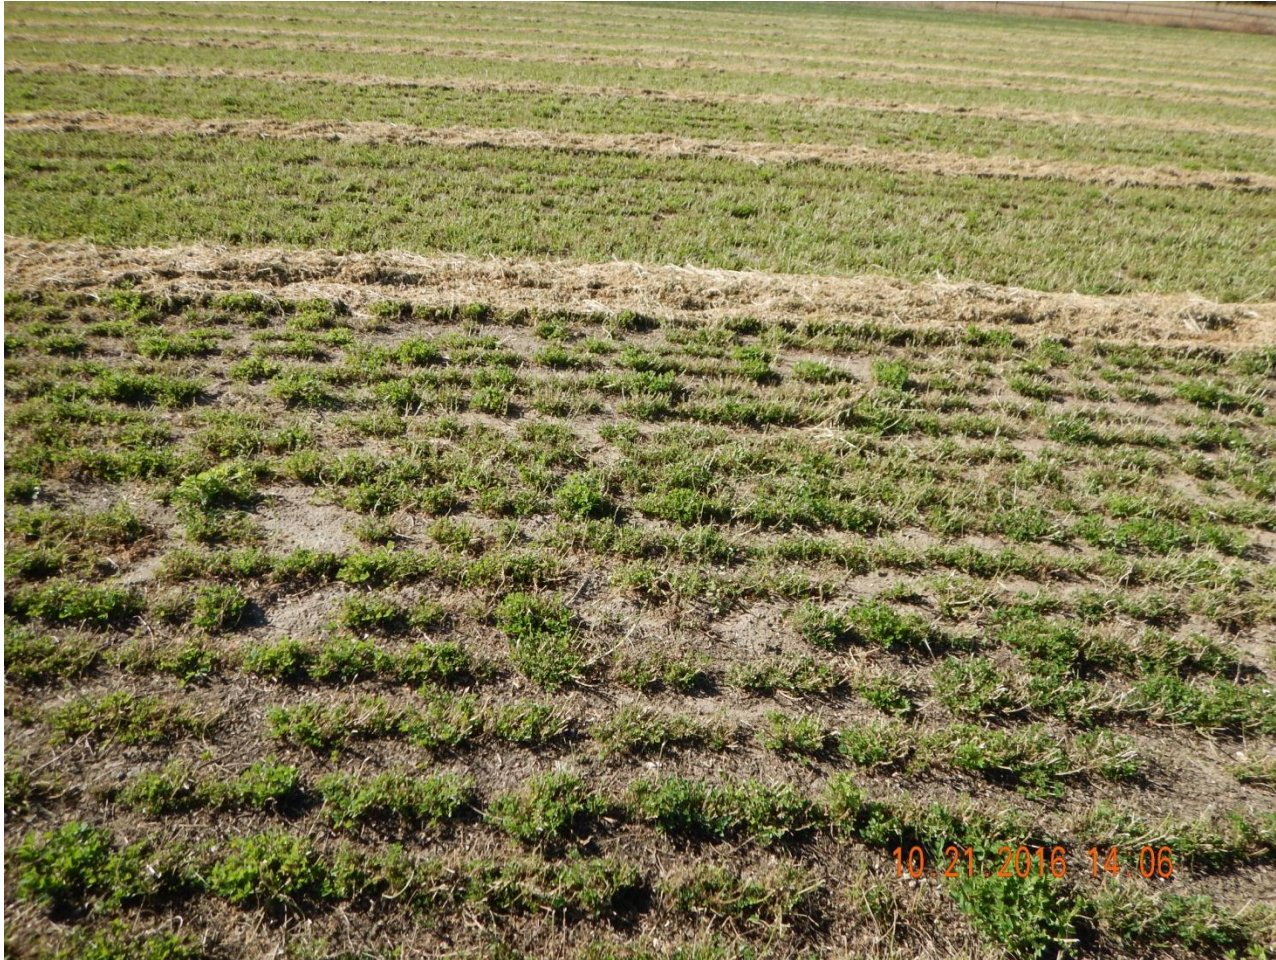
Photo 5. Reference photo taken west of location, facing West. Location appears to be reflective of crop reference areas.

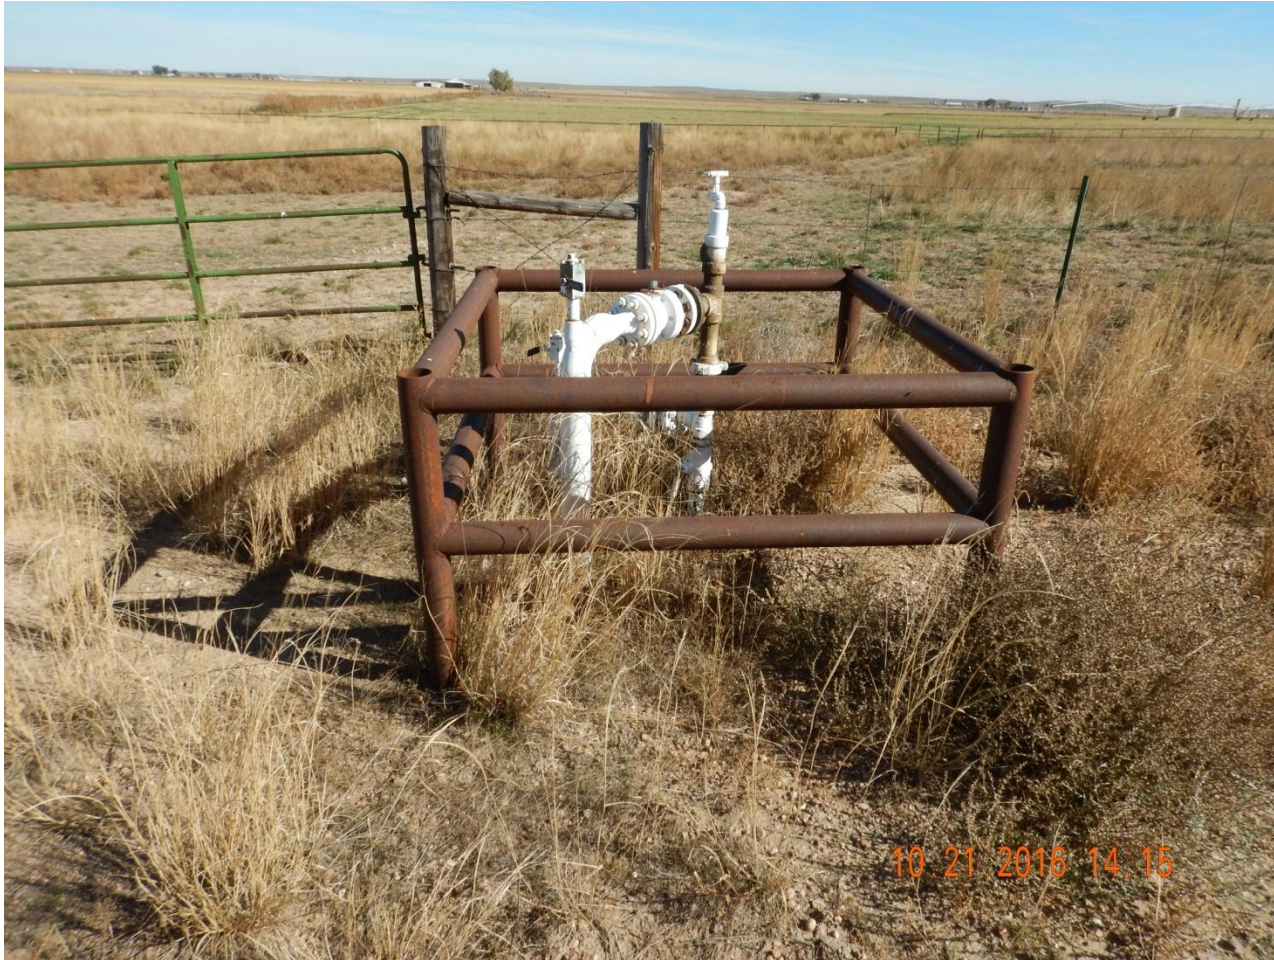
Photo 6. Photo taken from tank battery location, facing East. Need to remove pipeline risers per Rule 1004.

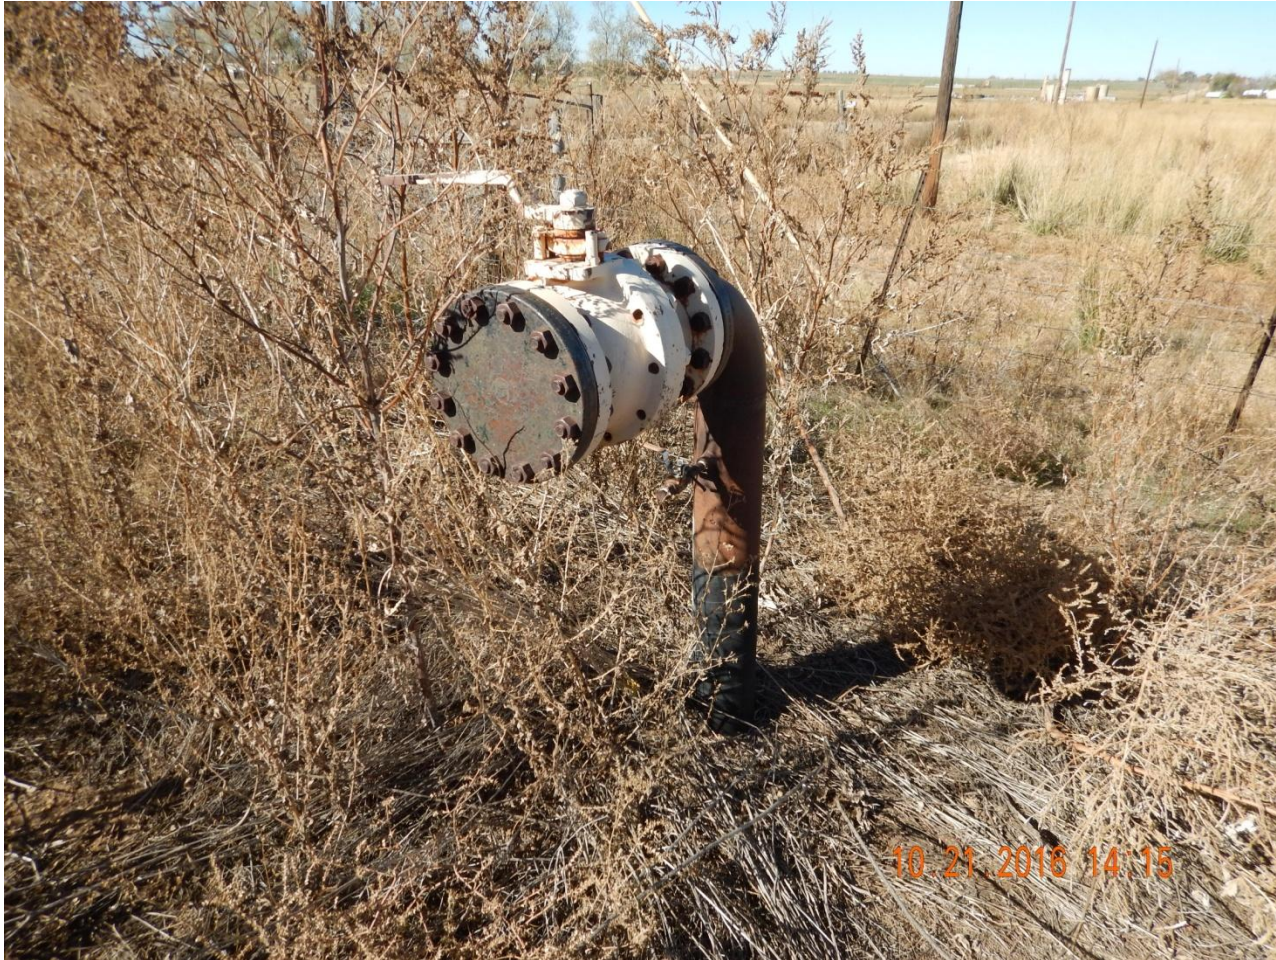
Photo 7. Photo taken from tank battery location, facing North. Need to remove pipeline risers per Rule 1004.
