Final Reclamation Inspection

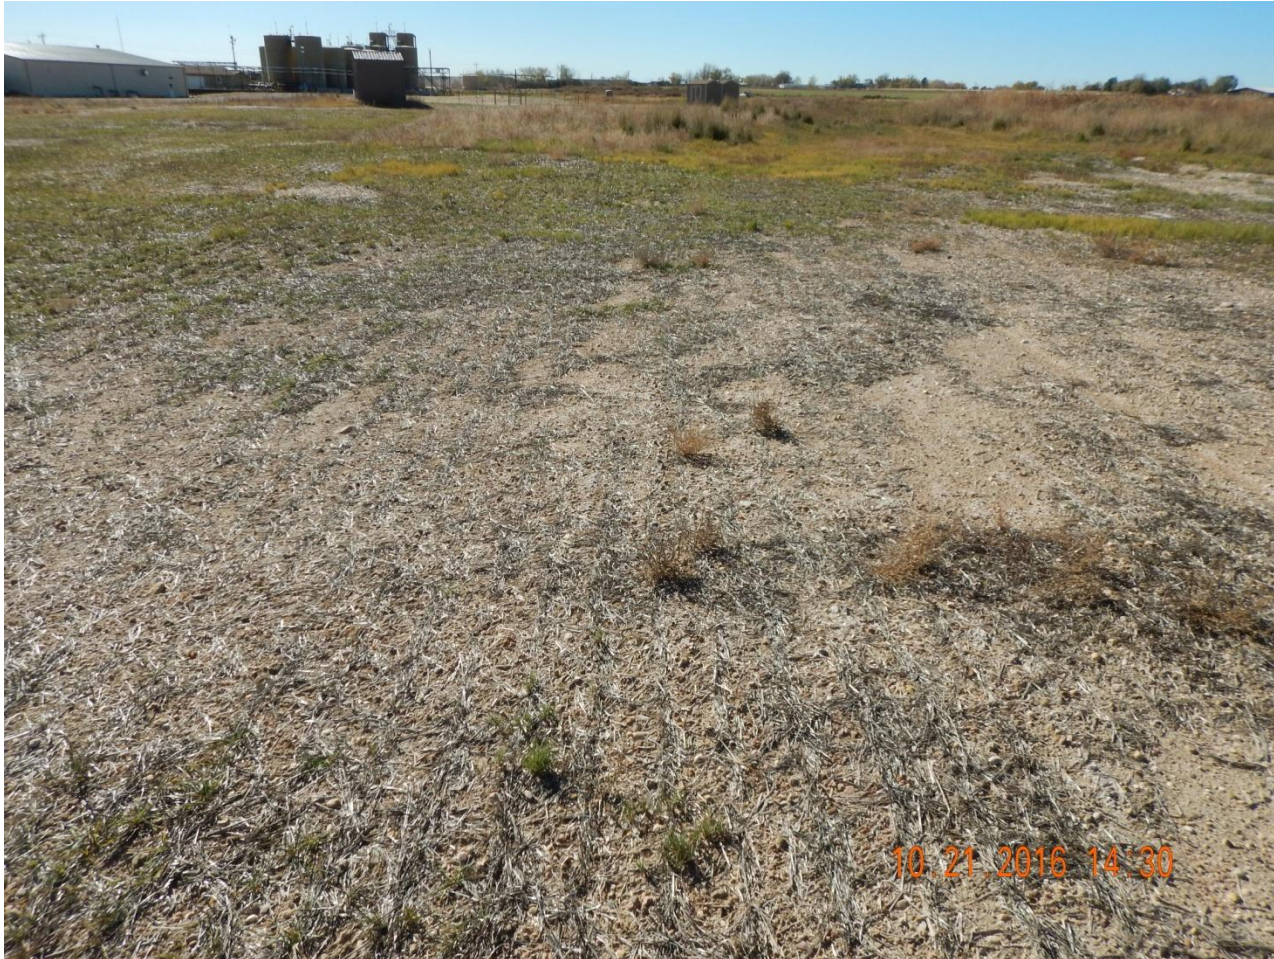
Photo 1. Photo taken from center of location, facing West. Vegetative growth IN-PROCESS at location. Evidence of seeding attempt evident from seed drilling rows but areas throughout location still have bare patches with little to no vegetative growth that is not reflective of reference areas.

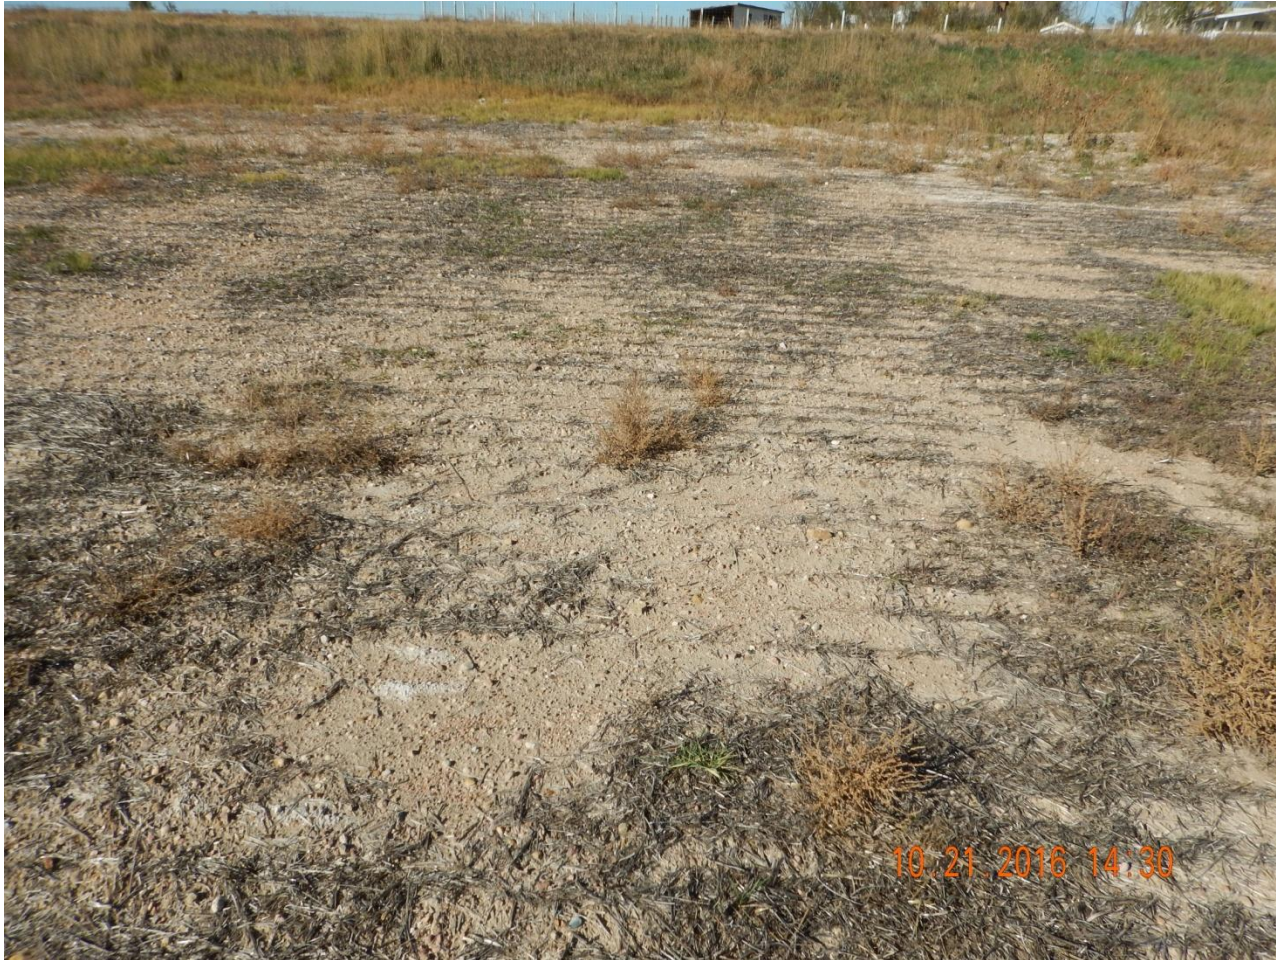
Photo 2. Photo taken from center of location, facing North. Vegetative growth IN-PROCESS at location. Evidence of seeding attempt evident from seed drilling rows but areas throughout location still have bare patches with little to no vegetative growth that is not reflective of reference areas.

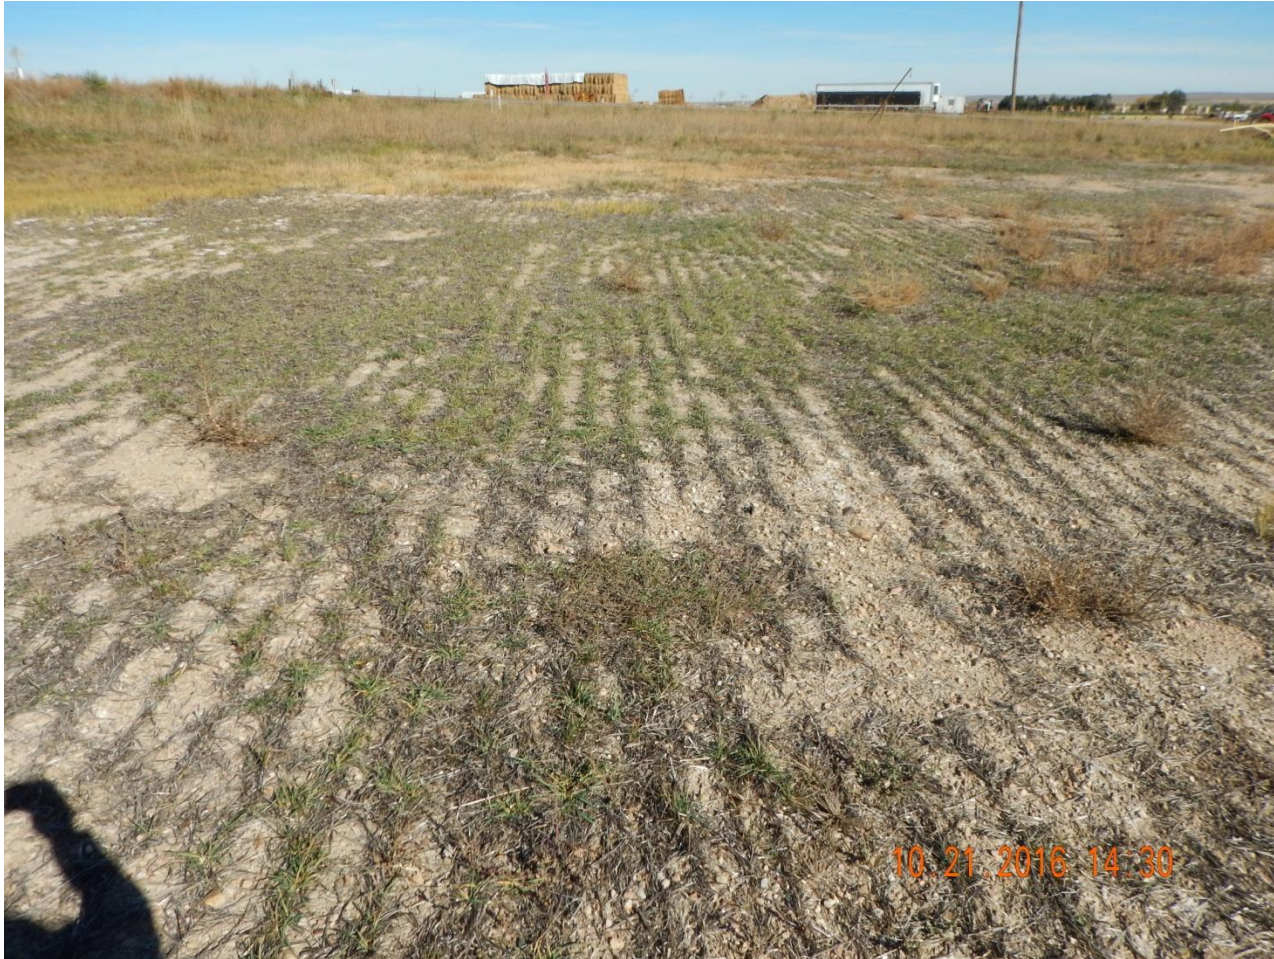
Photo 3. Photo taken from center of location, facing East. Vegetative growth IN-PROCESS at location. Evidence of seeding attempt evident from seed drilling rows but areas throughout location still have bare patches with little to no vegetative growth that is not reflective of reference areas.

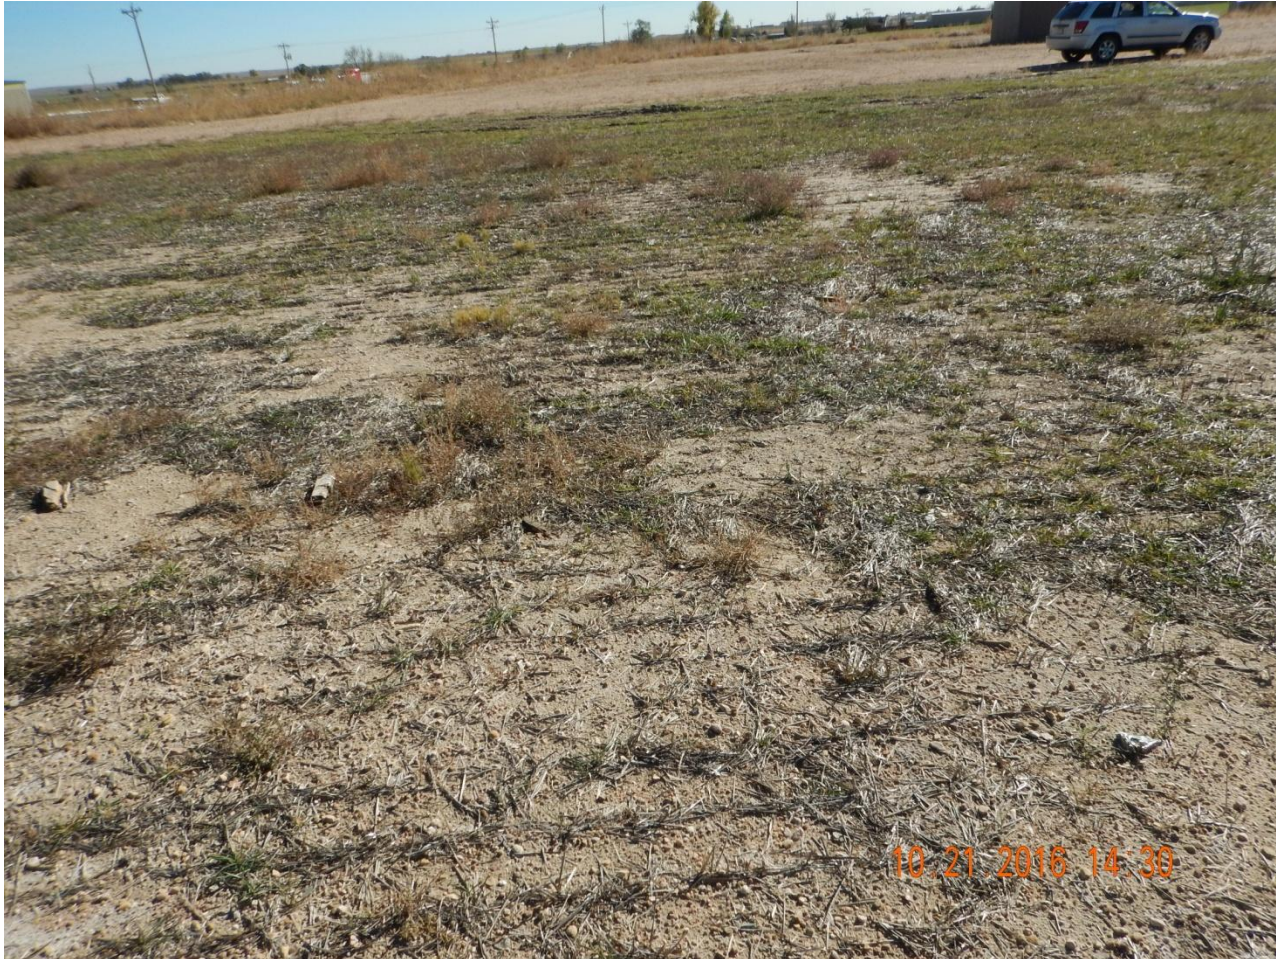
Photo 4. Photo taken from center of location, facing South. Vegetative growth IN-PROCESS at location. Evidence of seeding attempt evident from seed drilling rows but areas throughout location still have bare patches with little to no vegetative growth that is not reflective of reference areas.

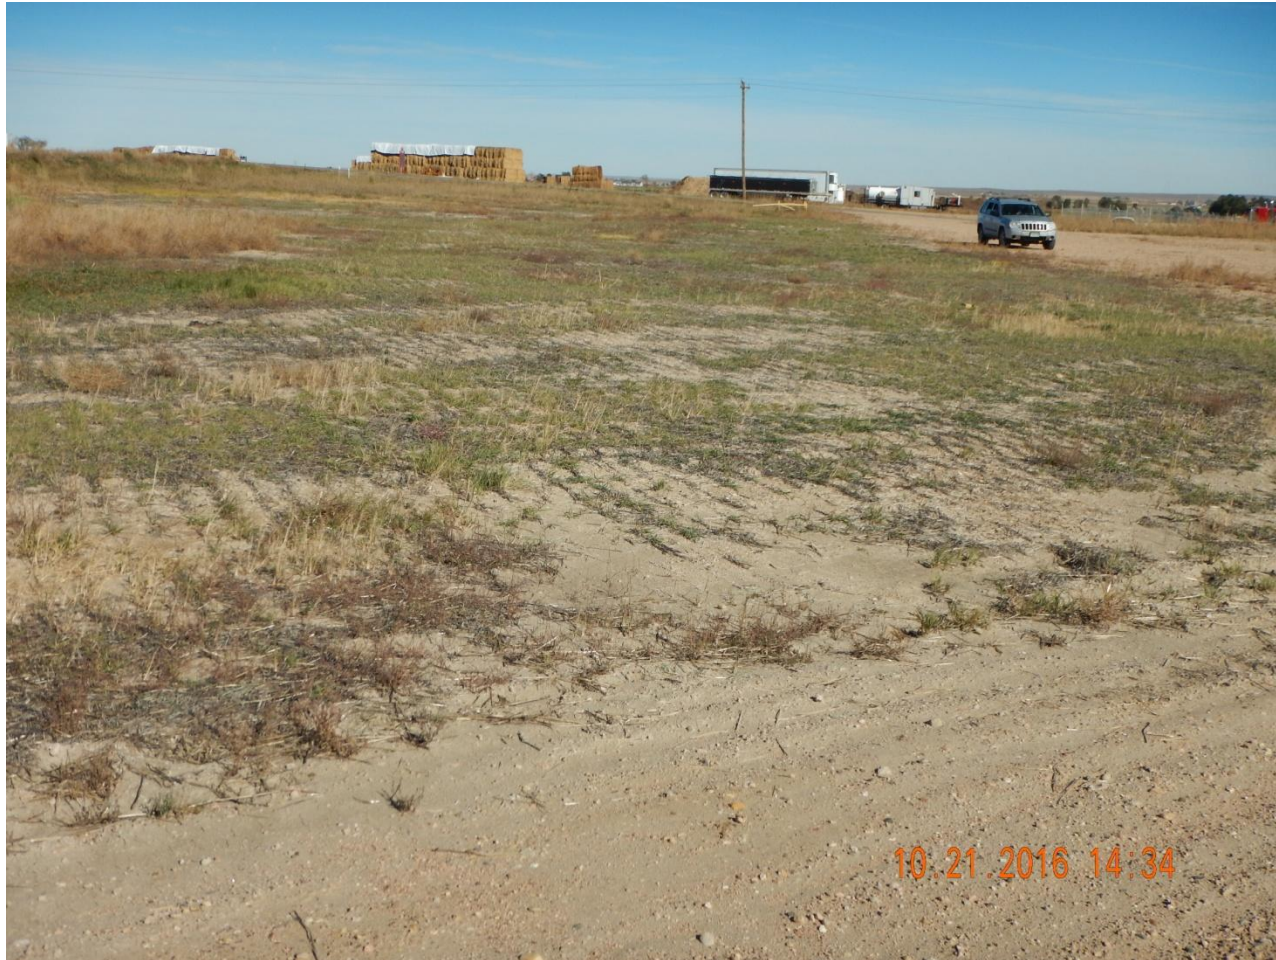
Photo 5. Photo taken from the western location, facing East. Vegetative growth IN-PROCESS at location. Evidence of seeding attempt evident from seed drilling rows but areas throughout location still have bare patches with little to no vegetative growth that is not reflective of reference areas.

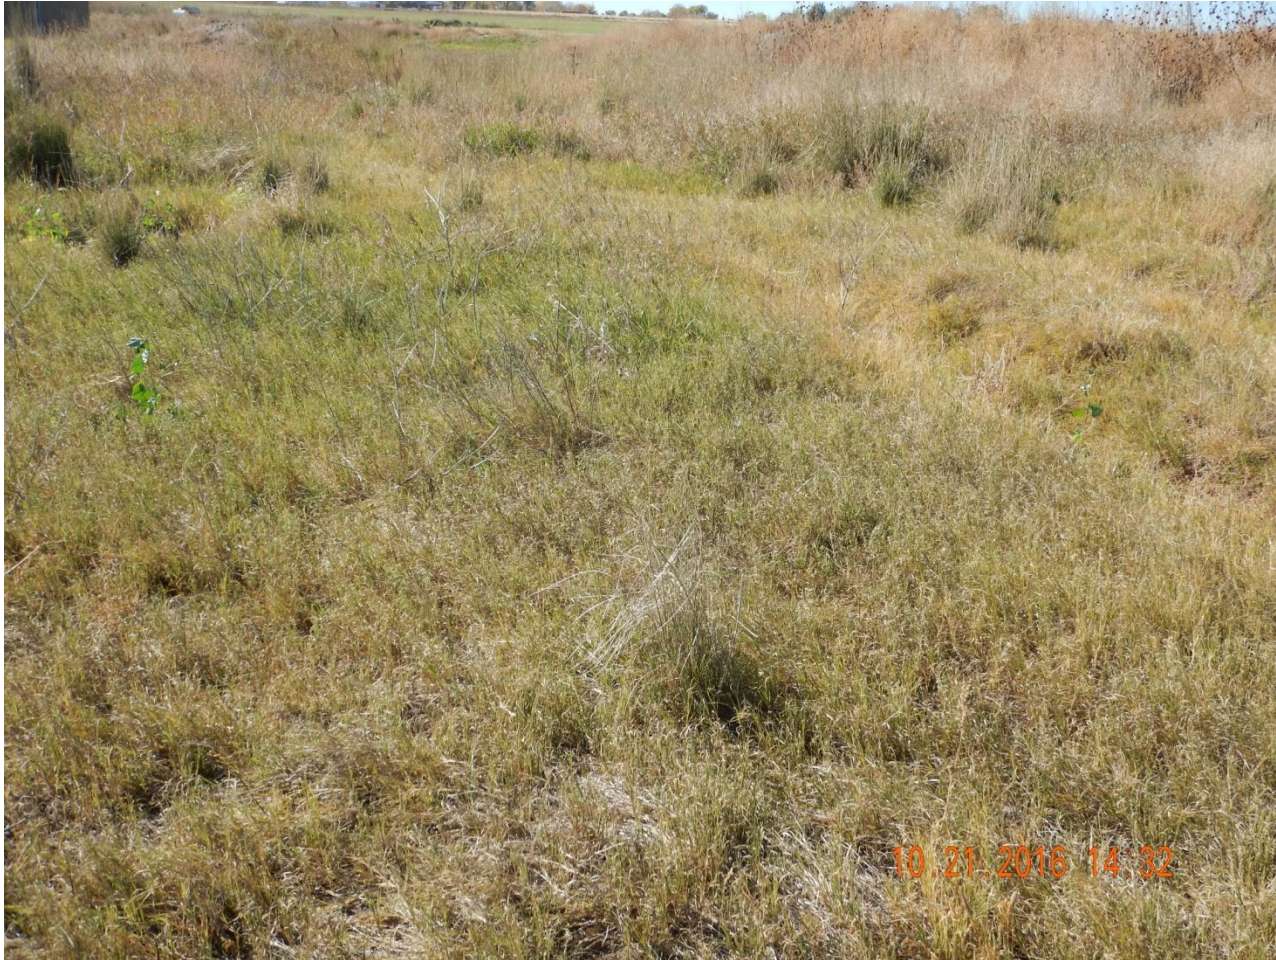
Photo 6. Reference photo taken west of location, facing West. Location still IN-PROCESS as vegetative growth is not reflective of reference areas.
