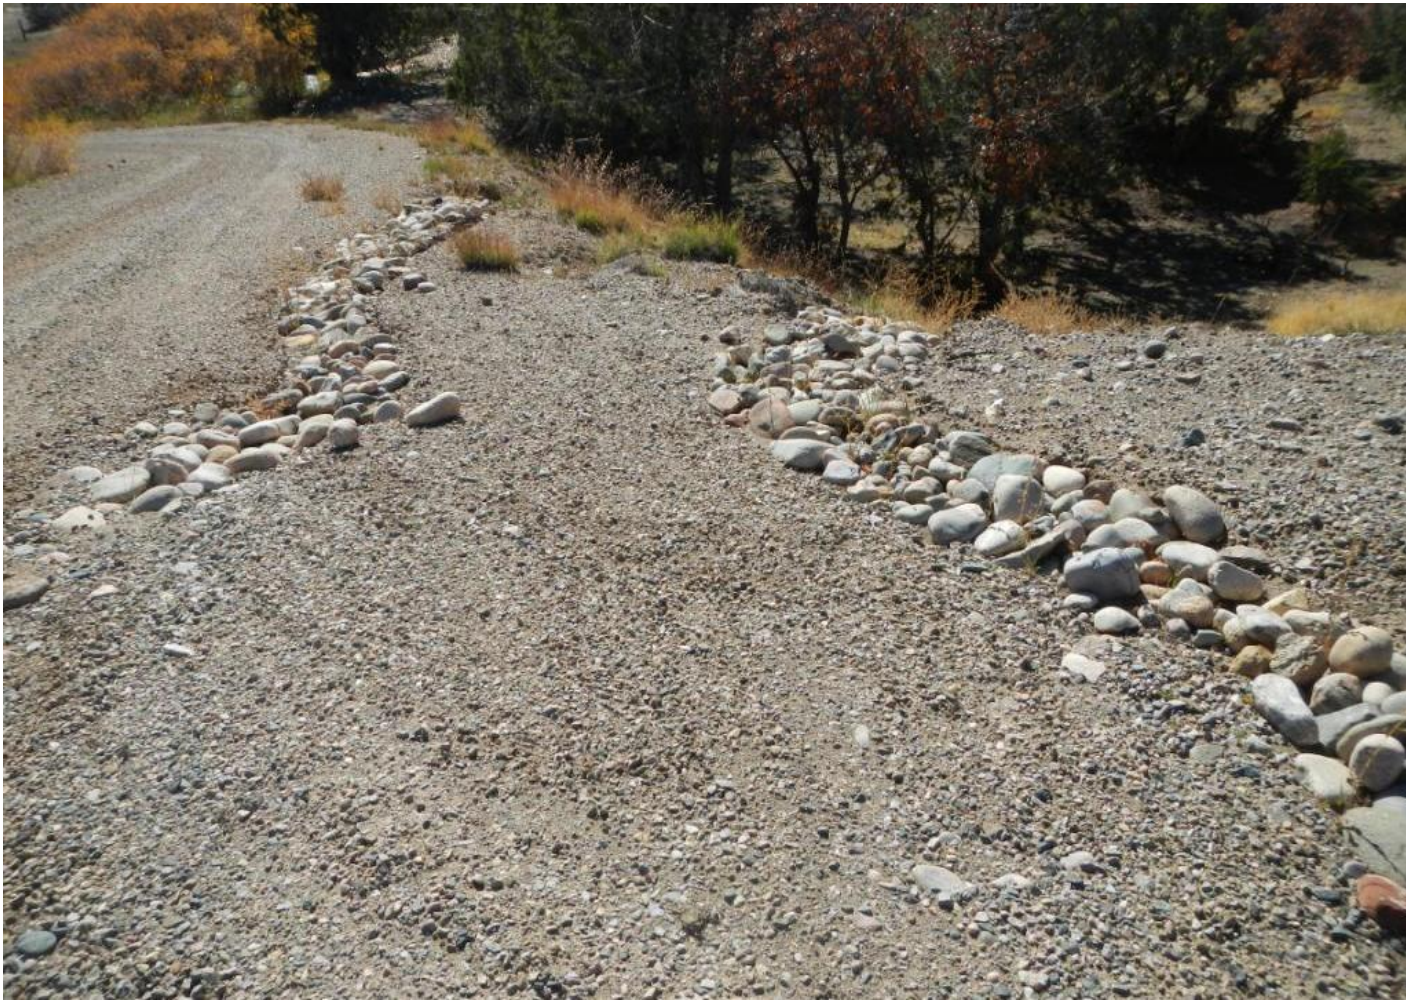
Photo 1. View of cobble run-downs and gravel at the entrance to the well pad. These appear to be functioning at this time.

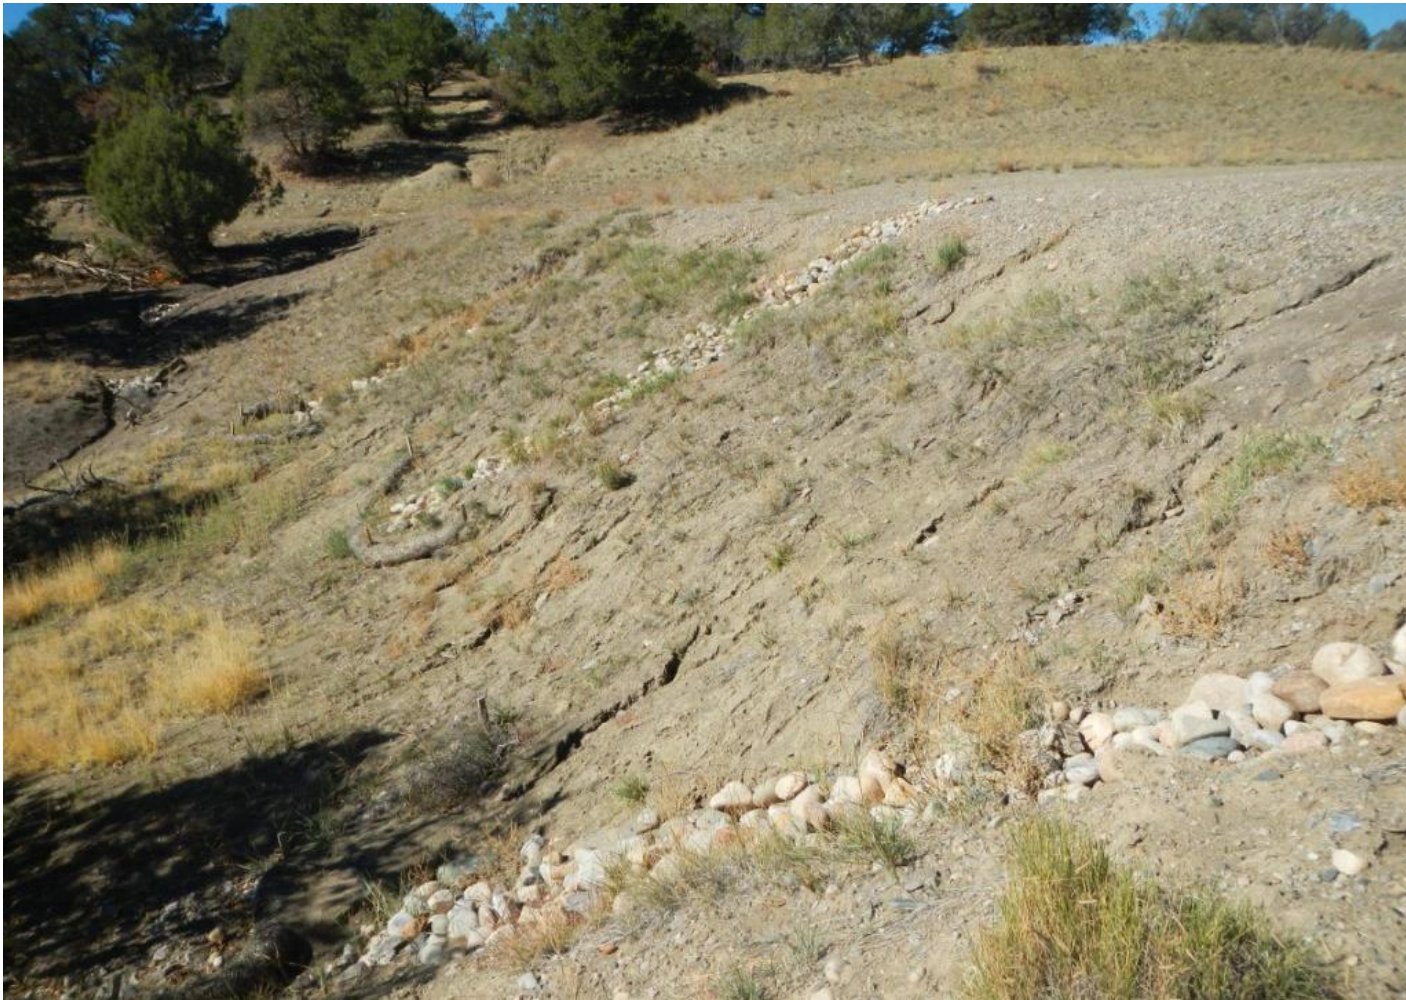
Photo 2. View of the southern portion of the project area from the well pad entrance facing westward. In some areas stormwater controls are functioning in other areas stormwater controls need maintenance (photo 6), and in other areas there are no controls and additional controls are needed. Rills and gullying are still present in the southern fill slope.

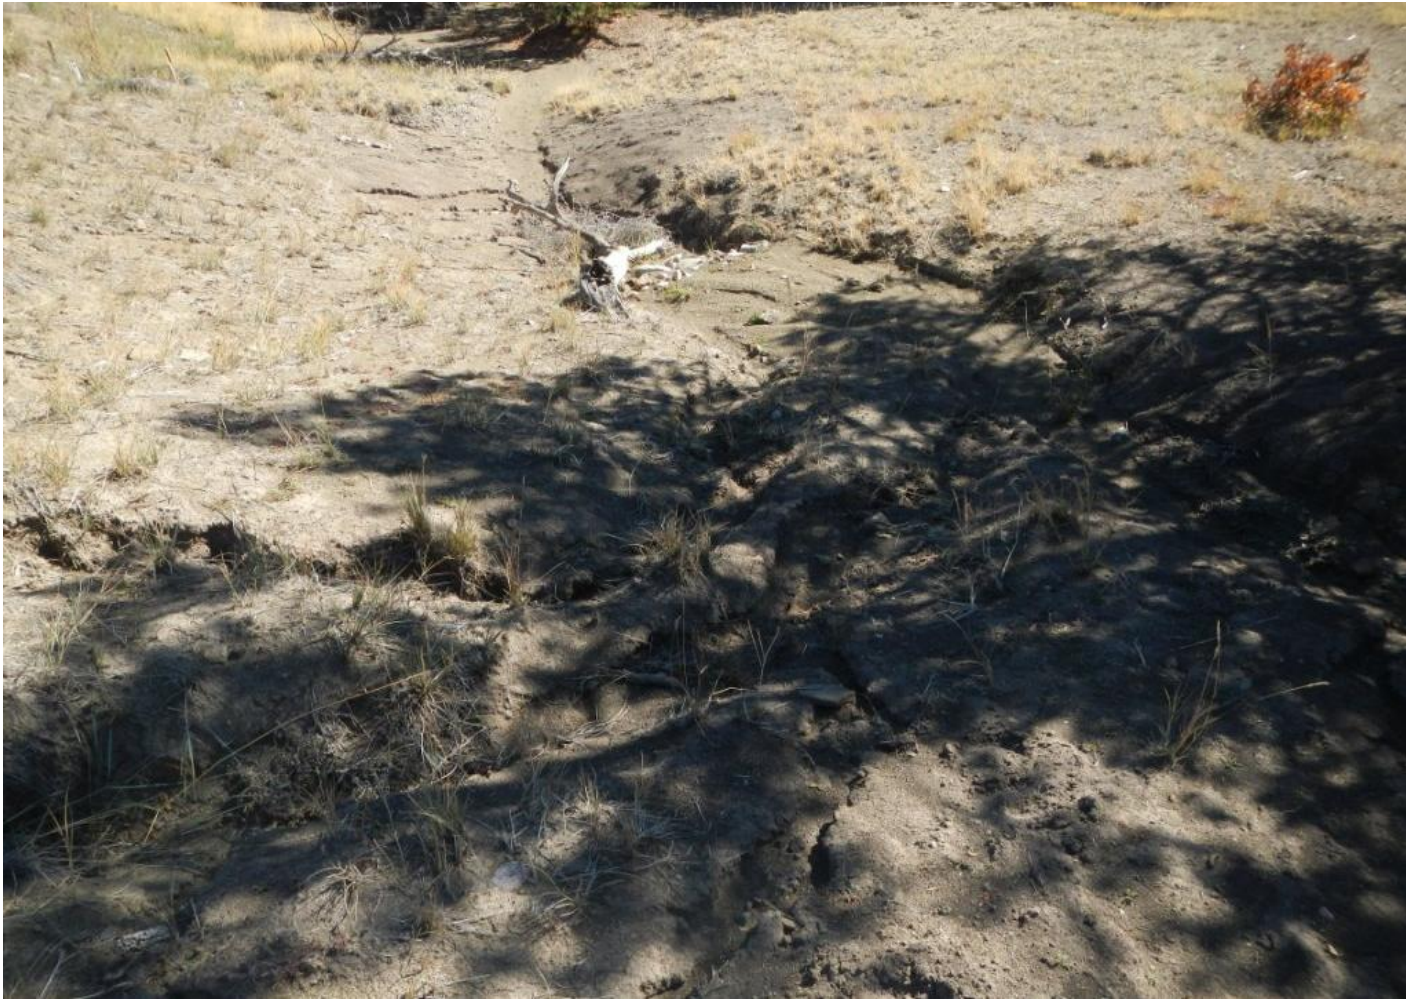
Photo 3. View of erosional channel off of southwestern corner of the well pad where stormwater controls are insufficient and those present need maintenance.

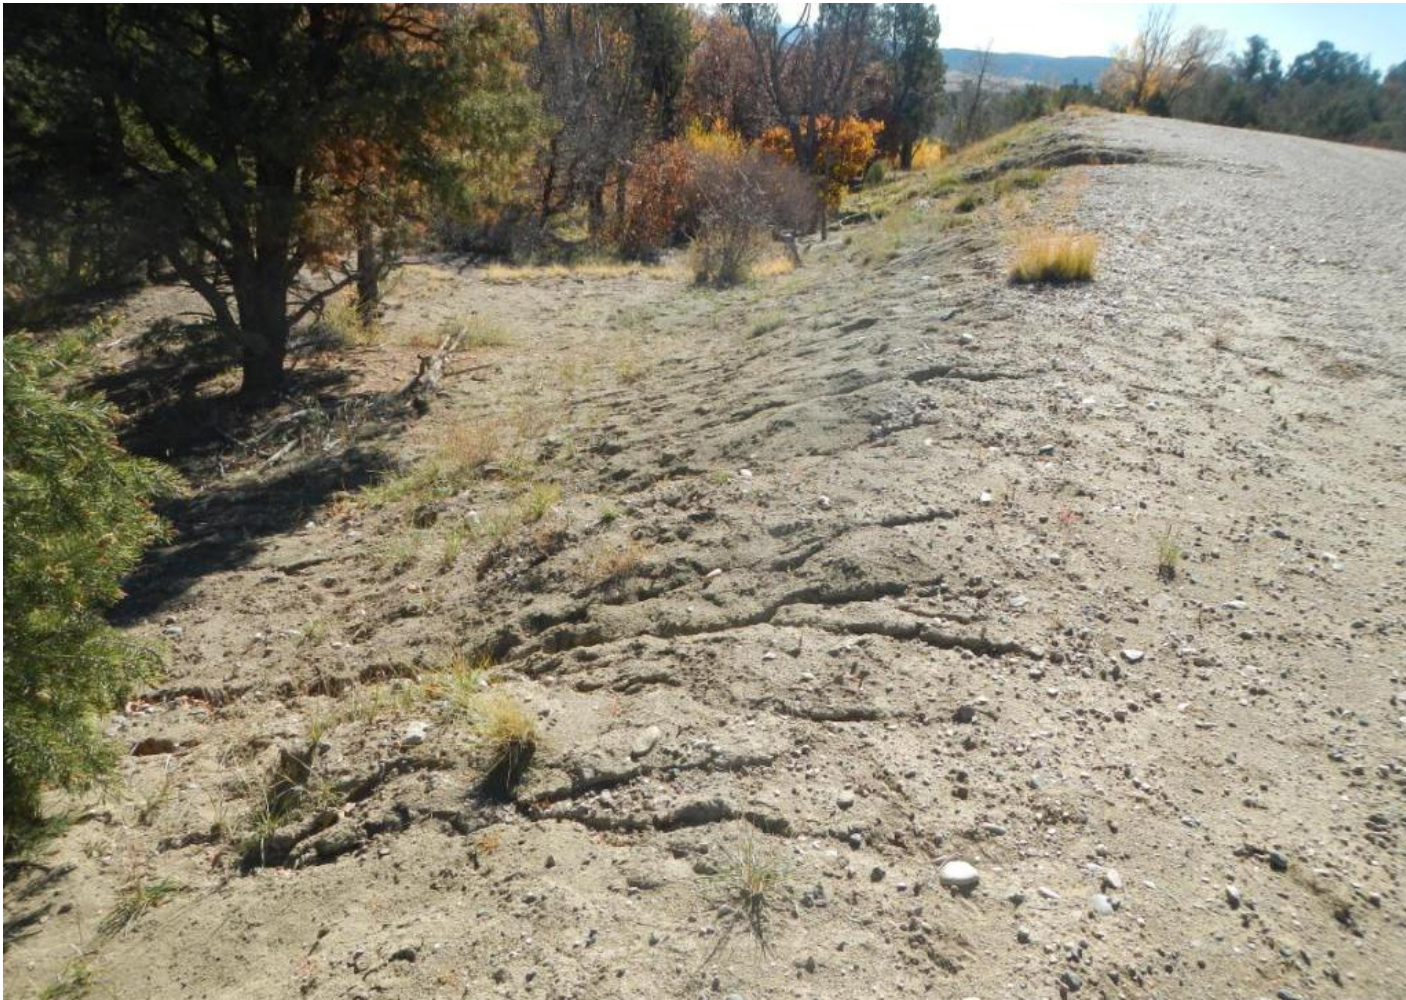
Photo 4. View of the eastern portion of the project area from the northeastern corner facing southward. Rill and gully erosion is still occurring and stormwater controls are not sufficient.

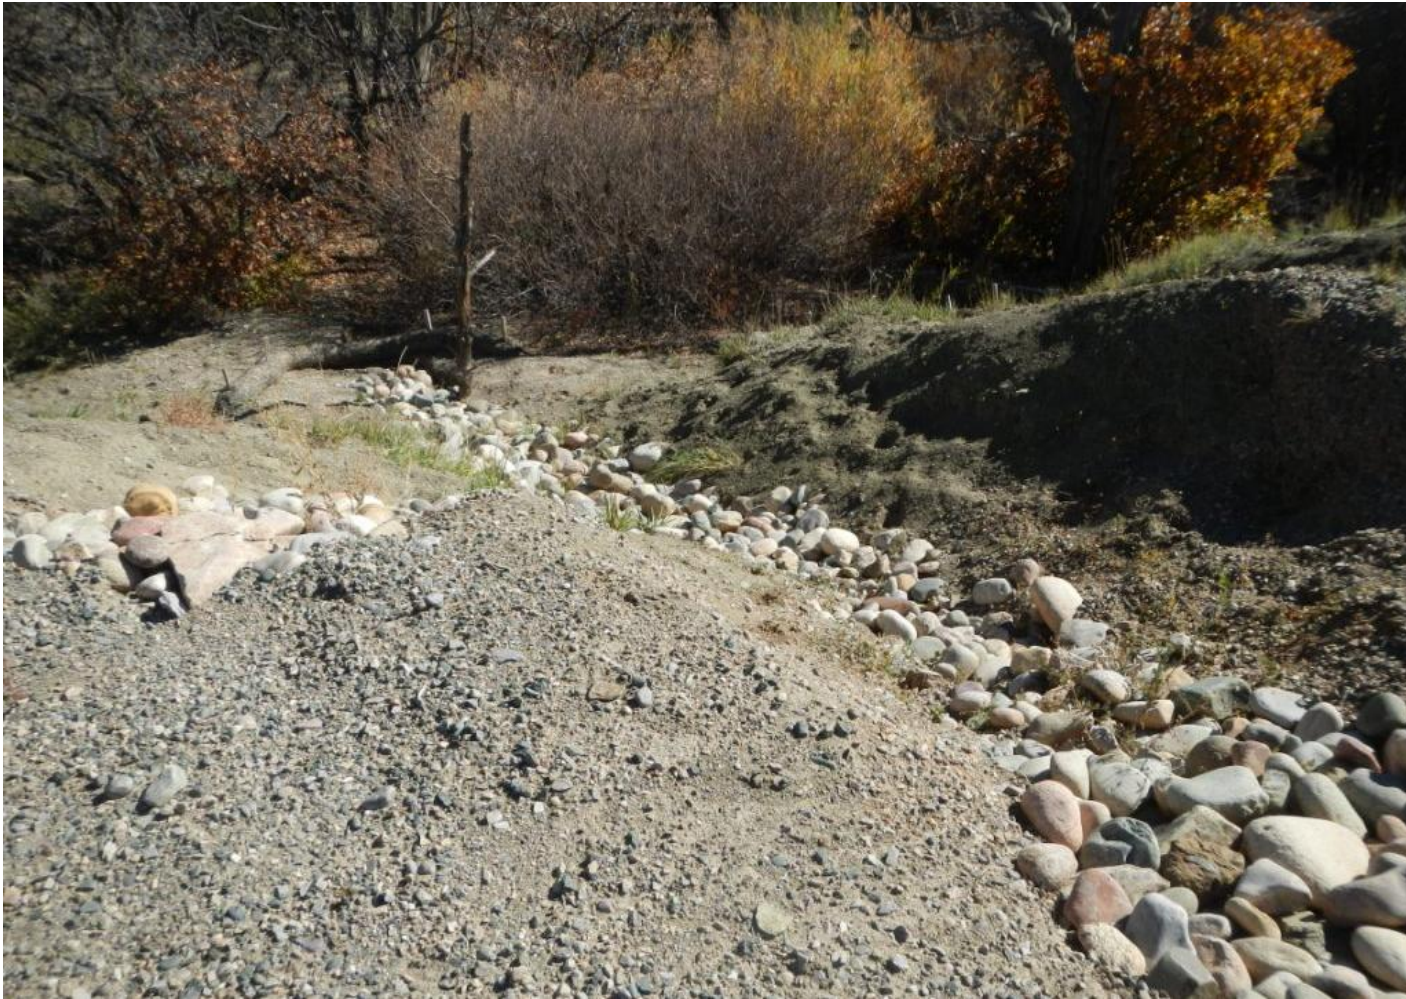
Photo 5. View of cobble run down in the eastern portion of the project area. Wattles at bottom of the slope need maintenance.

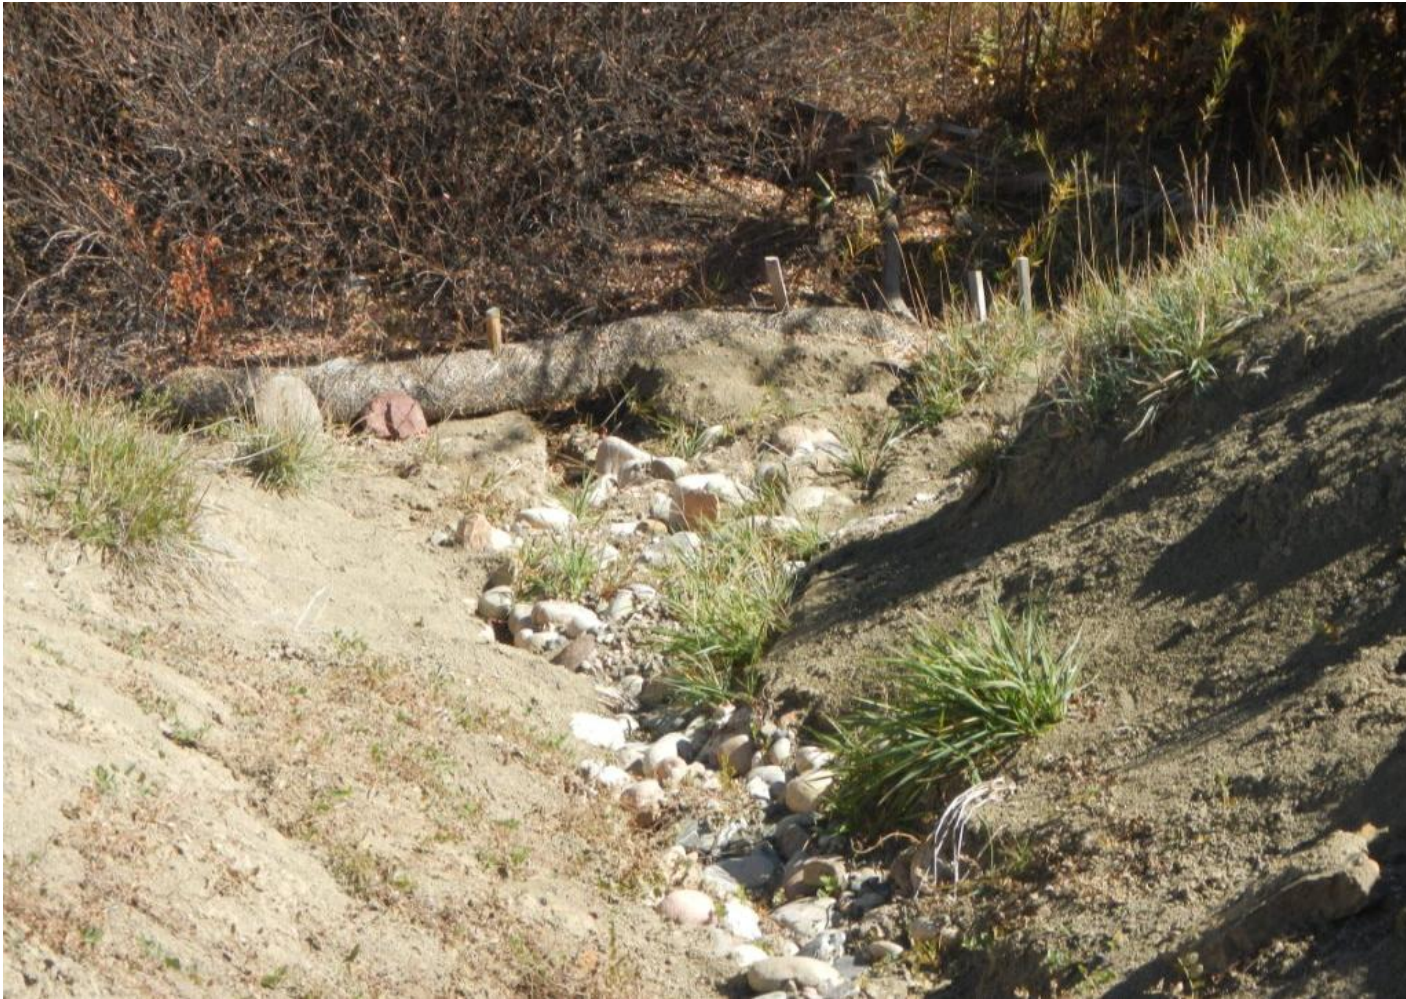
Photo 6. Closeup of straw wattles at bottom of eastern fill slope where sediment is accumulated and stormwater flows beneath the wattle. An irrigation ditch is just beyond the wattle.

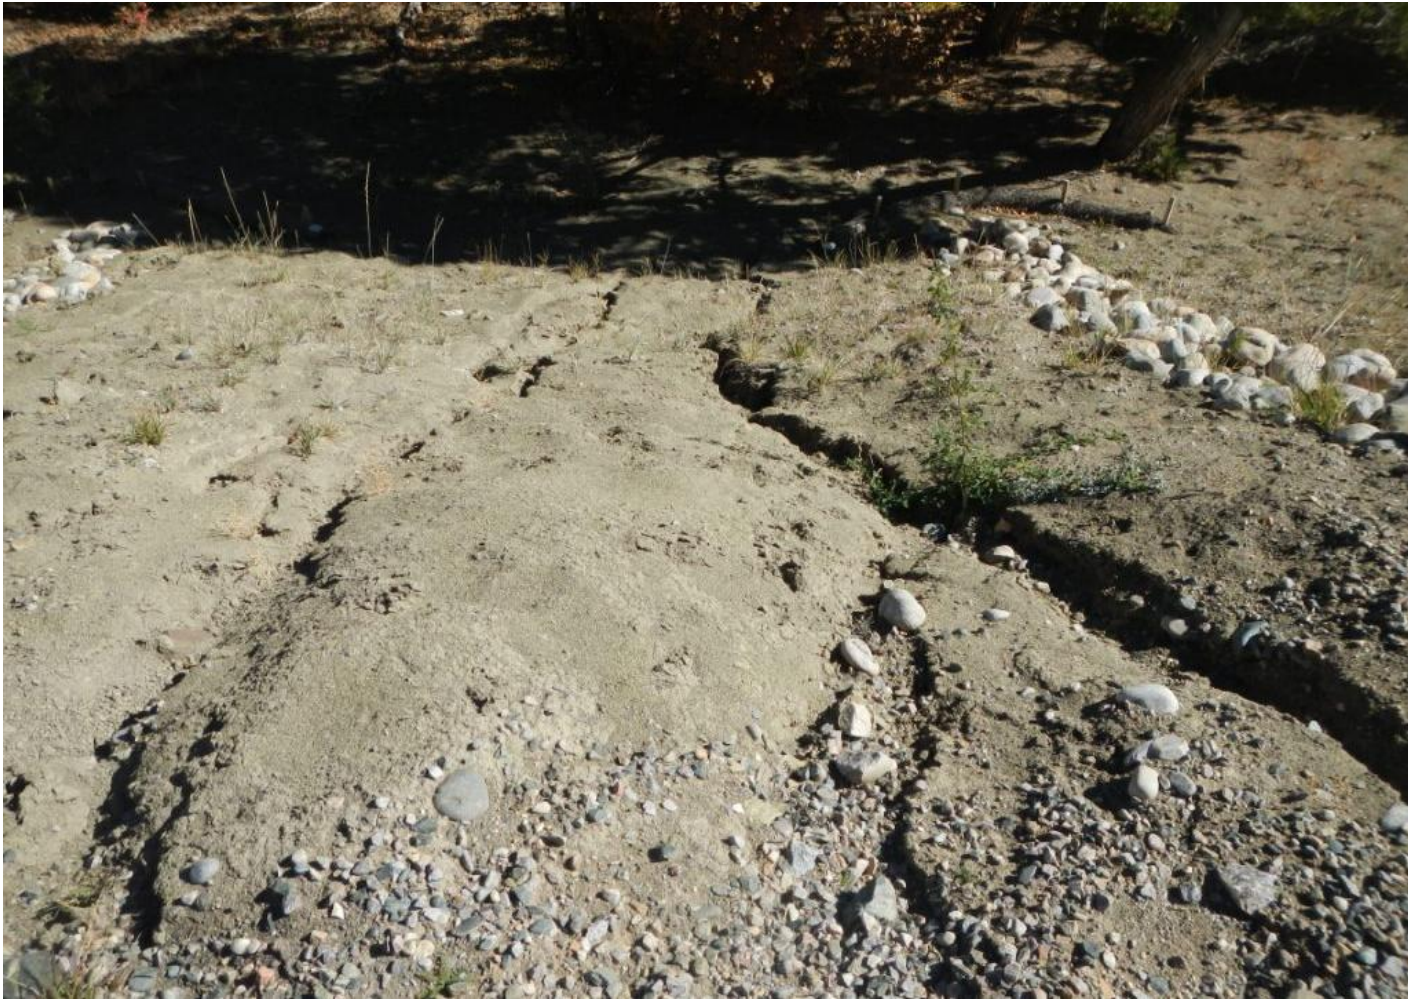
Photo 7. Another view of rills in the eastern portion of the project area that do not have sufficient stormwater controls.
