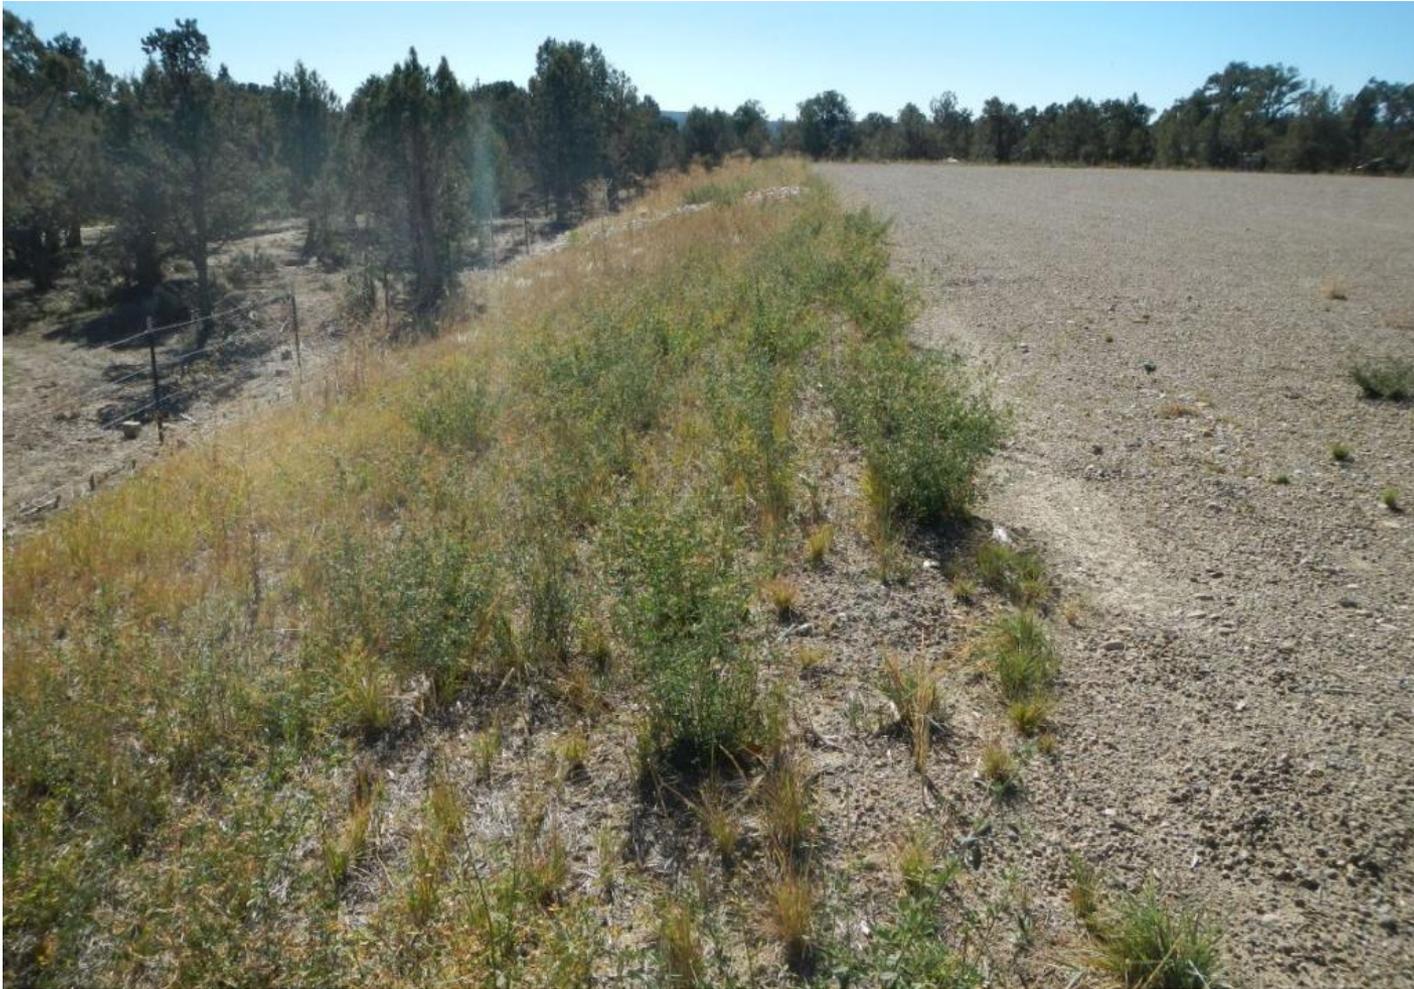
Photo 1. View of the eastern portion of the project area from the northeastern corner facing southward. Revegetation is progressing on the fill slope.

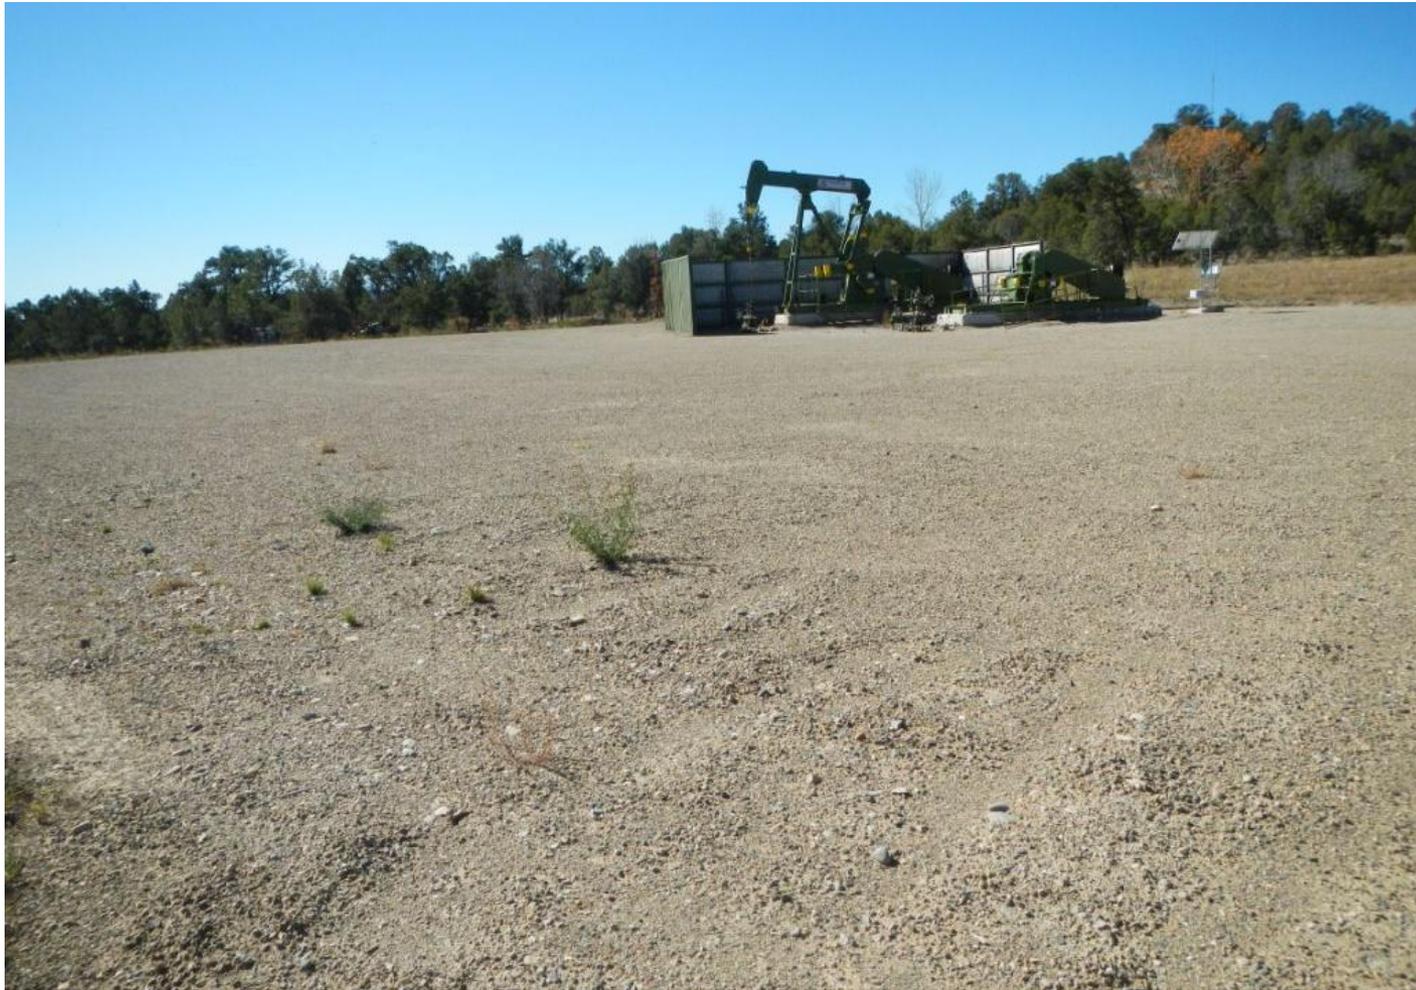
Photo 2. View of the project area from the northeastern corner facing center.

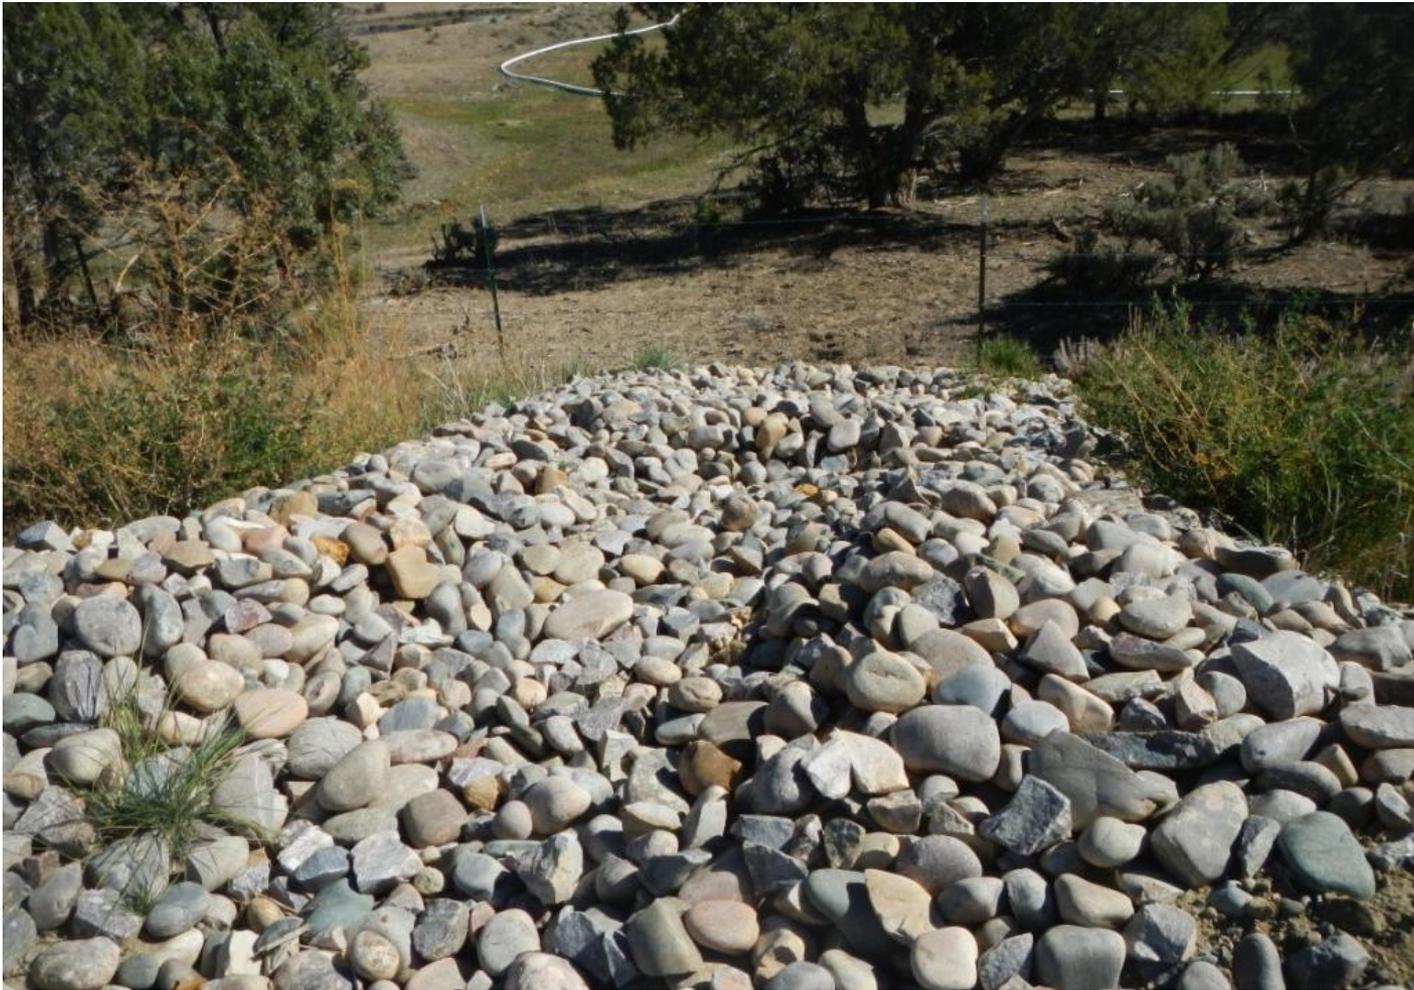
Photo 3. View of a cobble run-down in the eastern portion of the project area.

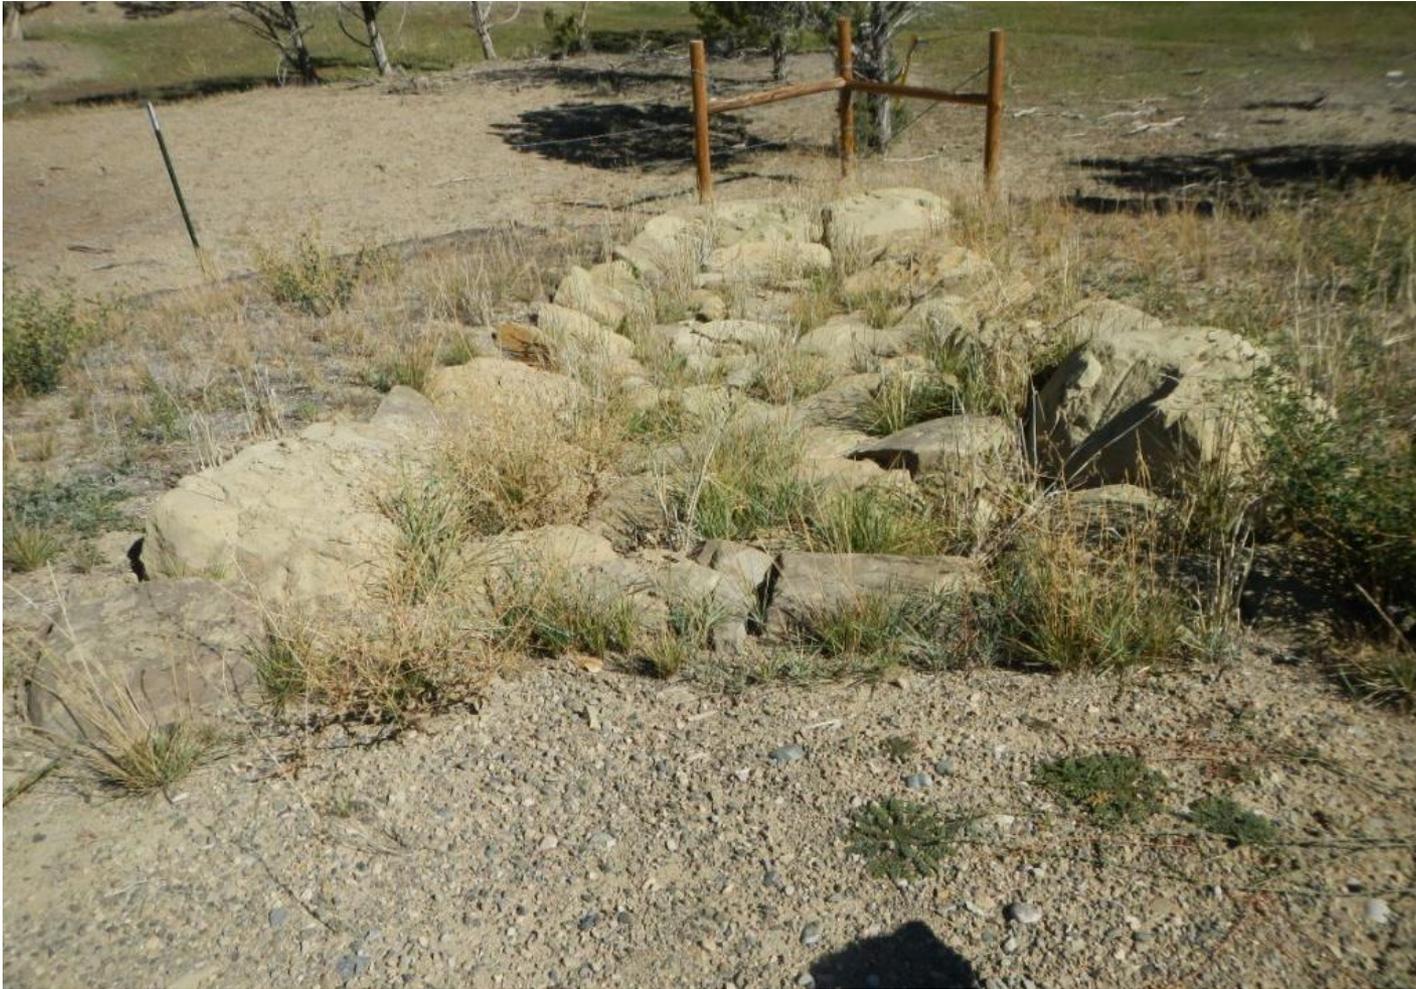
Photo 4. View of a rock run-down in the northeastern corner of the project area.

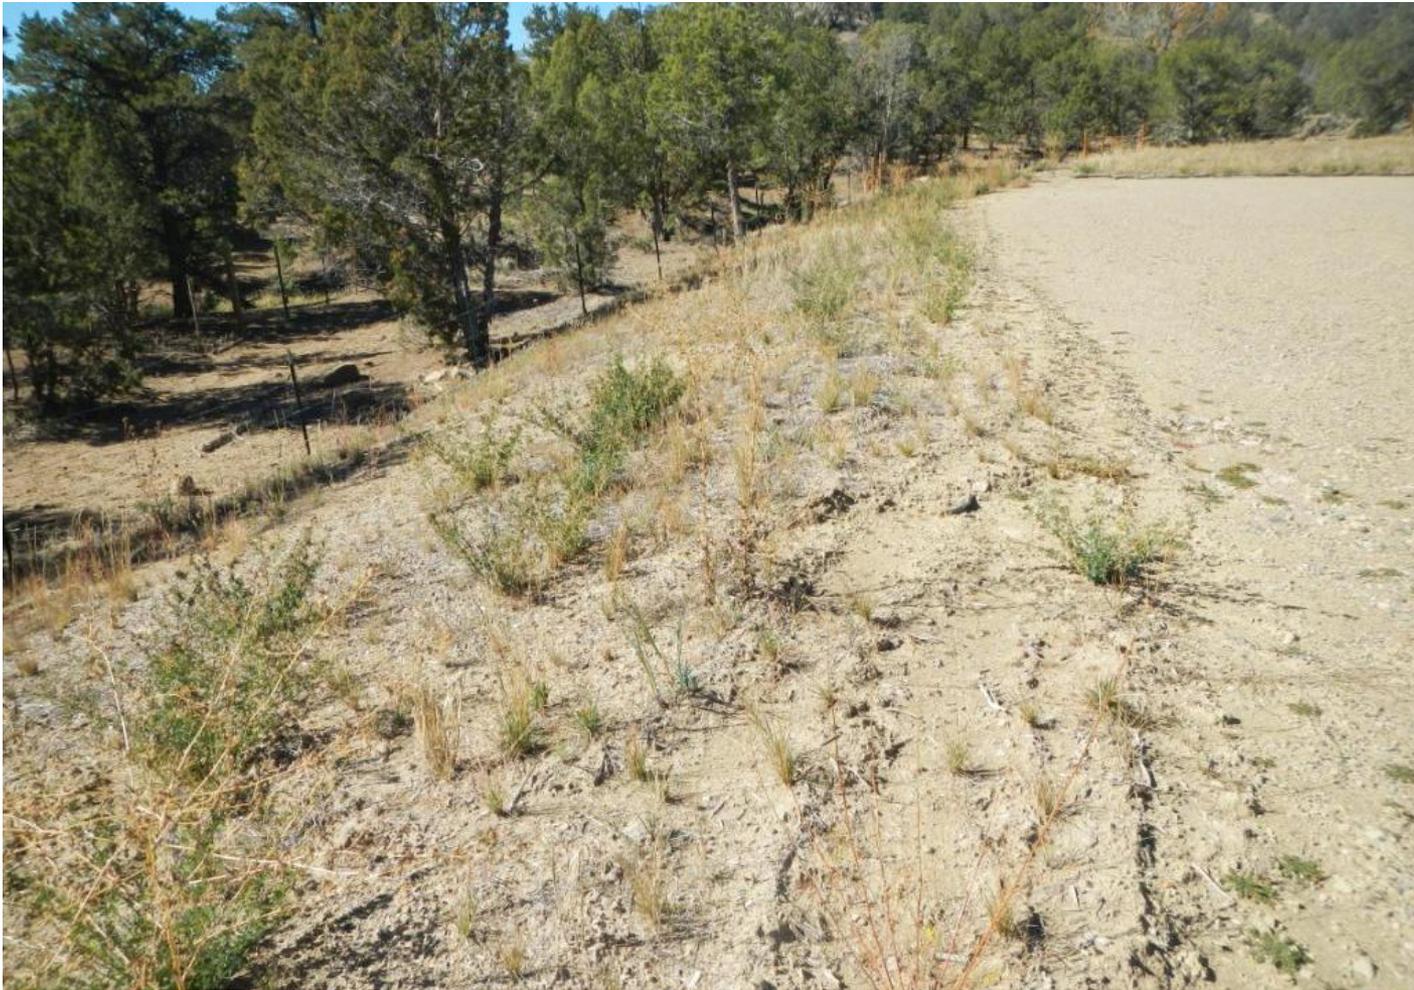
Photo 5. View of the southern portion of the project area from the southeastern corner facing westward.

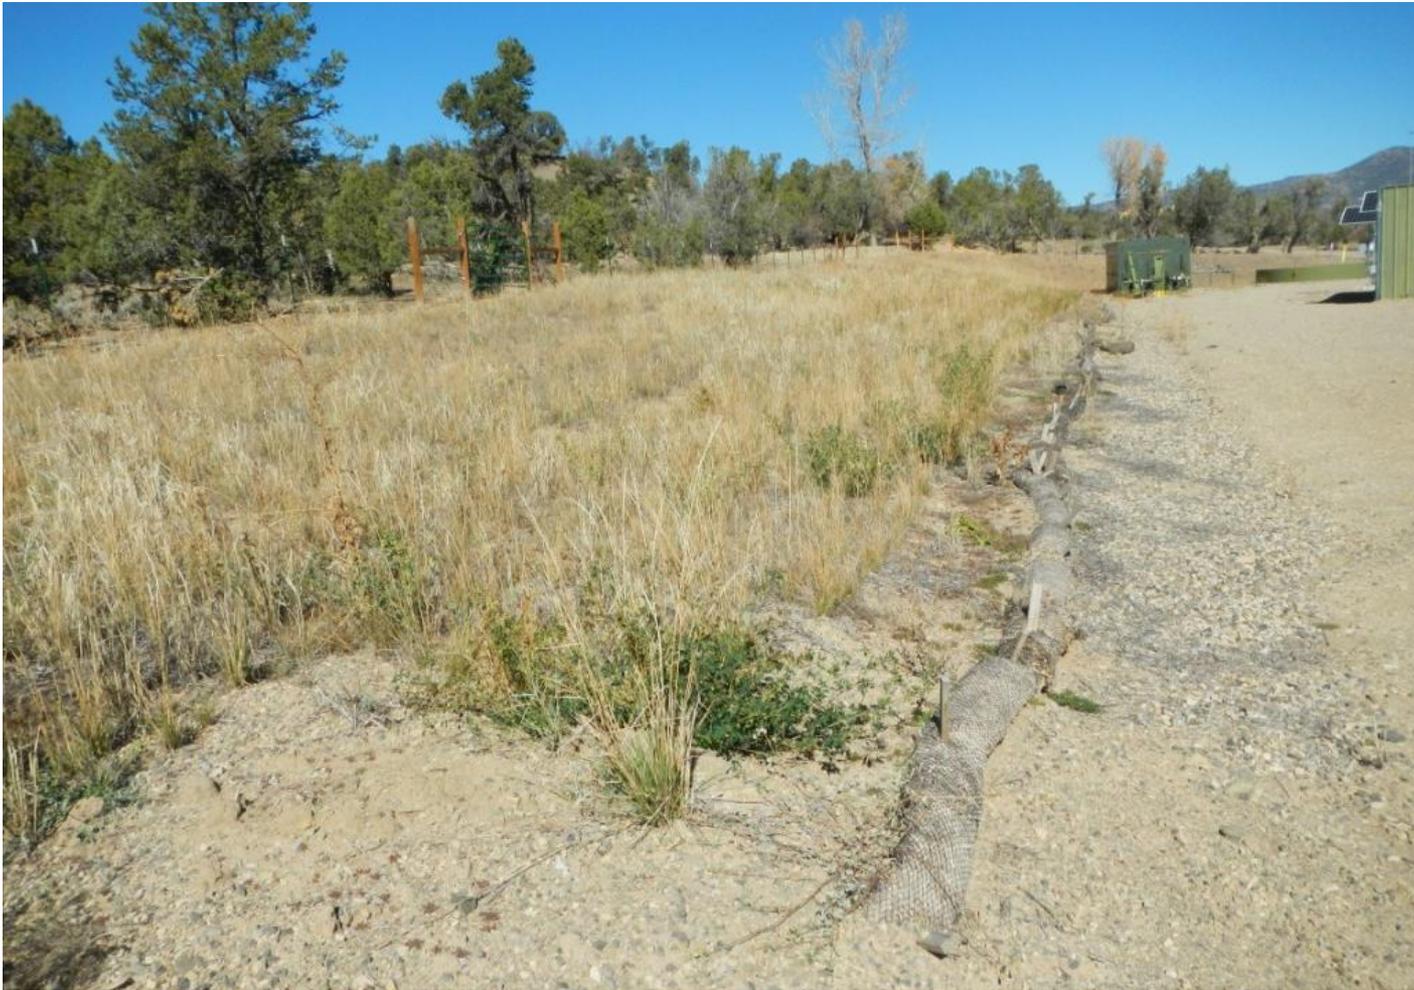
Photo 6. View of the western cut-slope from the southwestern corner of the well pad facing northward.

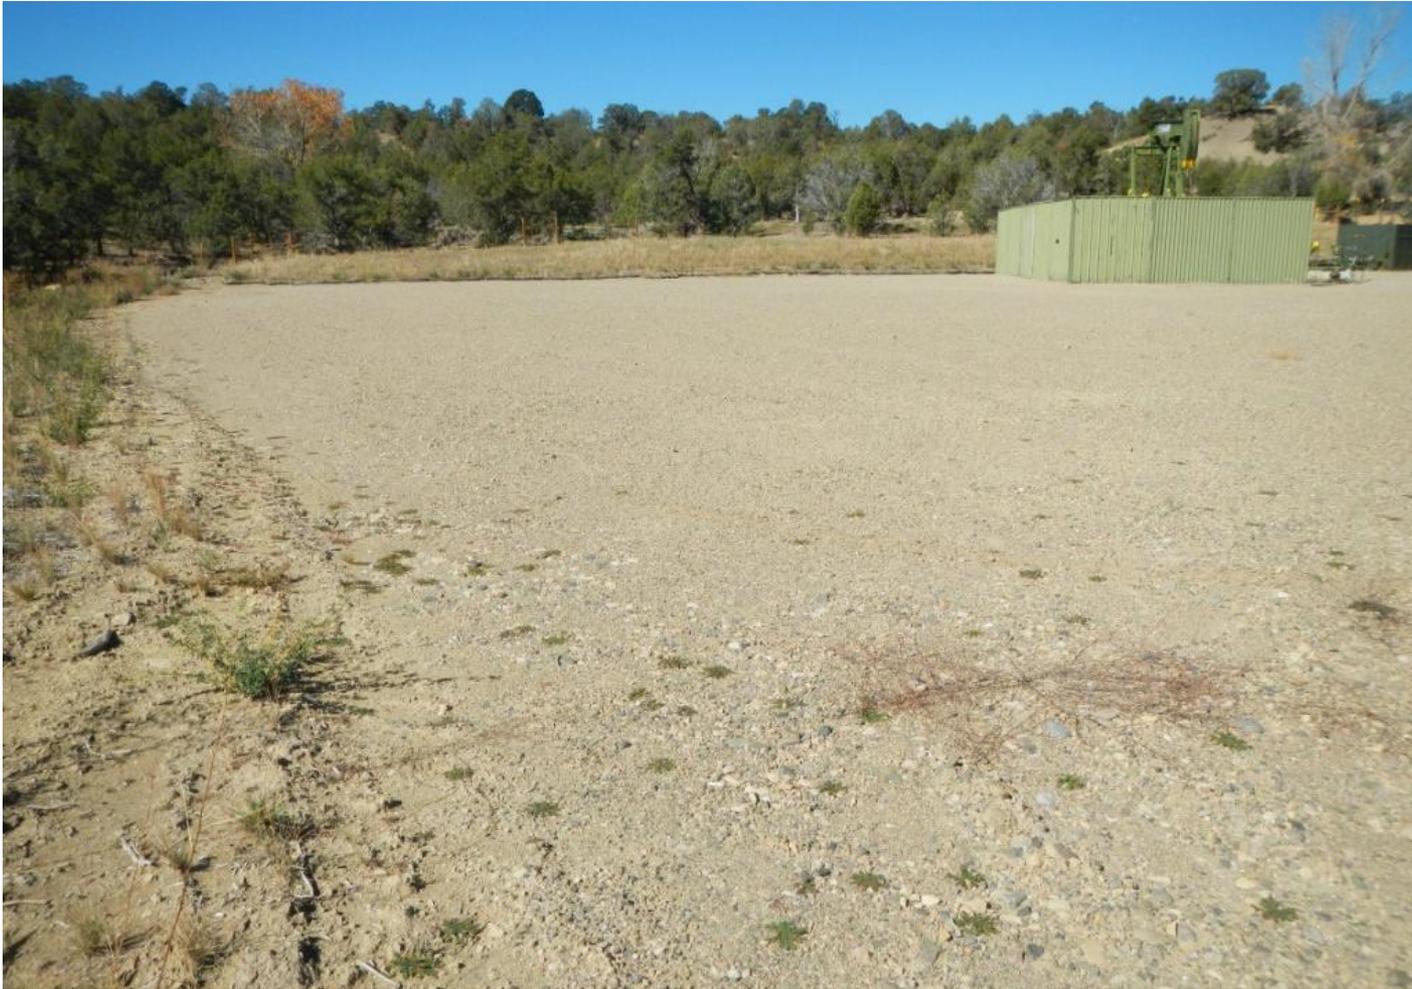
Photo 7. View of the southern portion of the well pad from the southeastern corner facing westward. If it is determined that this large area is not needed for production operations, than it should be reclaimed.
