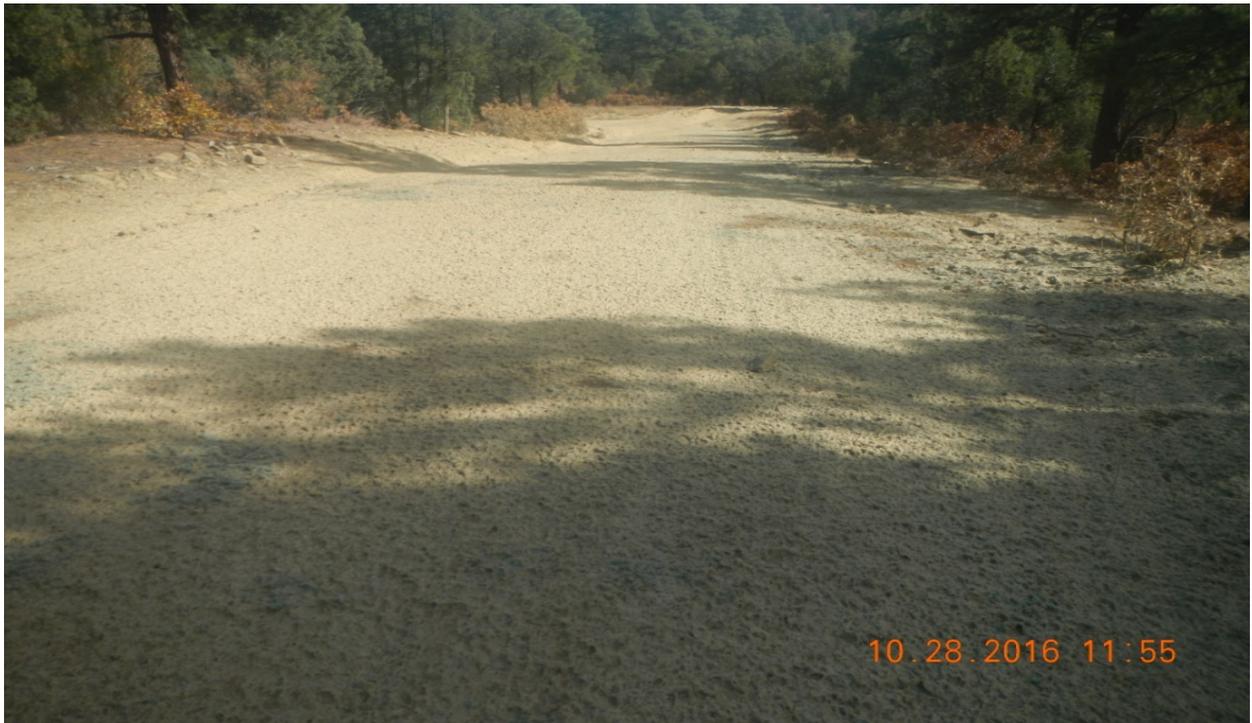
**photo 1:** Facing east along the access road near the Wriggly Red 44-21 location. This portion of pre-existing road had recently been seeded and hydromulched.

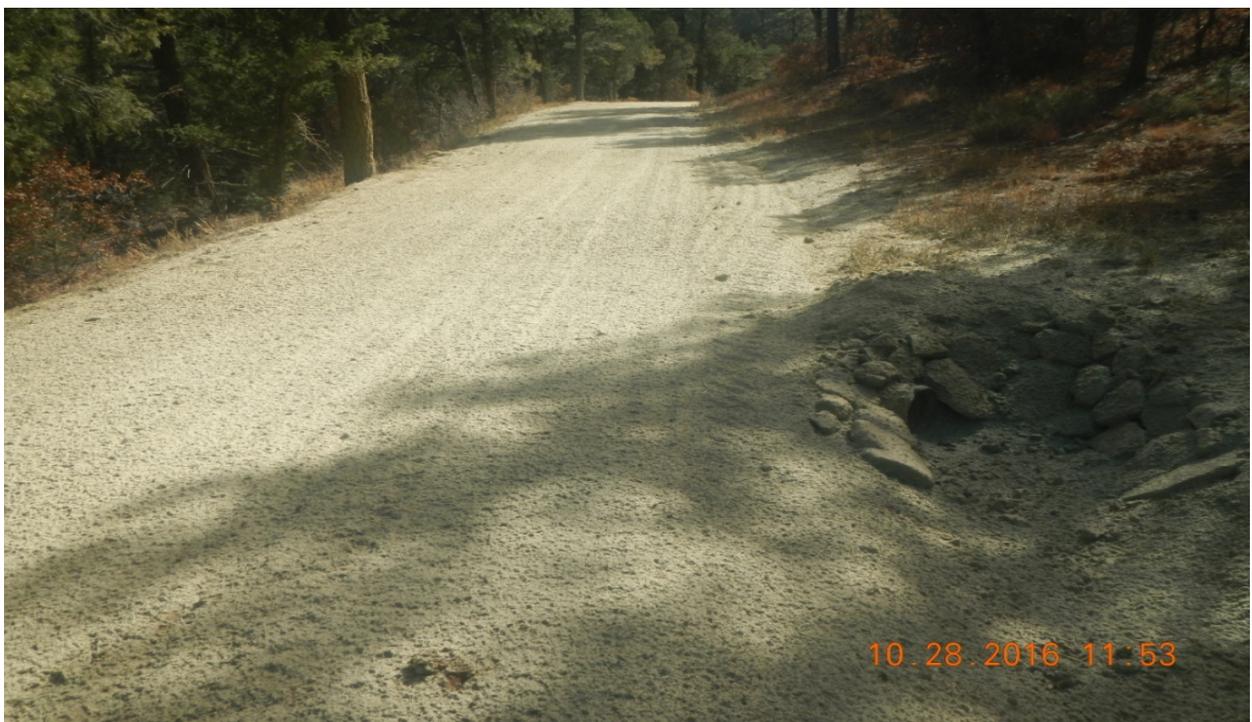
**photo 2:** Facing northeast along the access road near the Wriggly Red 44-21 location. This portion of pre-existing road had recently been seeded and hydromulched.

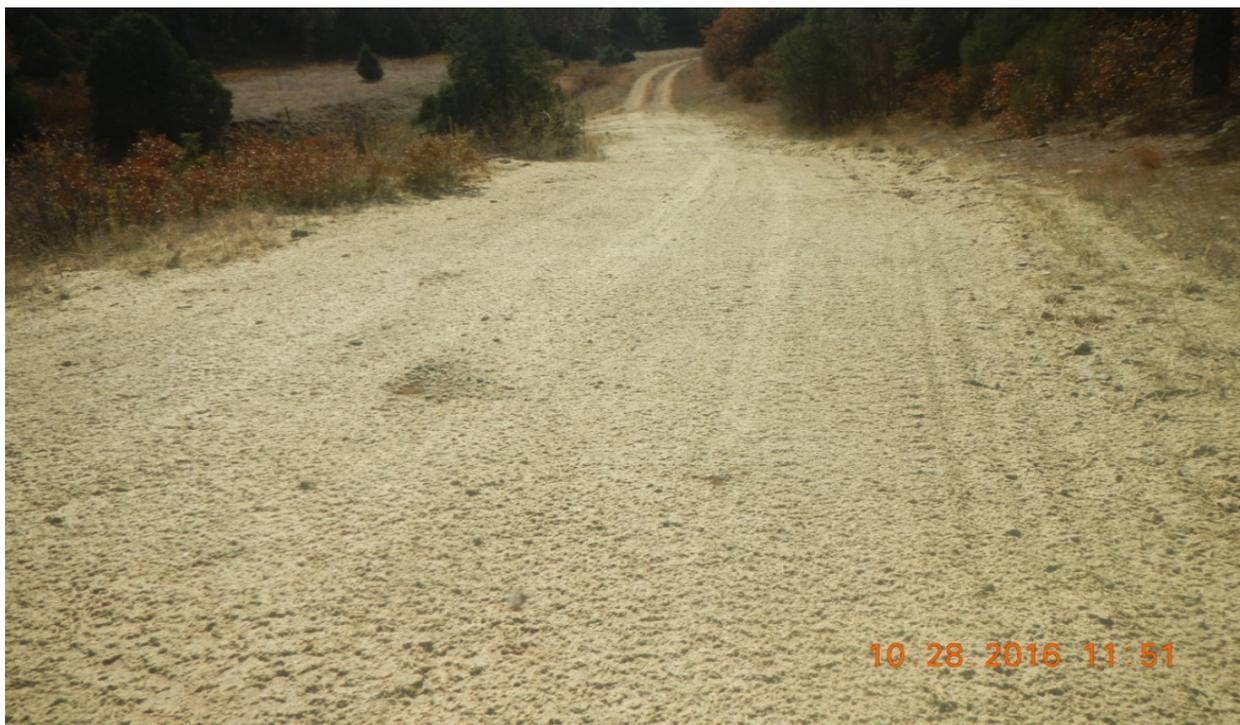
**photo 3:** Facing southeast along reclaimed access road which enters the canyon.

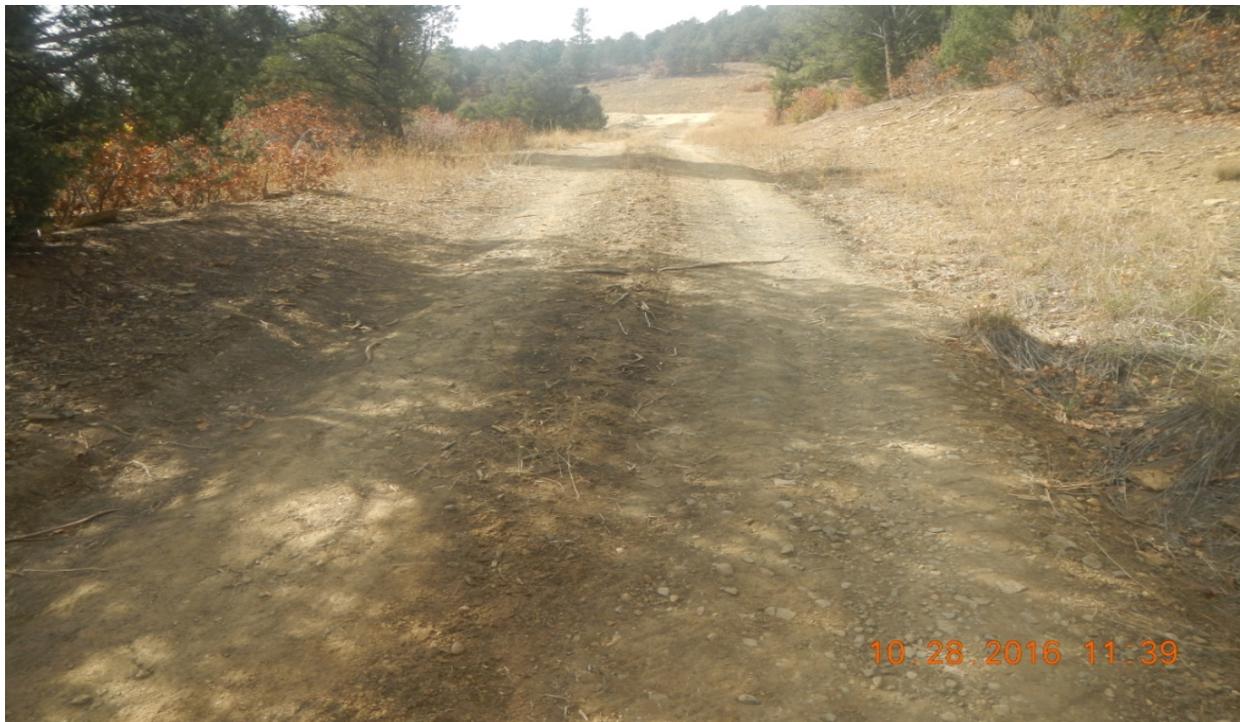
**photo 4:** Facing southwest toward along the access road near the Jumping Cow 42-28 location.

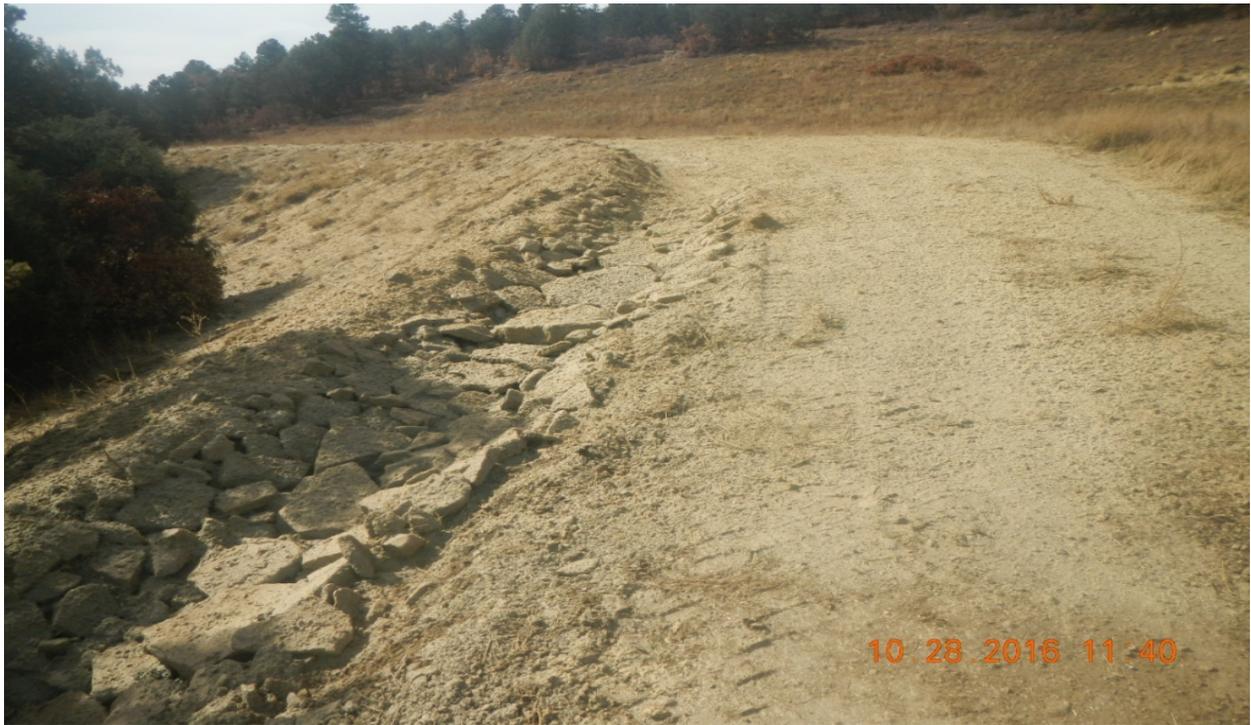
**photo 5:** Facing southwest toward the Jumping Cow 42-28 location.

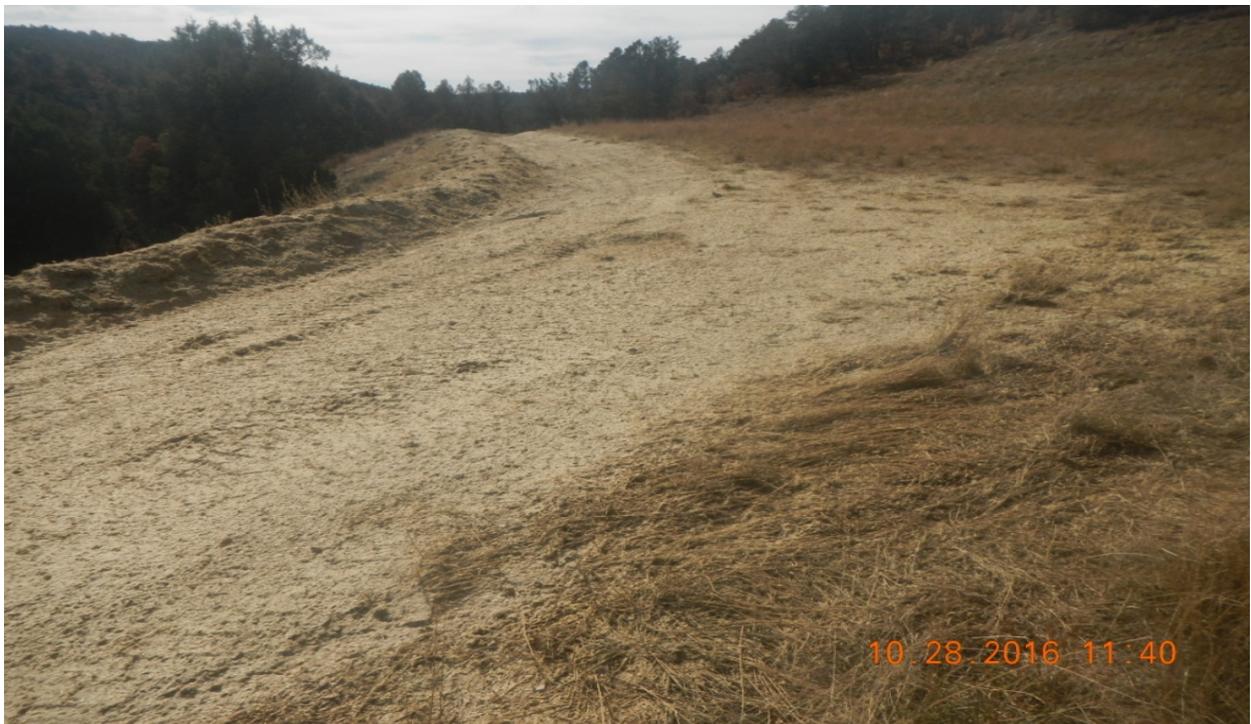
**photo 6:** Facing south toward the location. The east side has been seeded and hydromulched.

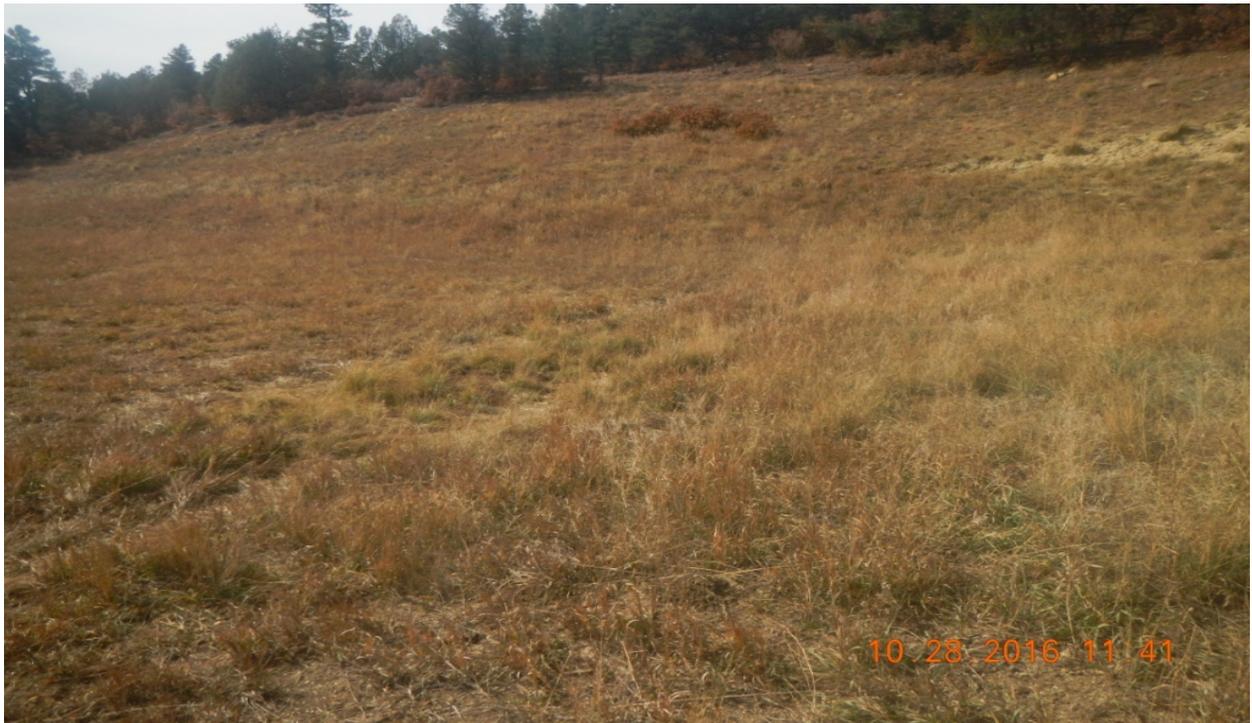
**photo 7:** North side of the location facing southwest toward the cut slope.

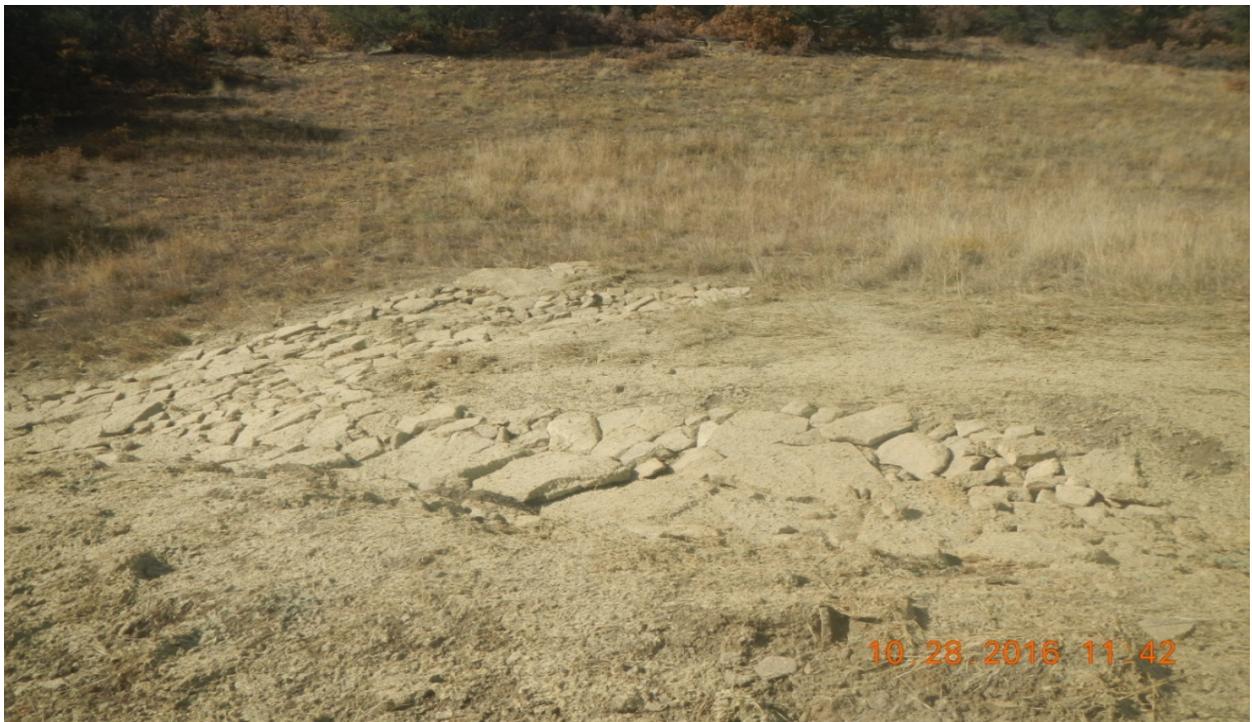
**photo 8:** South side of the location facing west. Rip/rap rock has been placed in this area for stormwater control.

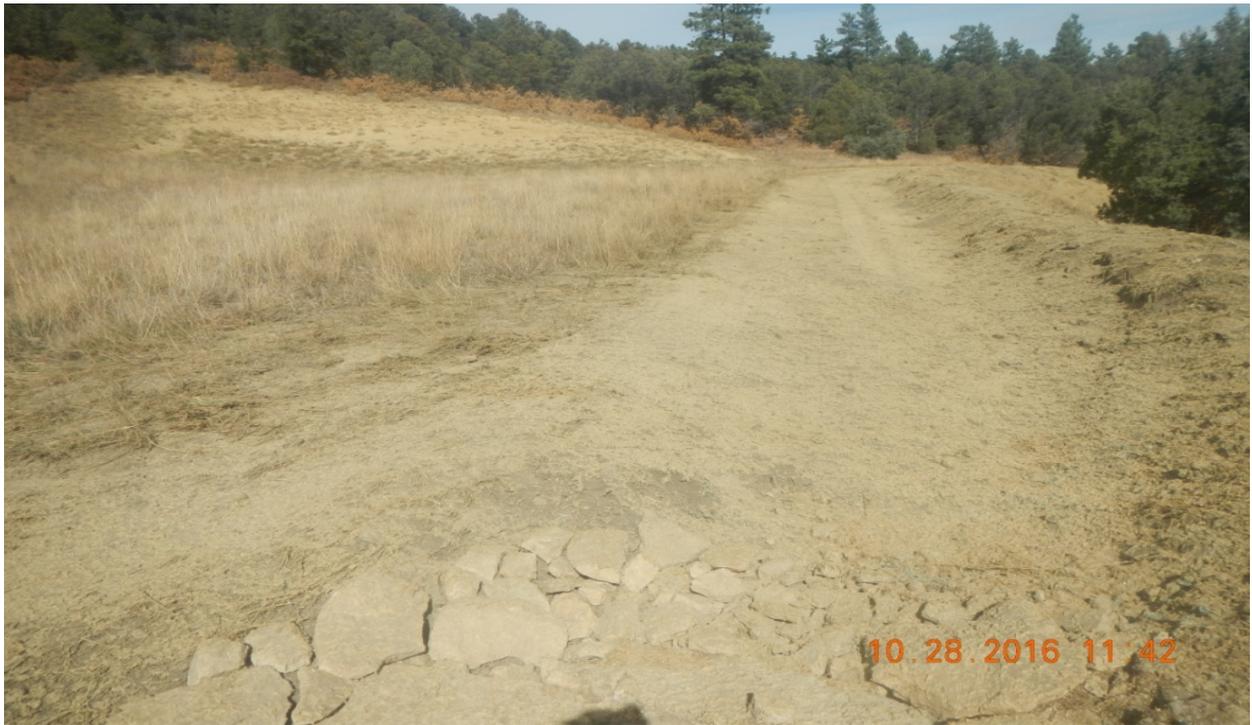
**photo 9:** South side of the location facing northeast.

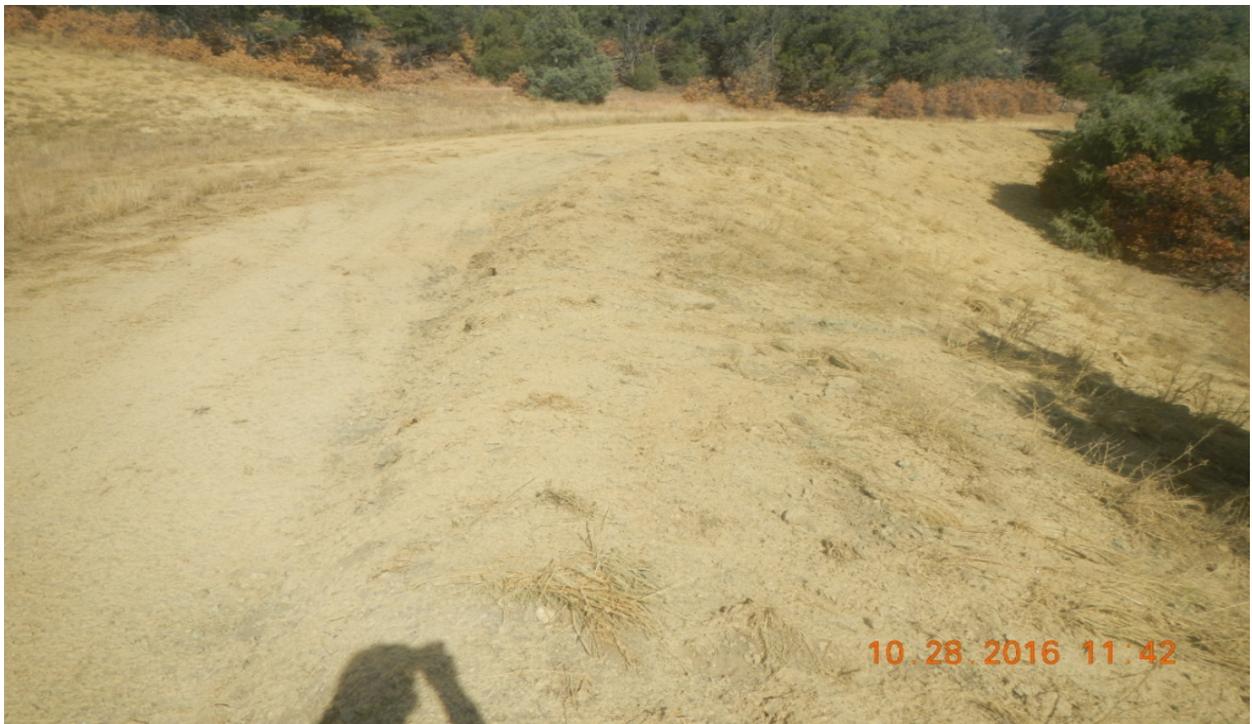
**photo 10:** East side of the location facing north along the fill slope.
