May 12, 2016

Inspection Photos: QuickSilver Alpha State #1-16

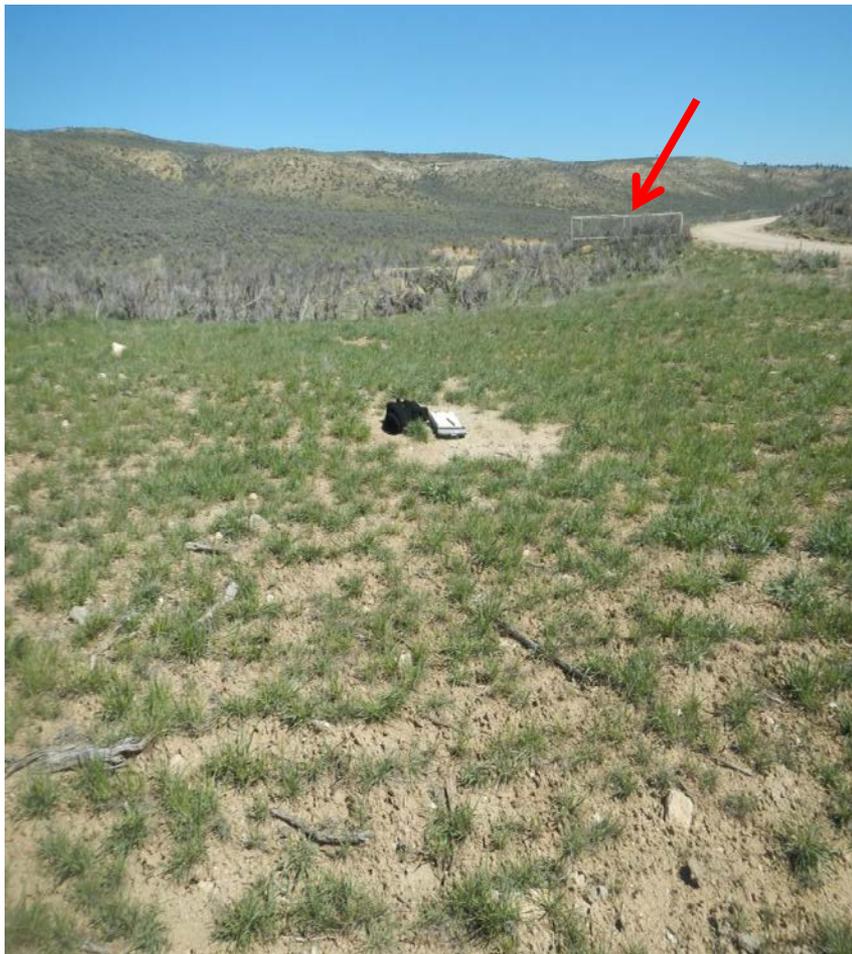
Photo#1:
View North over Location ;
Associated Facilities Marked with Arrow.

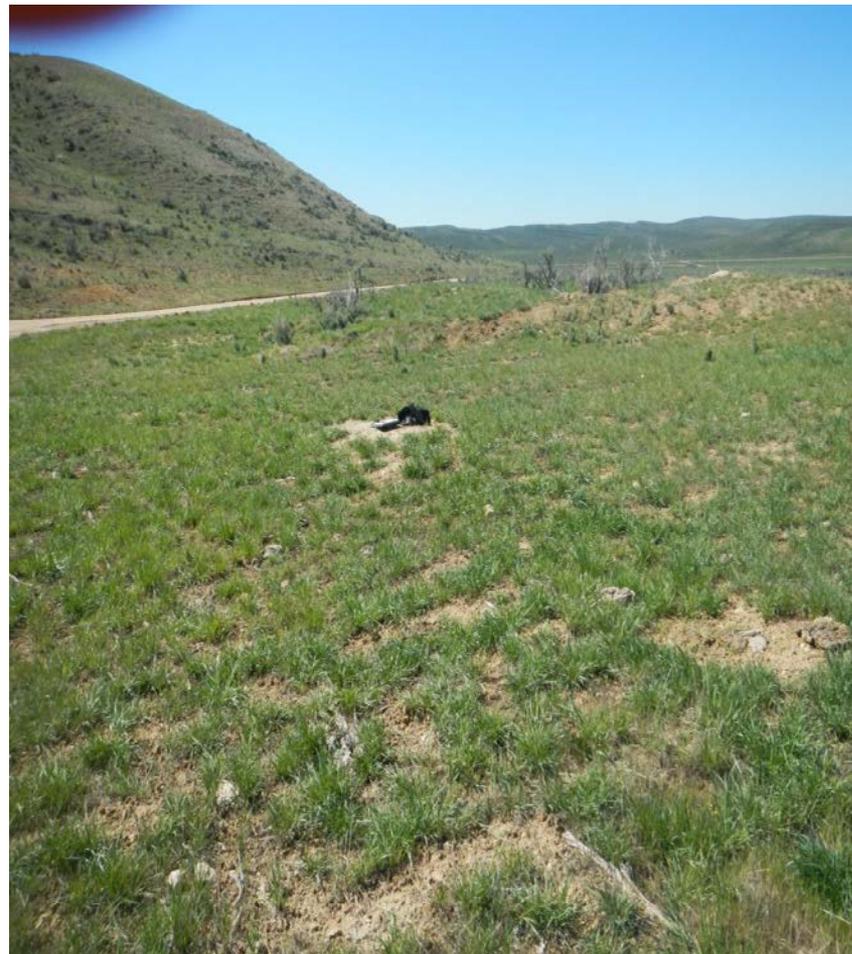
Photo#2:
View South over Location.

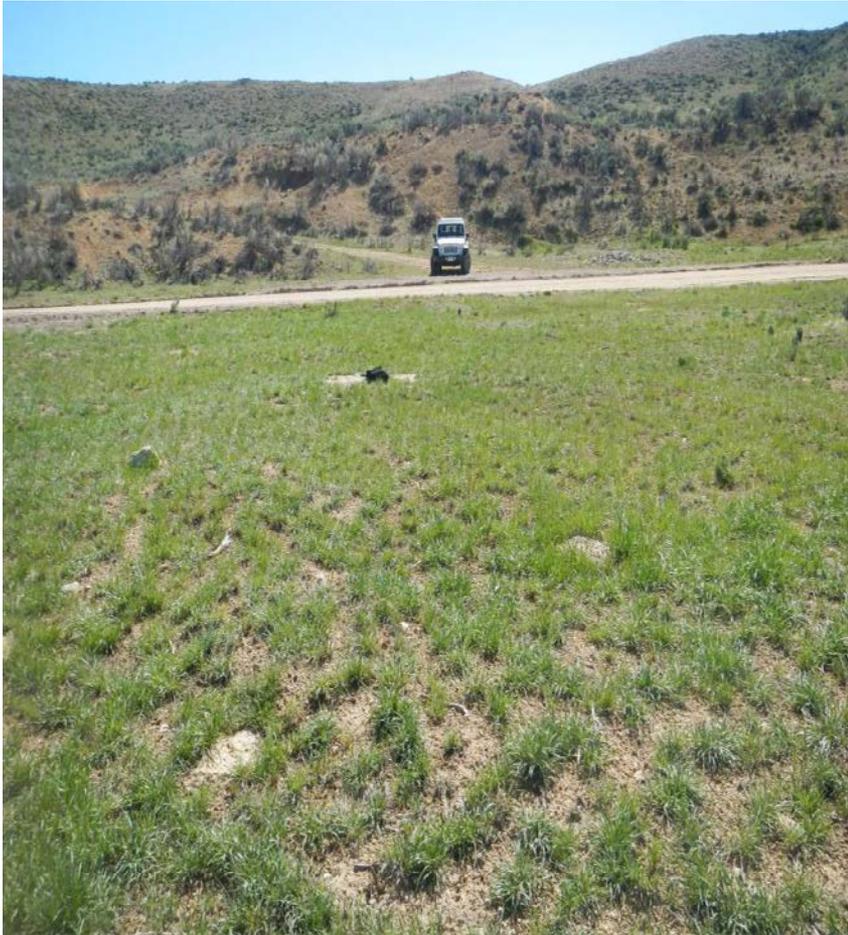
Photo#3:

View East over Location

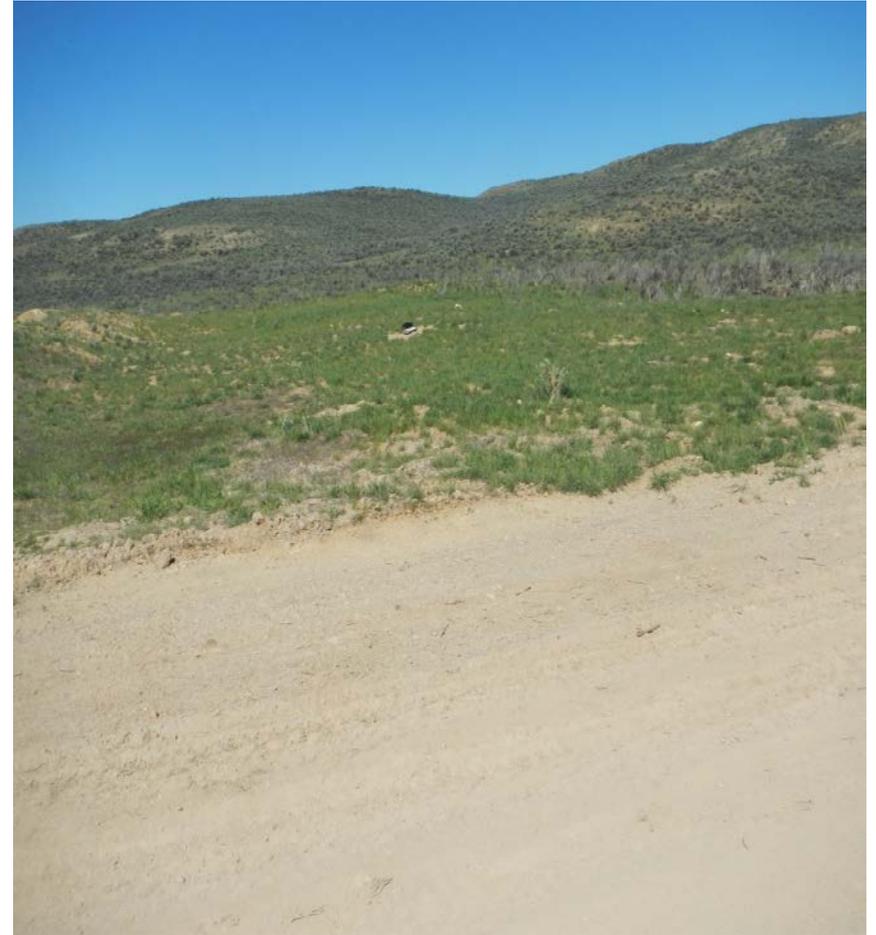
Photo#4:

View West over Location

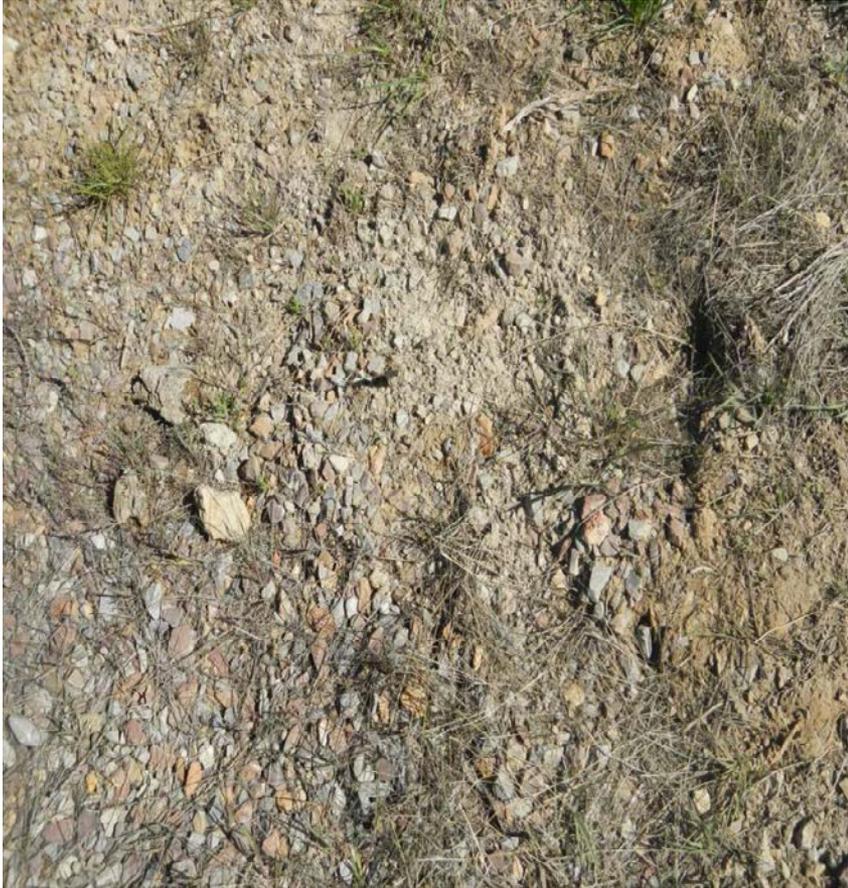
Photo#5:
Gravel on Location .

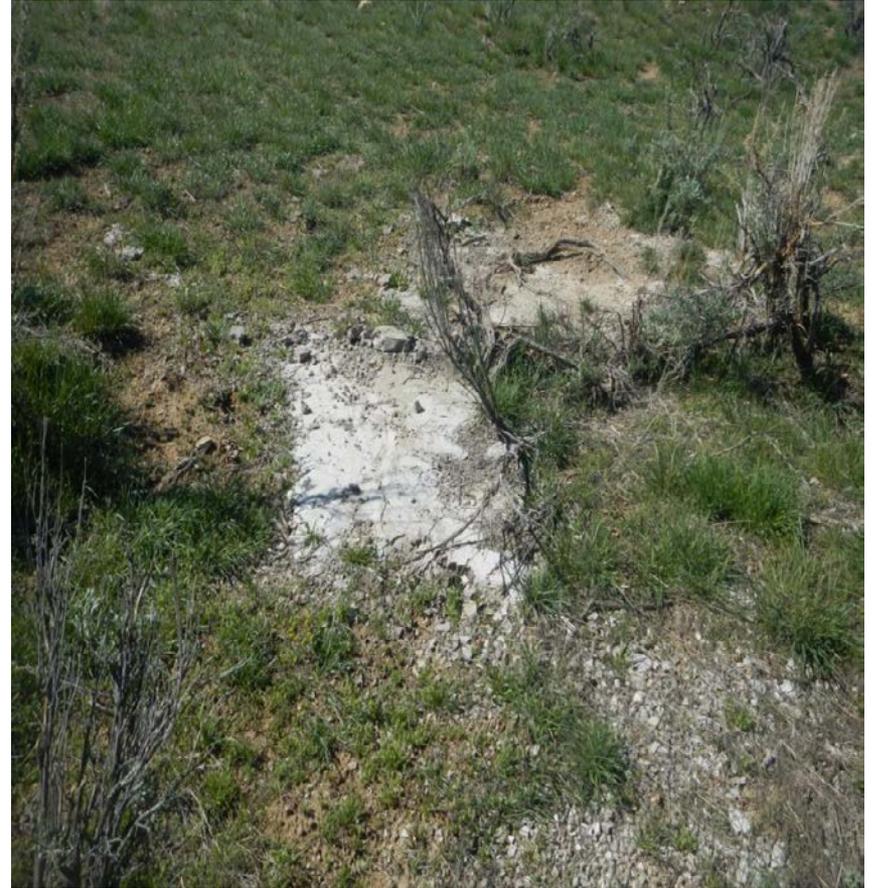
Photo#6:
Concrete wash out on Location

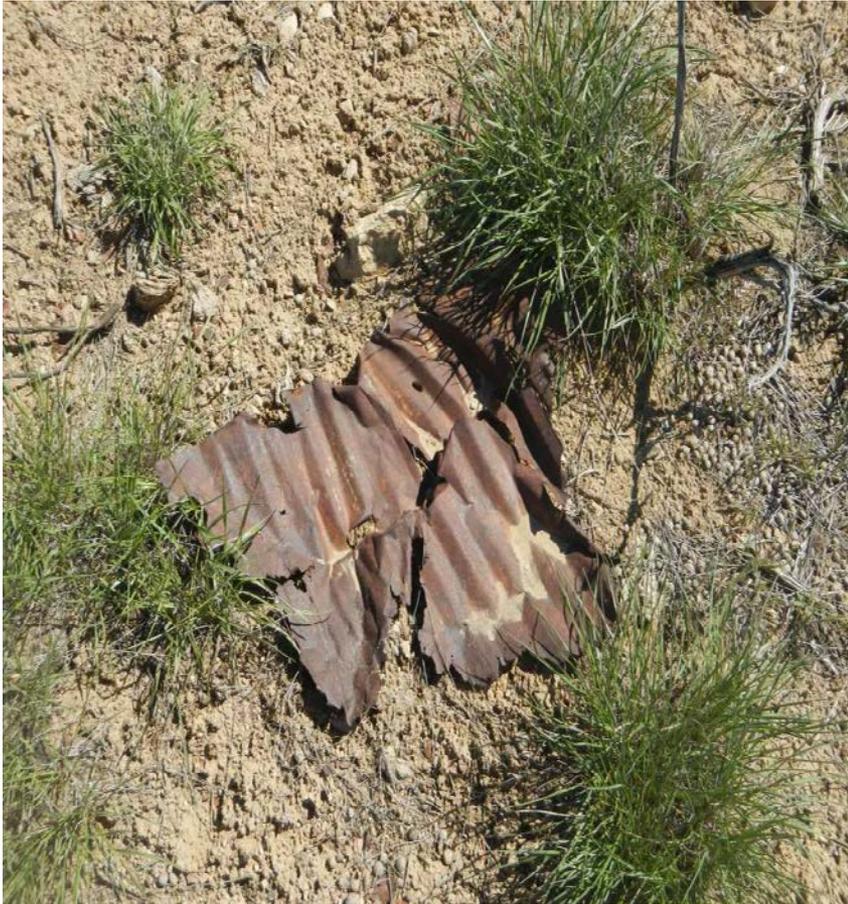
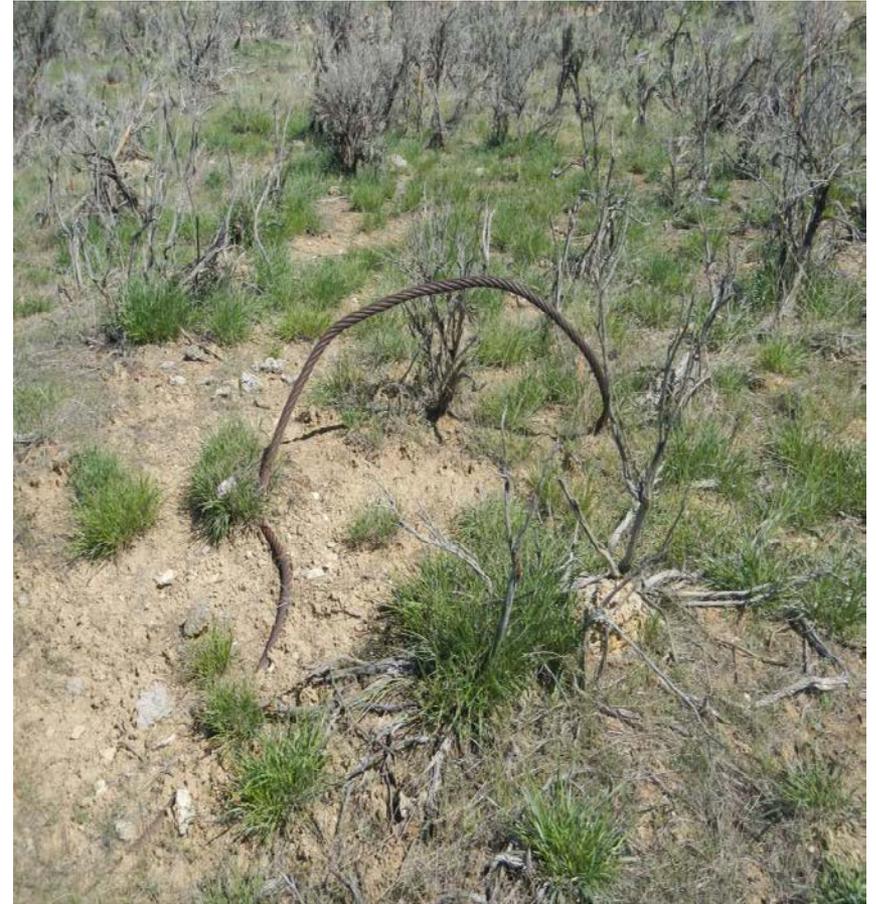
Debris remains on Location

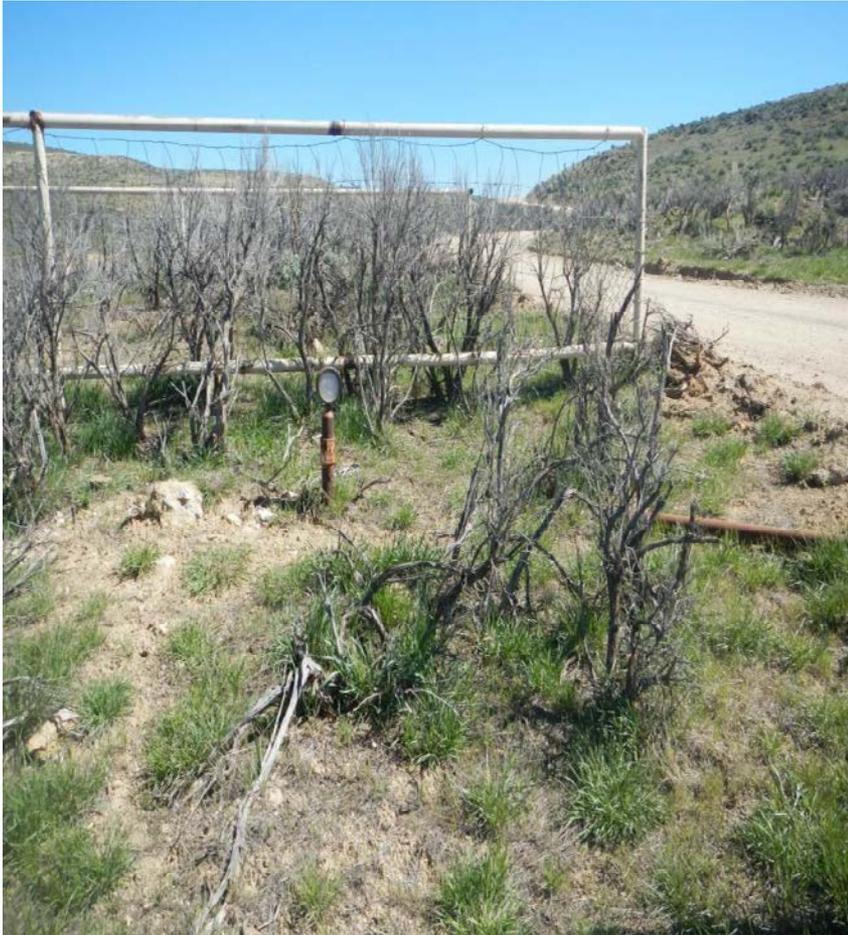
Photo#9:

View to North of Facilities Located North of Well.

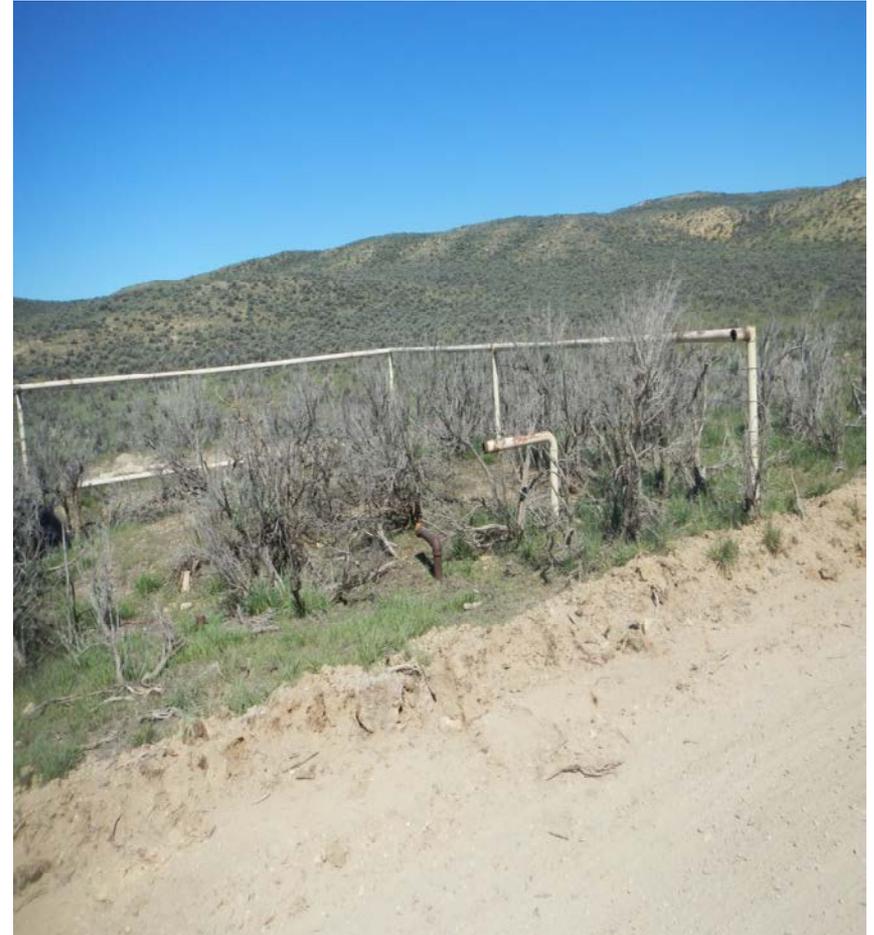
Photo#10:

View to West of same Facilities which appear to feed across Road East to Compressor Station (Photo #13)

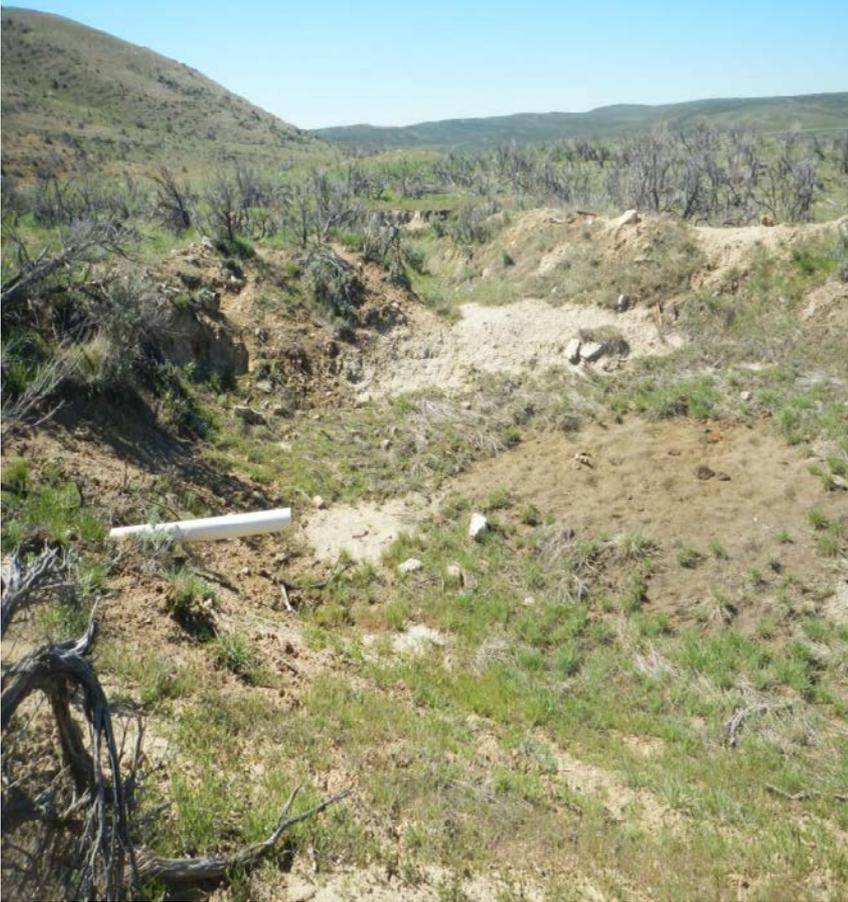
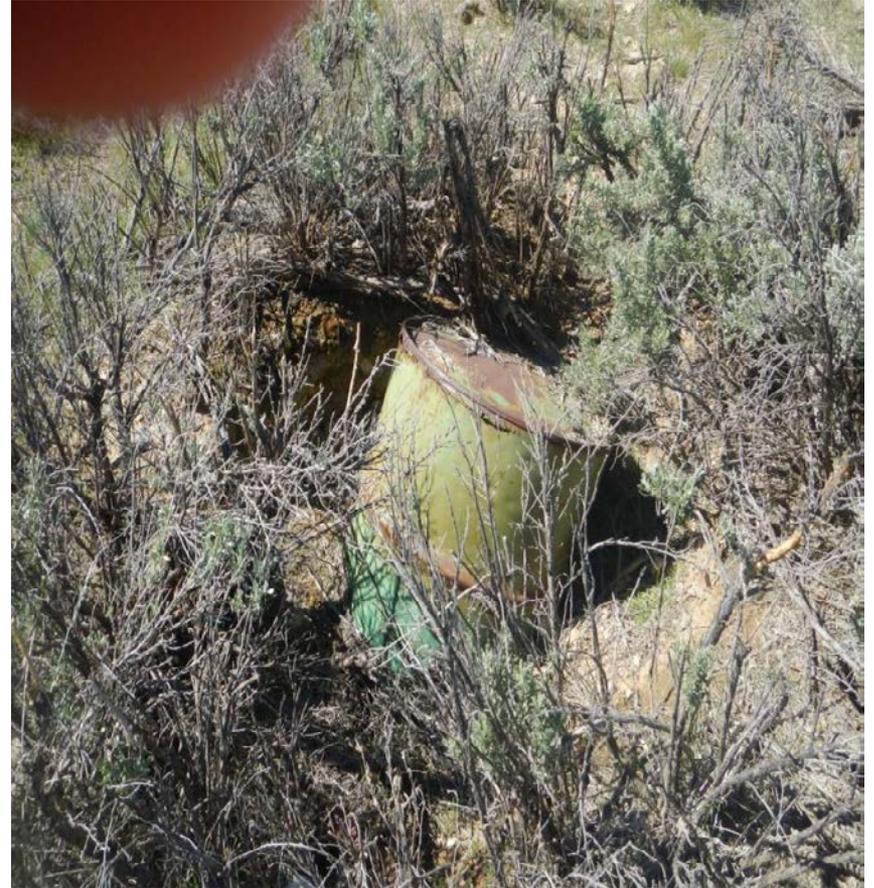
Retention/ drainage area and Debris West of Facilities

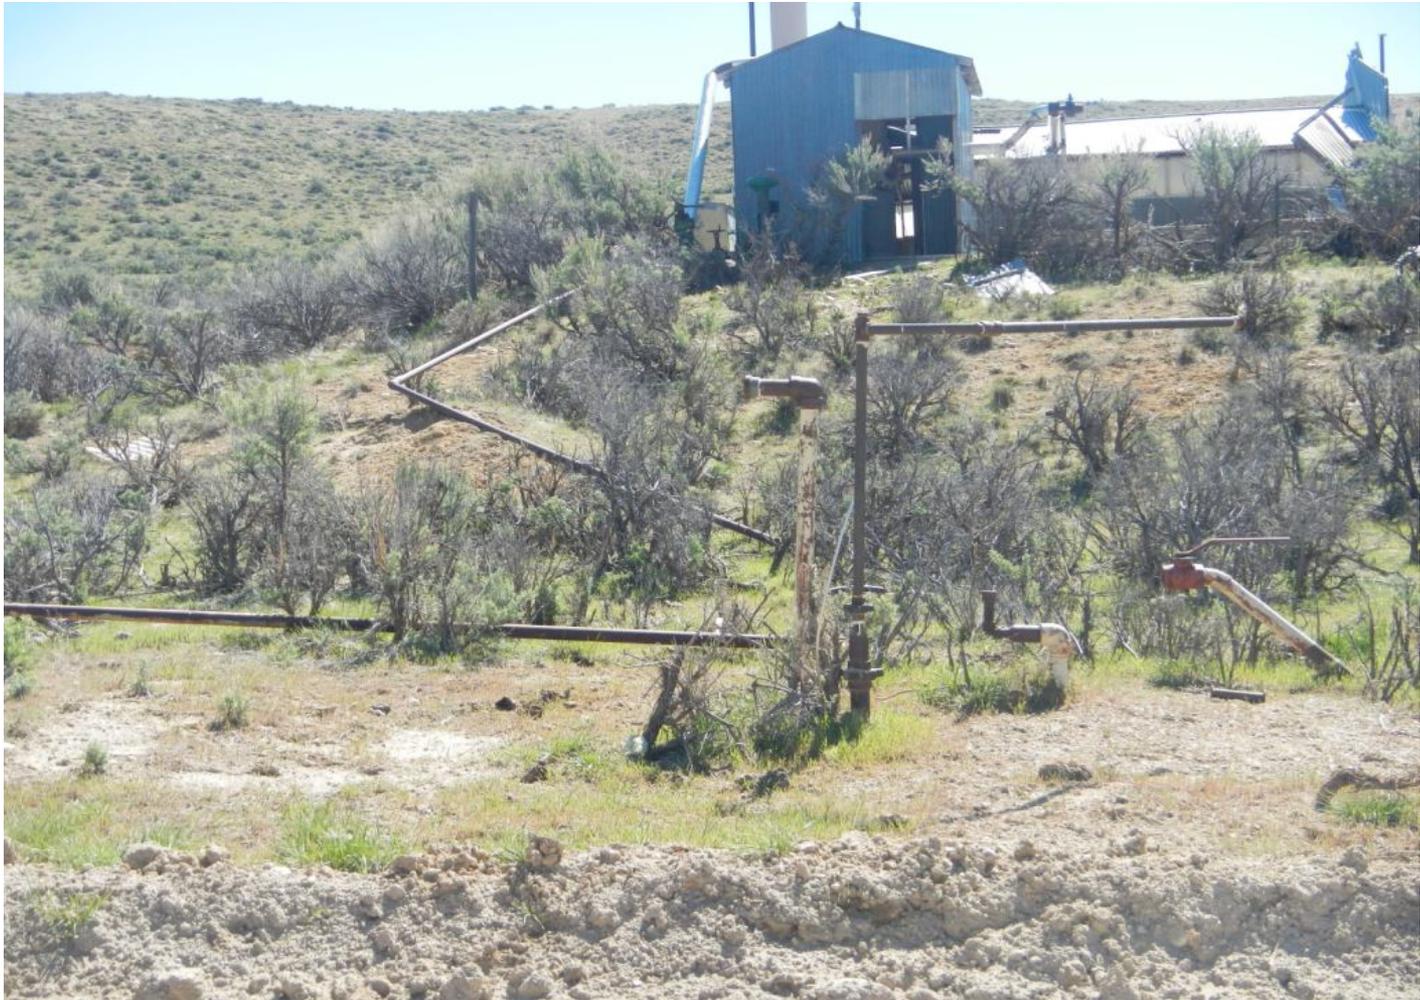
Photo#13: View across road to East from Facilities in Photos # 9 & 10; showing Compressor Station, associated Flow lines, Facilities.

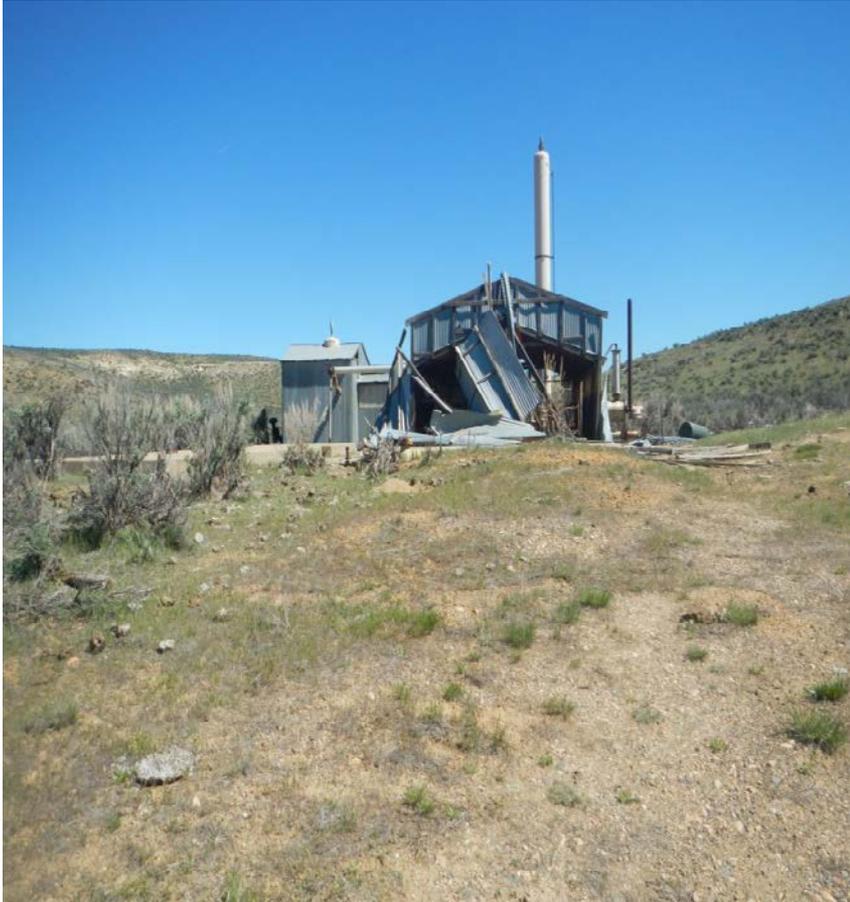
Photo#14:

View North at Compressor Station.

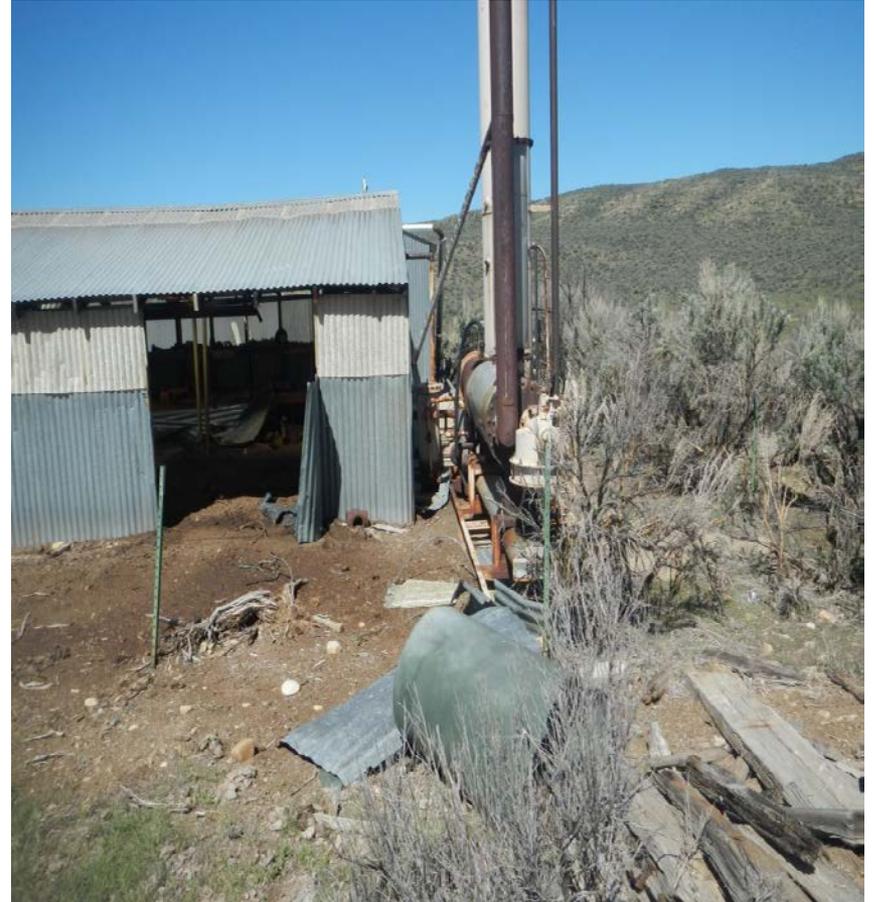
Photo#15:

View West at Compressor Station

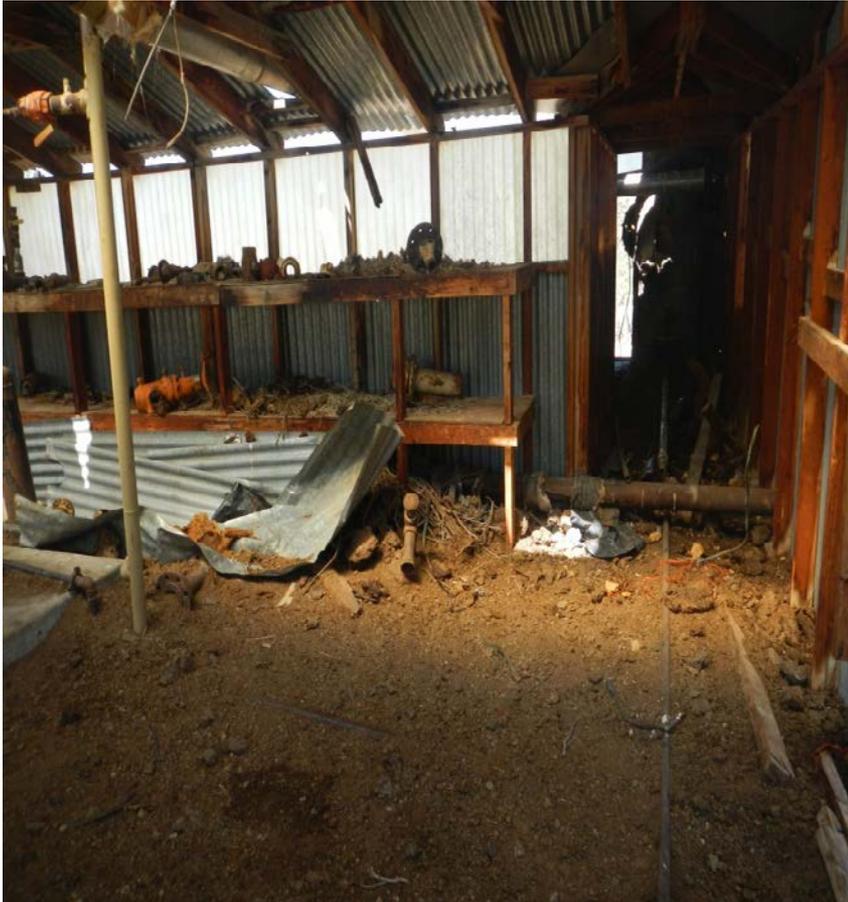
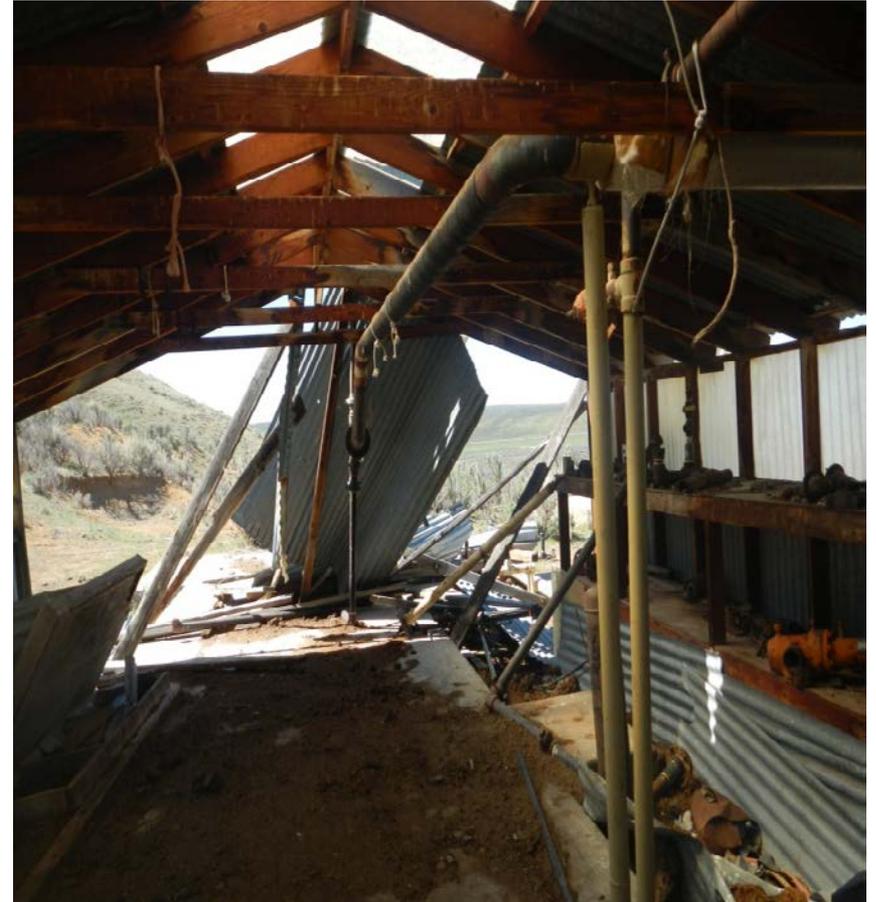
Inside Views of Compressor Station Building

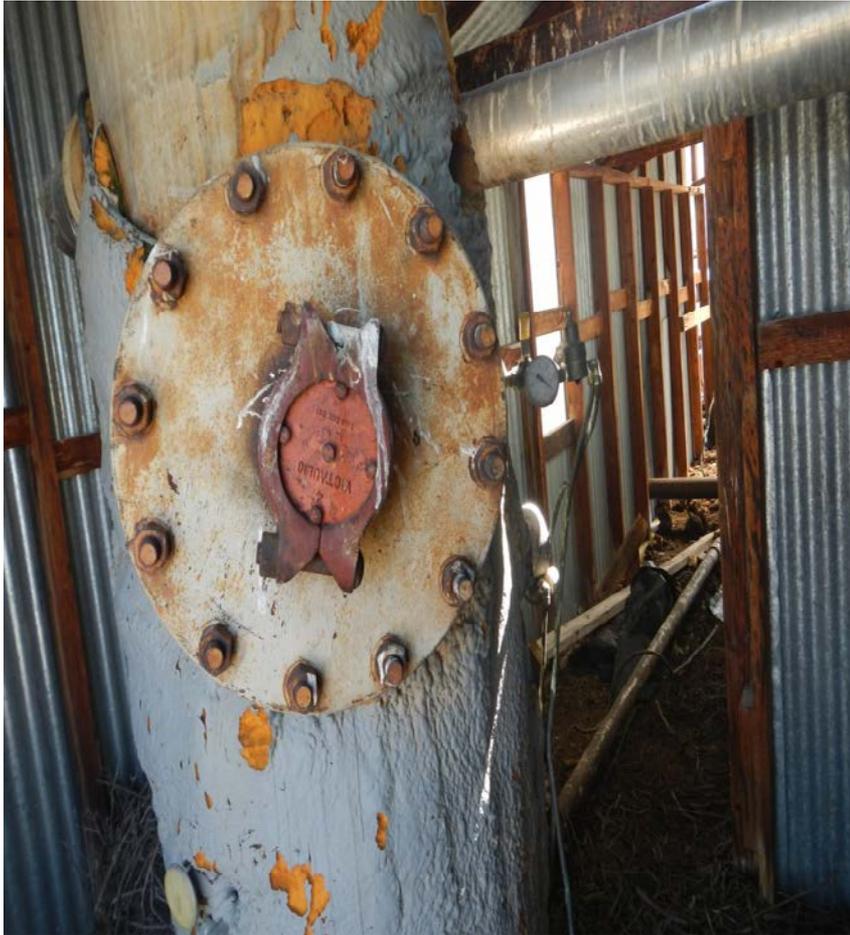
Photo#18:
Equipment inside Building

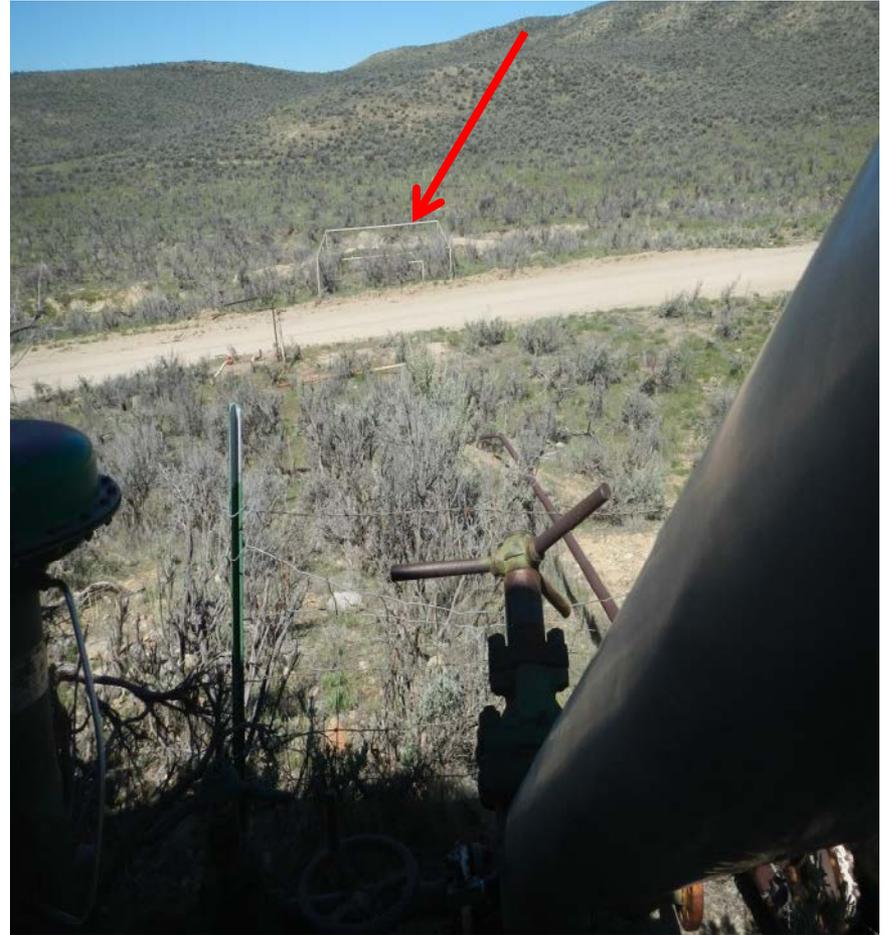
Photo#19:
View from Bldg to West; showing Facilities photo #9 & 10
