# Stormwater Inspection

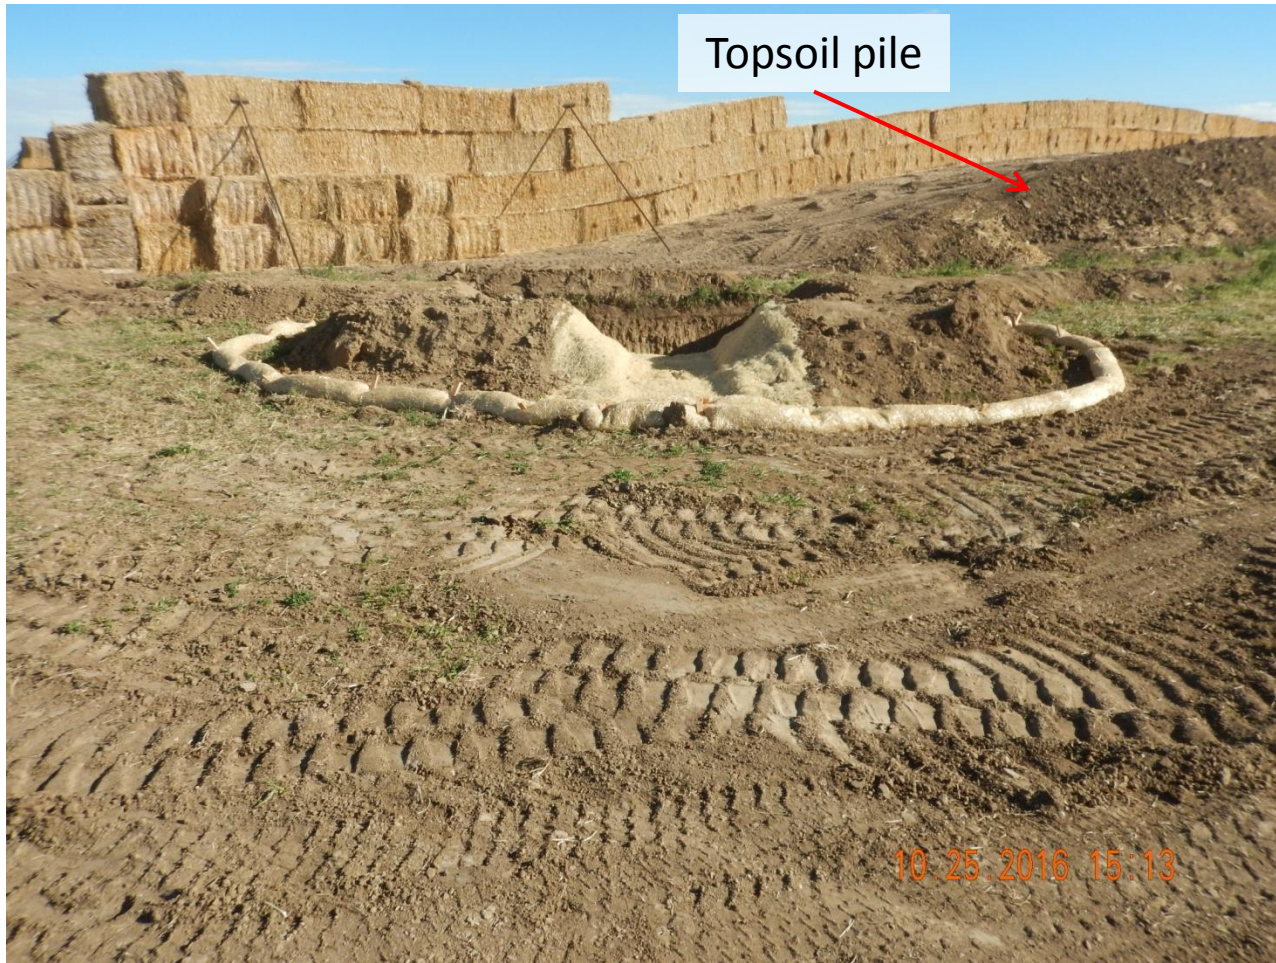
**Photo 1.** Photo taken from northwest corner of perimeter, facing East. Stabilized sediment trap installed. Topsoil pile stored along western location.

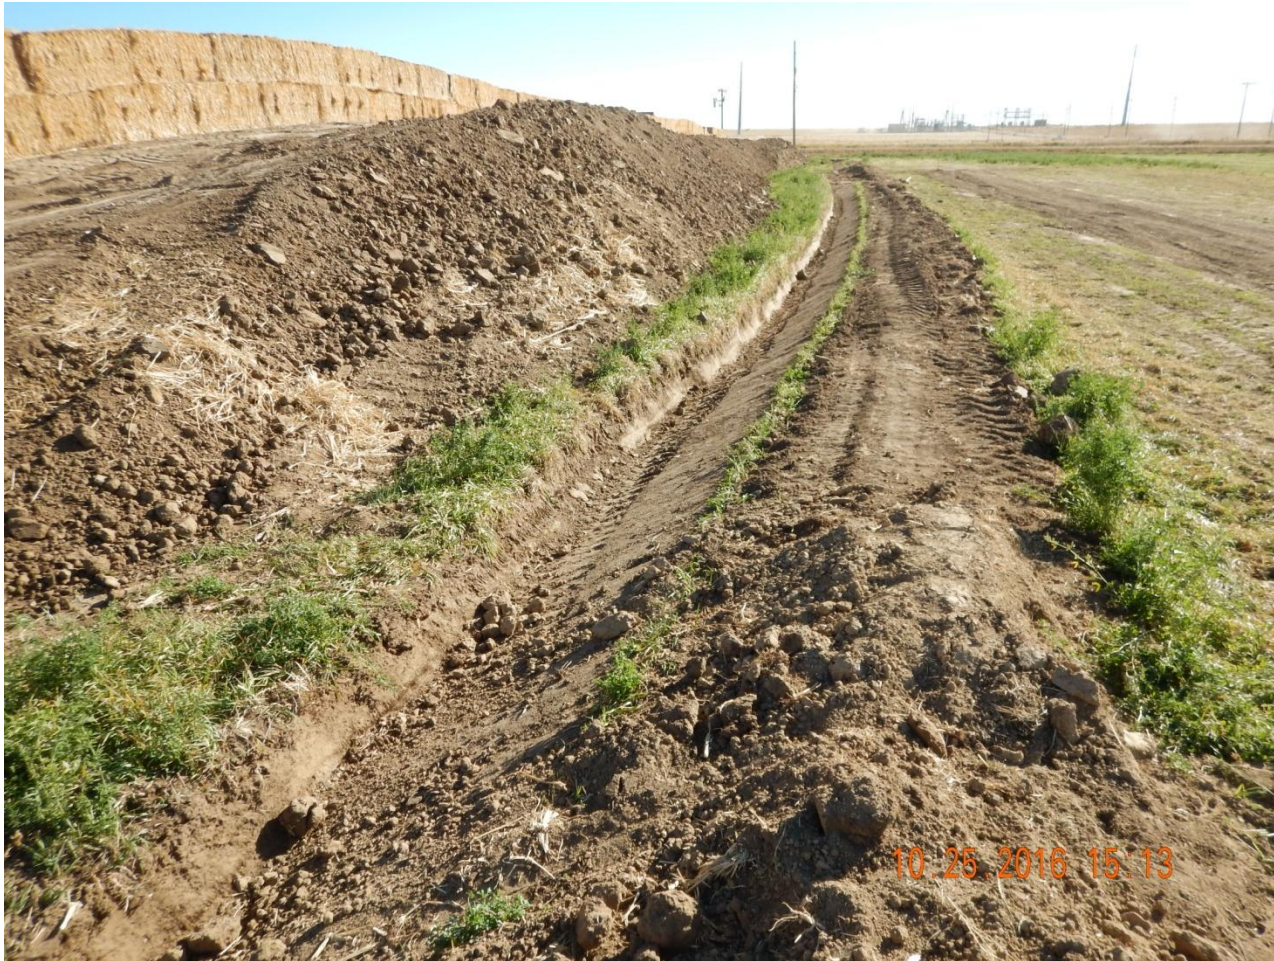
**Photo 2.** Photo taken from northwest corner of perimeter, facing South. Ditch and berm constructed around outer perimeter of the location.

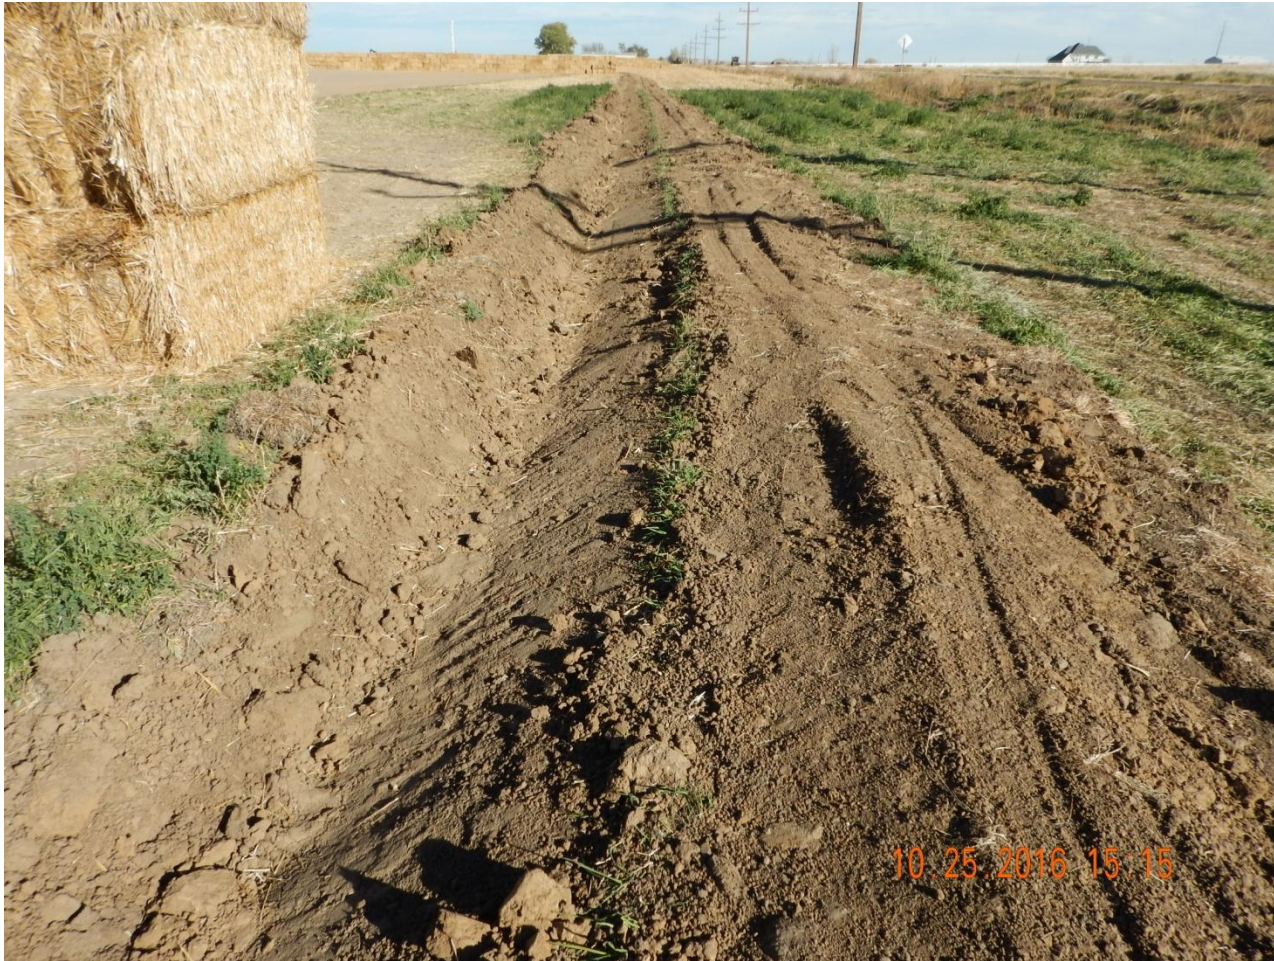
**Photo 3.** Photo taken from southwest corner of perimeter, facing East. Ditch and berm constructed around outer perimeter of the location.

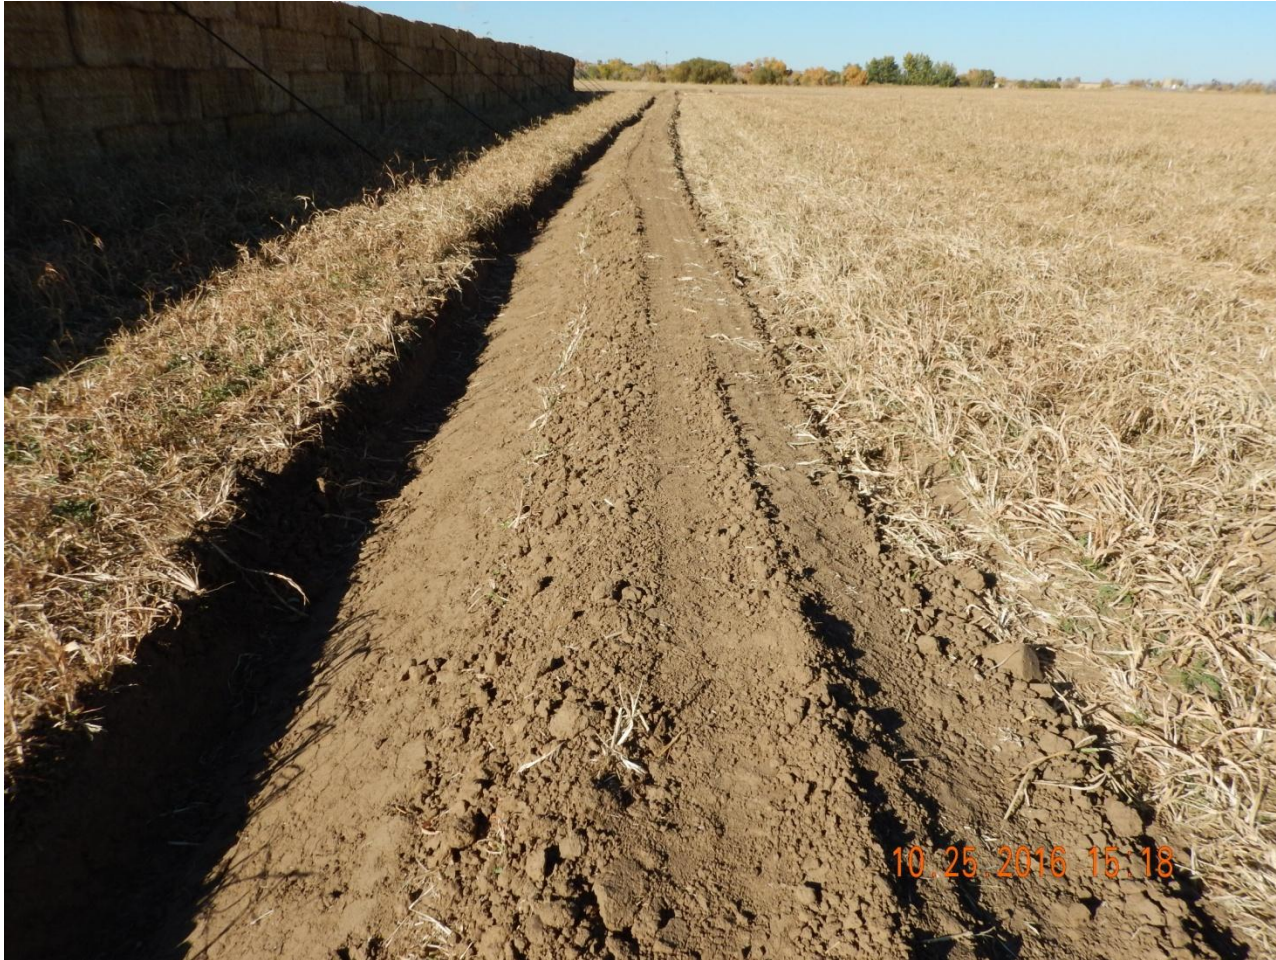
**Photo 4.** Photo taken from southeast corner of perimeter, facing North. Ditch and berm constructed around outer perimeter of the location.

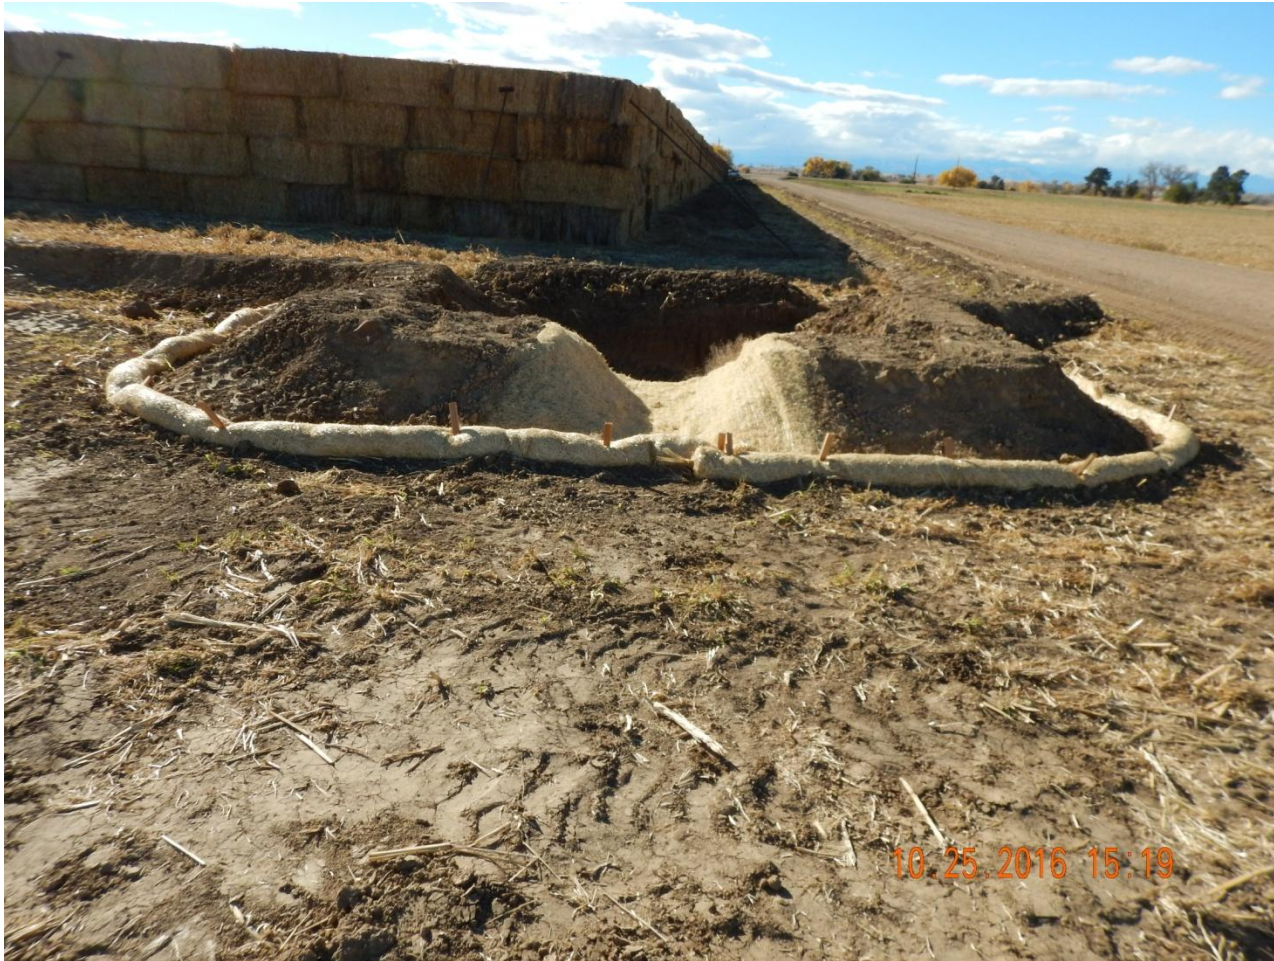
**Photo 5.** Photo taken from northeast corner of perimeter, facing West. Stabilized sediment trap installed.

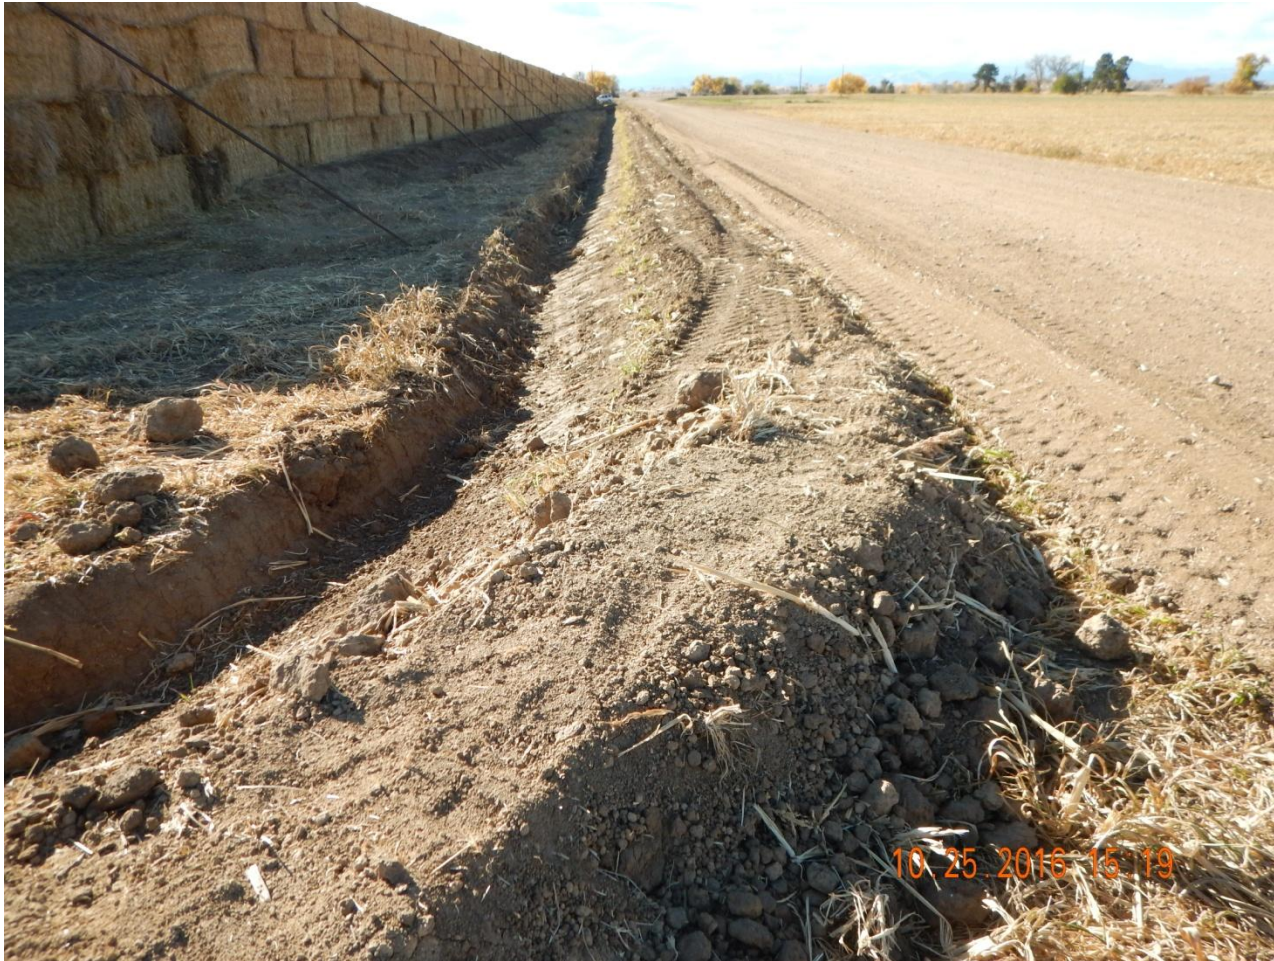
**Photo 6.** Photo taken from northeast corner of perimeter, facing West. Ditch and berm constructed around outer perimeter of the location.
