Stormwater Inspection

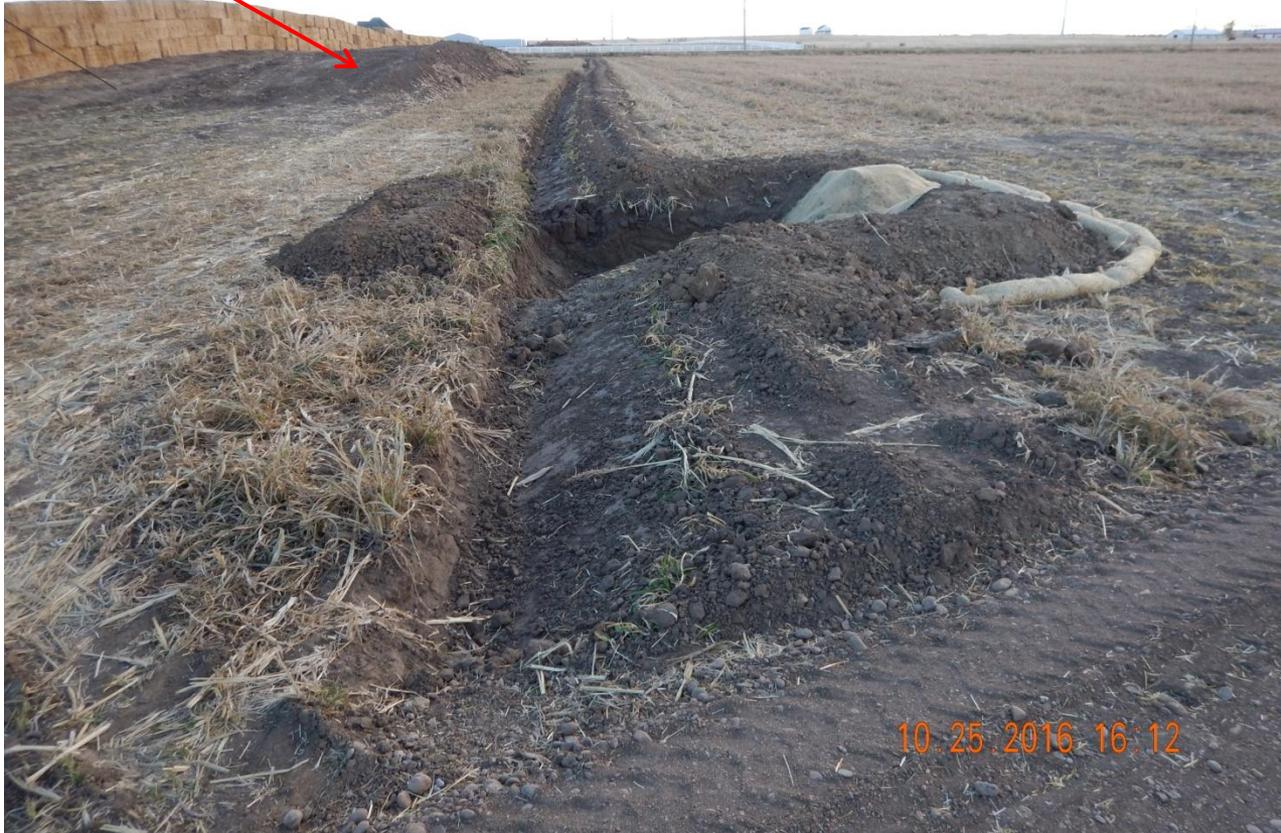
Photo 1. Photo taken from northwestern corner of perimeter, facing South, south of the access road. Stabilized sediment trap installed. Topsoil pile stored along western location. Ditch and berm constructed around outer perimeter of the location.

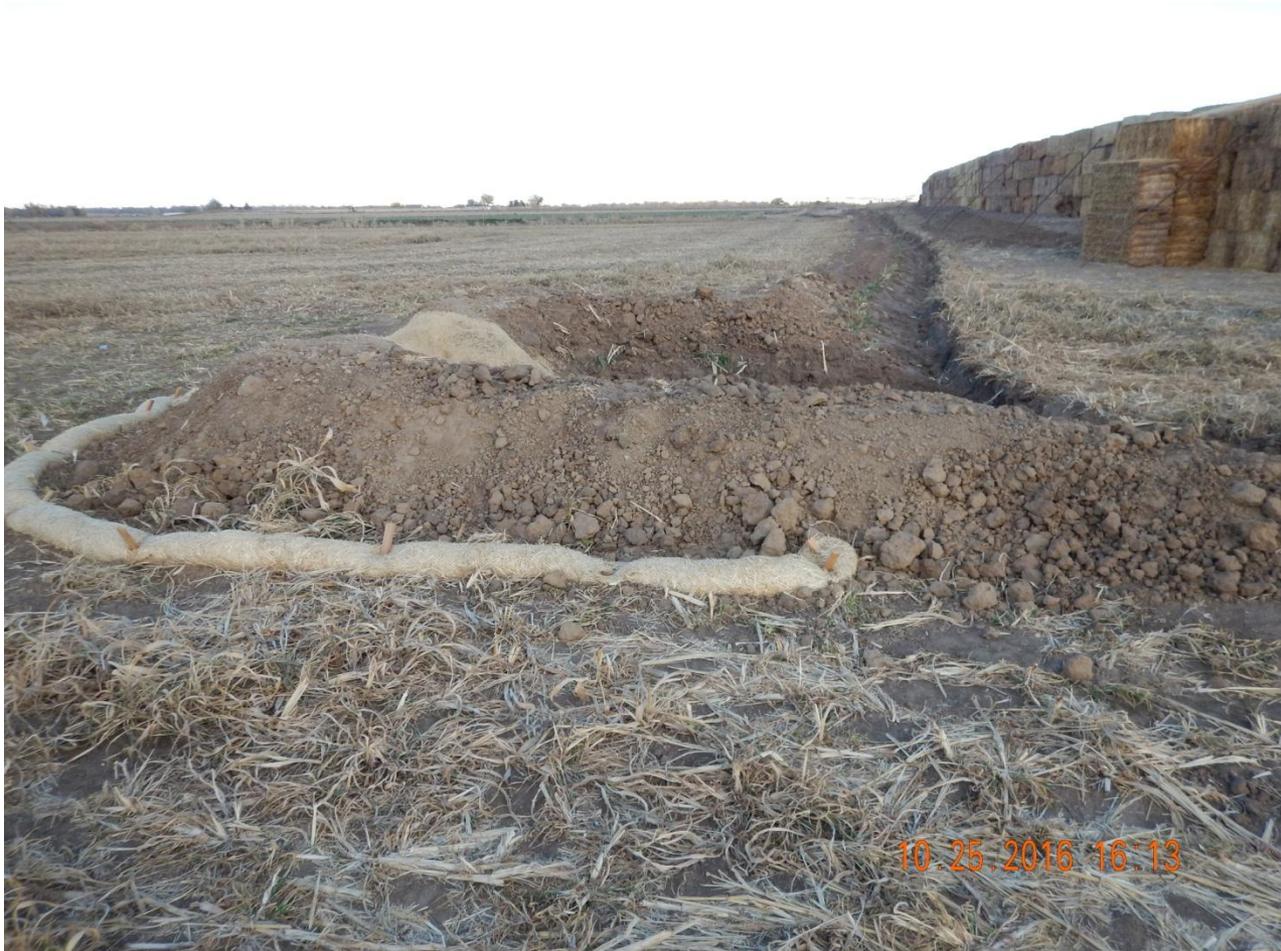
Photo 2. Photo taken from northwest corner of perimeter, facing East, north of the access road. Stabilized sediment trap installed. Ditch and berm constructed around outer perimeter of the location.

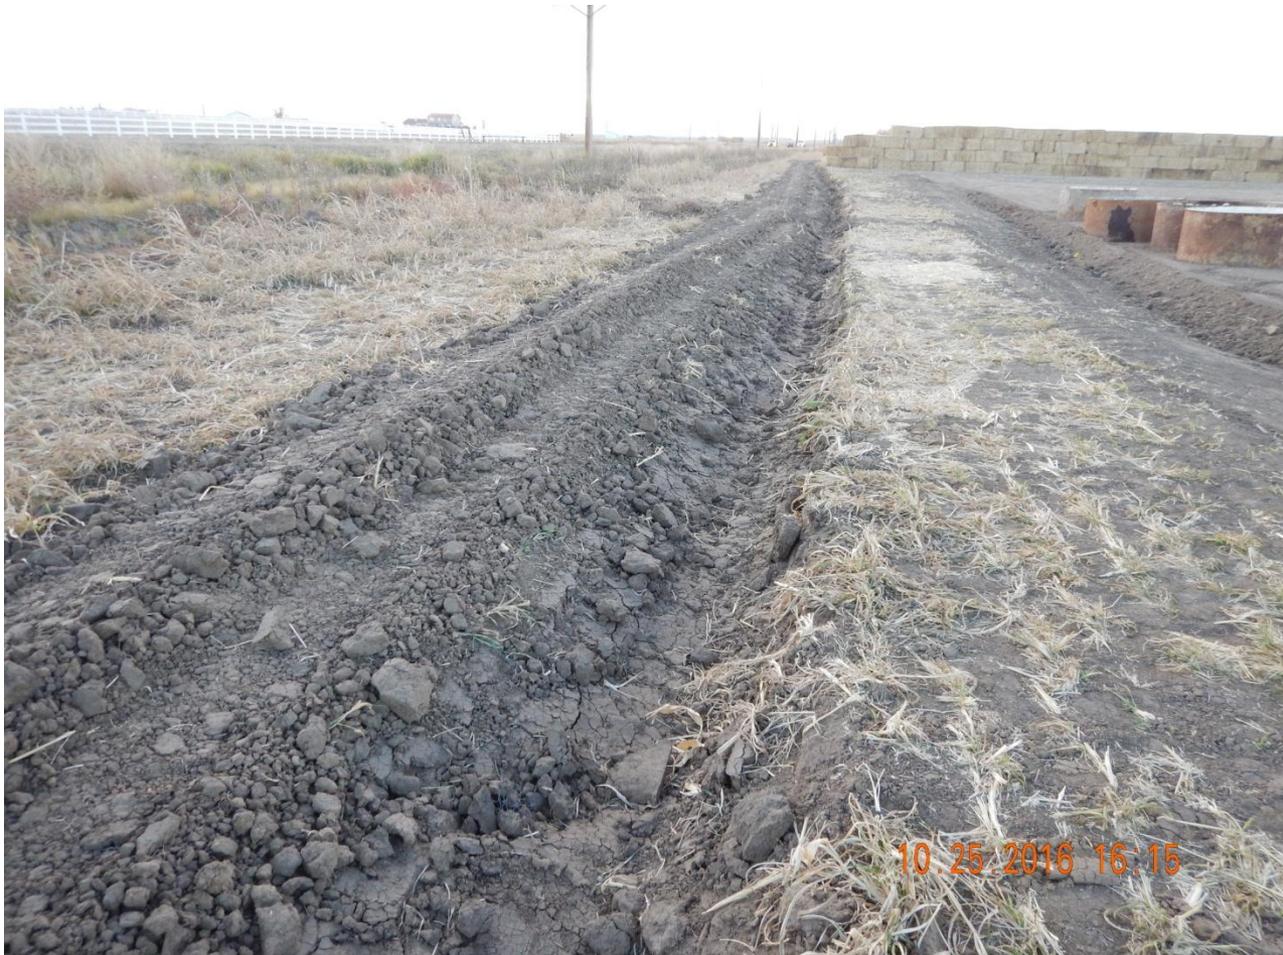
Photo 3. Photo taken from southern perimeter of the location, facing West. Ditch and berm constructed around outer perimeter of the location.

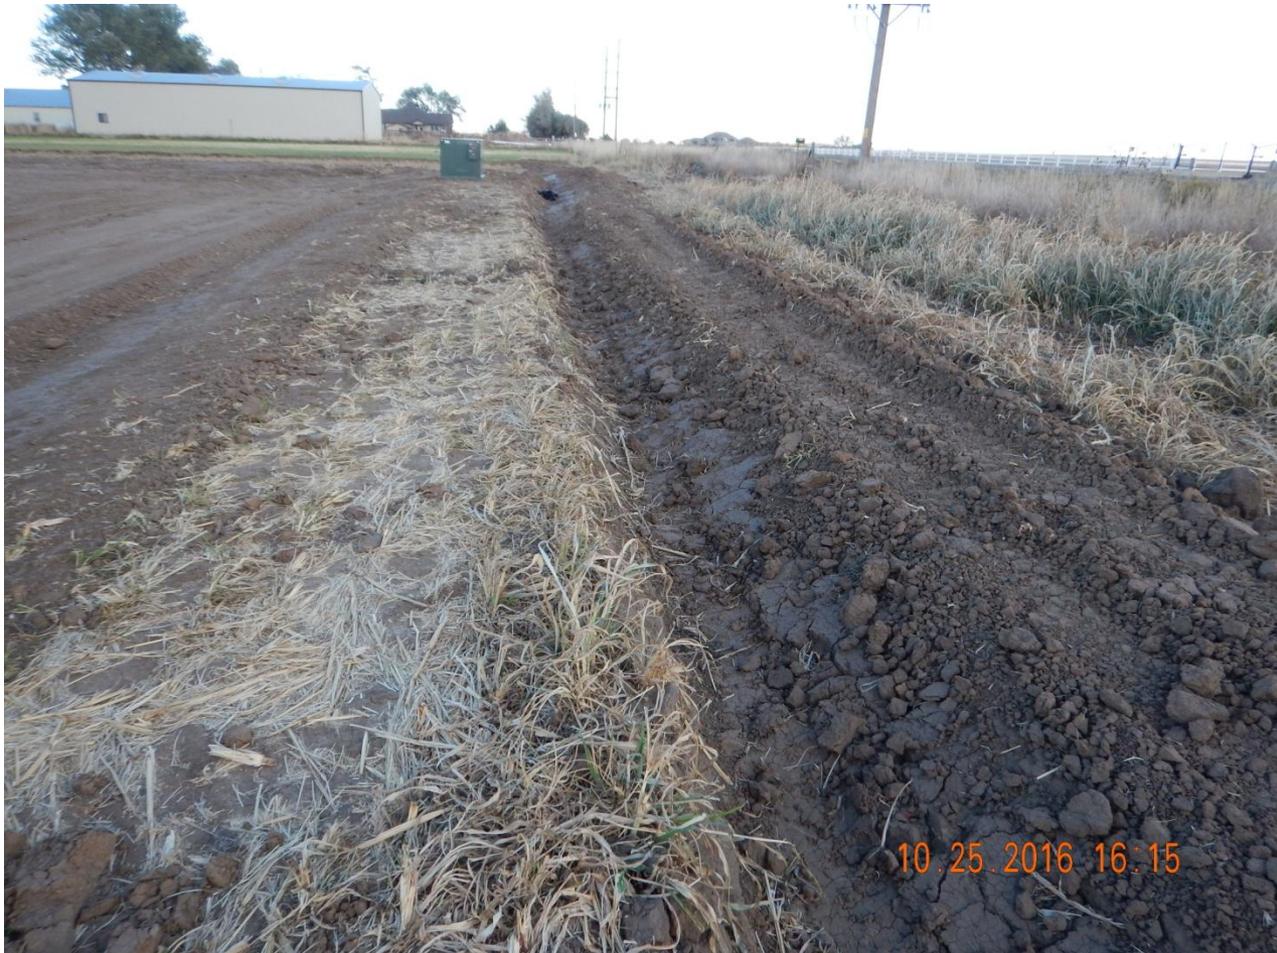
Photo 4. Photo taken from southern perimeter of the location, facing East. Ditch and berm constructed around outer perimeter of the location.

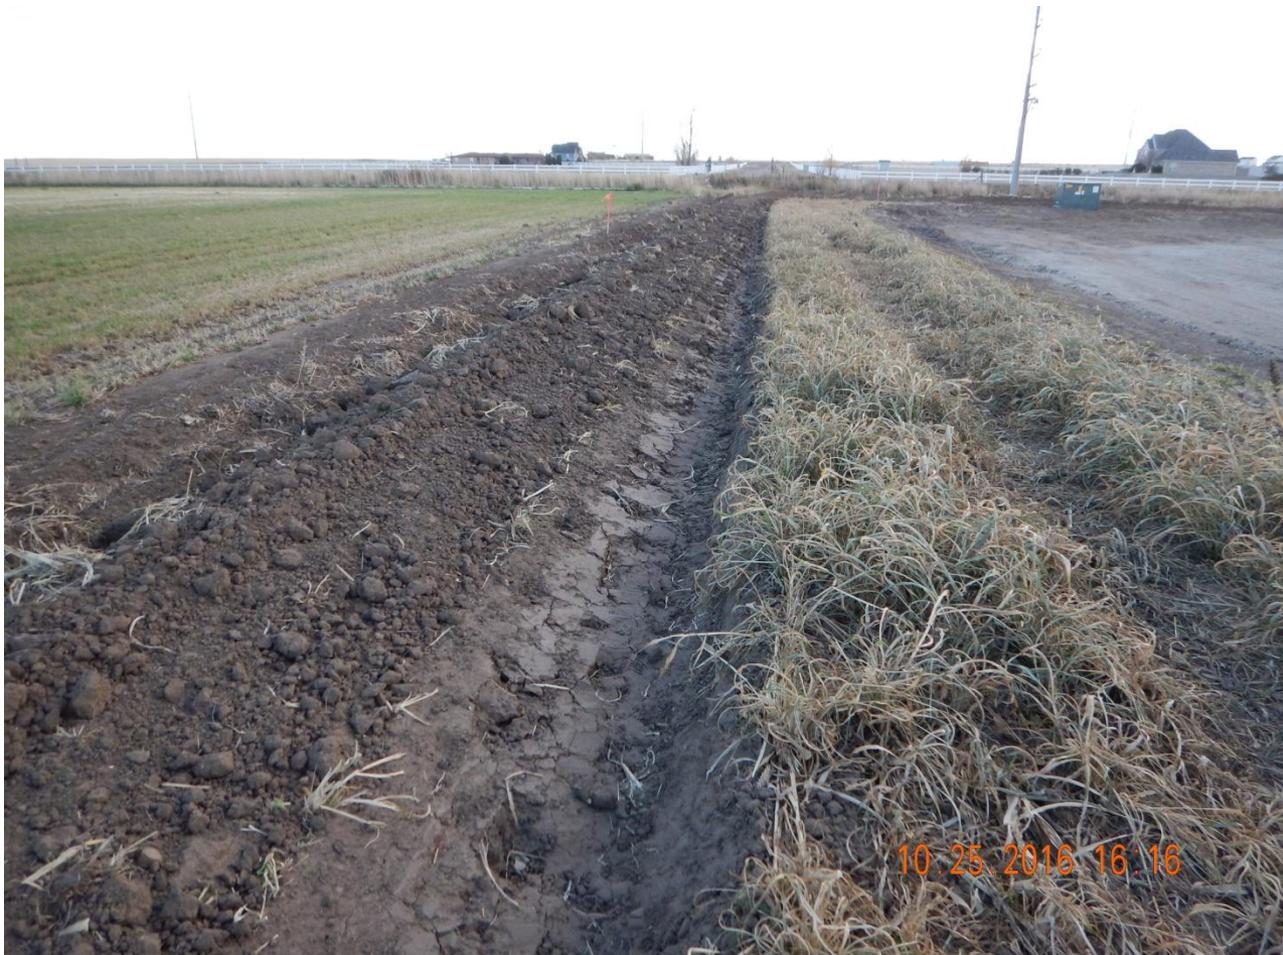
Photo 5. Photo taken from eastern perimeter of the location, facing South. Ditch and berm constructed around outer perimeter of the location.

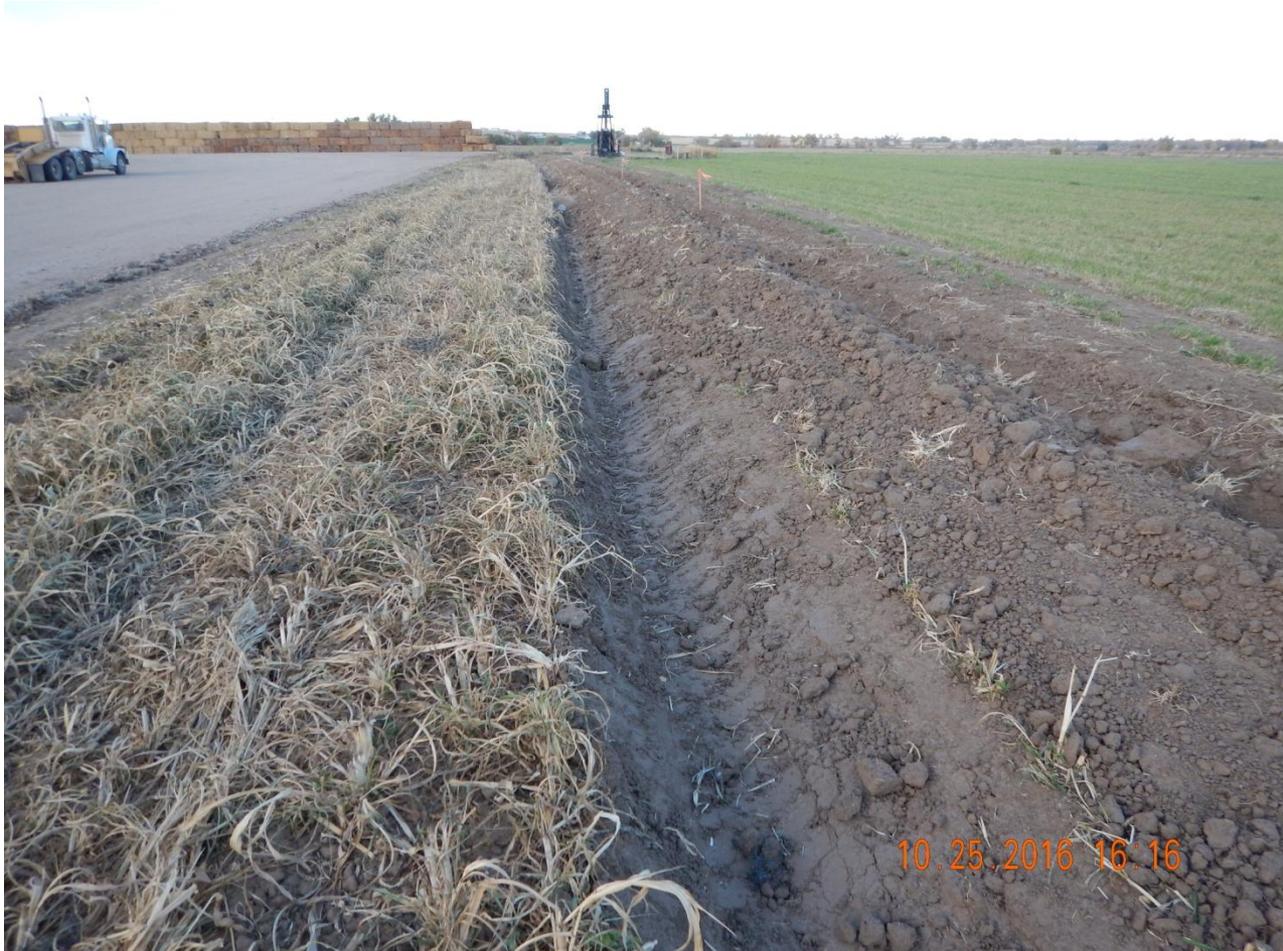
Photo 6. Photo taken from eastern perimeter of the location, facing North. Ditch and berm constructed around outer perimeter of the location.
