## Federal 4-35

Inspection# 673403813

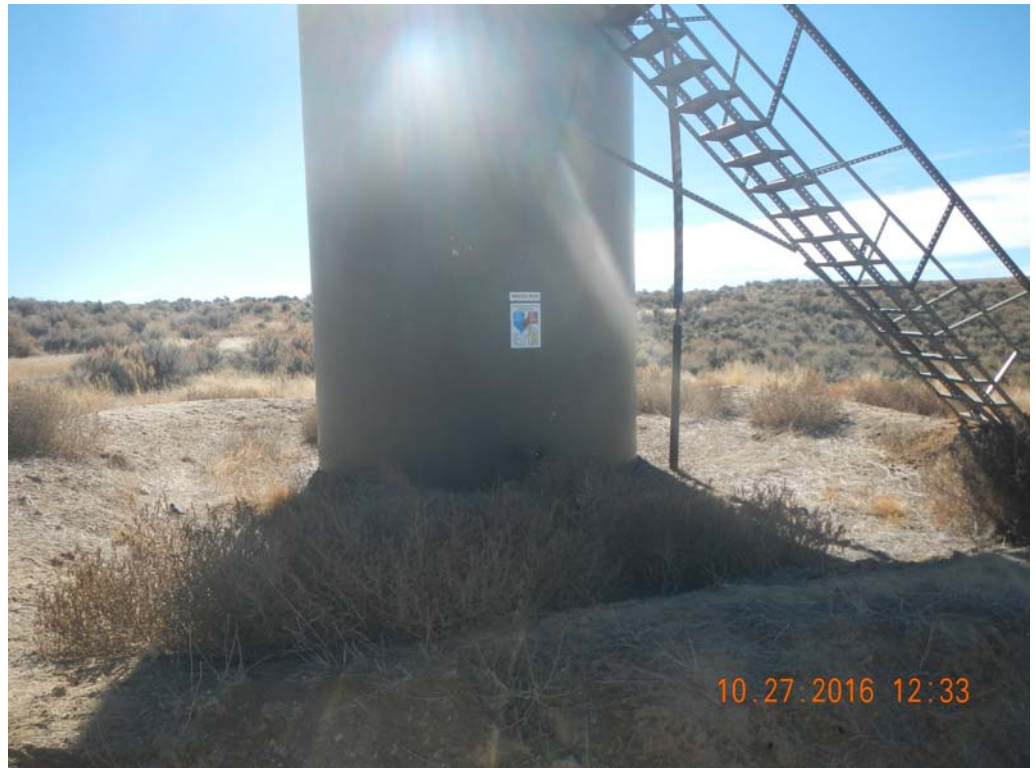
No capacity on tank label.  
Low berm with dried annual  
weeds adjacent to tank.

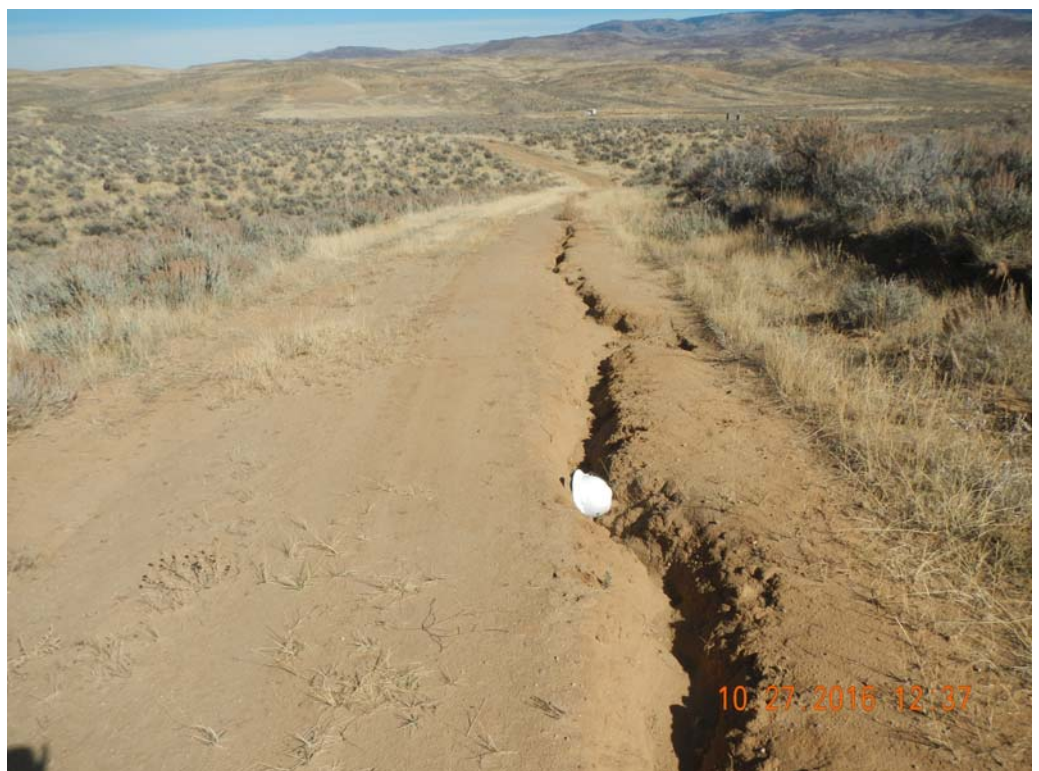
Erosion rills on access road.  
Hard hat for scale.

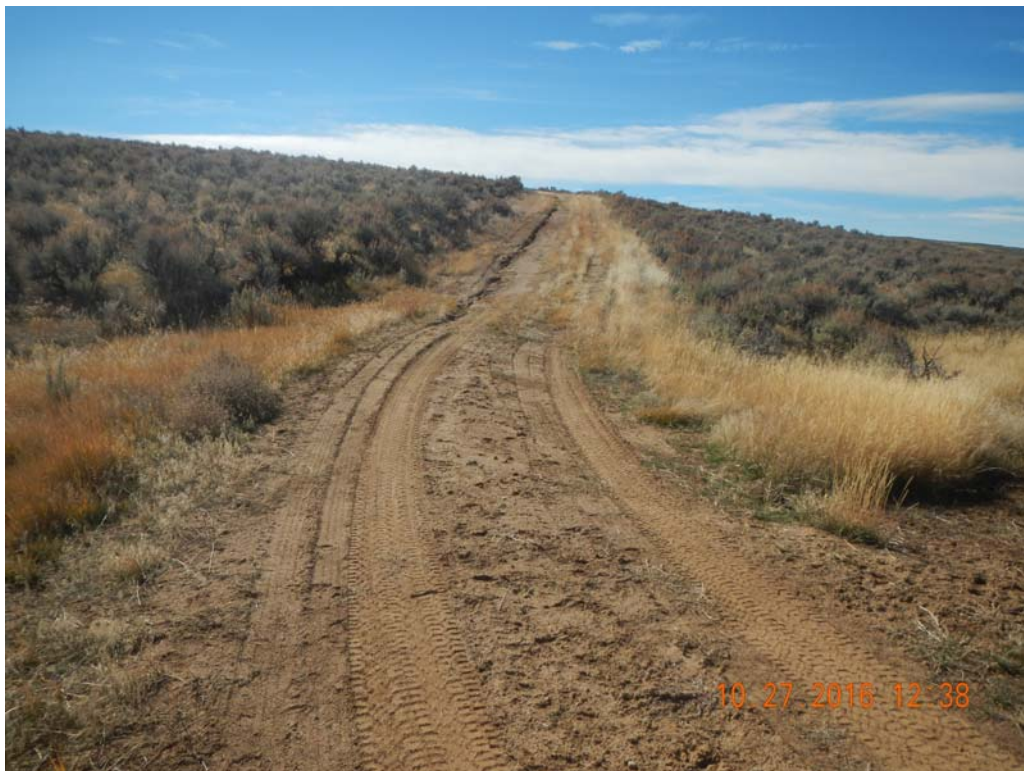
Standing in the drainage  
looking uphill at rill in  
previous picture.

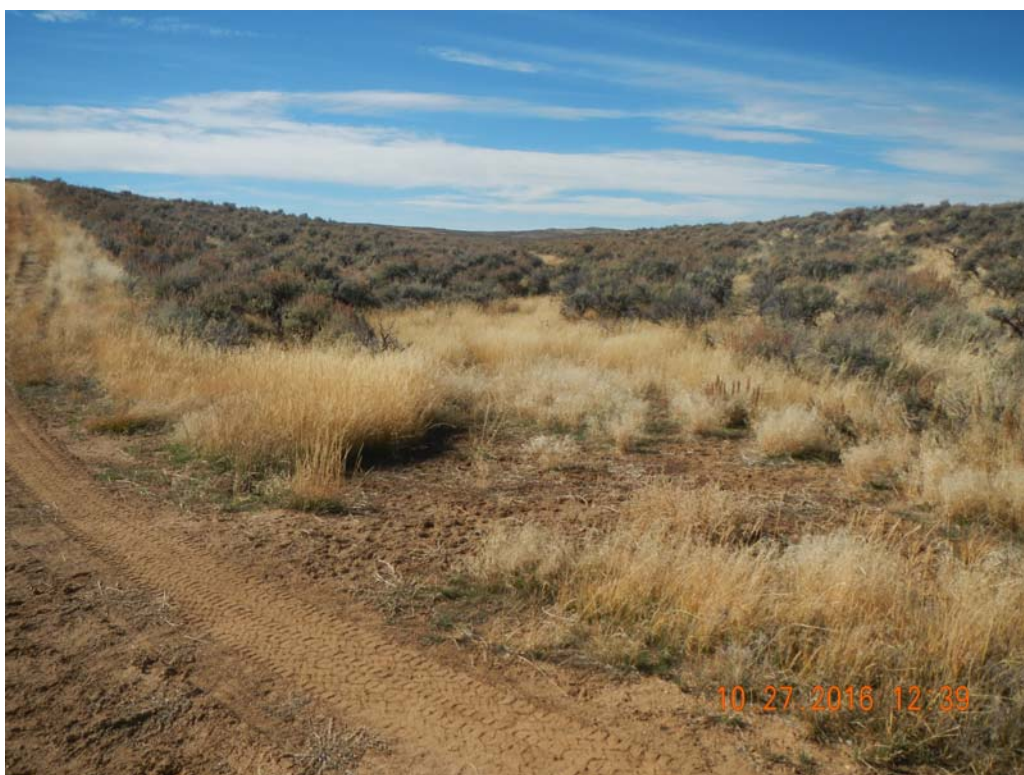
Sediment entering drainage  
from access road.
