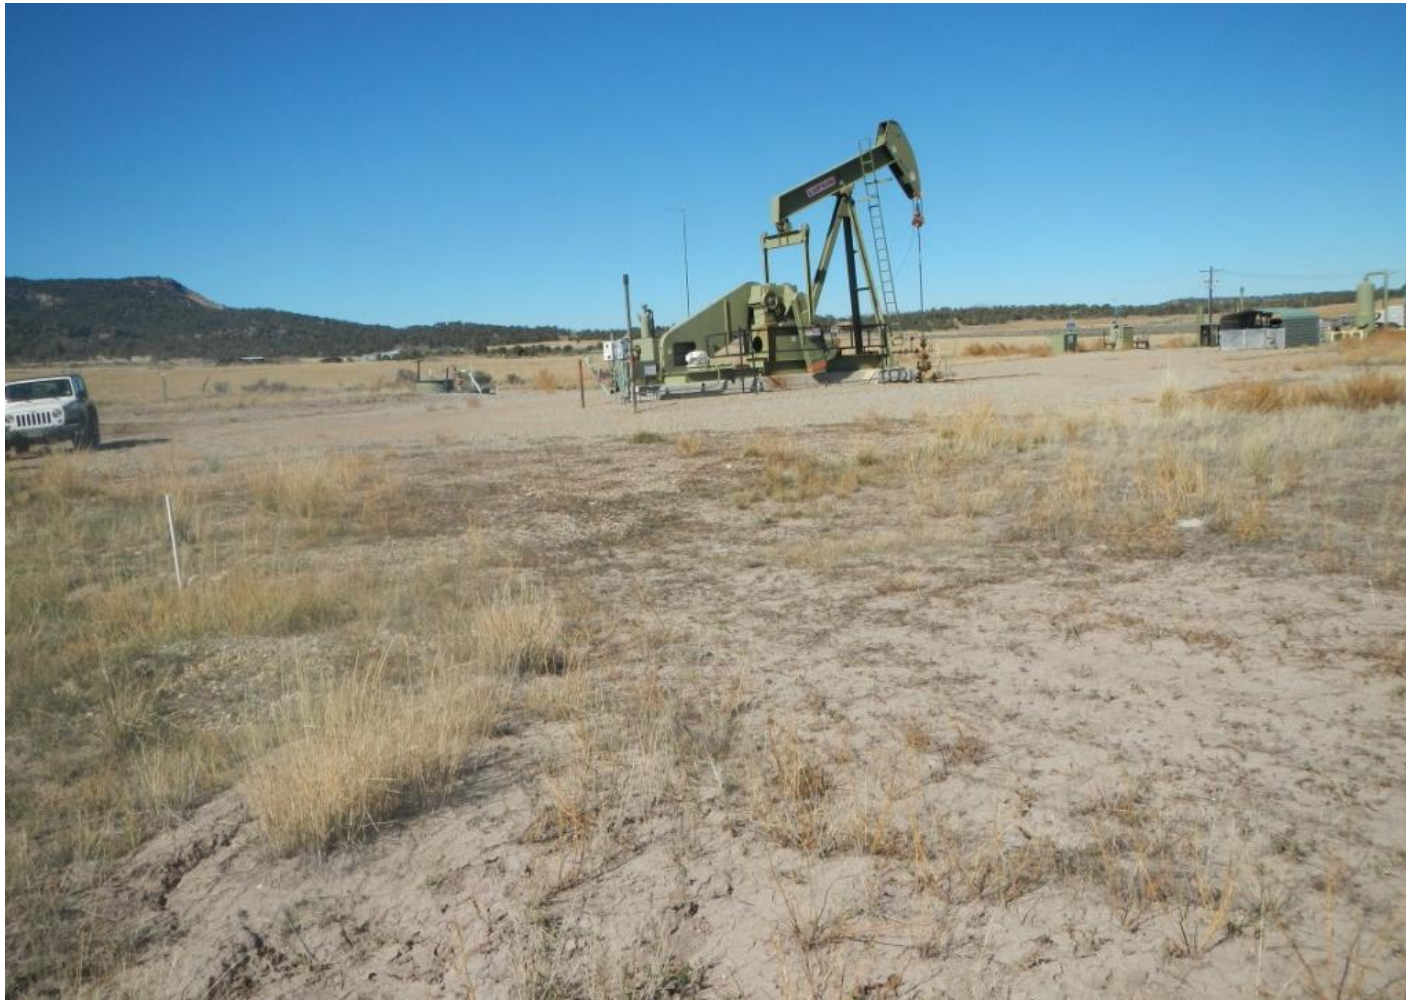
Photo 1. View of the southern portion of the project area from the southeastern corner facing center toward the well.

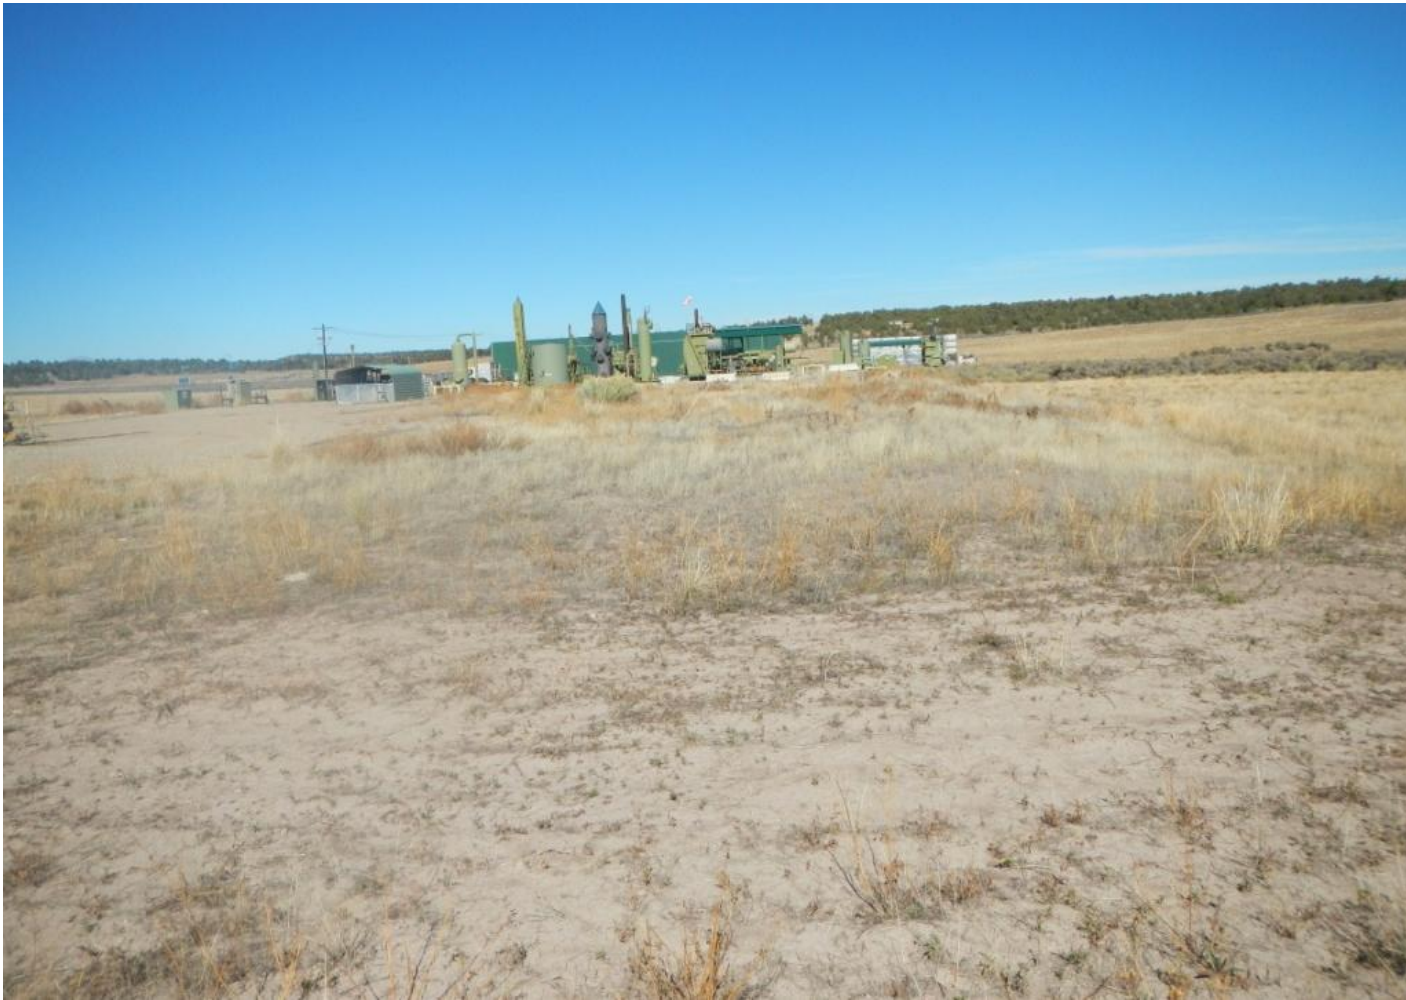
Photo 2. View of the eastern portion of the project area from the southeastern corner facing northward.

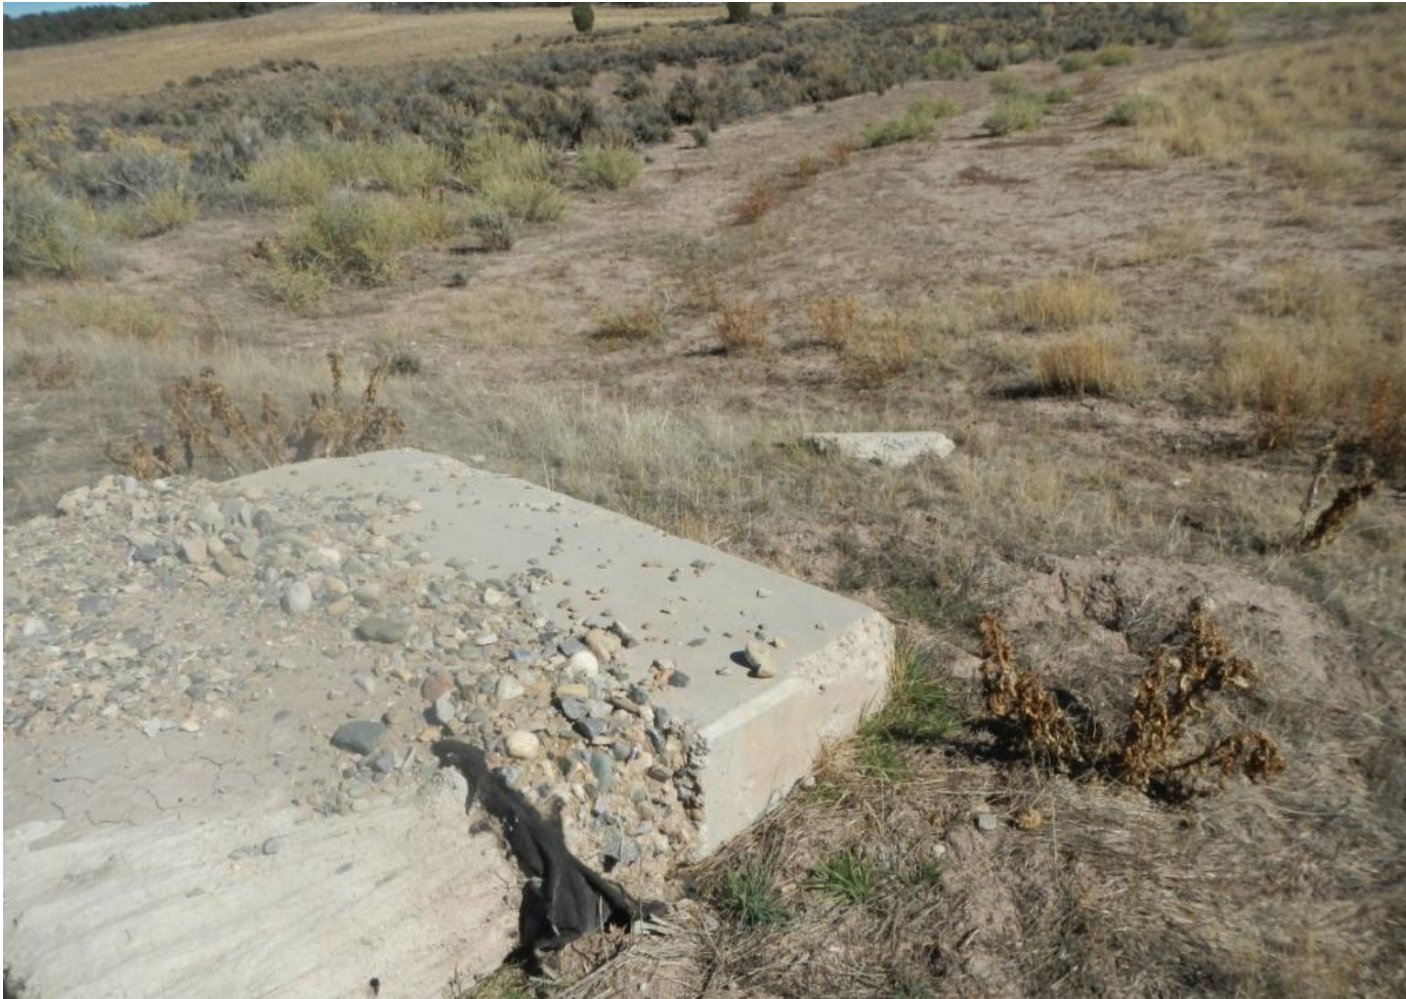
Photo 3. View of cement debris that needs to be removed in the eastern portion of the project area.

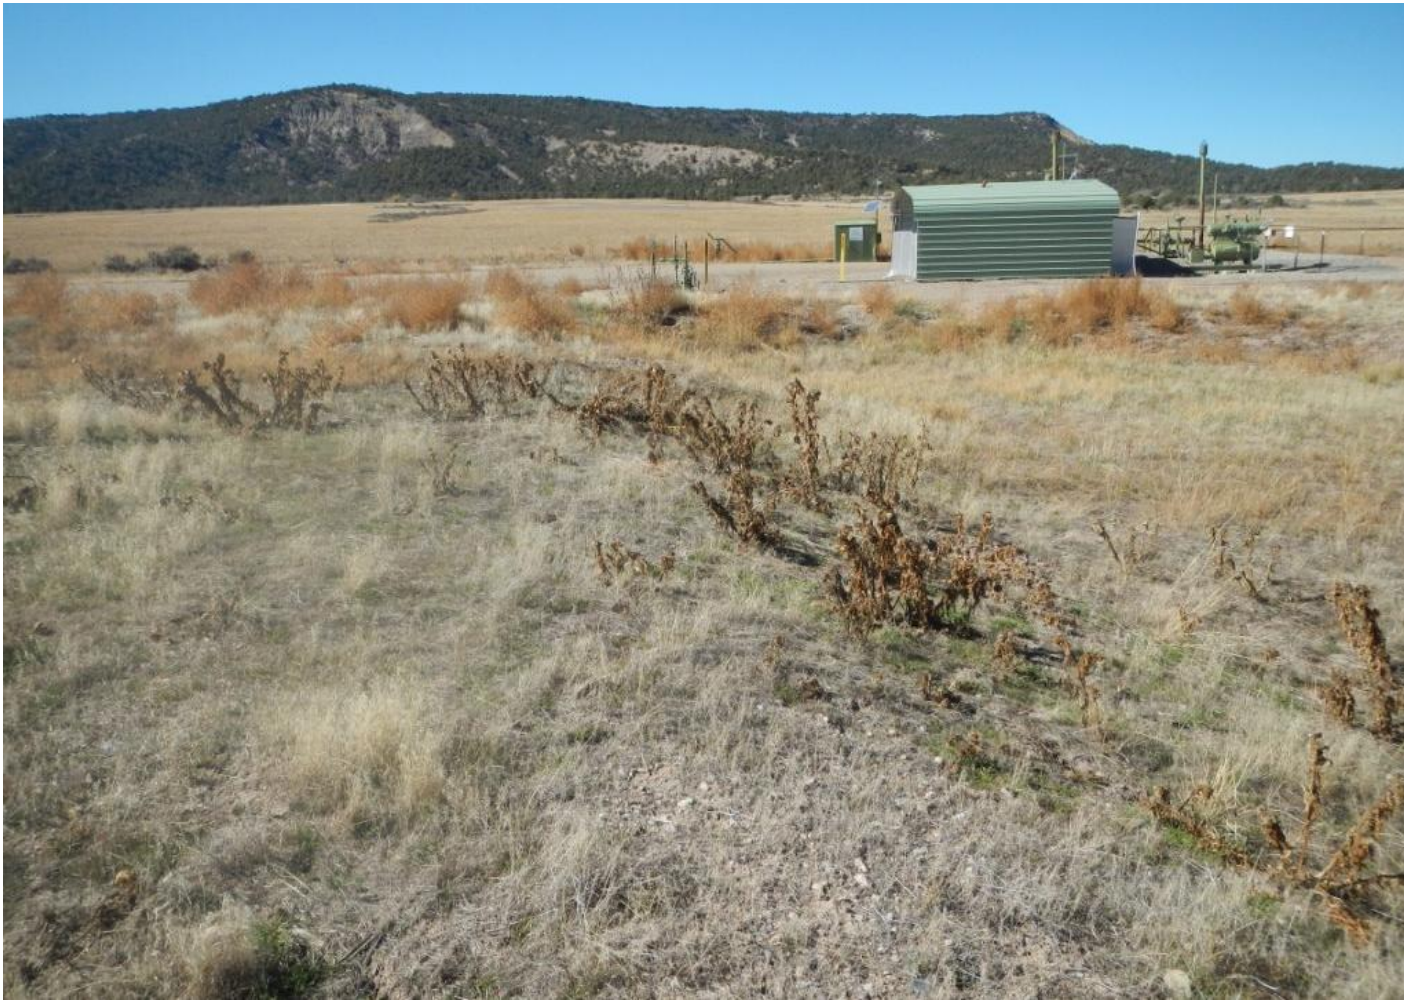
Photo 4. View of the northern portion of the project area from the northeastern edge facing westward. Musk thistles (*Carduus nutans*) from the 2016 growing season grew to maturity and are senescing.

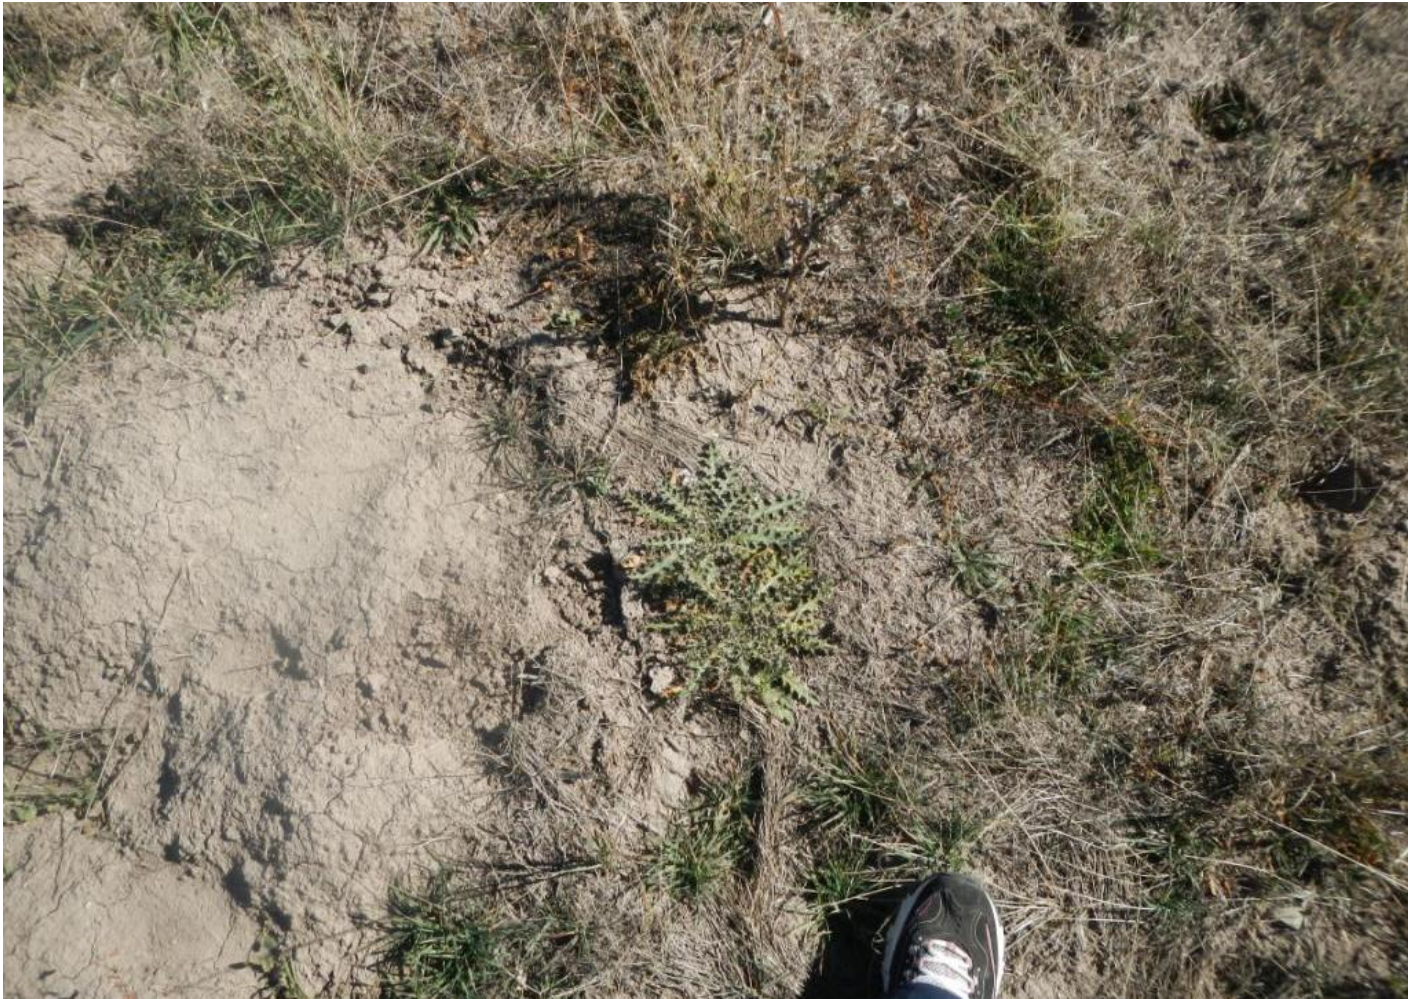
Photo 5. View of musk thistle rosettes in the eastern portion of the project area.

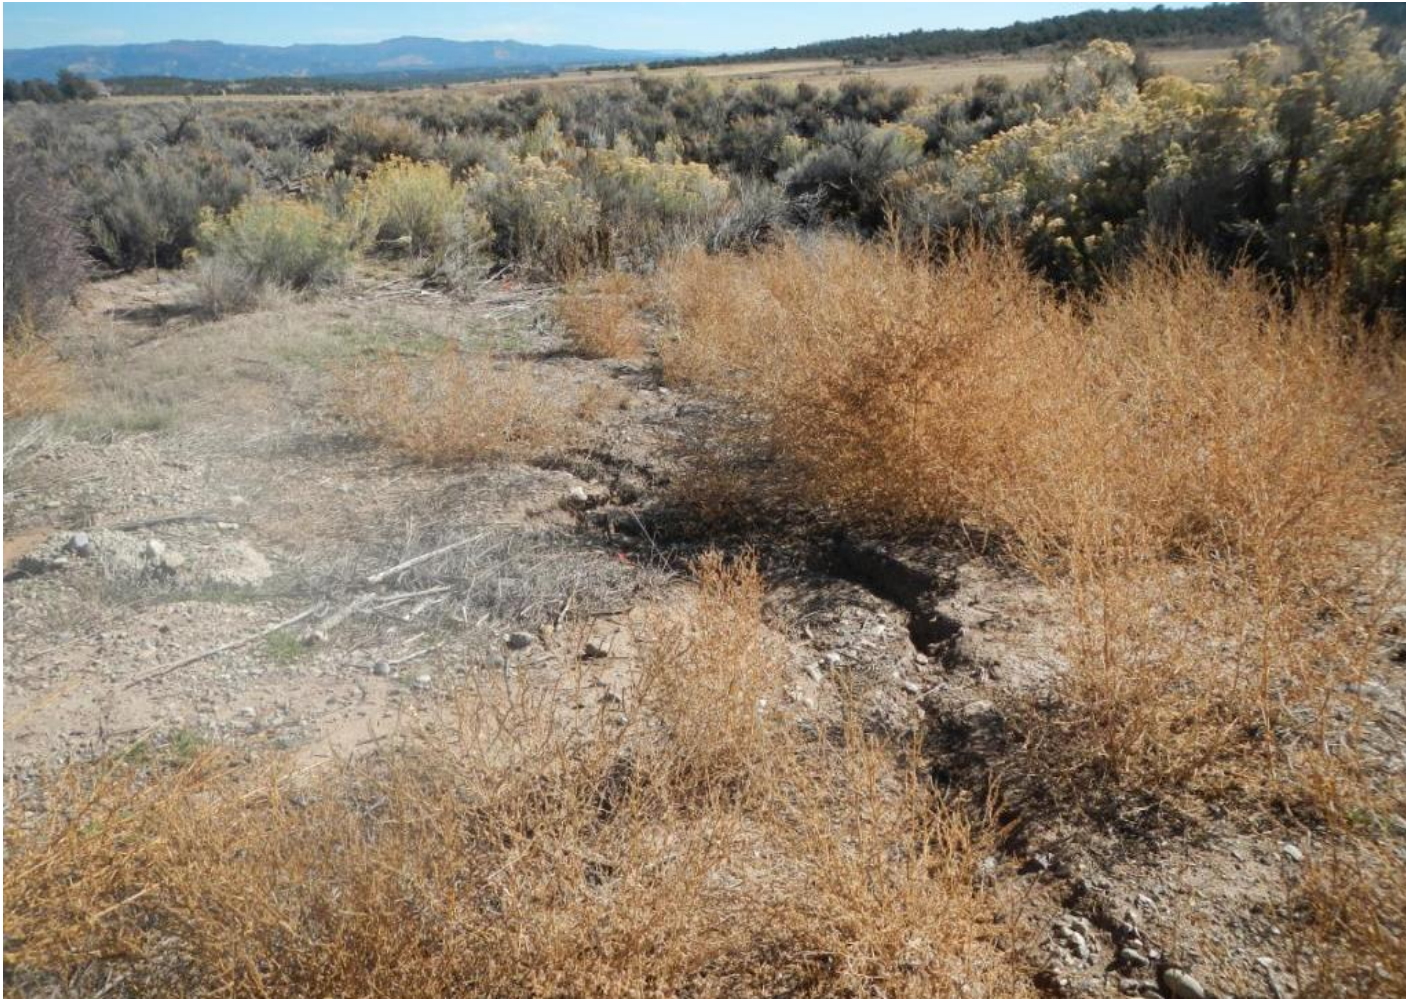
Photo 6. View of stormwater erosion and sediment deposition into a drainage in the northeastern corner of the project area.
