# RECLAMATION MONITORING REPORT

ALOHA MULA #3  
LINCOLN COUNTY, COLORADO

OCTOBER 2016

WIEPKING-FULLERTON ENERGY, L.L.C.  
Englewood, Colorado

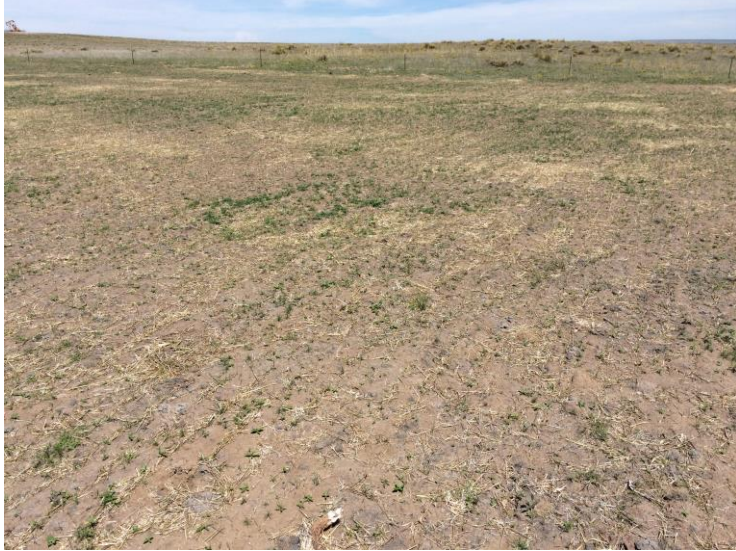
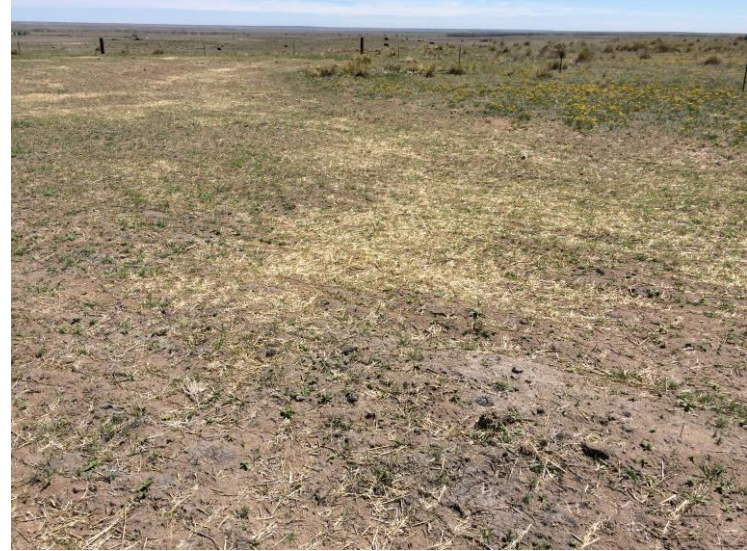
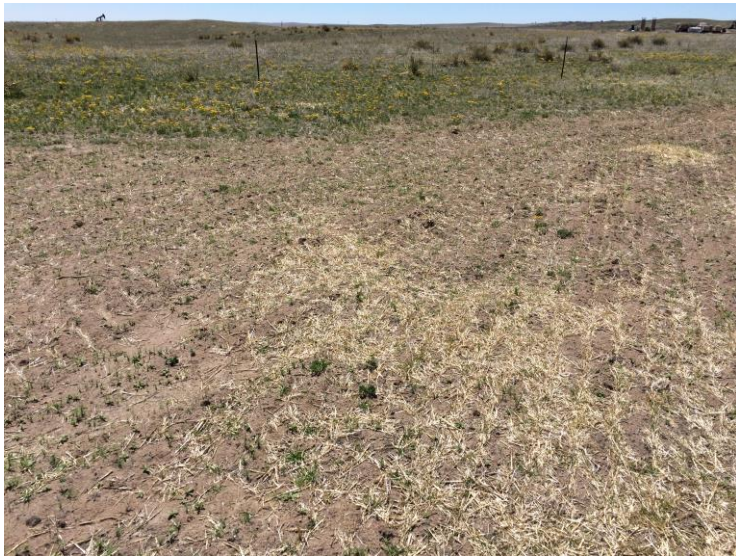
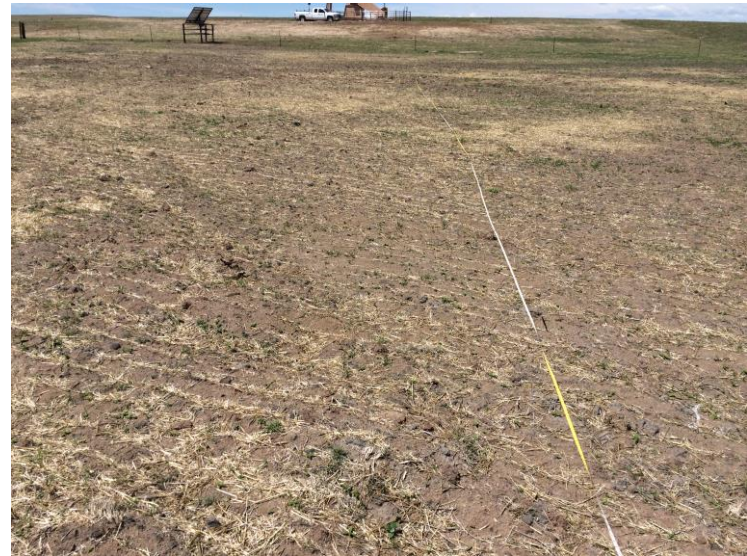
Photographs Taken: 05/20/2016

During the monitoring event on May 20, 2016, just two months after the March reclamation seeding event, the onsite vegetative cover was observed to be less than 80 percent (%) of the

Noxious weeds observed onsite: None  
 Species observed onsite: AMPS, BAPR5, CHAMA15, CELO3, HECO26, HELIA3, PGB1  
 Overall good, needs time for grasses to fill in

Ratio of % Non-weedy Canopy Cover Onsite to % Non-weedy Canopy Cover Offsite = 28%  
 Ratio of % Non-weedy Basal Cover Onsite to % Non-weedy Basal Cover Offsite = 36%

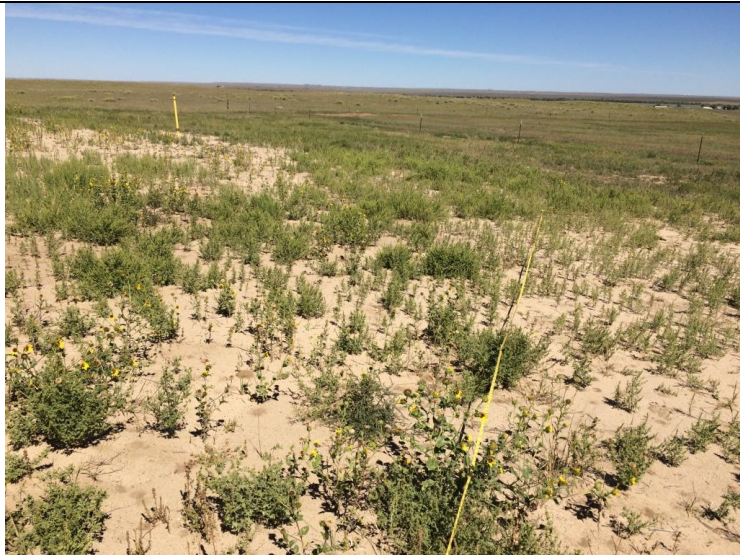
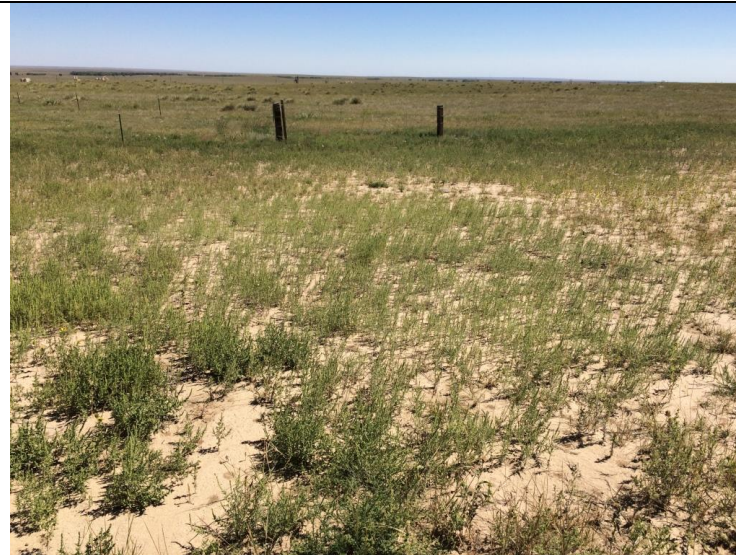
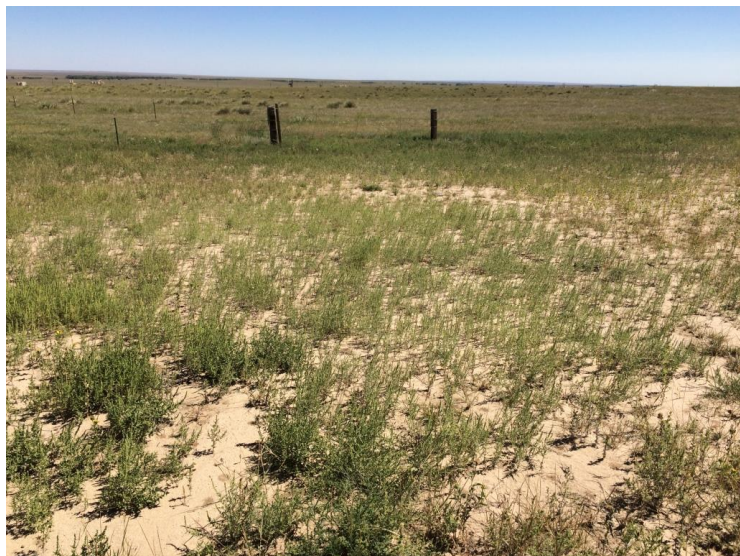
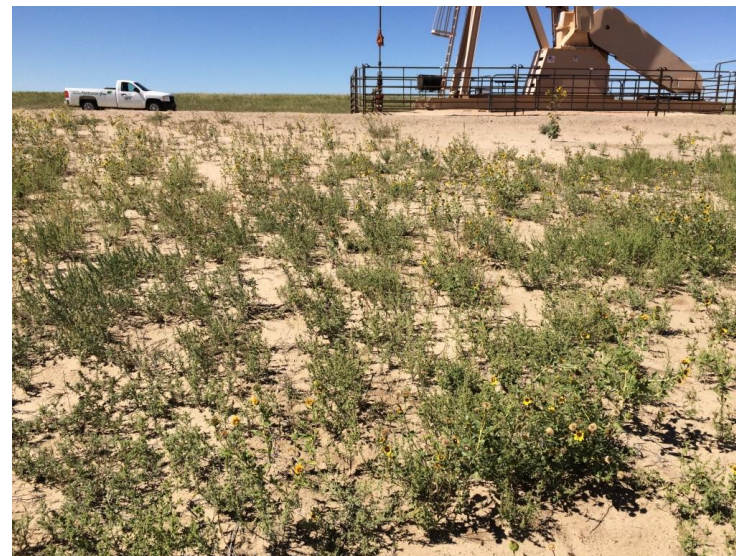
Photographs Taken: 09/09/2016

referenced offsite vegetation. During the monitoring event on September 9, 2016, the vegetative covers at the Site was still observed to be less than 80%, but had filled in slightly relative to the previous May 2016 monitoring event.
