# RECLAMATION MONITORING REPORT

ALOHA MULA #6  
LINCOLN COUNTY, COLORADO

OCTOBER 2016

WIEPKING-FULLERTON ENERGY, L.L.C.  
Englewood, Colorado

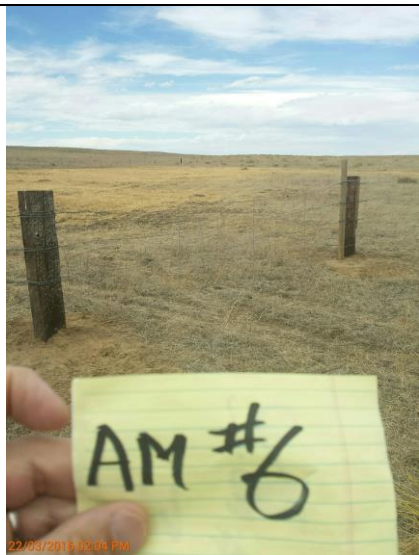
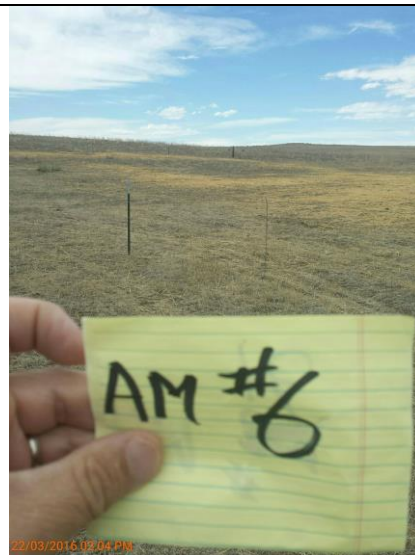
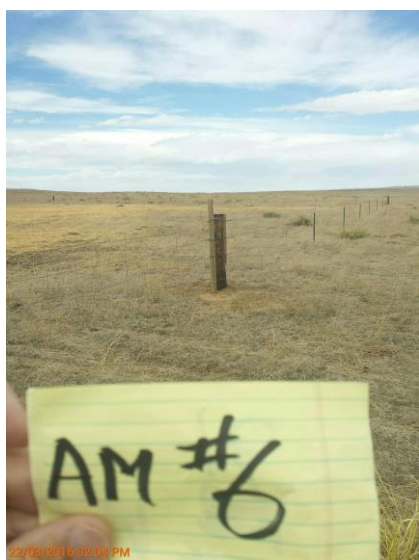
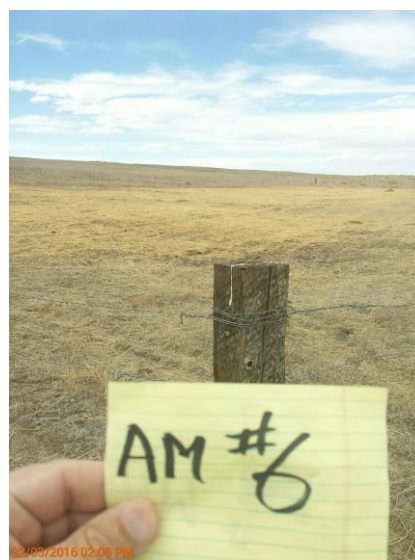
Aloha Mula 6 – Reclamation Work Completed

Photographs Taken: 03/22/2016

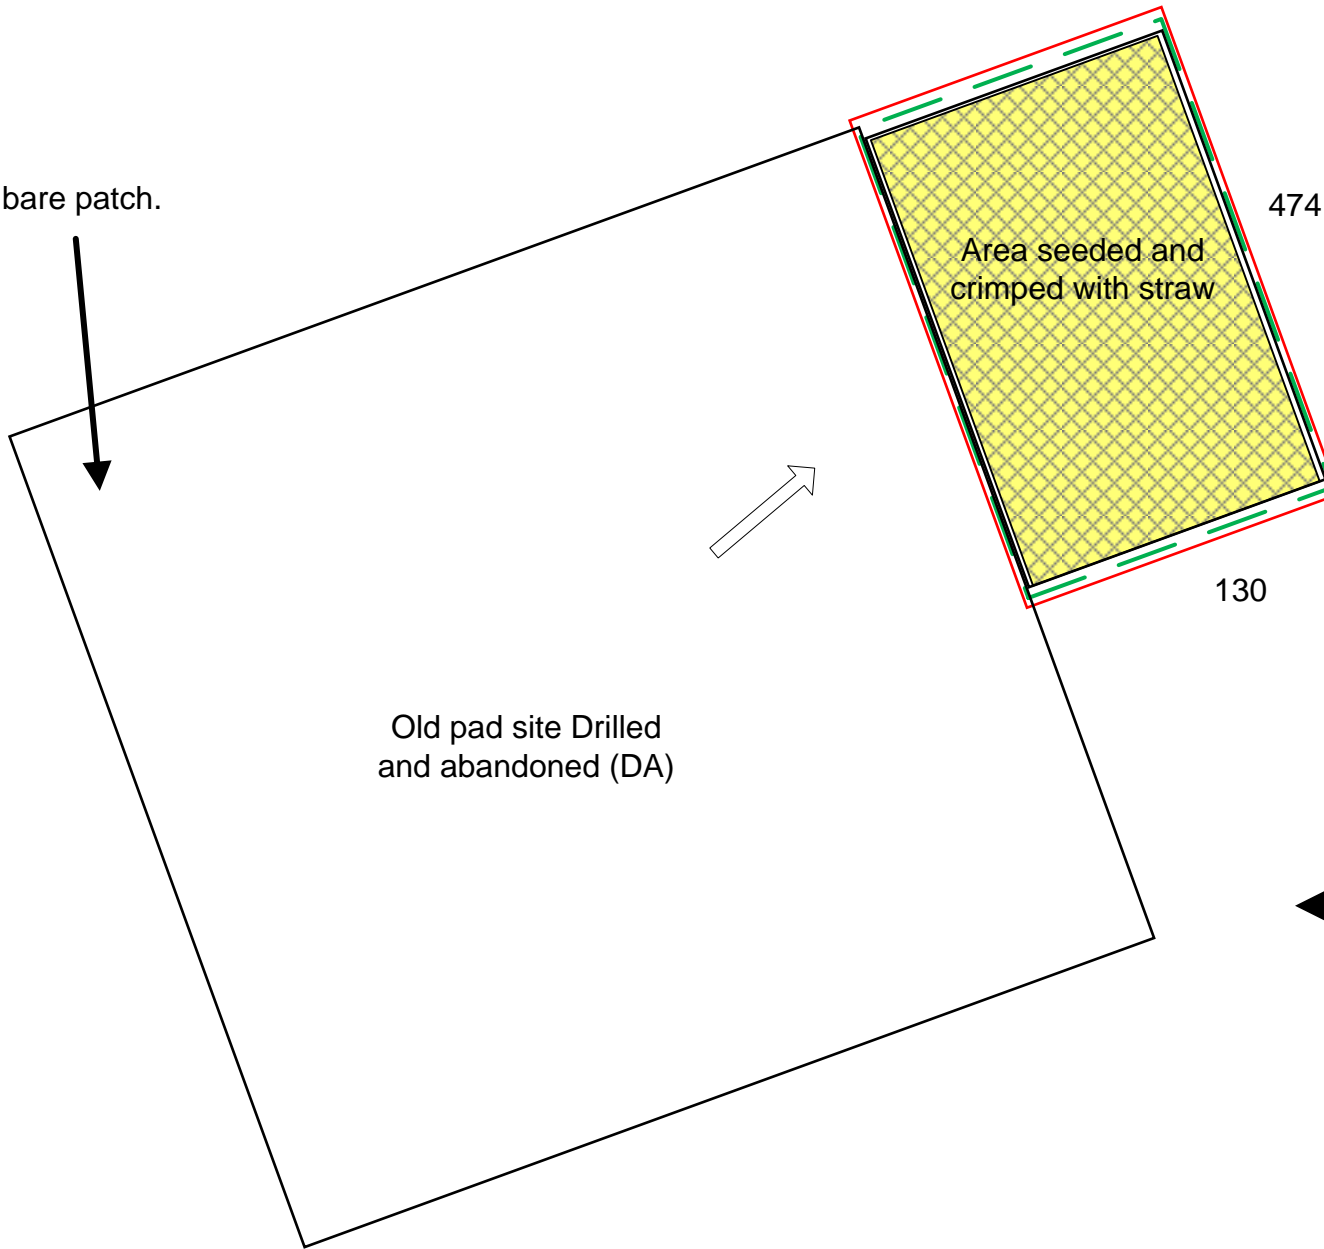
Inspection Date:  
8/1/16  
72hr storm event

Large bare patch.

Vegetation about  
50% and patchy,  
site recently  
mowed.

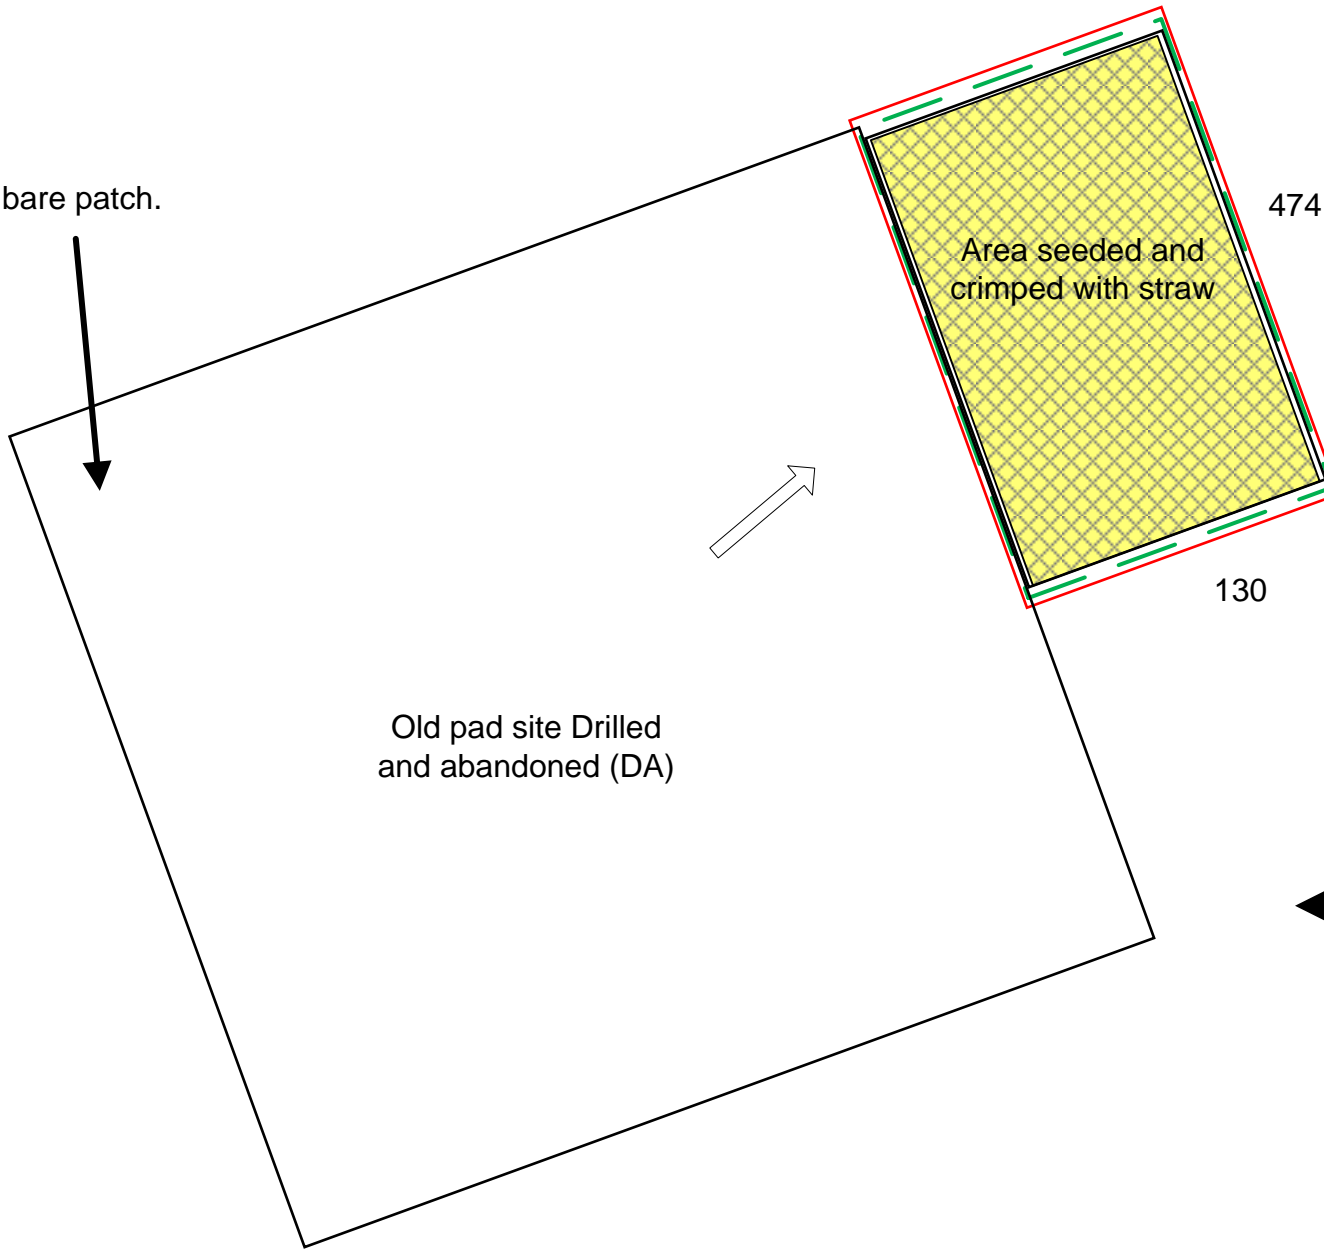
Inspection Date:  
9/8/16

Large bare patch.

Semi-annual LPI  
measurement

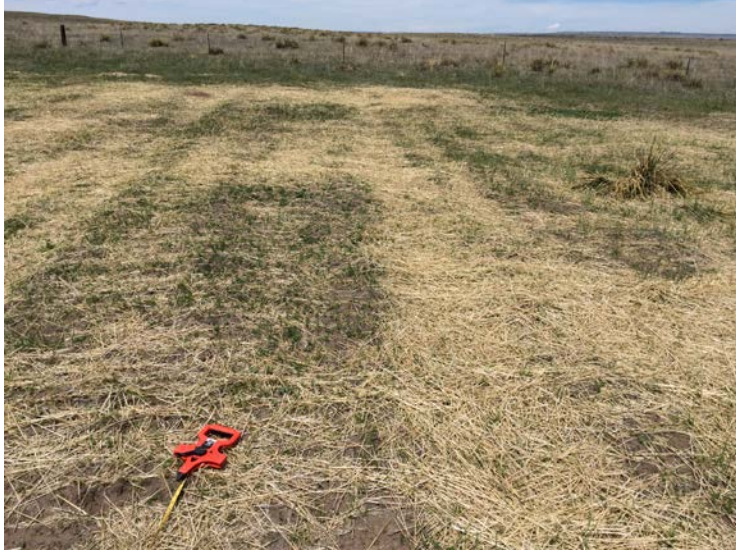
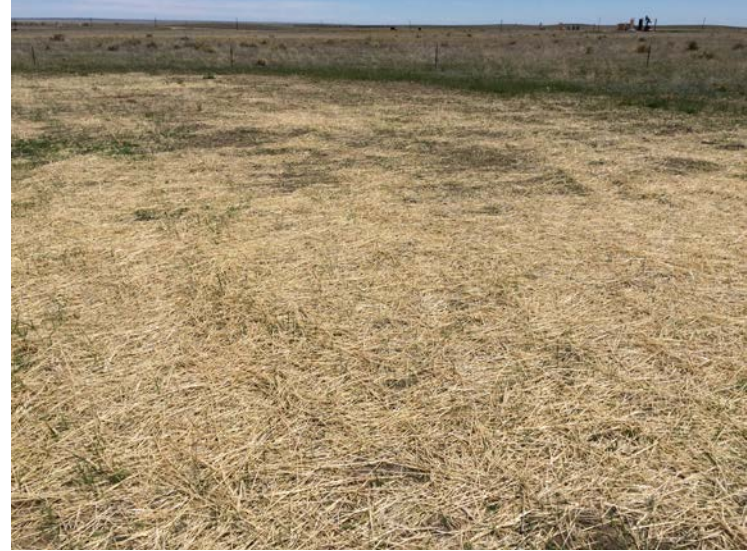
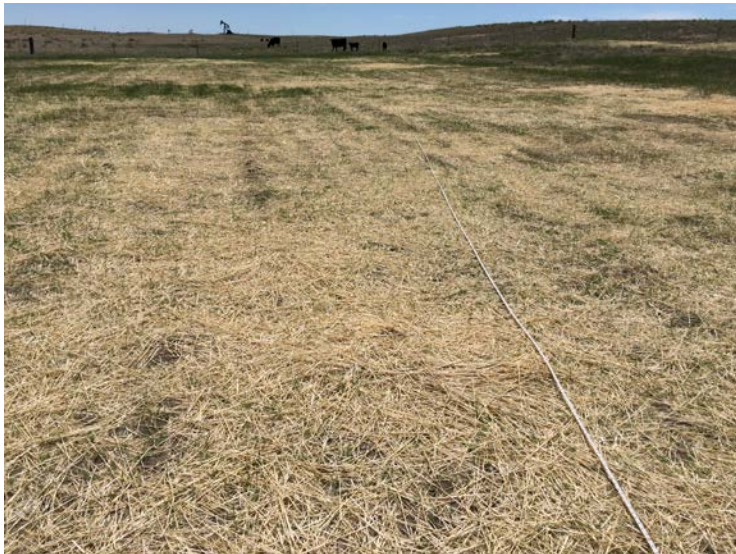
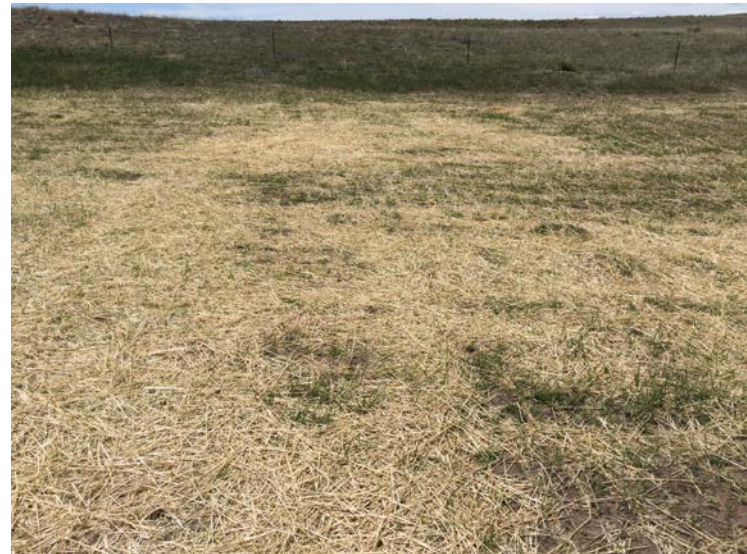
Photographs Taken: 05/20/2016

During the monitoring event on May 20, 2016, just two months after the March reclamation seeding event, the onsite vegetative cover was observed to be less than 80 percent (%) of the

Noxious weeds observed onsite: PAMI2  
 Species observed onsite: AMPS, BAPR5, CHAMA15, COCAC3, DACA6, ARPO2, BOCU, BOGR2, ERIGE2, ERIGE3, LIPU, MUSQ3, PGB1  
 Two track visible on access.

Ratio of % Non-weedy Canopy Cover Onsite to % Non-weedy Canopy Cover Offsite = 67%  
 Ratio of % Non-weedy Basal Cover Onsite to % Non-weedy Basal Cover Offsite = 44%

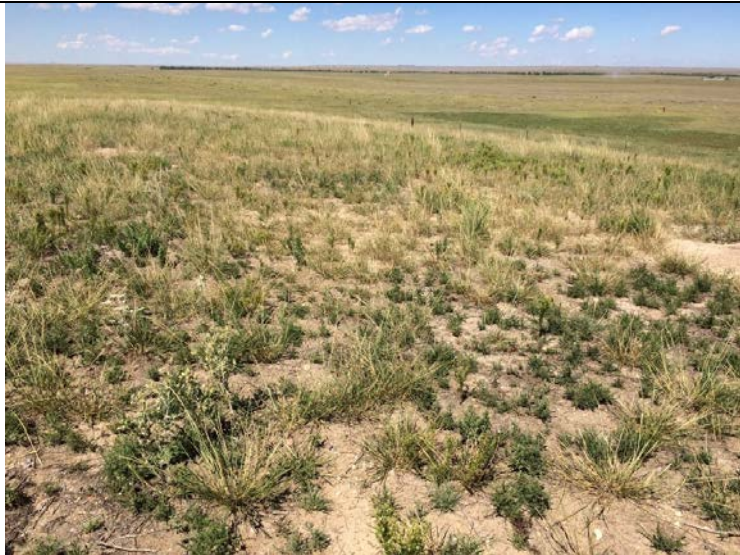
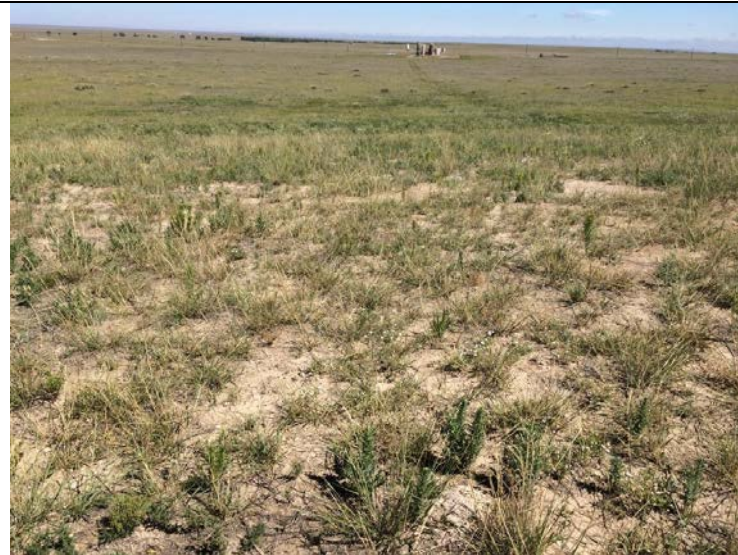
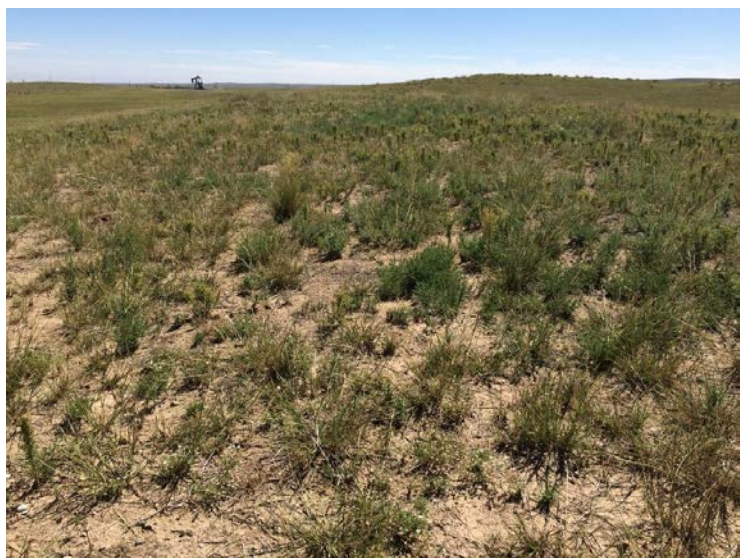
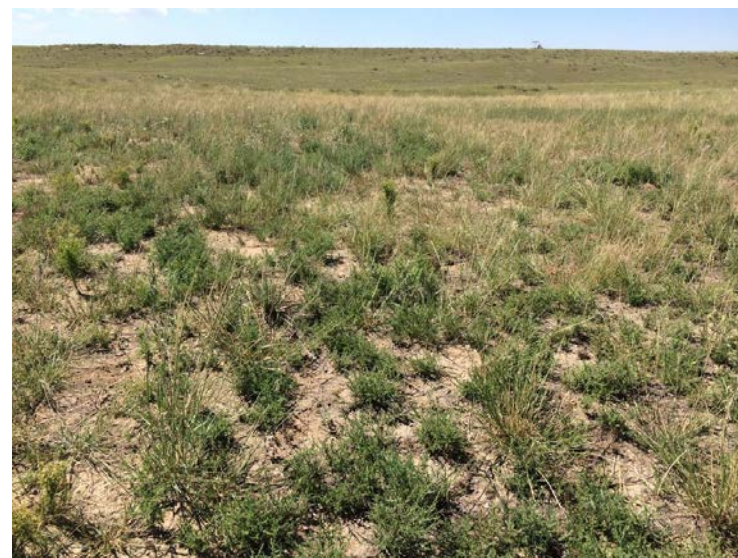
Photographs Taken: 09/08/2016

referenced offsite vegetation. During the monitoring event on September 8, 2016, the vegetative covers at the Site was still observed to be less than 80%, but had filled in slightly relative to the previous May 2016 monitoring event.
