November 8, 2016

Inspection Photos: Gulfport Energy DA Juniper4-3 API#081-07587

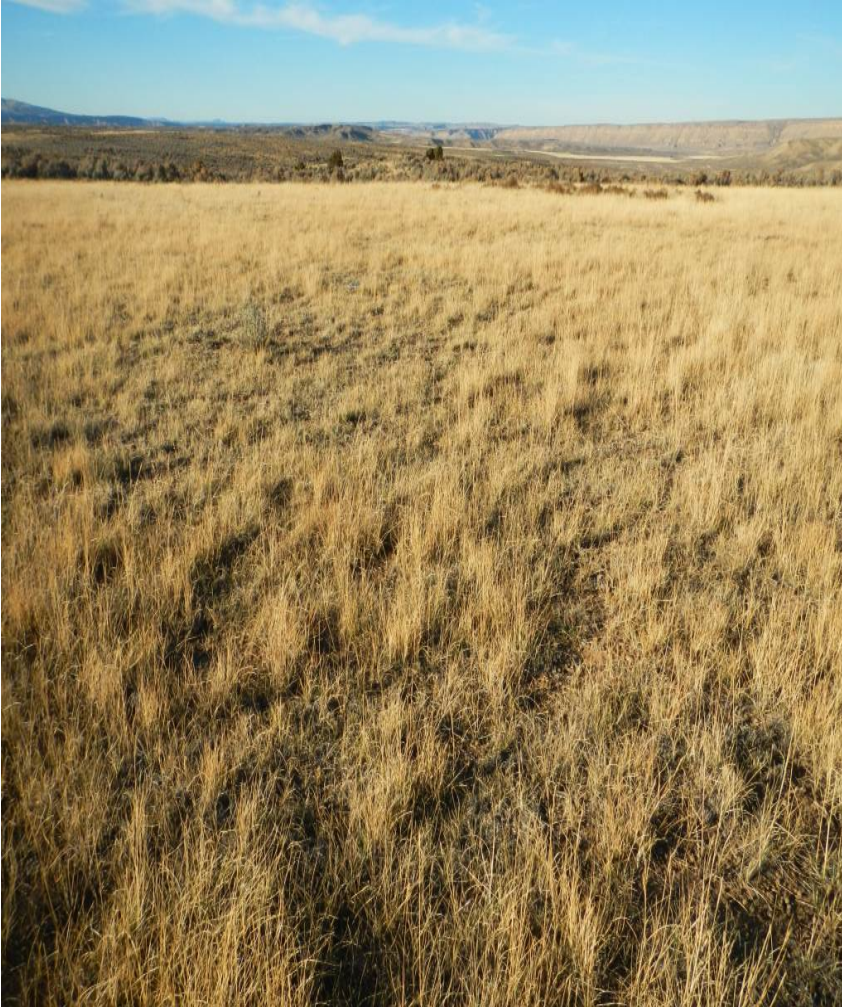
Photo#1:

View North over Location Center

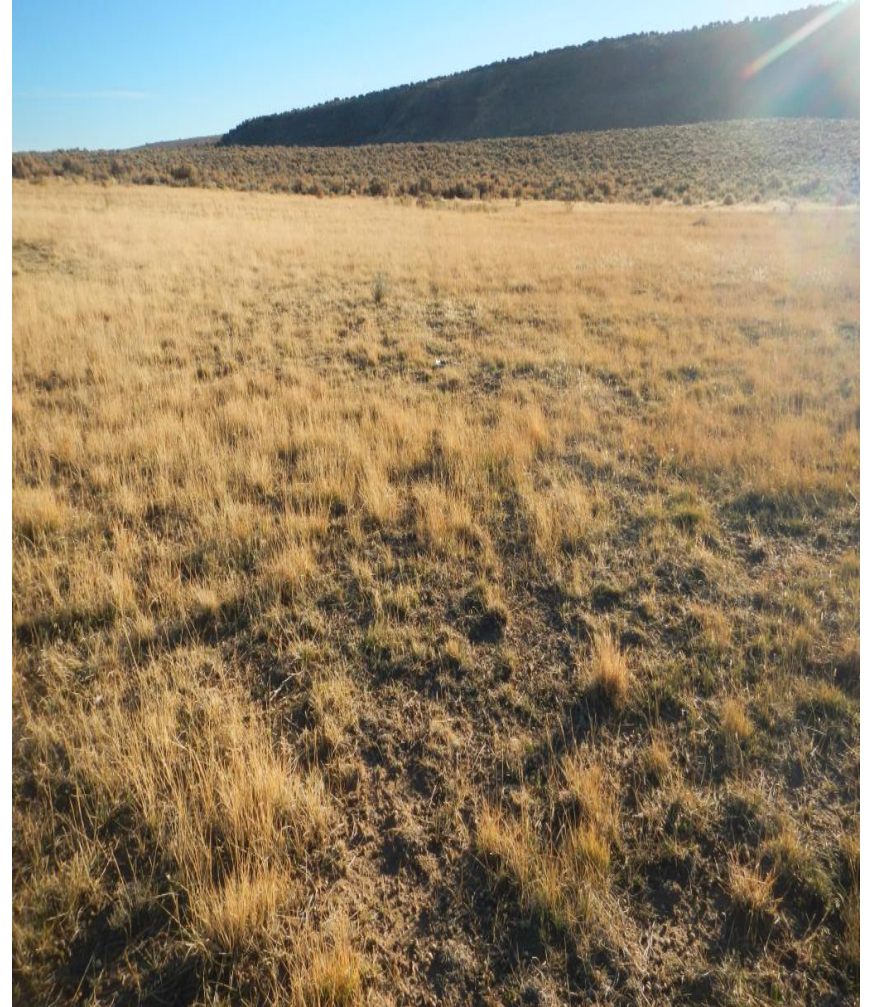
Photo#2:

View South over Location Center

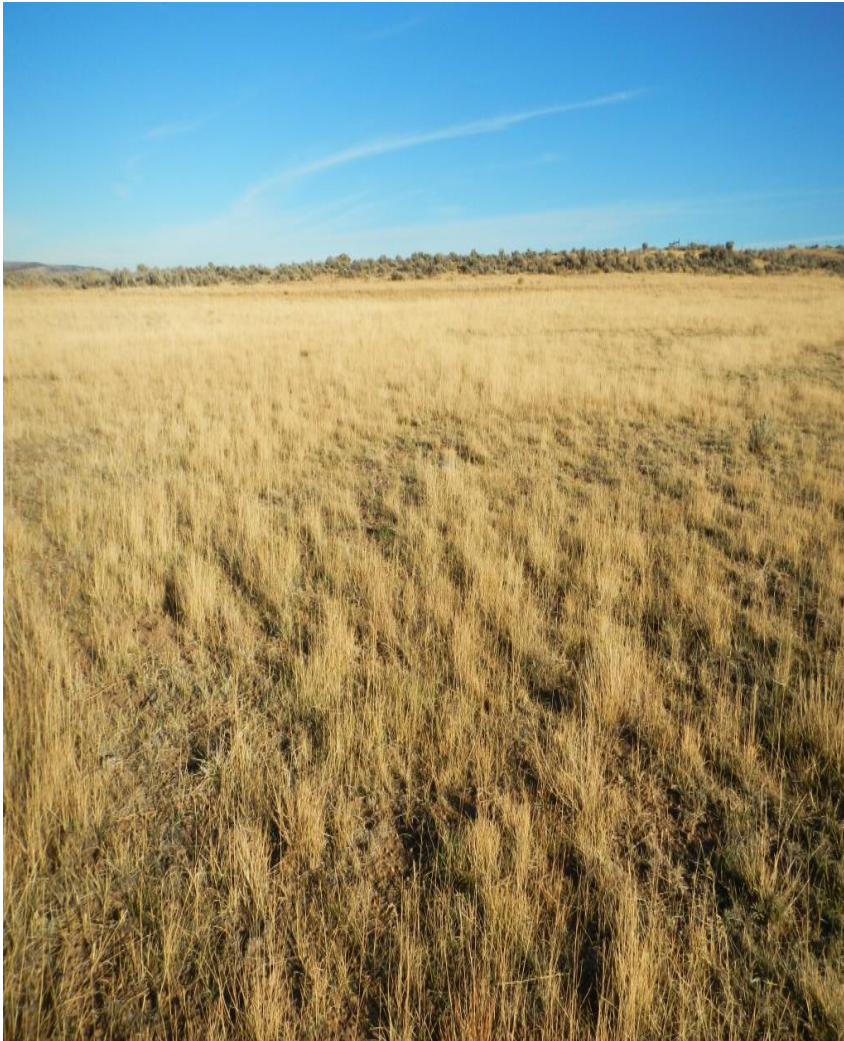
Photo#3:

View East over Location Center

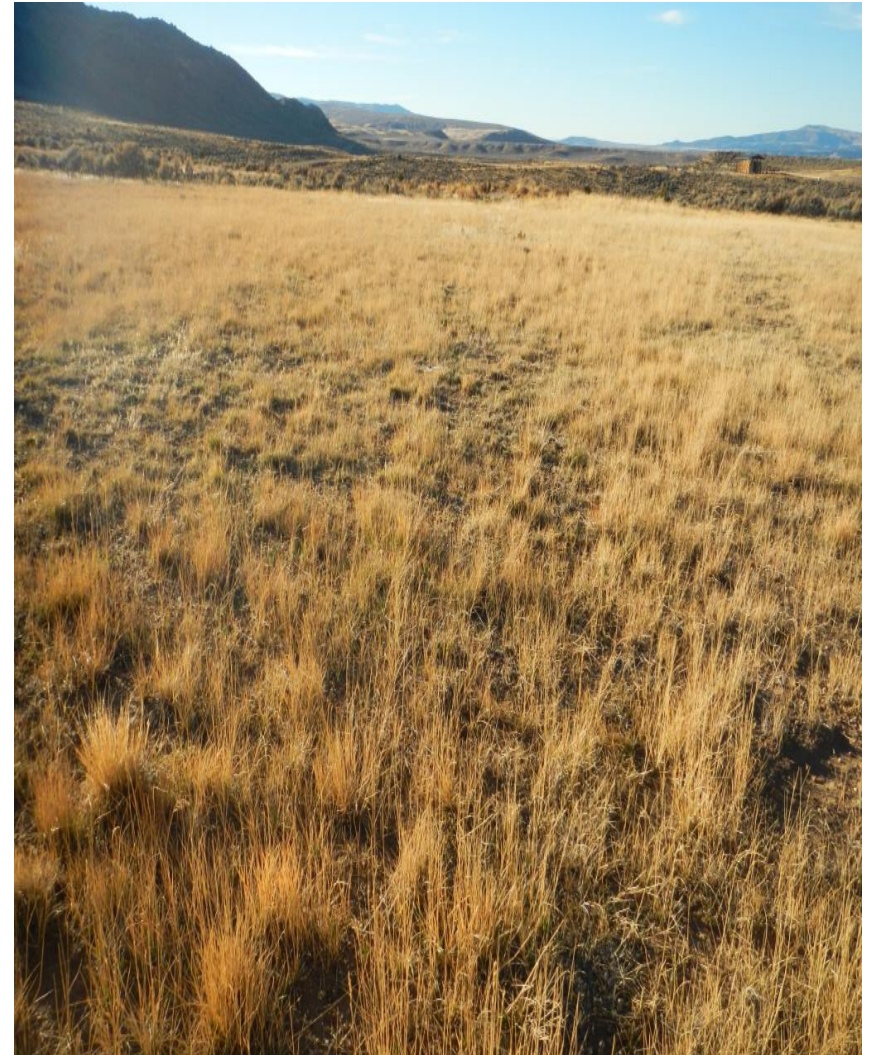
Photo#4:

View West over Location Center

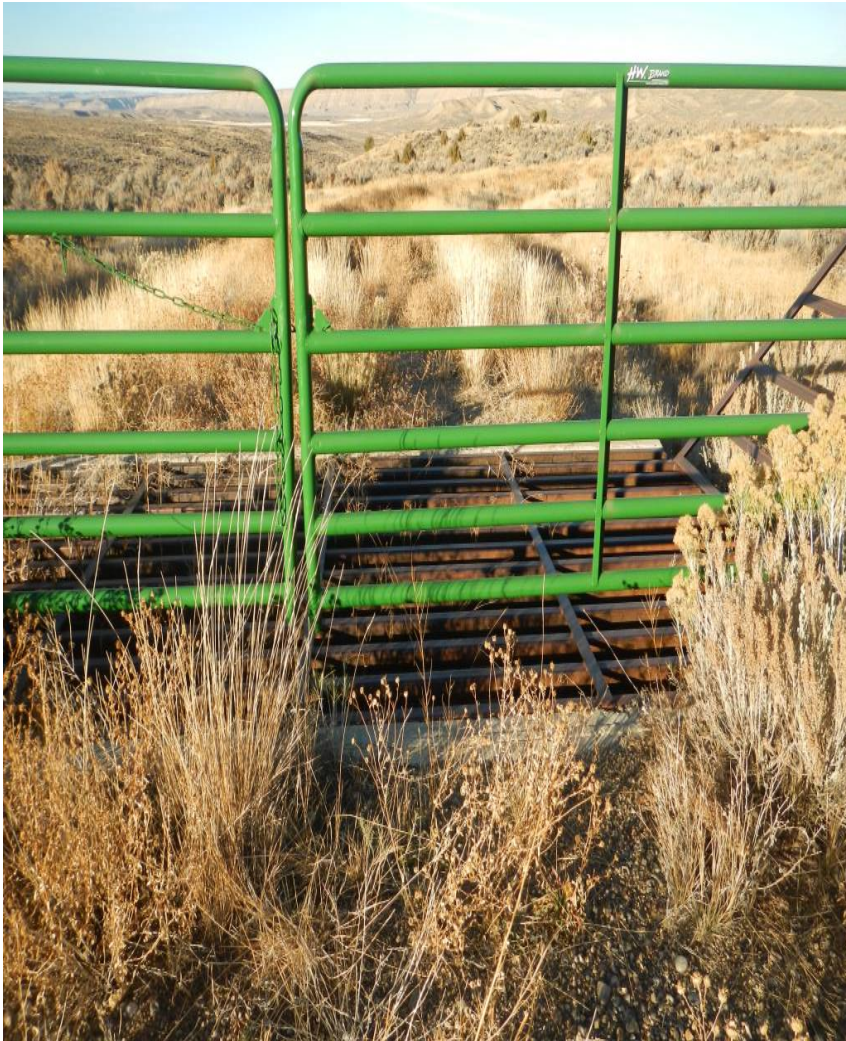
Photo#5:
Entry into Location

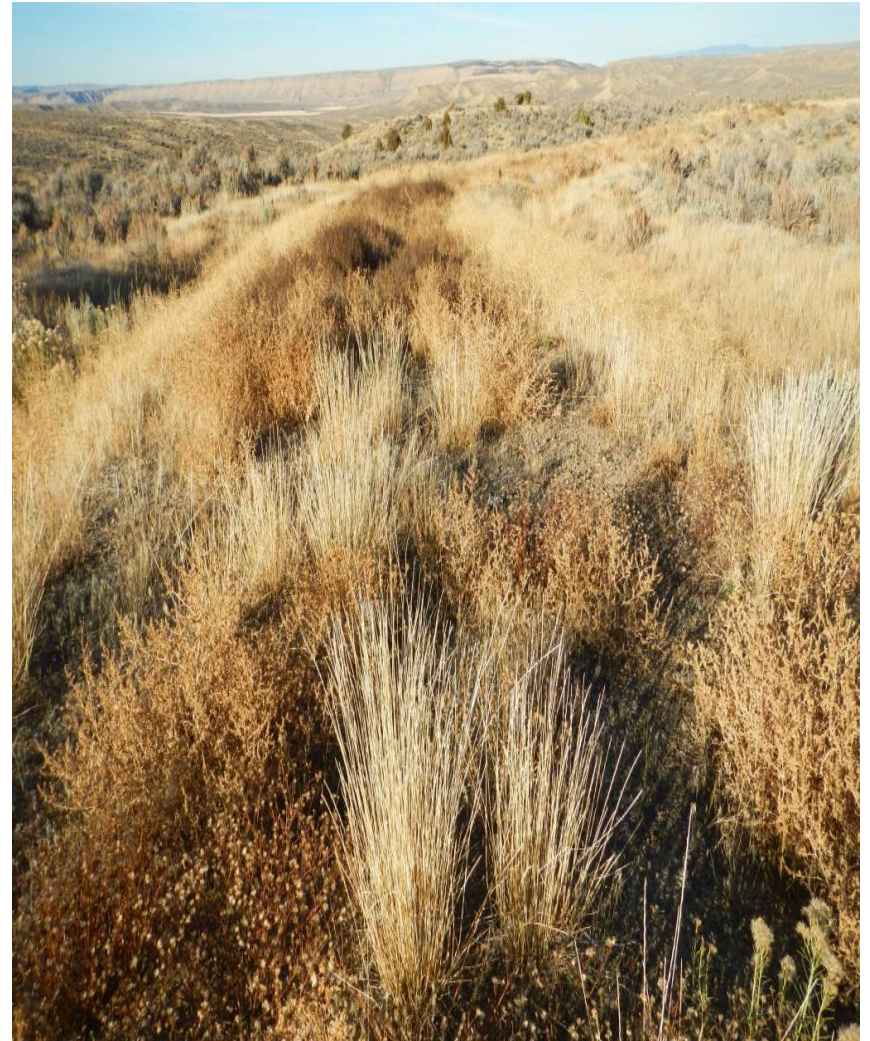
Photo#6:
View NE along Access Road into Location

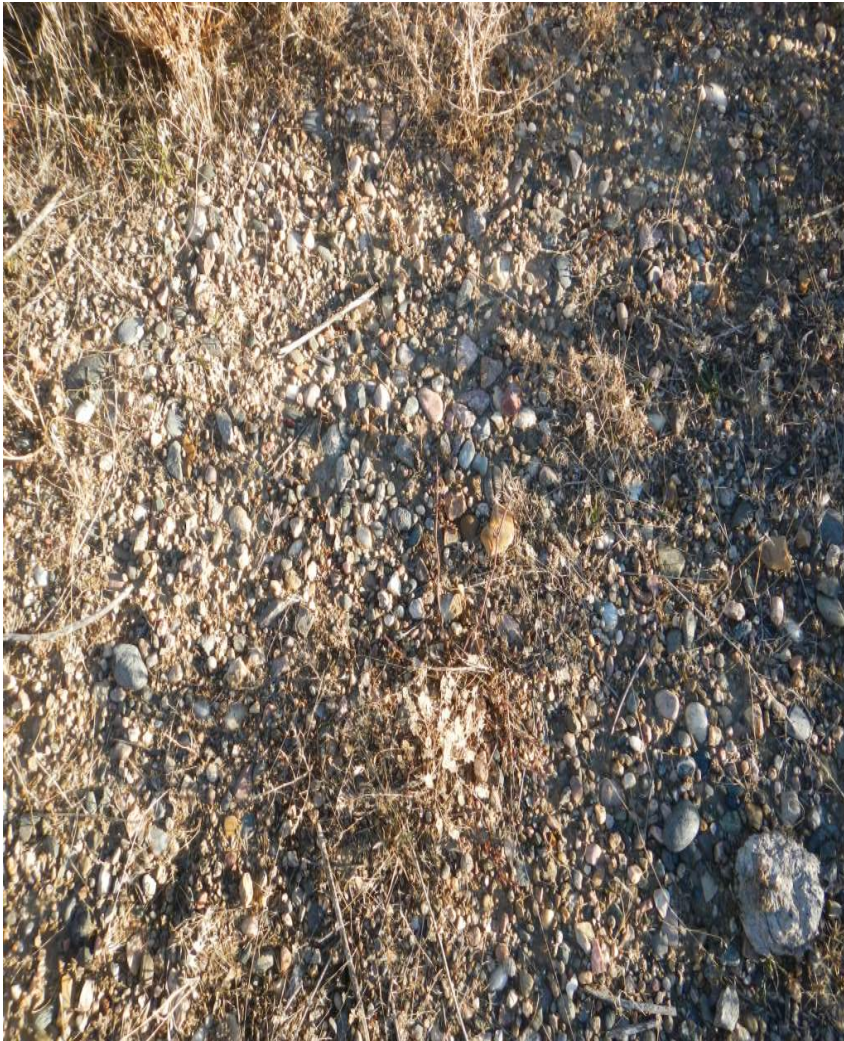
Photo#7:

Gravel not Removed from Access Road.

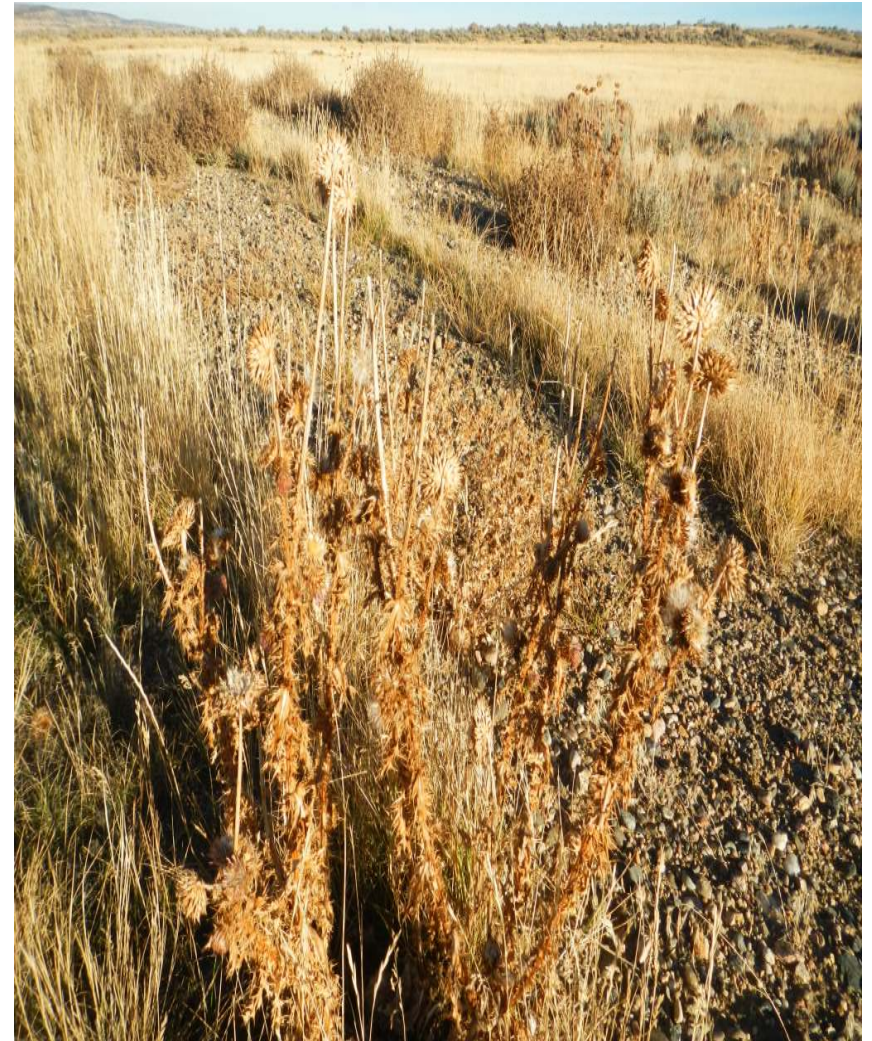
Photo#8:

Noxious Weeds establishing on un-reclaimed Access Road

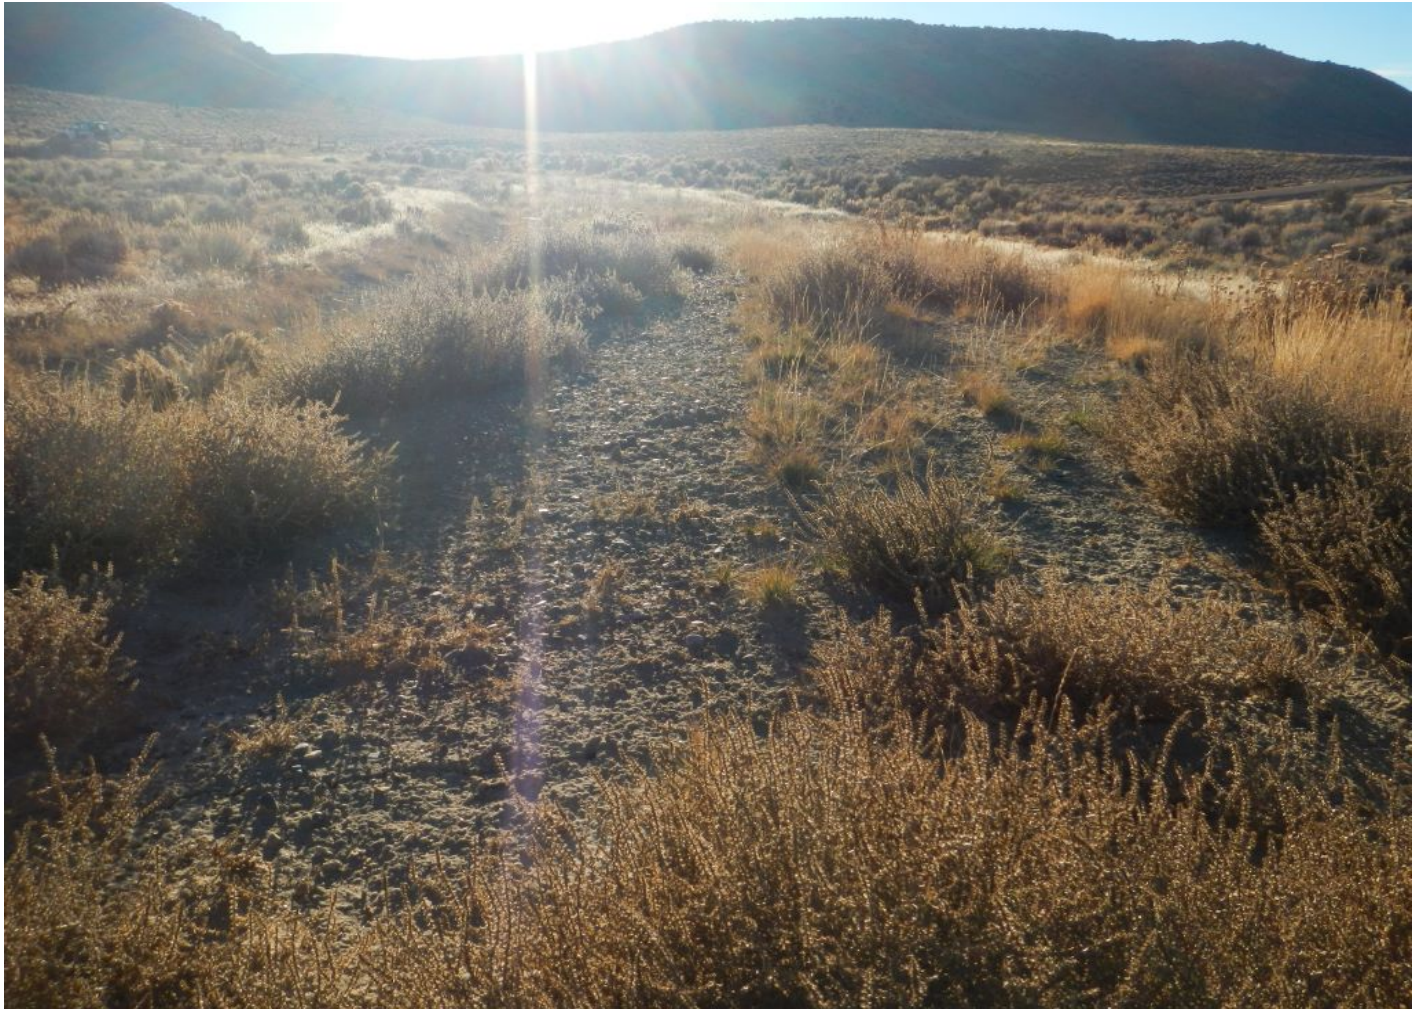
Photo#9: View up Access Road exiting Location to West.
