**Foundation Energy Management LLC  
Federal 12-3 Second Follow up  
Inspection Doc#675203618**

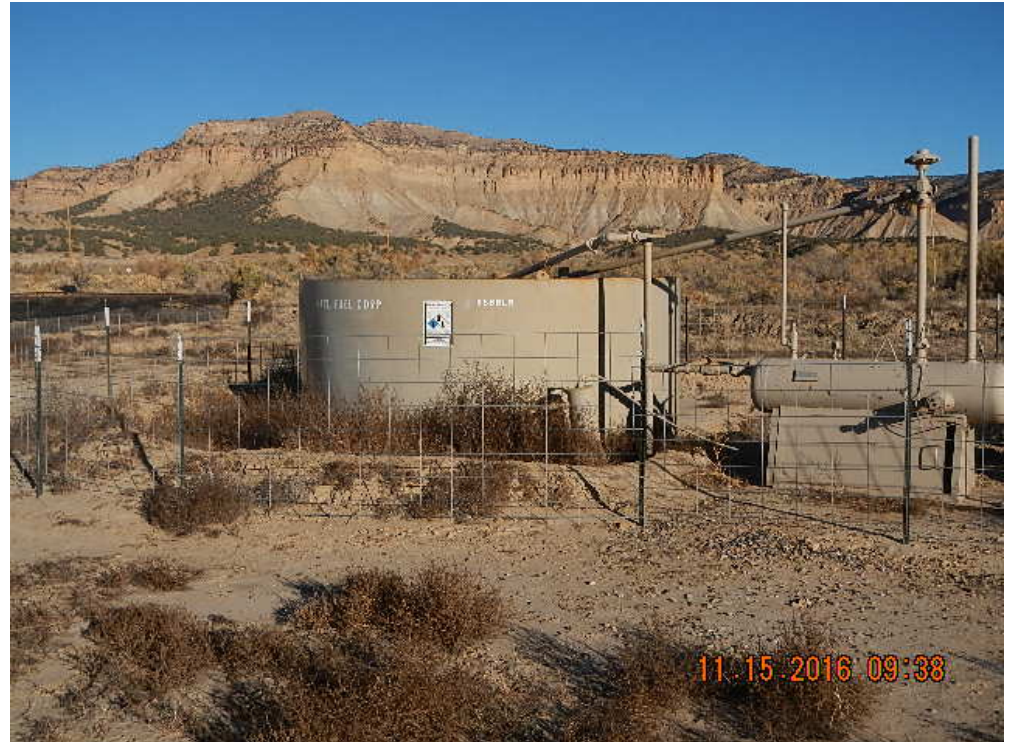
Vegetaion/ Vegetation  
debris in tank containment.

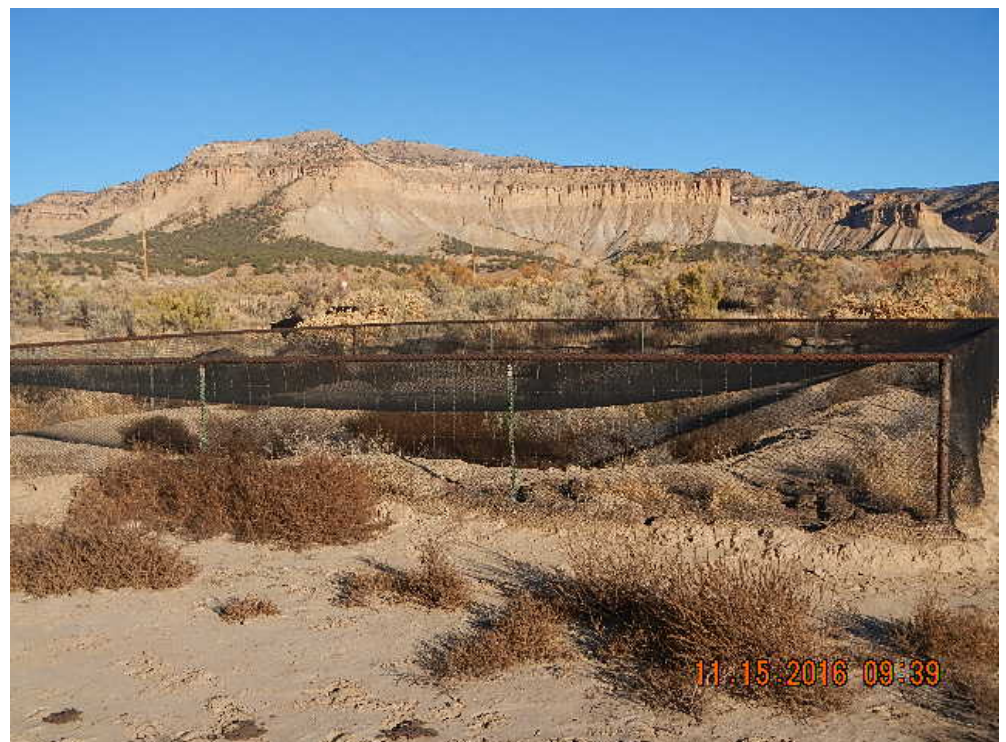
Vegetation/ vegetation  
debris in pit

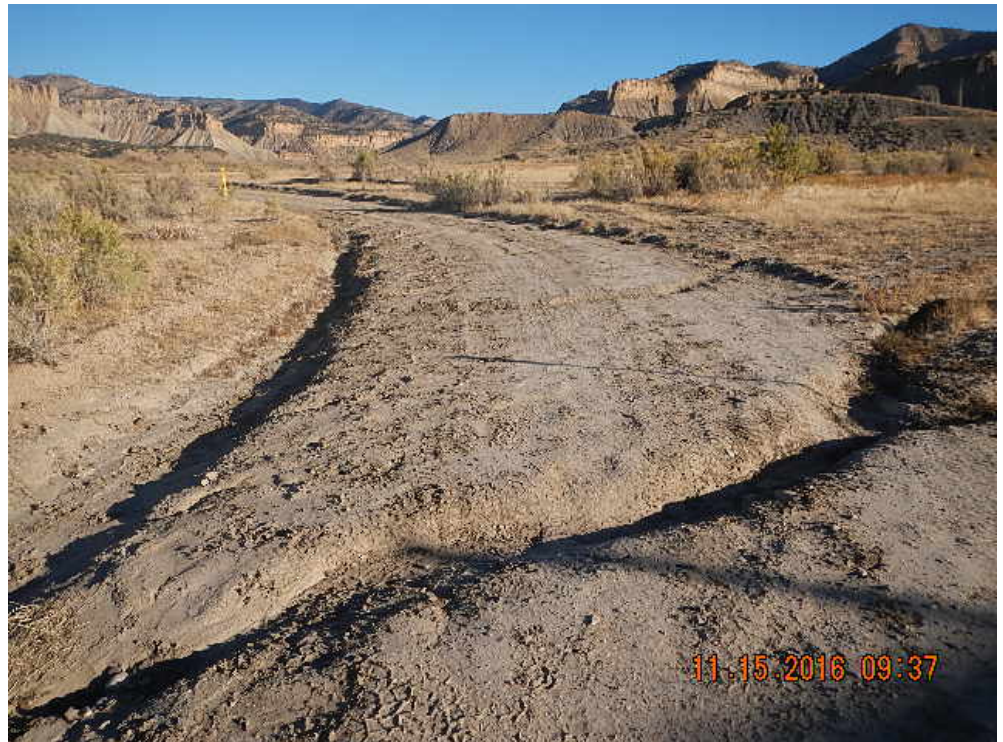
Erosion across roadway

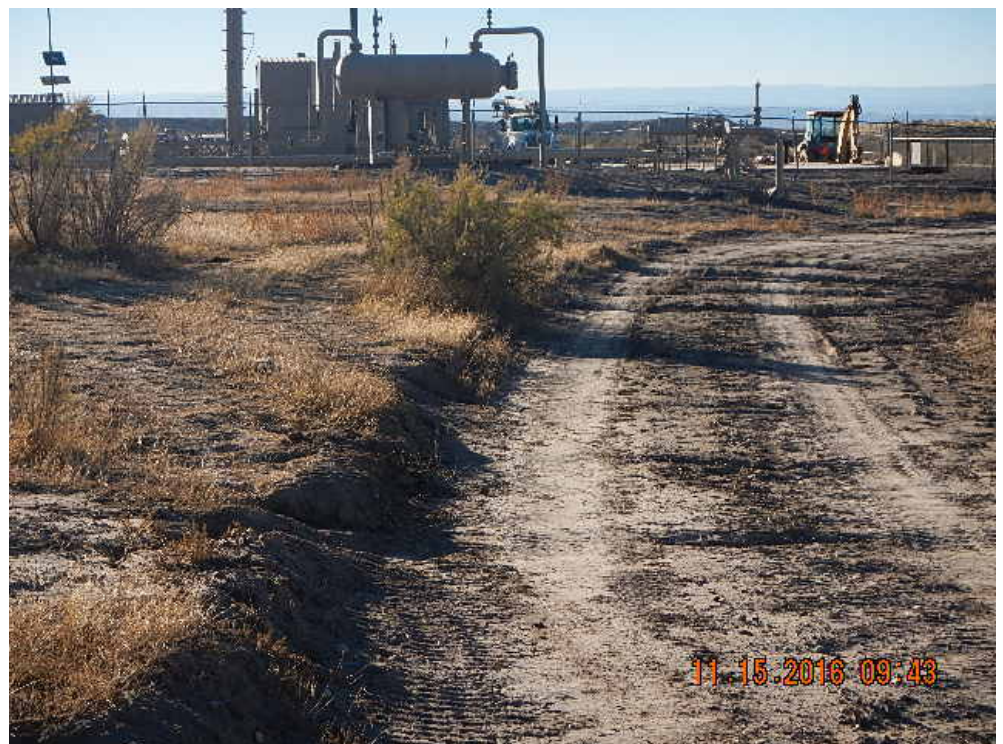
Traffic driving around area of erosion in access road

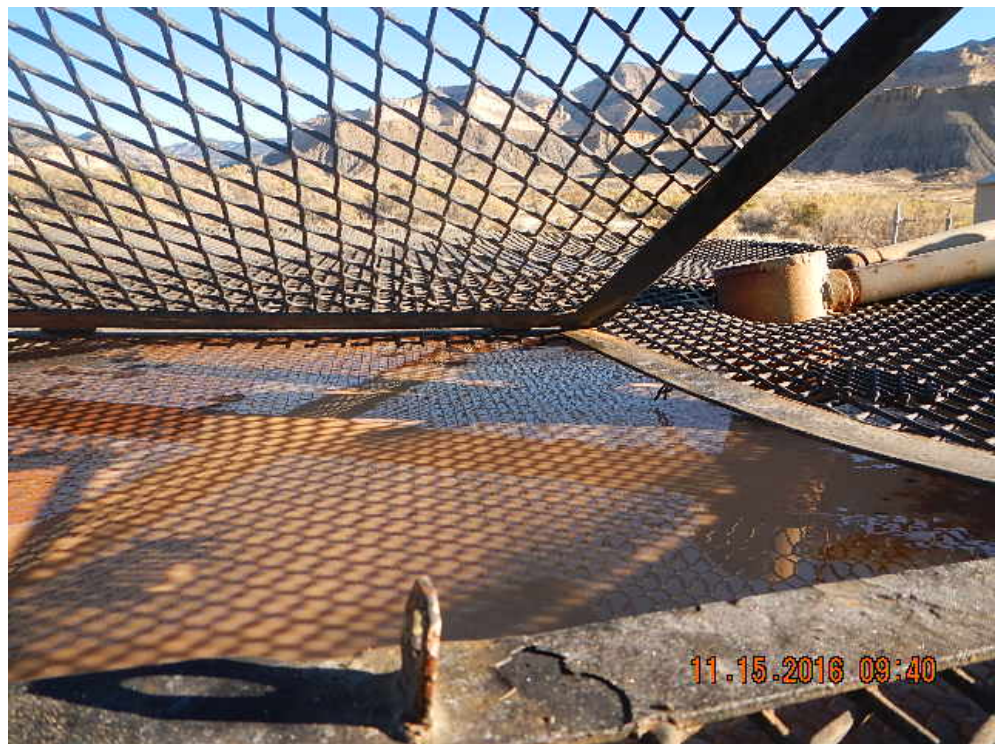
Open top tank near capacity
