Interim Reclamation Inspection

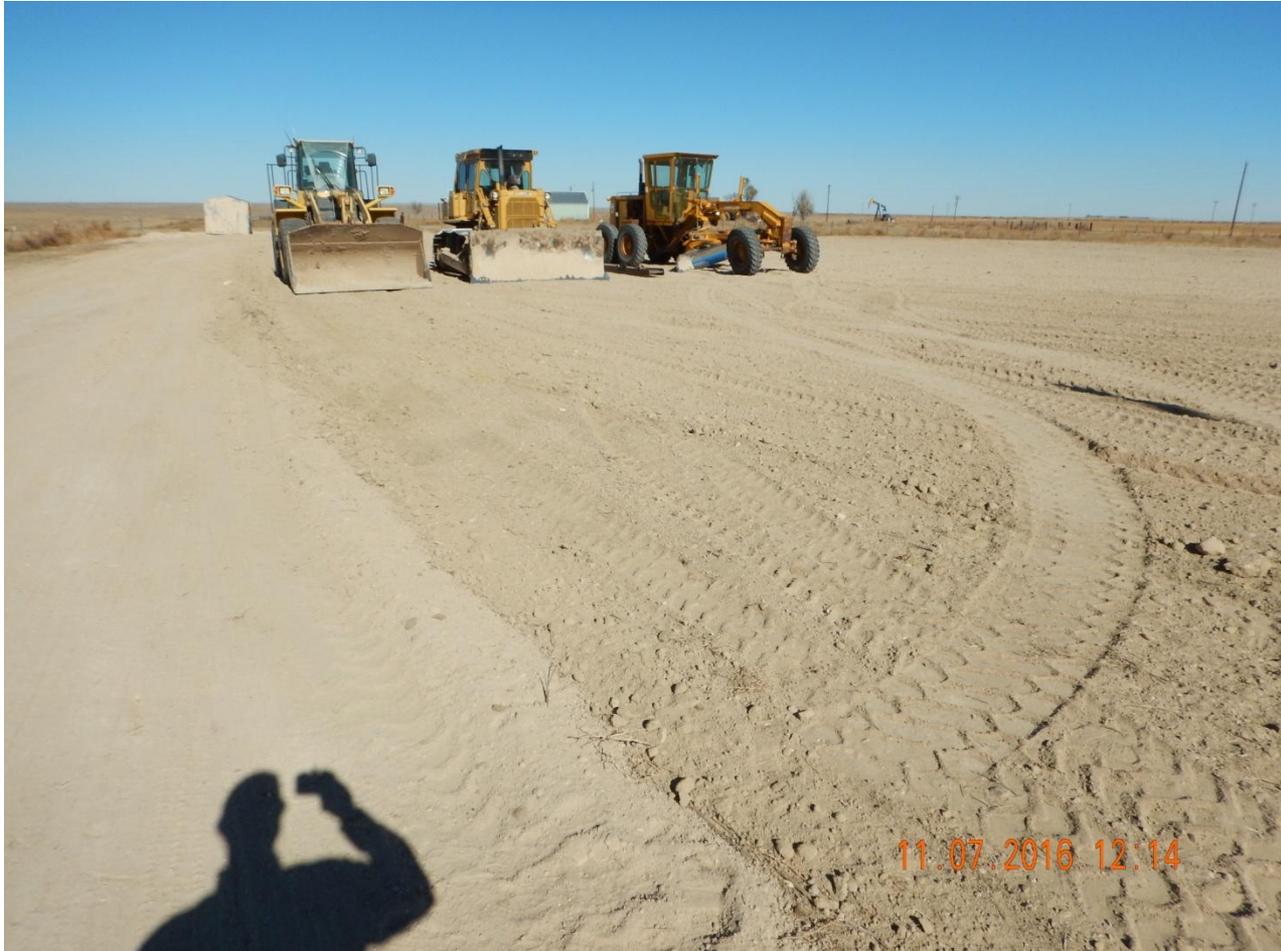
Photo 1. Photo taken from southwest location, facing North. Interim reclamation IN-PROCESS.

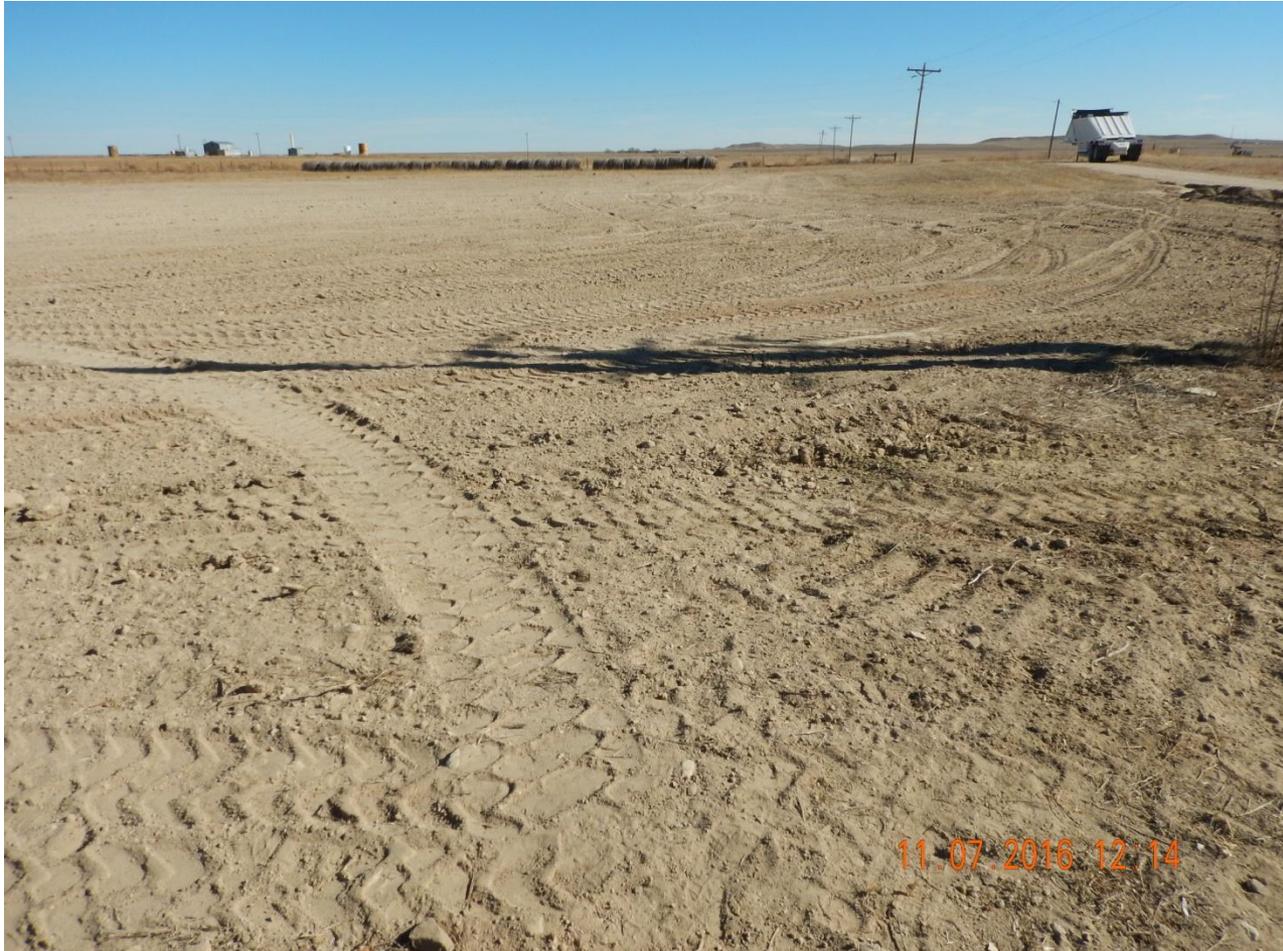
Photo 2. Photo taken from southwest location, facing East. Interim reclamation IN-PROCESS.
