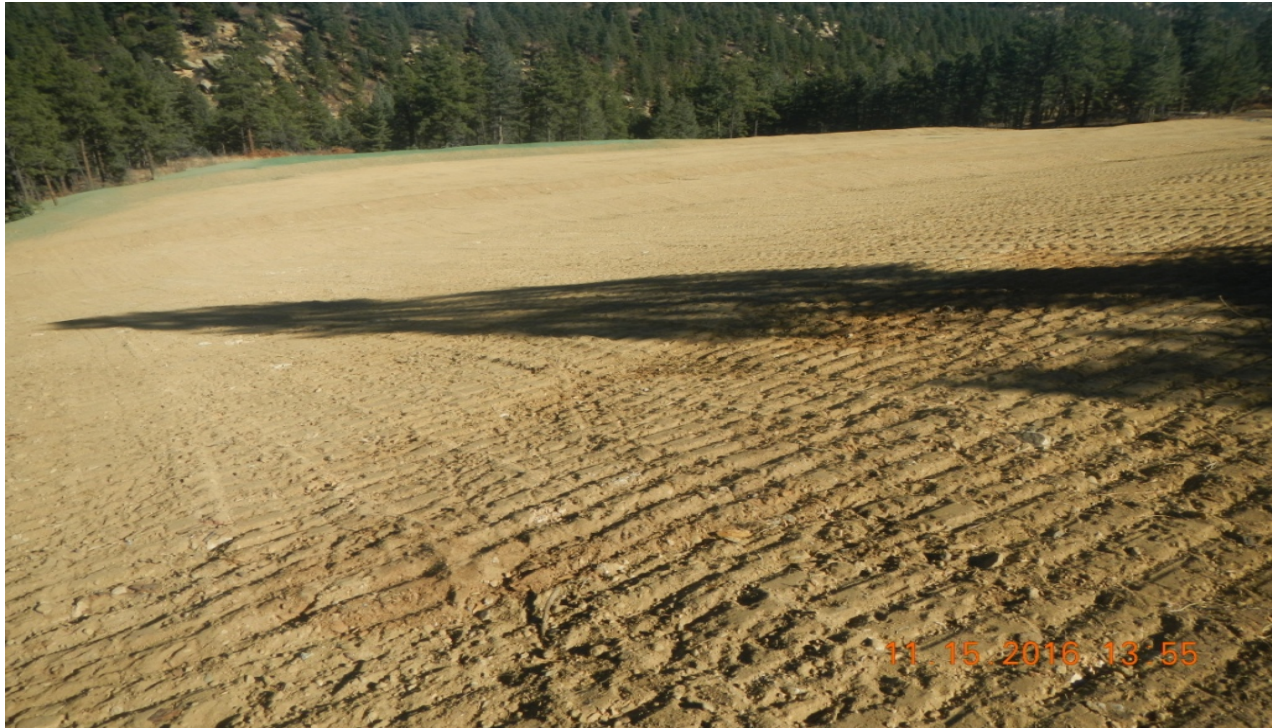
**photo 1:** Facing northeast toward the location which has been recontoured.

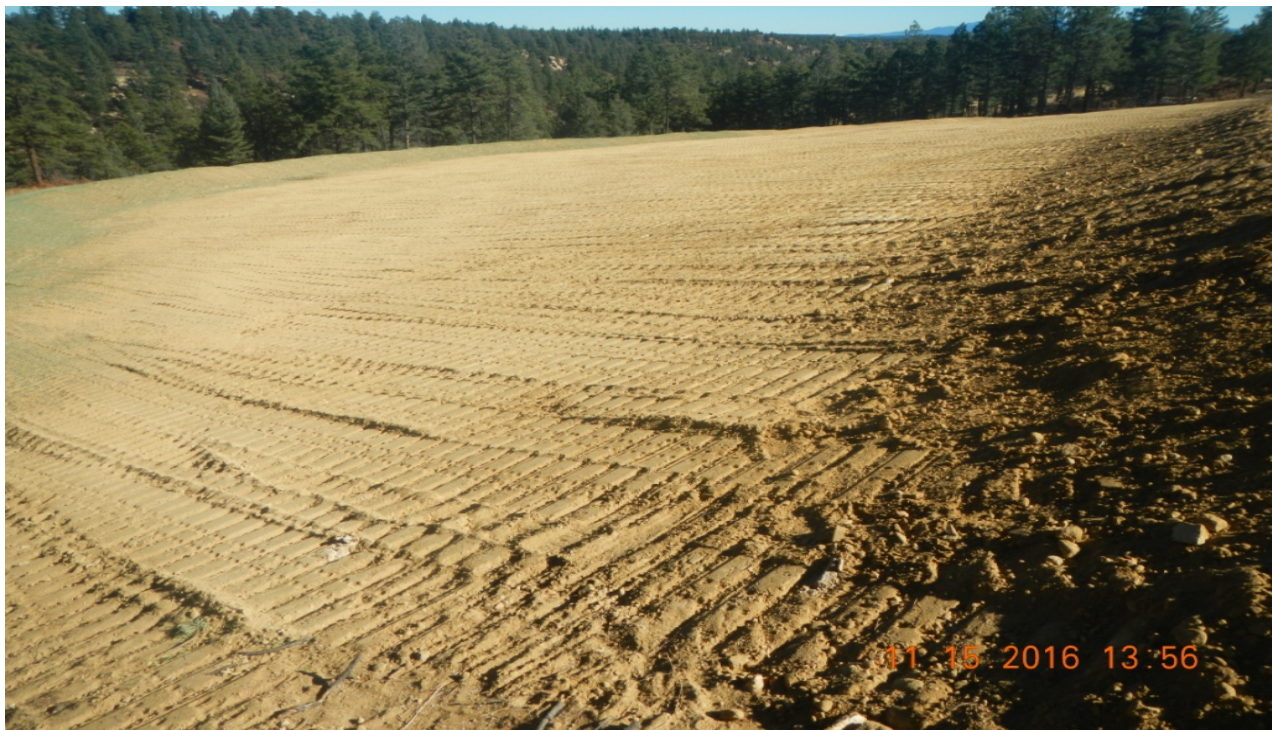
**photo 2:** West side of the location facing east.

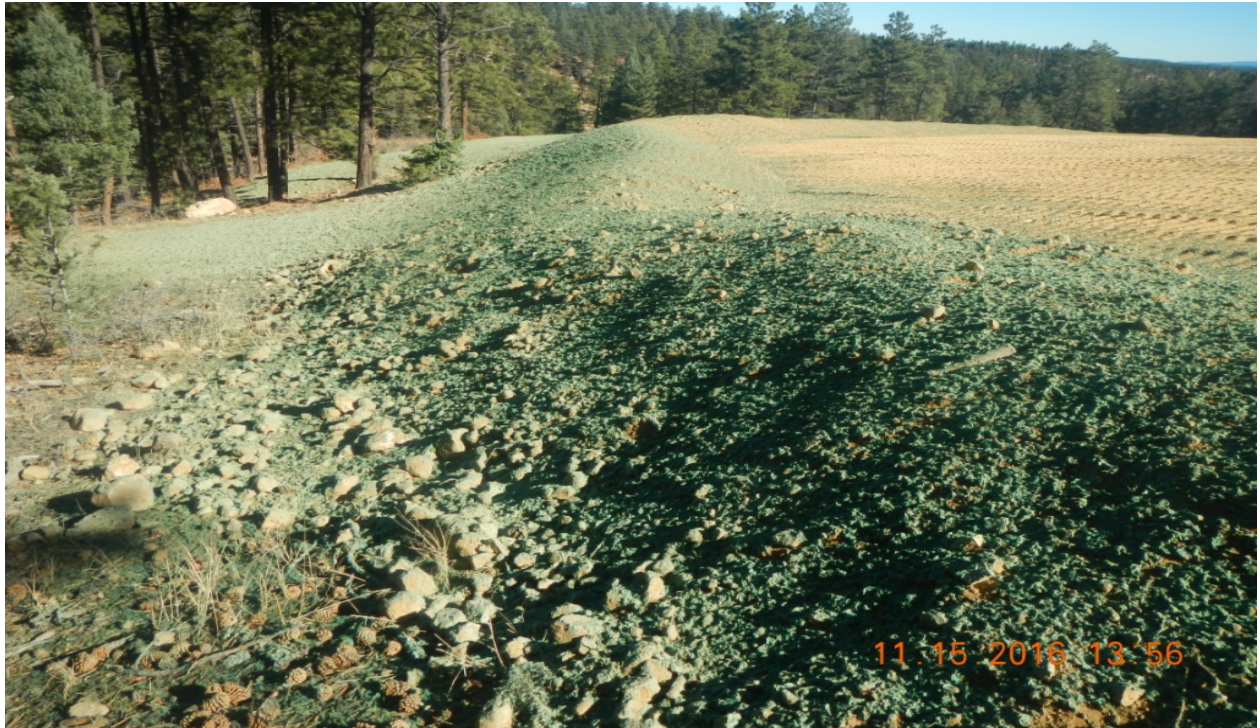
**photo 3:** North side of the location which was being hydro-mulched.

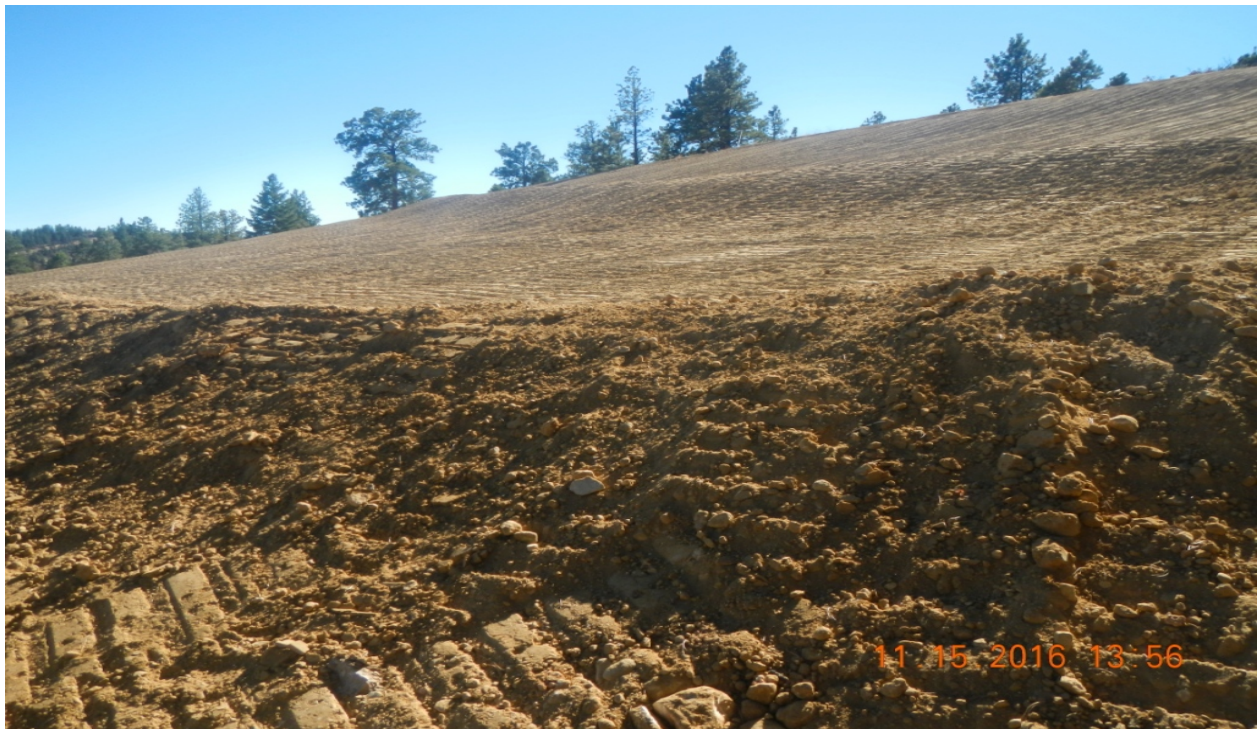
**photo 4:** West side of the location facing southeast.

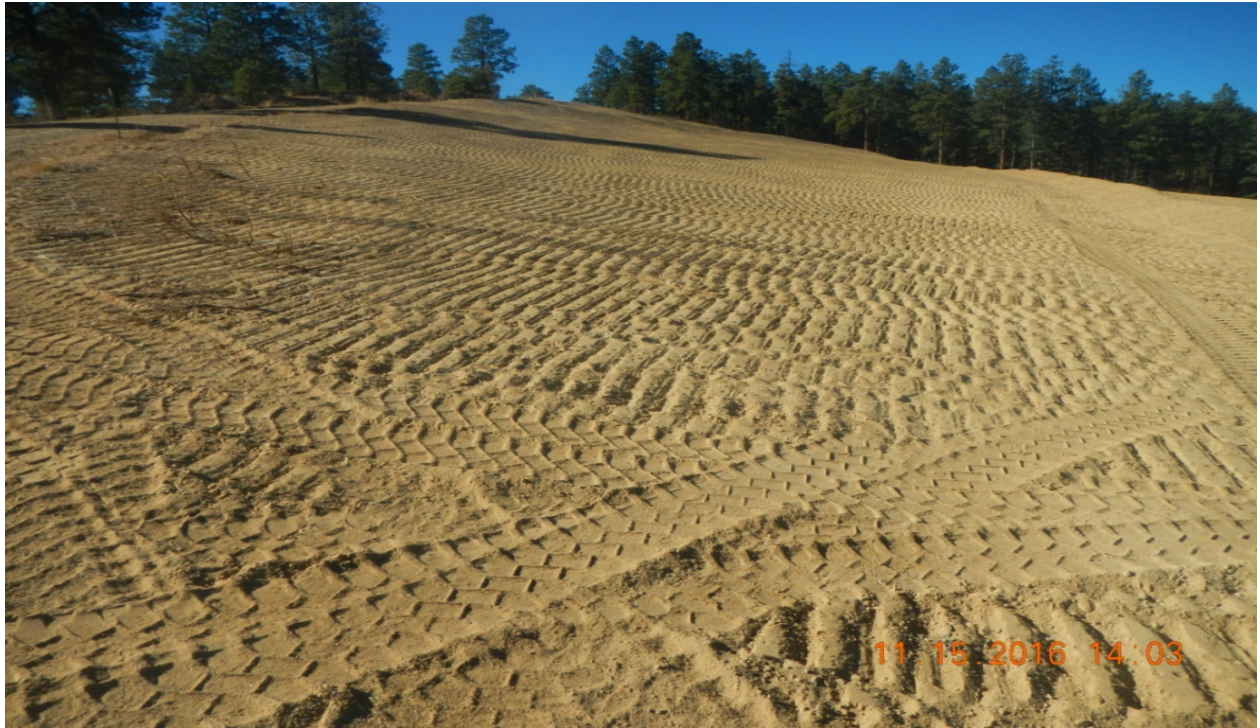
**photo 5:** East side of the location facing west.

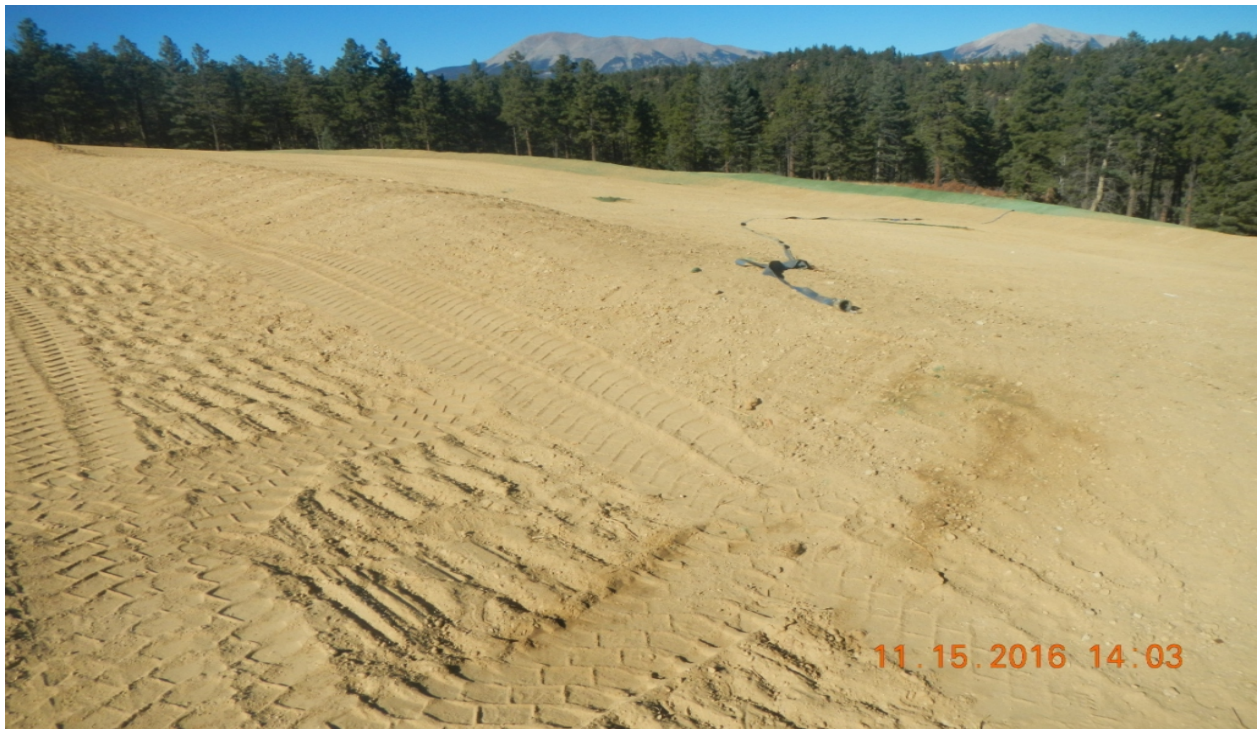
**photo 6:** East side of the location facing north.
