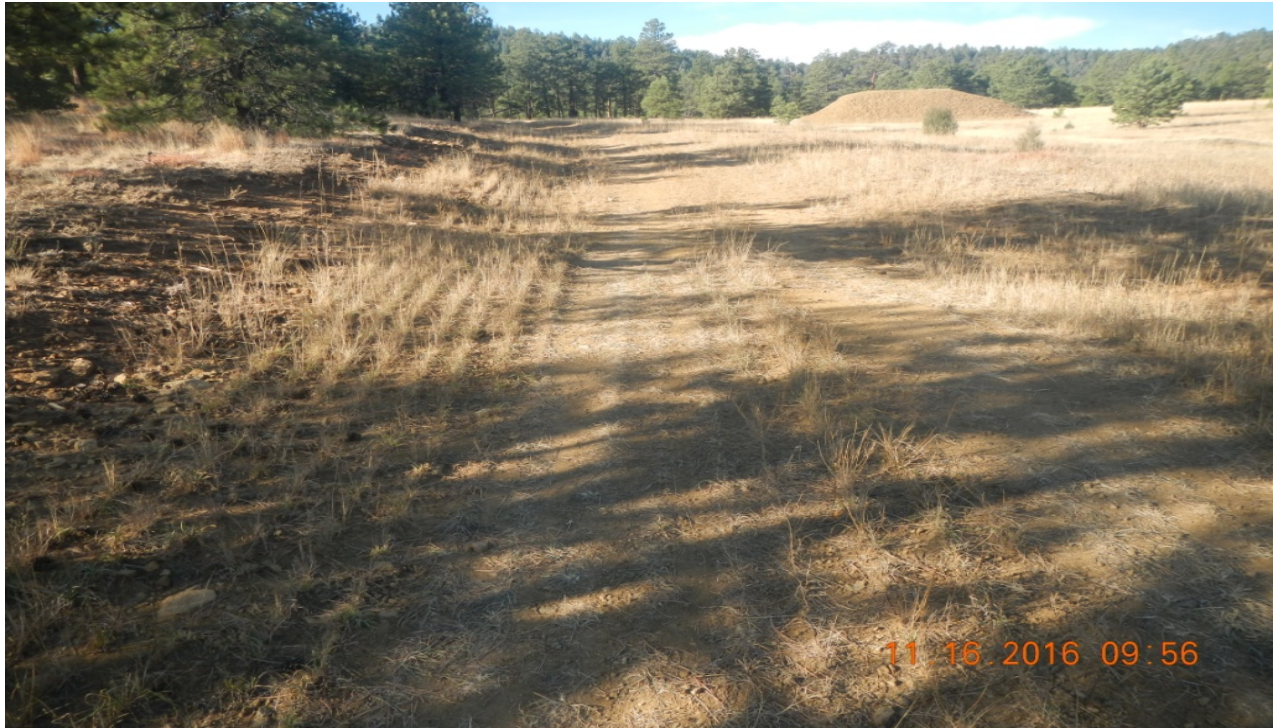
photo 1: Facing west along the access road.

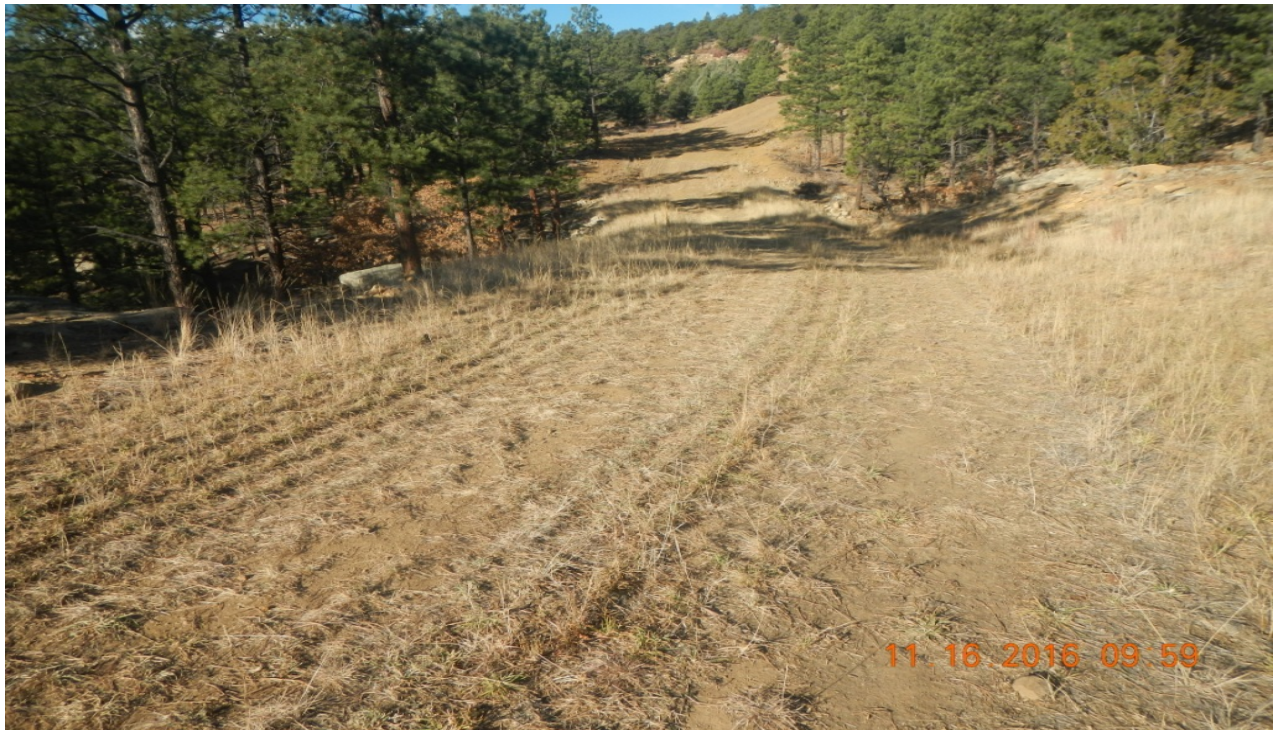
photo 2: Facing west along the access road.

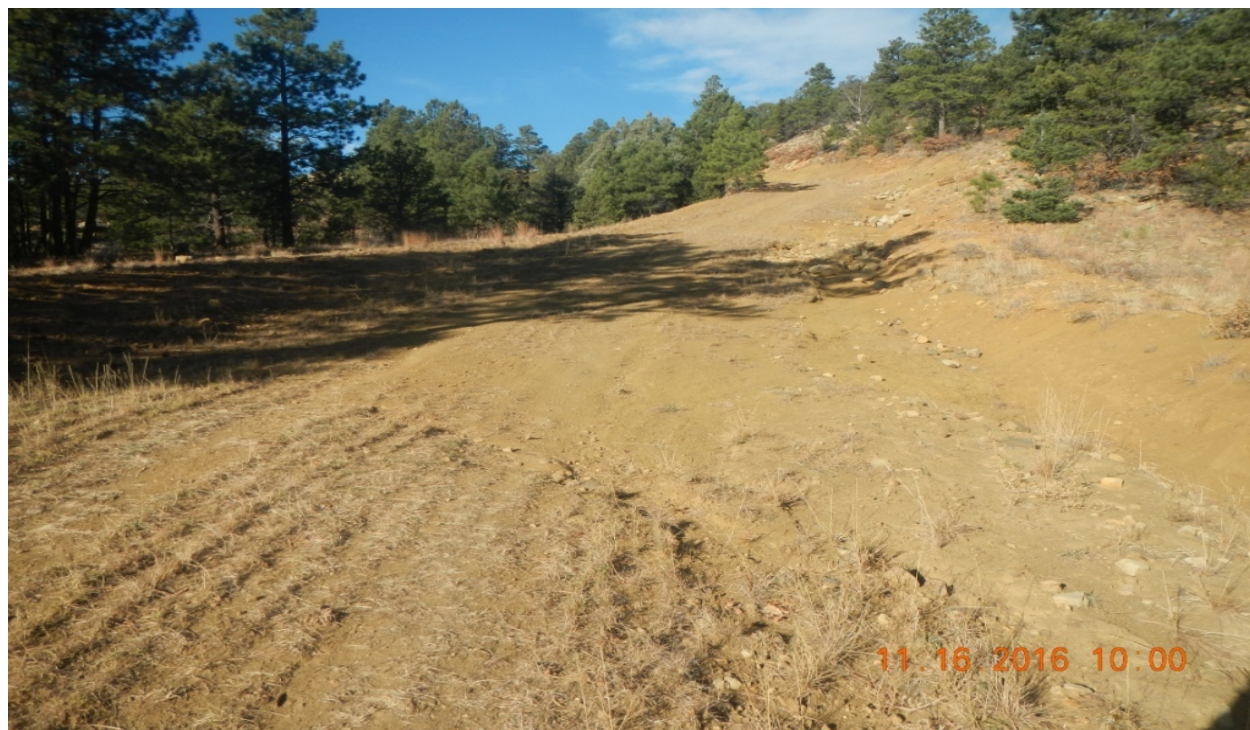
photo 3: Facing west along the access road.

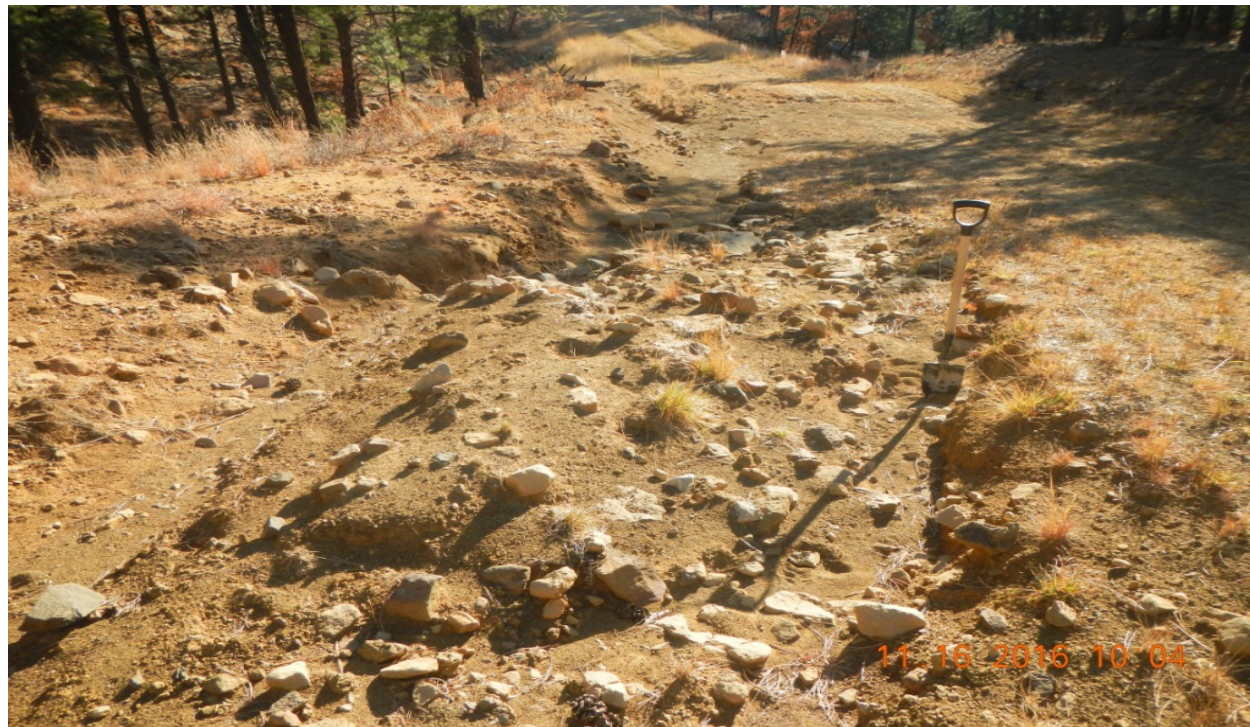
photo 4: Facing back to the east along the access road. There are signs of erosion occurring.

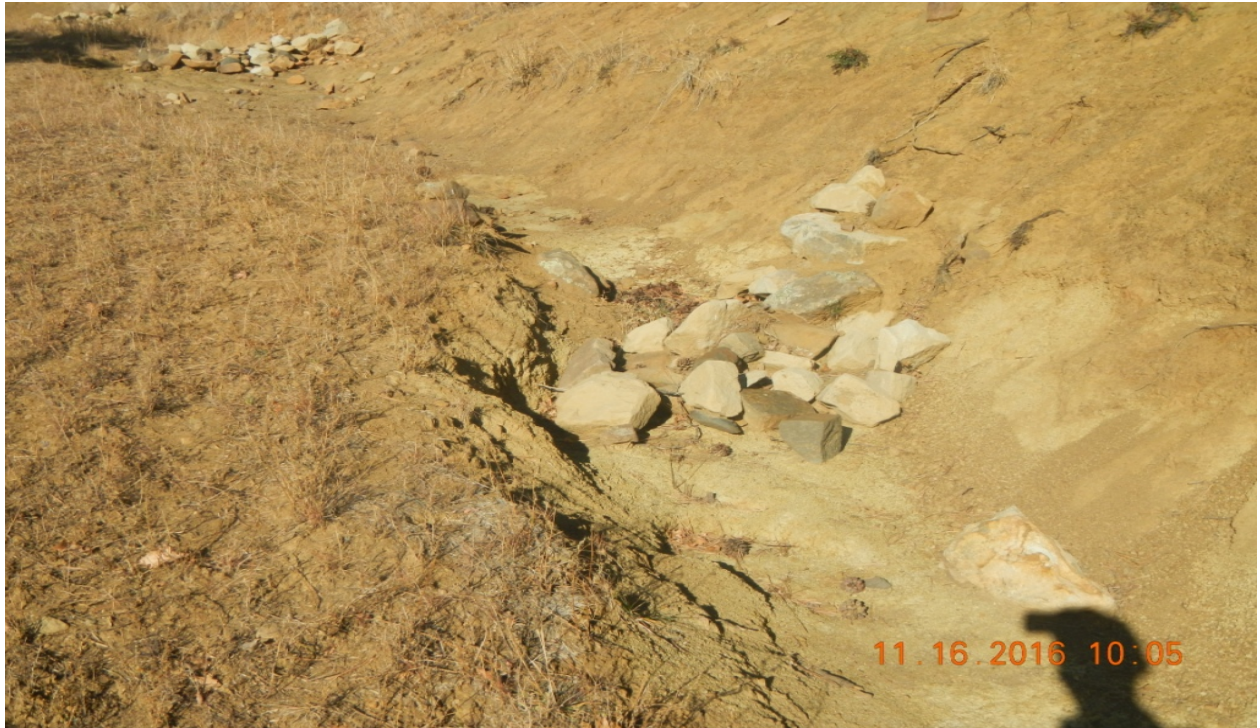
photo 5: The rock check dams are not maintained and erosion is occurring along the road side.

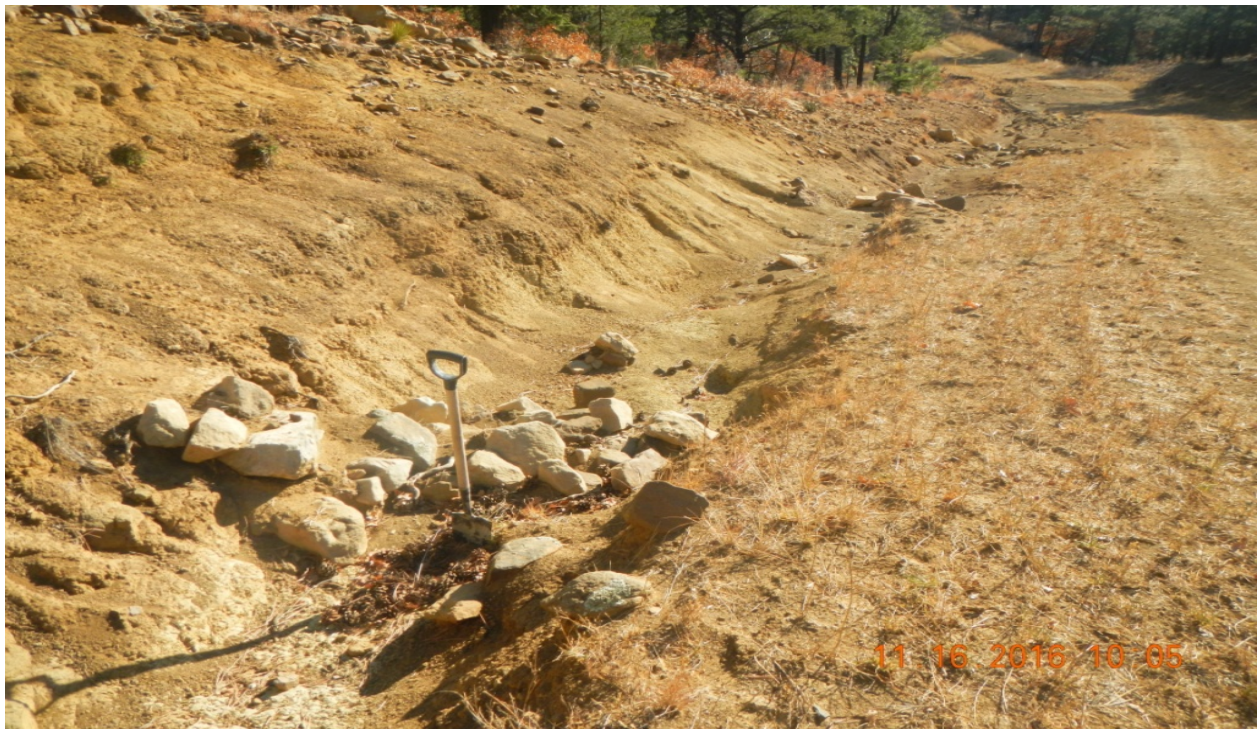
photo 6: The rock check dams are not maintained and erosion is occurring along the road side.

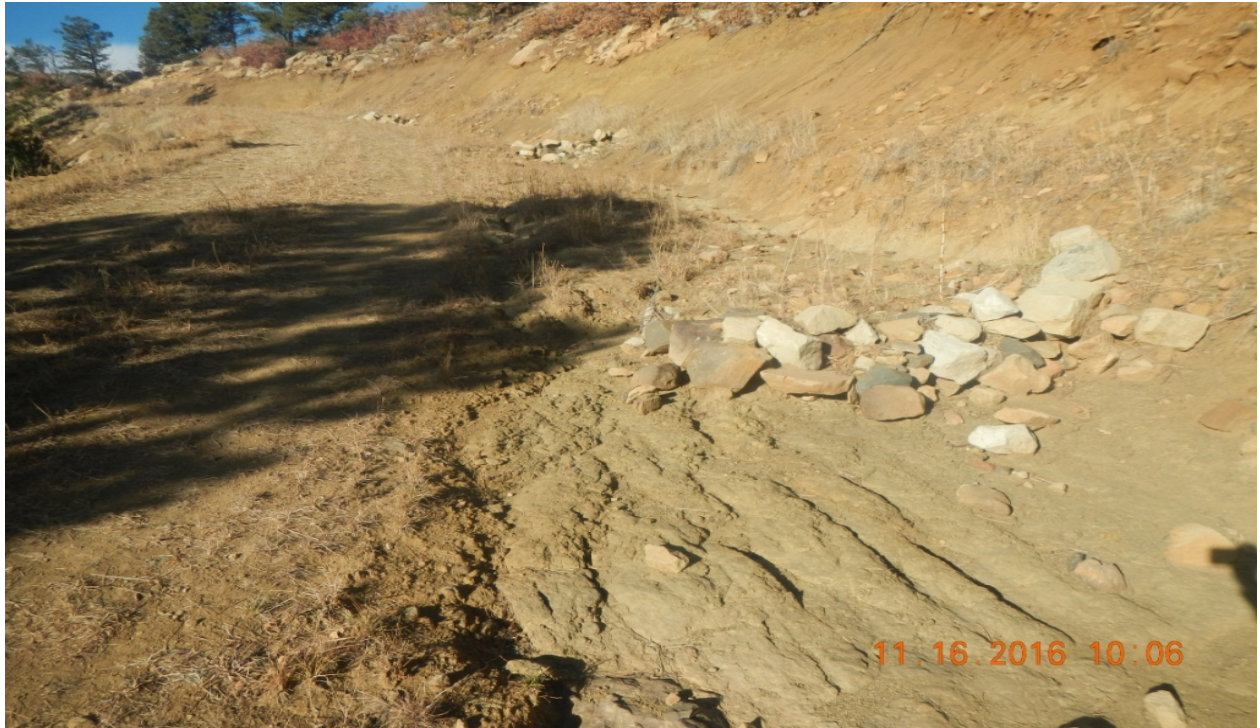
photo 7: Rock rip/rap has been placed at the north side of the location.

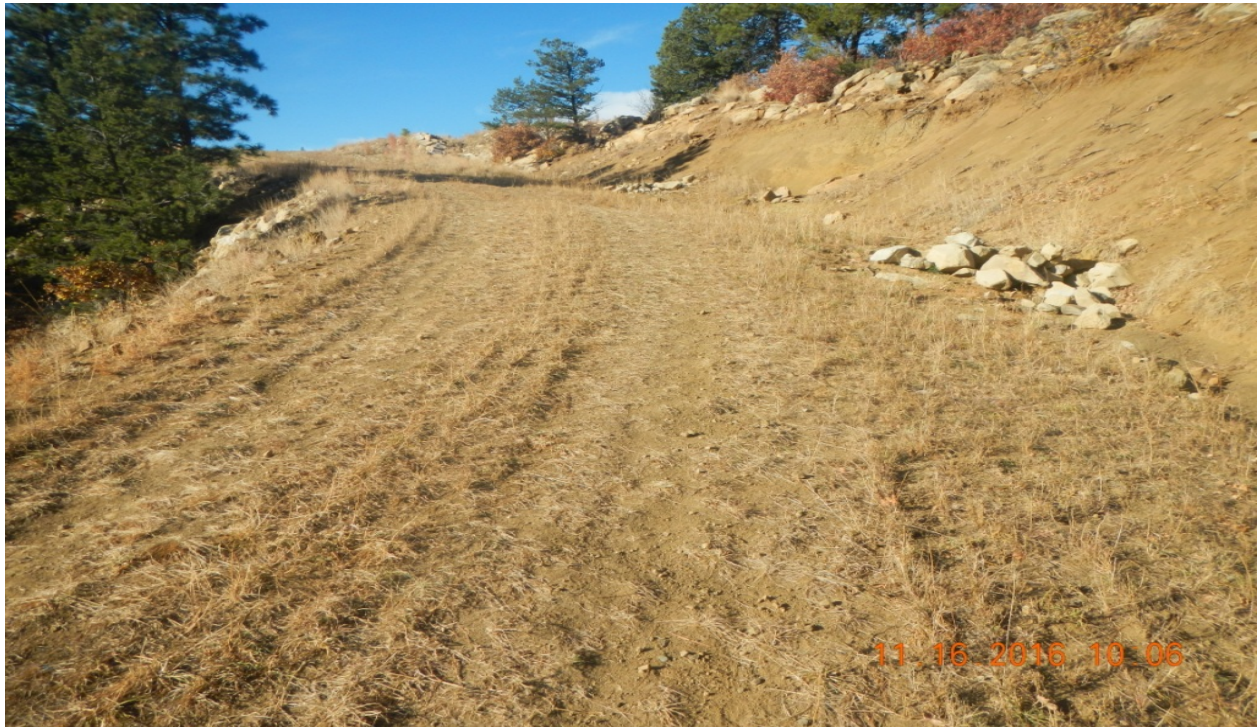
photo 8: Facing west along the access road.

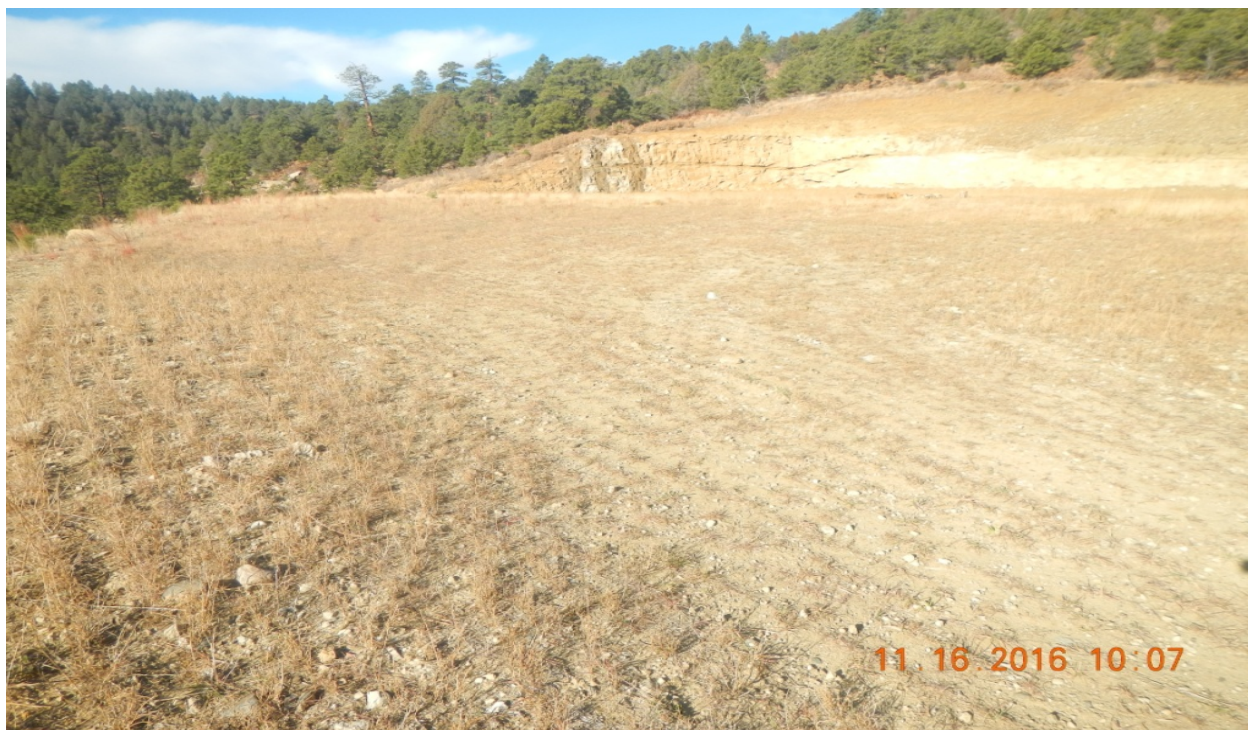
photo 9: Facing west toward the location.

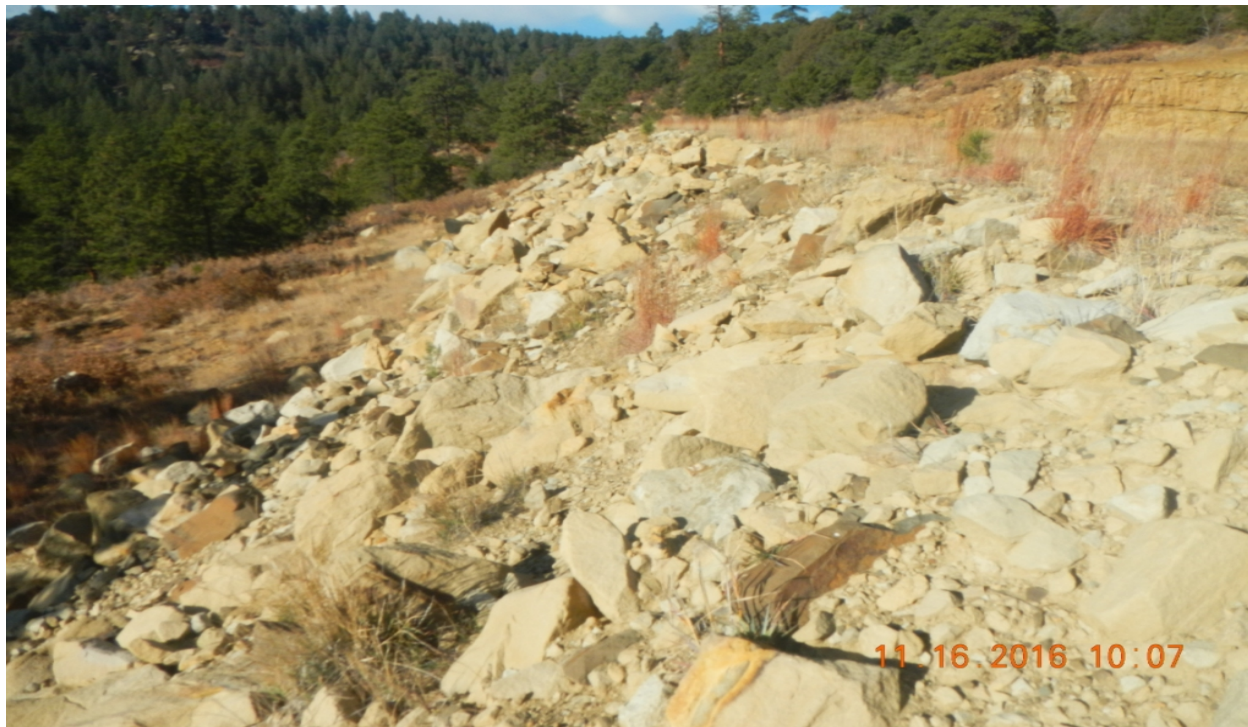
photo 10: East side of the location facing west toward the rocky fill slope.

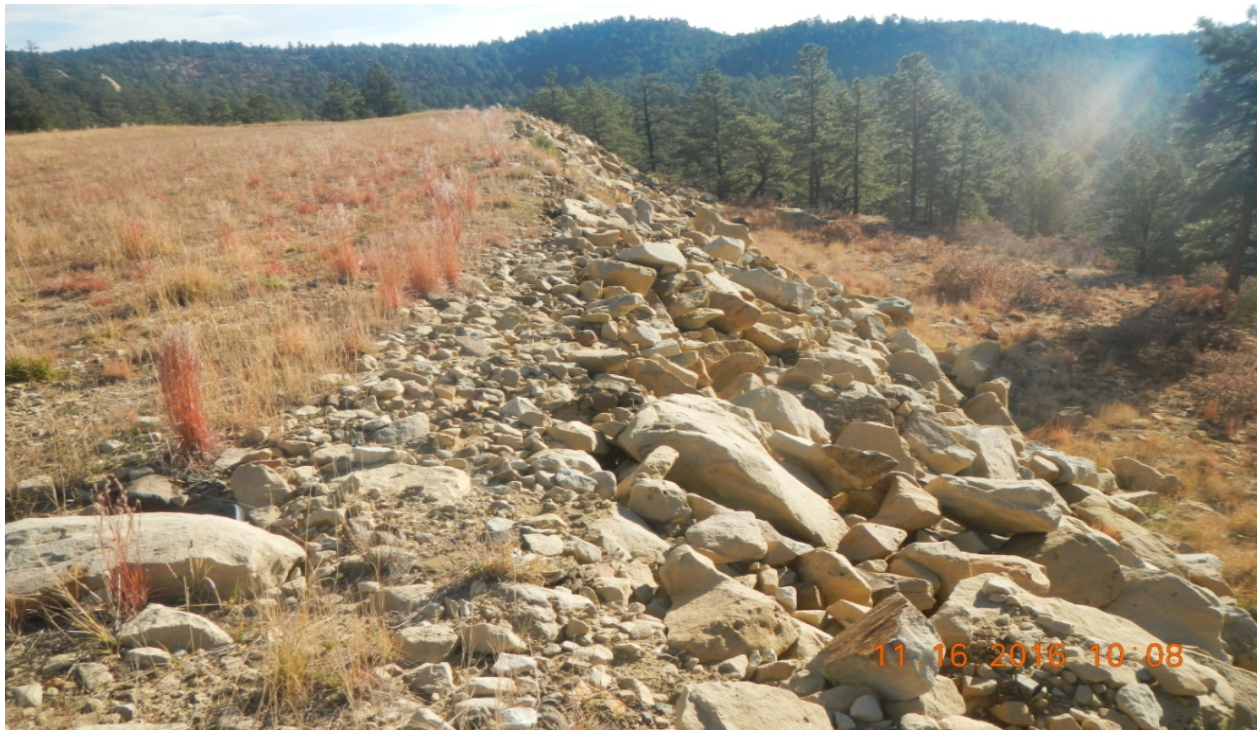
photo 11: West side of the location facing east toward the rocky fill slope.

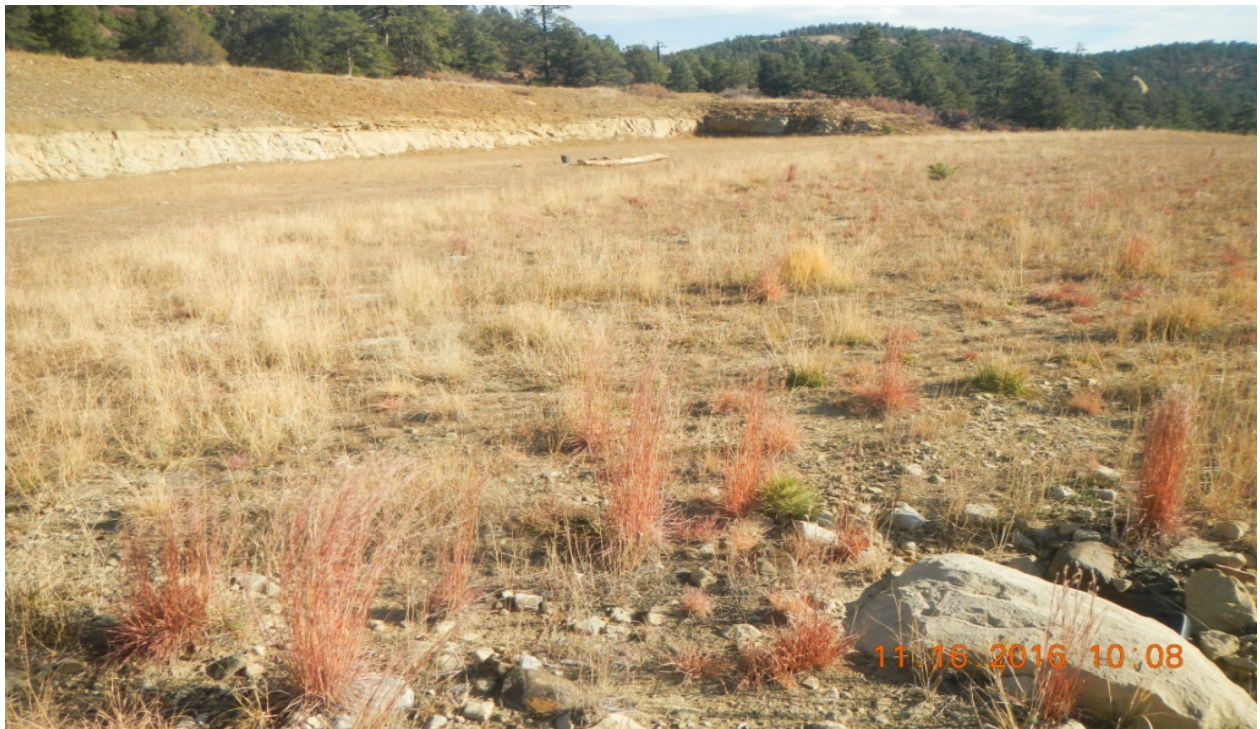
photo 12: East side of the location facing northeast.

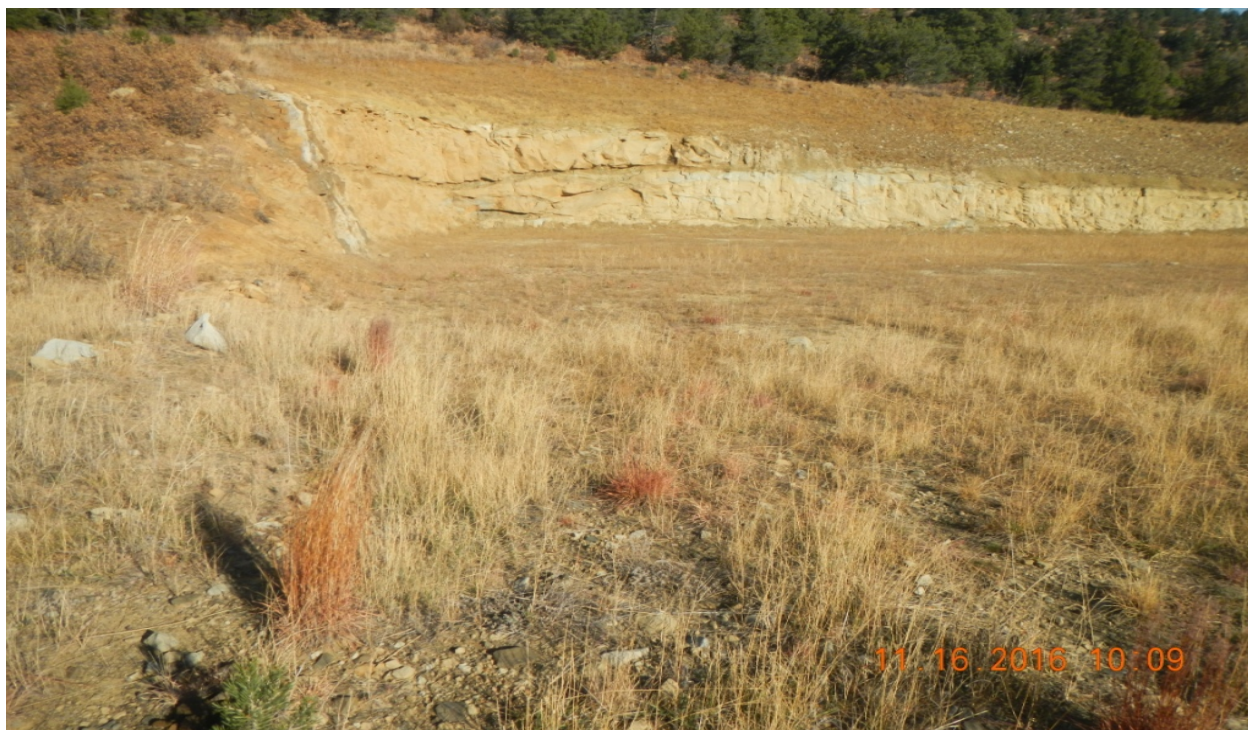
photo 13: East side of the location facing north toward the cut slope.

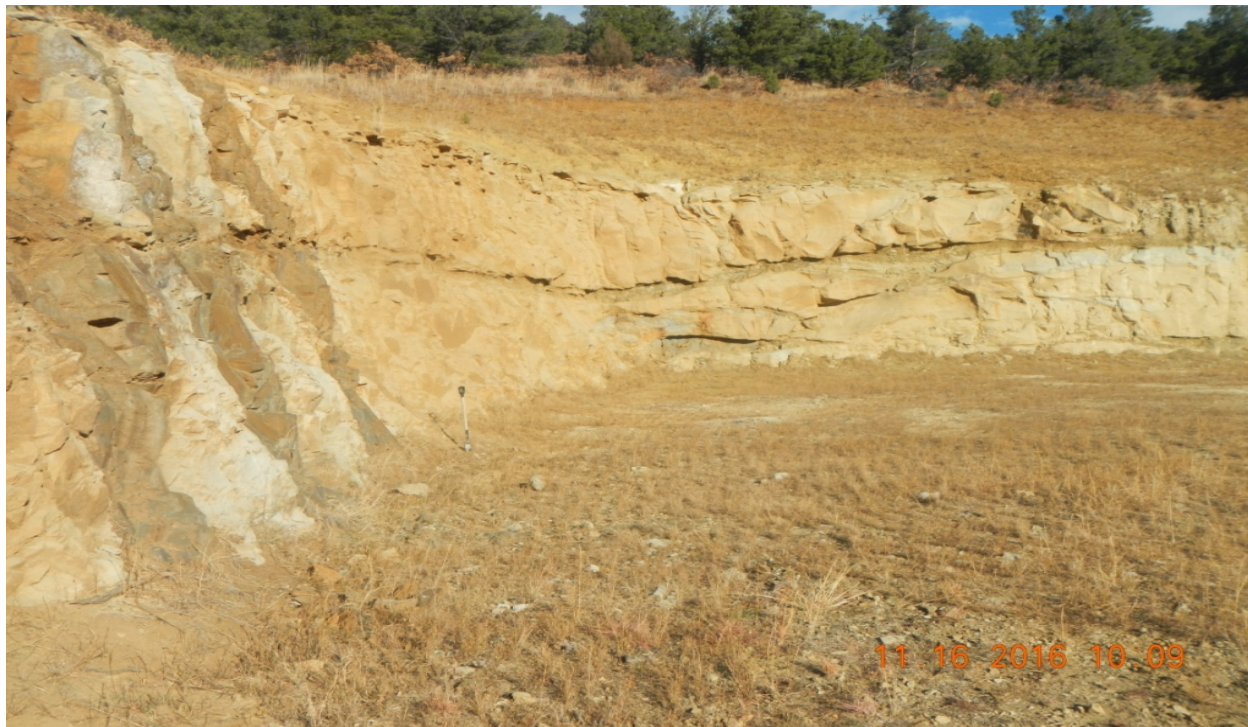
photo 14: Facing toward the rock cut slope at the northwest side of the location.

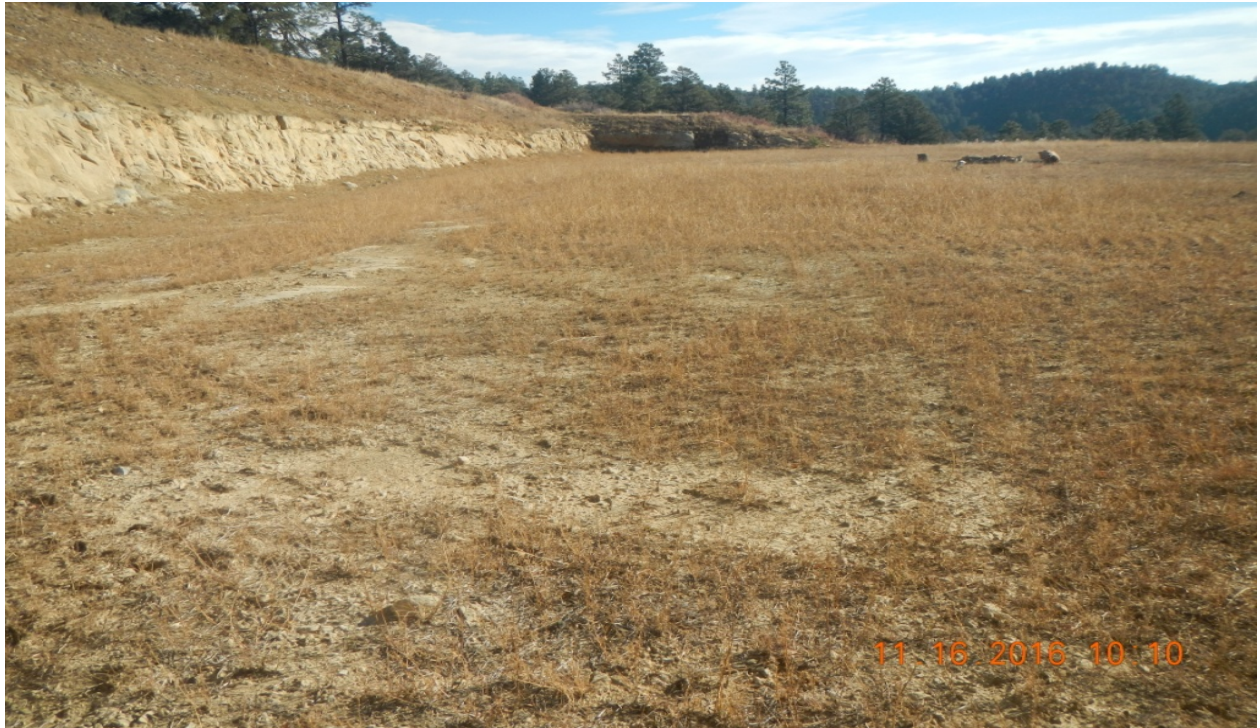
photo 15: West side of the location facing east.

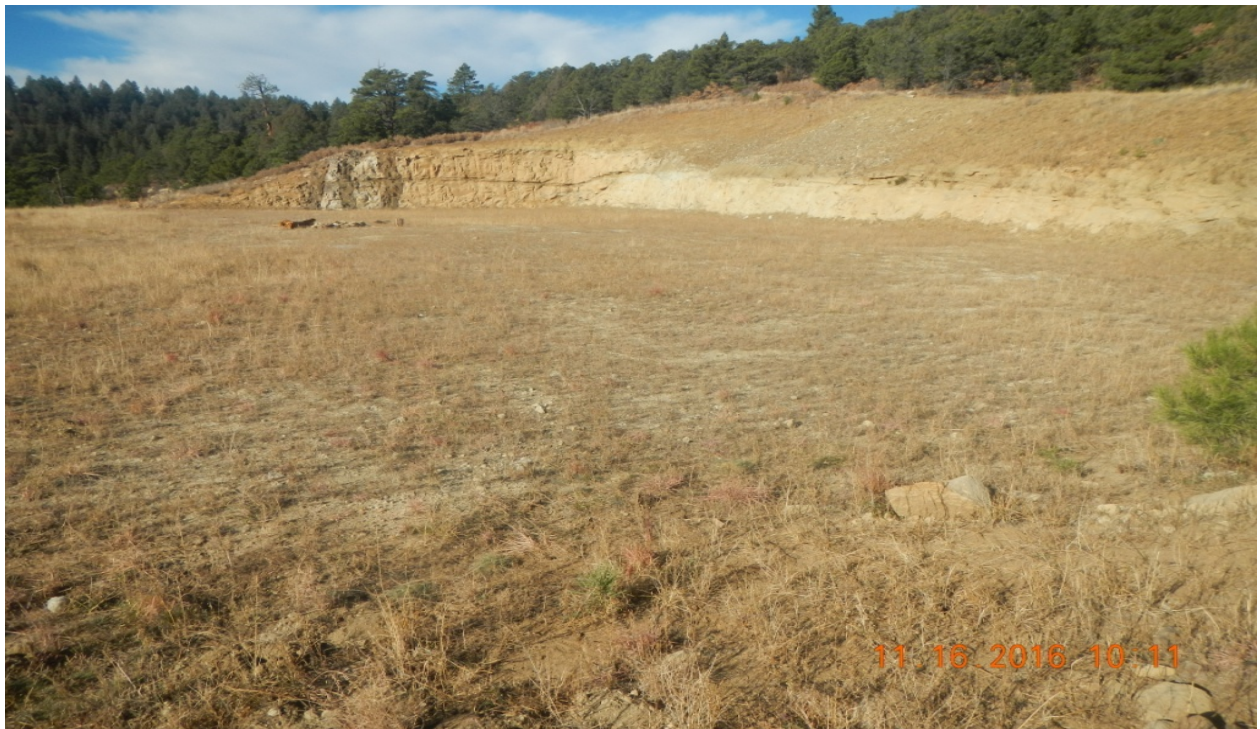
photo 16: East side of the location facing west.
