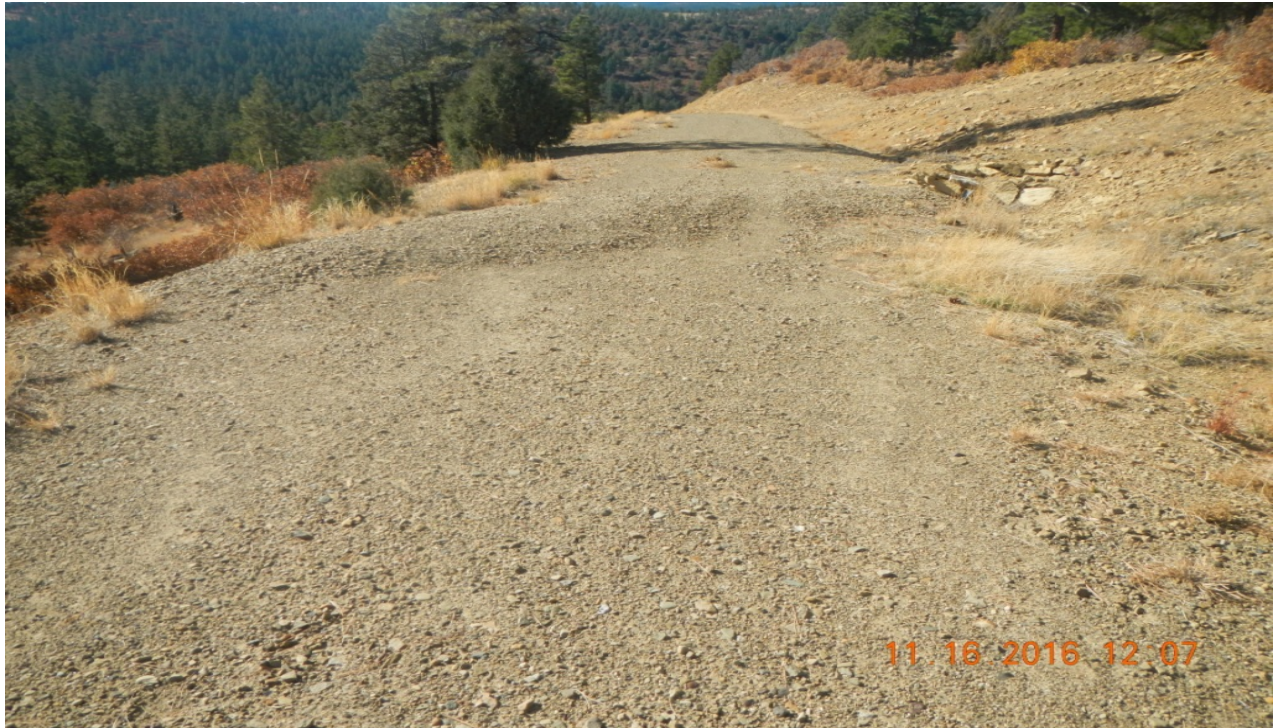
**photo 1:** Facing west along the access road.

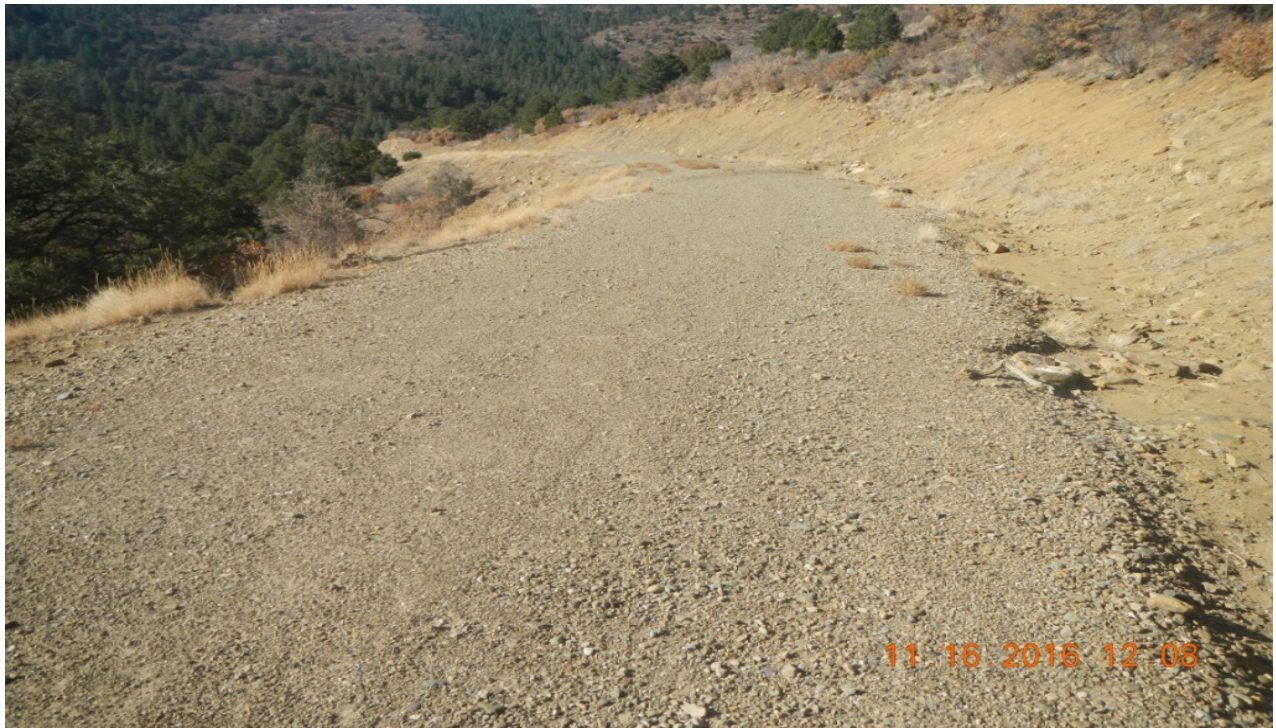
**photo 2:** Facing west along the access road.

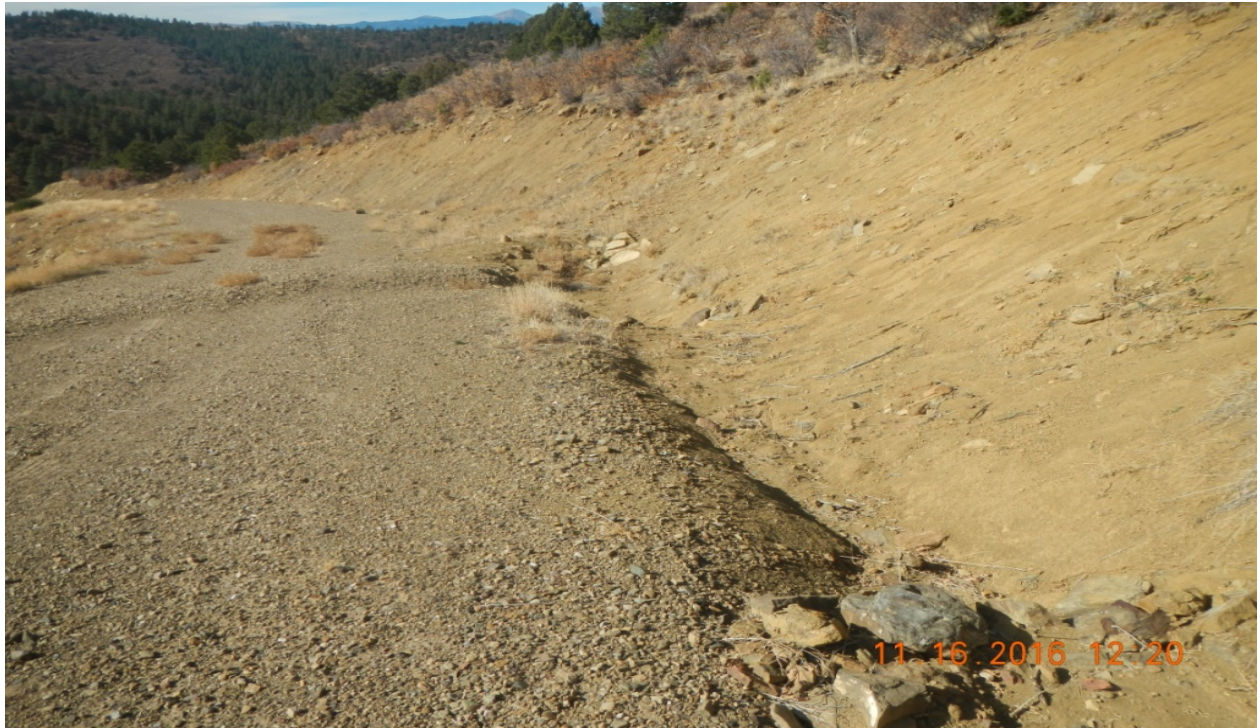
**photo 3:** The cut slope of the access road does not have much vegetation establishment for stabilization.

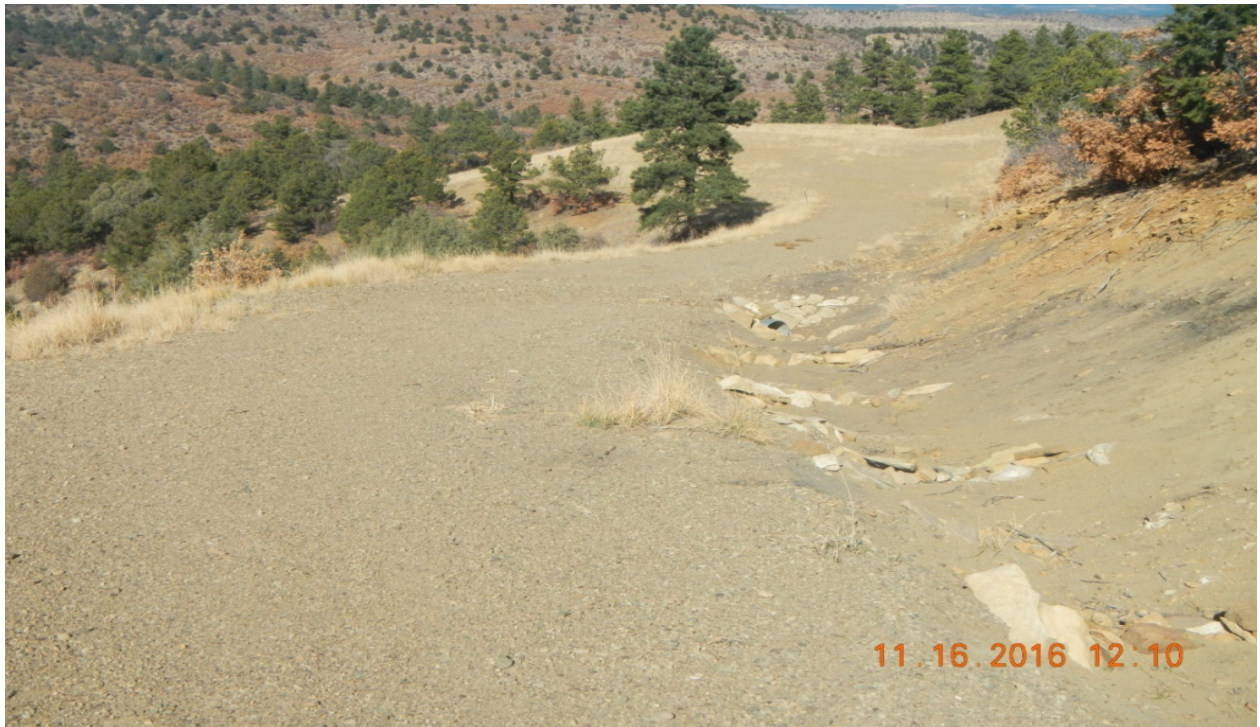
**photo 4:** Facing north toward the location along the access road.

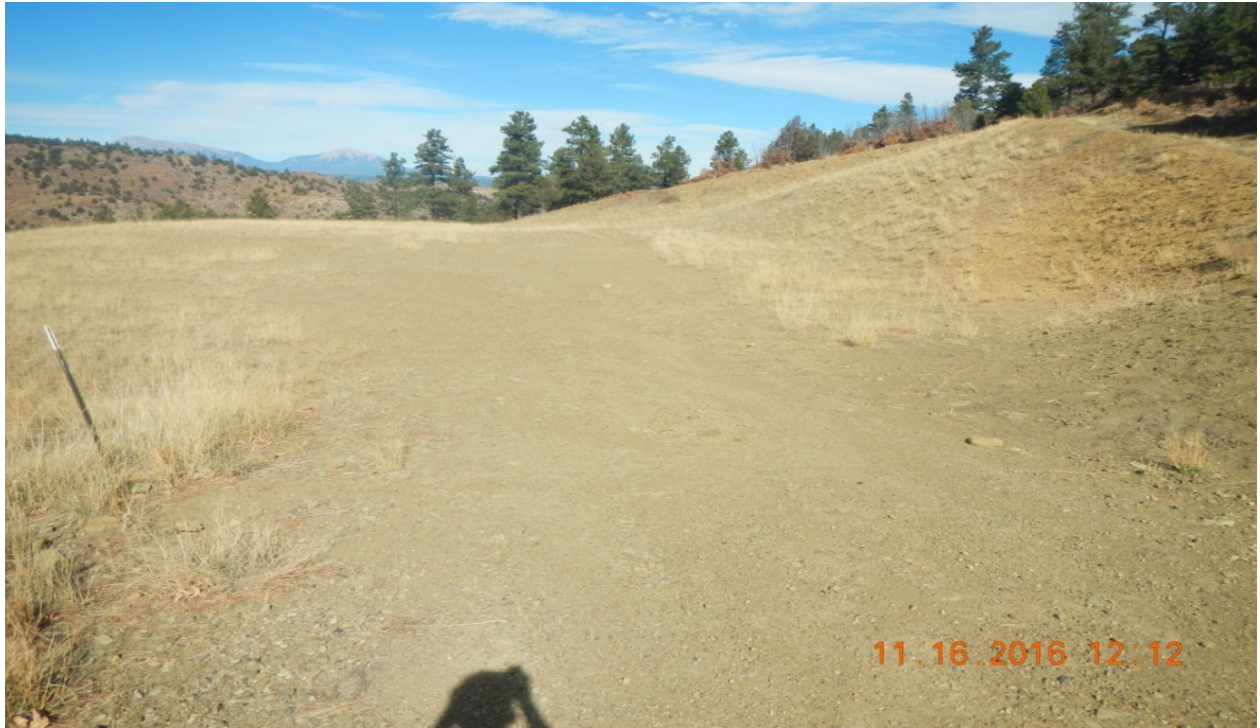
**photo 5:** Facing north toward the location.

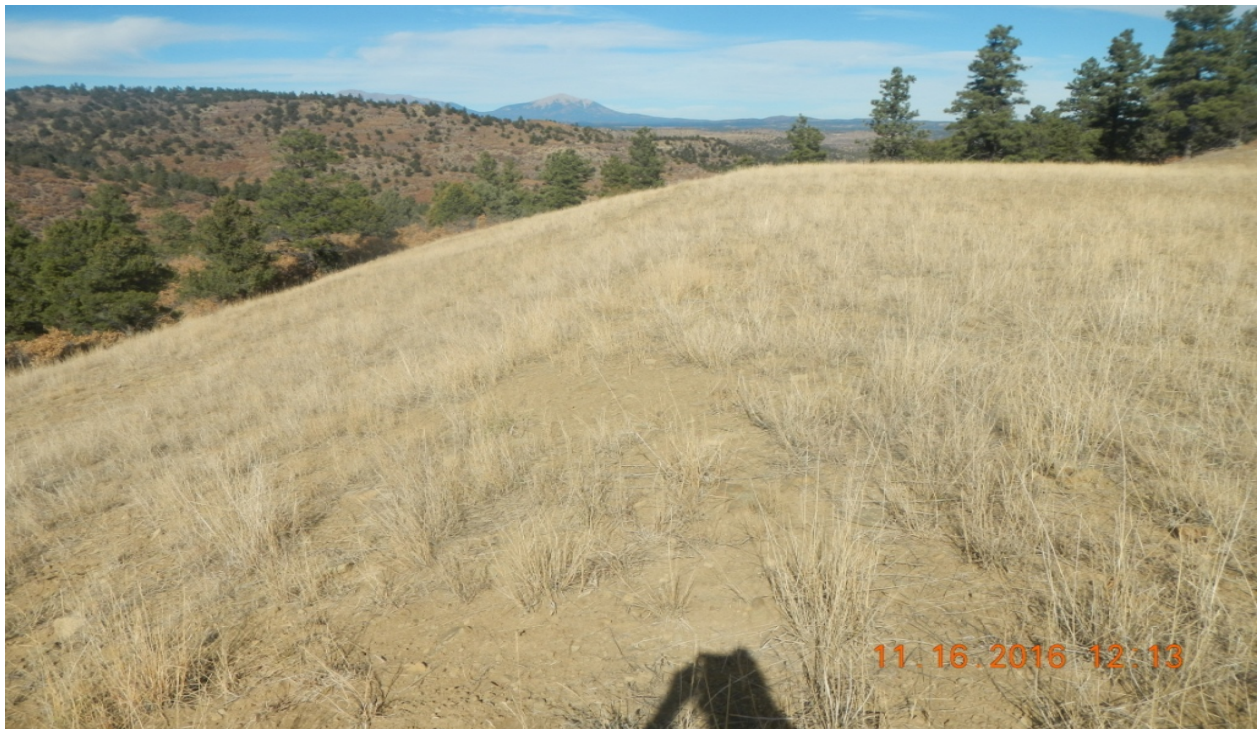
**photo 6:** Facing north along the west fill slope of the location.

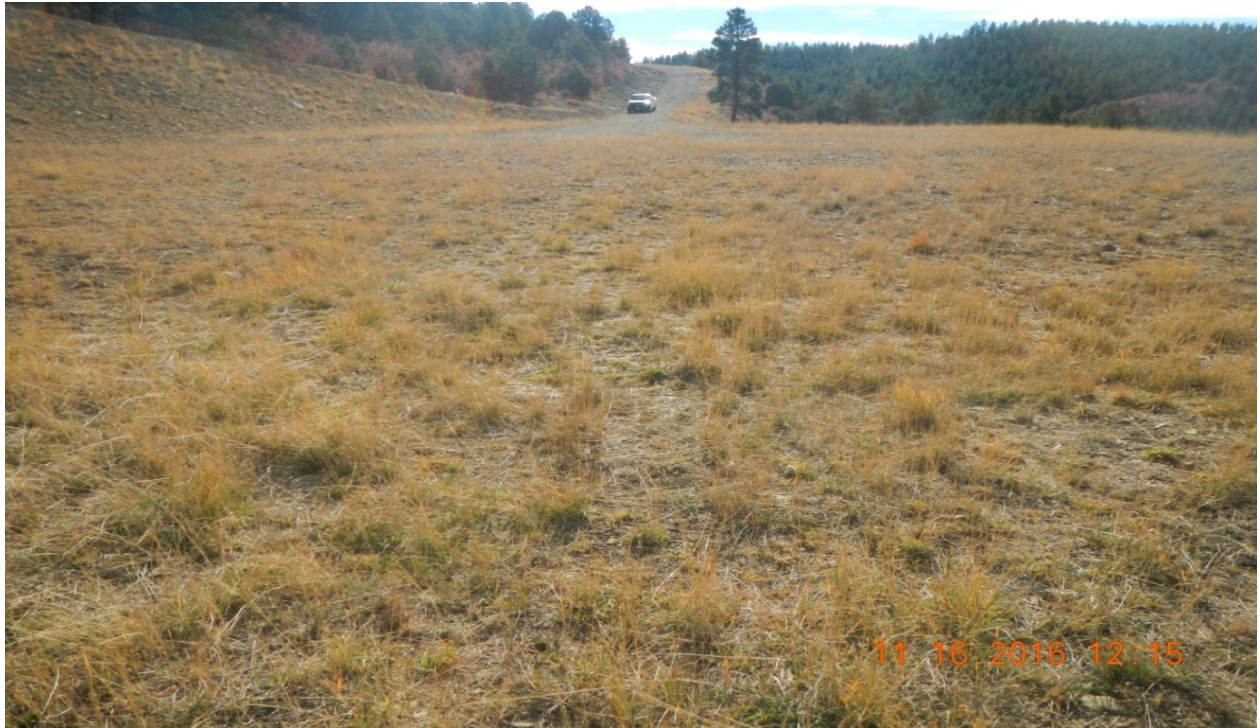
**photo 7:** Facing south toward the location.

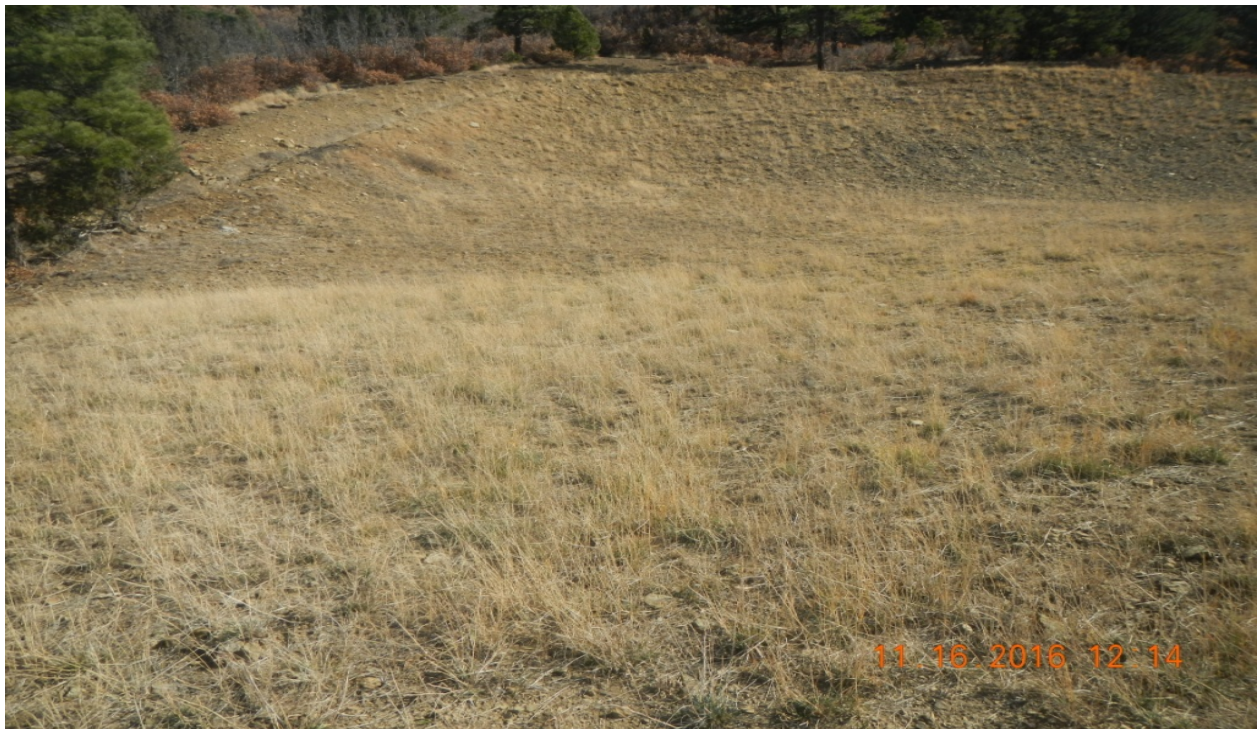
**photo 8:** Facing east toward the cut slope side of the location.

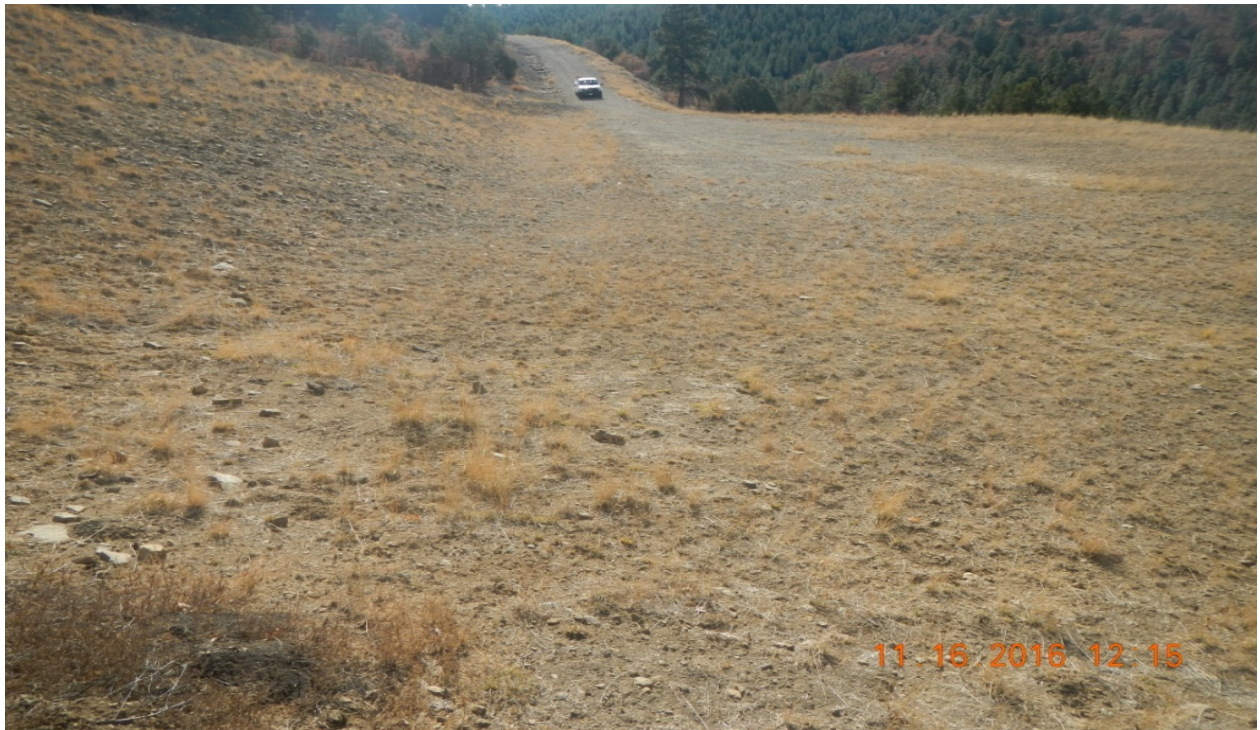
**photo 9:** Facing south toward the location.

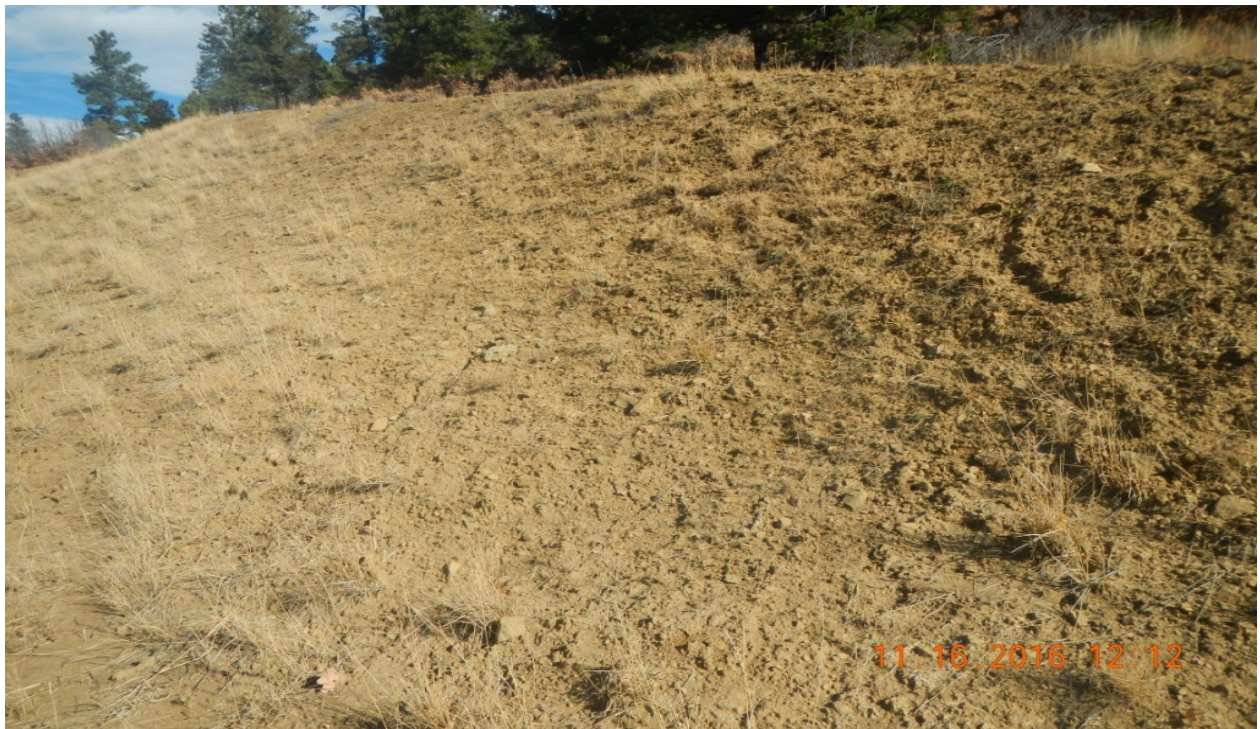
**photo 10:** The vegetation along areas of the cut slope does not appear to be adequately established.
