# Construction and Stormwater Inspection

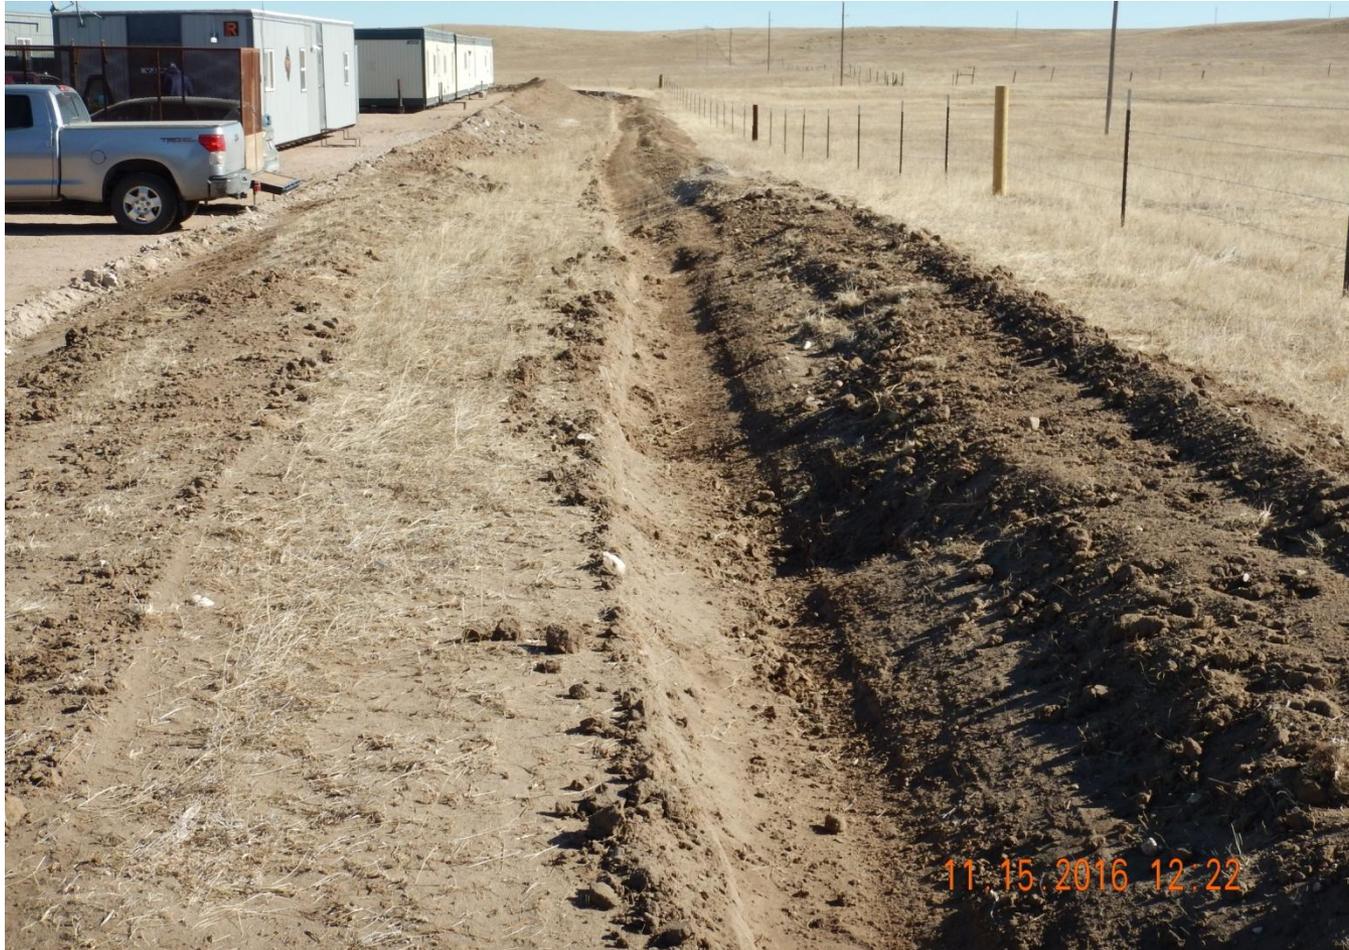
**Photo 1.** Photo taken from the southern location , facing East. Ditch and berm BMP installed around the location perimeter.

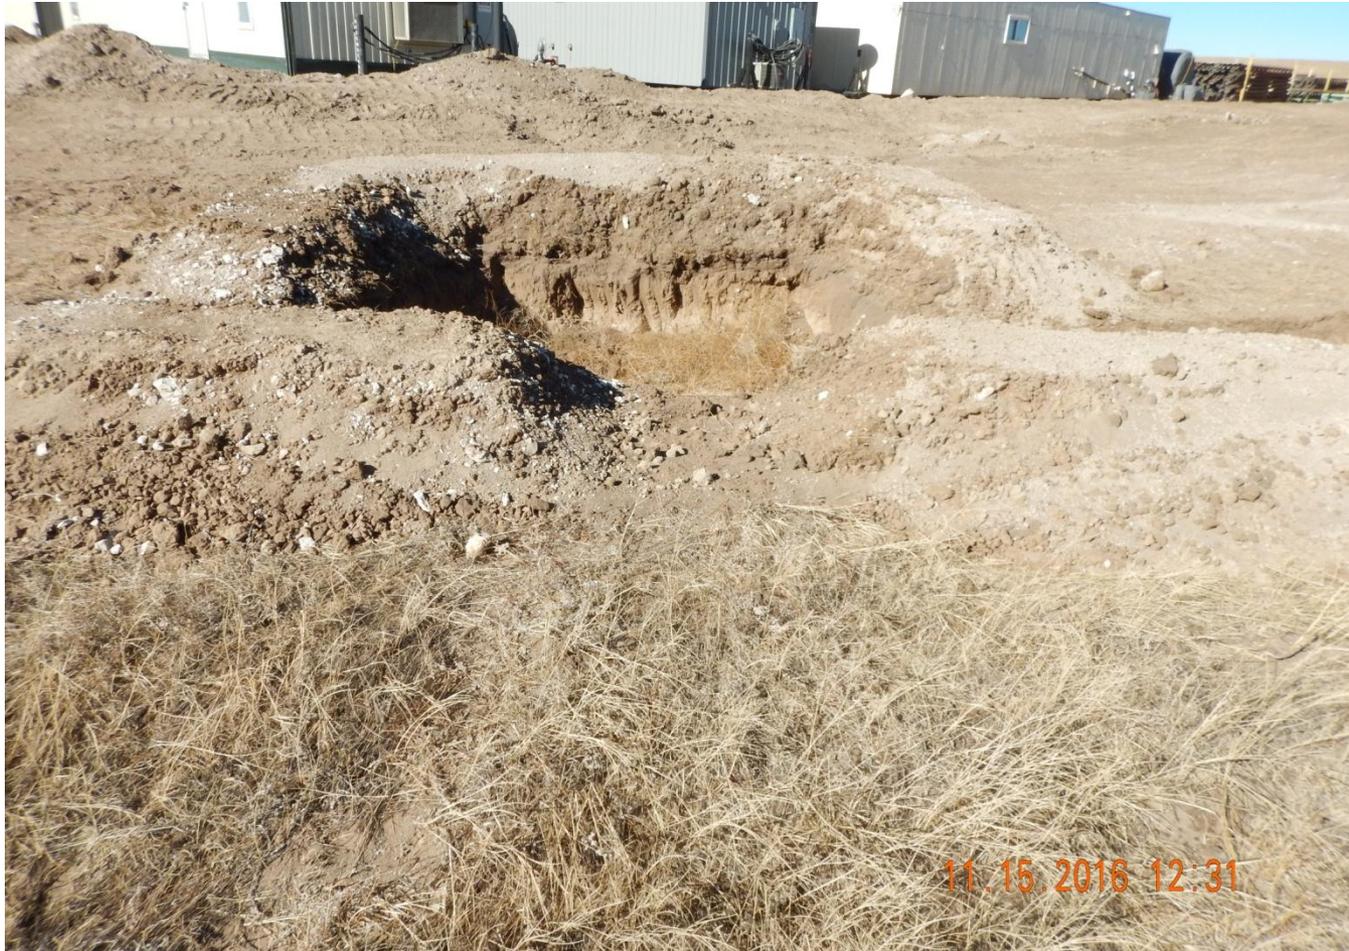
**Photo 2.** Photo taken from the southeastern location, facing West, towards the sediment trap. Sediment trap side slopes should not be steeper than 2:1 and the outlet should be stabilized (e.g., geotextile with rip rap on top).

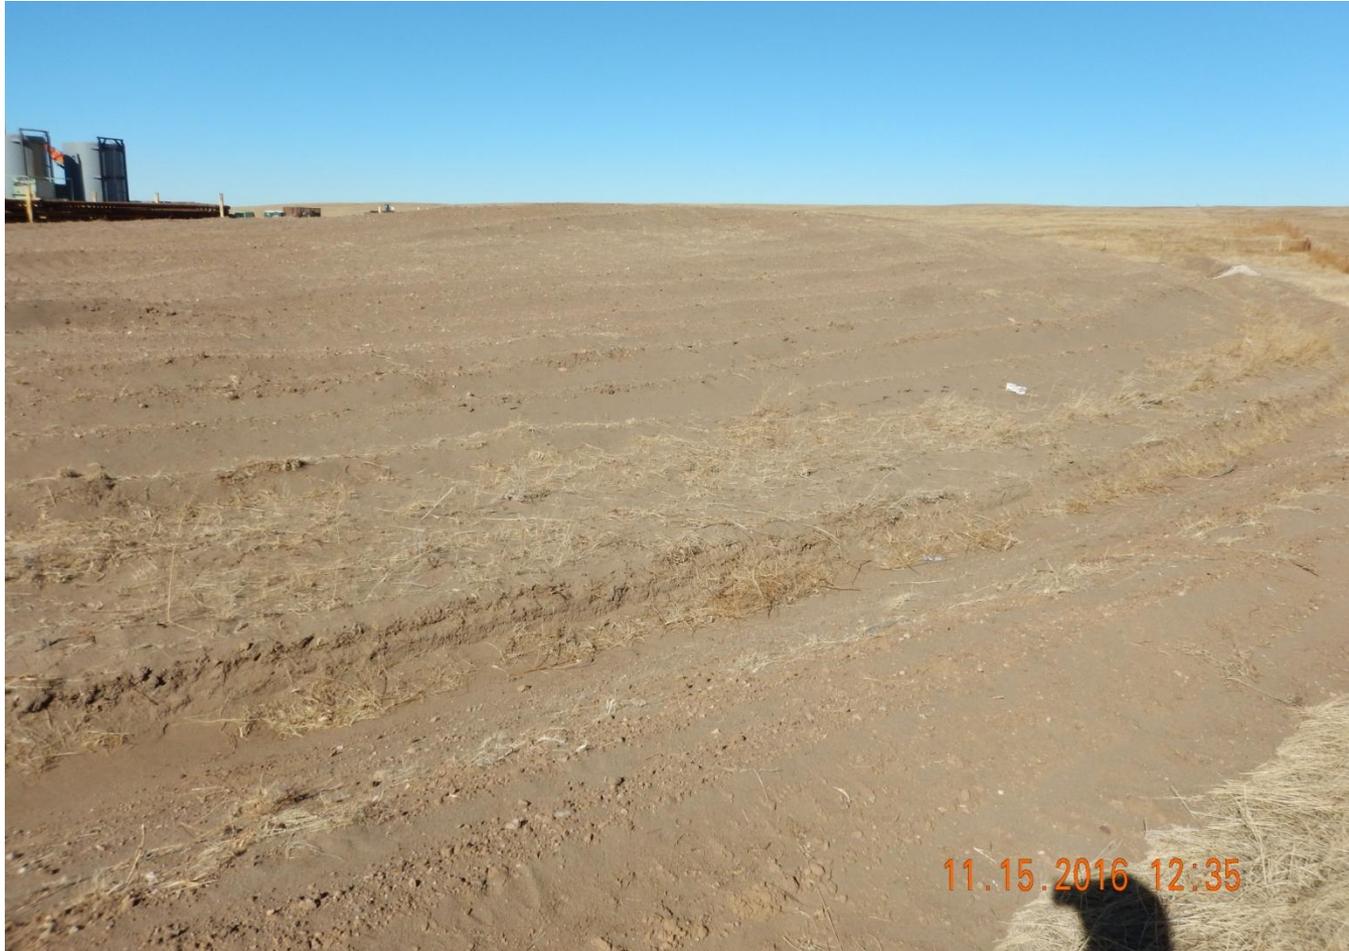
**Photo 3.** Photo taken from the eastern location, facing West, towards the topsoil stockpile. Topsoil needs to be stabilized and protected from degradation due to wind and water erosion.

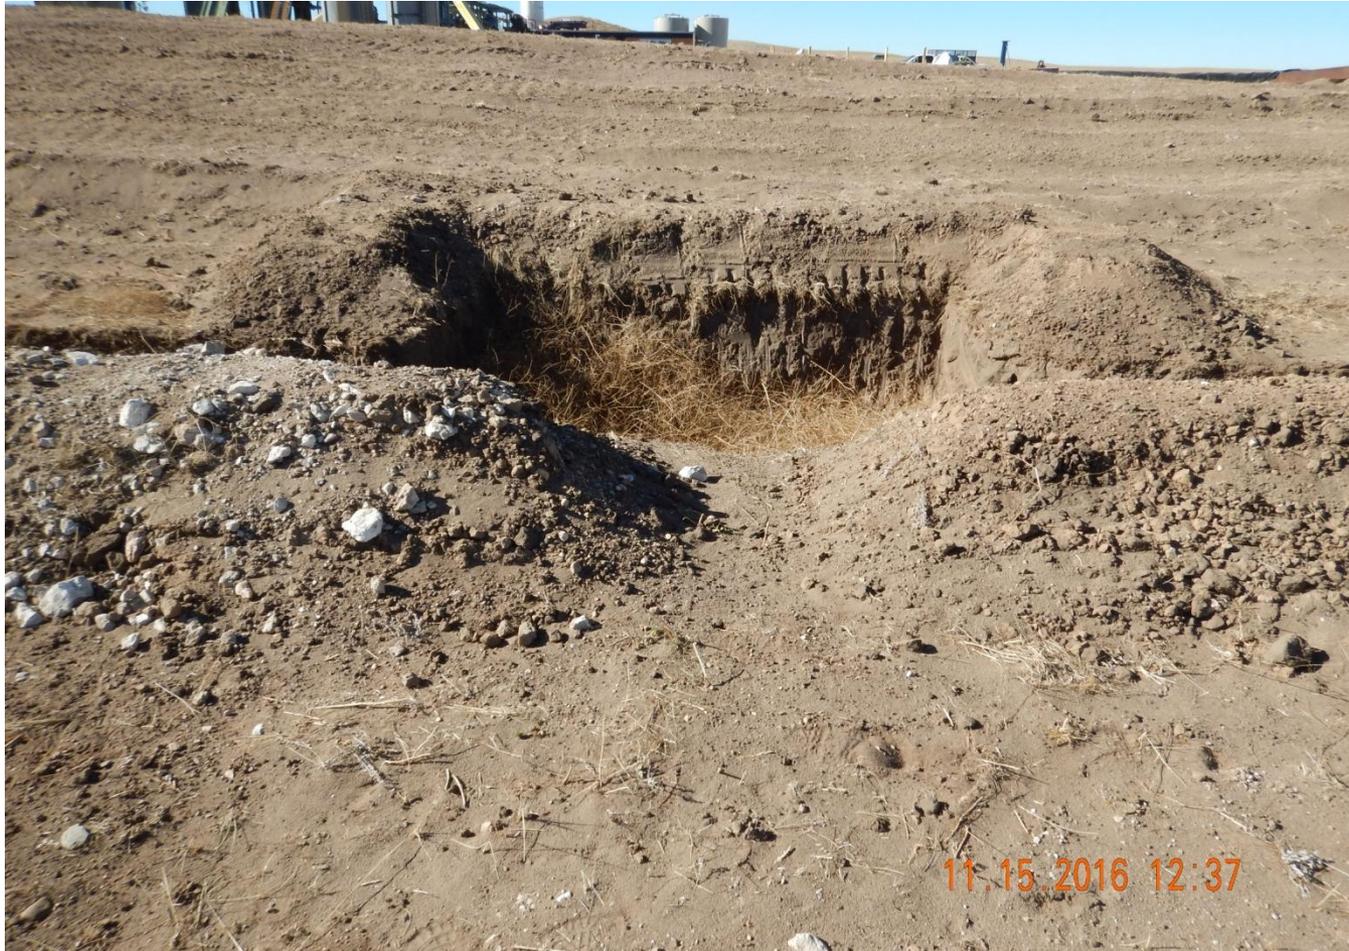
**Photo 4.** Photo taken from the northeastern location, facing West, towards the sediment trap. Sediment trap side slopes should not be steeper than 2:1 and the outlet should be stabilized (e.g., geotextile with rip rap on top). May need to consider where to locate sediment trap in the future because the topsoil stockpile material is almost coming over the west-berm of the sediment trap.

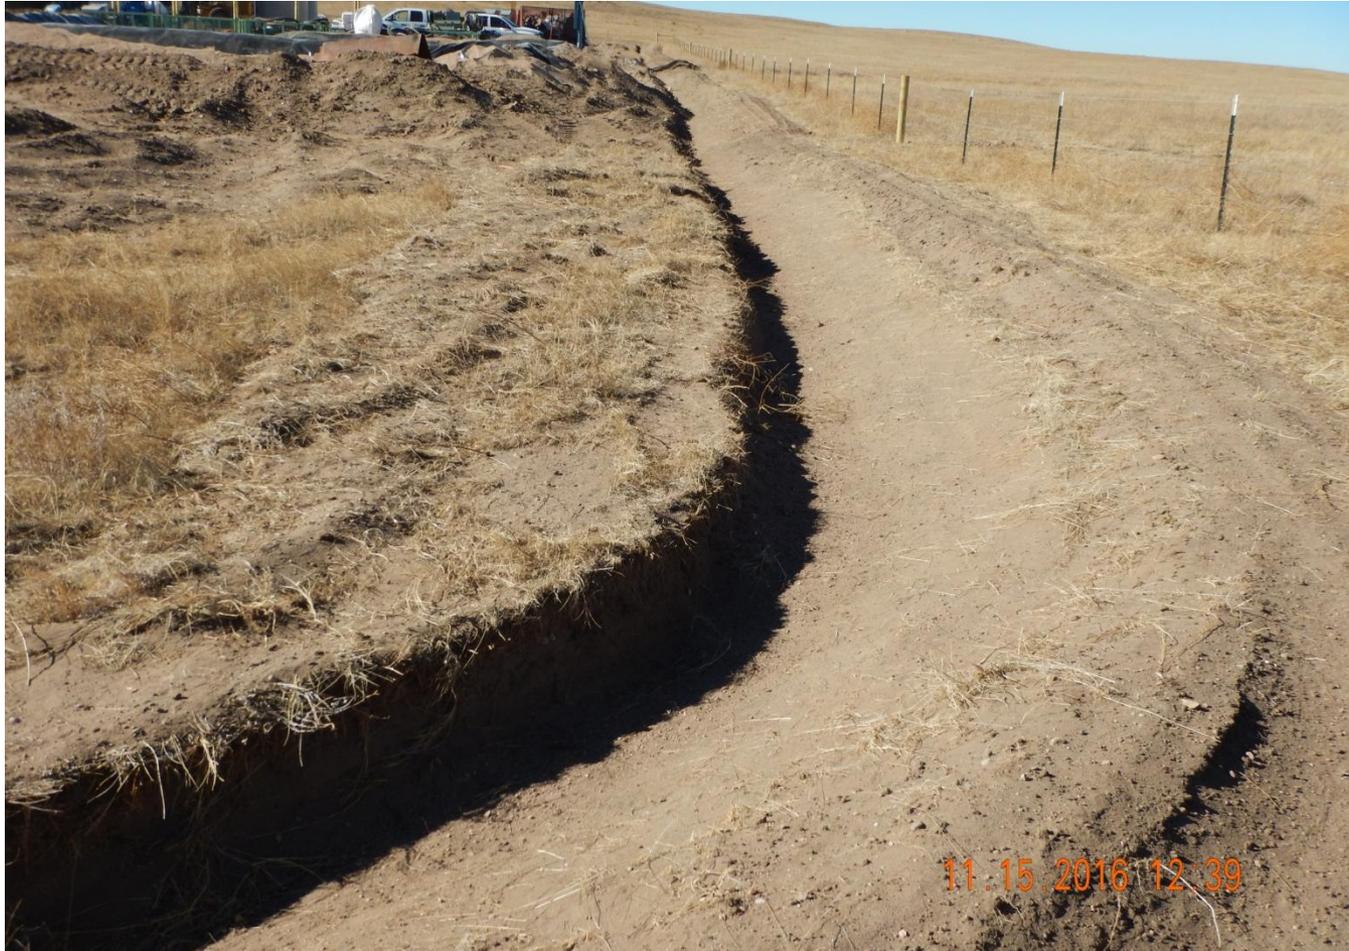
**Photo 5.** Photo taken from the northeast location , facing West. Ditch and berm BMP installed around the location perimeter. Ditch should be constructed with a 2:1 slope on both sides.

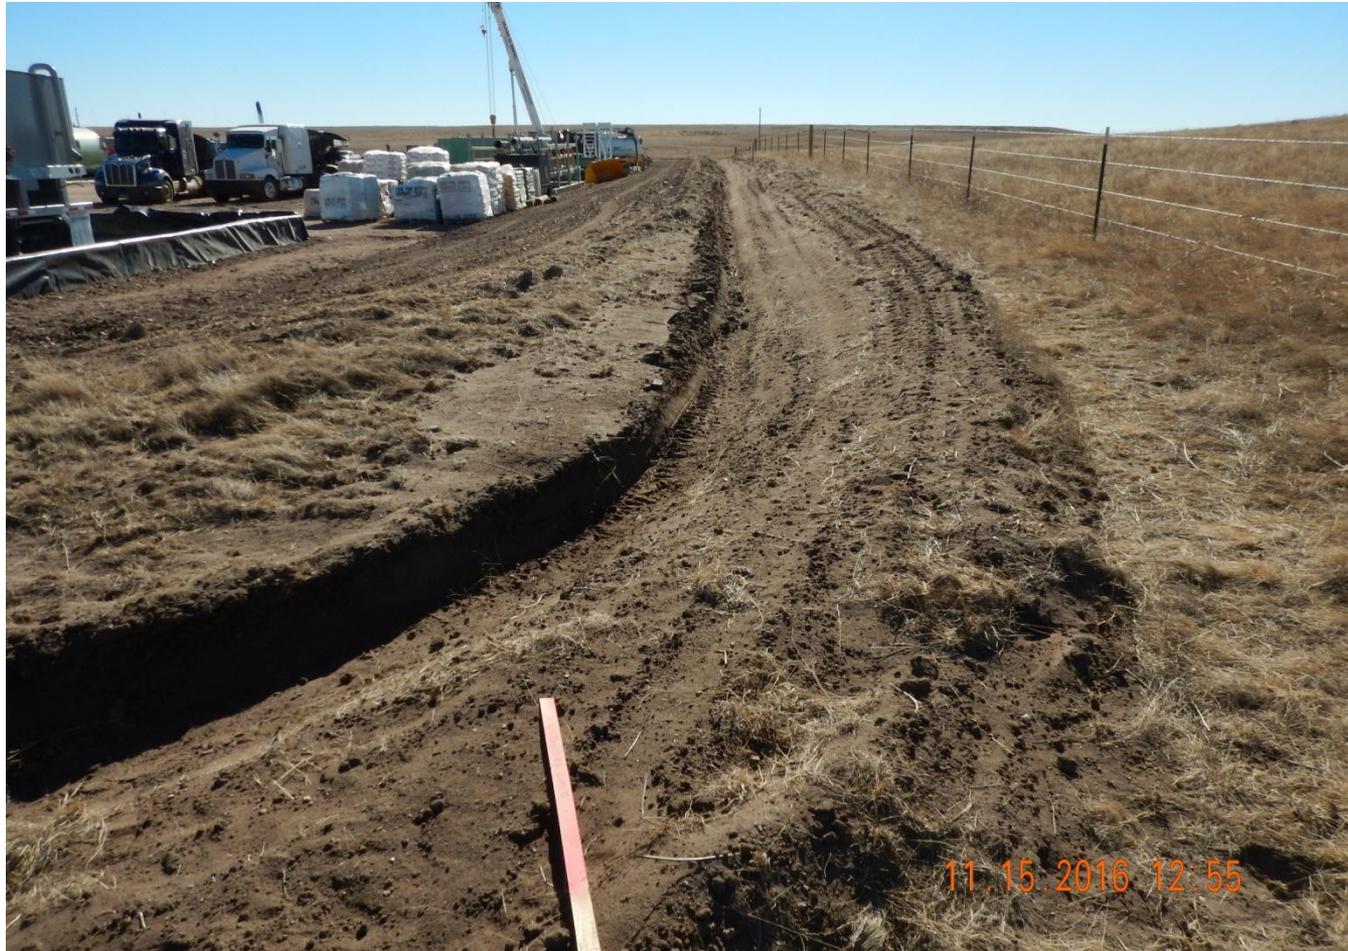
**Photo 6.** Photo taken from the northwest location , facing South. Ditch and berm BMP installed around the location perimeter. Ditch should be constructed with a 2:1 slope on both sides.
