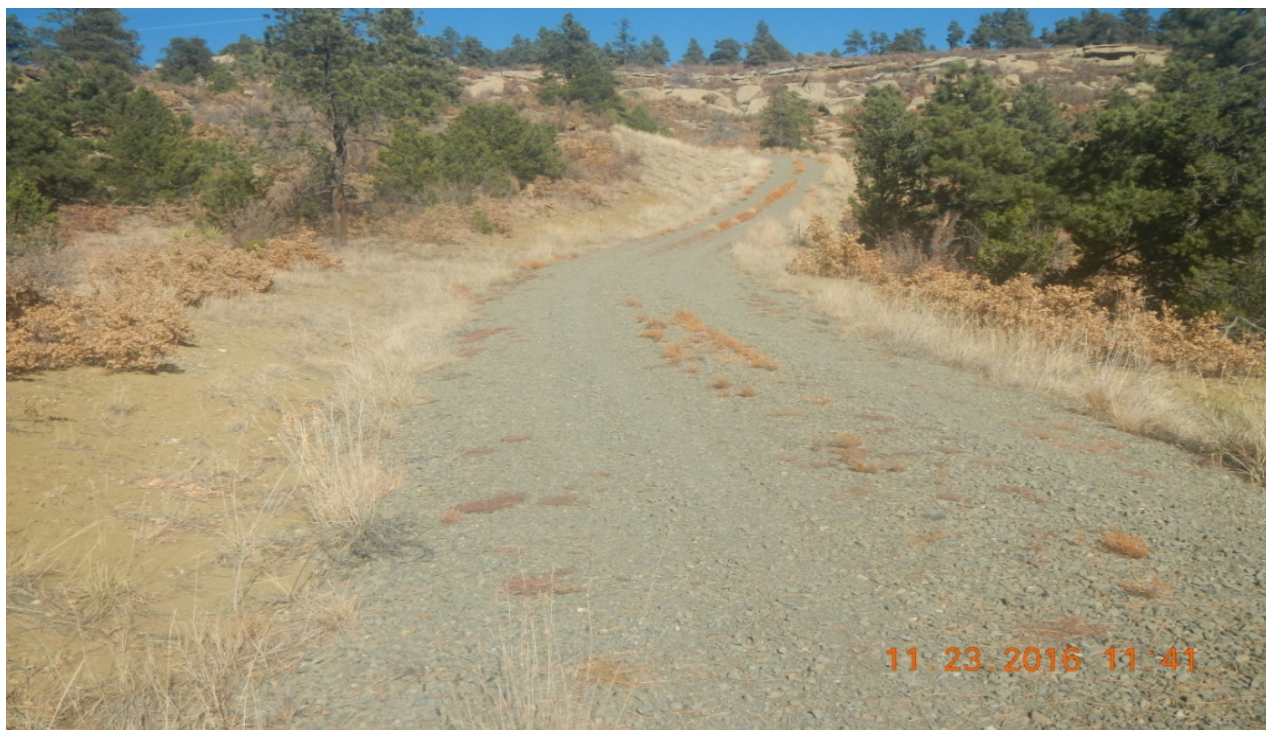
**photo 1:** Facing north along the access road.

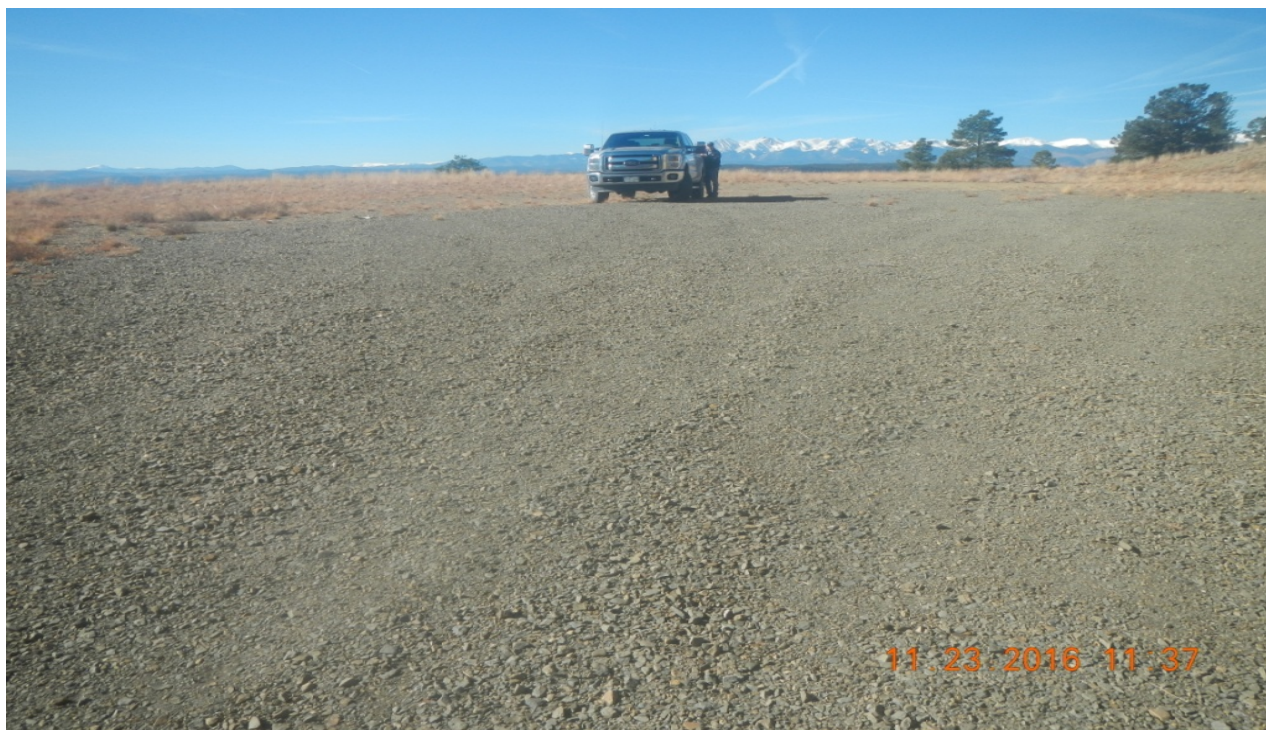
**photo 2:** Facing west toward the location.

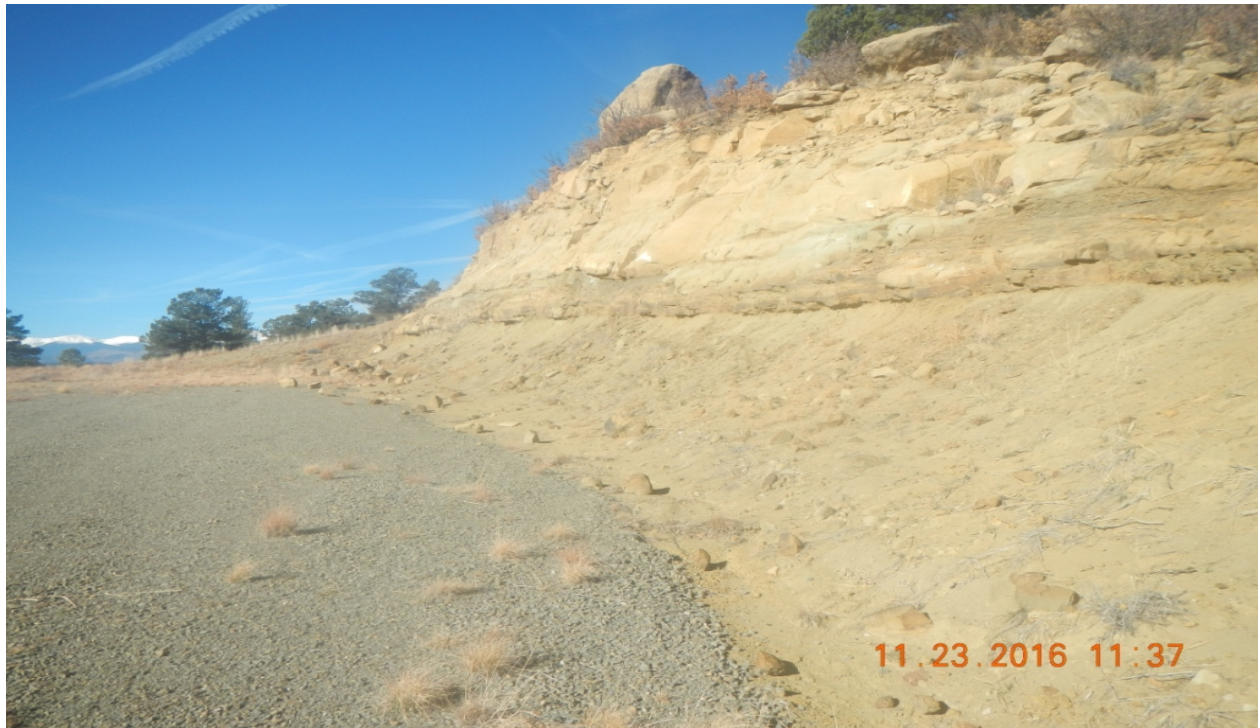
**photo 3:** Facing west along the north cut slope.

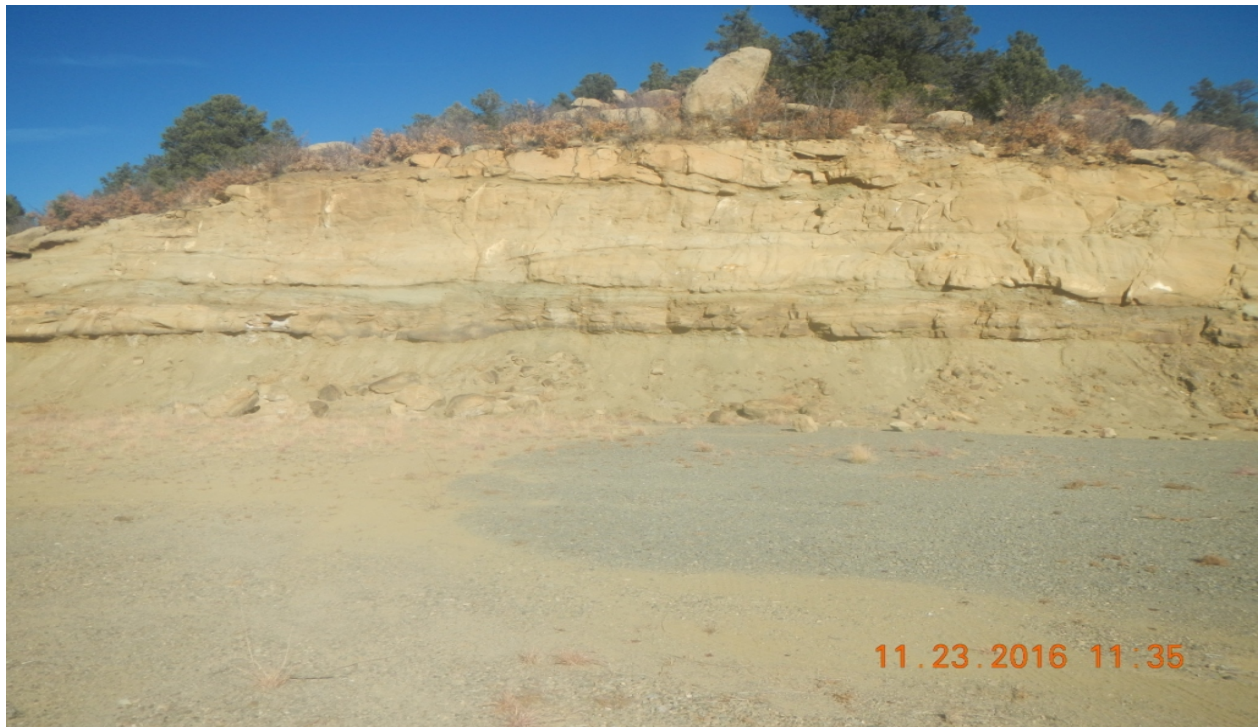
**photo 4:** Center of the location facing toward the north cut slope.

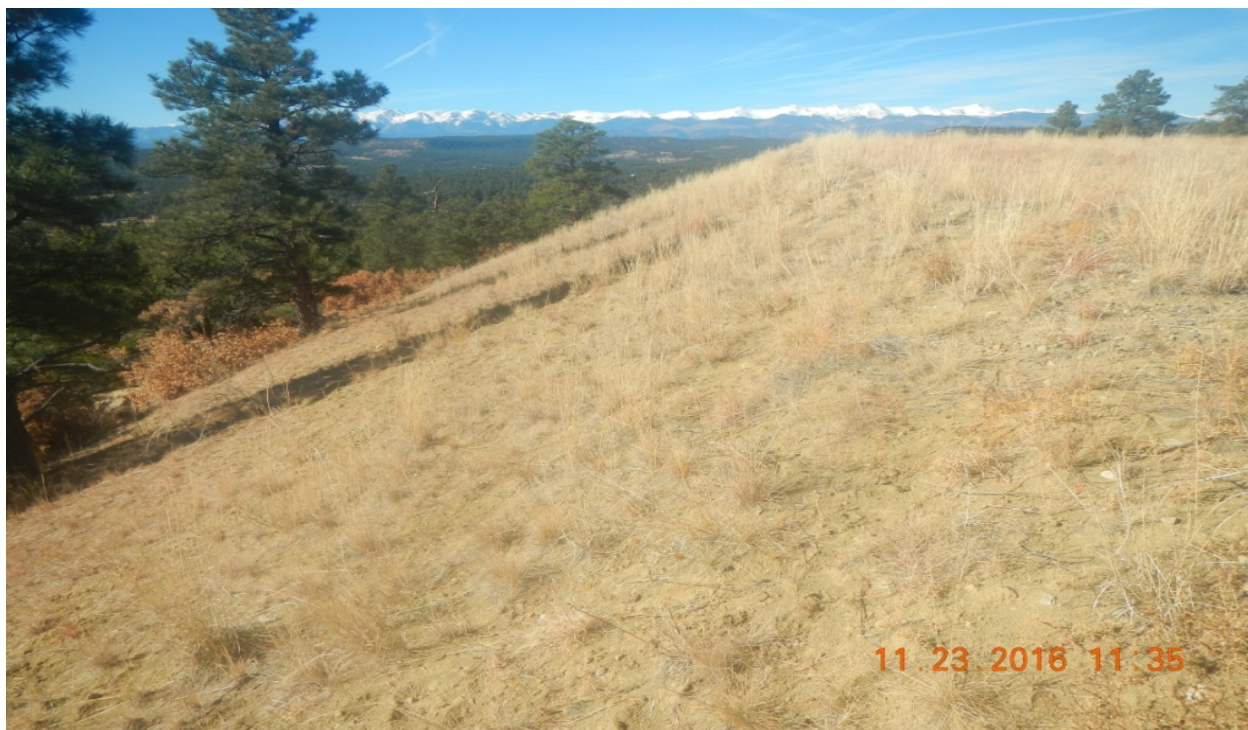
**photo 5:** Facing west along the south fill slope.

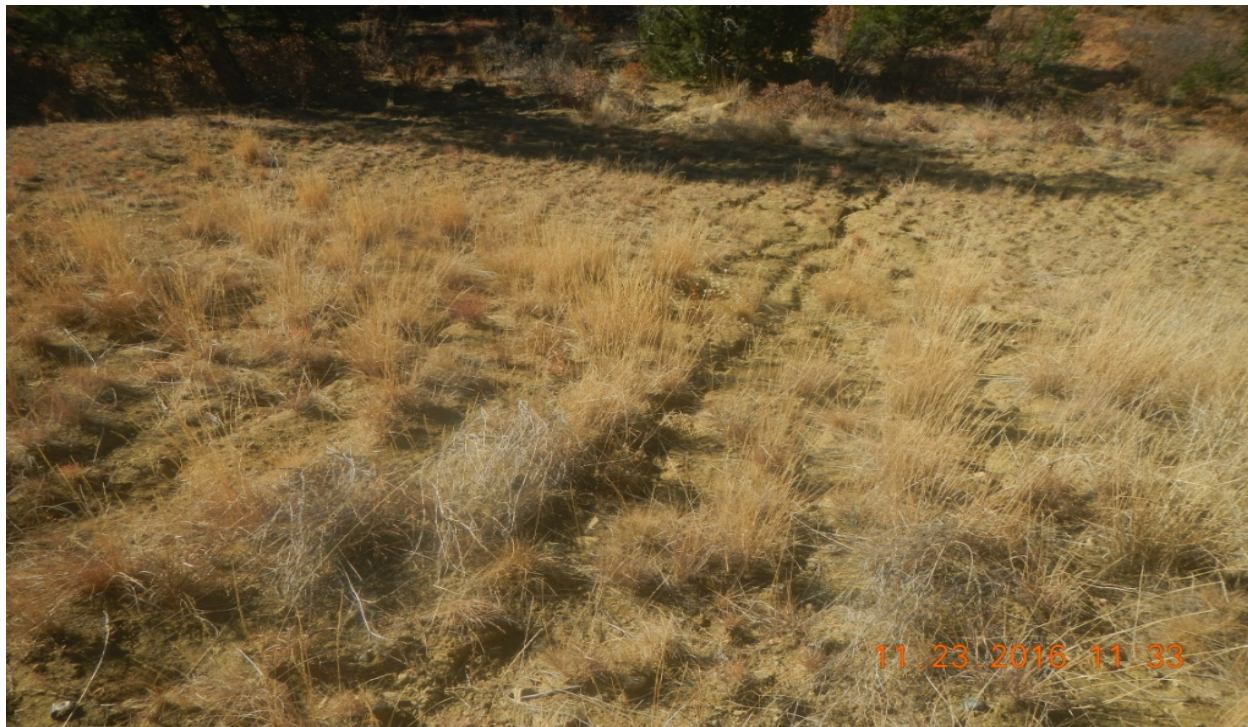
**photo 6:** Facing toward the southwest side of the location. There are signs of minor riling beginning to occur.
