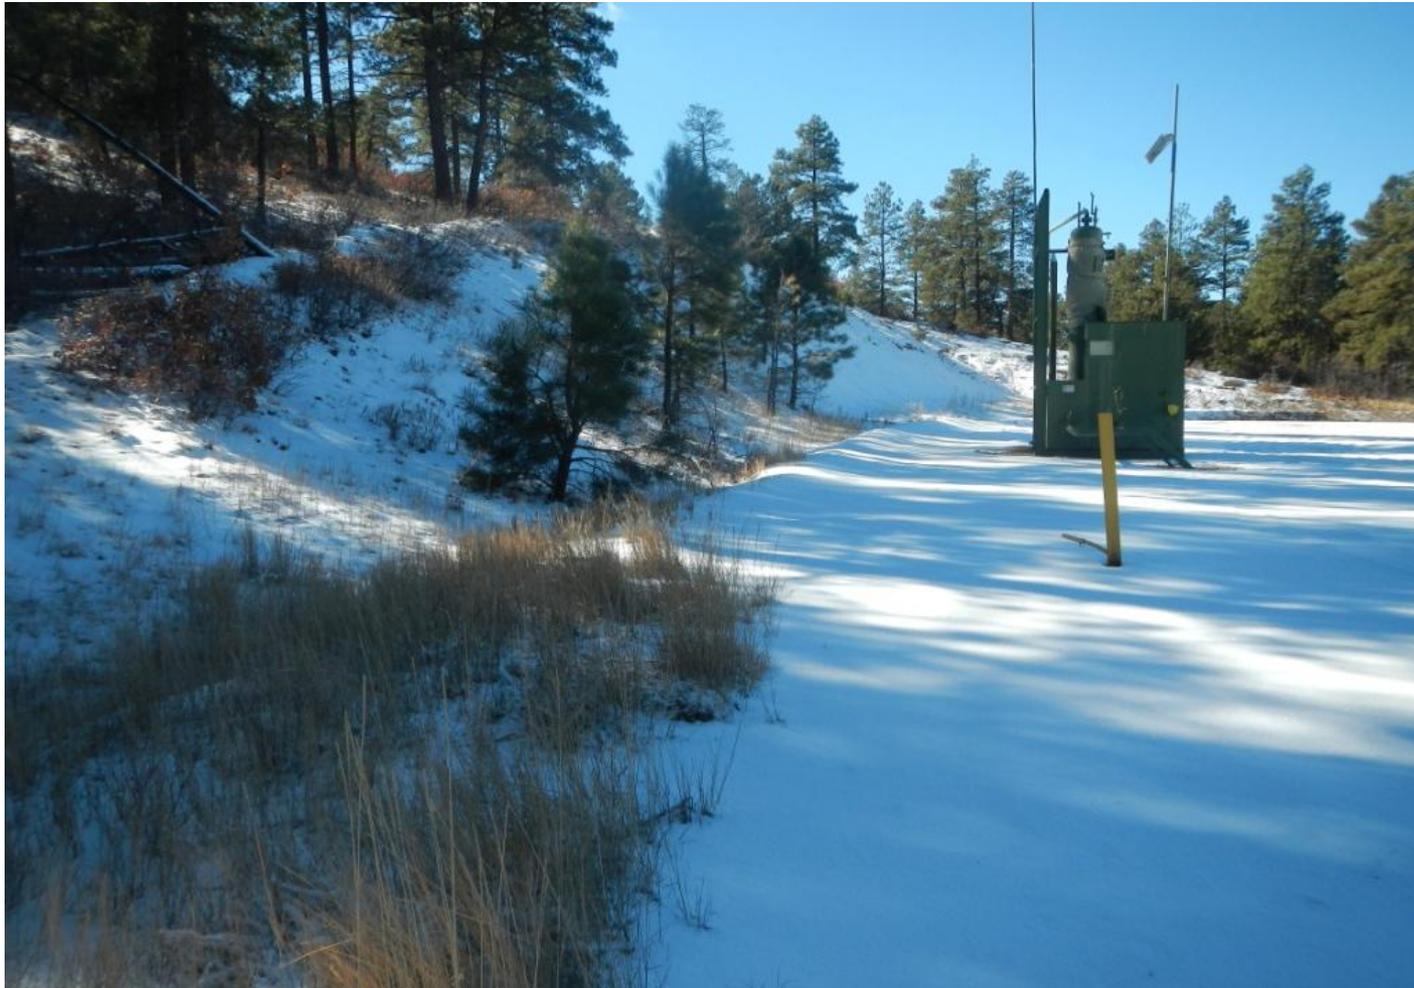
Photo 1. View of the southern portion of the project area from the southeastern corner facing westward. Revegetation is progressing on flatter well pad areas with dropseed (*Sporobolus* sp.) and smooth brome (*Bromus inermis*), western wheatgrass (*Pascopyrum smithii*), ponderosa pine (*Pinus ponderosa*) on cut and fill slopes.

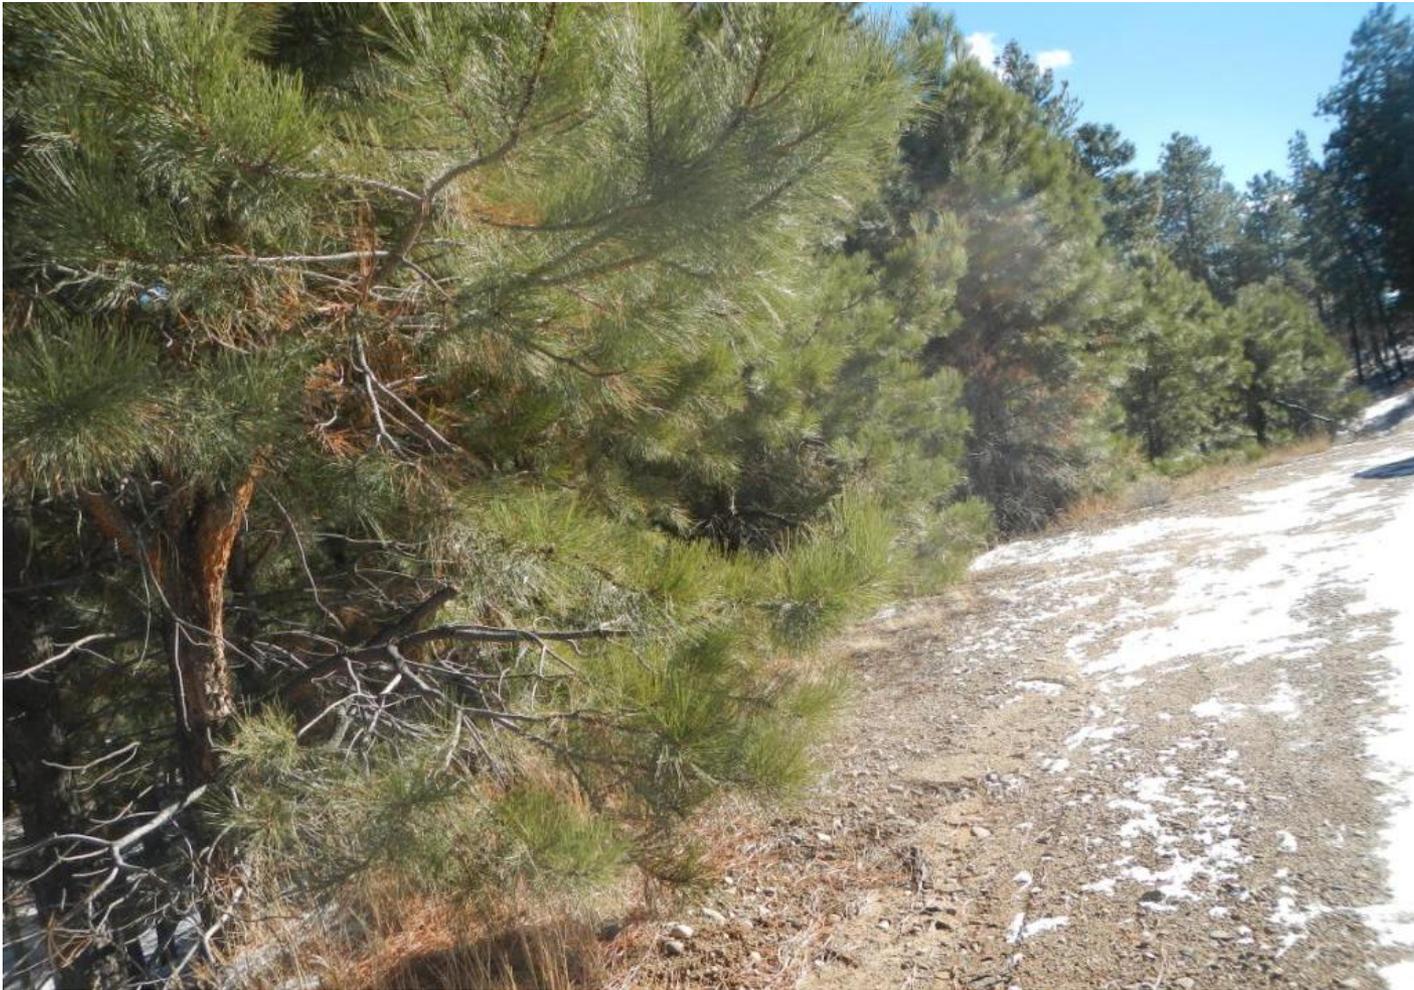
Photo 2. View of the eastern portion of the project area. Fill slopes are revegetating and edge of well pad is lined with a ponderosa pine tree screen.

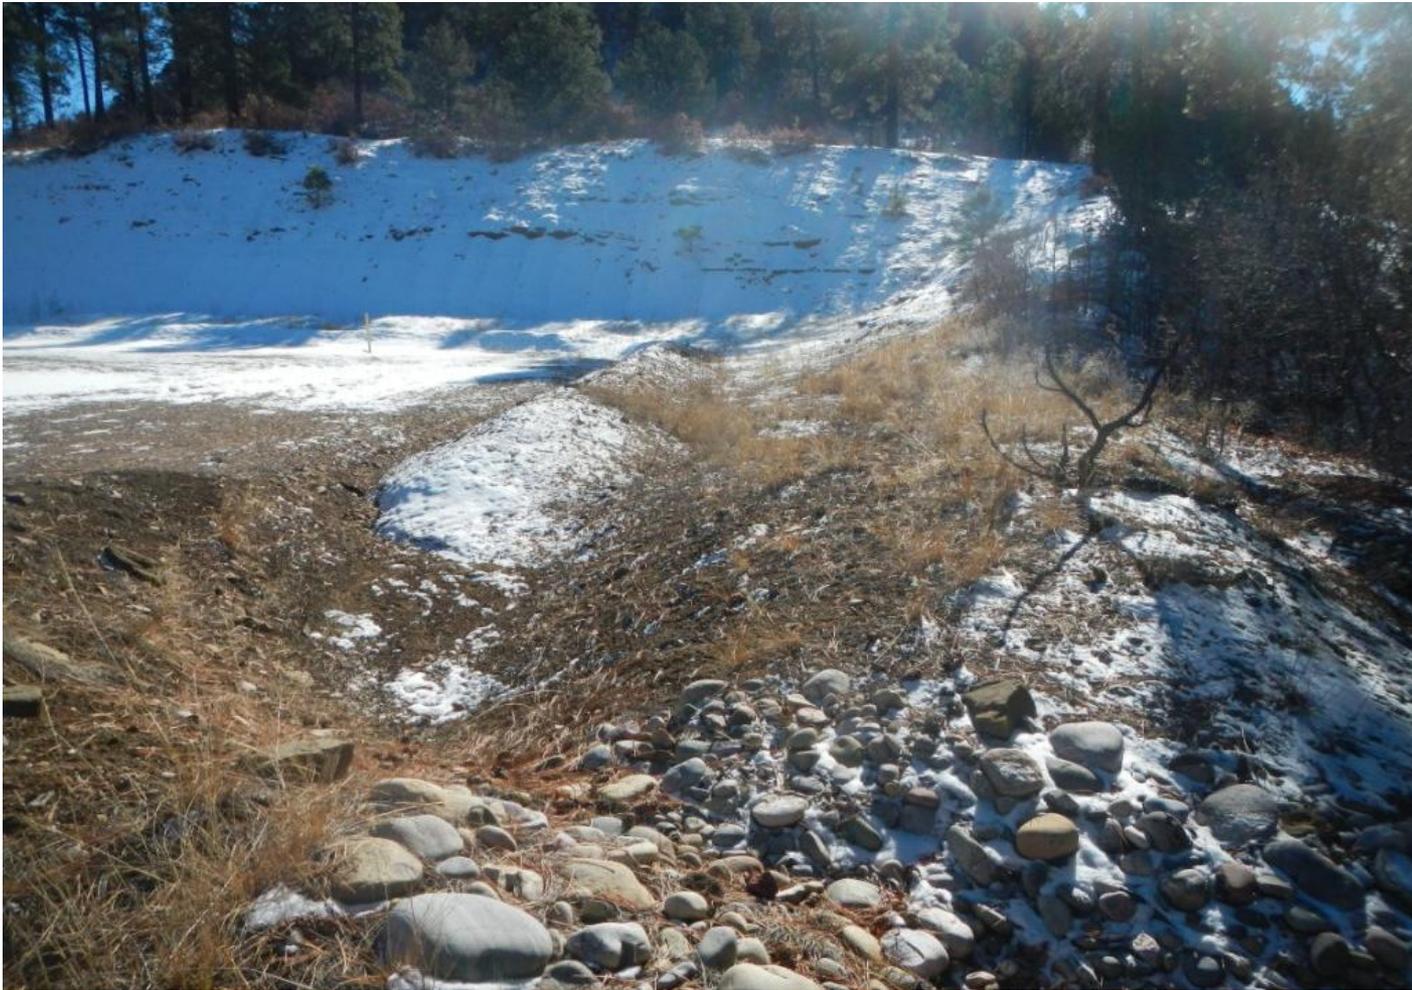
Photo 3. View of the western portion of the project area from the northwestern edge facing southward. Stormwater diversion is in good condition and revegetation is progressing on fill slopes.

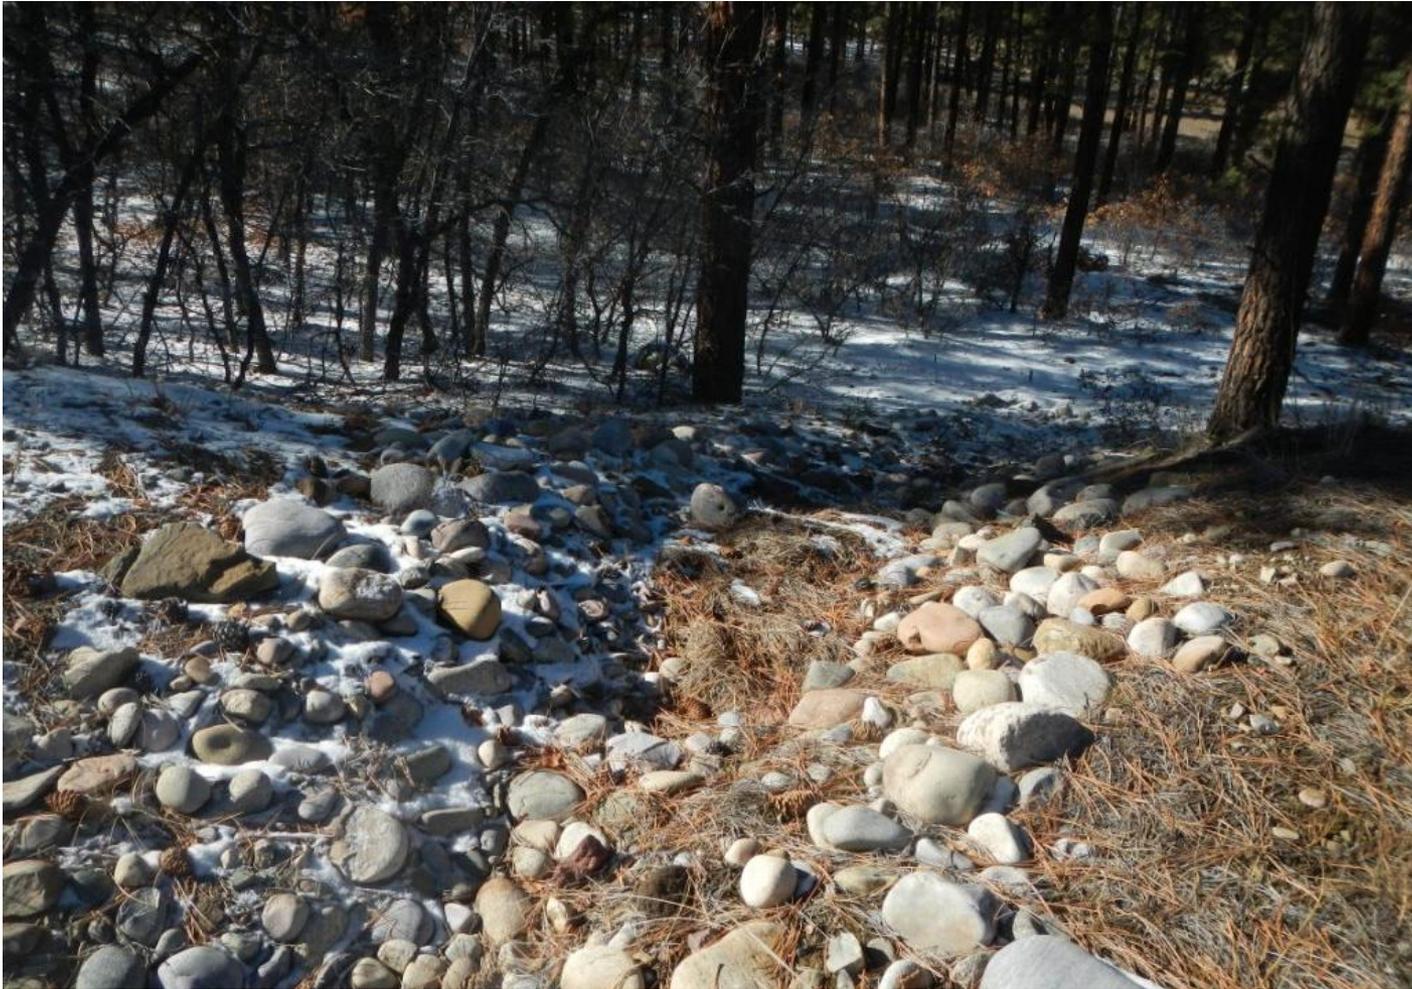
Photo 4. View of cobble run-down in northwestern portion of the project area that is downstream from diversion in Photo 3. Run-down is in good condition.

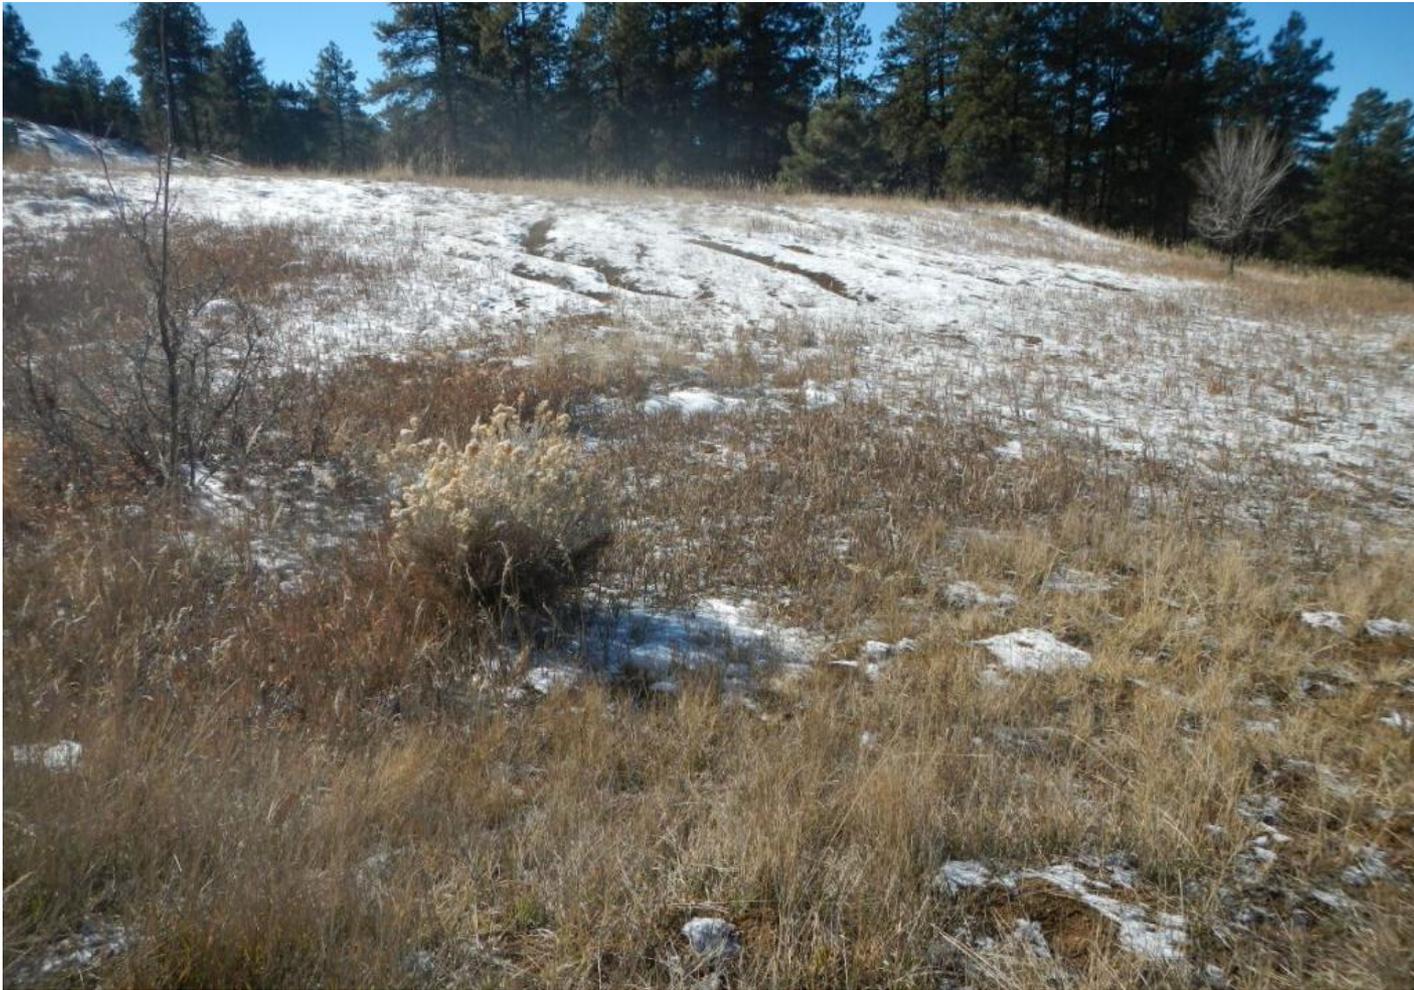
Photo 5. View of the northern portion of the project area from the access road facing southwestward. Rill erosion is occurring on the fill slopes. This should be monitored and BMPs applied if erosion worsens.
