Construction and Stormwater Inspection

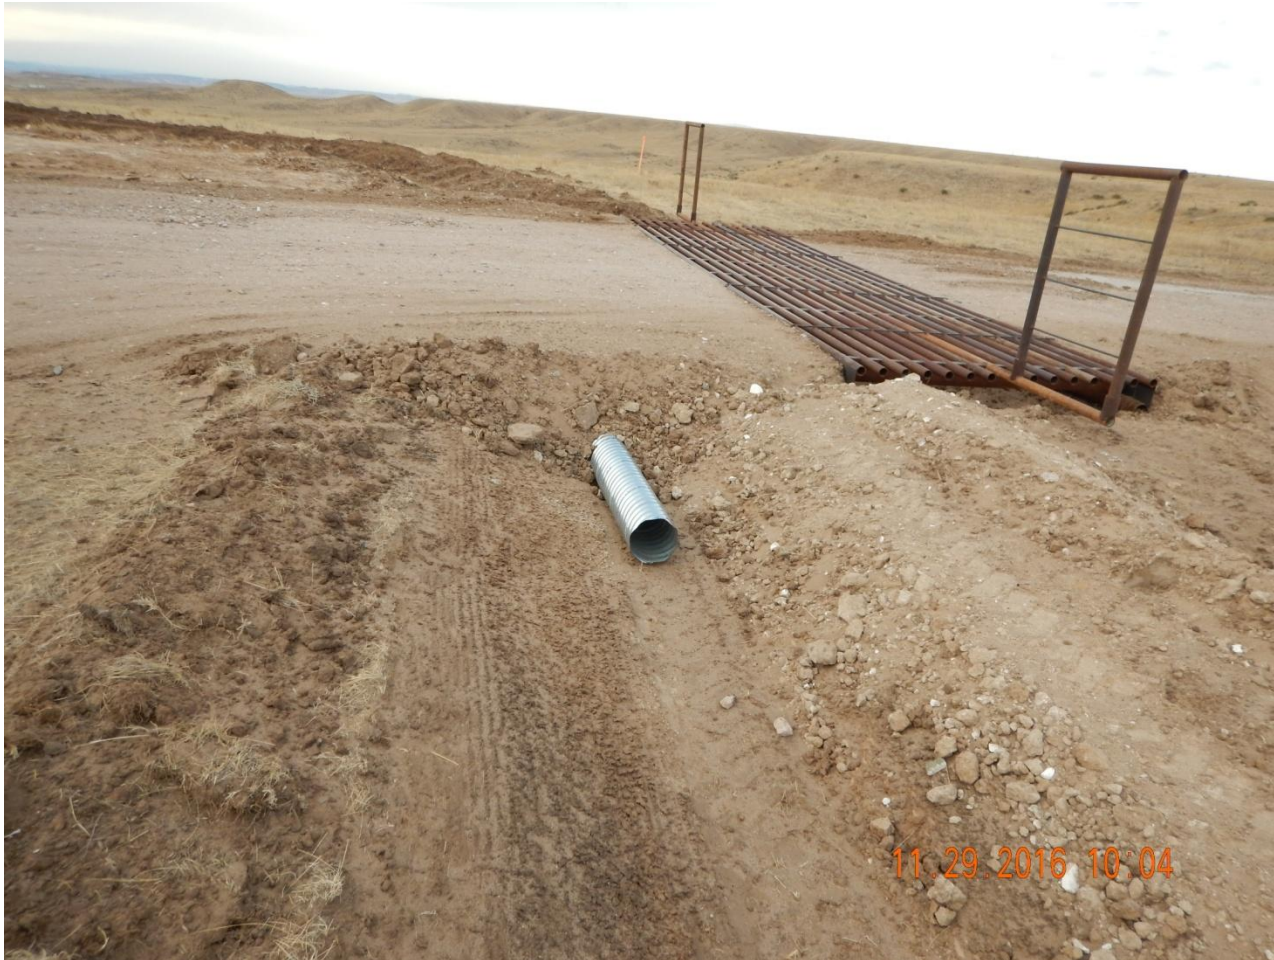
Photo 1. Photo taken from entrance of location , facing West. Ditch and berm BMP installed around the location perimeter. Berm shall be compacted to ensure containment of sediment laden storm runoff is directed to the sediment trap. Culvert installed in conjunction with ditch and berm BMP.

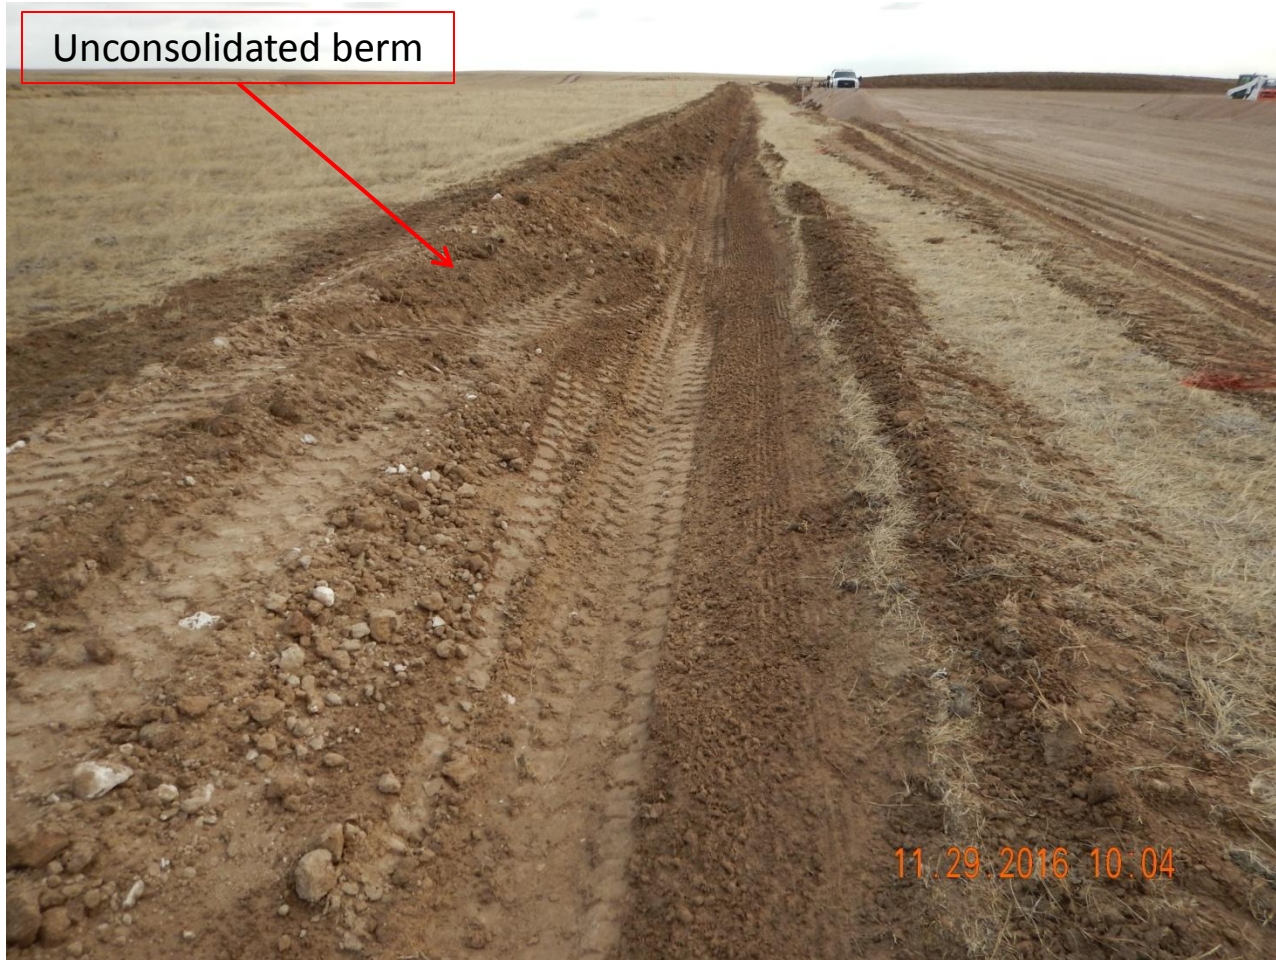
Photo 2. Photo taken from entrance of location , facing East. Ditch and berm BMP installed around the location perimeter. Berm shall be compacted to ensure containment of sediment laden storm runoff is directed to the sediment trap.

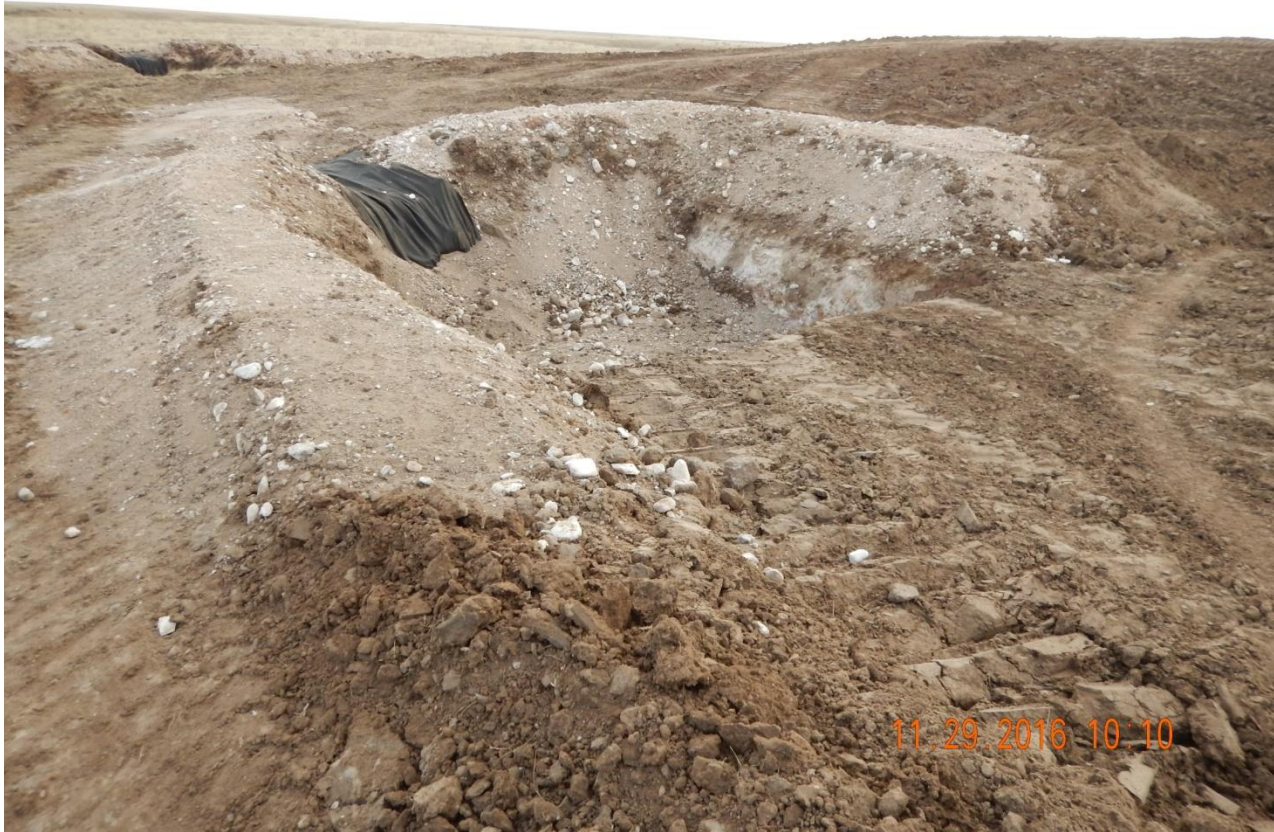
Photo 3. Photo taken from the northeastern location, facing East, towards the sediment trap. Sediment trap side slopes should not be steeper than 2:1 and the inlet and outlet should be stabilized. Berms around sediment trap have been stabilized.

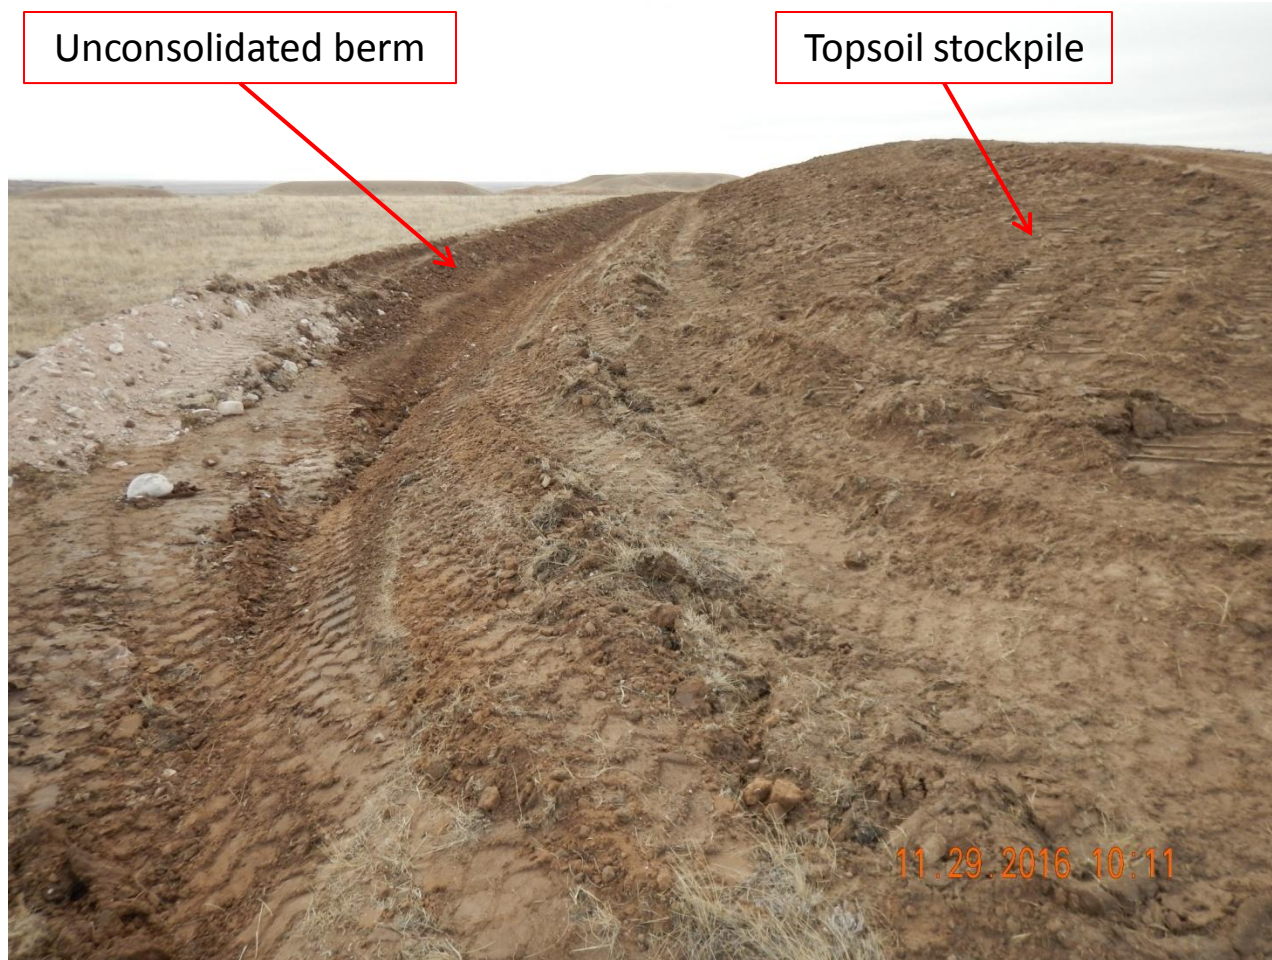
Photo 4. Photo taken from the northeast location , facing South. Ditch and berm BMP installed around the location perimeter. Berm shall be compacted to ensure containment of sediment laden storm runoff is directed to the sediment trap. Topsoil stockpile has been stored and separated along the eastern location. Need to stabilize topsoil stockpile from degradation due to wind and water erosion per Rule 1002.c.

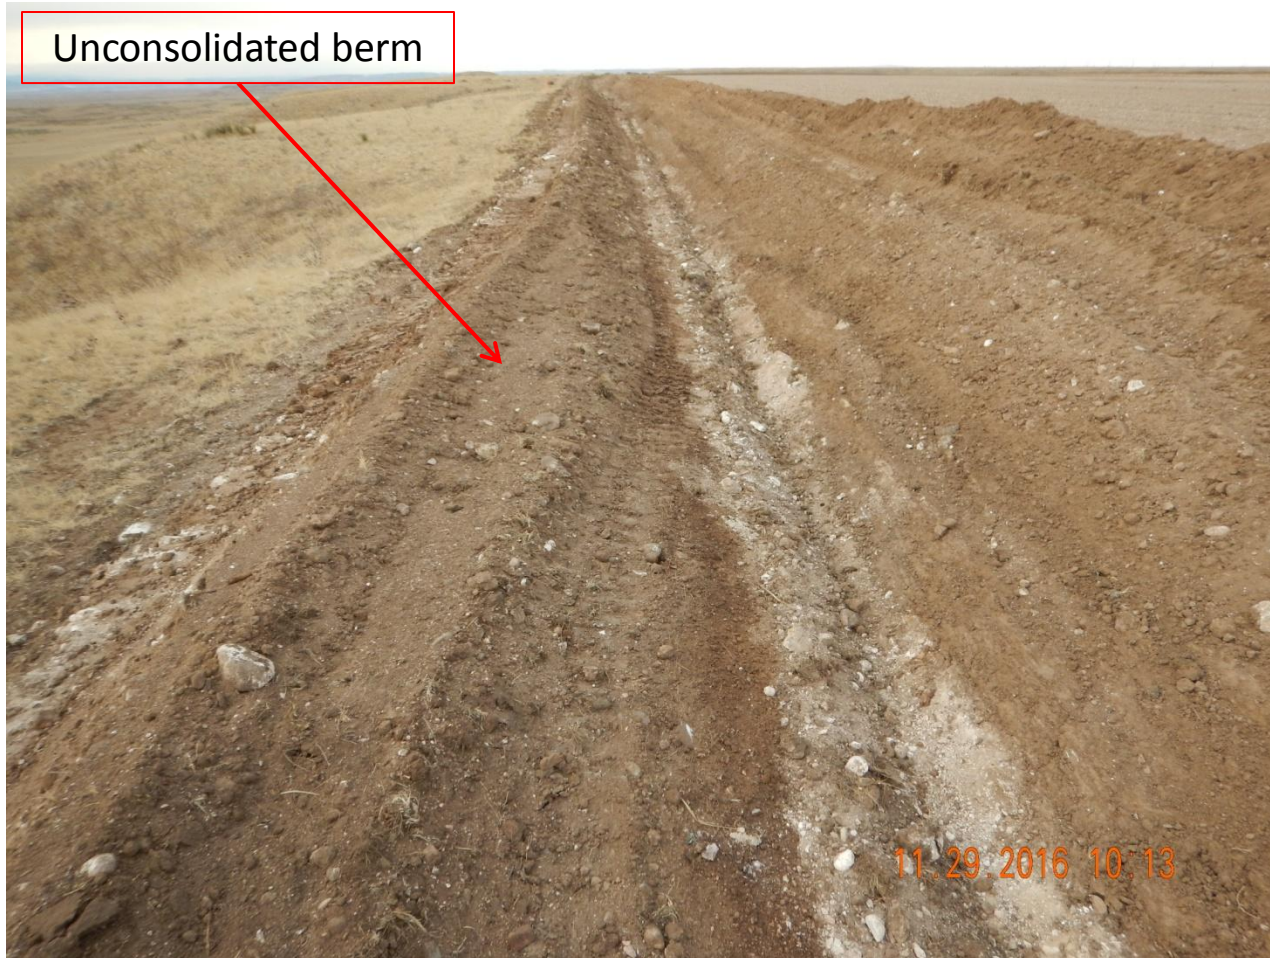
Photo 5. Photo taken from the southern location , facing West. Ditch and berm BMP installed around the location perimeter. Berm shall be compacted to ensure containment of sediment laden storm runoff is directed to the sediment trap.

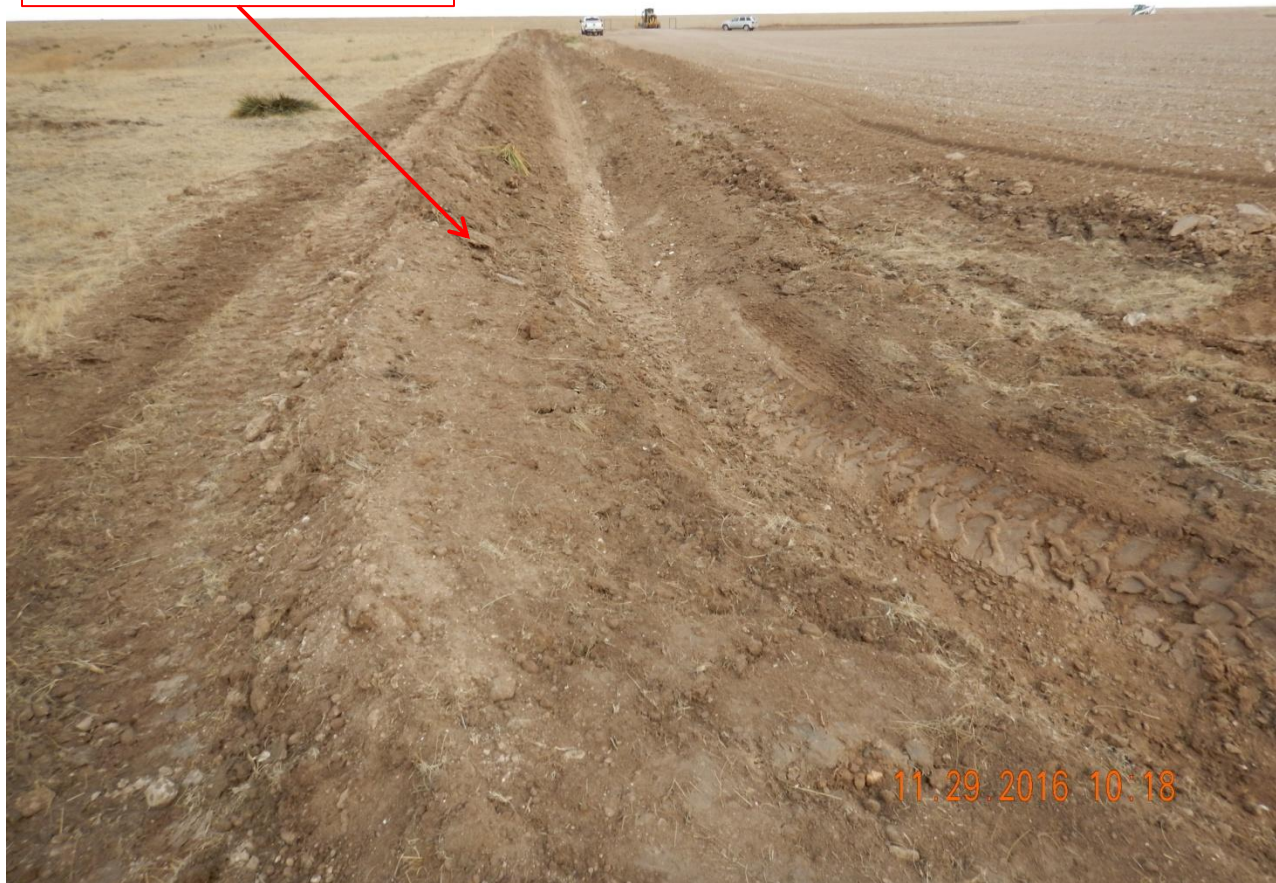
Unconsolidated berm

Photo 6. Photo taken from the western location , facing North. Ditch and berm BMP installed around the location perimeter. Berm shall be compacted to ensure containment of sediment laden storm runoff is directed to the sediment trap.
