Construction and Stormwater Inspection

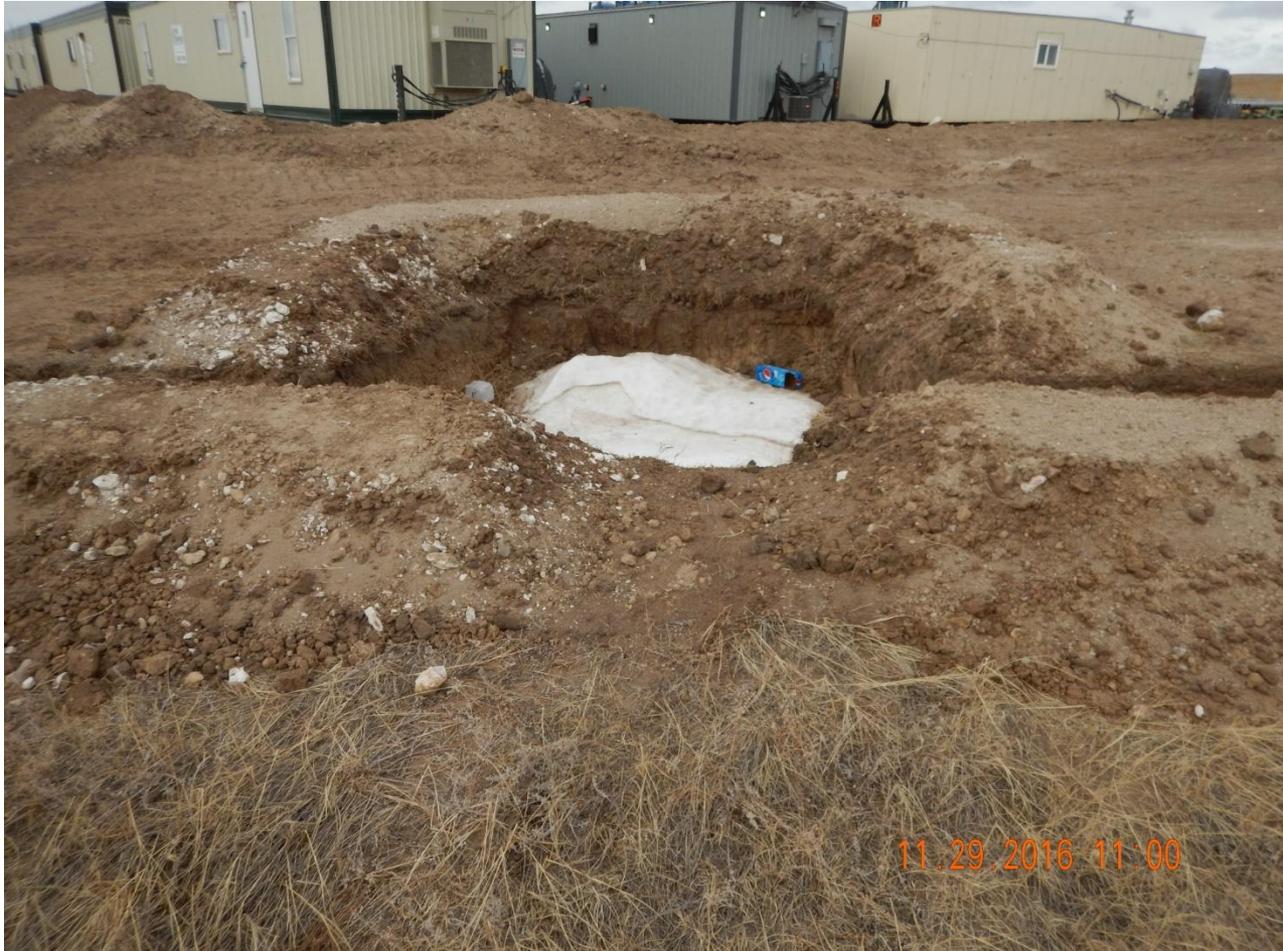
Photo 1. Photo taken from the southeastern location, facing West, towards the sediment trap. Sediment trap does not have a stabilized outlet.

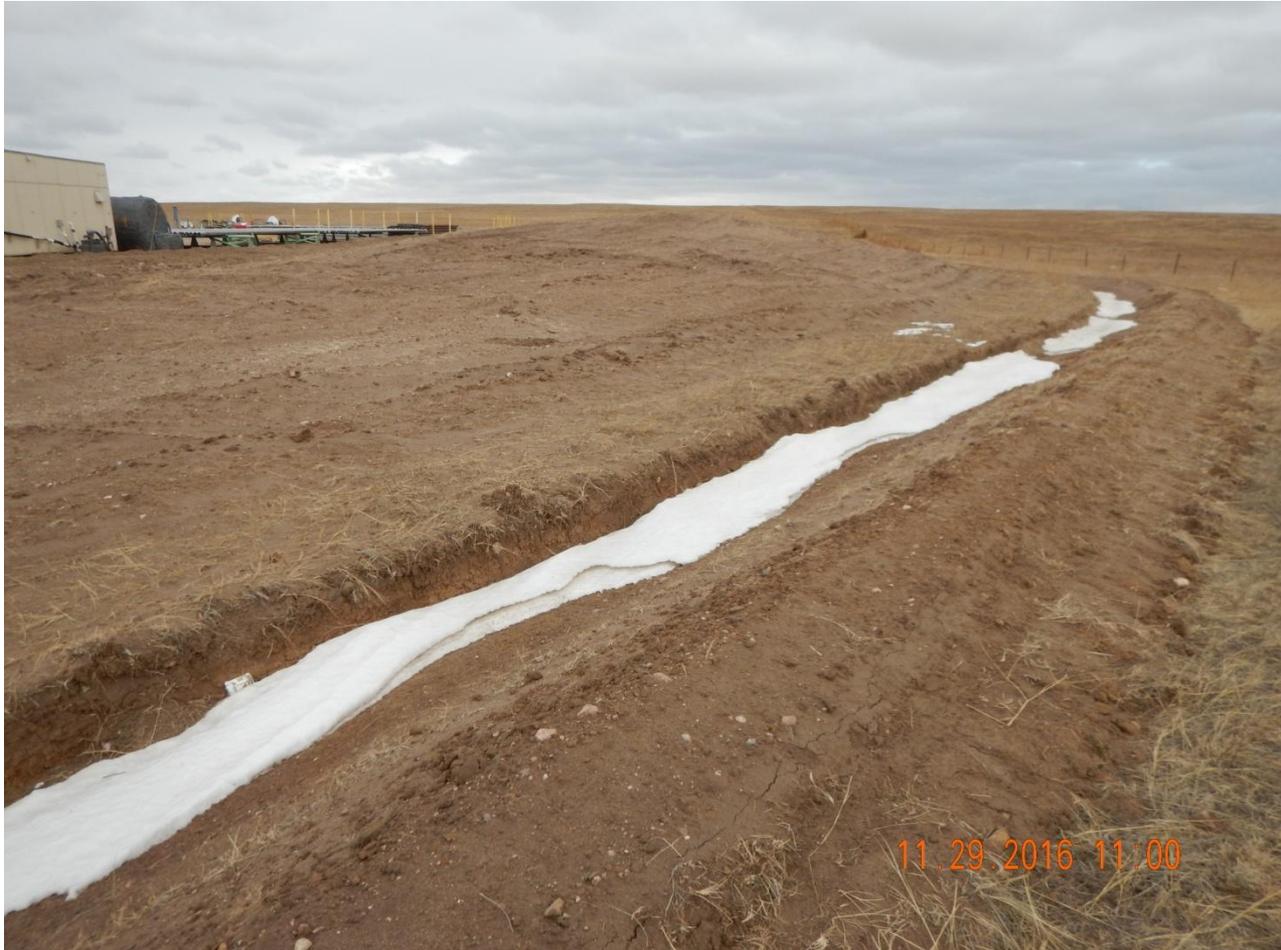
Photo 2. Photo taken from the eastern location, facing West, towards the topsoil stockpile. Topsoil has not been stabilized and protected from degradation due to wind and water erosion.

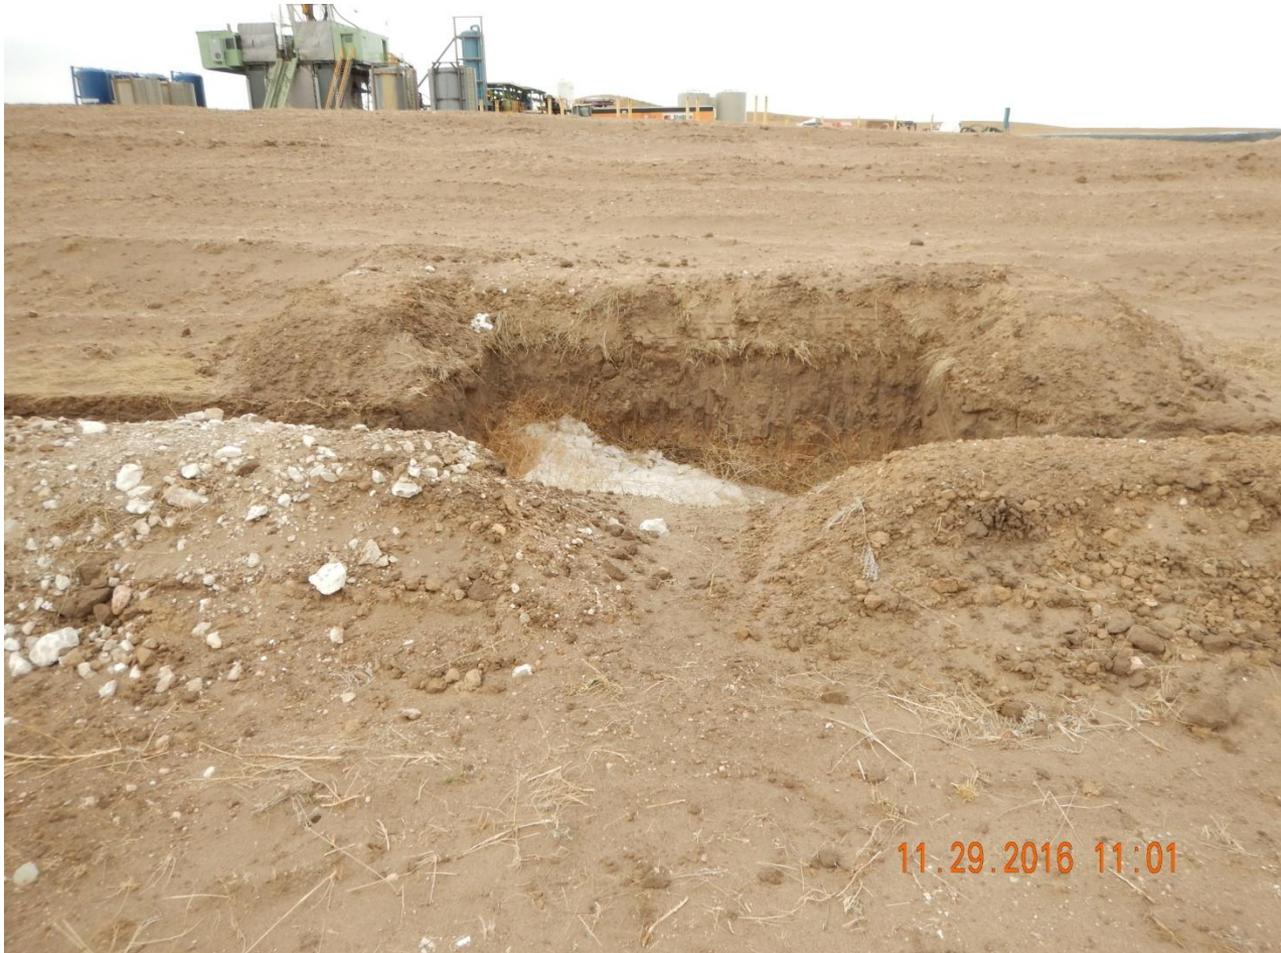
Photo 3. Photo taken from the northeastern location, facing West, towards the sediment trap. Sediment trap does not have a stabilized outlet.

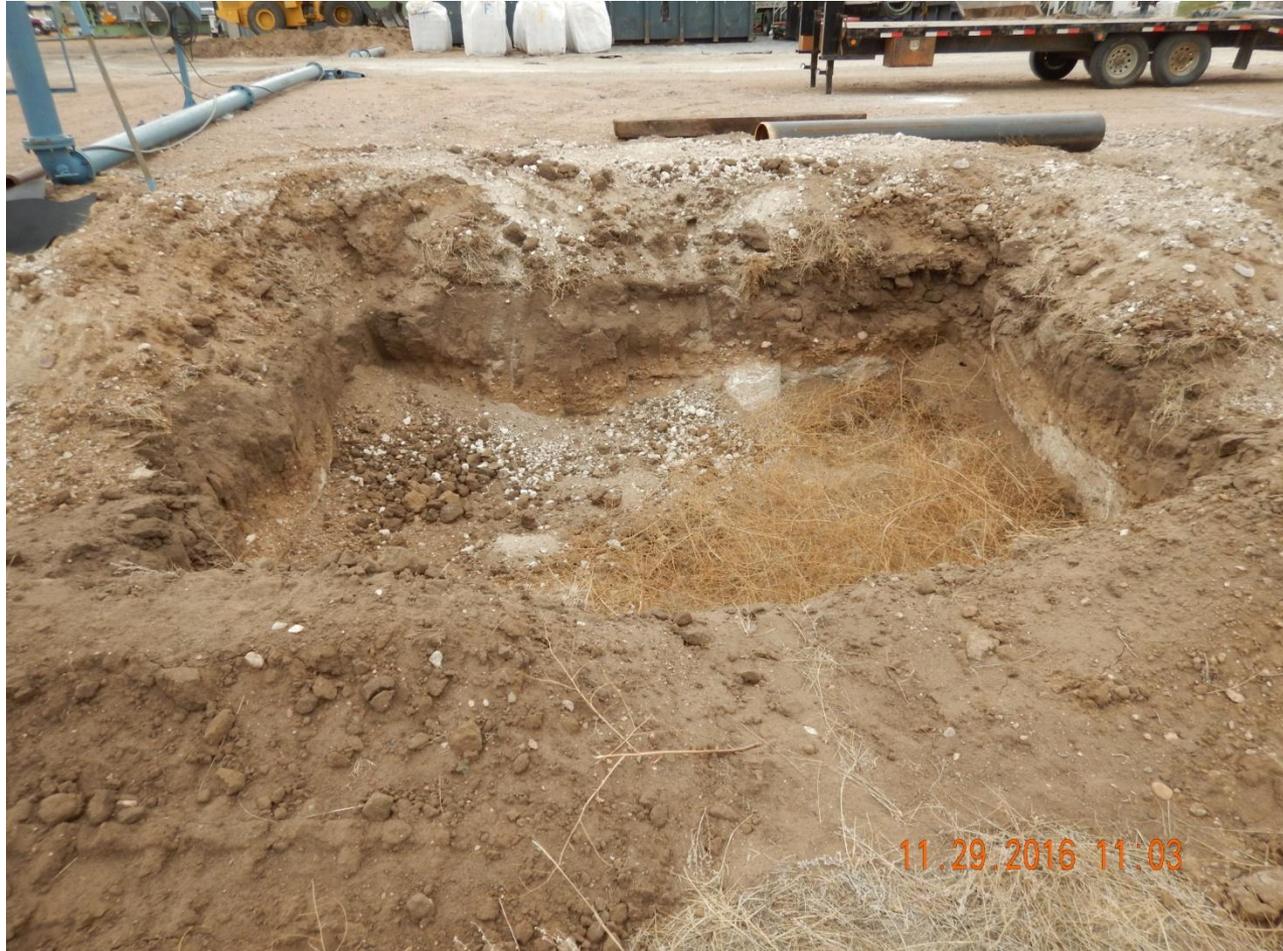
Photo 4. Photo taken from the northern location, facing South, towards the sediment trap. Sediment trap does not have a stabilized outlet.

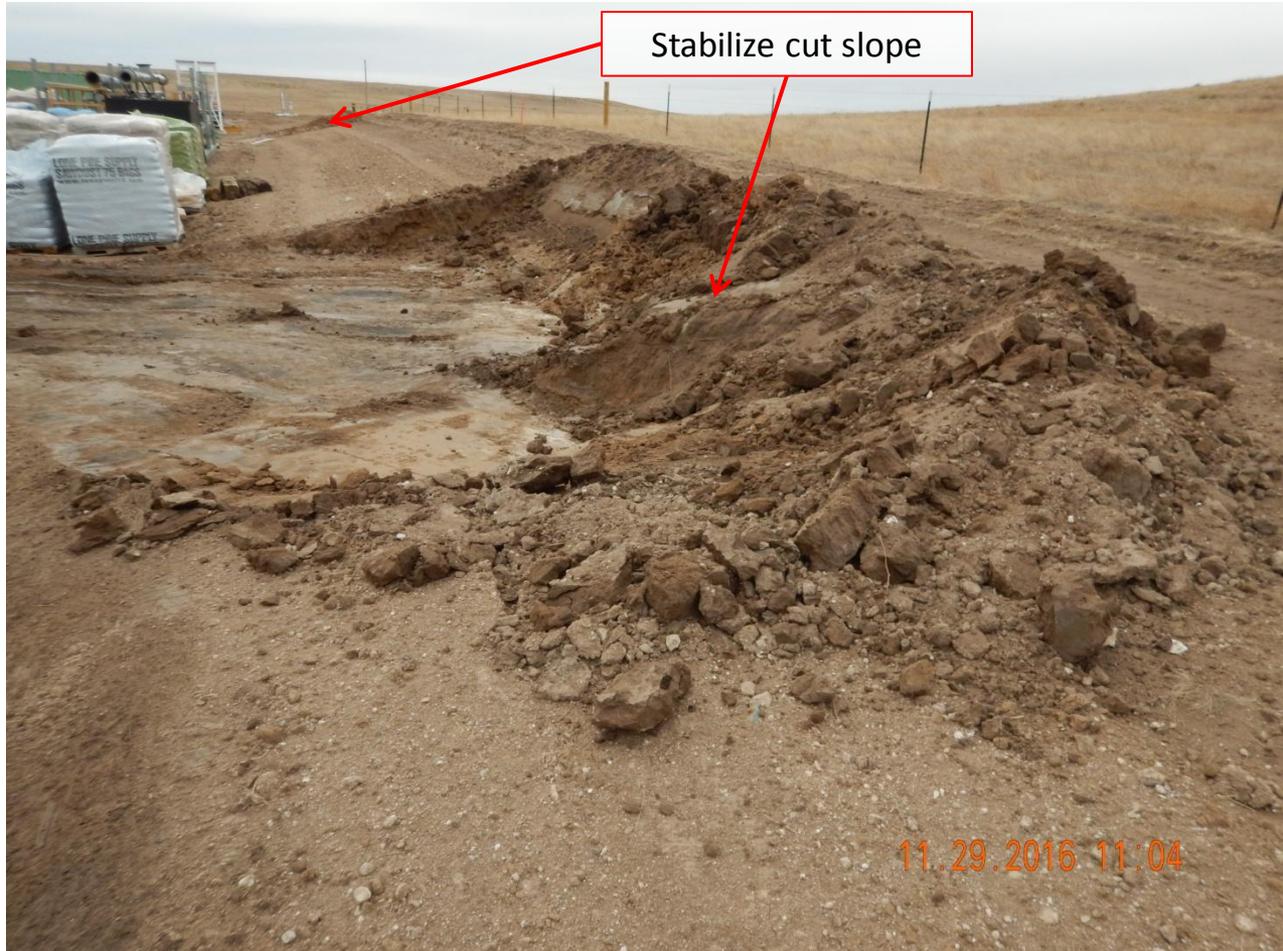
Photo 5. Photo taken from the north, western location , facing South. Stabilize the cut slope where soil was moved.

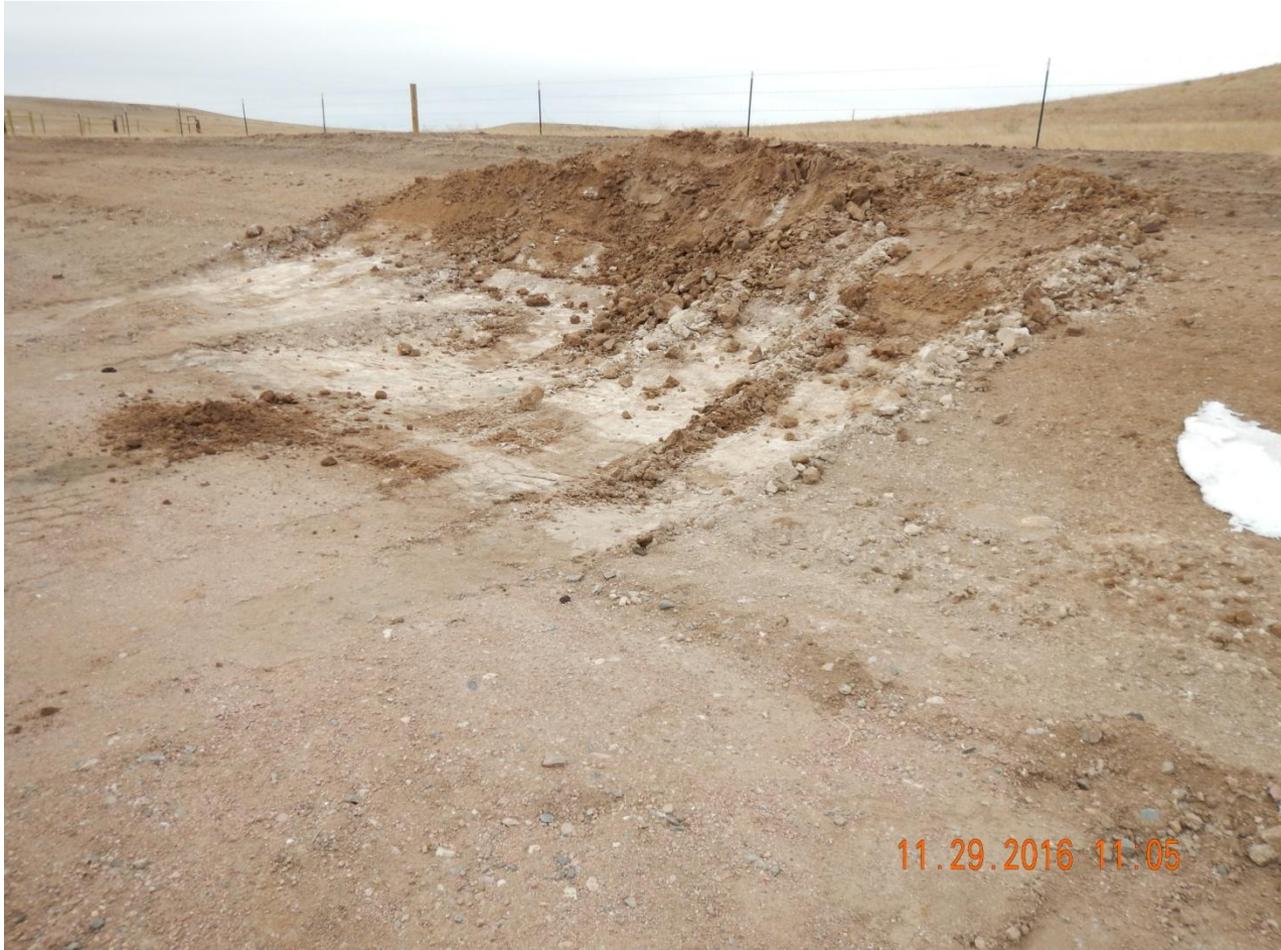
Photo 6. Photo taken from the south, western location , facing South. Stabilize the cut slope where soil was moved.
