Follow-up Inspection

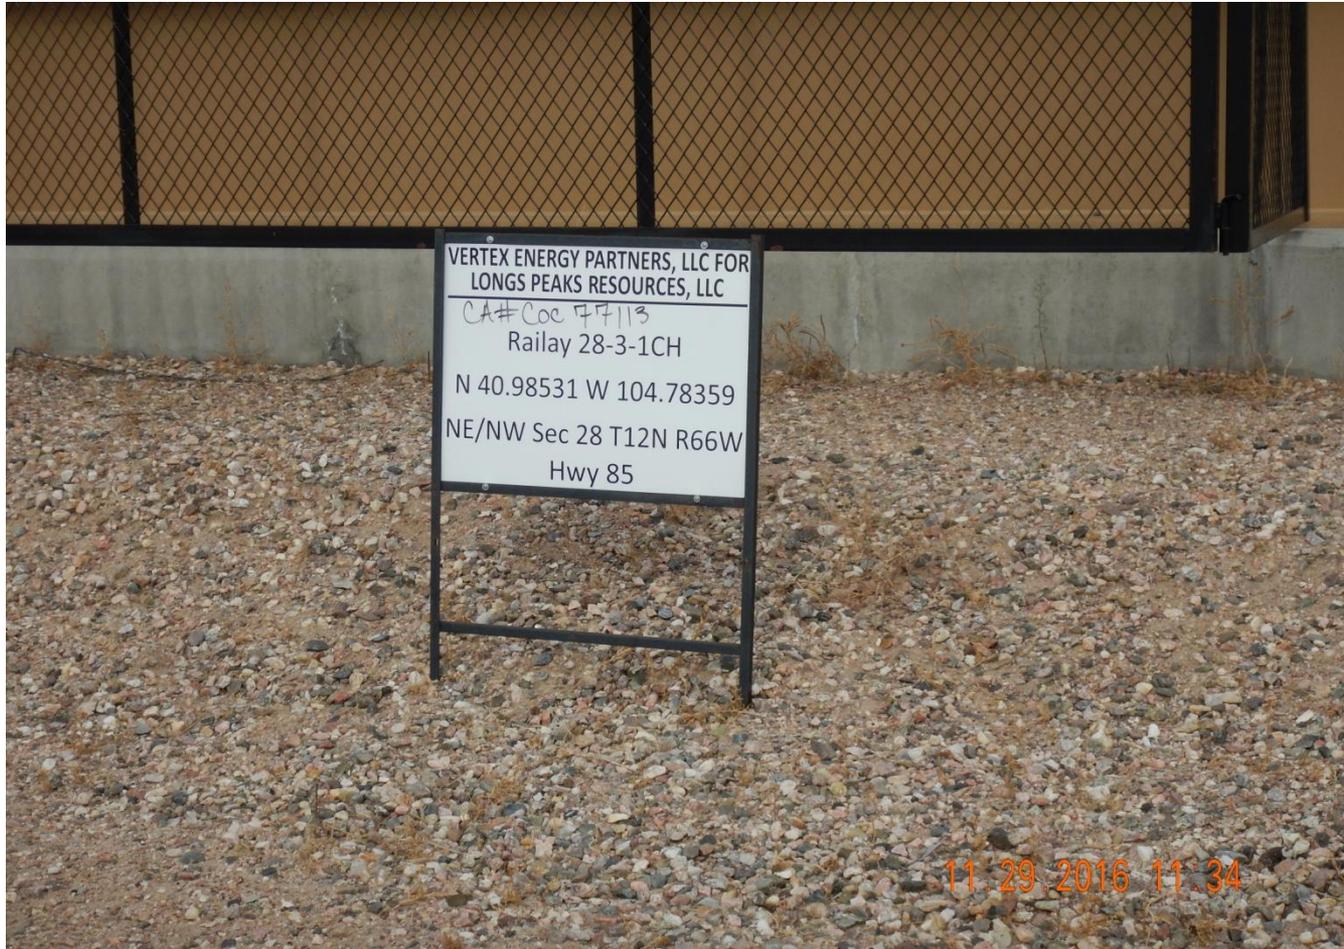
Photo 1. Photo taken of wellhead sign. Sign is sufficient with the addition of the entrance sign- refer to Photo 3.

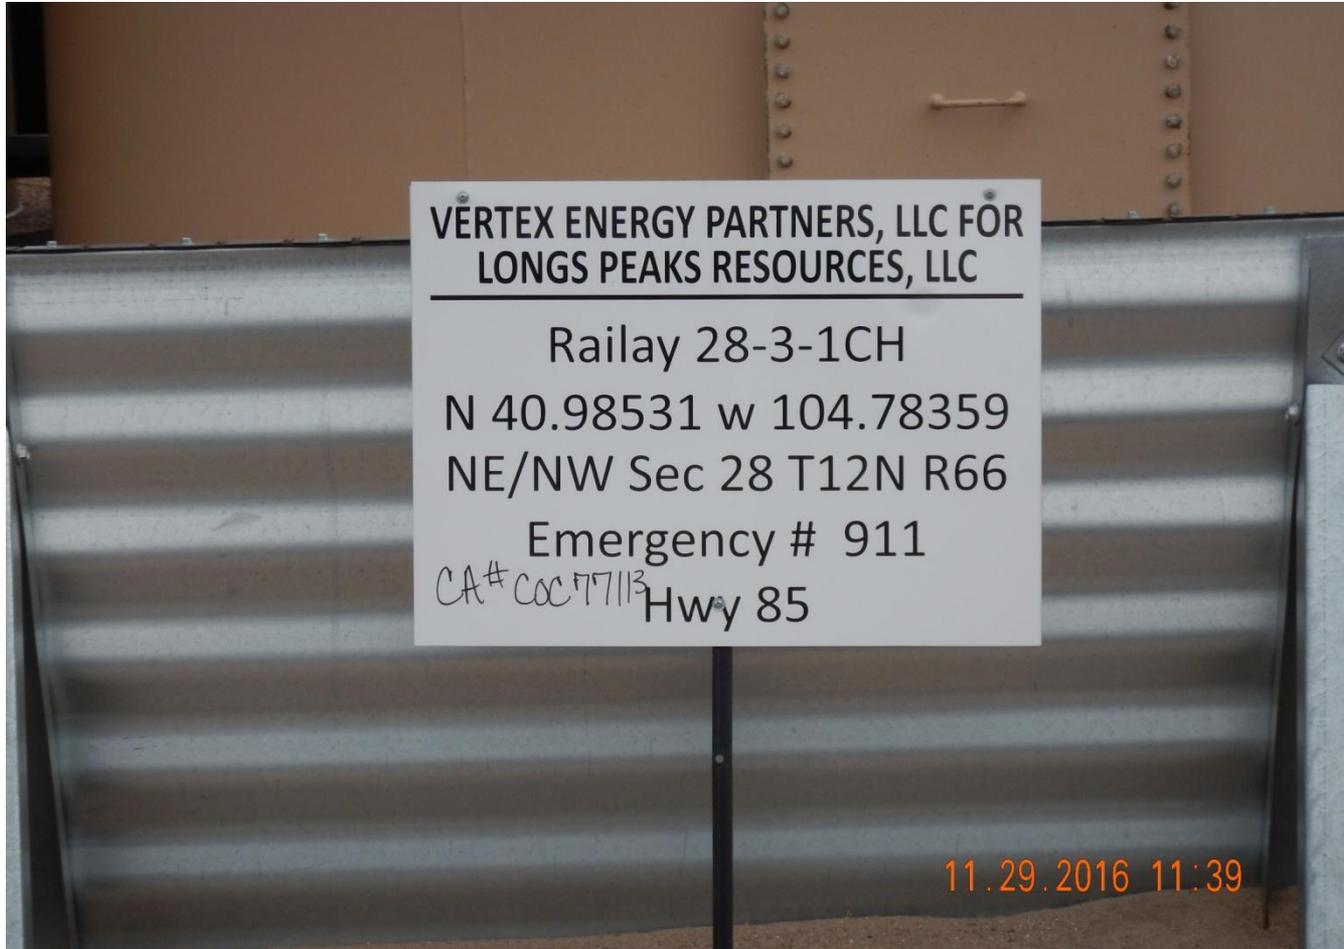
Photo 2. Photo taken of battery sign. Sign is sufficient with the addition of the entrance sign- refer to Photo 3.

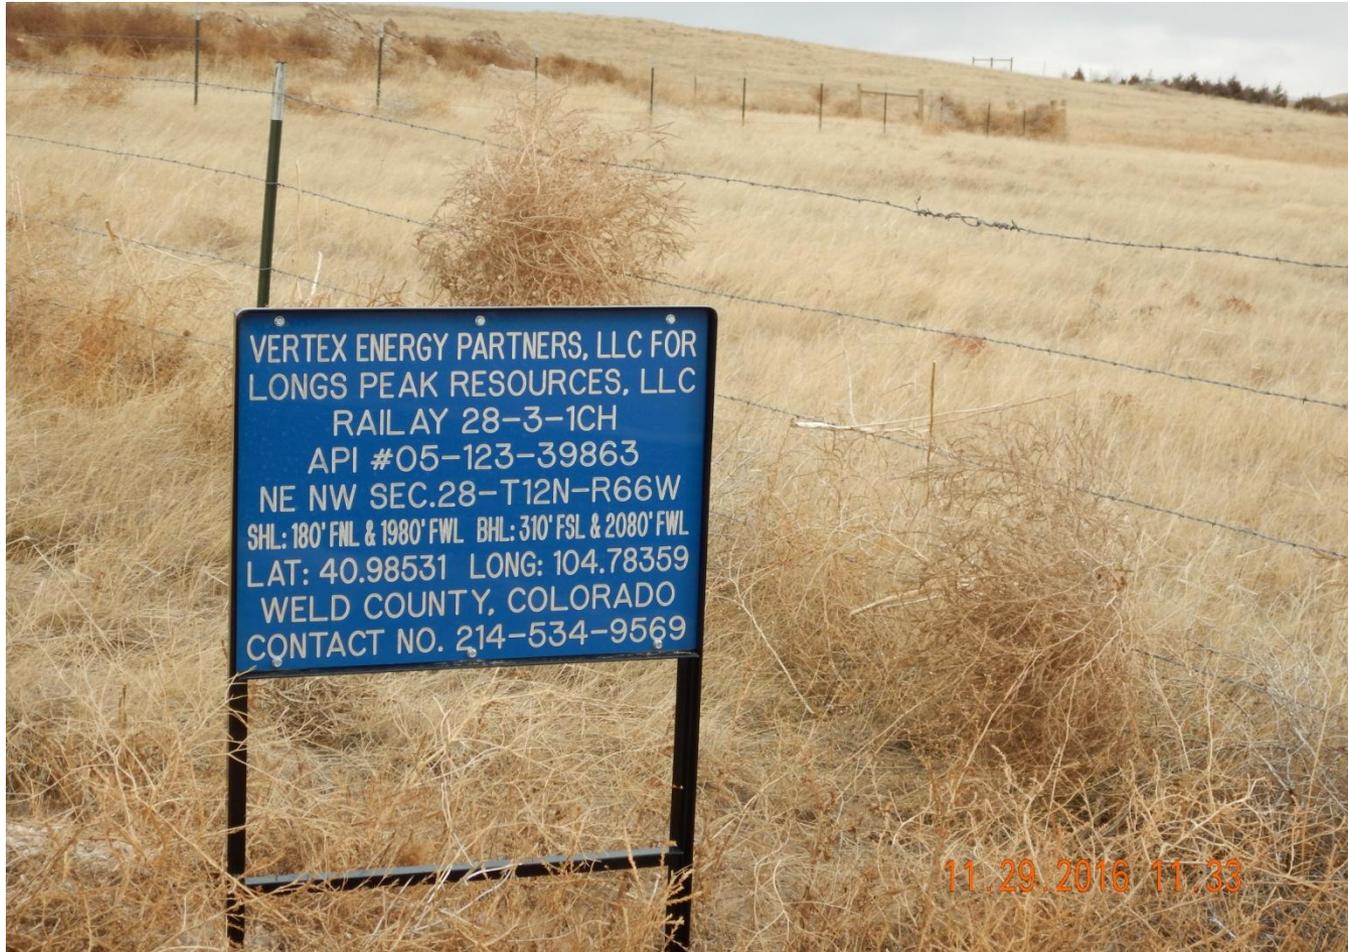
Photo 3. Photo taken of sign at the entrance.

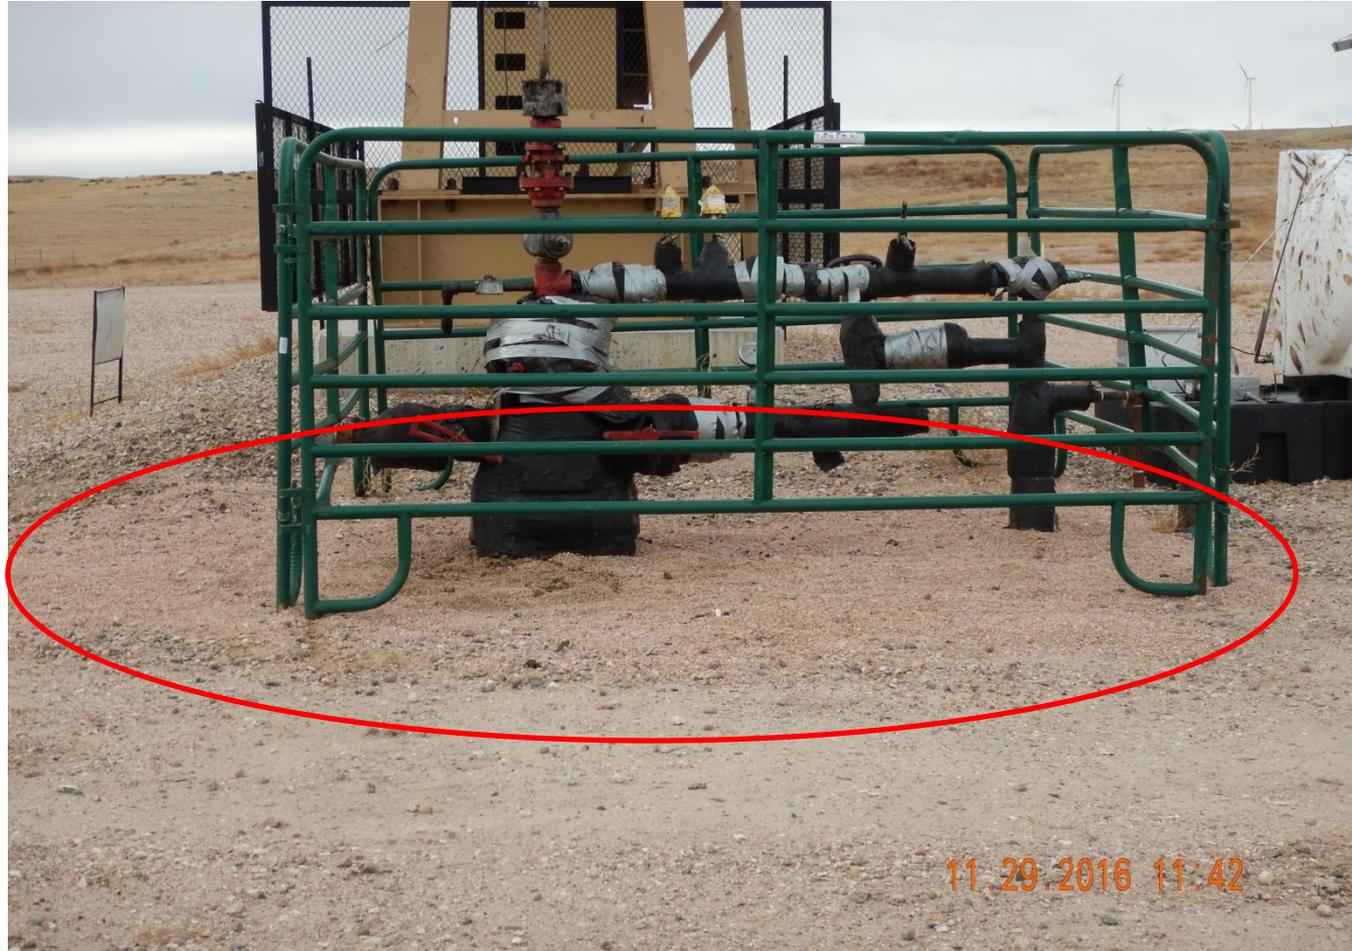
Photo 4. Photo taken of gravel placed around wellhead.

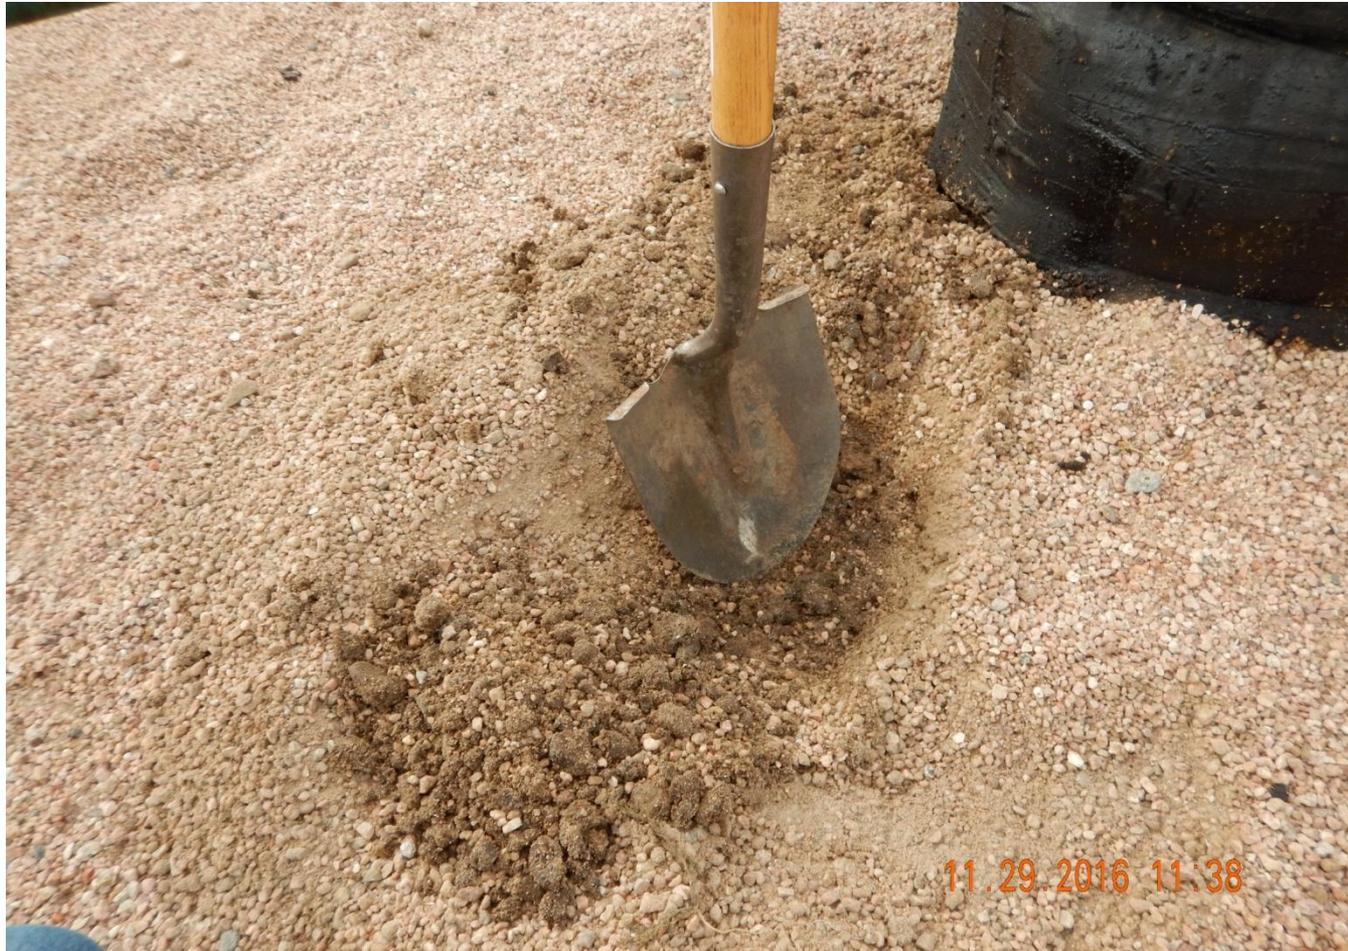
Photo 5. Photo taken at wellhead. It appears the impacted soil around the wellhead has not been removed. Removal of 3"-4" of gravel on top reveals stained soil with a hydrocarbon like odor.
