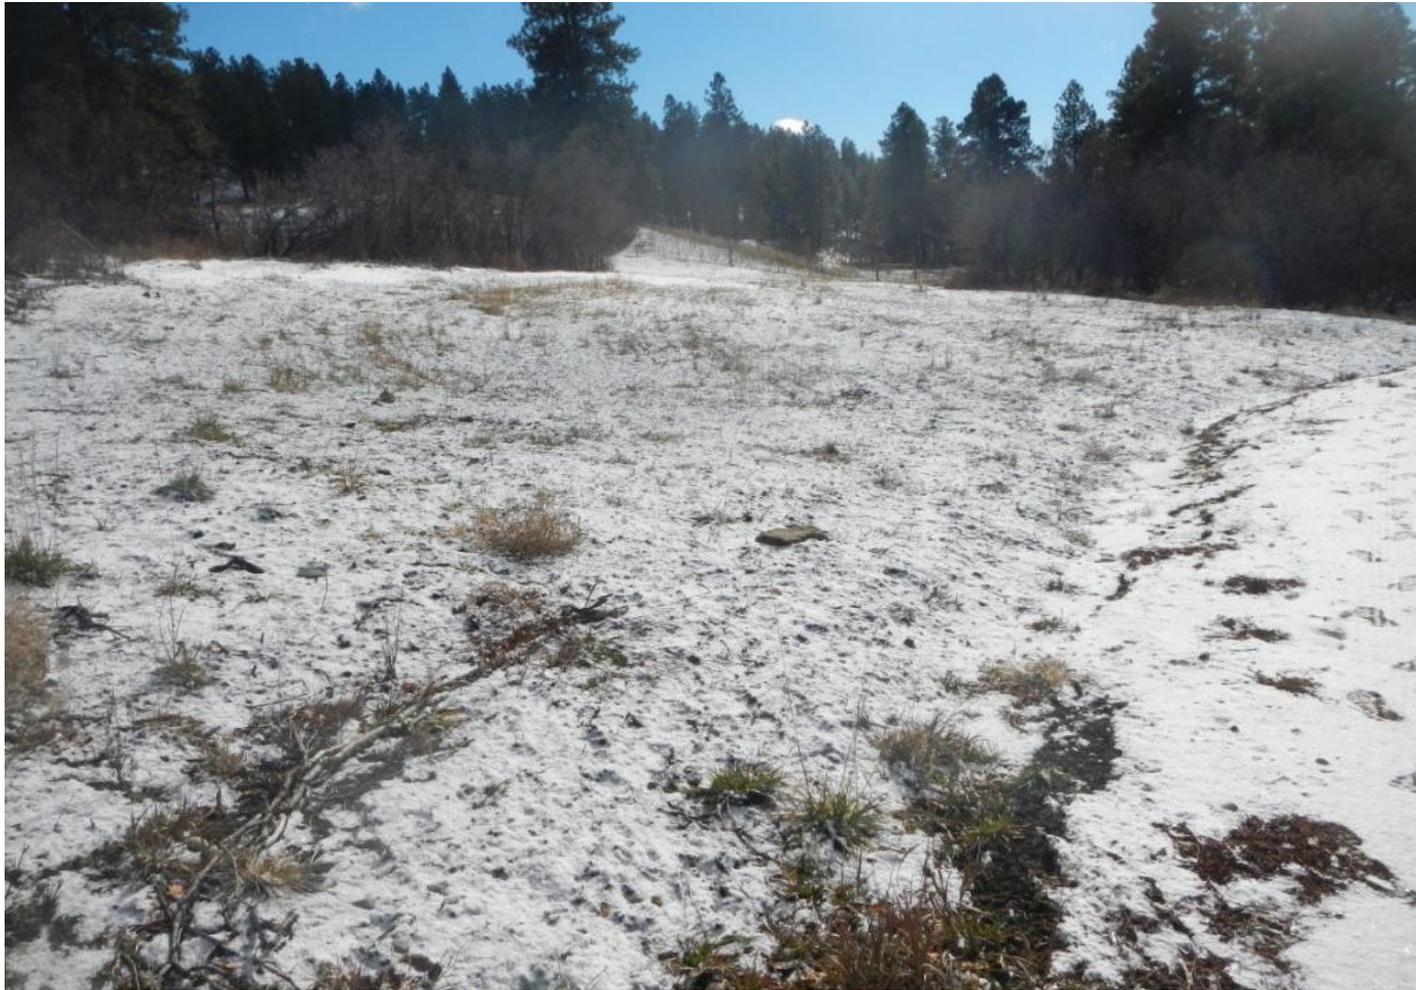
Photo 1. View of the beginning of the reclaimed access road facing southward.

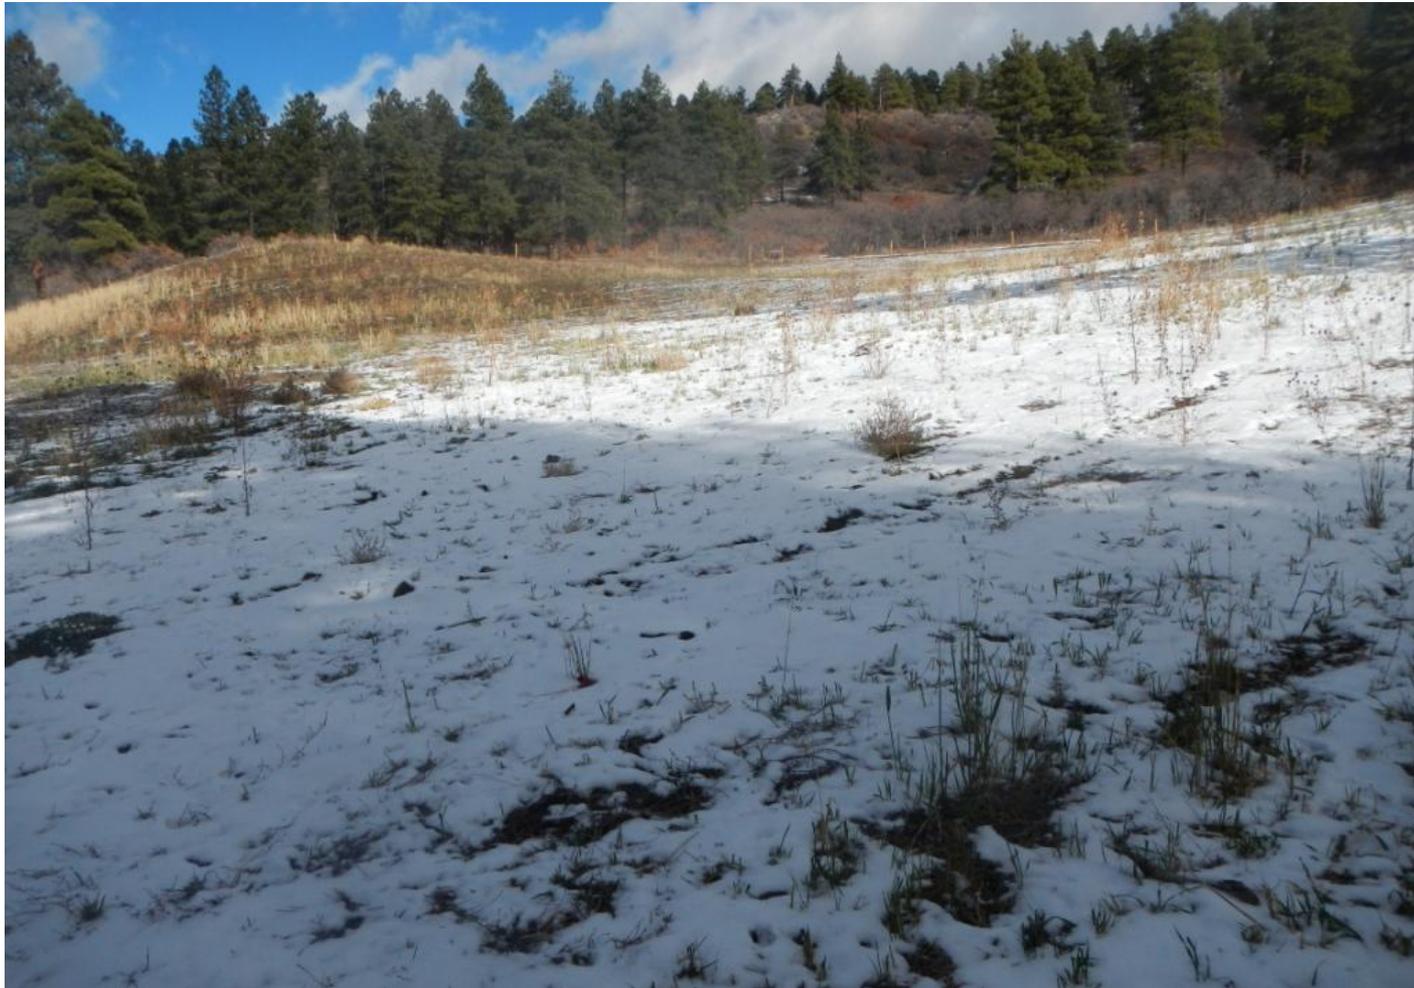
Photo 2. View of the project area from the southwestern corner facing center. Revegetation is progressing with annual grasses and some perennial grasses such as smooth brome (*Bromus inermis*) and intermediate wheatgrass (*Thinopyron intermedium*)

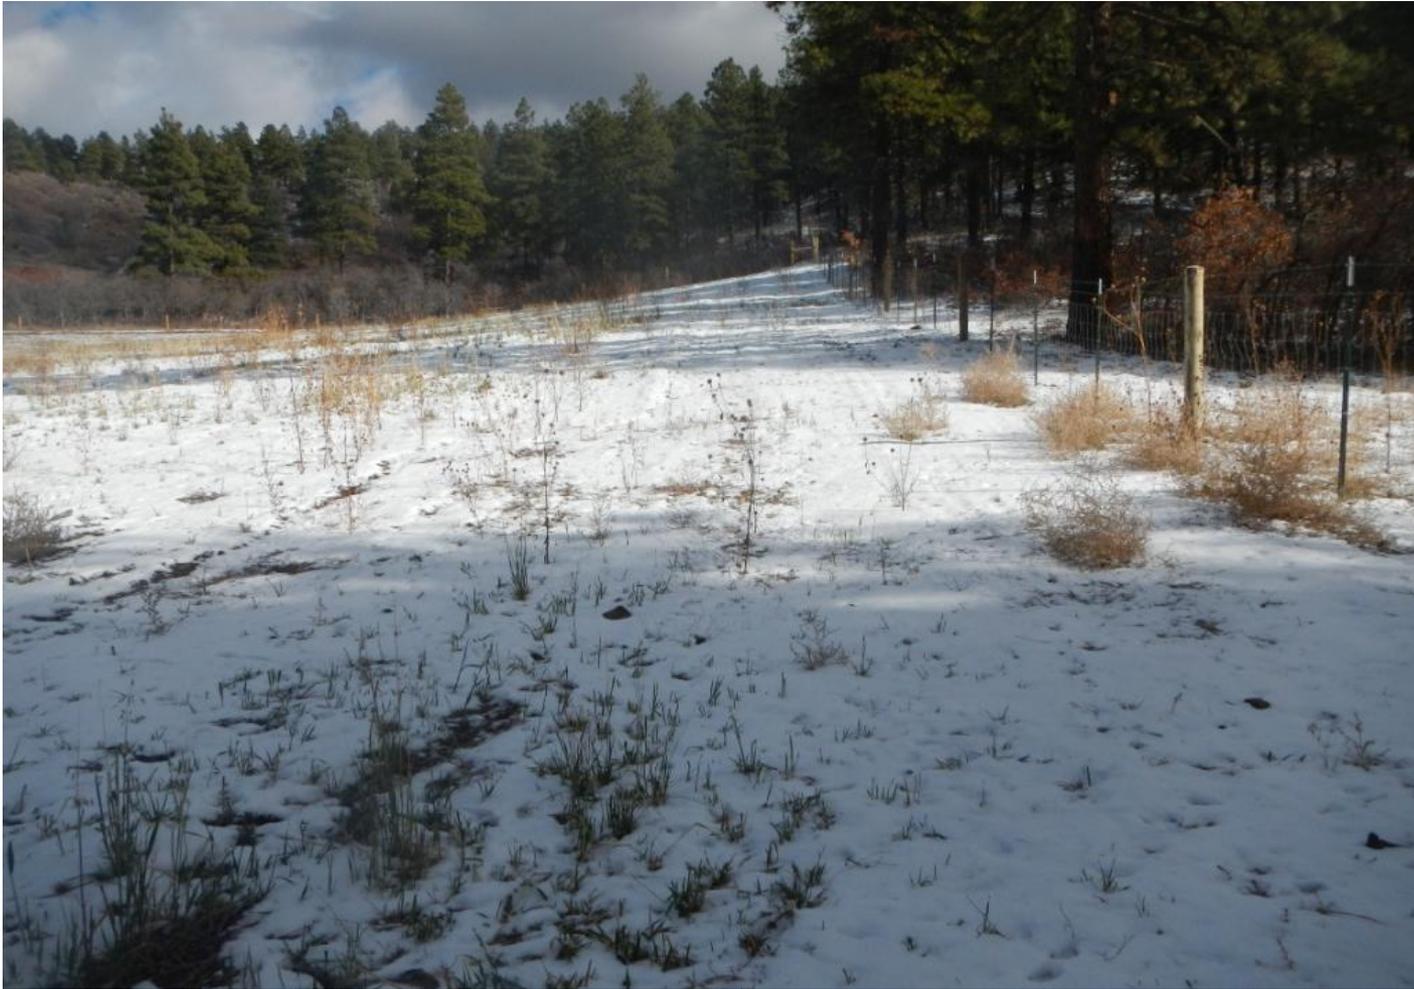
Photo 3. View of the southern portion of the project area from the southwestern corner facing eastward.

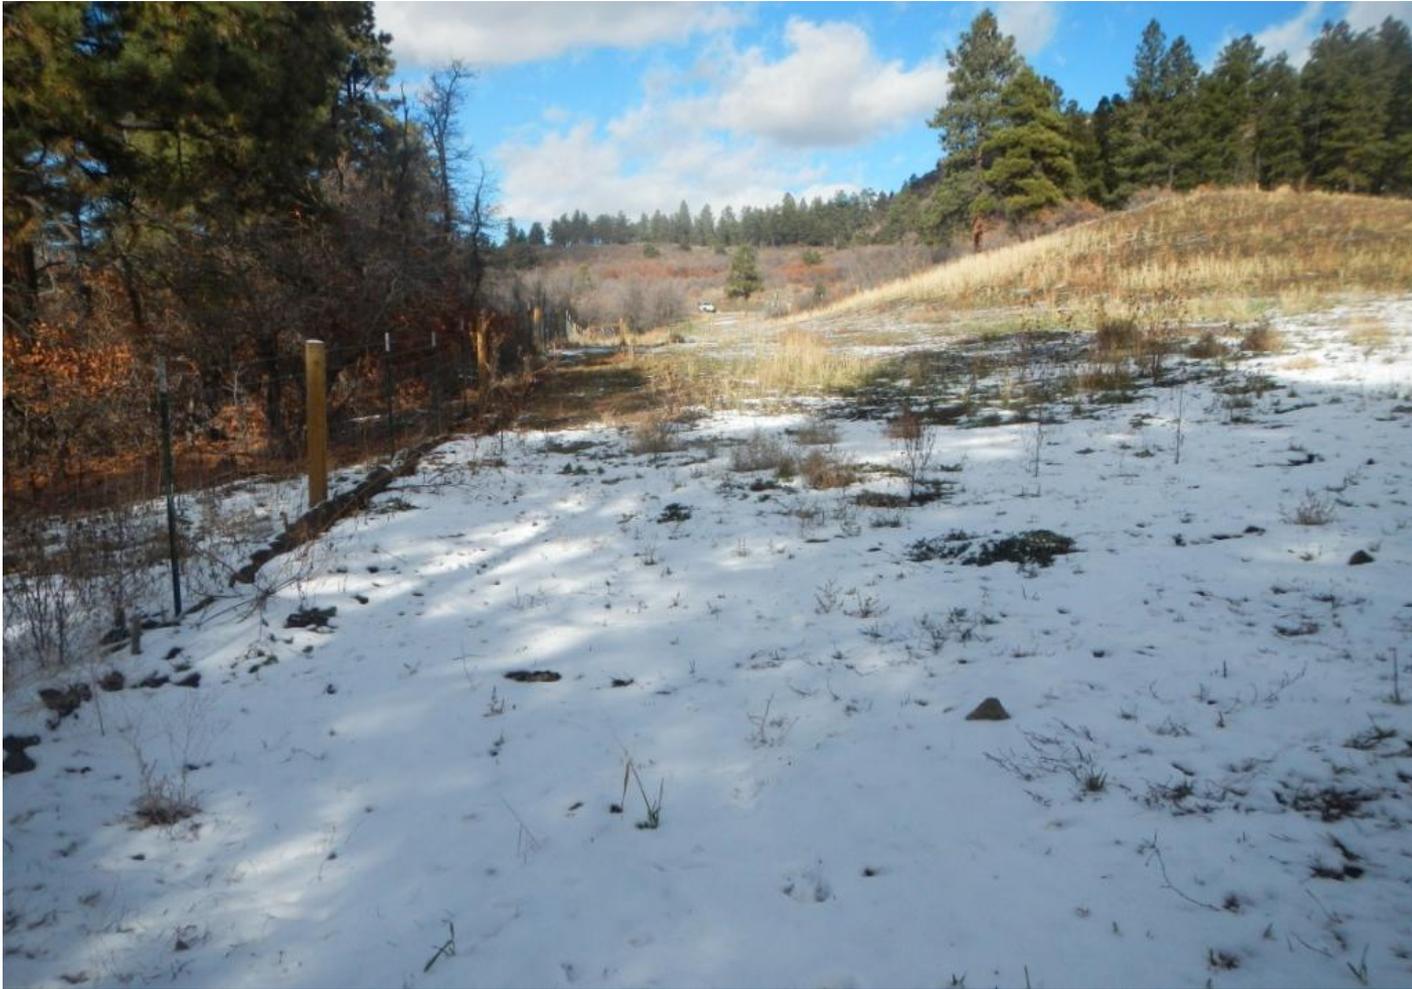
Photo 4. View of the western portion of the project area from the southwestern corner facing northward. Wattles appear to be in functioning condition.

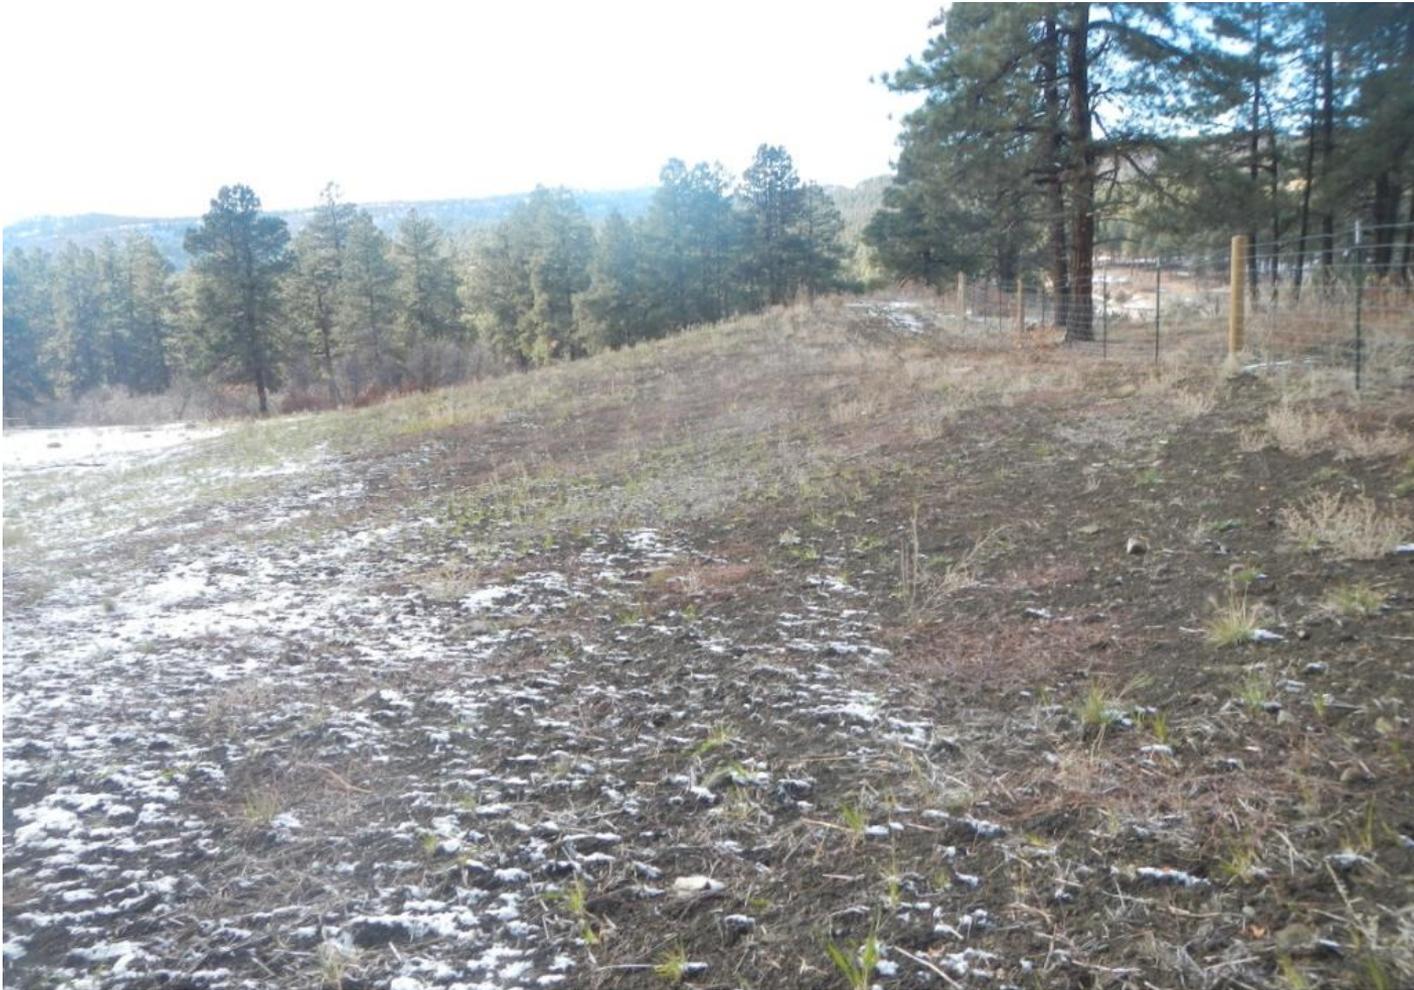
Photo 5. View of the northern portion of the project area from the northeastern corner facing southward. Revegetation is progressing here.

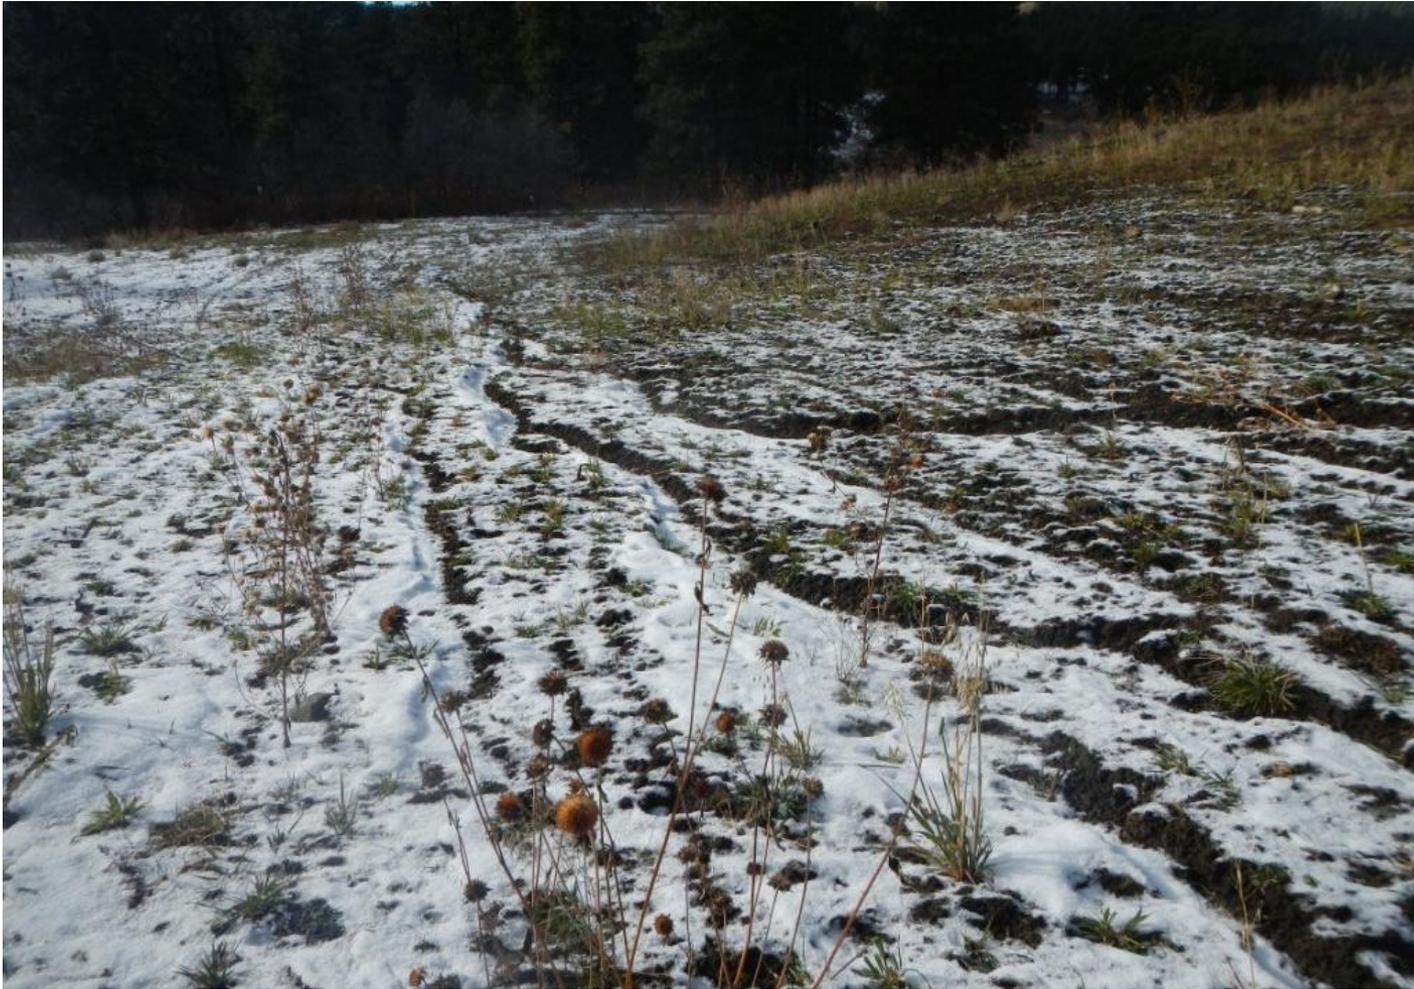
Photo 6. View of rills in the northern portion of the project area. These need to be carefully monitored and stormwater BMPs applied if erosion worsens.

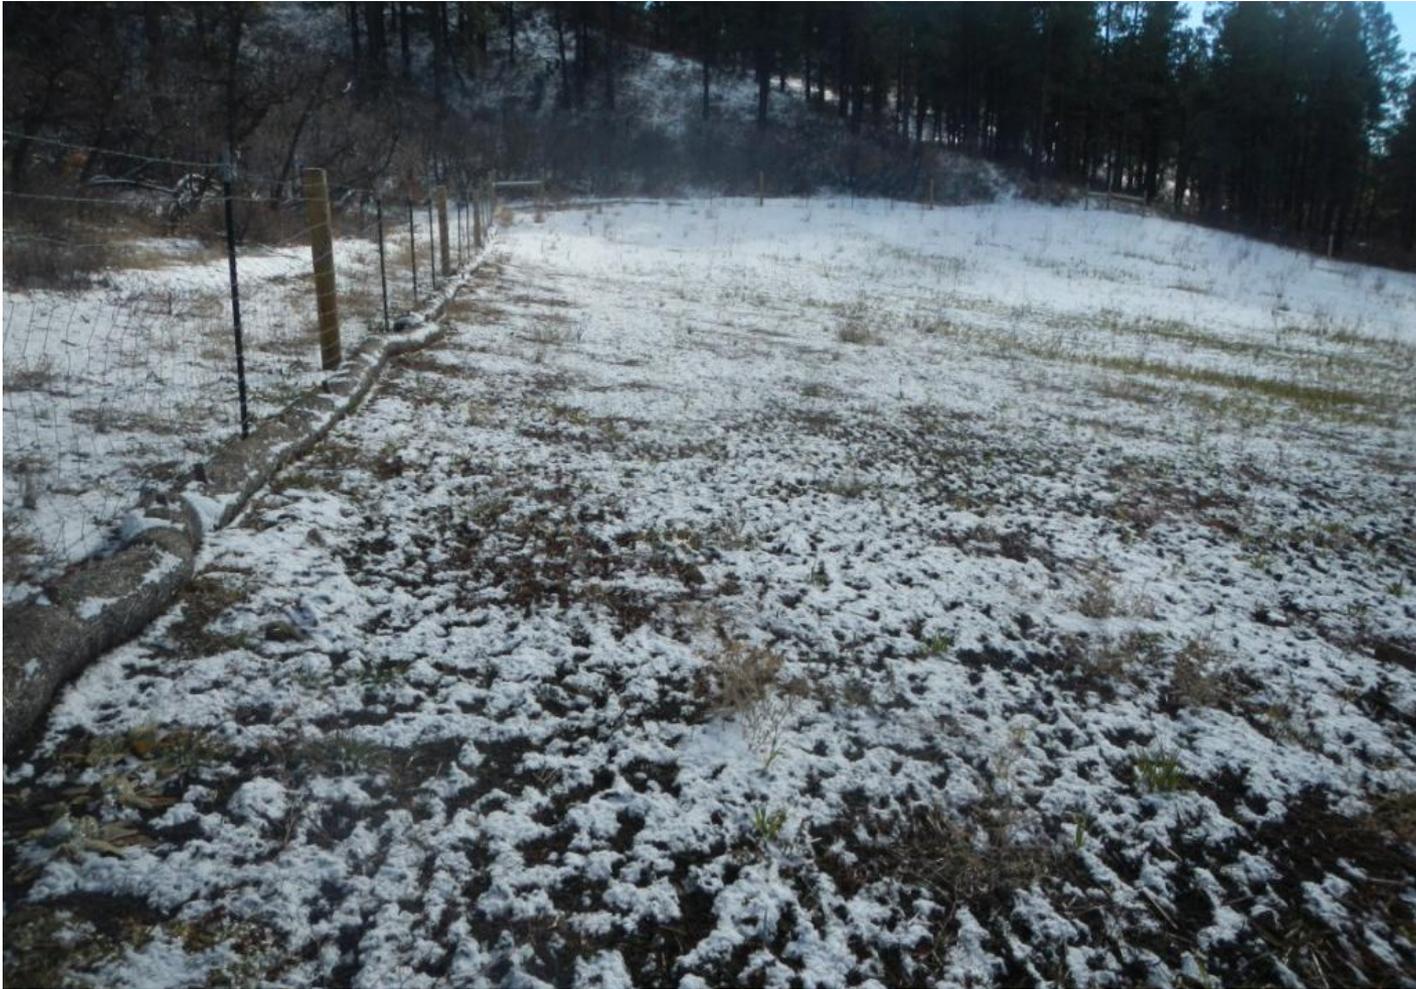
Photo 7. View of the eastern portion of the project area from the northeastern corner facing southward.

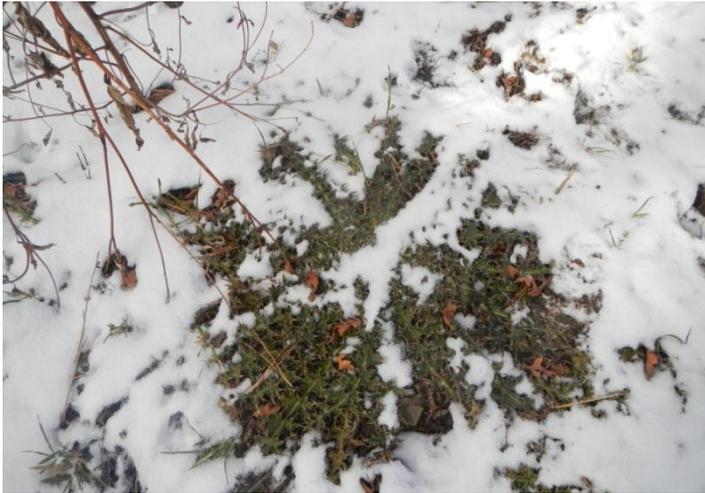
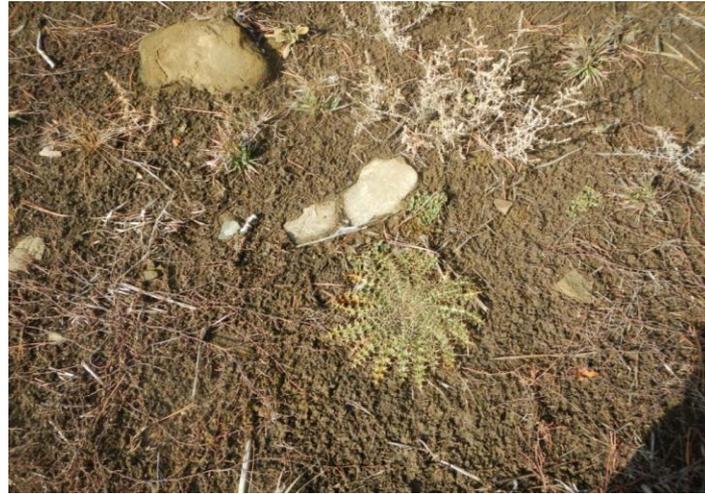
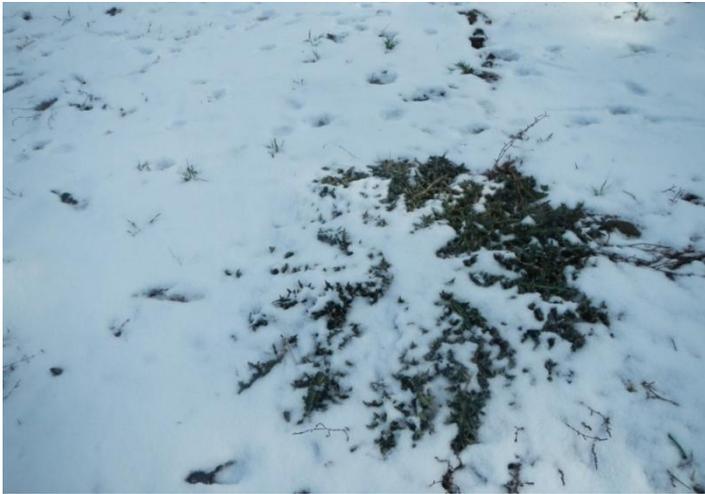
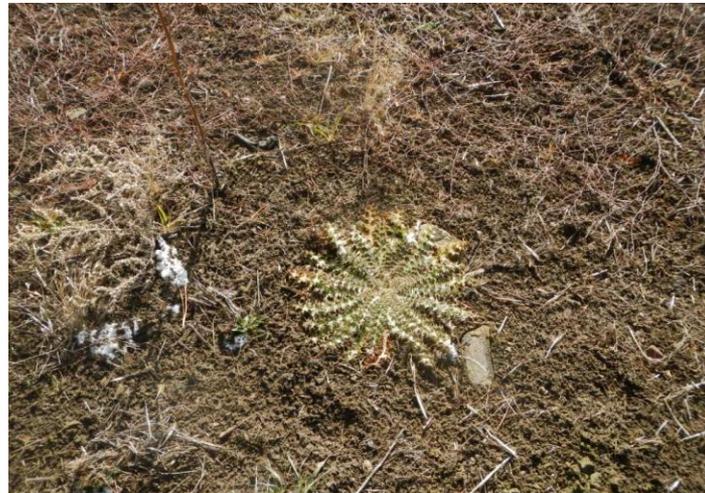
Photos 8-11. View of musk thistles (*Carduus nutans*) observed growing throughout the project area.
