Construction and Stormwater Inspection

[Location ID 447778]

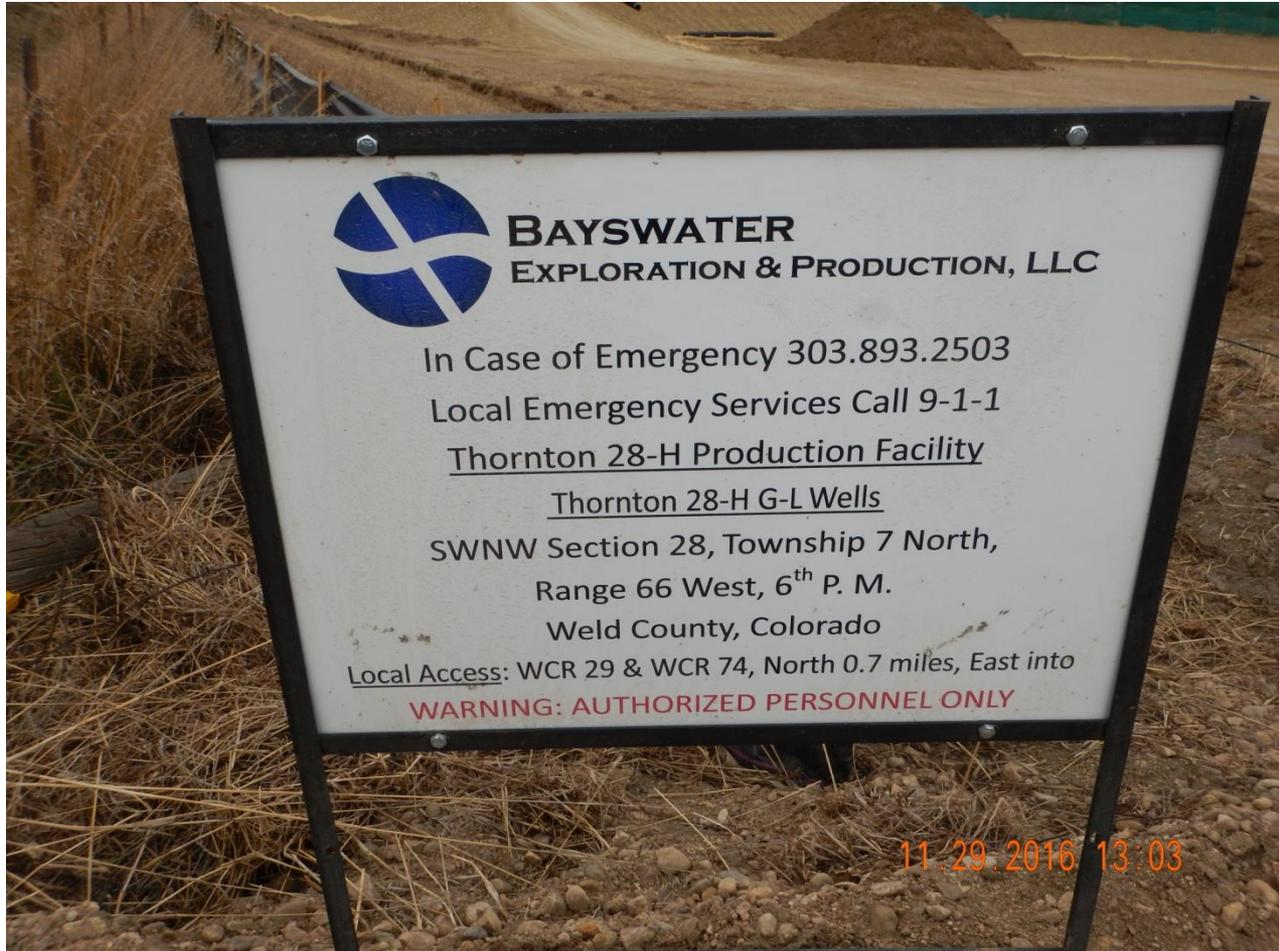
Photo 1. Photo taken of location sign at the entrance.

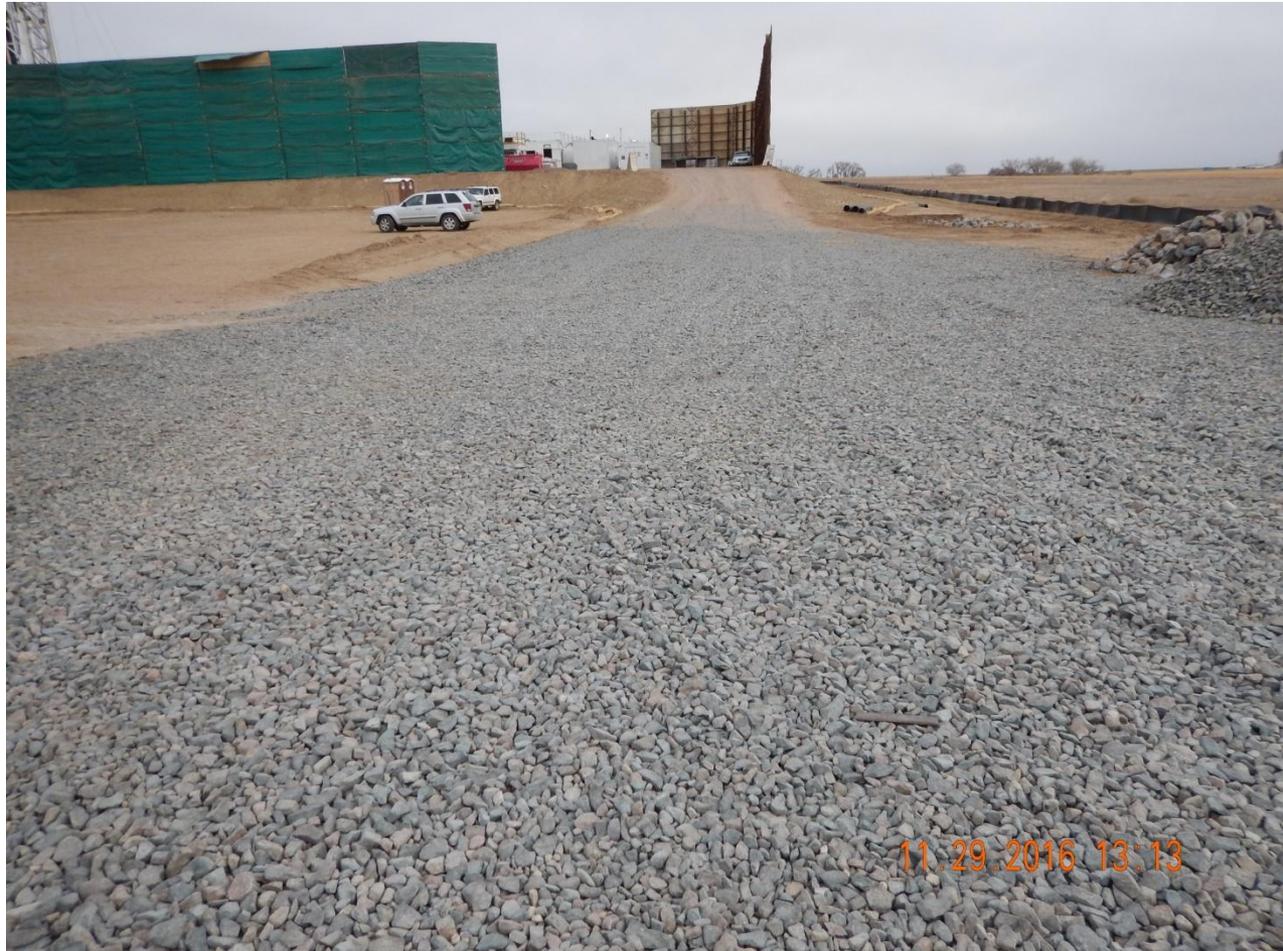
Photo 2. Photo taken from the entrance of location, facing East. Gravel installed to help control vehicle tracking and transport of sediment offsite.

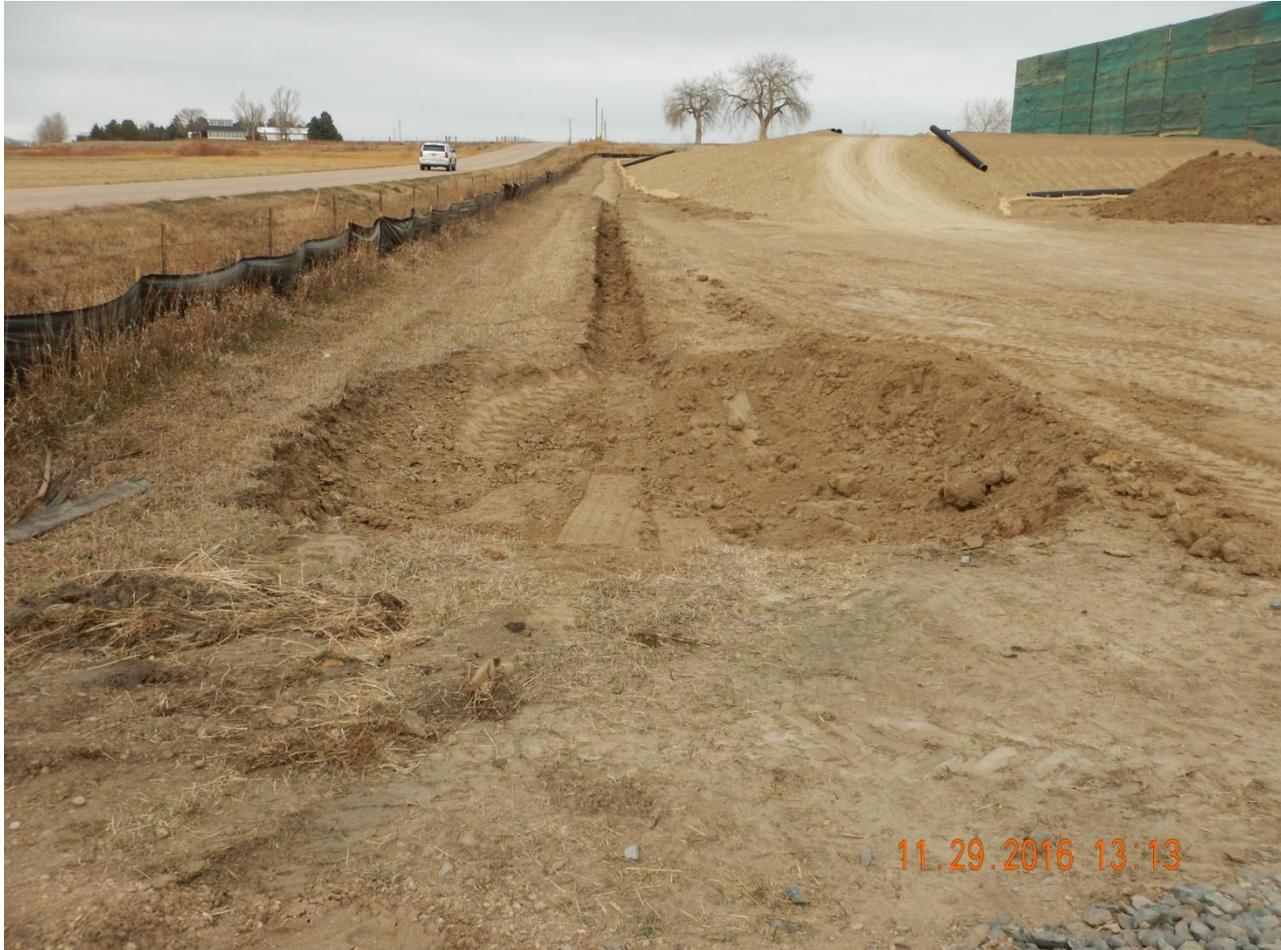
Photo 3. Photo taken from entrance of location, facing North. Sediment trap or retention pond IN-PROCESS. Silt fence installed around perimeter of location.

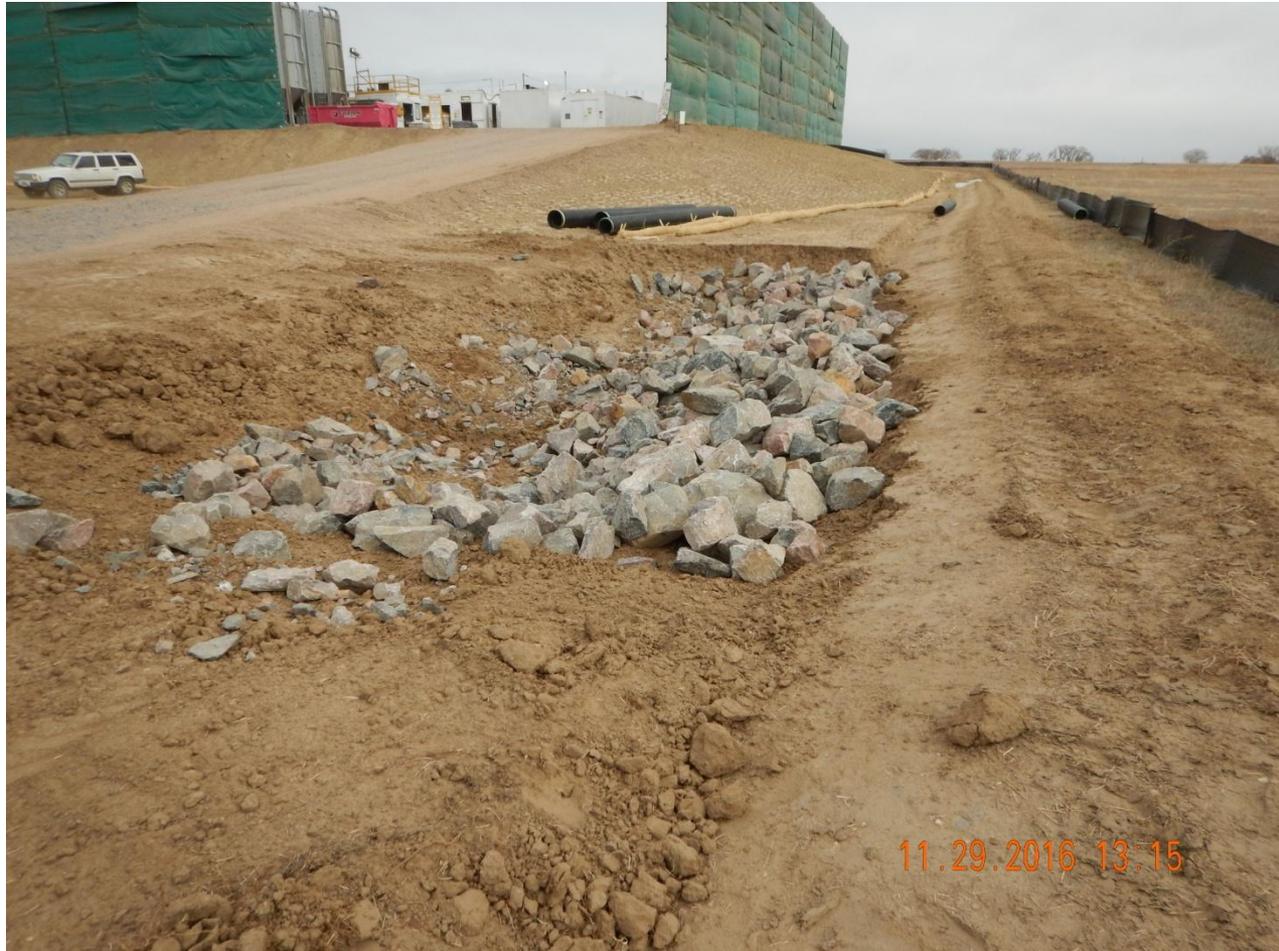
Photo 4. Photo taken from the southwest location, facing East. Ditch and berm installed around the perimeter of location with a sediment trap or retention pond IN-PROCESS. Silt fence installed around perimeter of location.

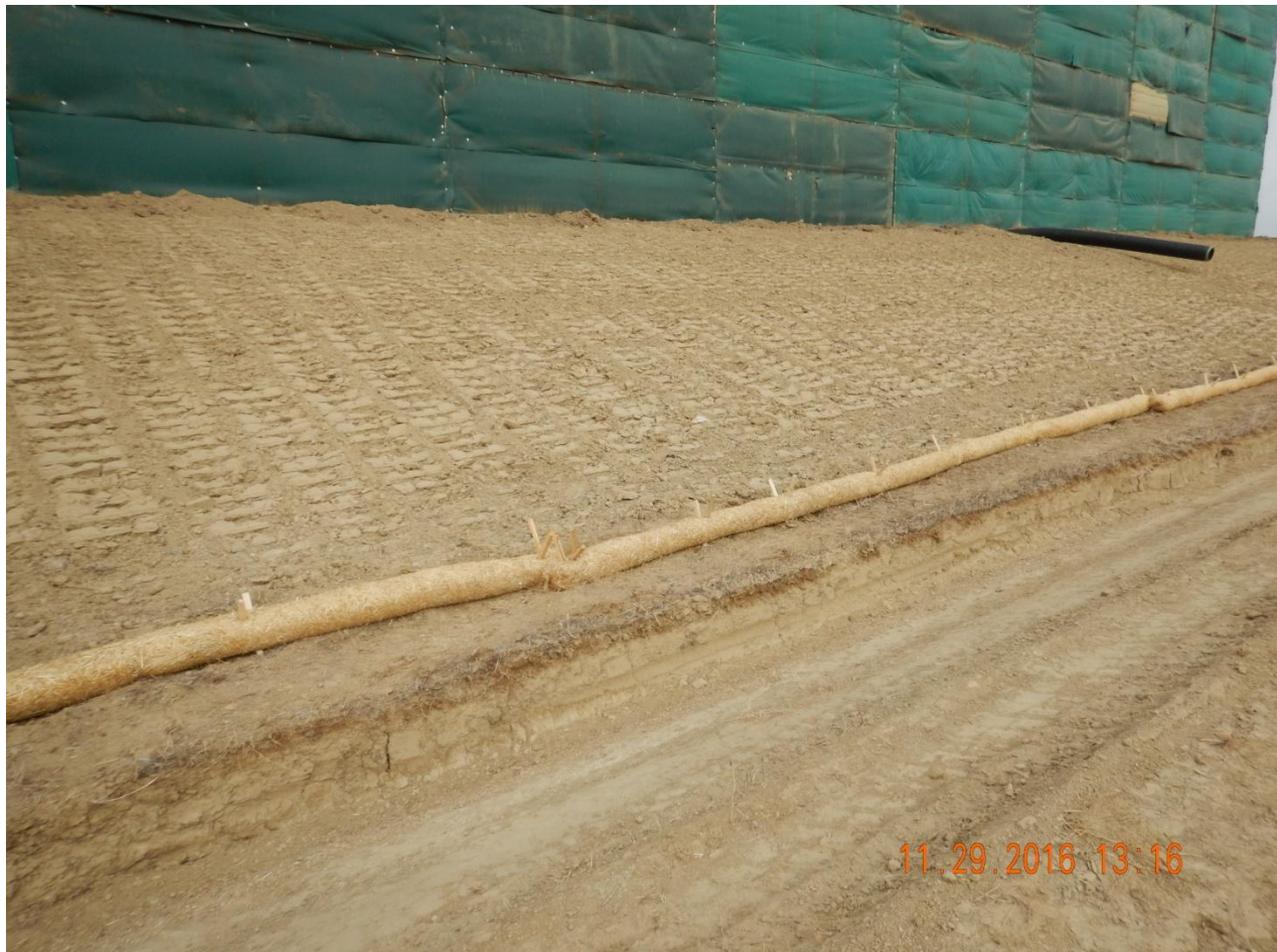
Photo 5. Photo taken from the southern location, facing North. Fill slope has been stabilized and additional, temporary BMP (i.e., wattle) installed at toe of the slope.

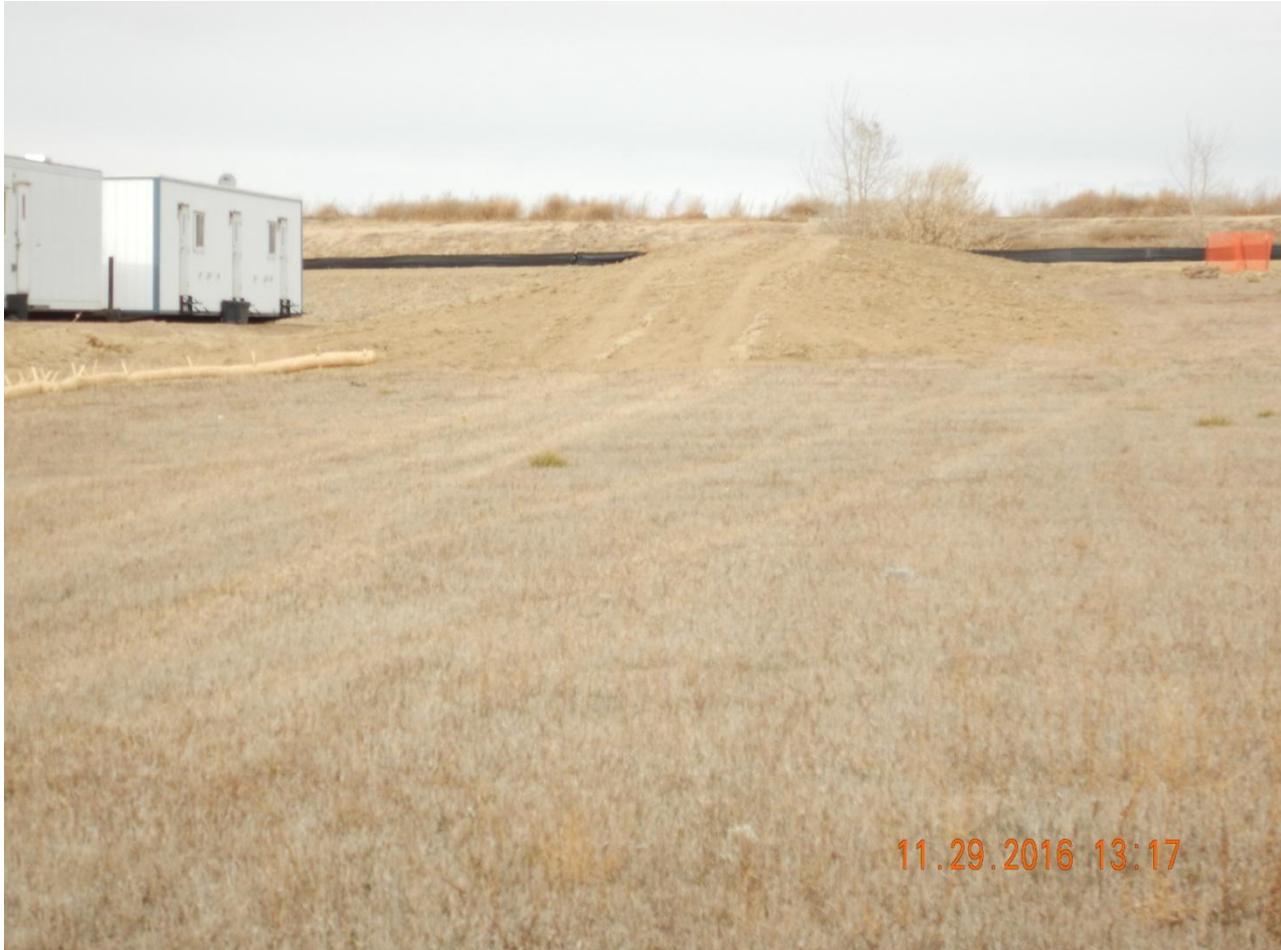
Photo 6. Photo taken from the eastern location, facing North. Topsoil stockpile stored along the eastern location.

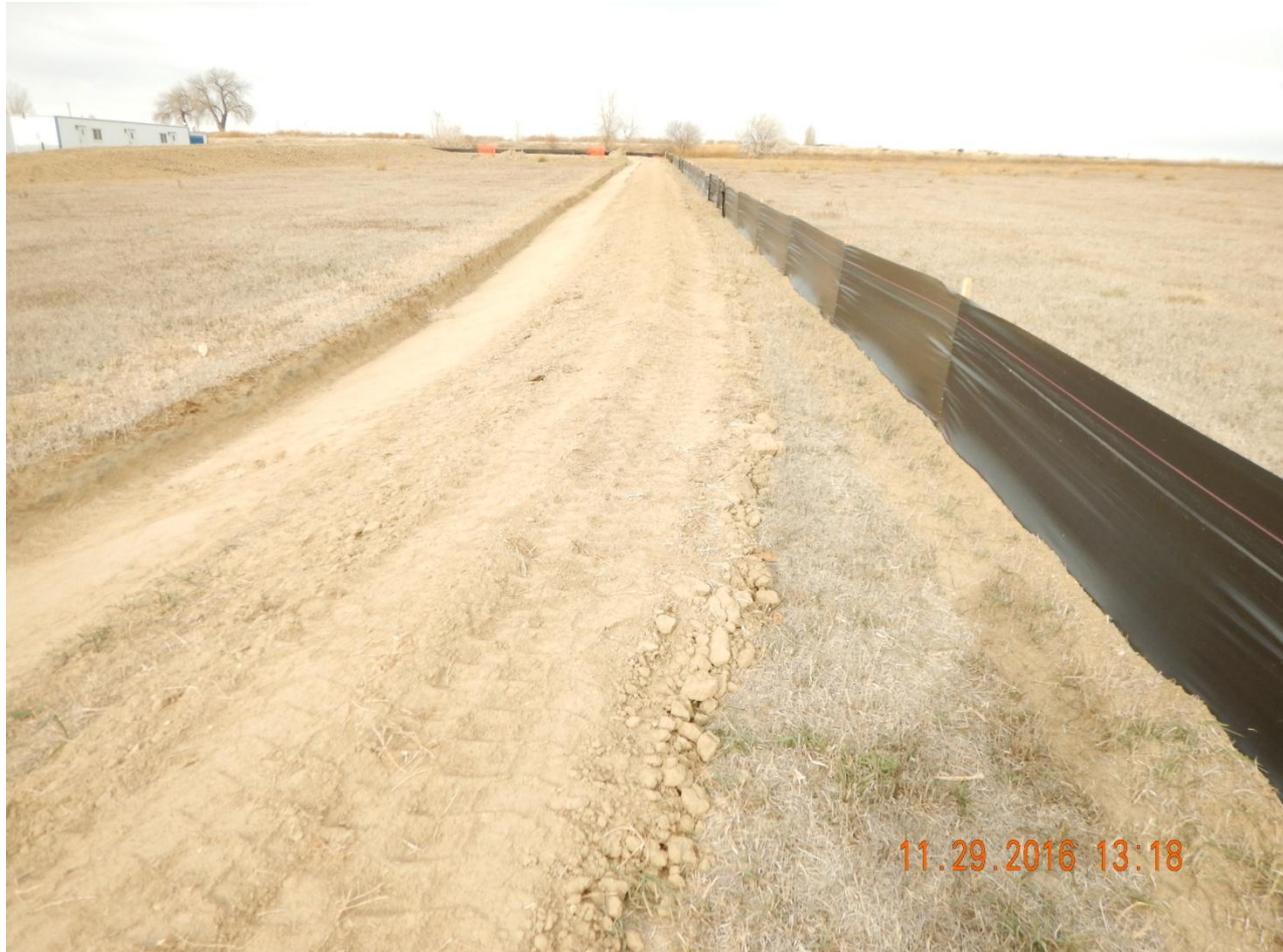
Photo 7. Photo taken from the eastern location, facing North. Ditch and berm installed around the perimeter of location with the addition of a silt fence installed around perimeter of location.

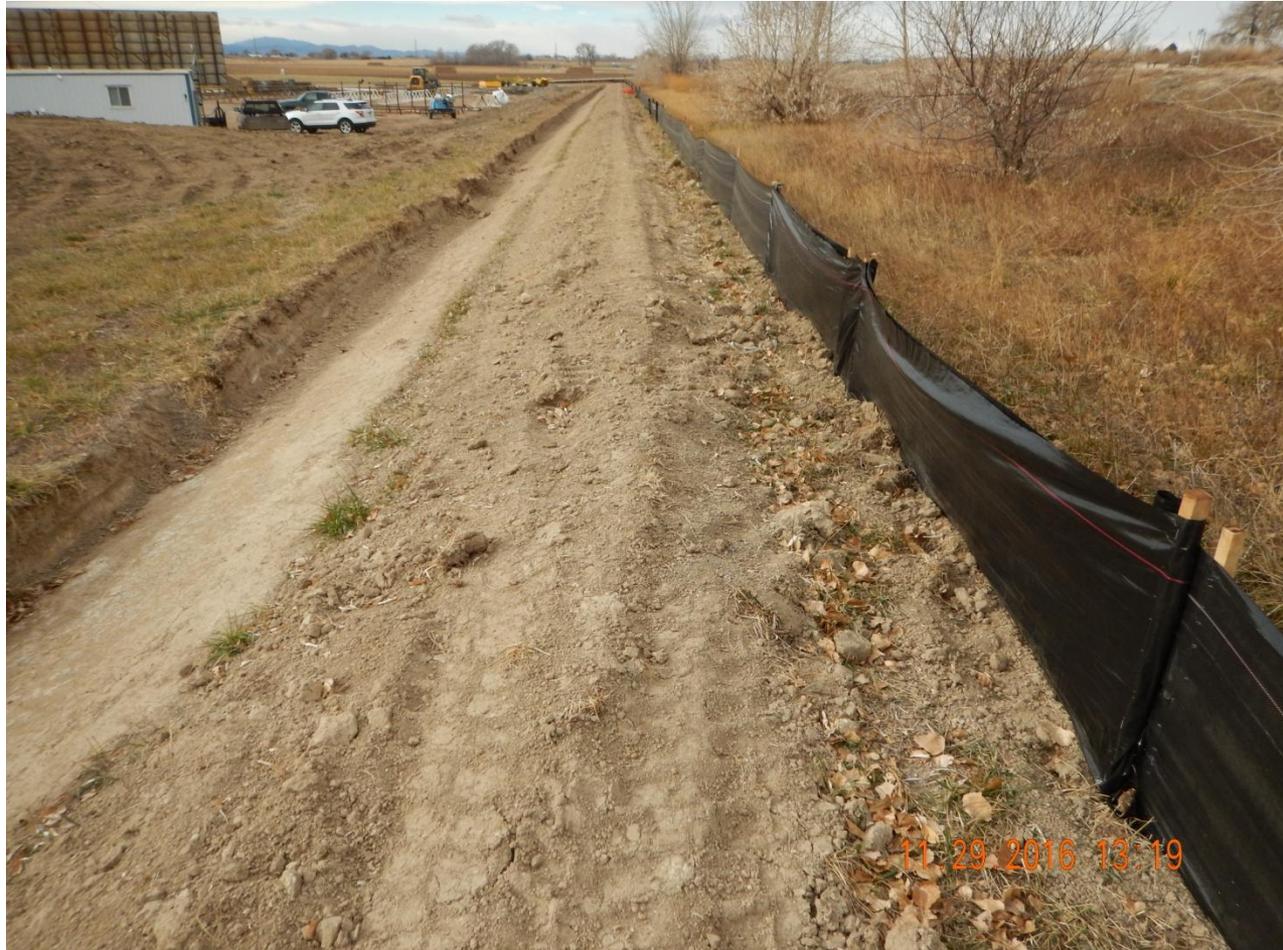
Photo 8. Photo taken from the northeast location, facing West. Ditch and berm installed around the perimeter of location with the addition of a silt fence installed around perimeter of location.

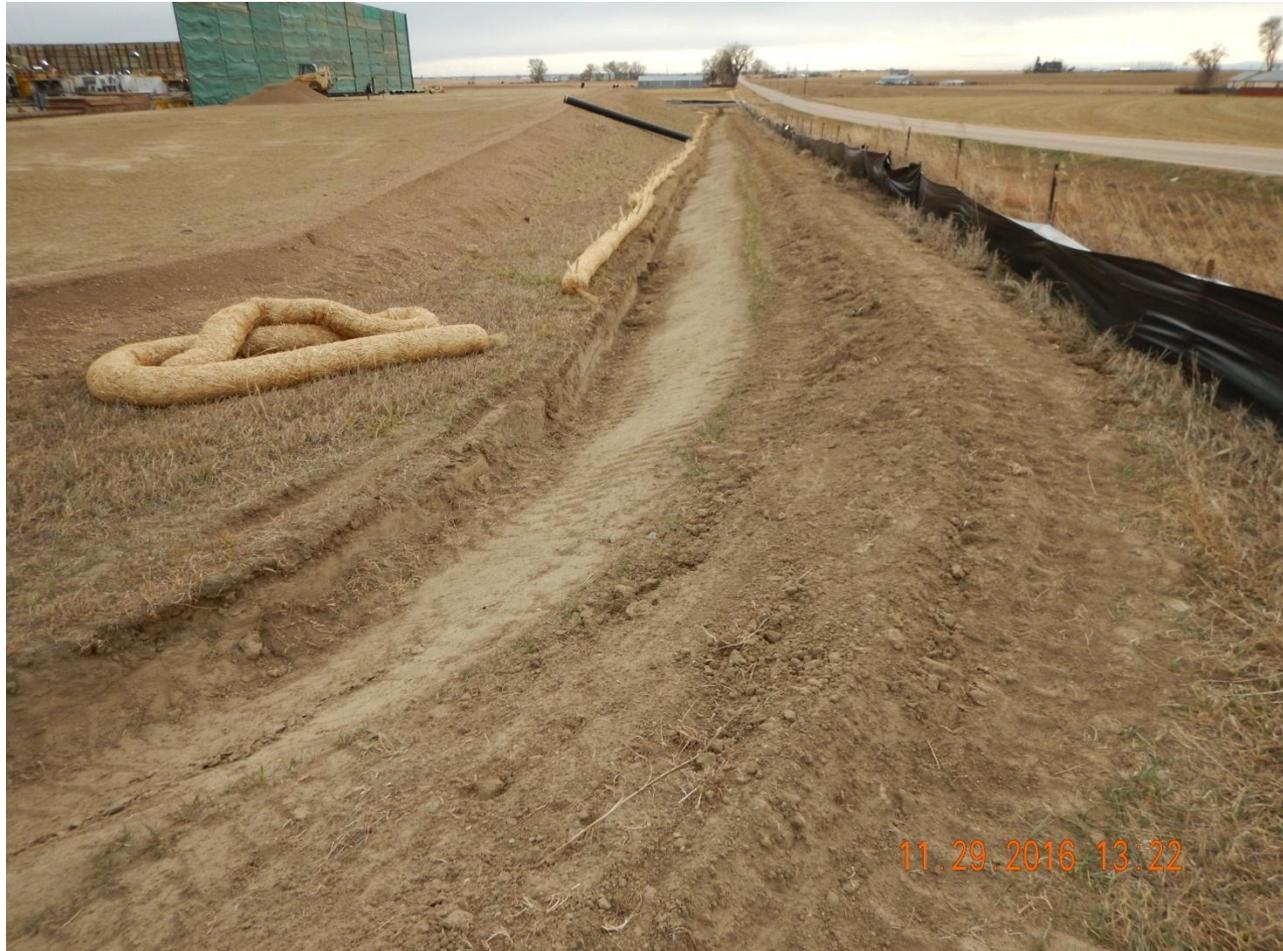
Photo 9. Photo taken from the northwest location, facing South. Ditch and berm installed around the perimeter of location with the addition of a silt fence installed around perimeter of location.

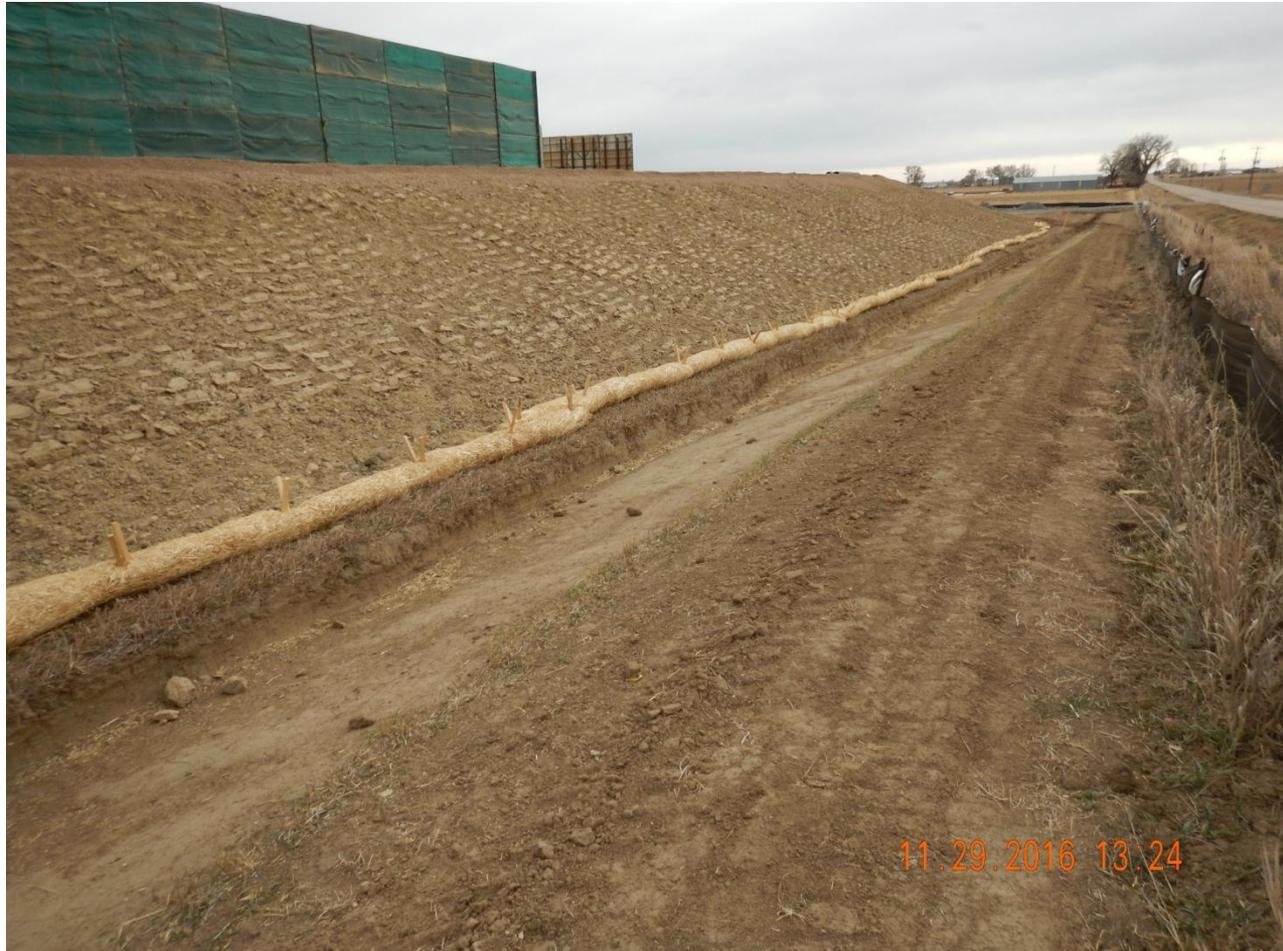
Photo 10. Photo taken from the western location, facing Southeast. Fill slope has been stabilized and additional, temporary BMP (i.e., wattle) installed at toe of the slope.

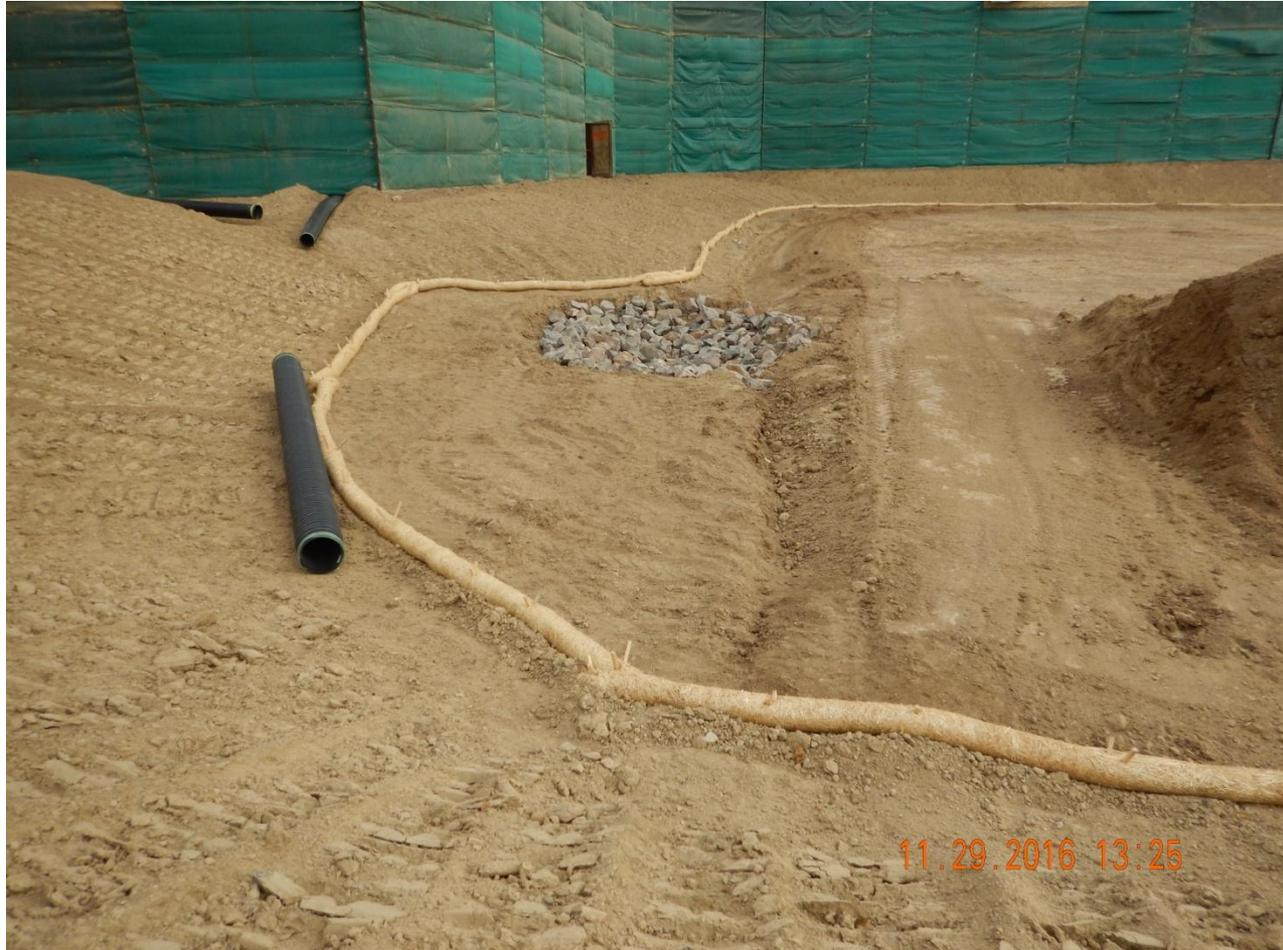
Photo 11. Photo taken from the western location, facing East. Retention pond installed at base of slope, fill slope stabilized with additional, temporary BMP (i.e., wattle) installed at toe of the slope.

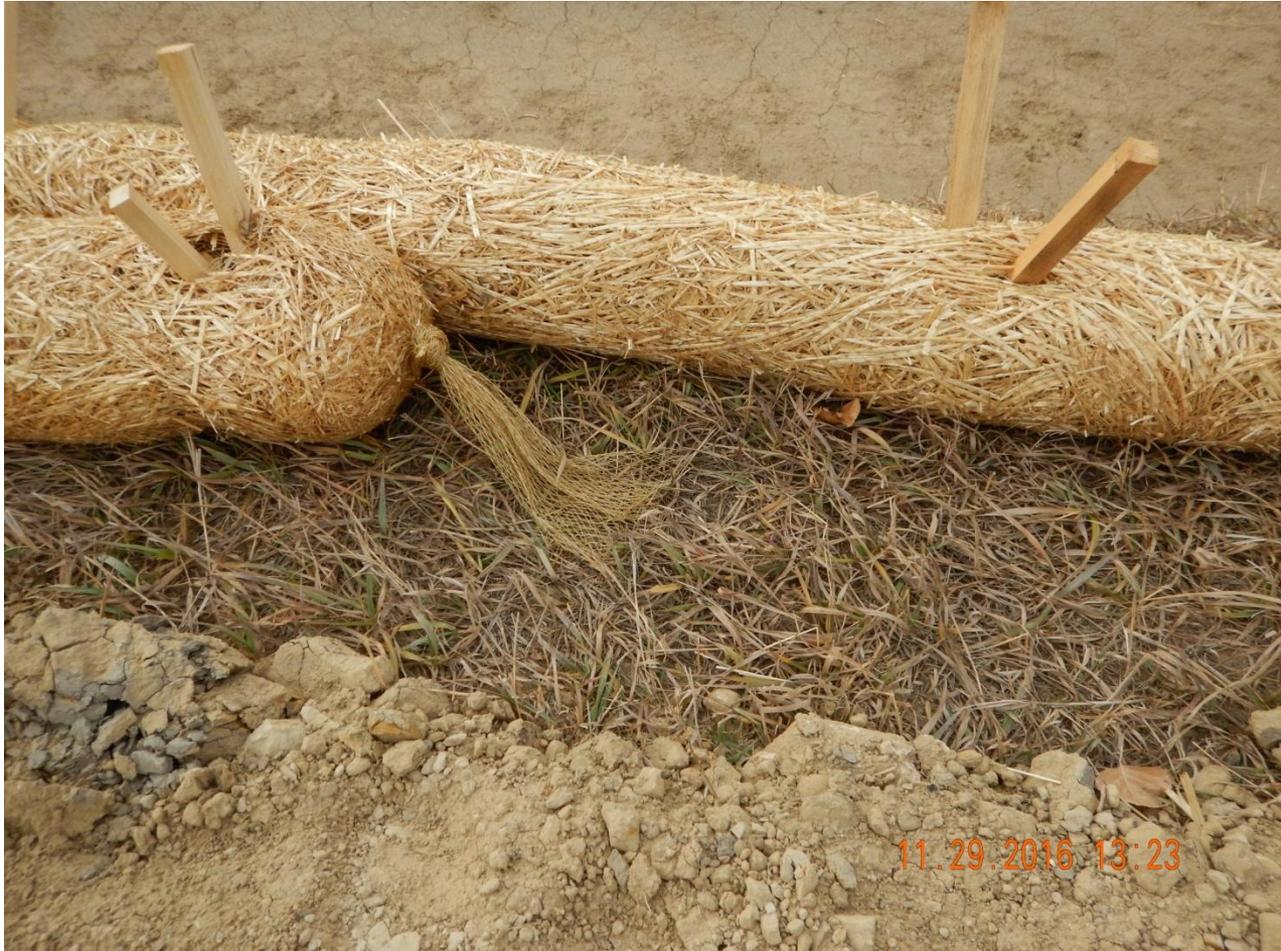
Photo 12. Close-up photo taken of the wattle installation. Wattles have been overlapped but not trenched and backfilled to prevent undermining.
