Final Reclamation Inspection

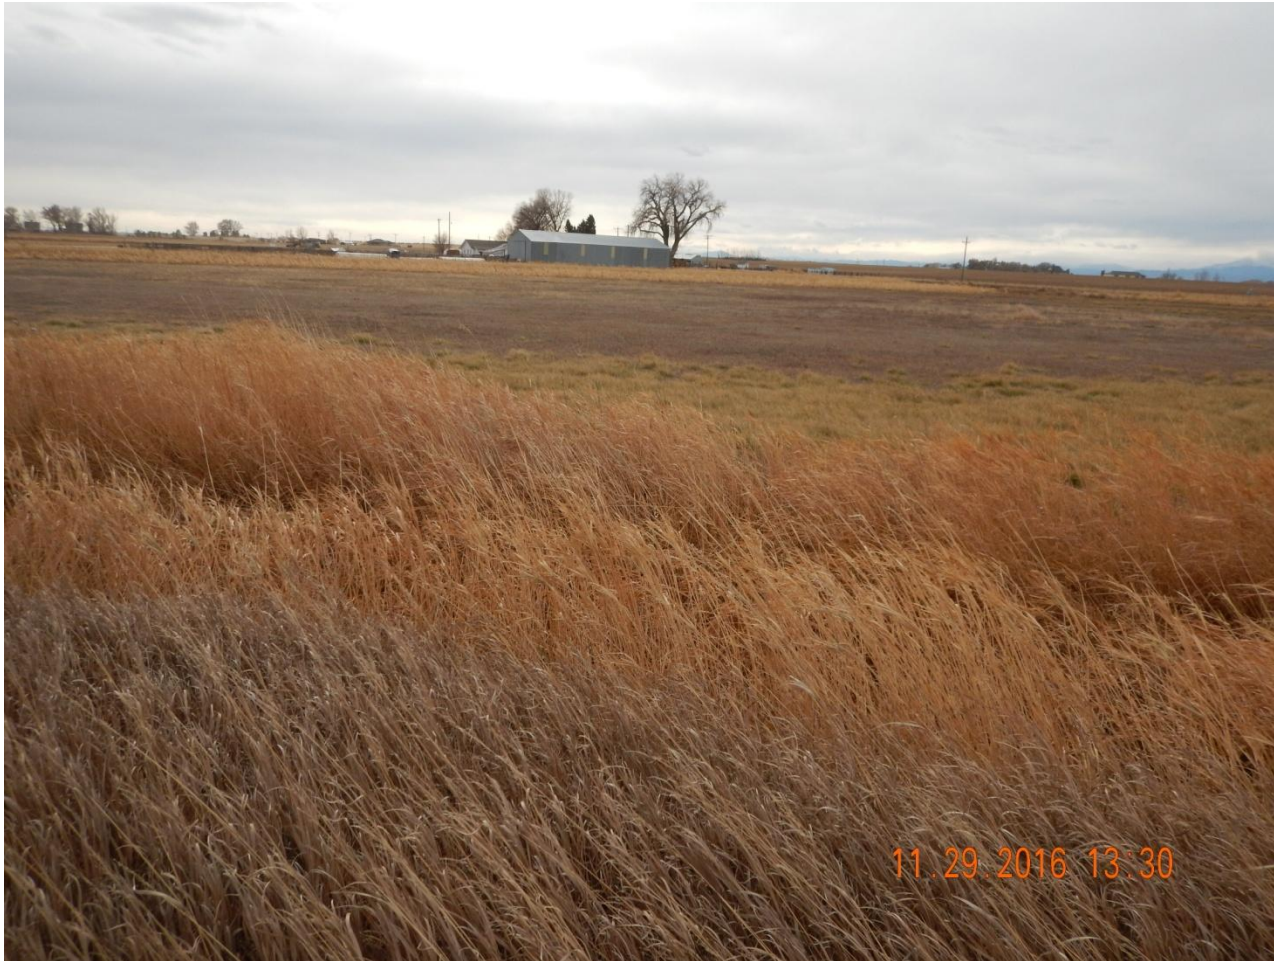
Photo 1. Photo taken north of location, facing Southwest. Does not appear the well was constructed at the proposed location based off field observations.

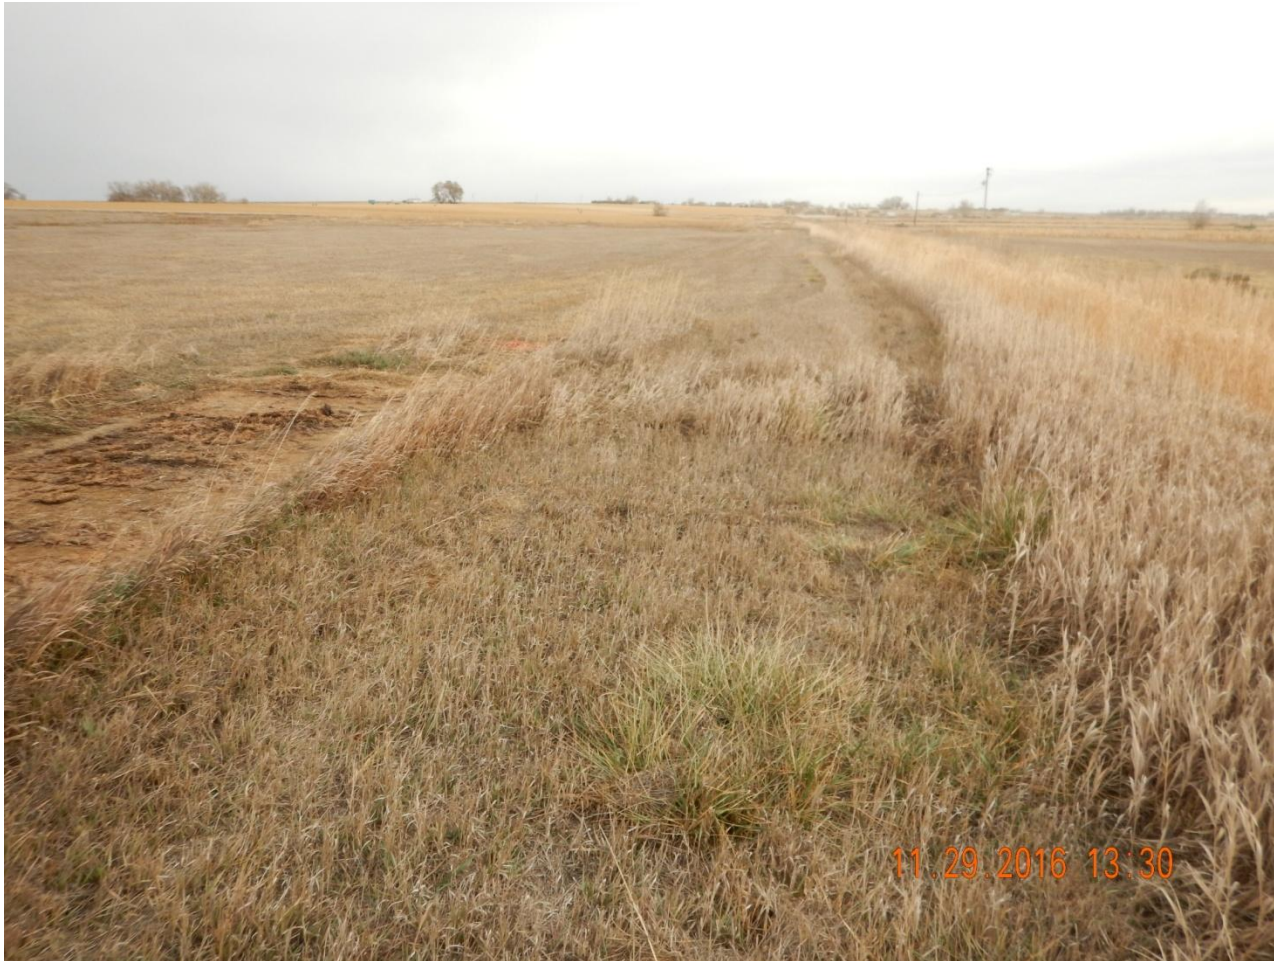
Photo 2. Photo taken north of location, facing Southeast. Does not appear the well was constructed at the proposed location based off field observations.
