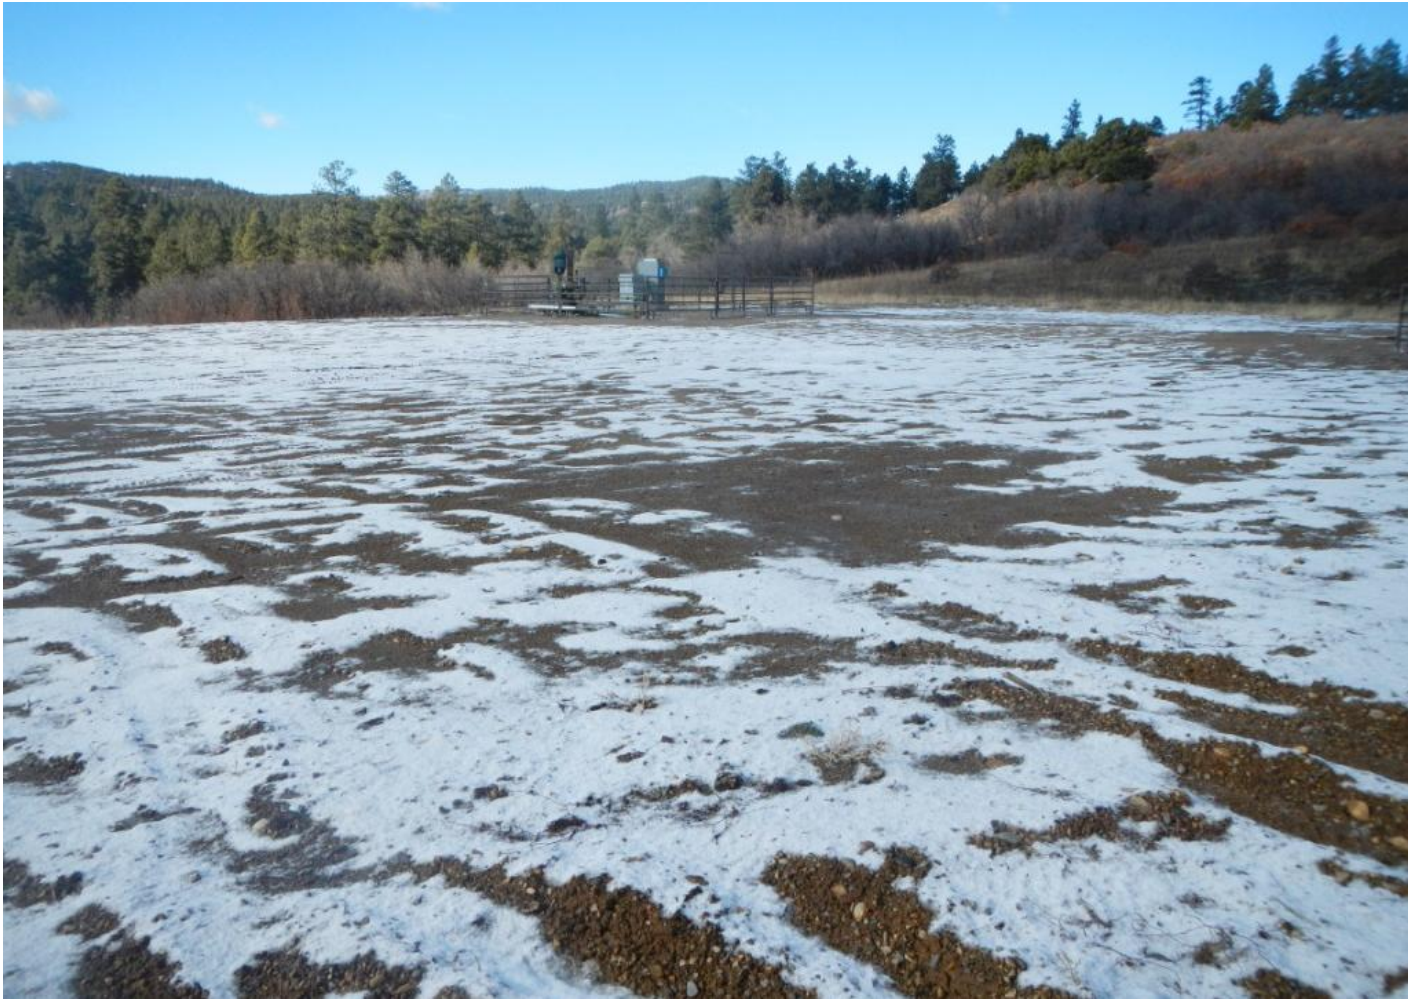
Photo 1. View of the project area from the southeastern corner facing center.

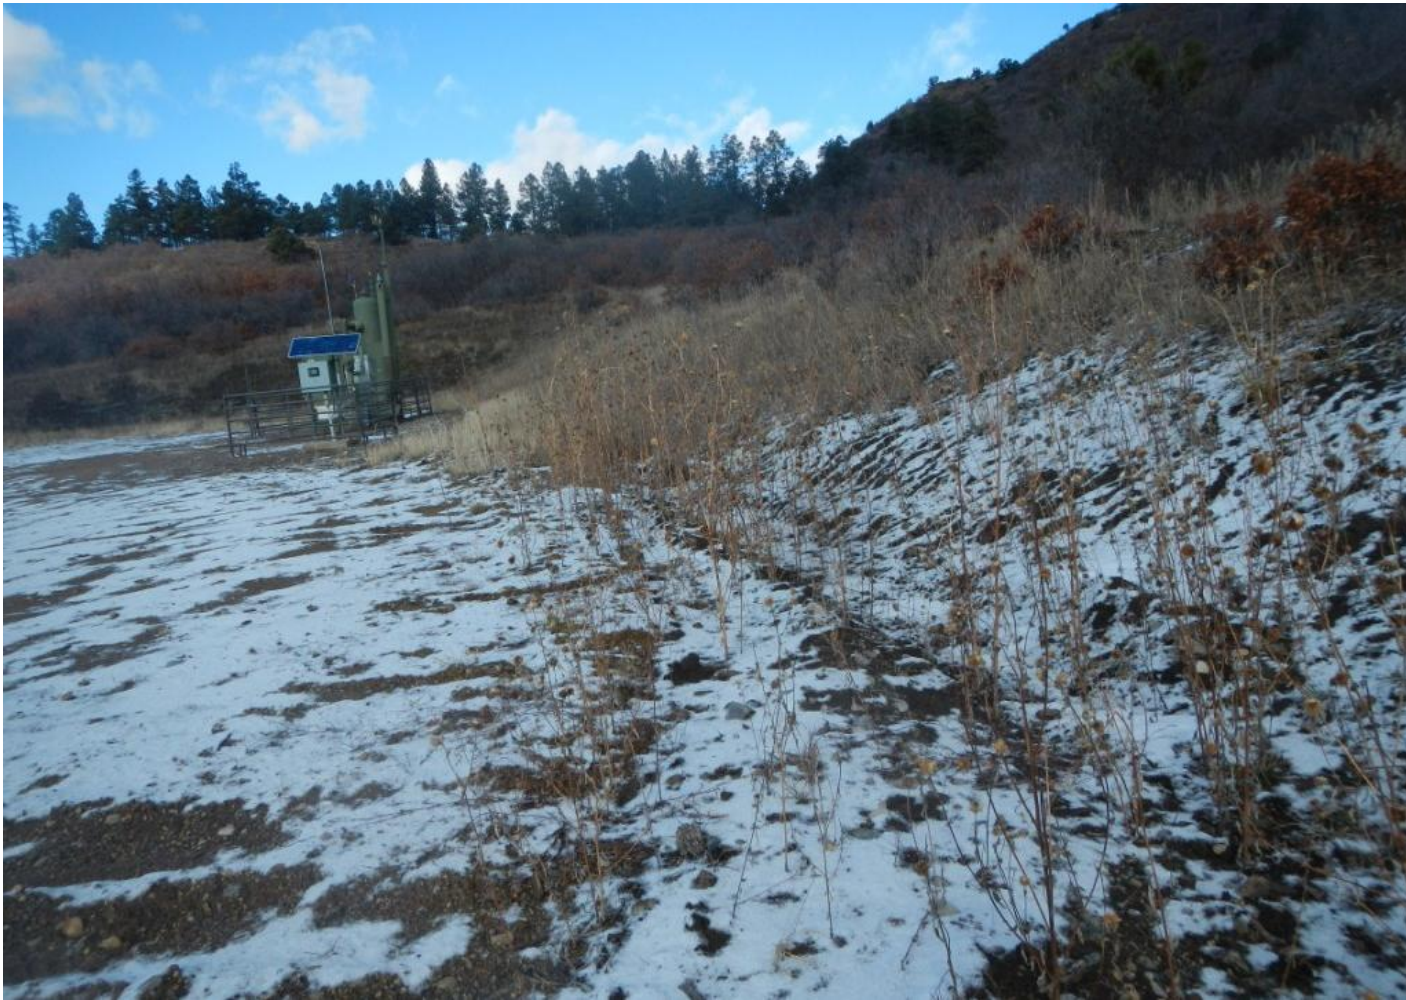
Photo 2. View of the eastern portion of the project area from the southeastern corner facing northward. Wood debris described in the August 2015 inspection has been removed.

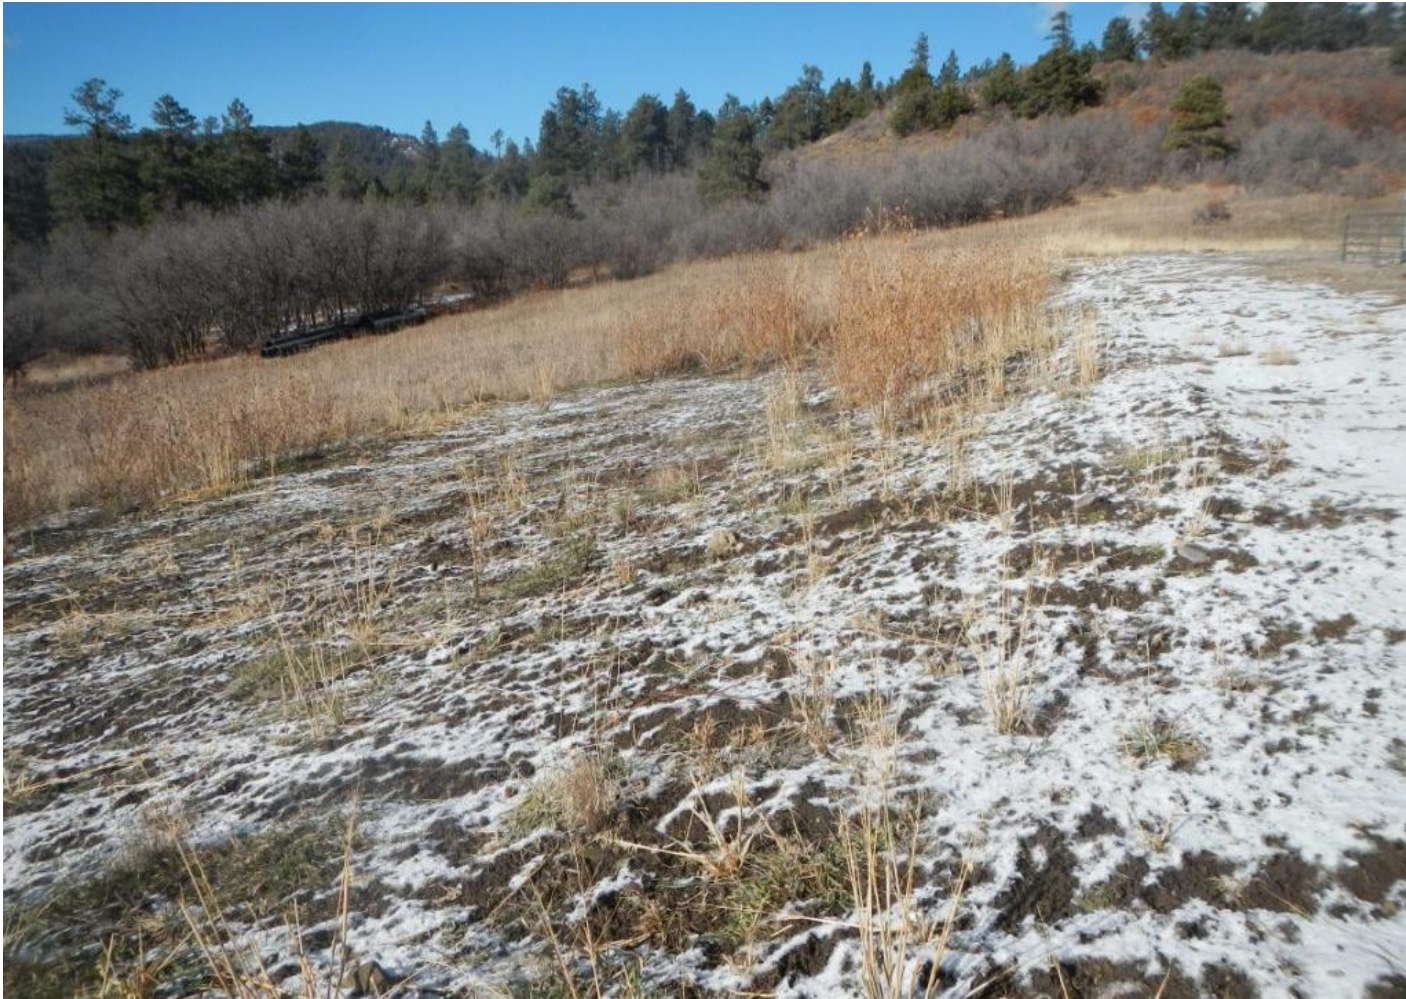
Photo 3. View of the western portion of the project area from the southwestern corner facing northward.

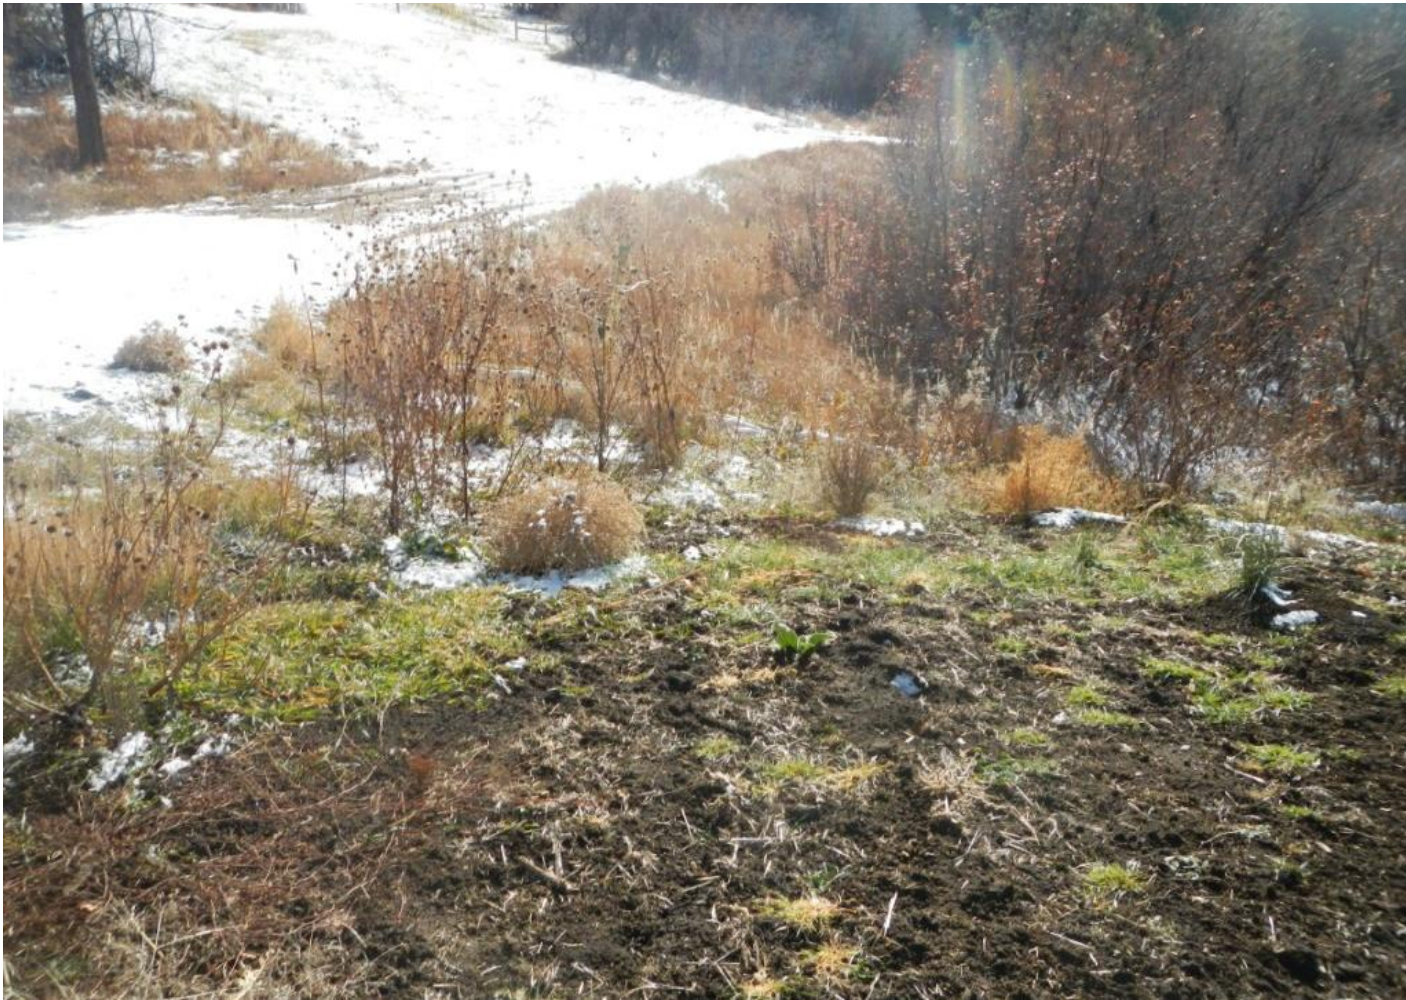
Photo 4. View of area near well pad entrance where it appears stormwater erosion is repaired.
