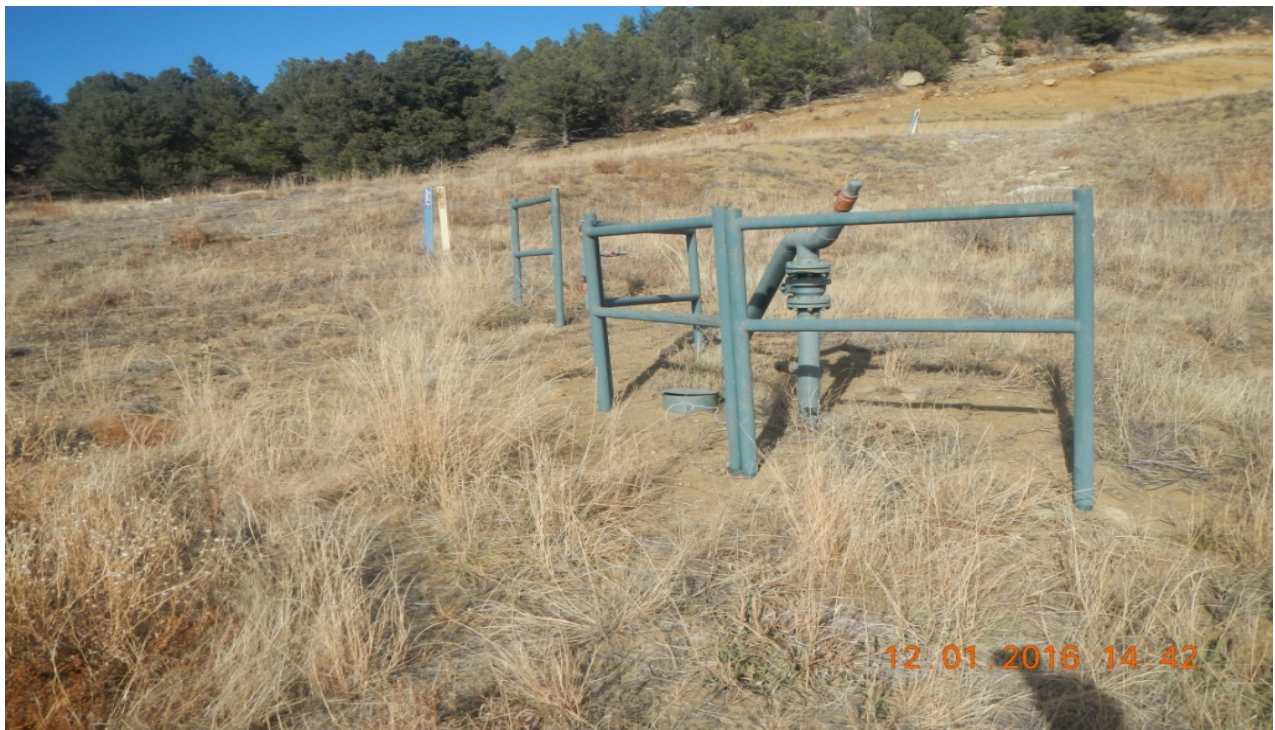
photo 2: Pipe risers remain near the location.

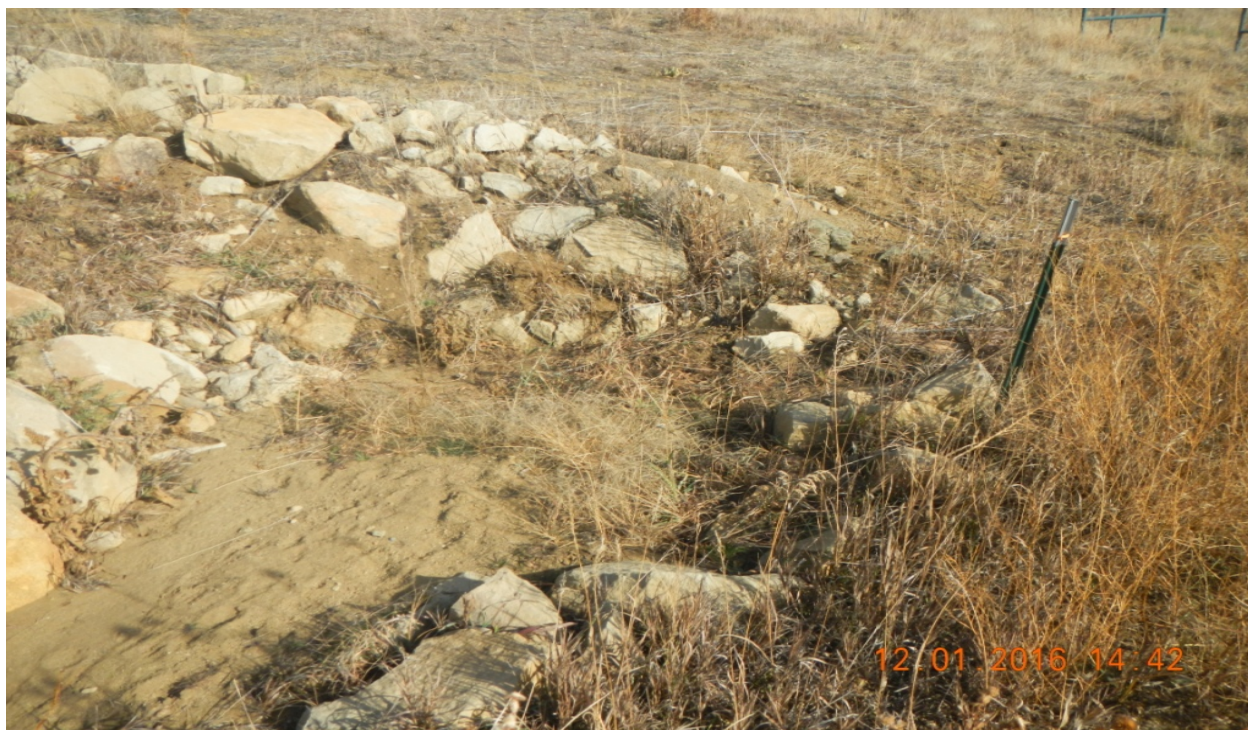
photo 3: The culvert near the access road is filled in with sediment.

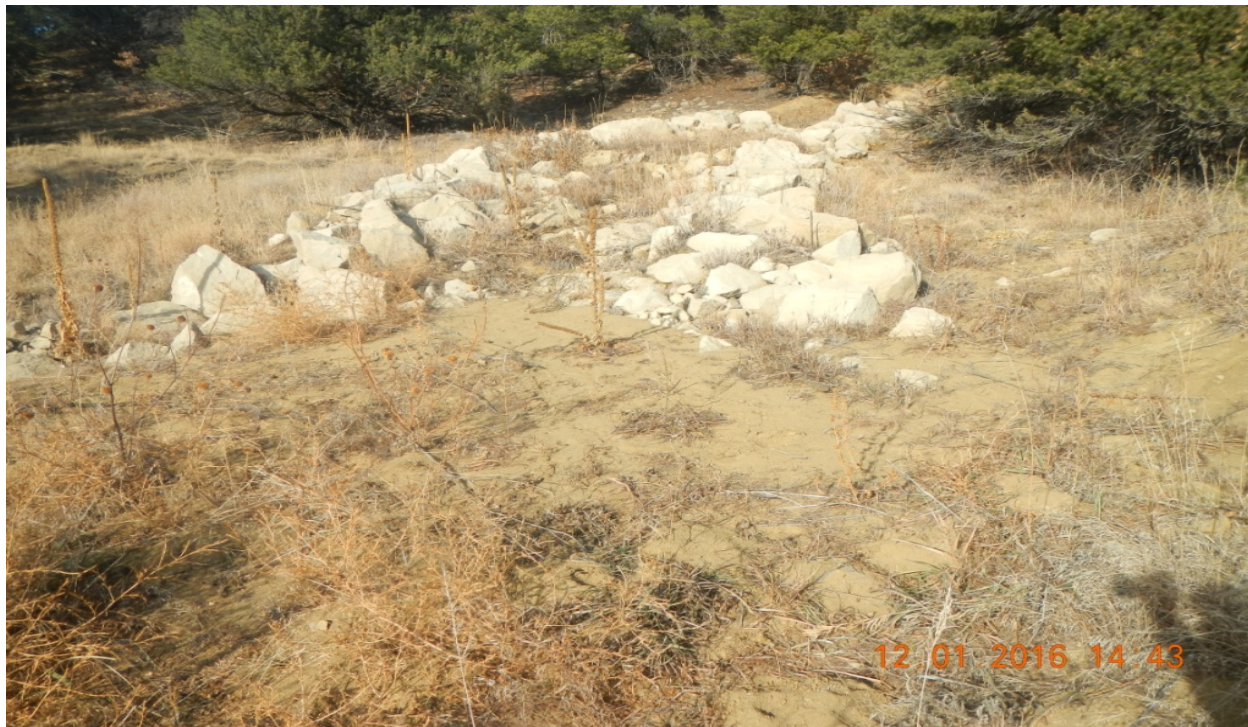
photo 4: A sediment trap along the western side of the location is filled in with sediment.

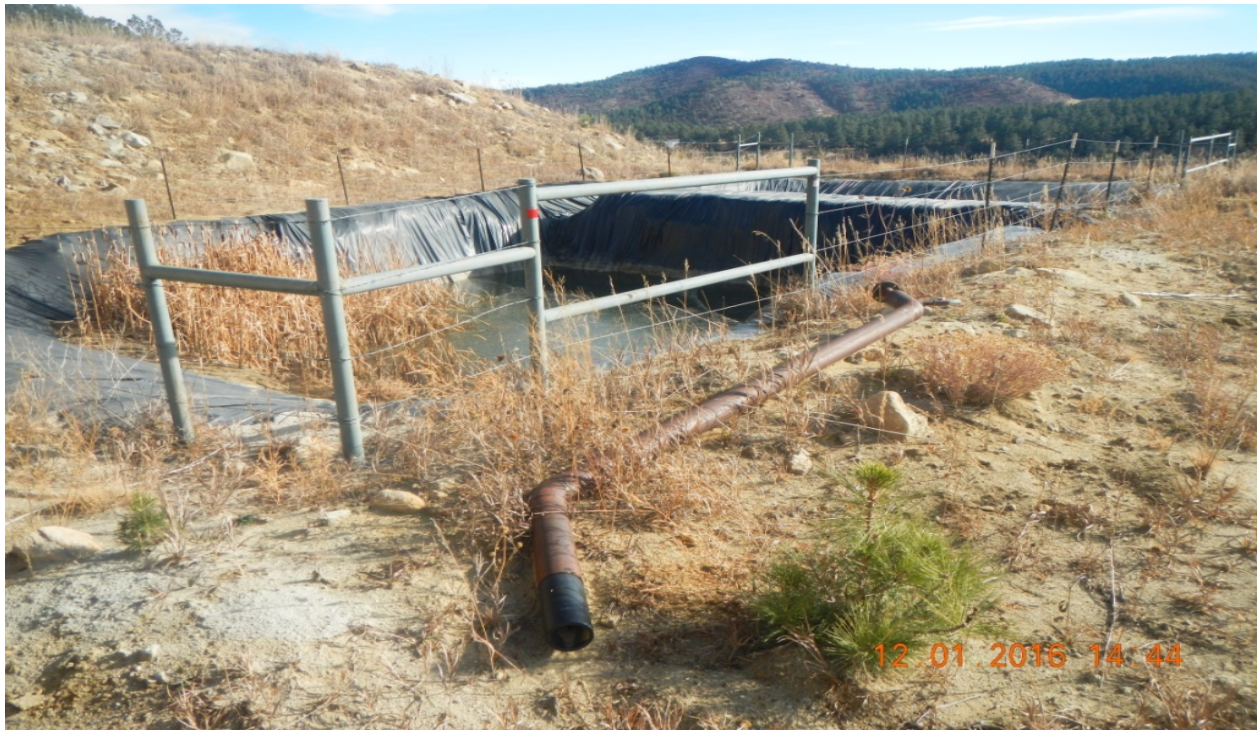
photo 7: The lined pit remains at the east side of the location.

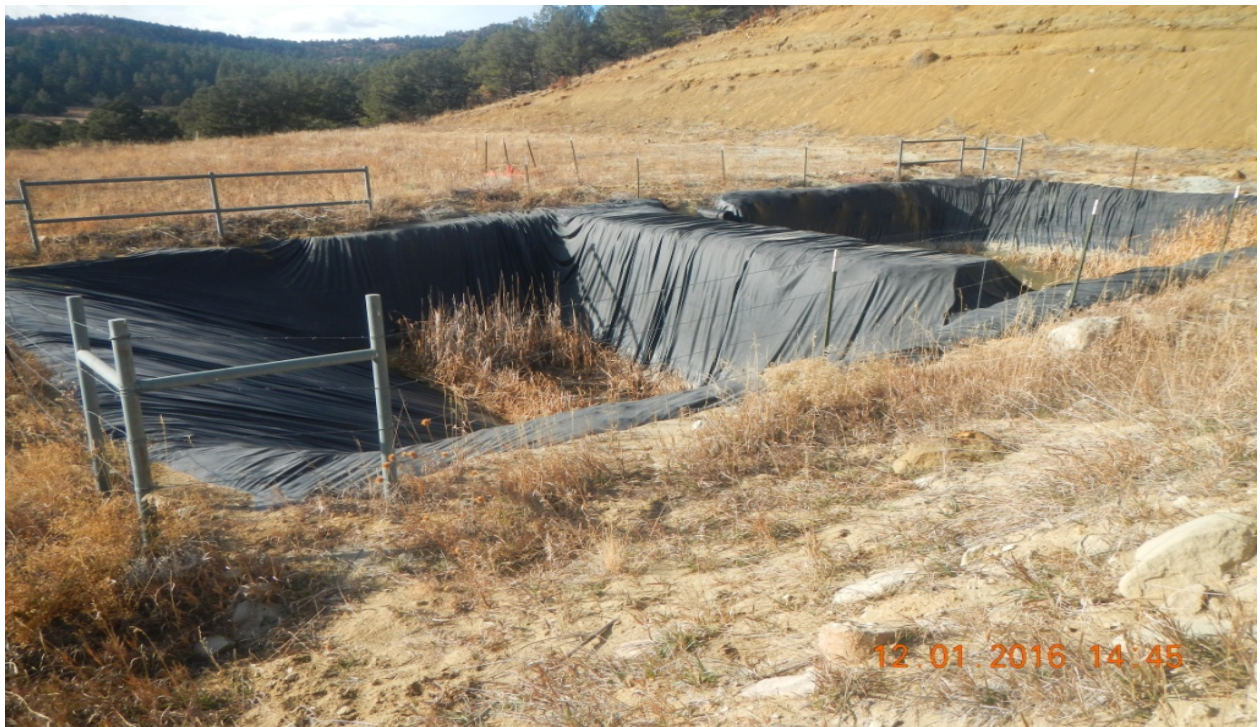
photo 8: Facing northwest. The lined pit remains at the east side of the location.

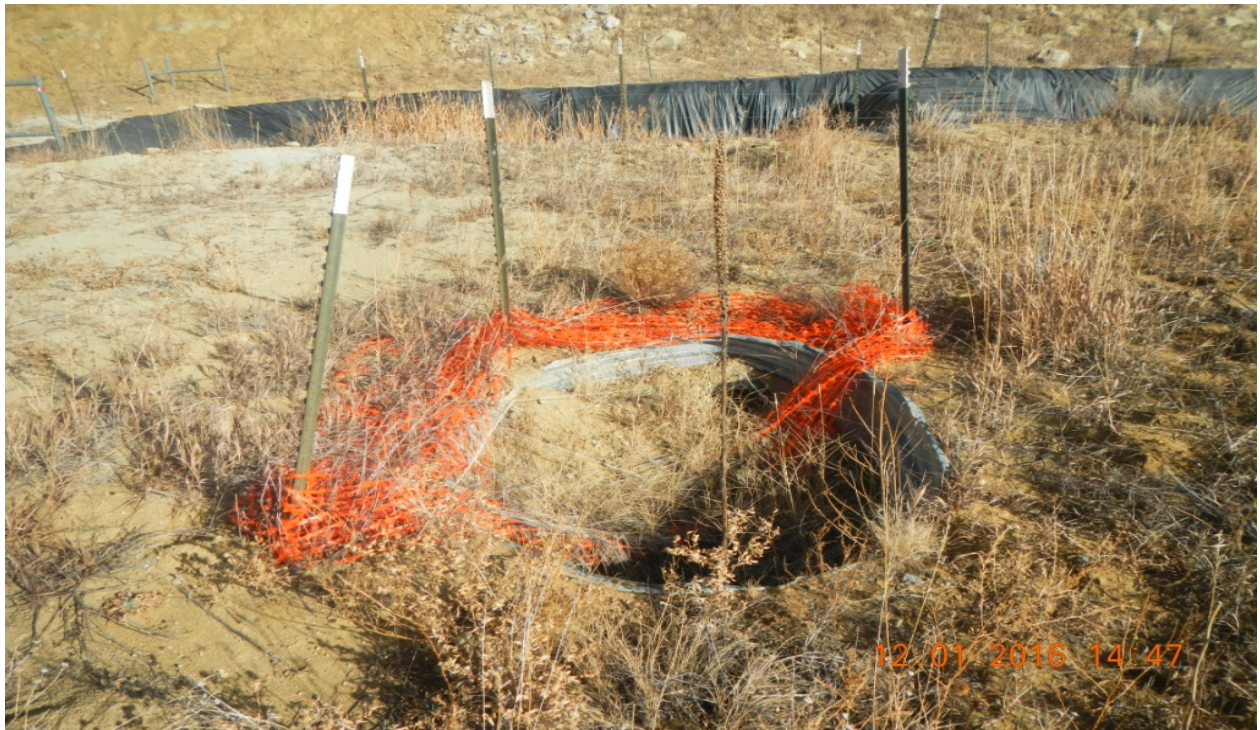
photo 11: Center of the location a conductor is present. Plastic safety fence is in disrepair.
