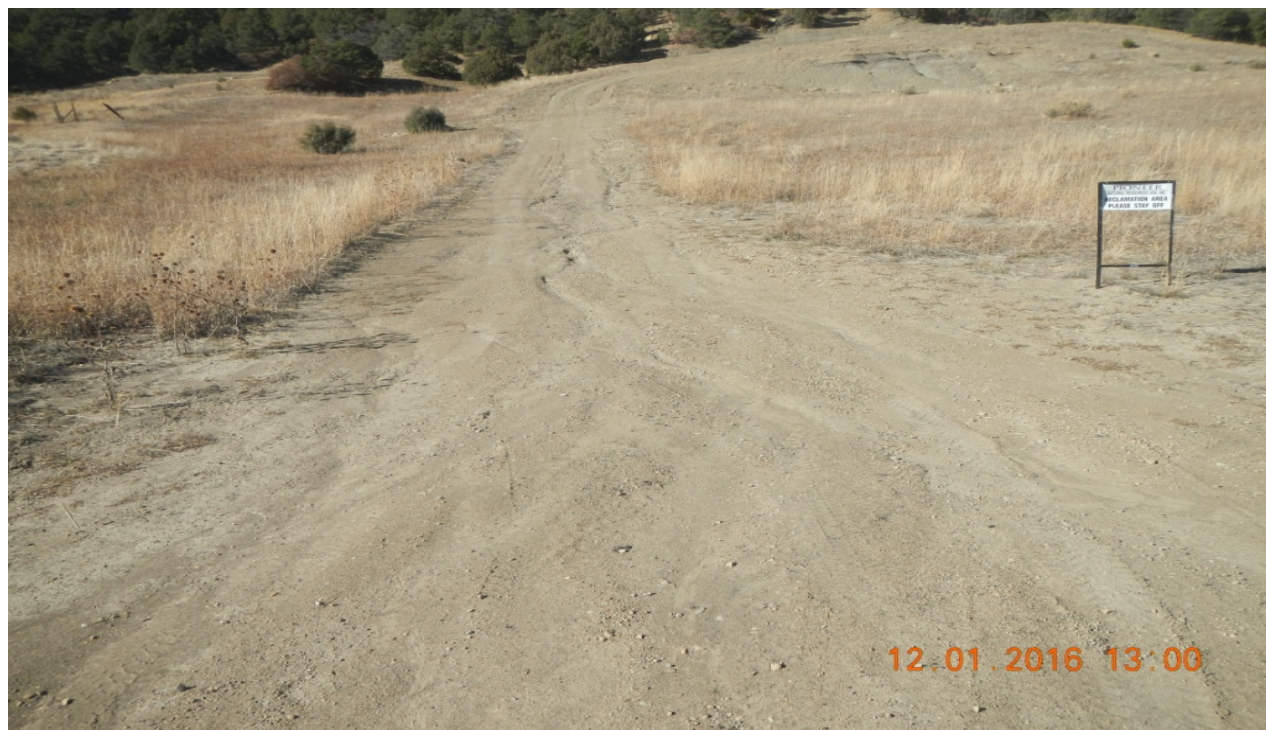
photo 1: Facing northwest at the beginning of the access road.

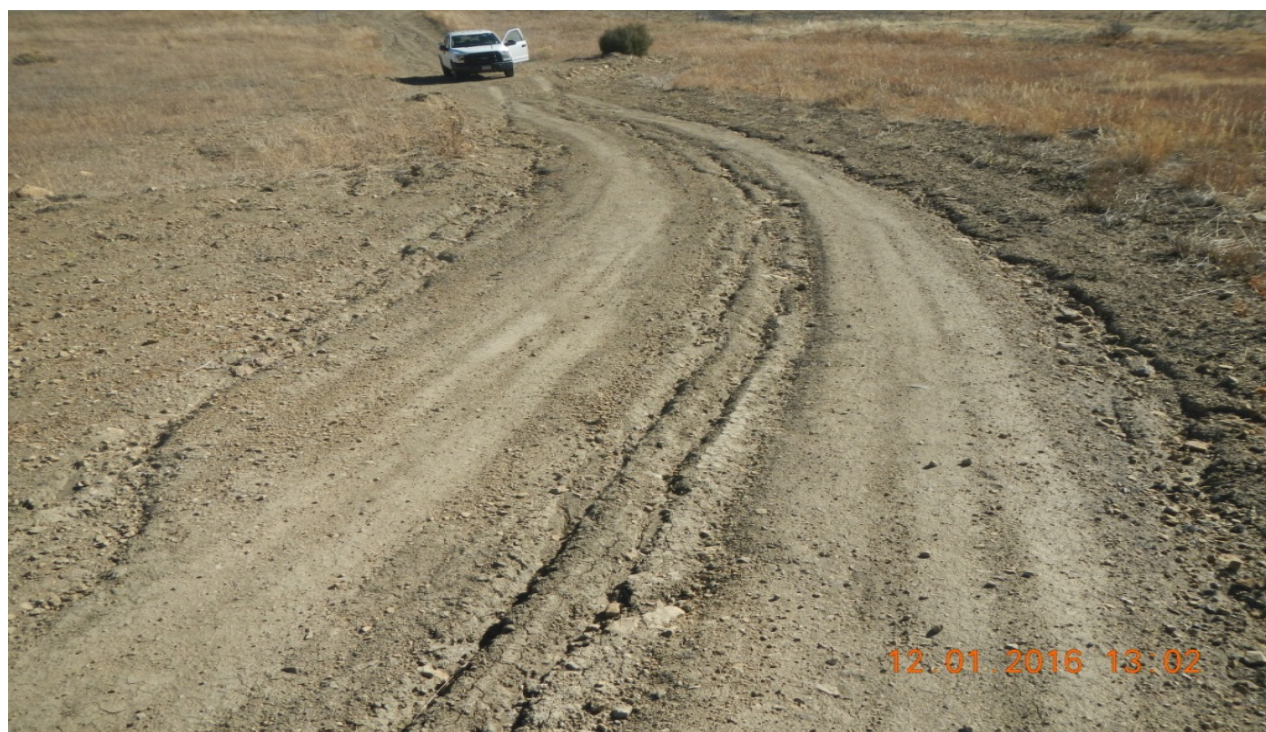
photo 2: Facing back to the southeast along the access road. There are signs of erosion occurring down along the road.

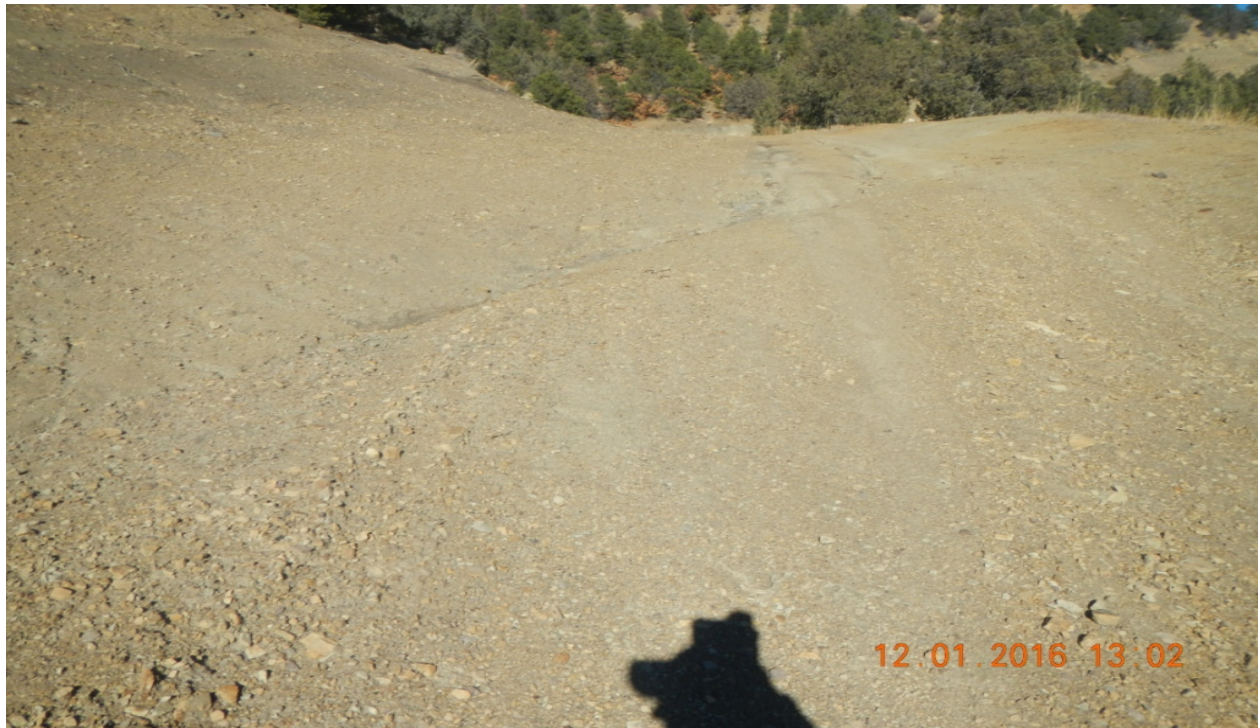
photo 3: There are water bars placed along the road.

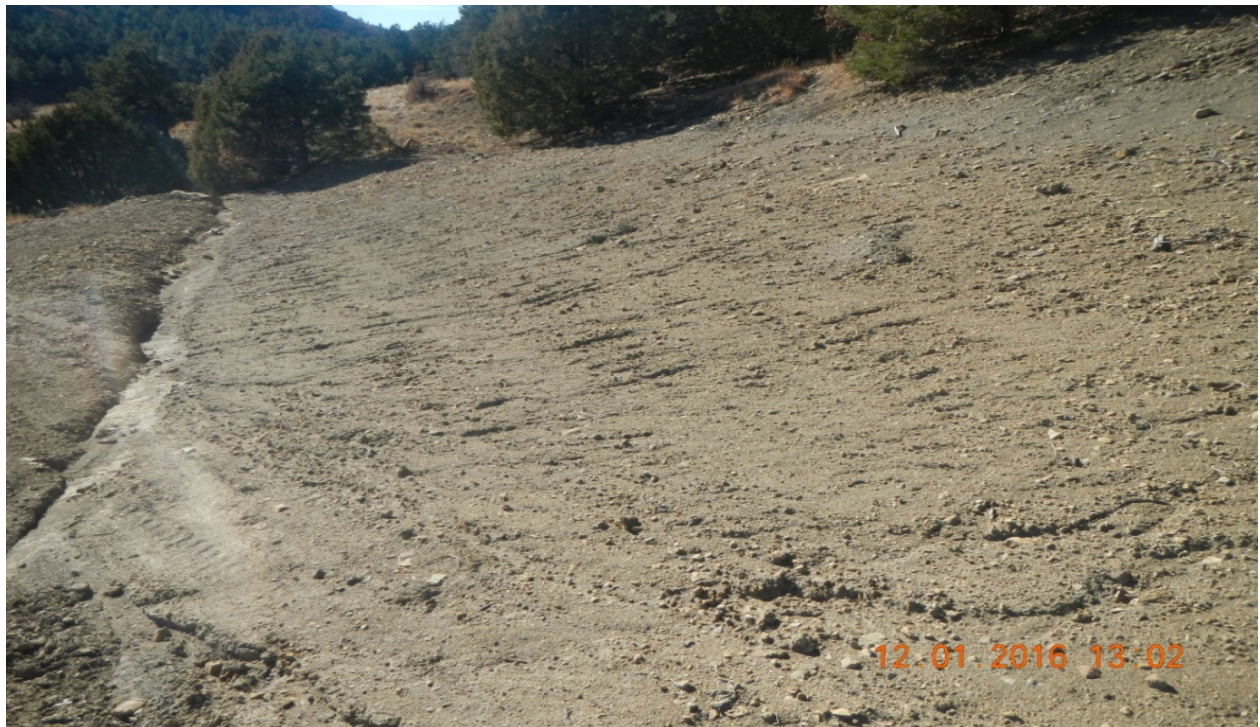
photo 4: The disturbance along the side of the road has not been reclaimed and stabilized.

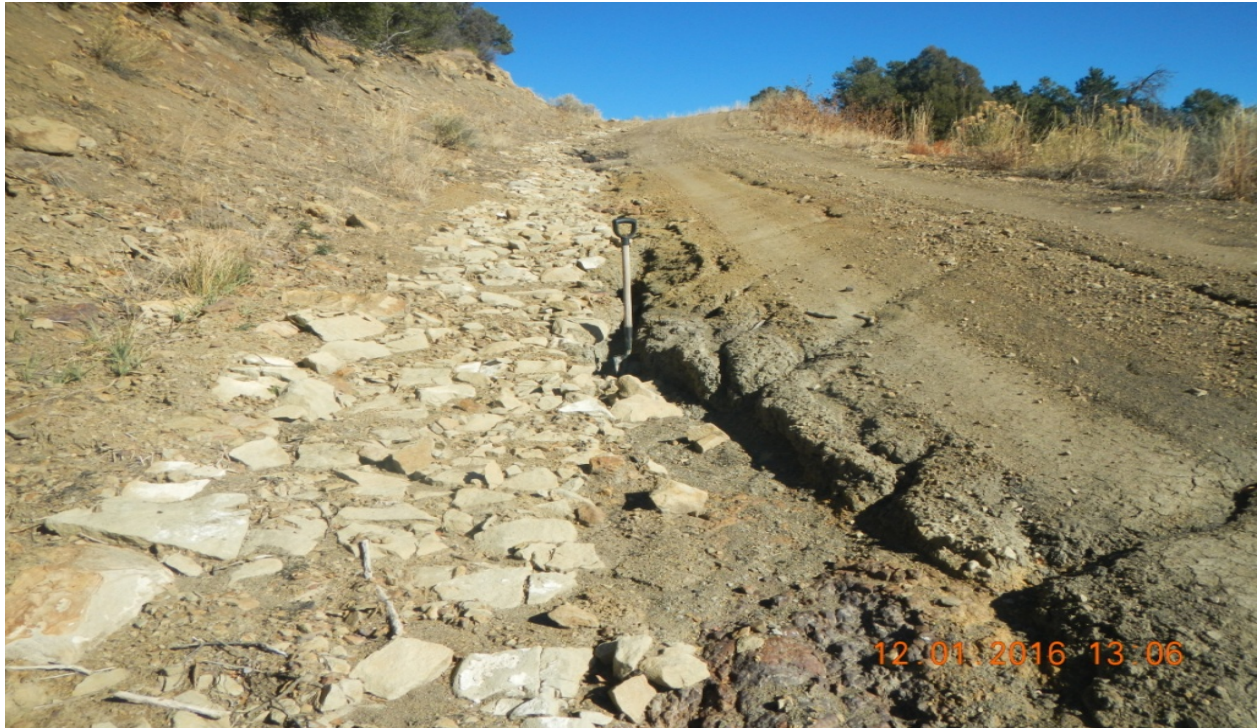
photo 5: Erosion is occurring along the rock rip/rap cutting into the road. It appears sediment has filled into the rip/rap.

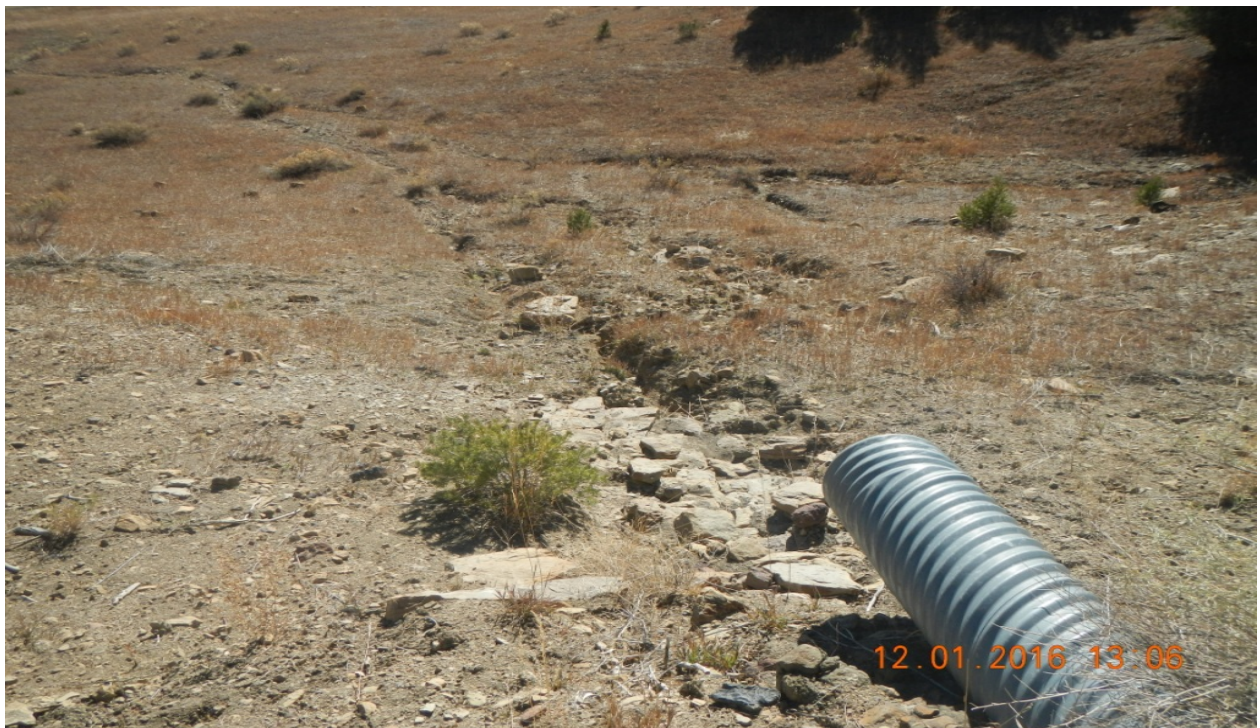
photo 6: Stormwater draining from the culvert is creating erosion out into the pasture.

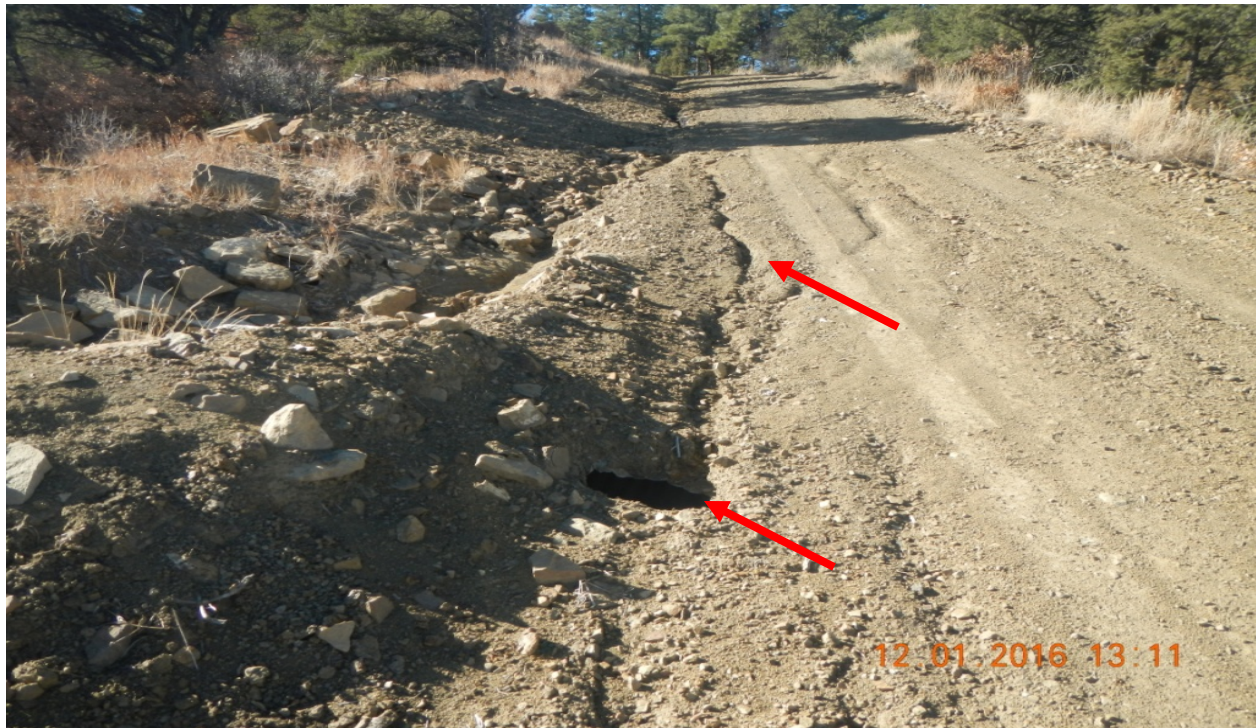
photo 7: There are signs where stormwater is not draining towards the culvert, instead flowing down the road. There is a hole in the culvert where bottom red arrow points to.

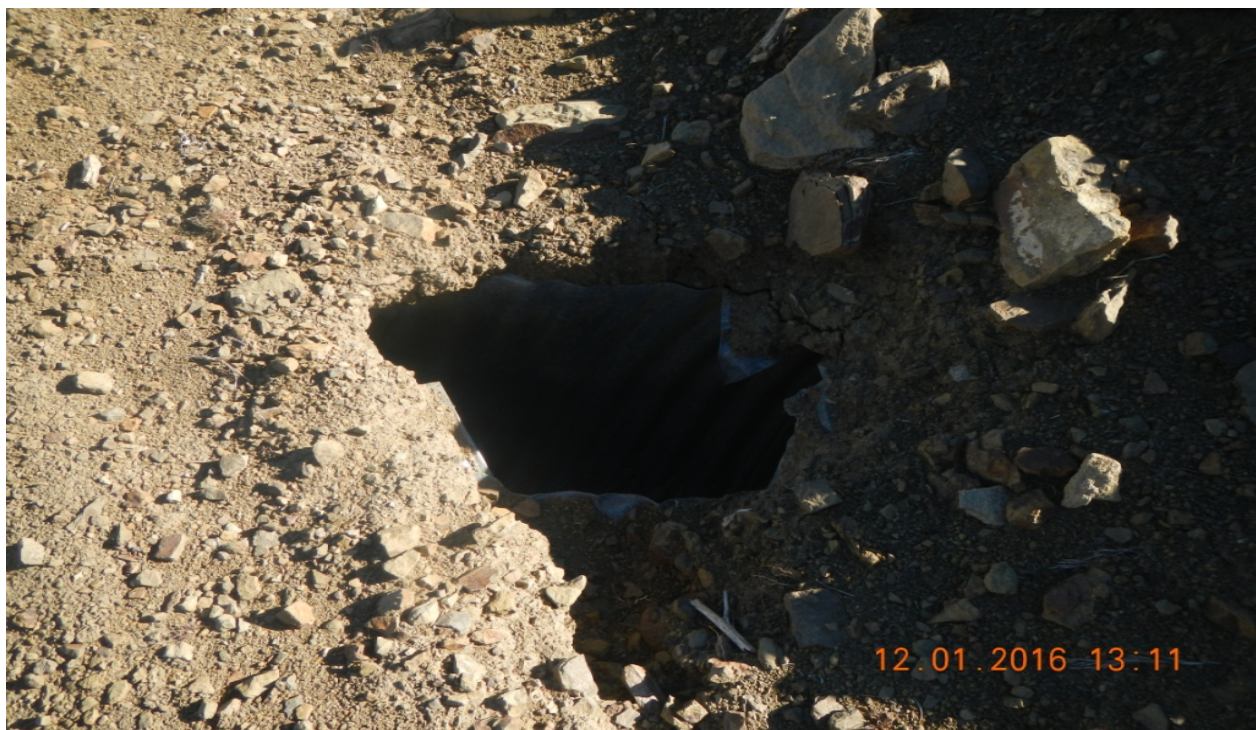
photo 8: A damaged culvert as shown in the above photo.

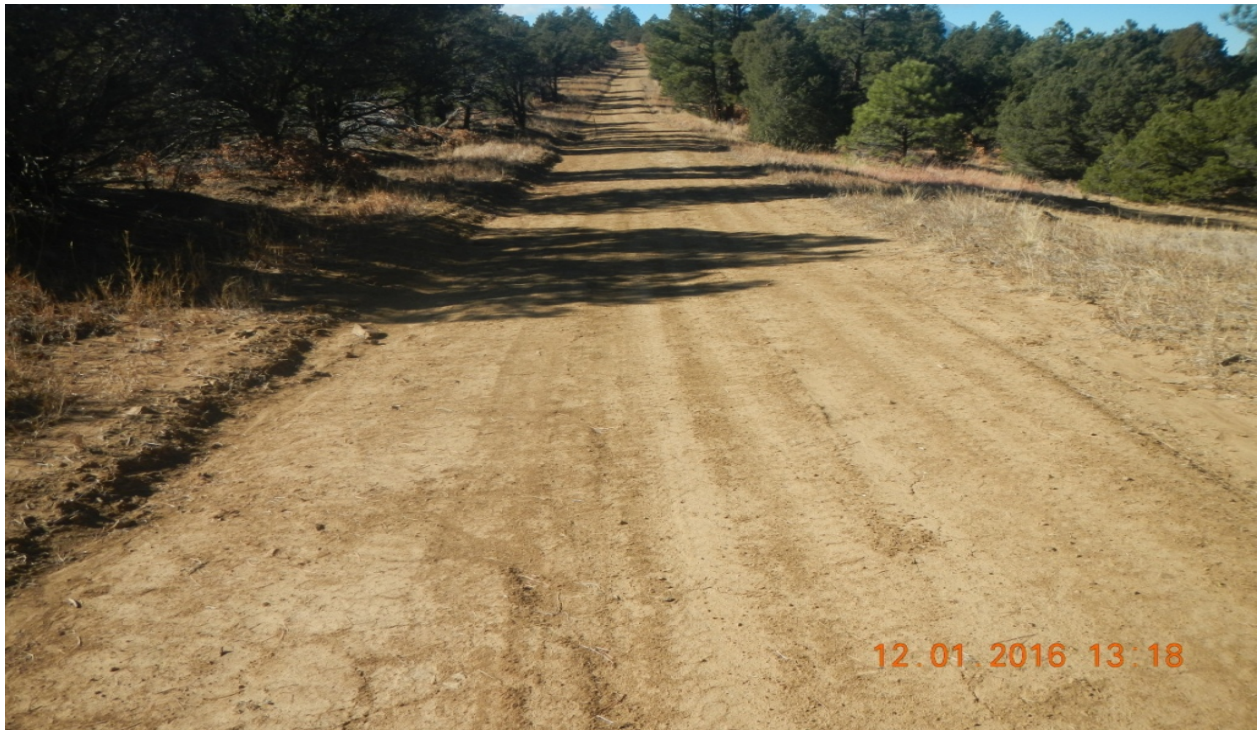
photo 9: Facing west further along the access road.

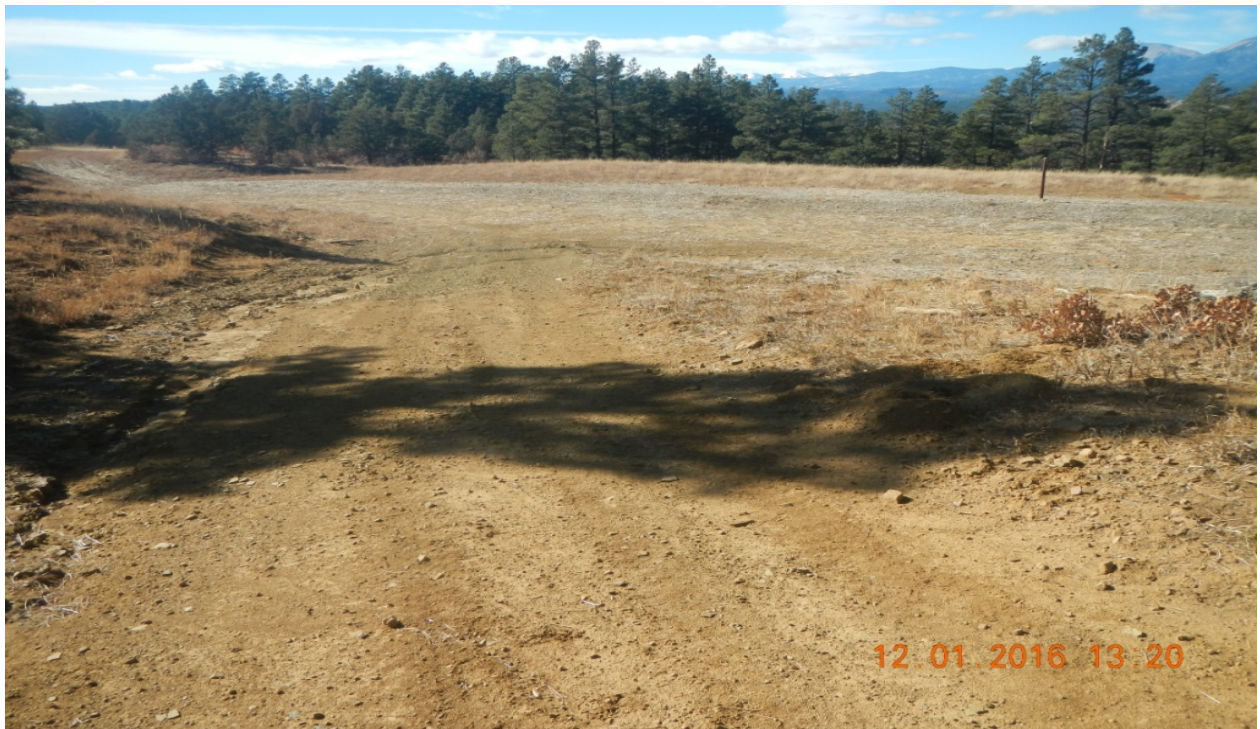
photo 10: Facing west toward the location.

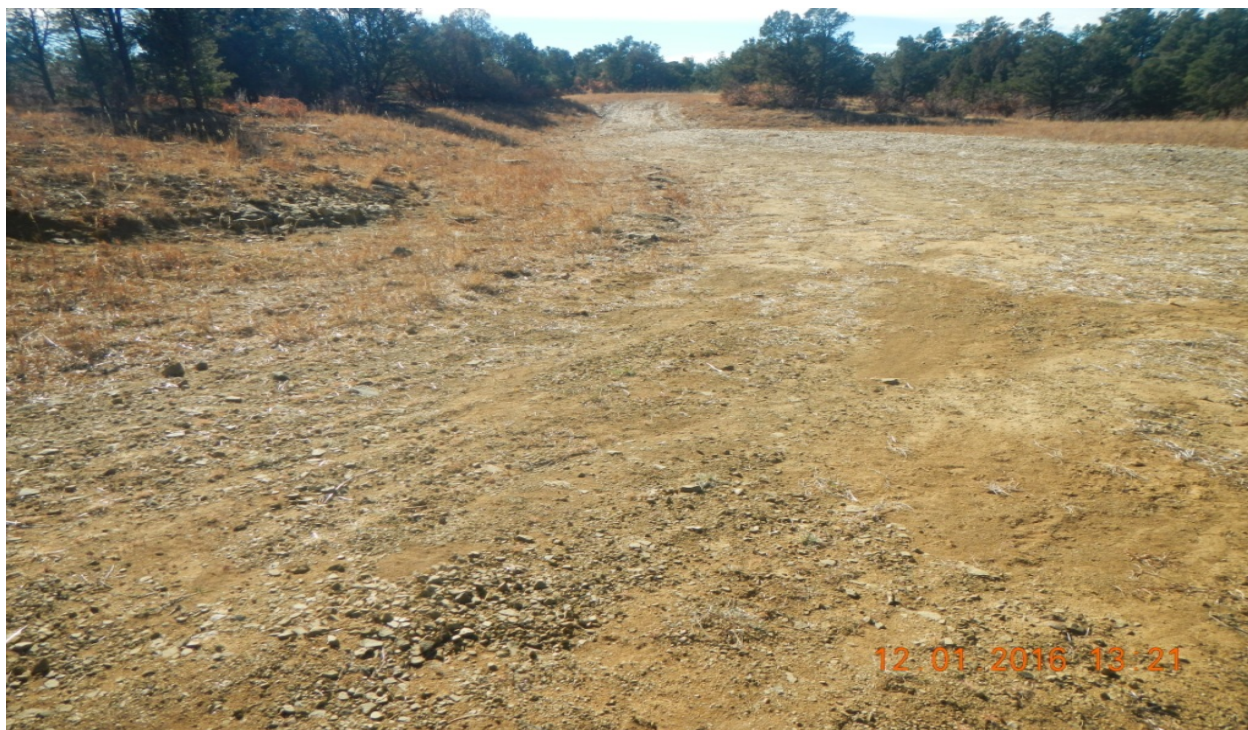
photo 11: Facing southwest at the location.

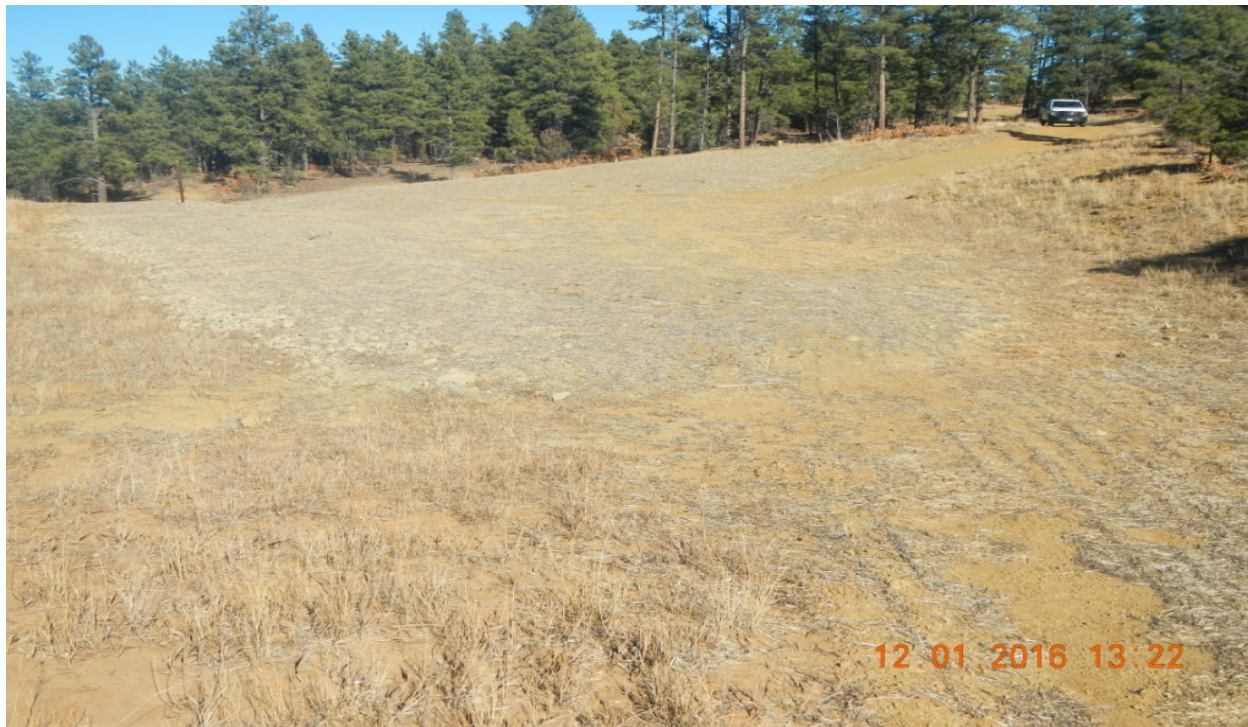
photo 12: Facing northeast at the location. The southeast side has recently been seeded and mulched with vegetation beginning to establish.

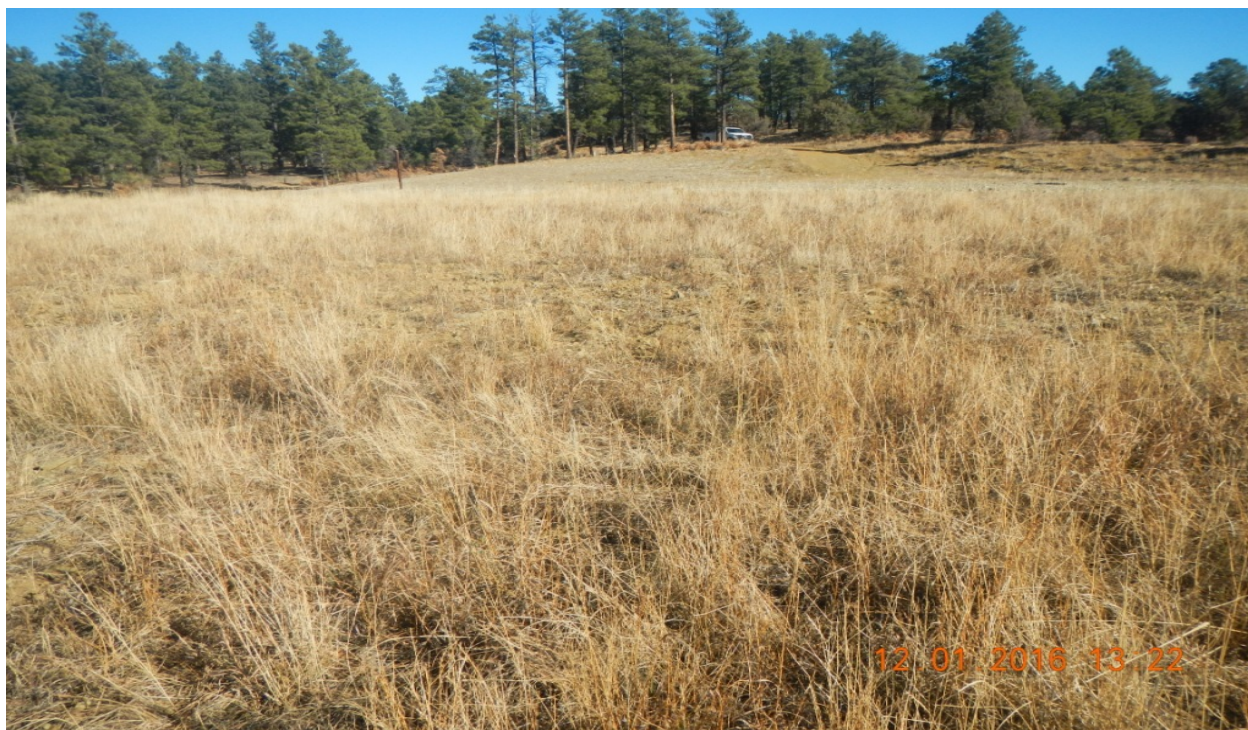
photo 13: West side of the location facing east.

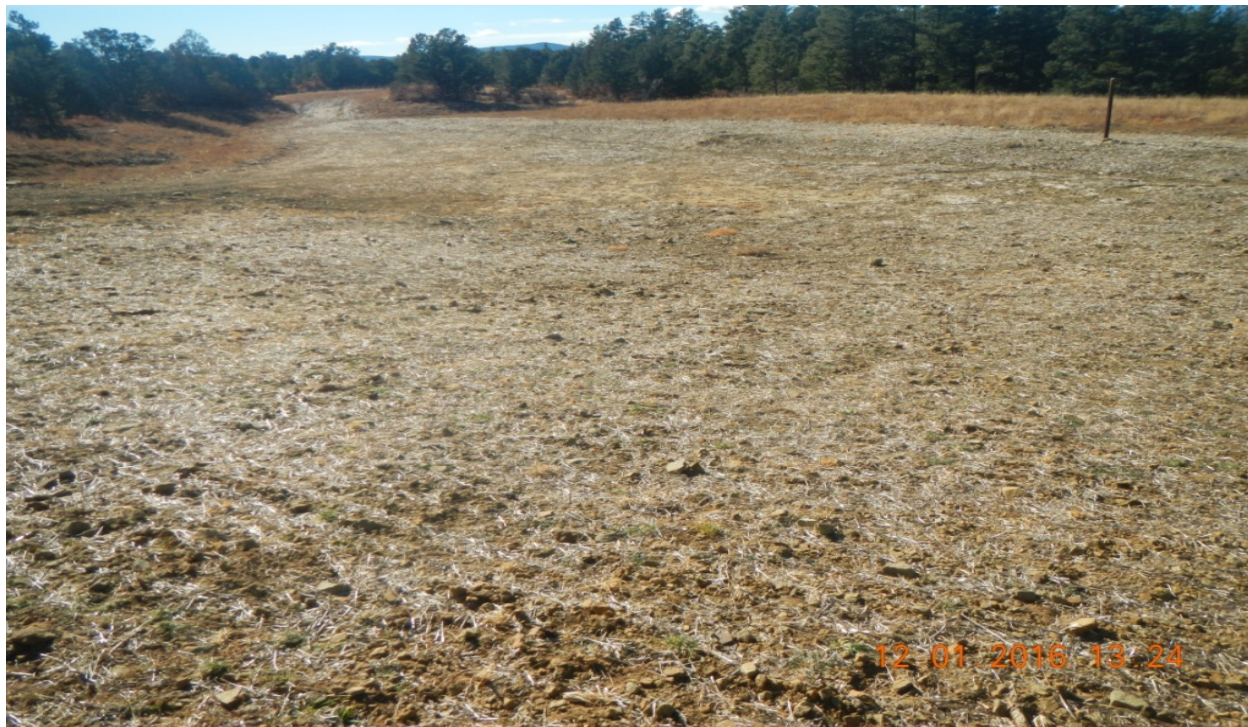
photo 14: East side of the location facing southwest.
