Reclamation Inspection

10/28/2016

Operator: Markus Production Inc.

Location ID: 406198

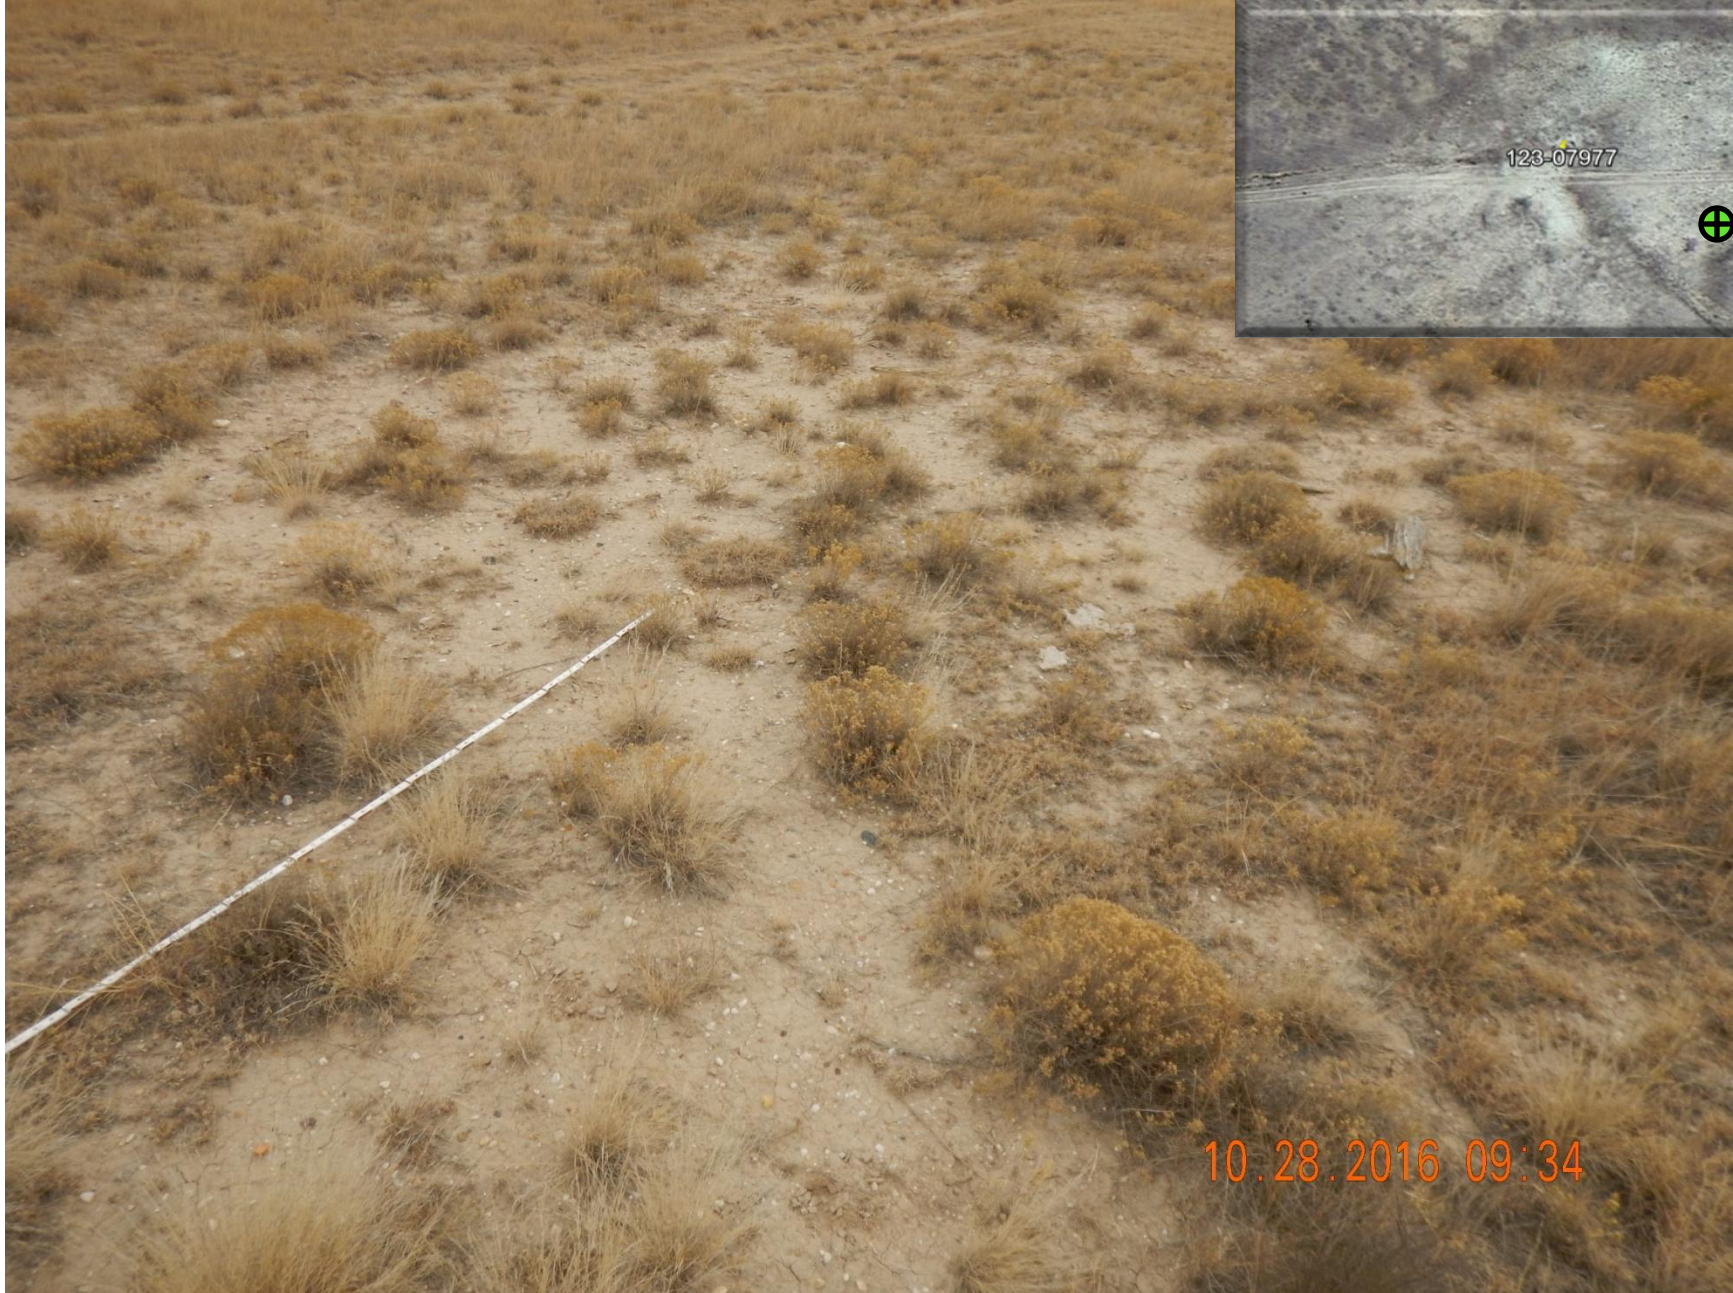
Figure 3: Photo taken from the southeast corner of the well location, facing northeast. Photo shows vegetation over the reclamation area has not achieved uniform cover.

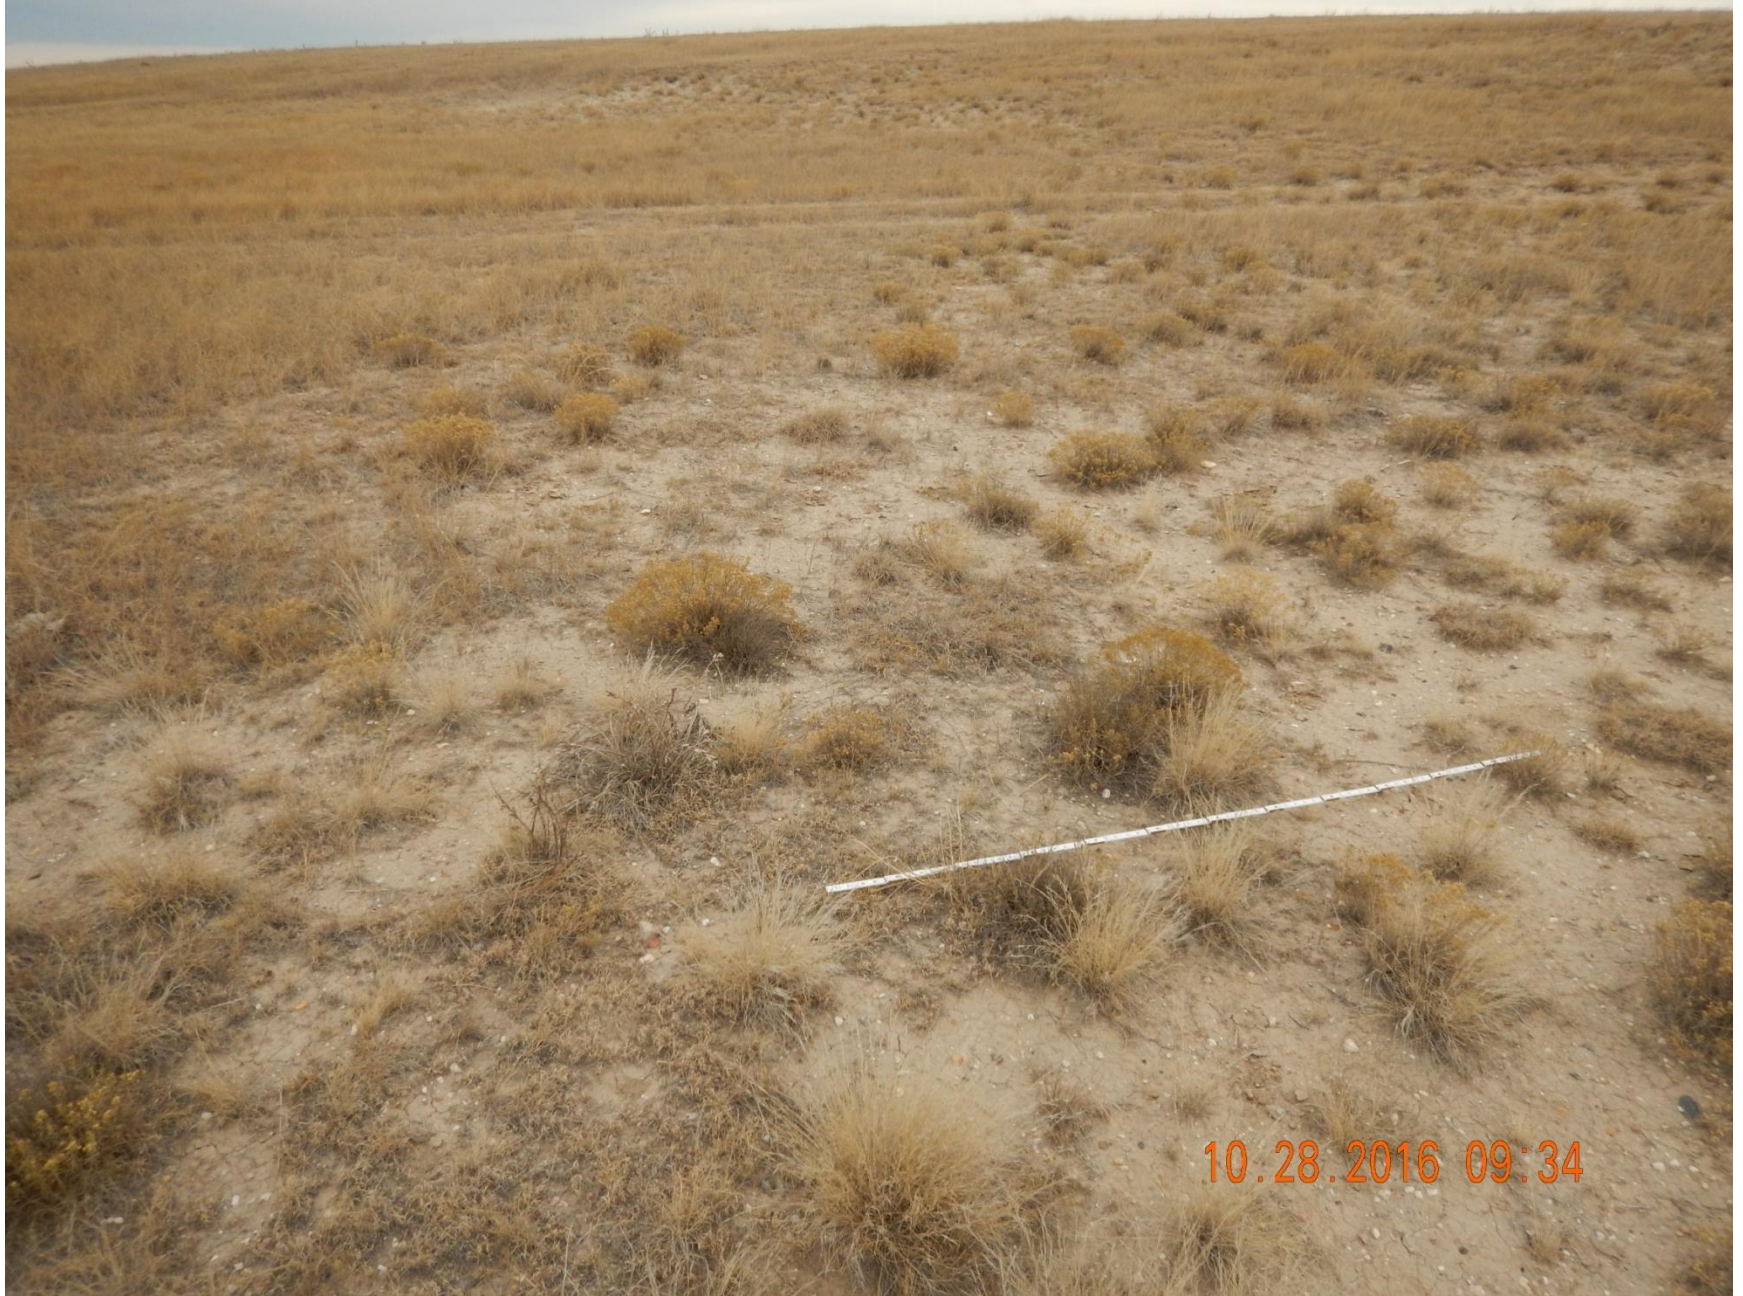
Figure 4: Photo taken from the southeast corner of the location , facing north. Photo shows vegetation over the reclamation area has not achieved uniform cover. 6' measuring stick for reference.

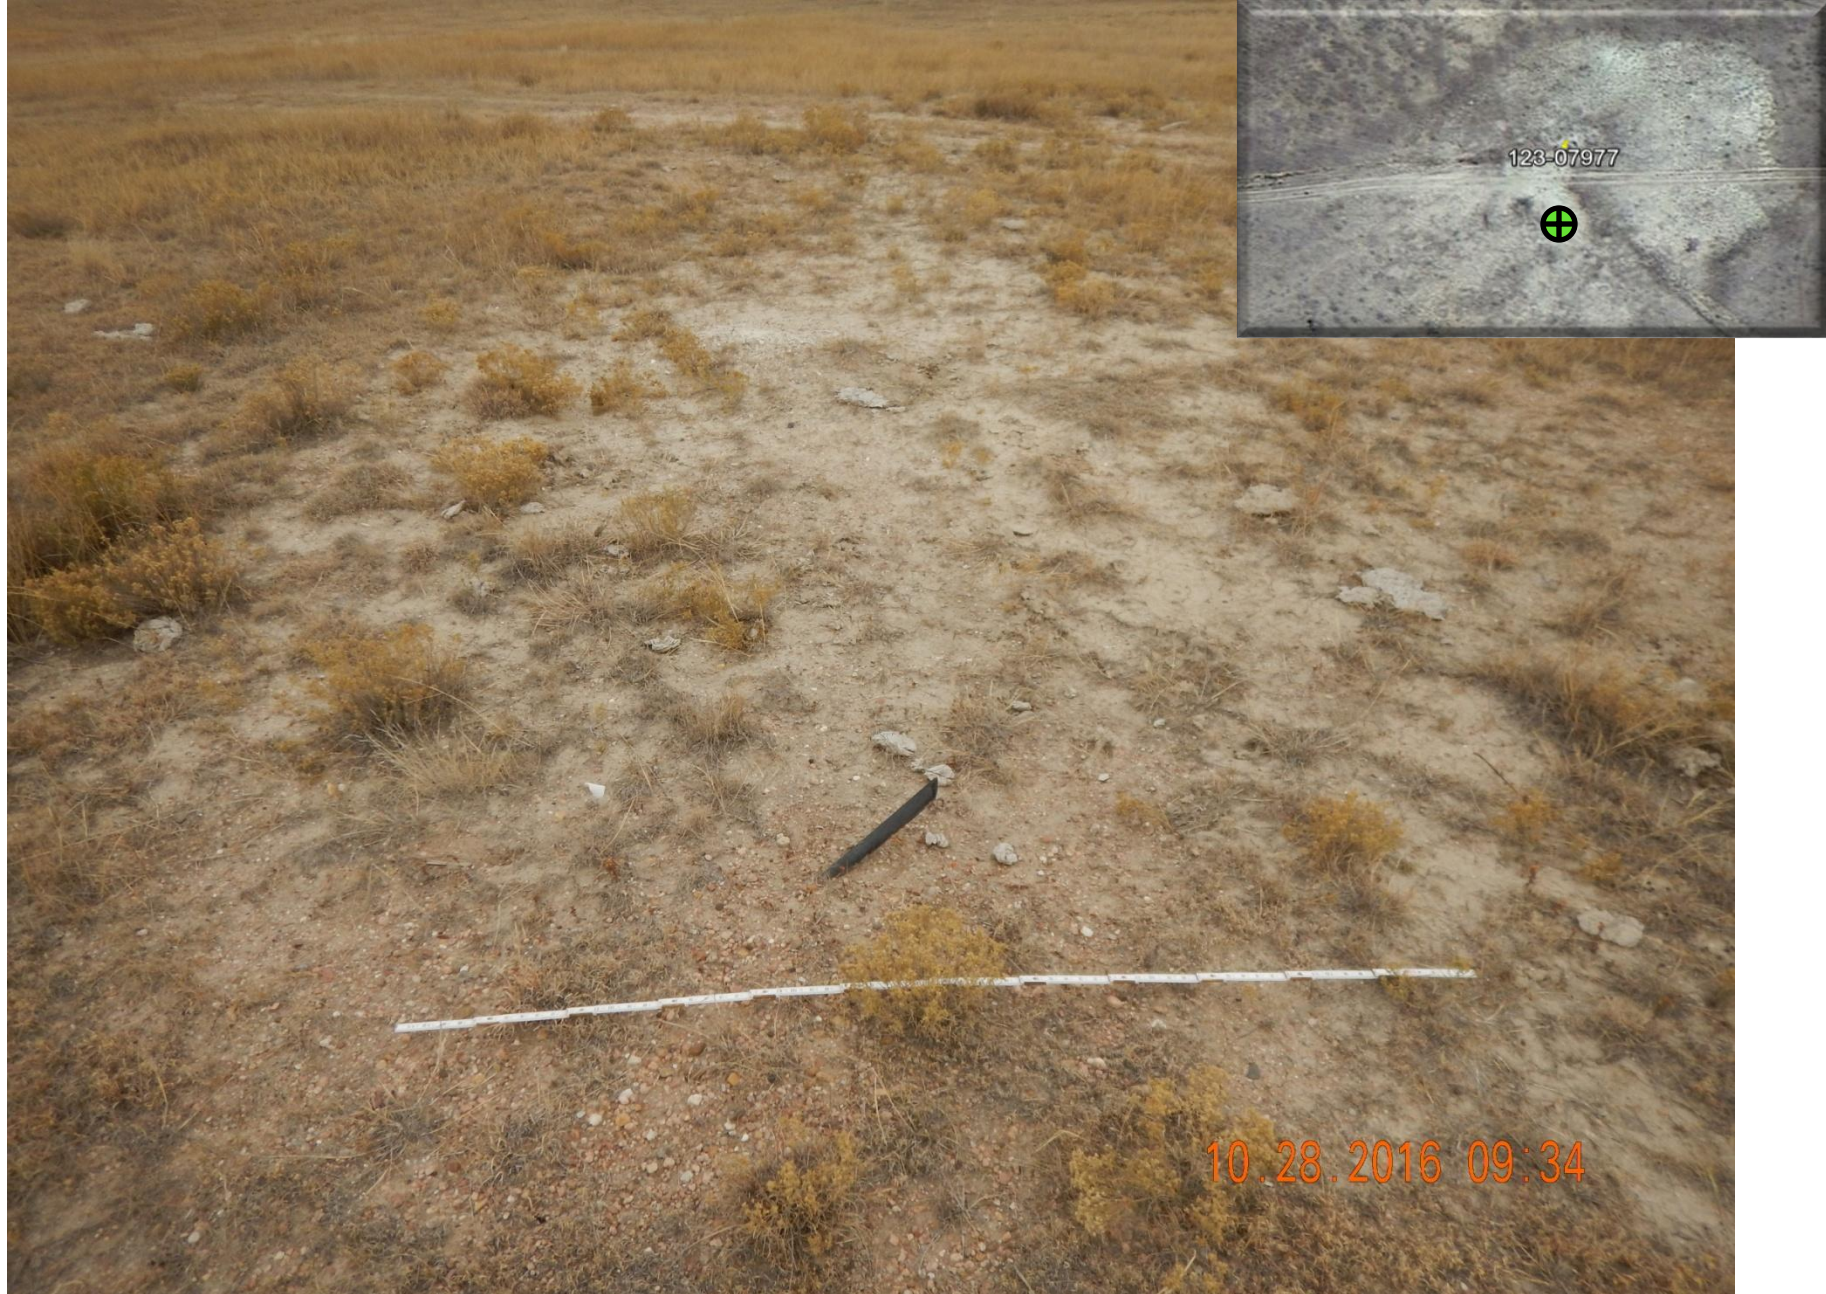
Figure 5: Photo taken from the southwest corner of the location , facing north. Photo shows vegetation over the reclamation area has not achieved uniform cover, and debris remains. 6' measuring stick for reference.

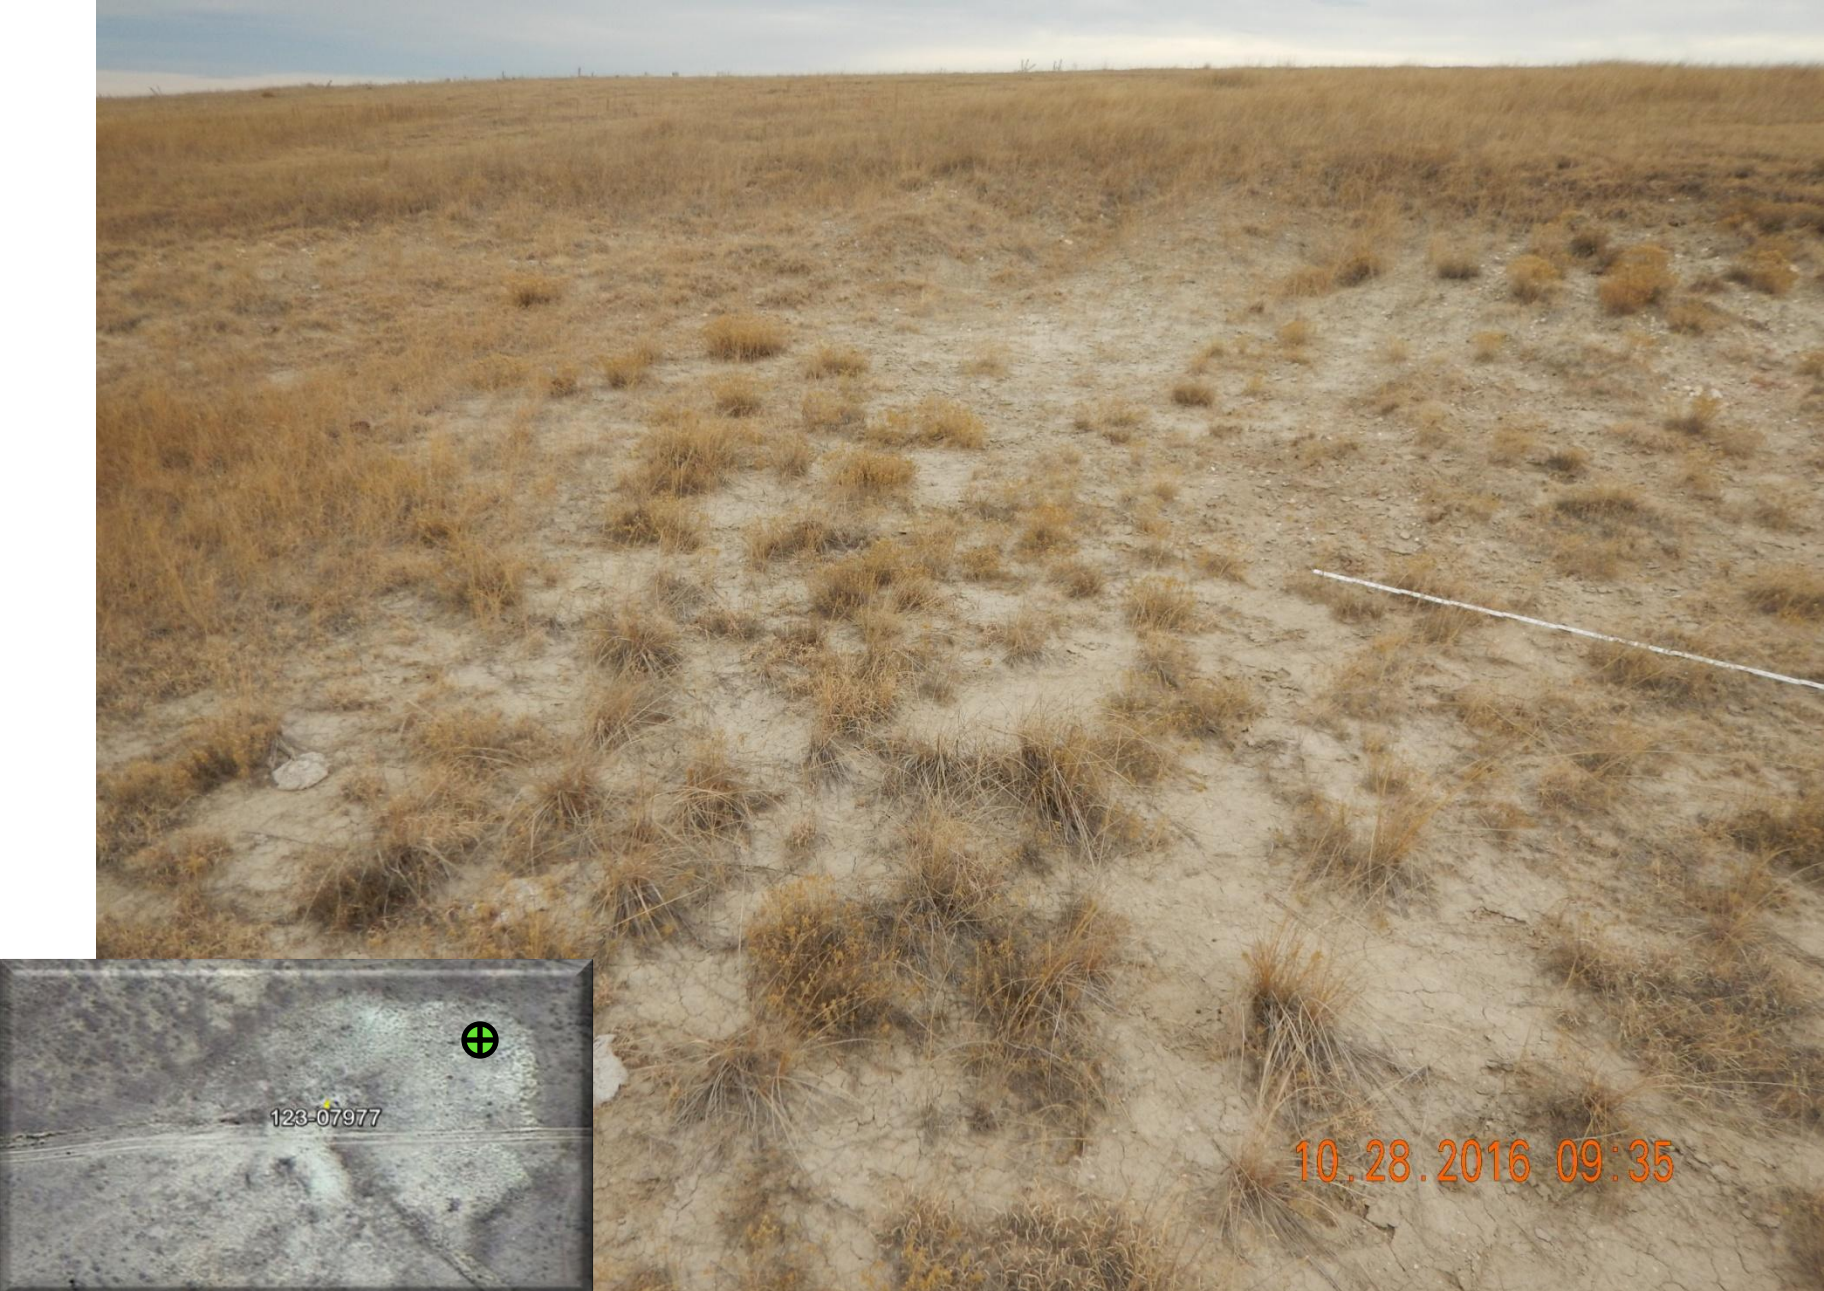
Figure 6: Photo taken from the northeast corner of the location, facing northeast. Photo shows areas on the east end of the location experiencing degradation due to erosion. Photo also shows location has not achieved uniform vegetative cover. 6' measuring stick for reference.

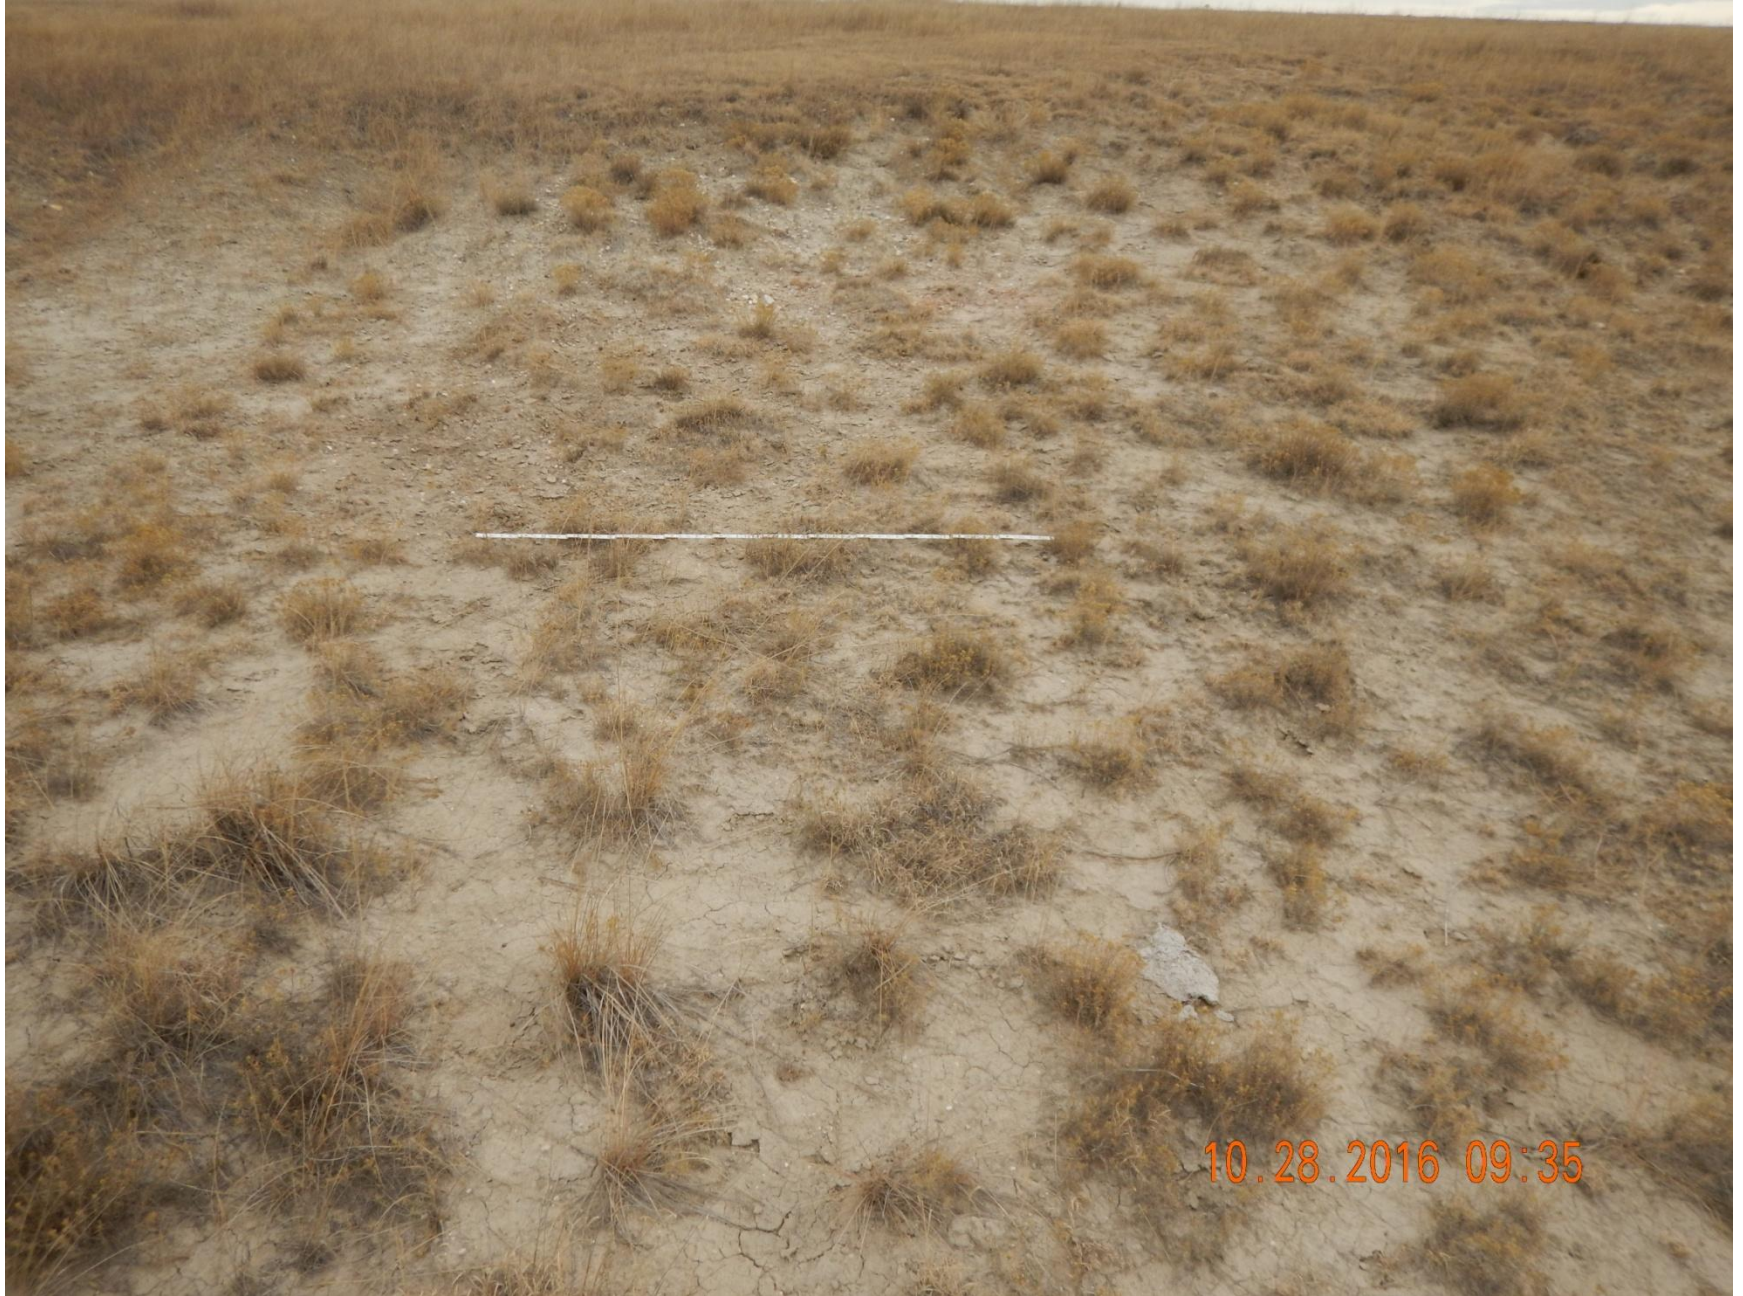
Figure 7: Photo taken from the northeast corner of the location, facing east. Photo shows areas on the east end of the location experiencing degradation due to erosion. Photo also shows location has not achieved uniform vegetative cover. 6' measuring stick for reference.

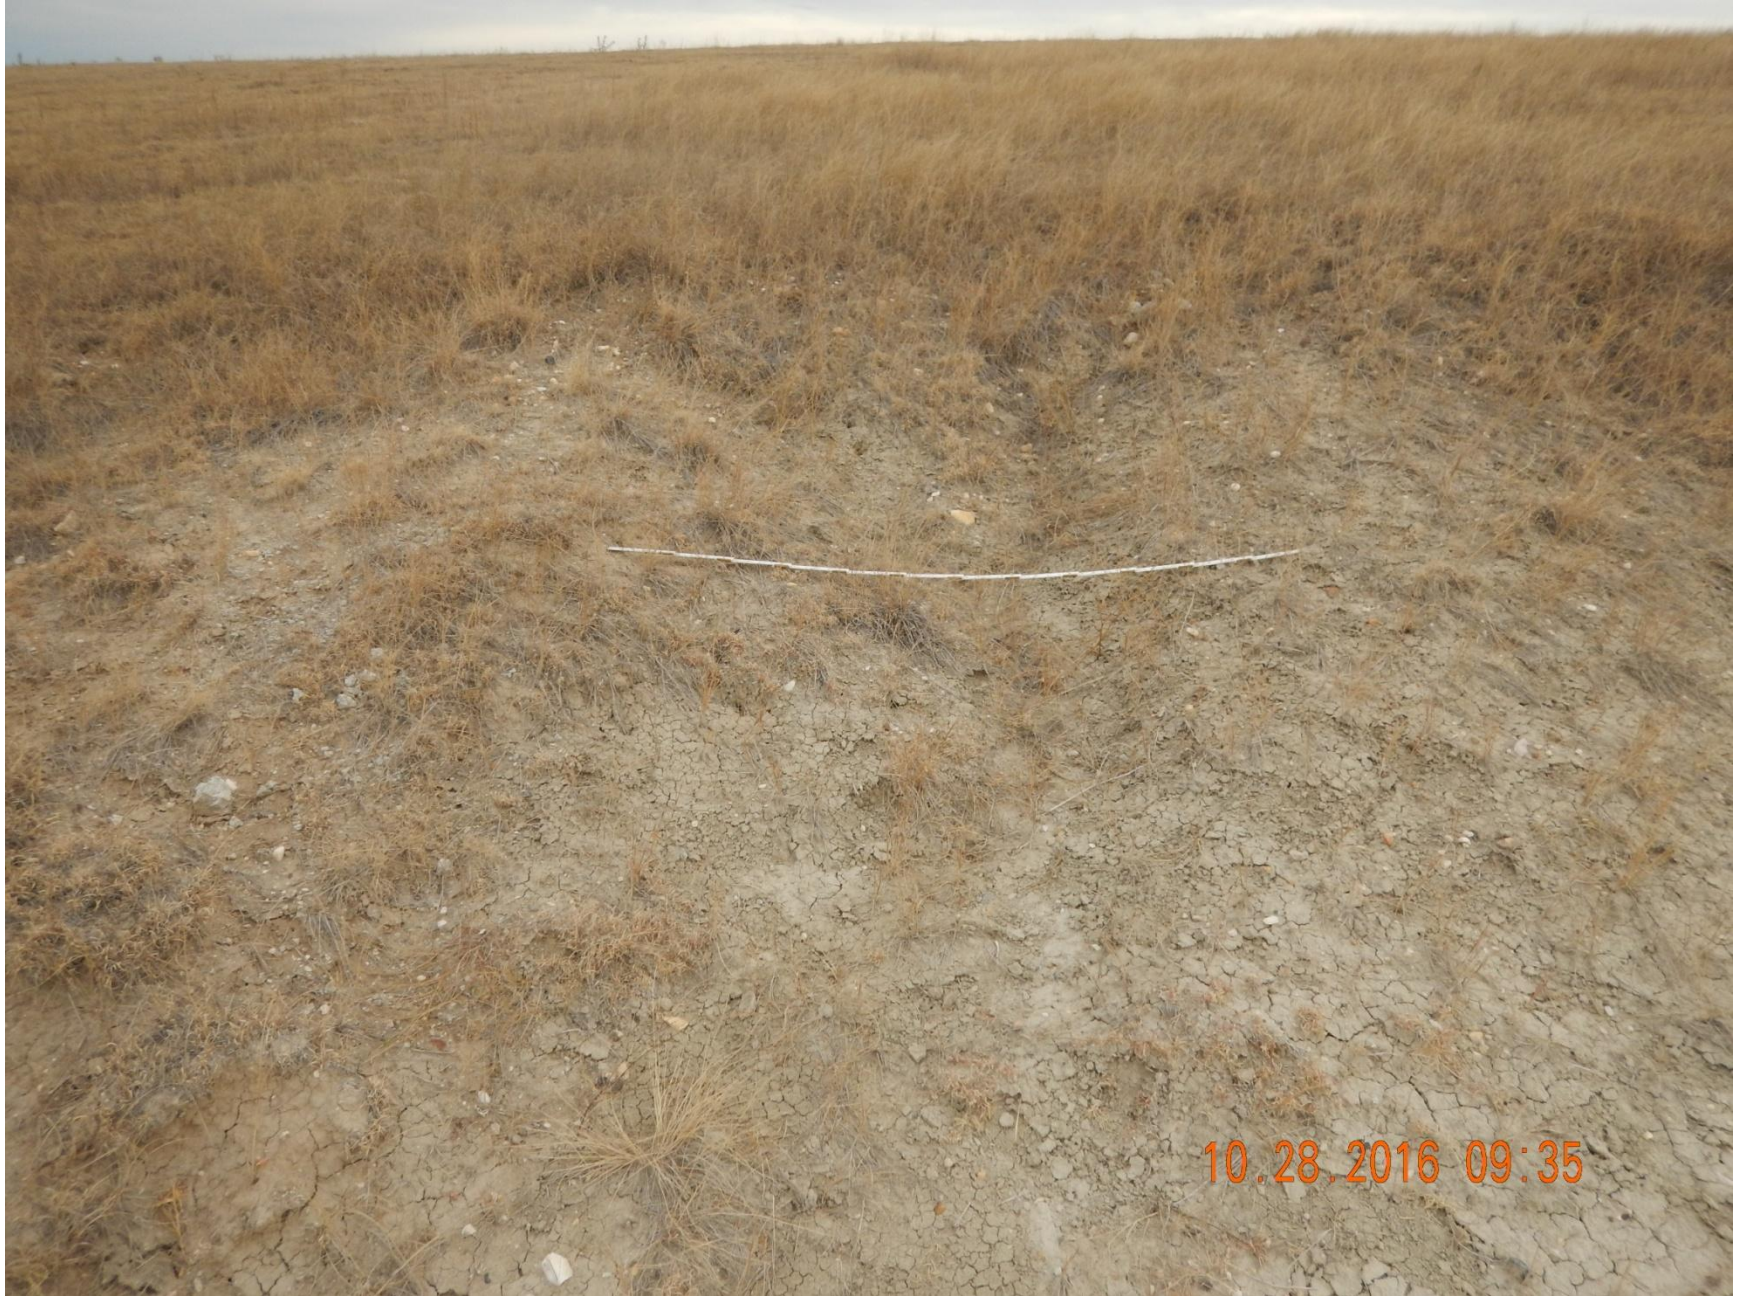
Figure 8: Photo taken from the east end of the location, facing east. Photo shows areas on the east end of the location experiencing degradation due to erosion 6' measuring stick for reference.

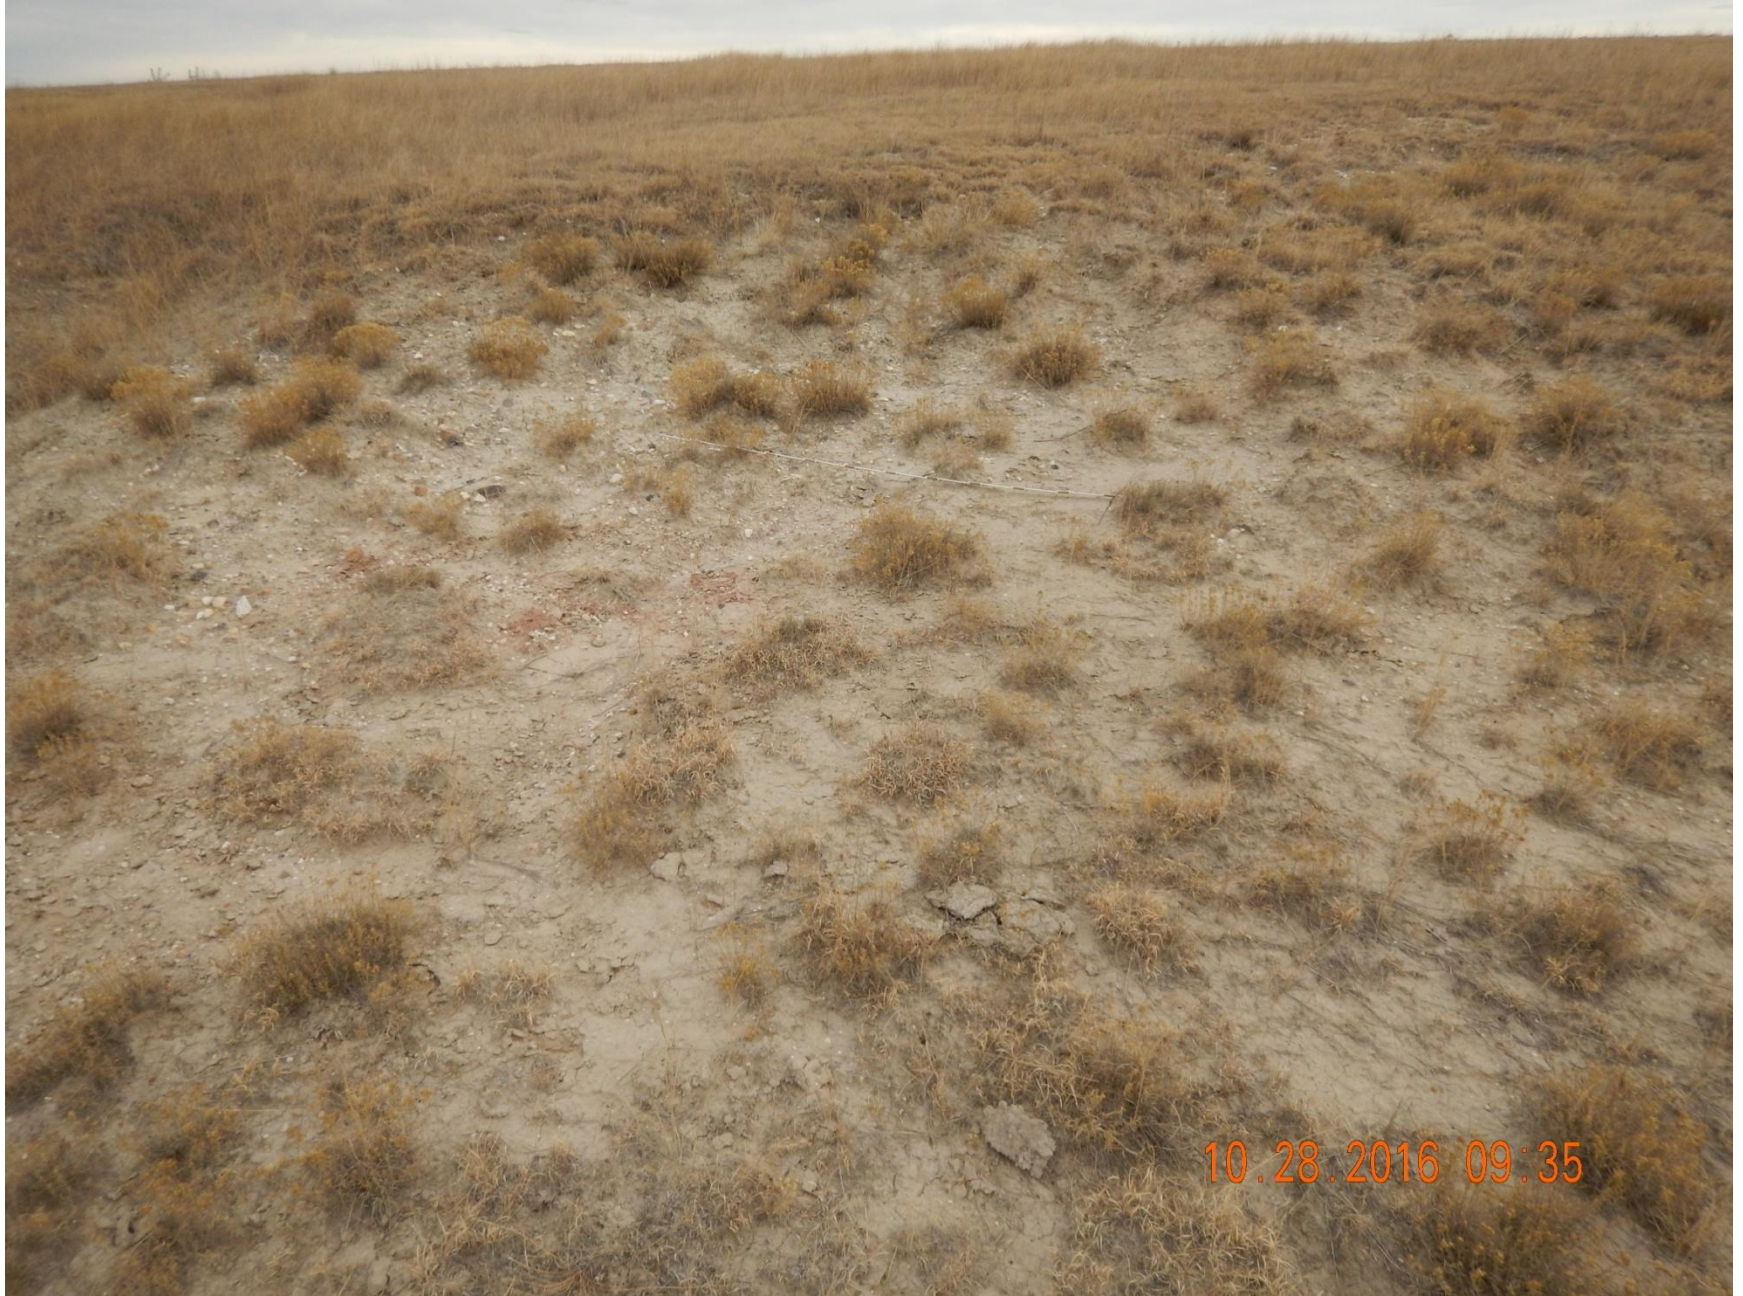
Figure 9: Photo taken from the east end of the location, facing east. Photo shows areas on the east end of the location experiencing degradation due to erosion 6' measuring stick for reference

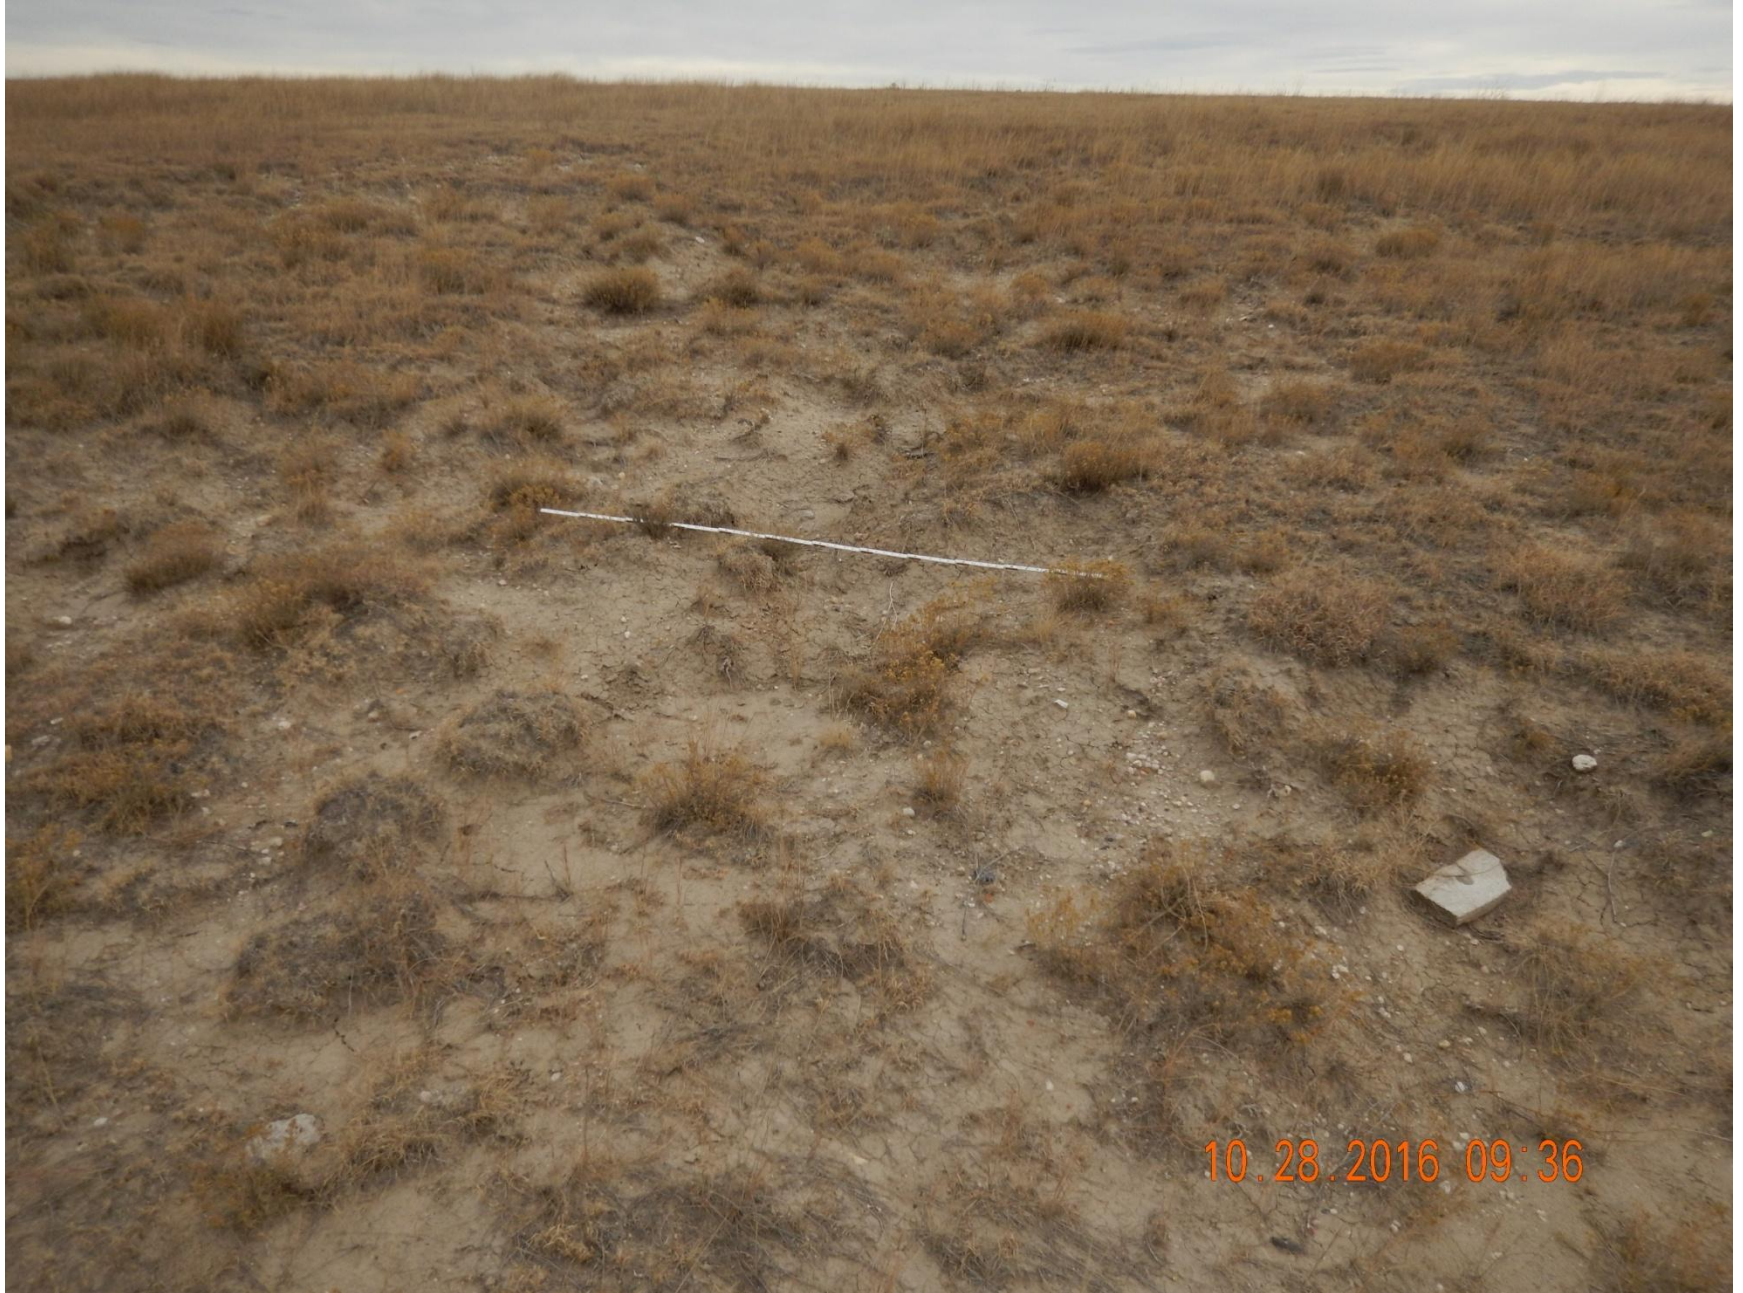
Figure 10: Photo taken from the east end of the location, facing east. Photo shows areas on the east end of the location experiencing degradation due to erosion 6' measuring stick for reference

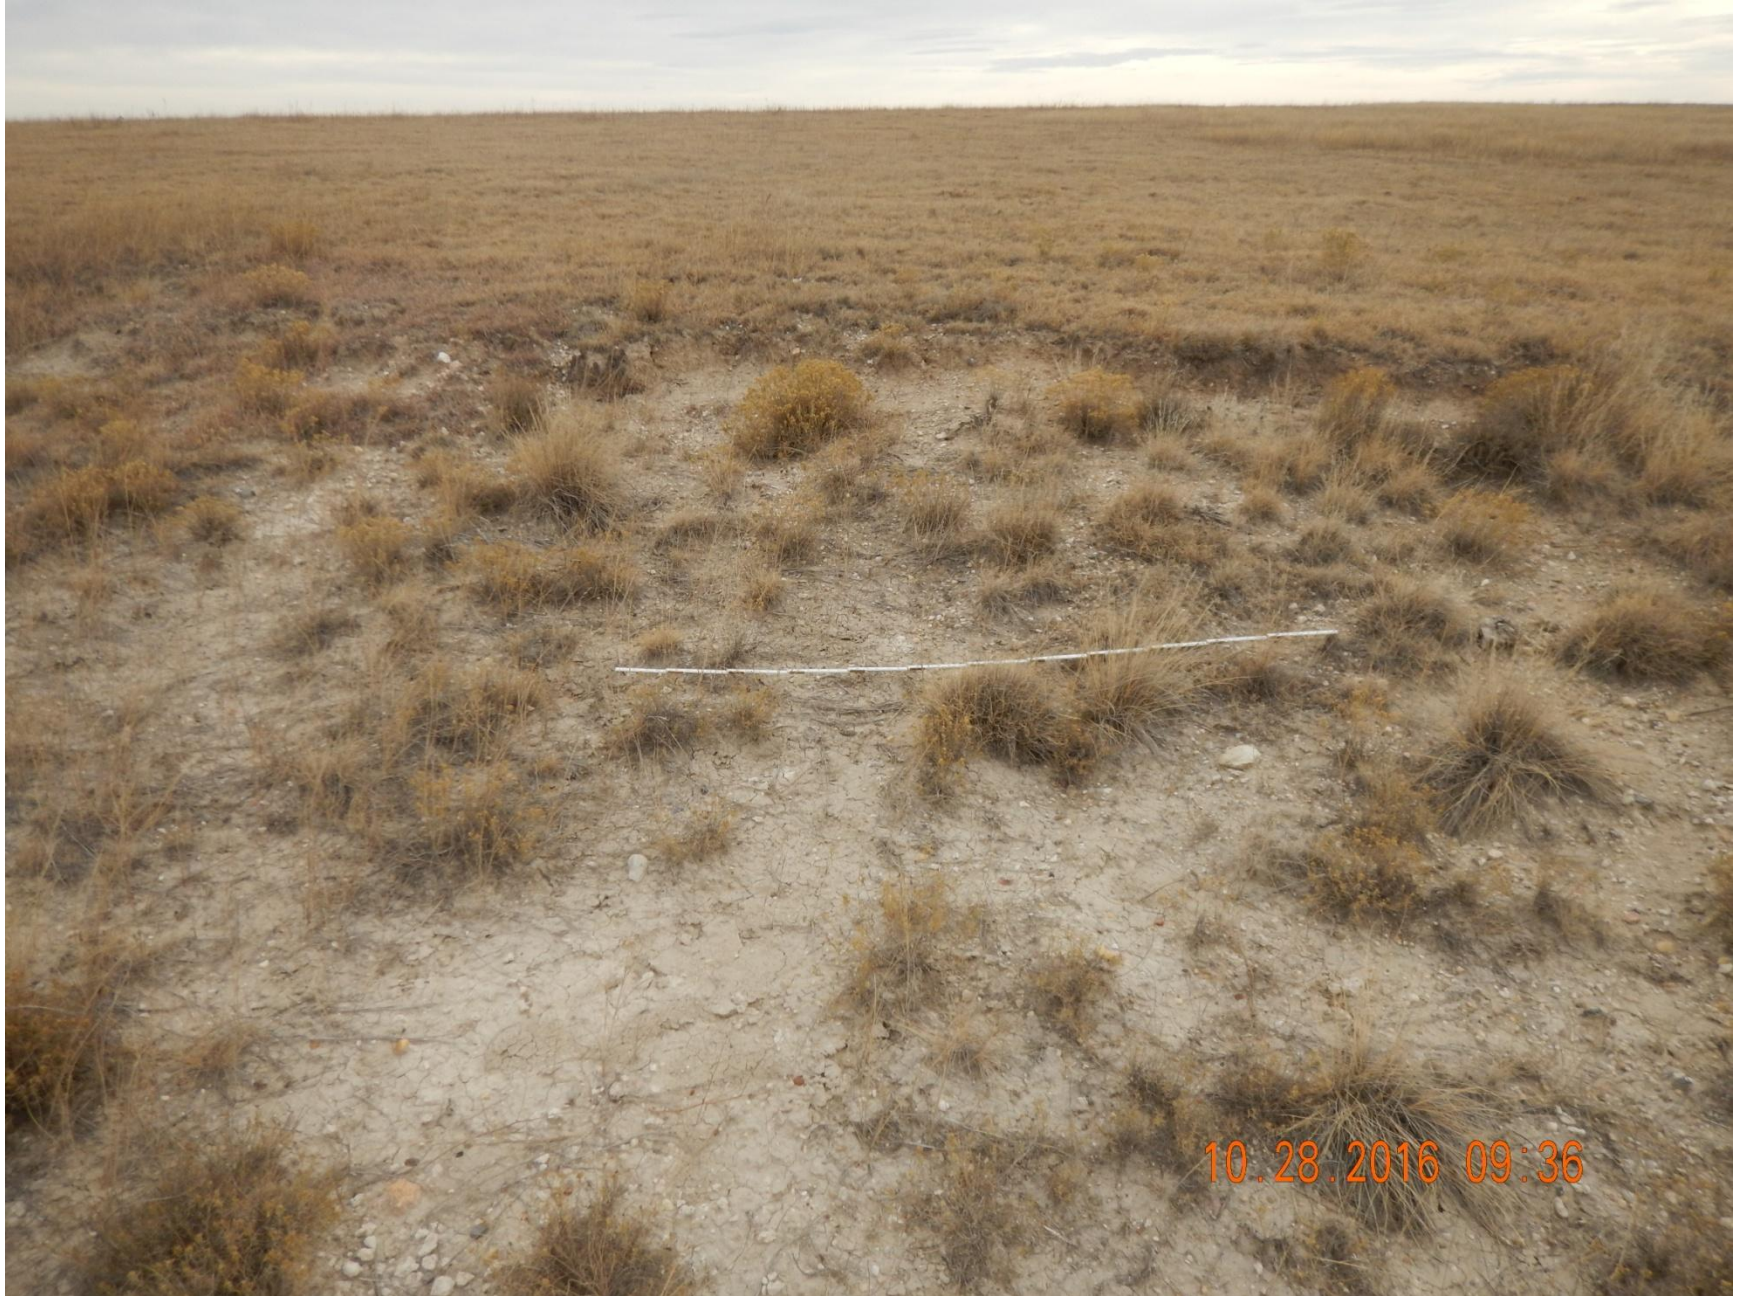
Figure 11: Photo taken from the east end of the location, facing east. Photo shows areas on the east end of the location experiencing degradation due to erosion 6' measuring stick for reference
