Reclamation Inspection

10/28/2016

Operator: Markus Production Inc.

Location ID: 406198

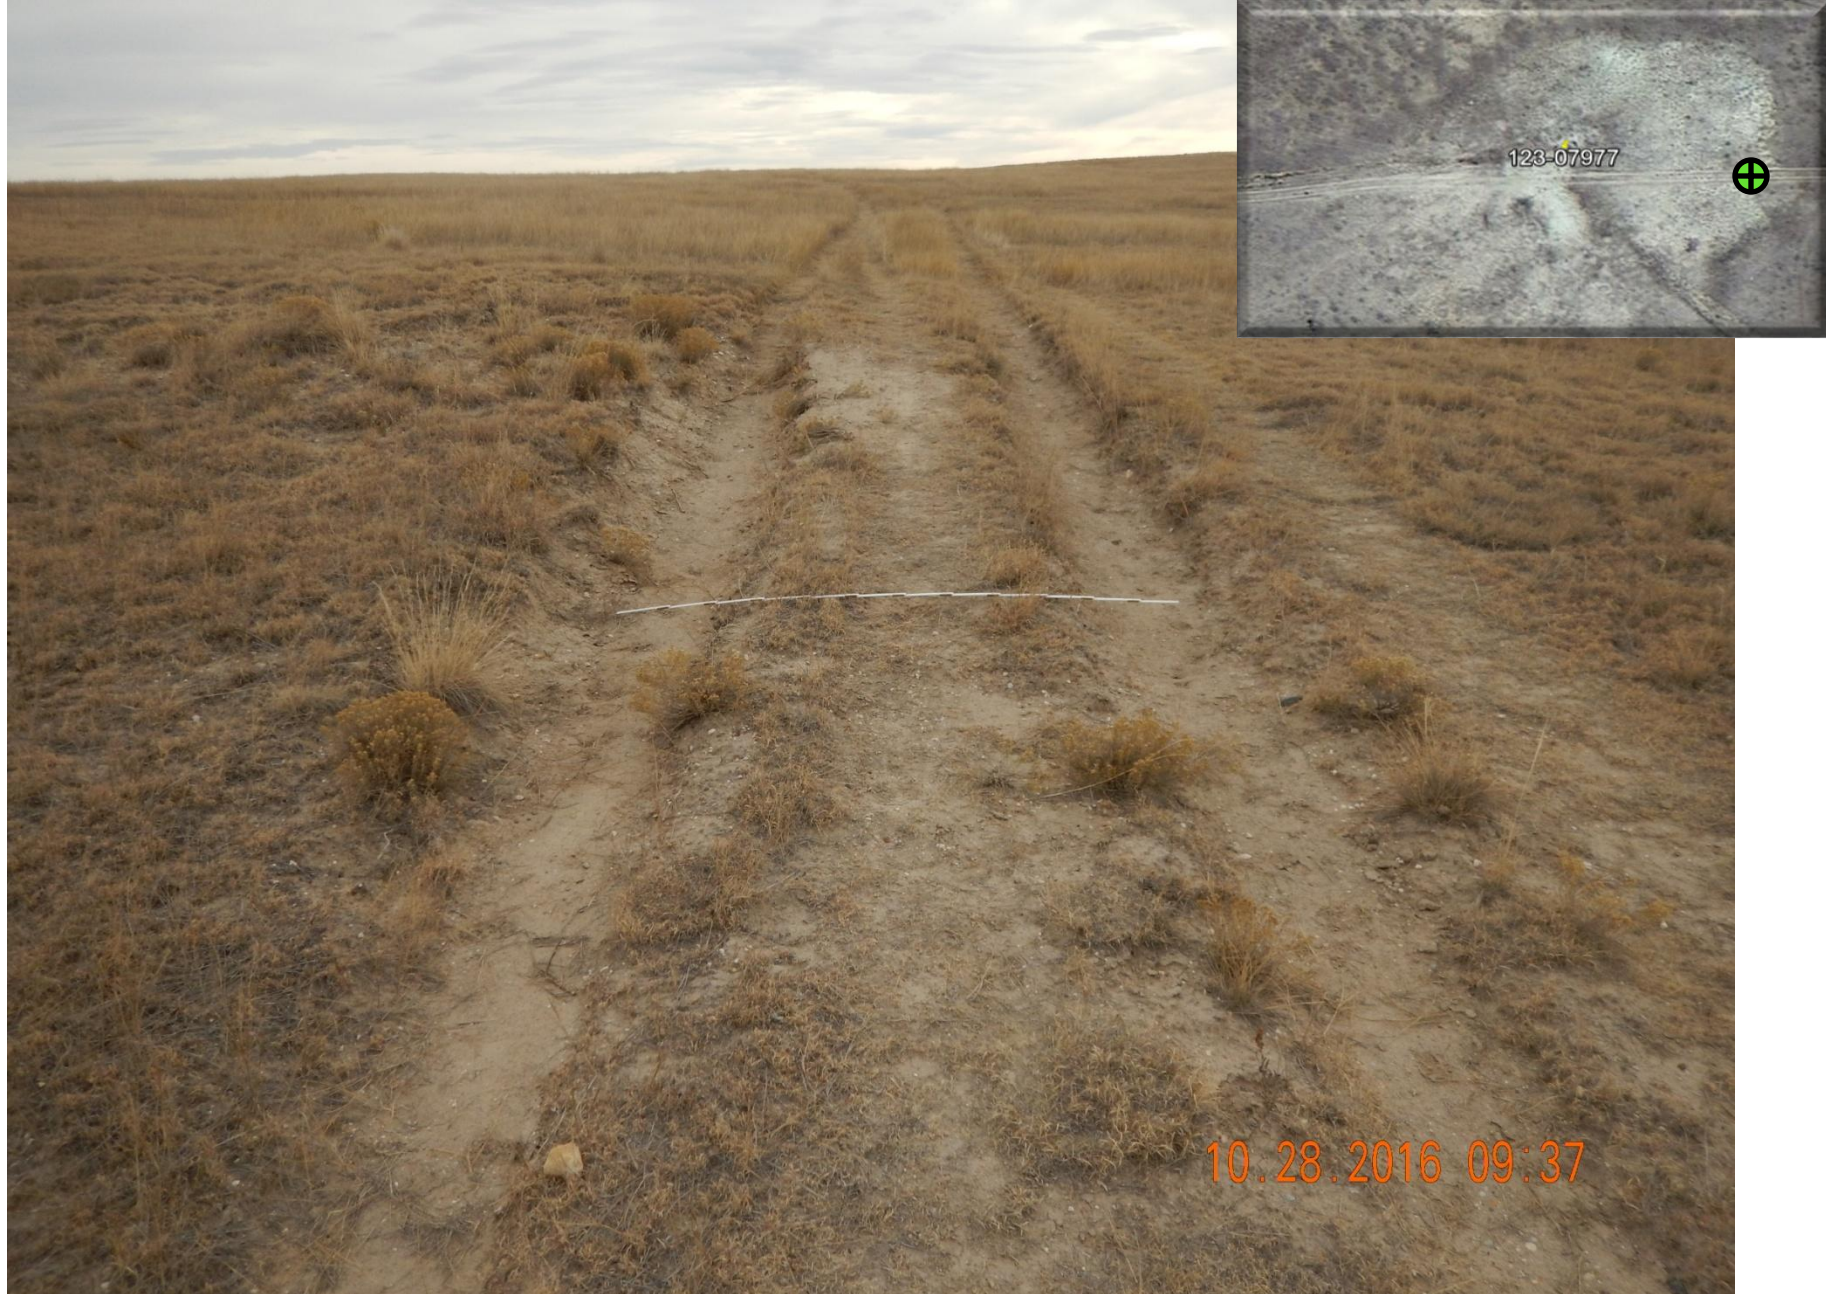
Figure 12: Photo taken from the access road entrance, on the east end of the location, facing east. Photo shows areas where erosion has deepened the ruts in the access road. 6' measuring stick for reference.

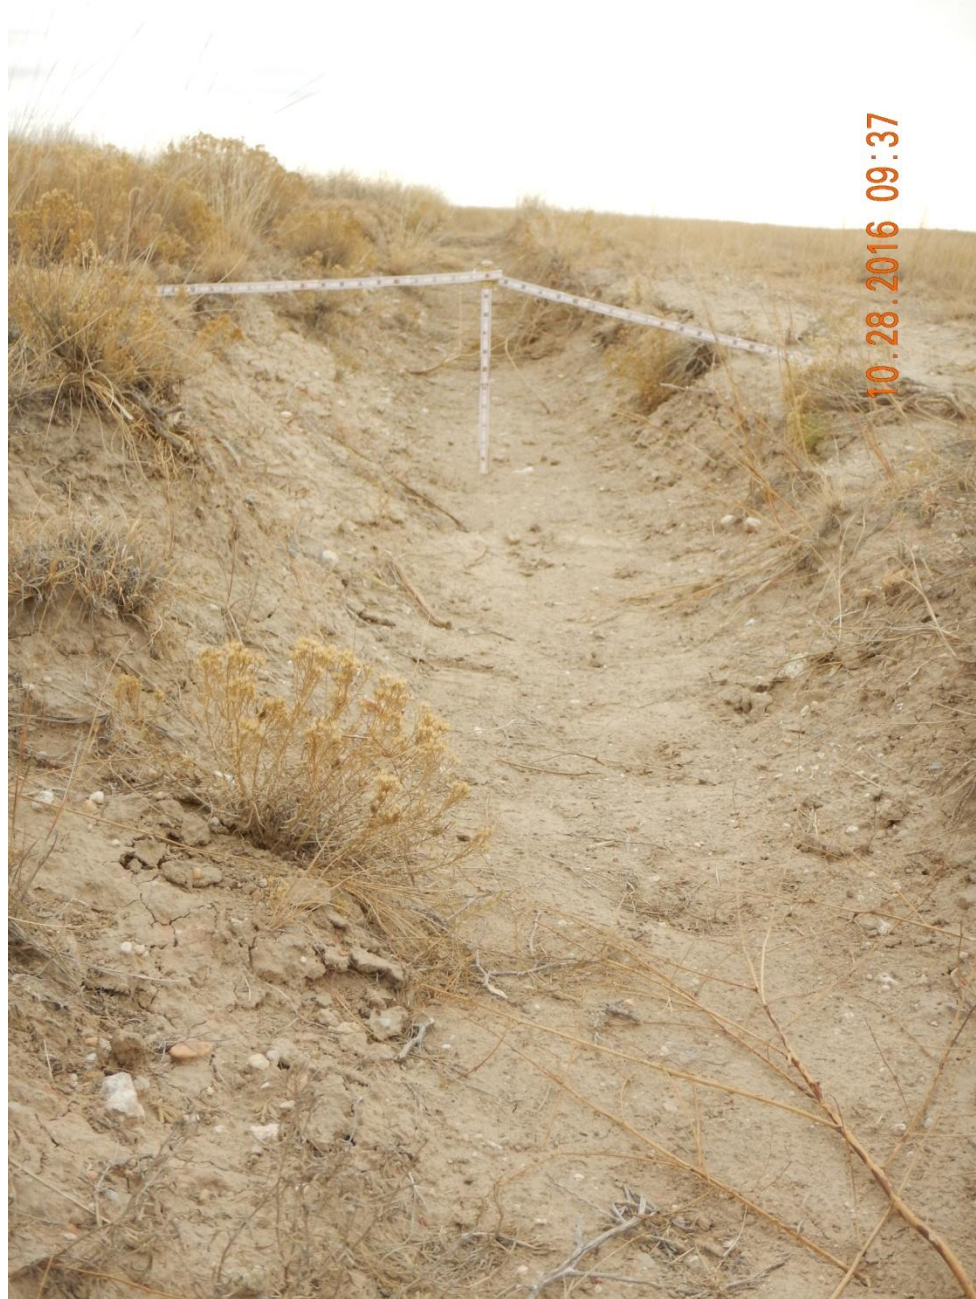
Figure 13: Photo taken from the access road entrance, on the east end of the location, facing east. Photo shows areas where erosion has deepened the ruts in the access road. Measuring stick for reference.

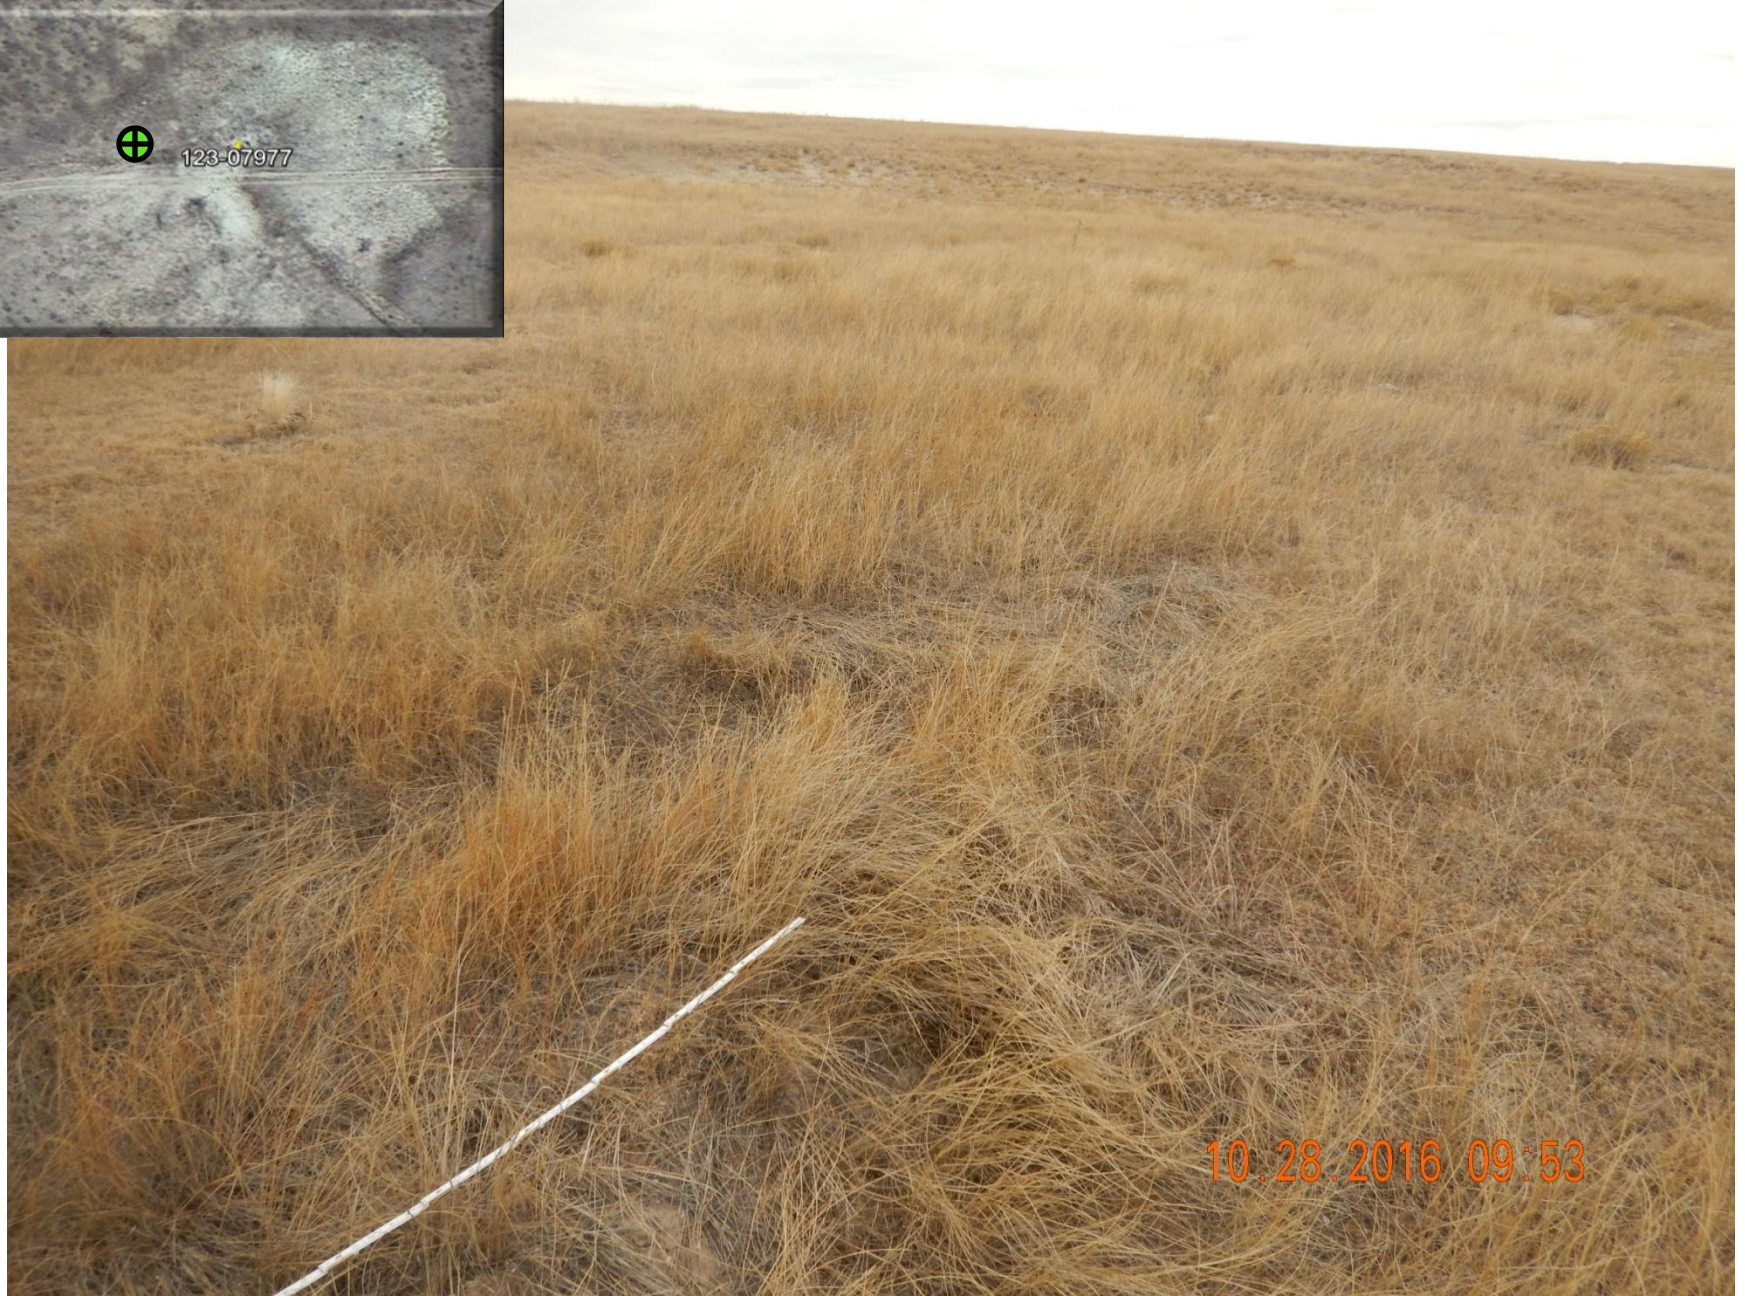
Figure 14: Photo taken from the west end of the location, facing northwest. Photo shows “starting” area where a gulley forming to the west of the location has formed.

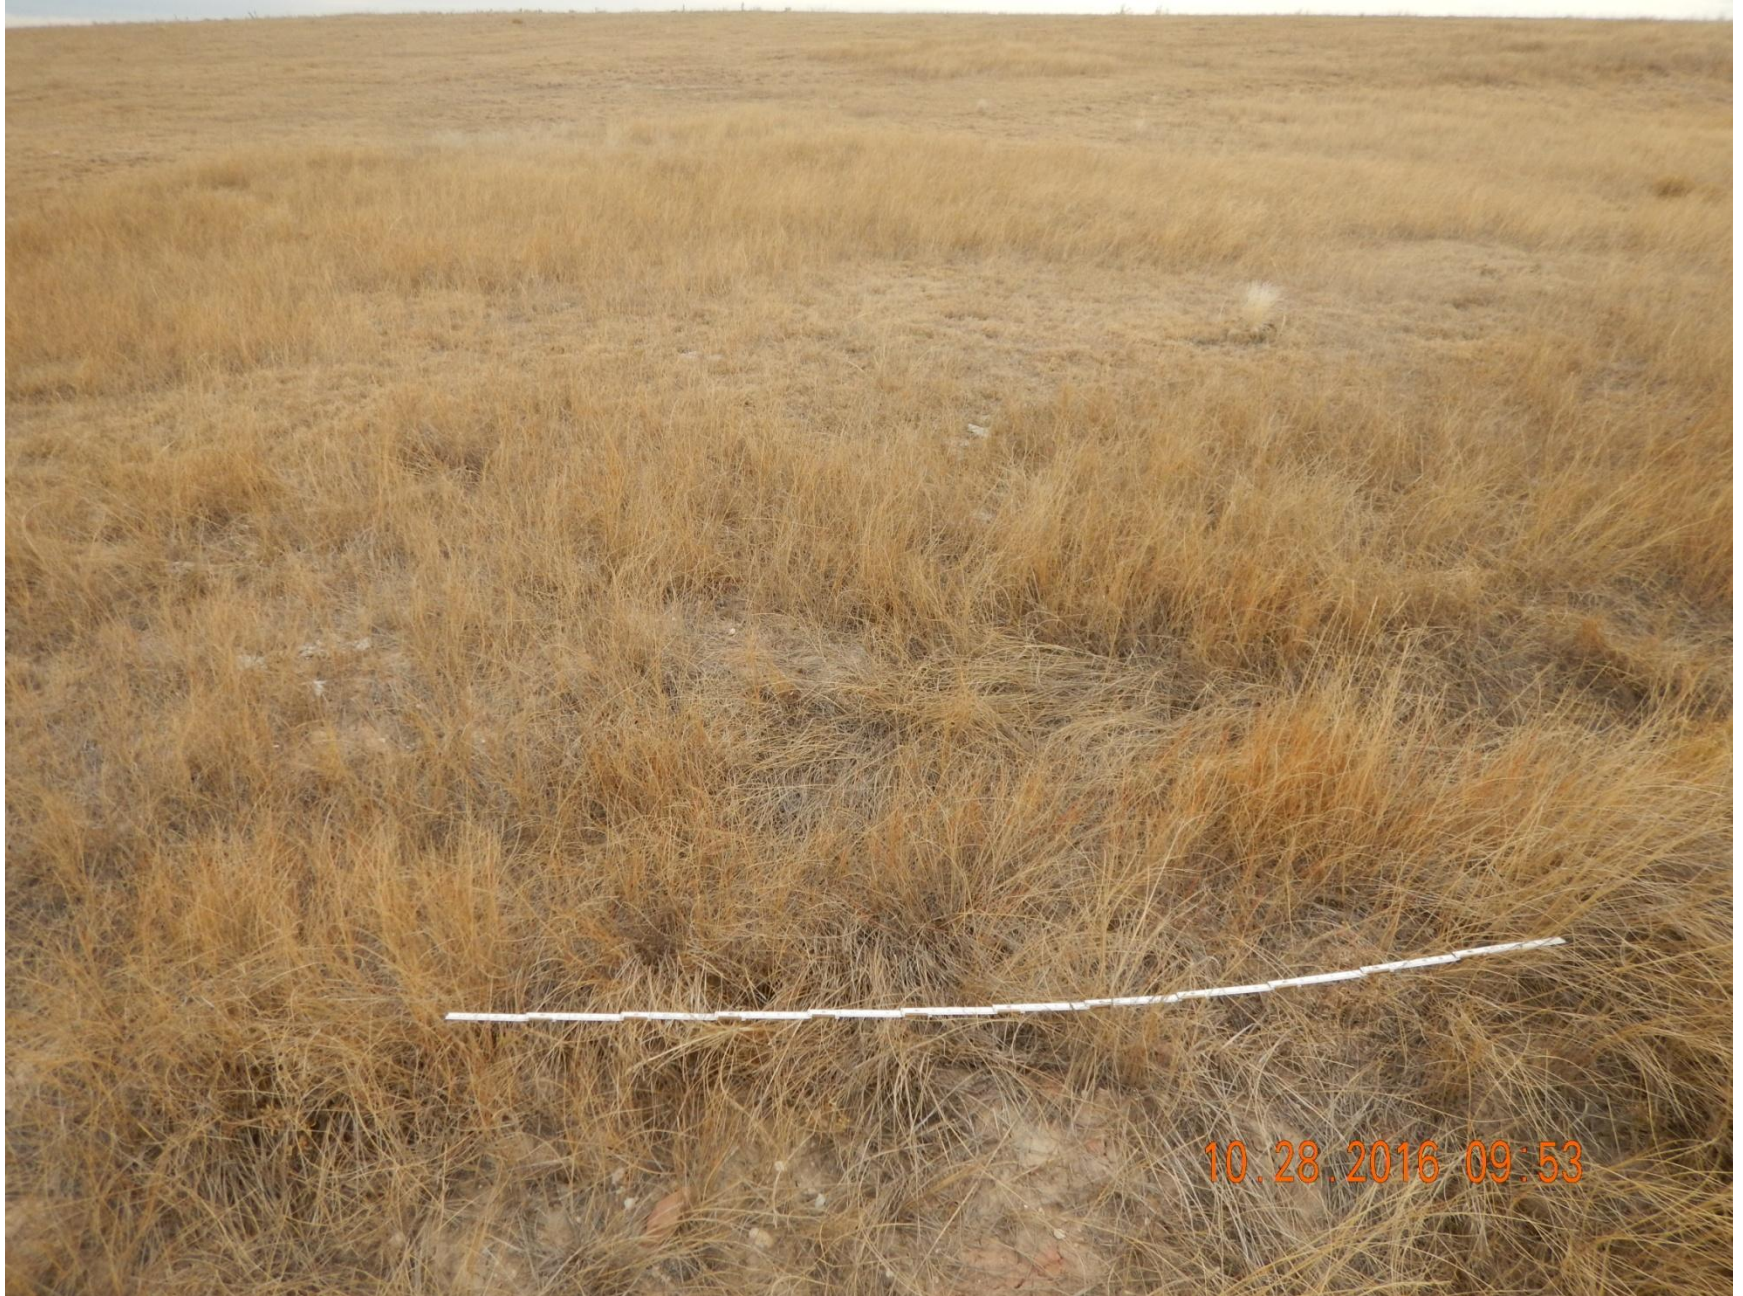
Figure 15: Photo taken from the west end of the location, facing north. Photo shows “starting” area where a gulley forming to the west of the location has formed. 6’ measuring stick for reference.

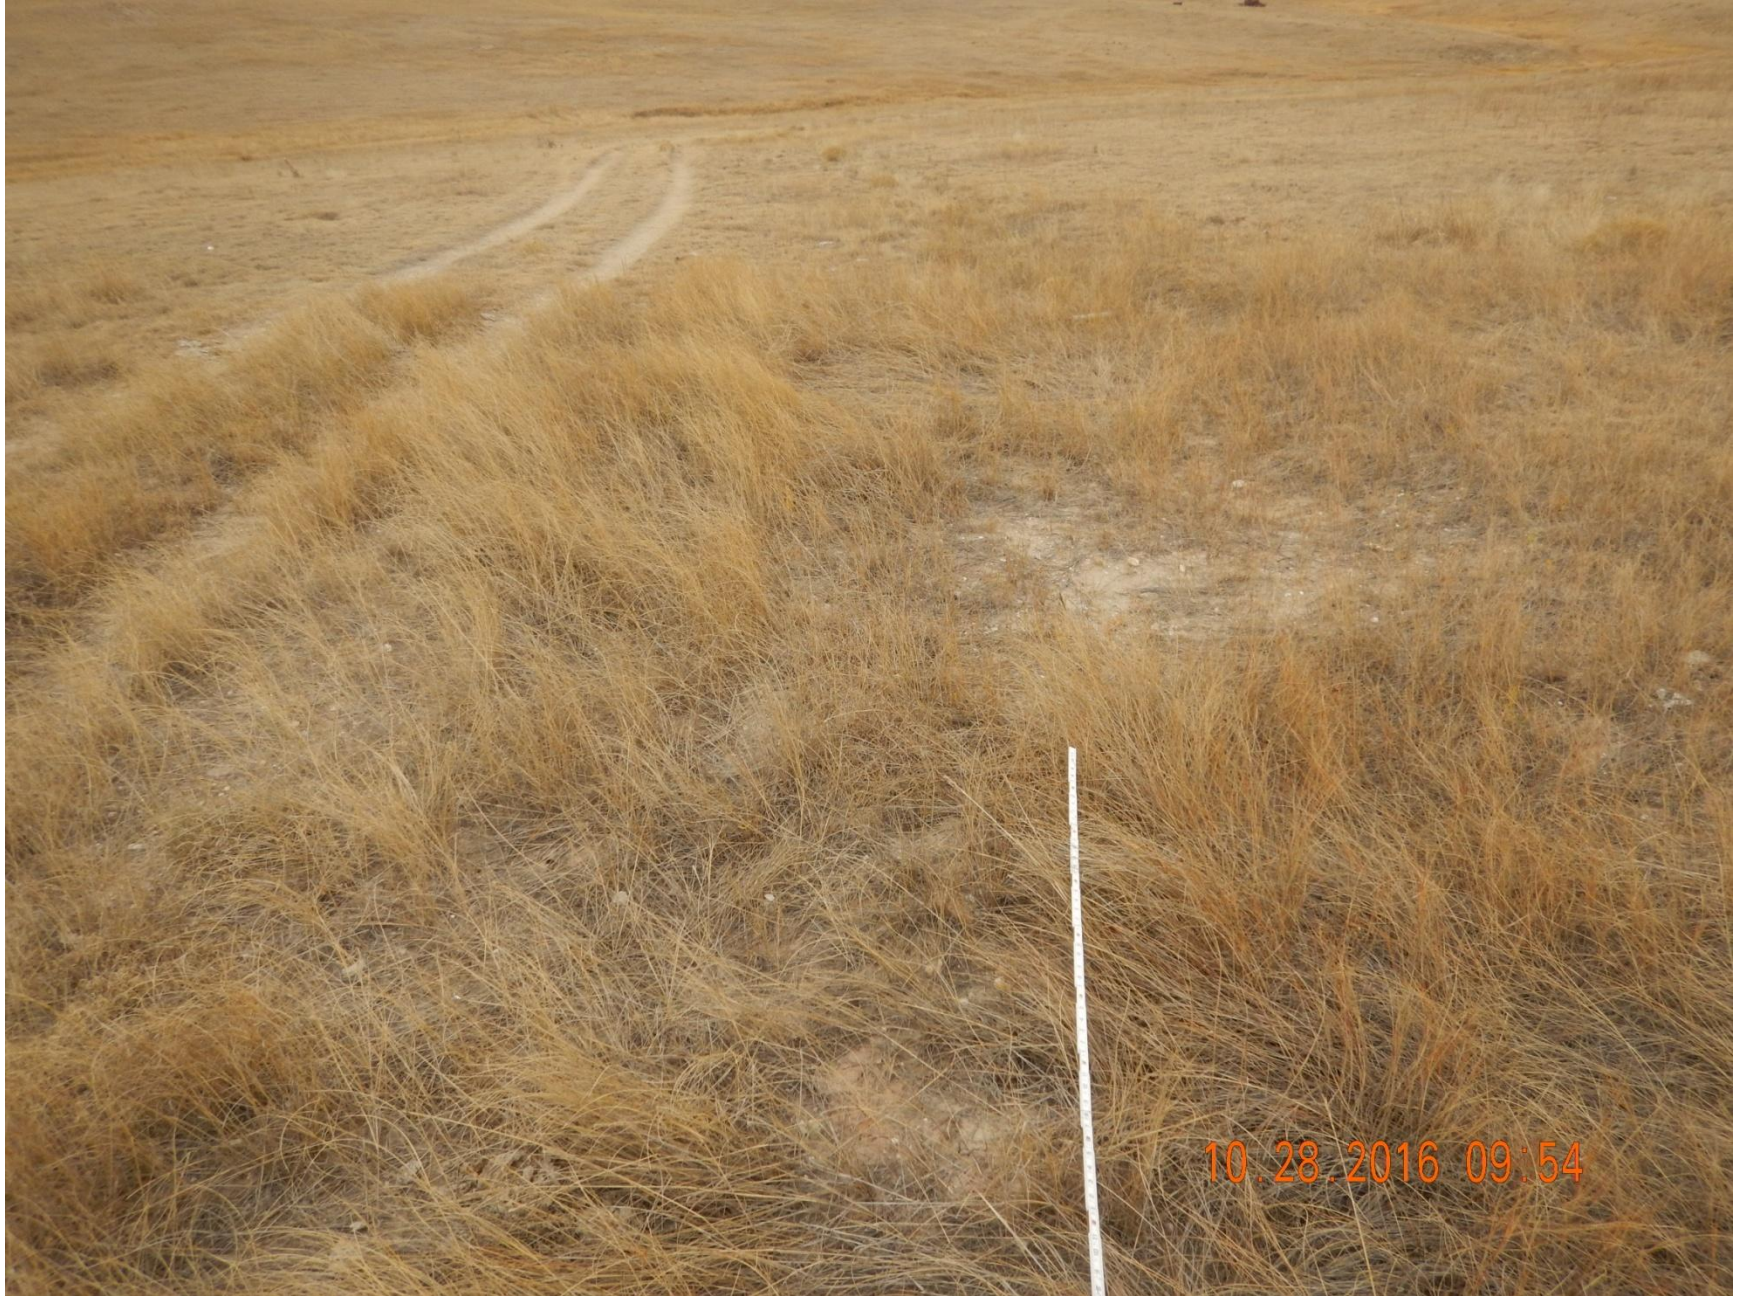
Figure 16: Photo taken from the west end of the location, facing north. Photo shows “starting” area where a gulley forming to the west of the location has formed. 6’ measuring stick for reference.

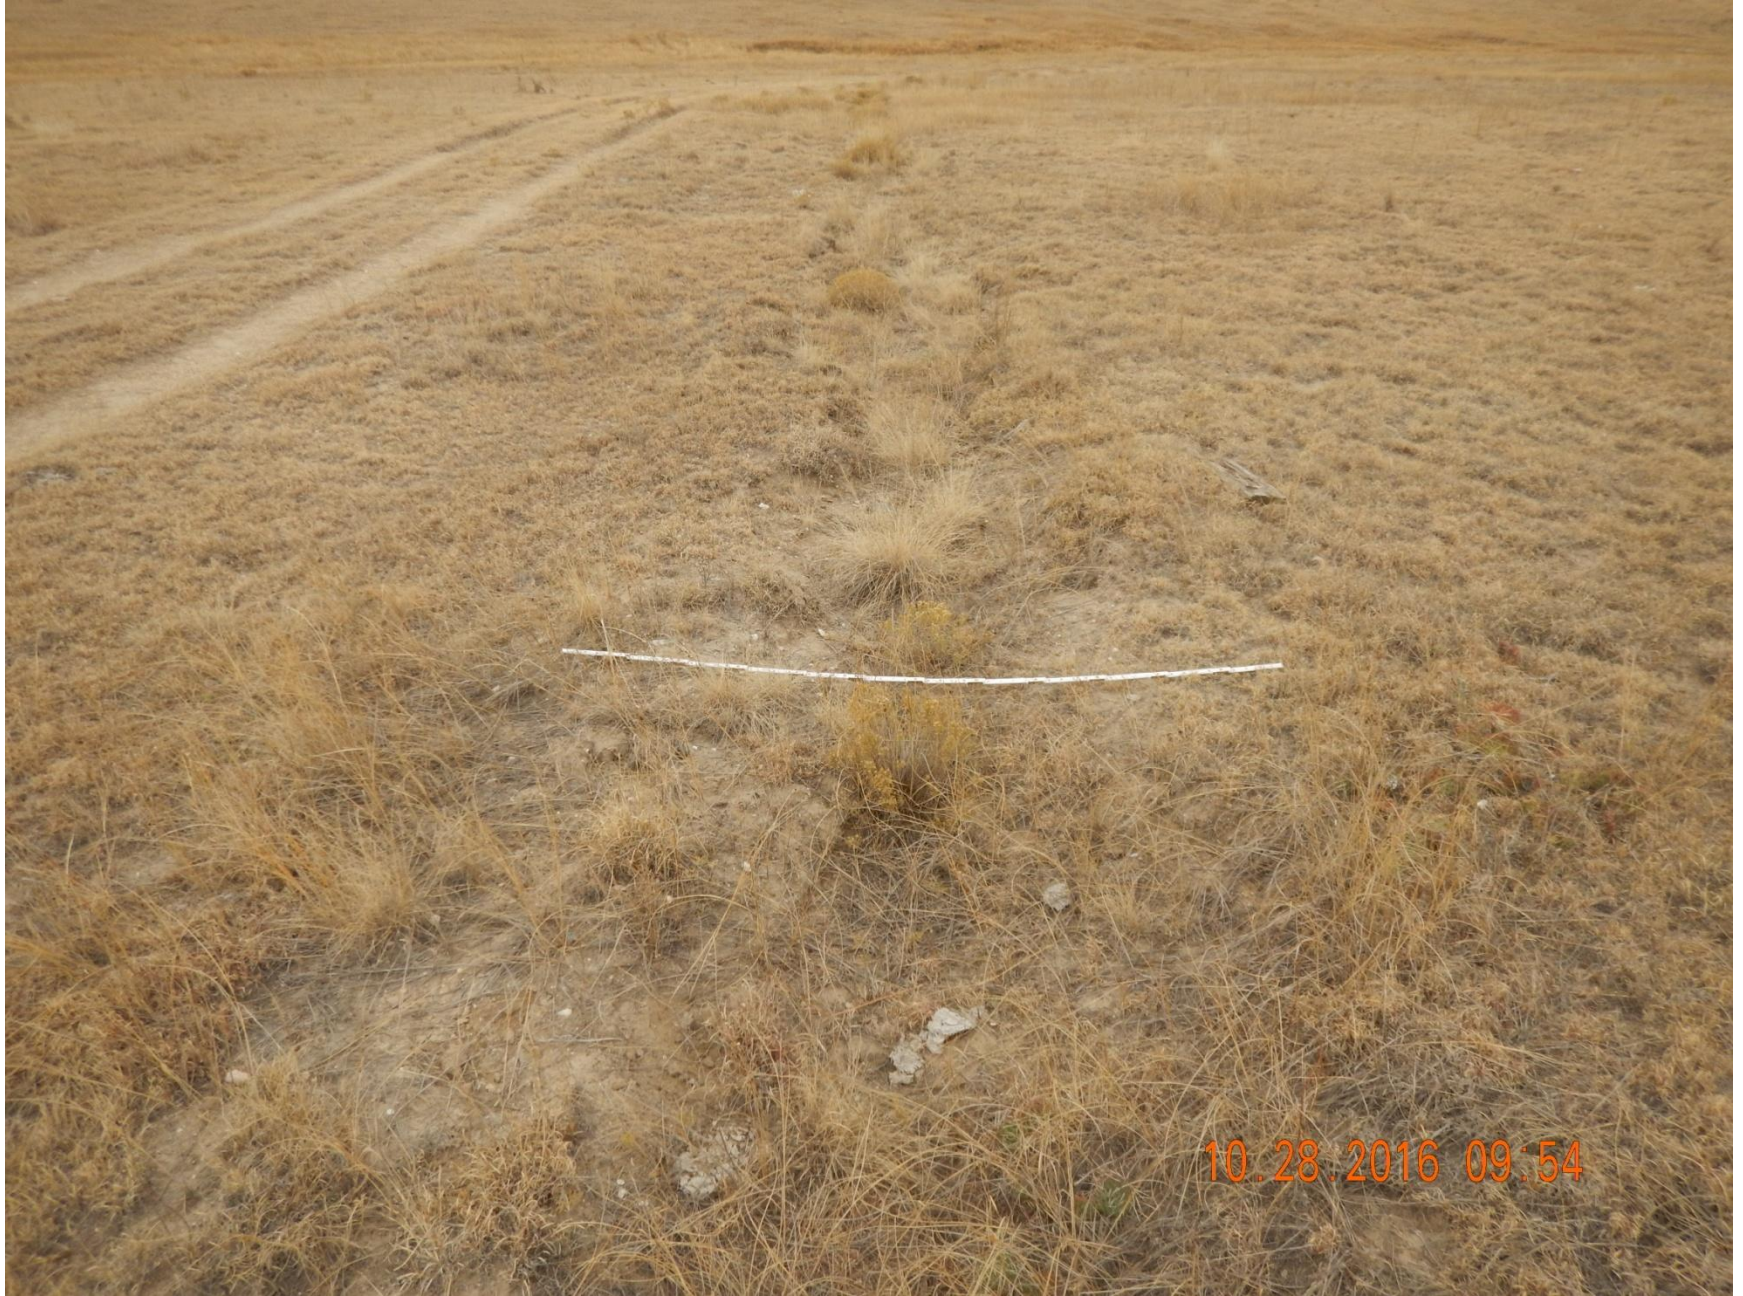
Figure 17: Photo taken west of the location, facing west. Photo shows gully formed by stormwater originating from the location. 6' measuring stick for reference.

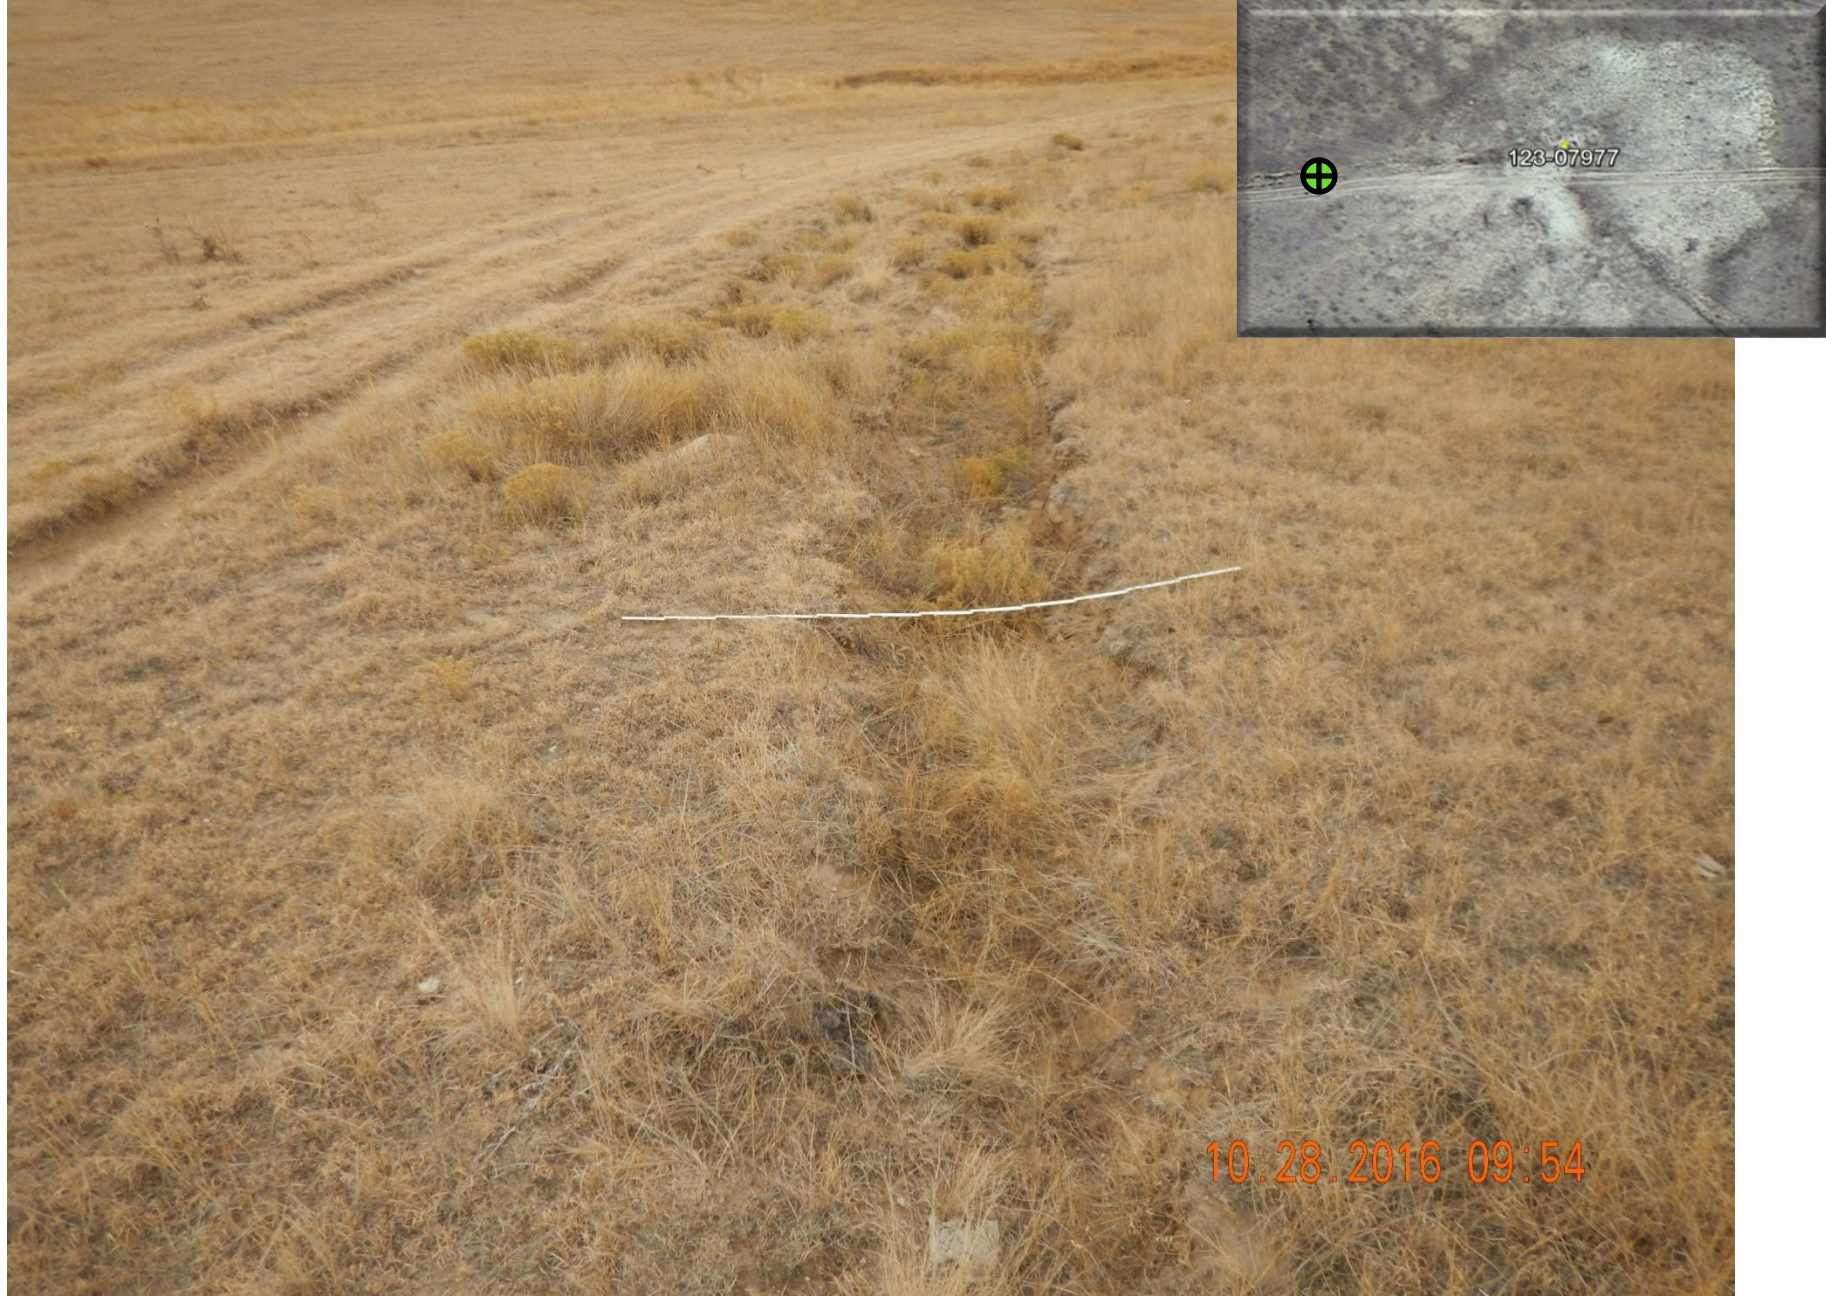
Figure 18: Photo taken west of the location, facing west. Photo shows gully formed by stormwater originating from the location. 6' measuring stick for reference.

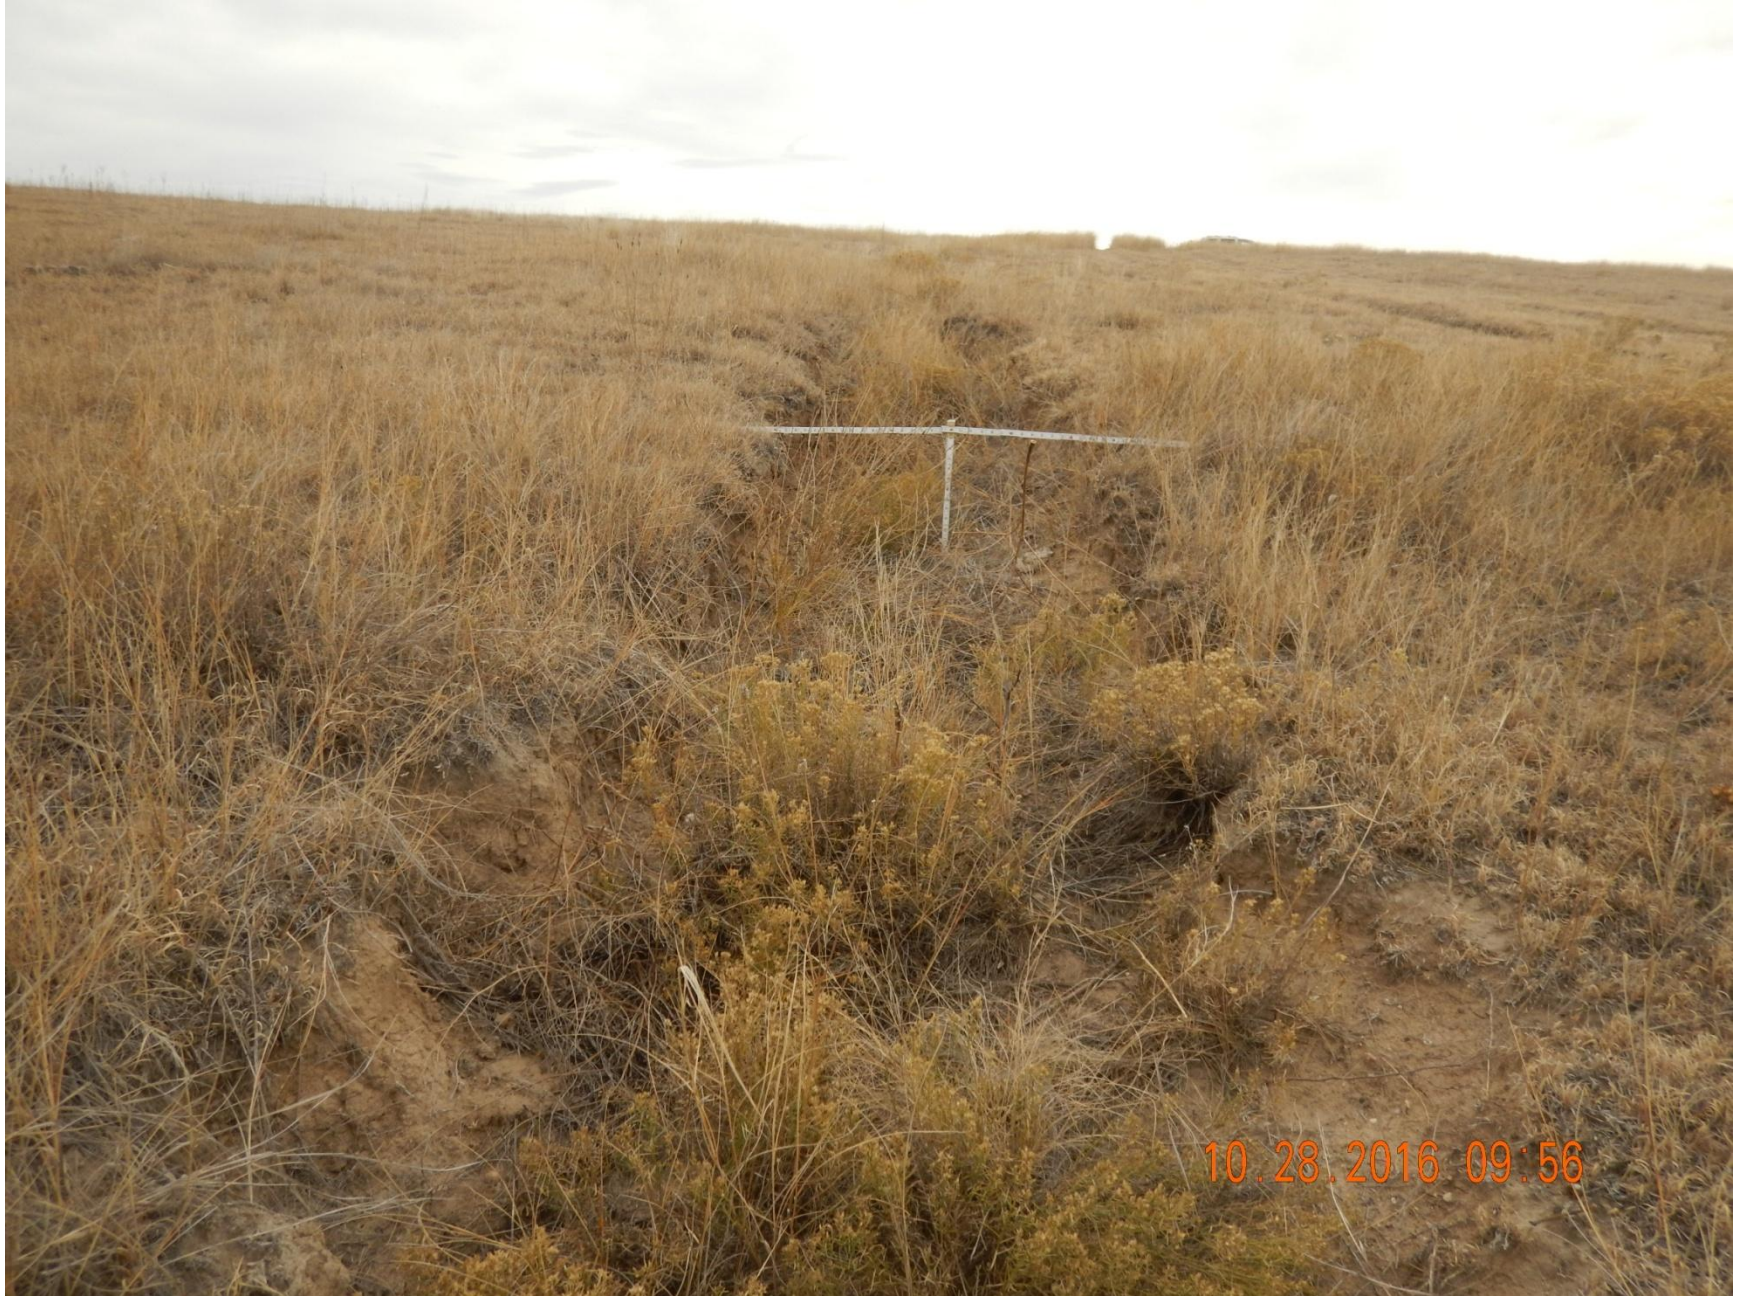
Figure 19: Photo taken west of the location, facing east. Photo shows gully formed by stormwater originating from the location. Measuring stick for reference.

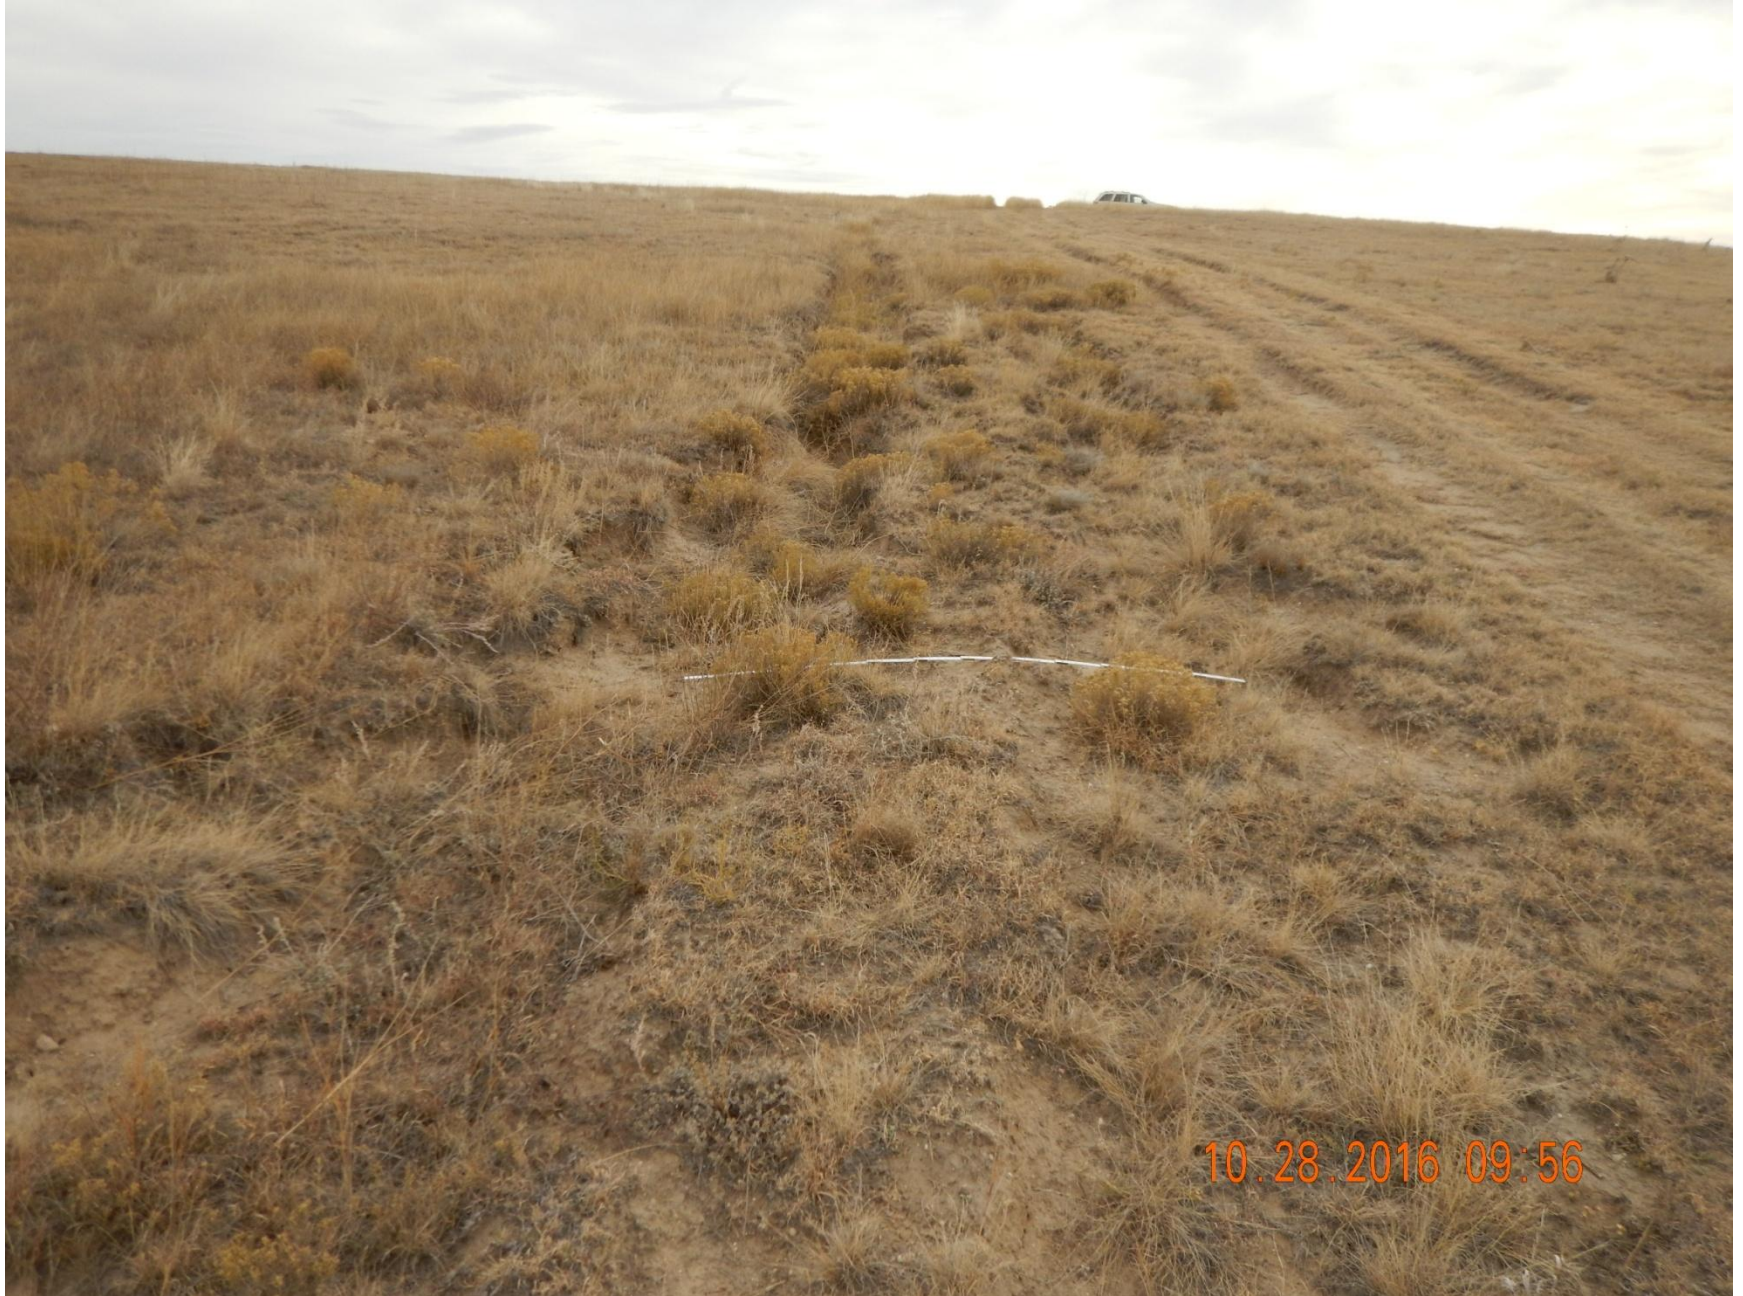
Figure 20: Photo taken west of the location, facing east. Photo shows gully formed by stormwater originating from the location. 6' measuring stick for reference.

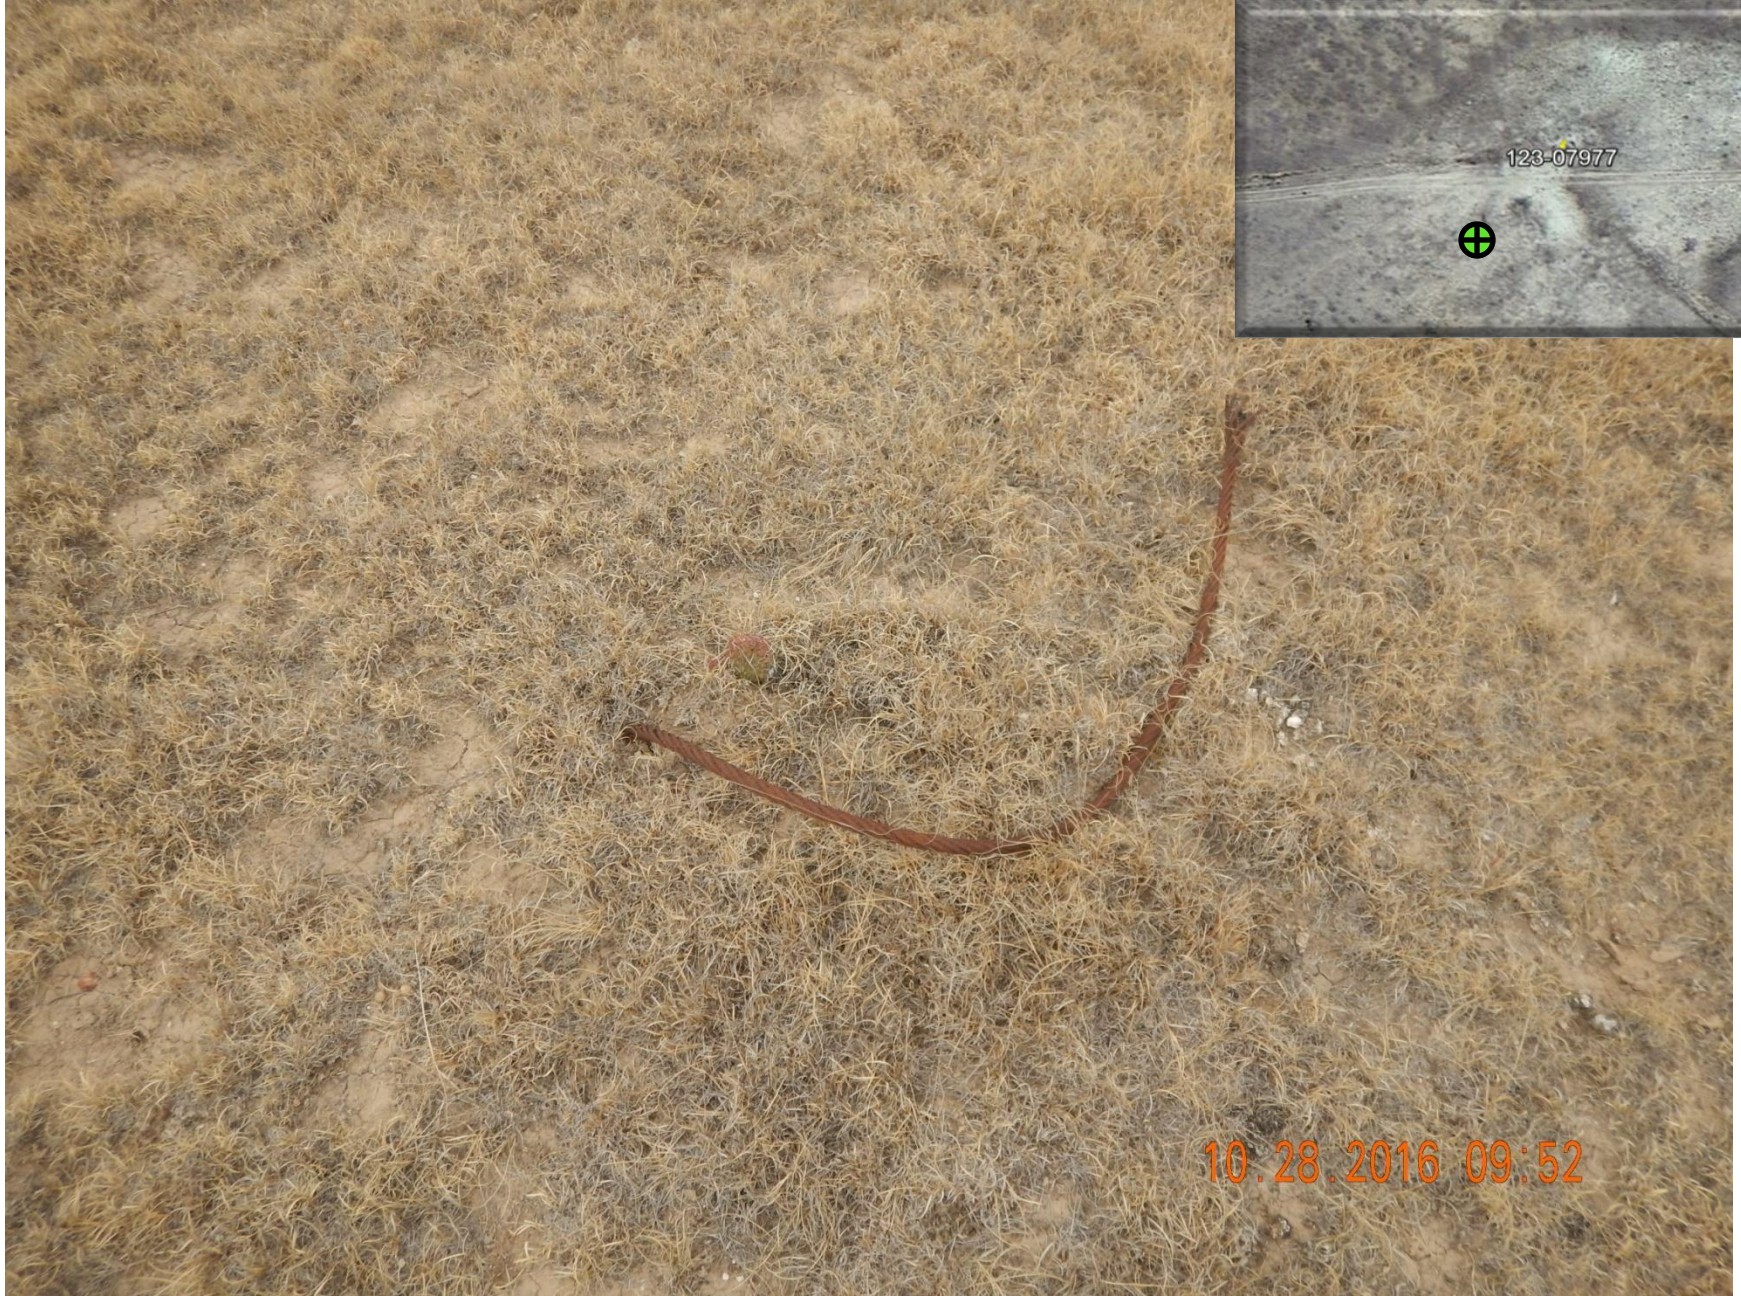
Figure 21: Photo taken from the southwest end of the location. Photo shows cable still remaining.
