Reclamation Inspection

10/28/2016

Operator: Markus Production Inc.

Location ID: 406198

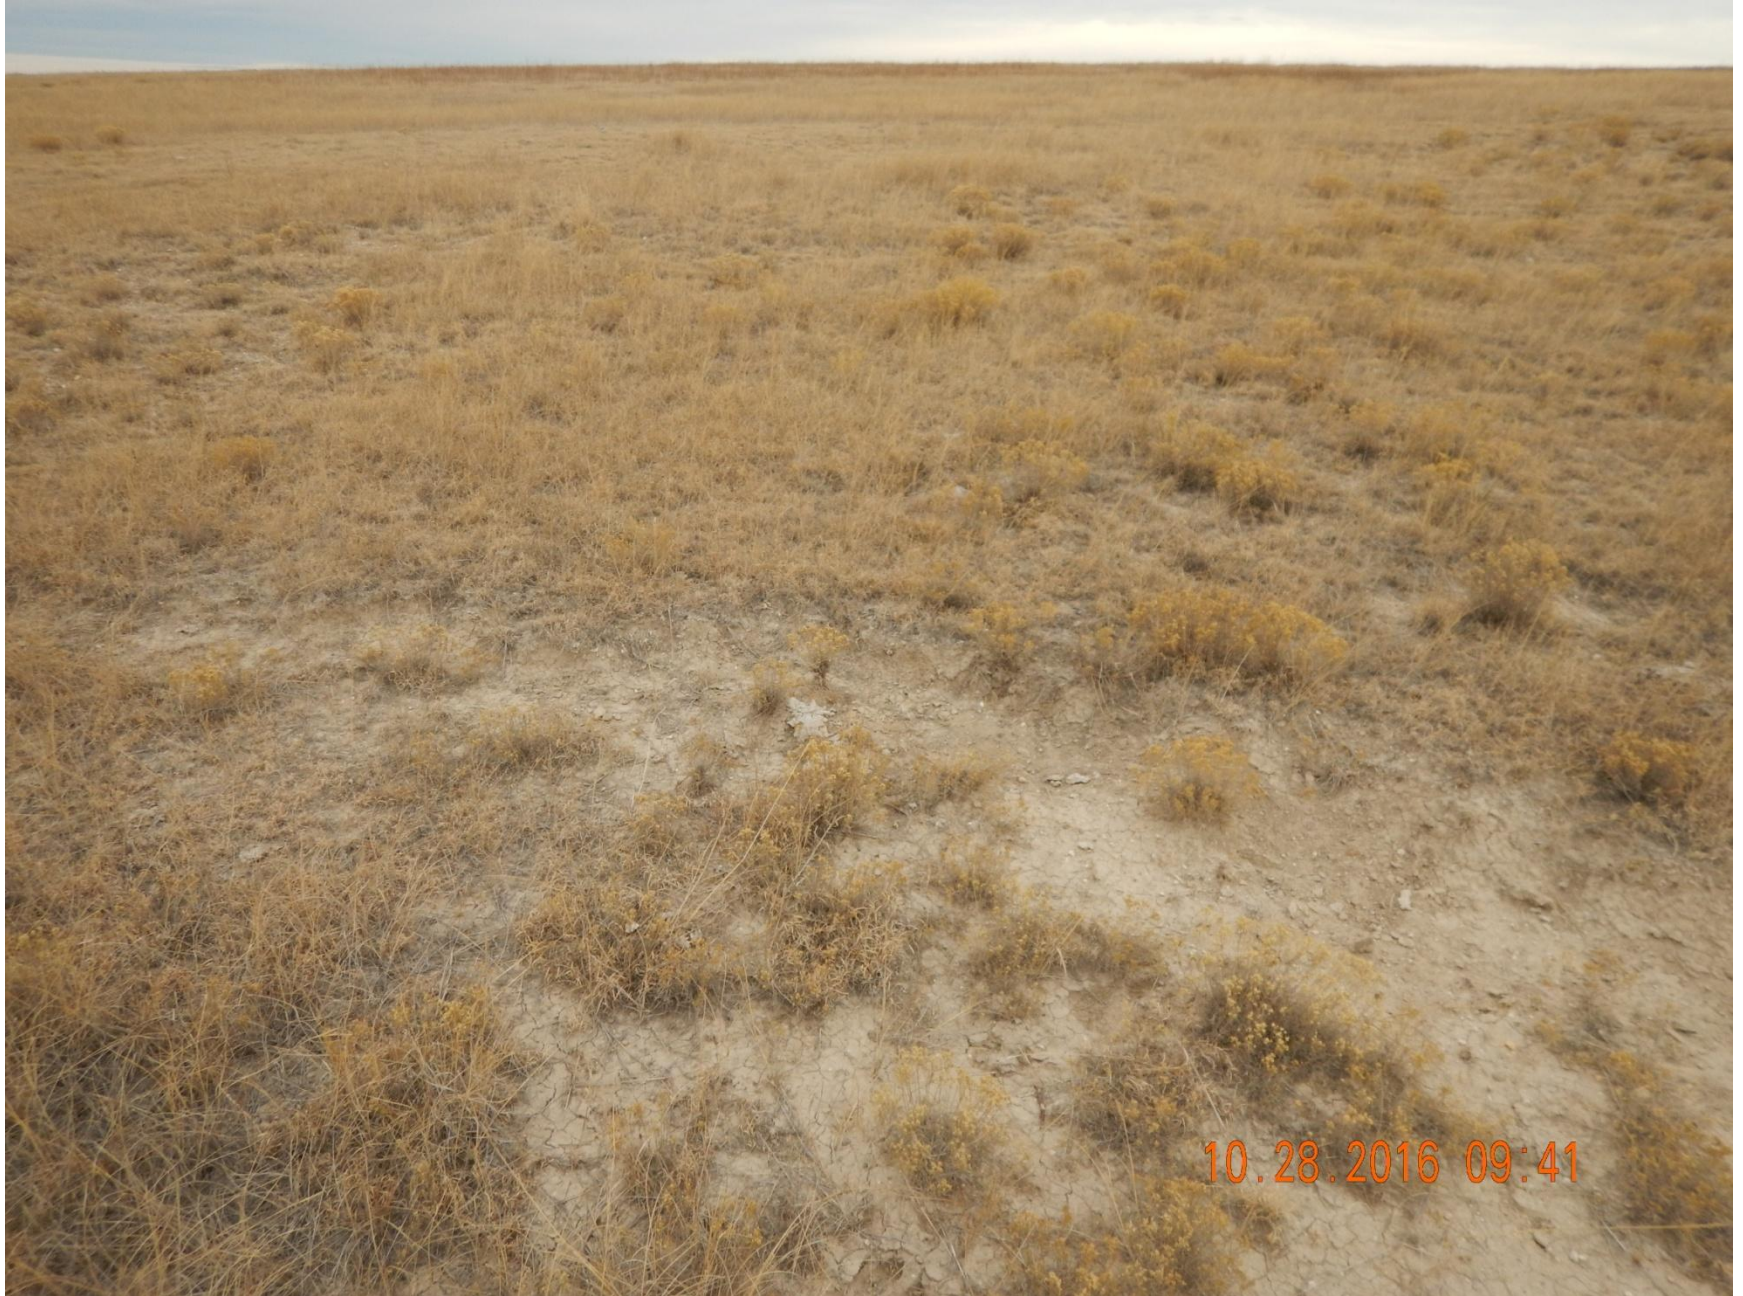
Figure 25: Photo taken from the access road, on the north end of the pit/battery location, facing north. Photo shows areas that remain unvegetated.

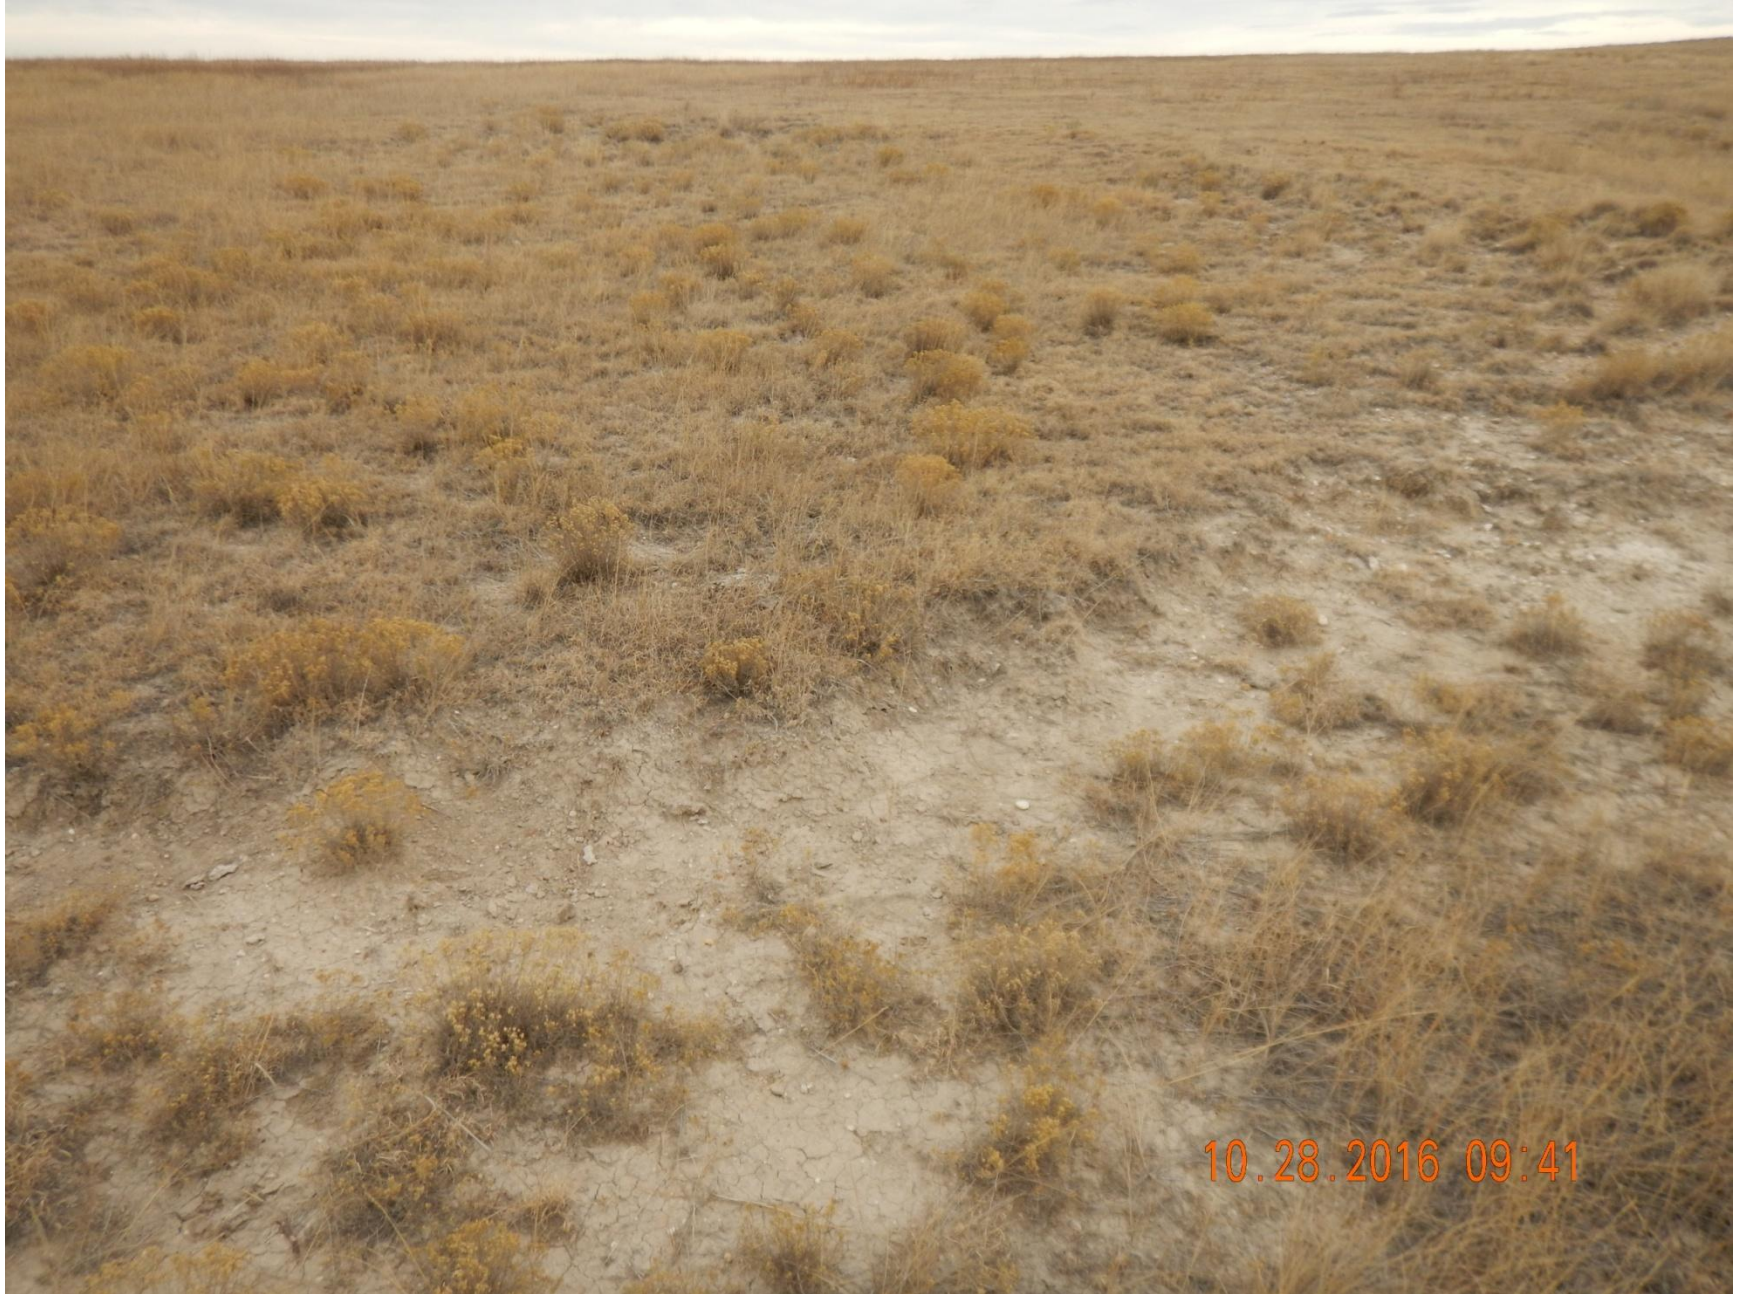
Figure 26: Photo taken from the access road, on the north end of the pit/battery location, facing northwest. Photo shows areas that remain unvegetated.

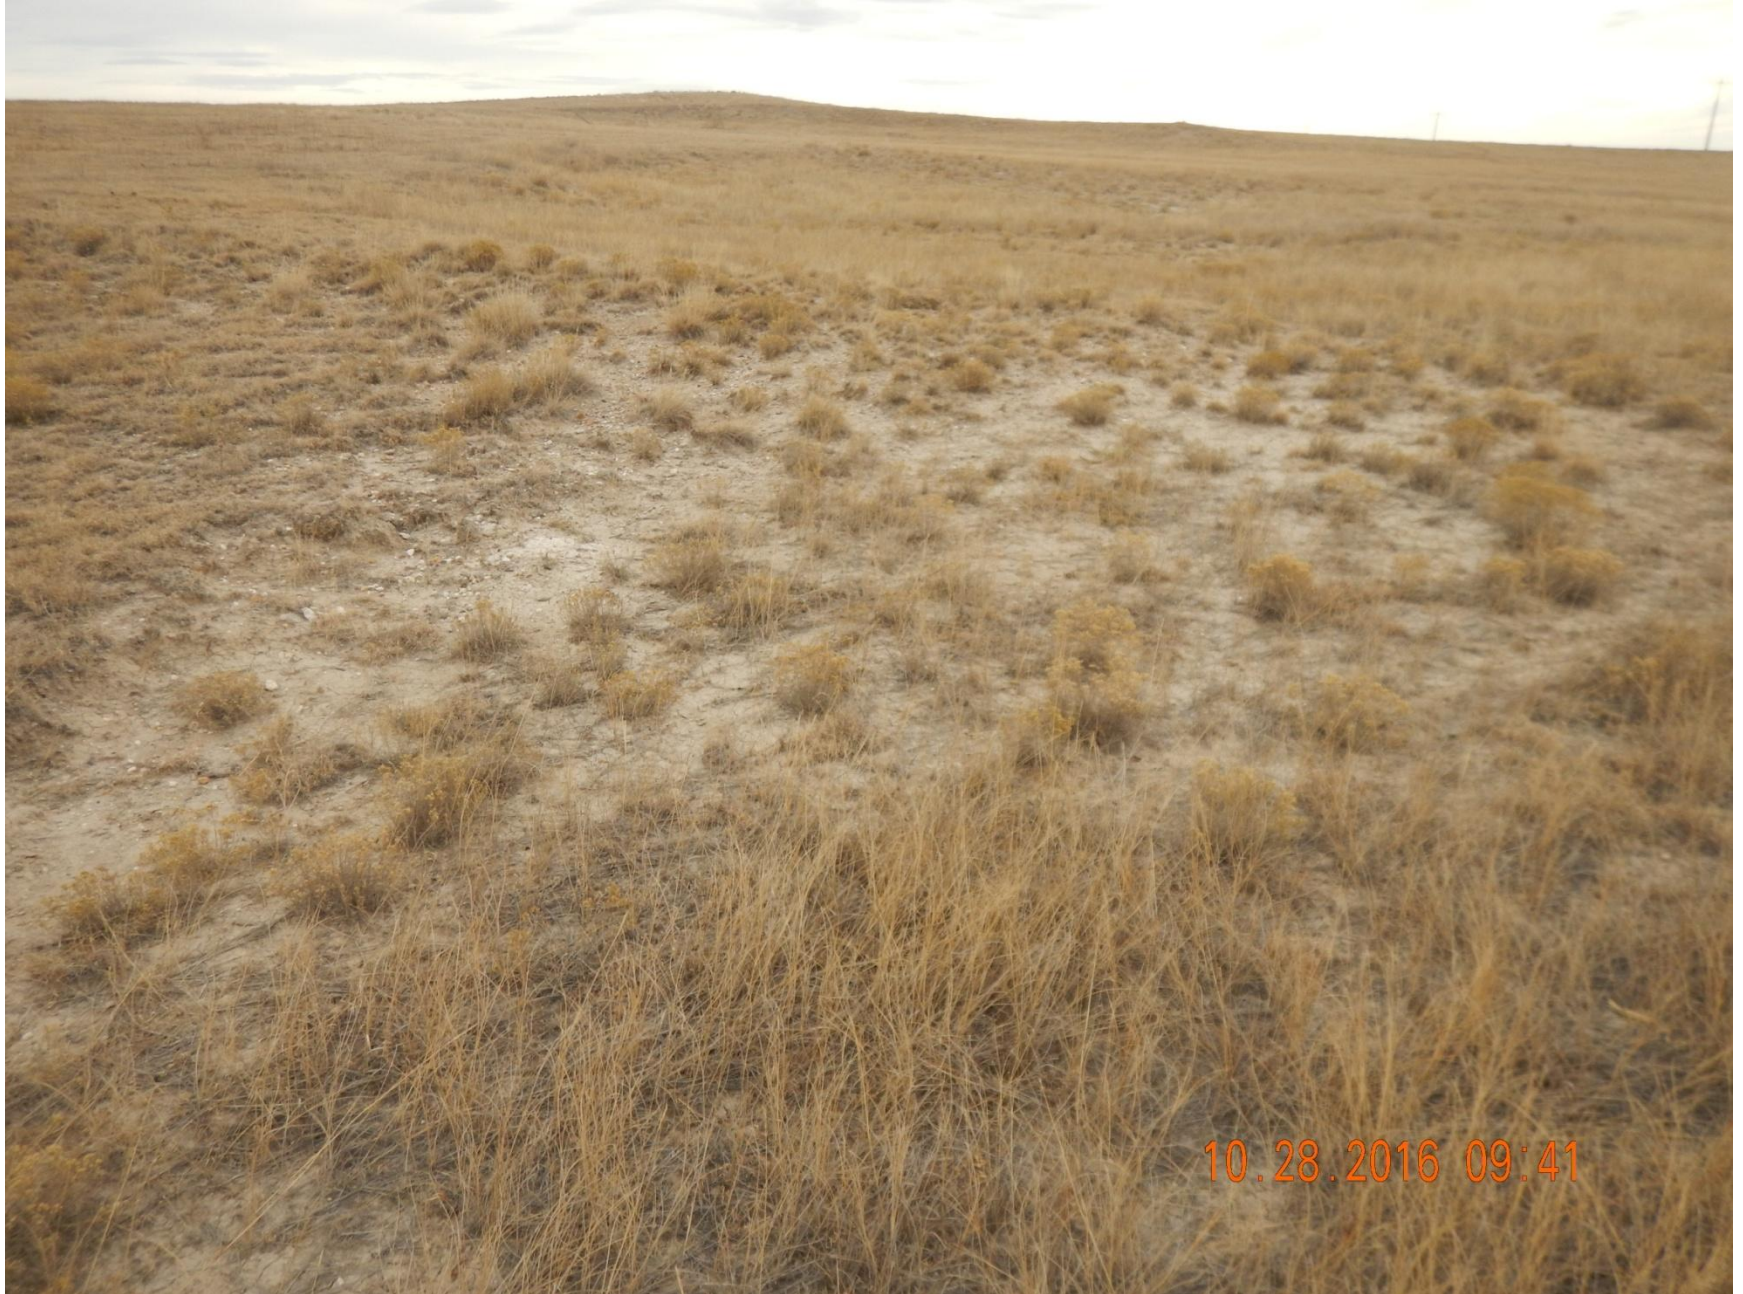
Figure 27: Photo taken from the access road, on the north end of the pit/battery location, facing northeast. Photo shows areas that remain unvegetated.

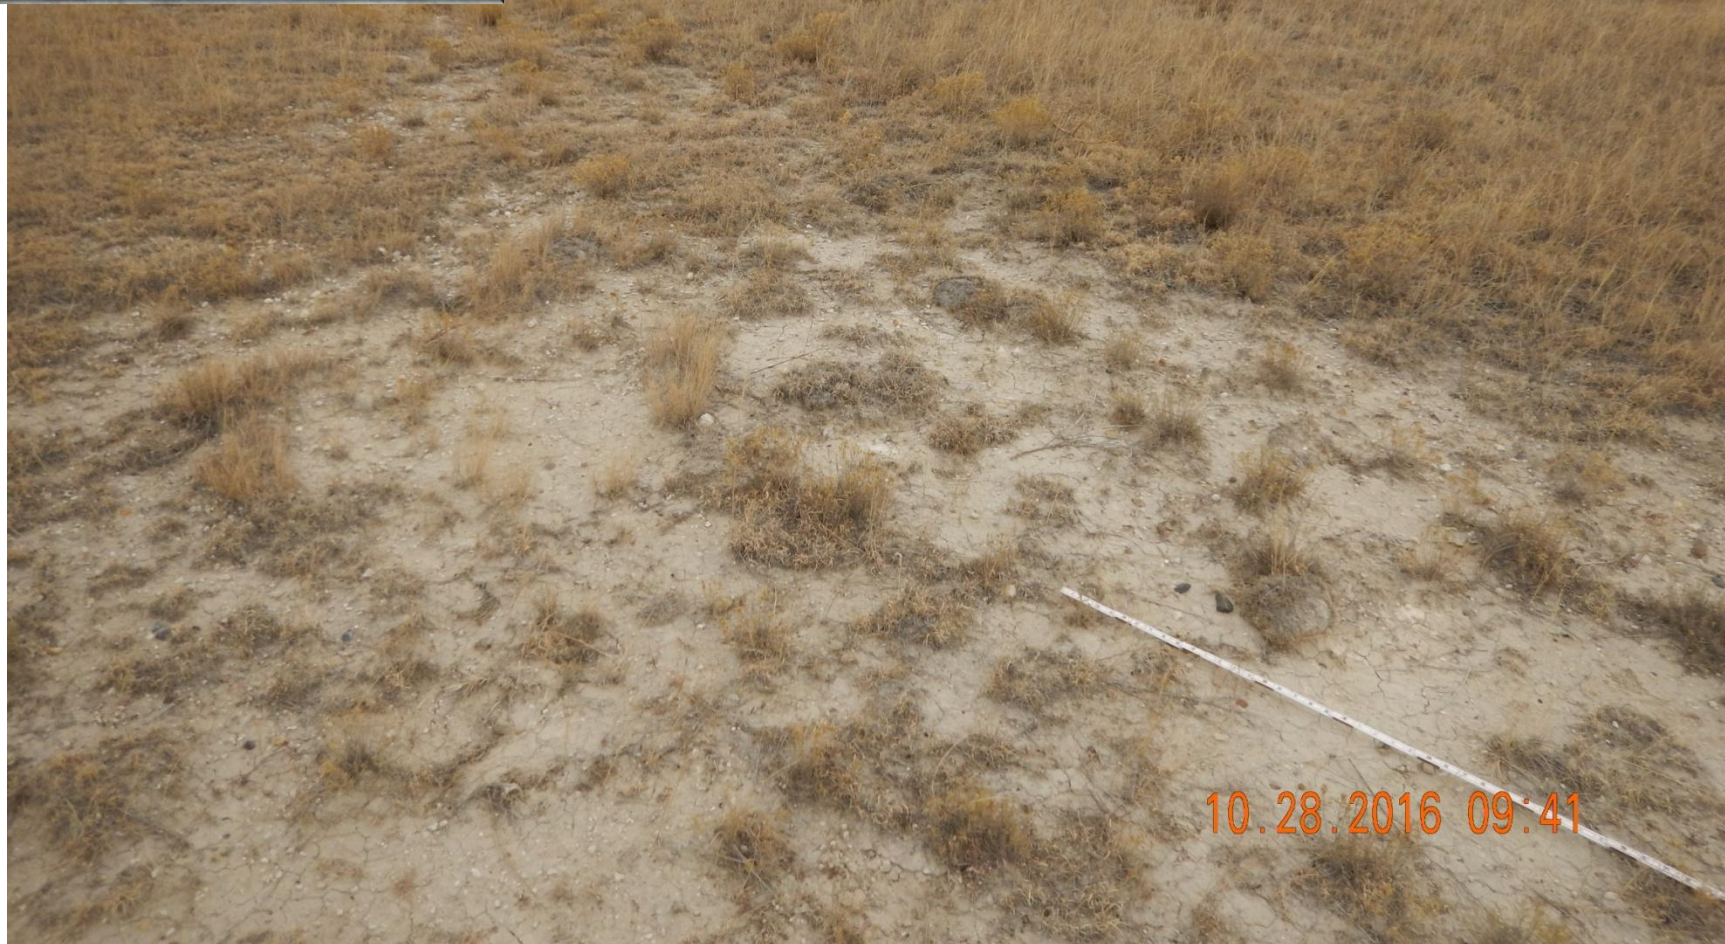
Figure 28: Photo taken from the access road, on the northeast end of the pit/battery location, facing northwest. Photo shows areas that remain unvegetated.

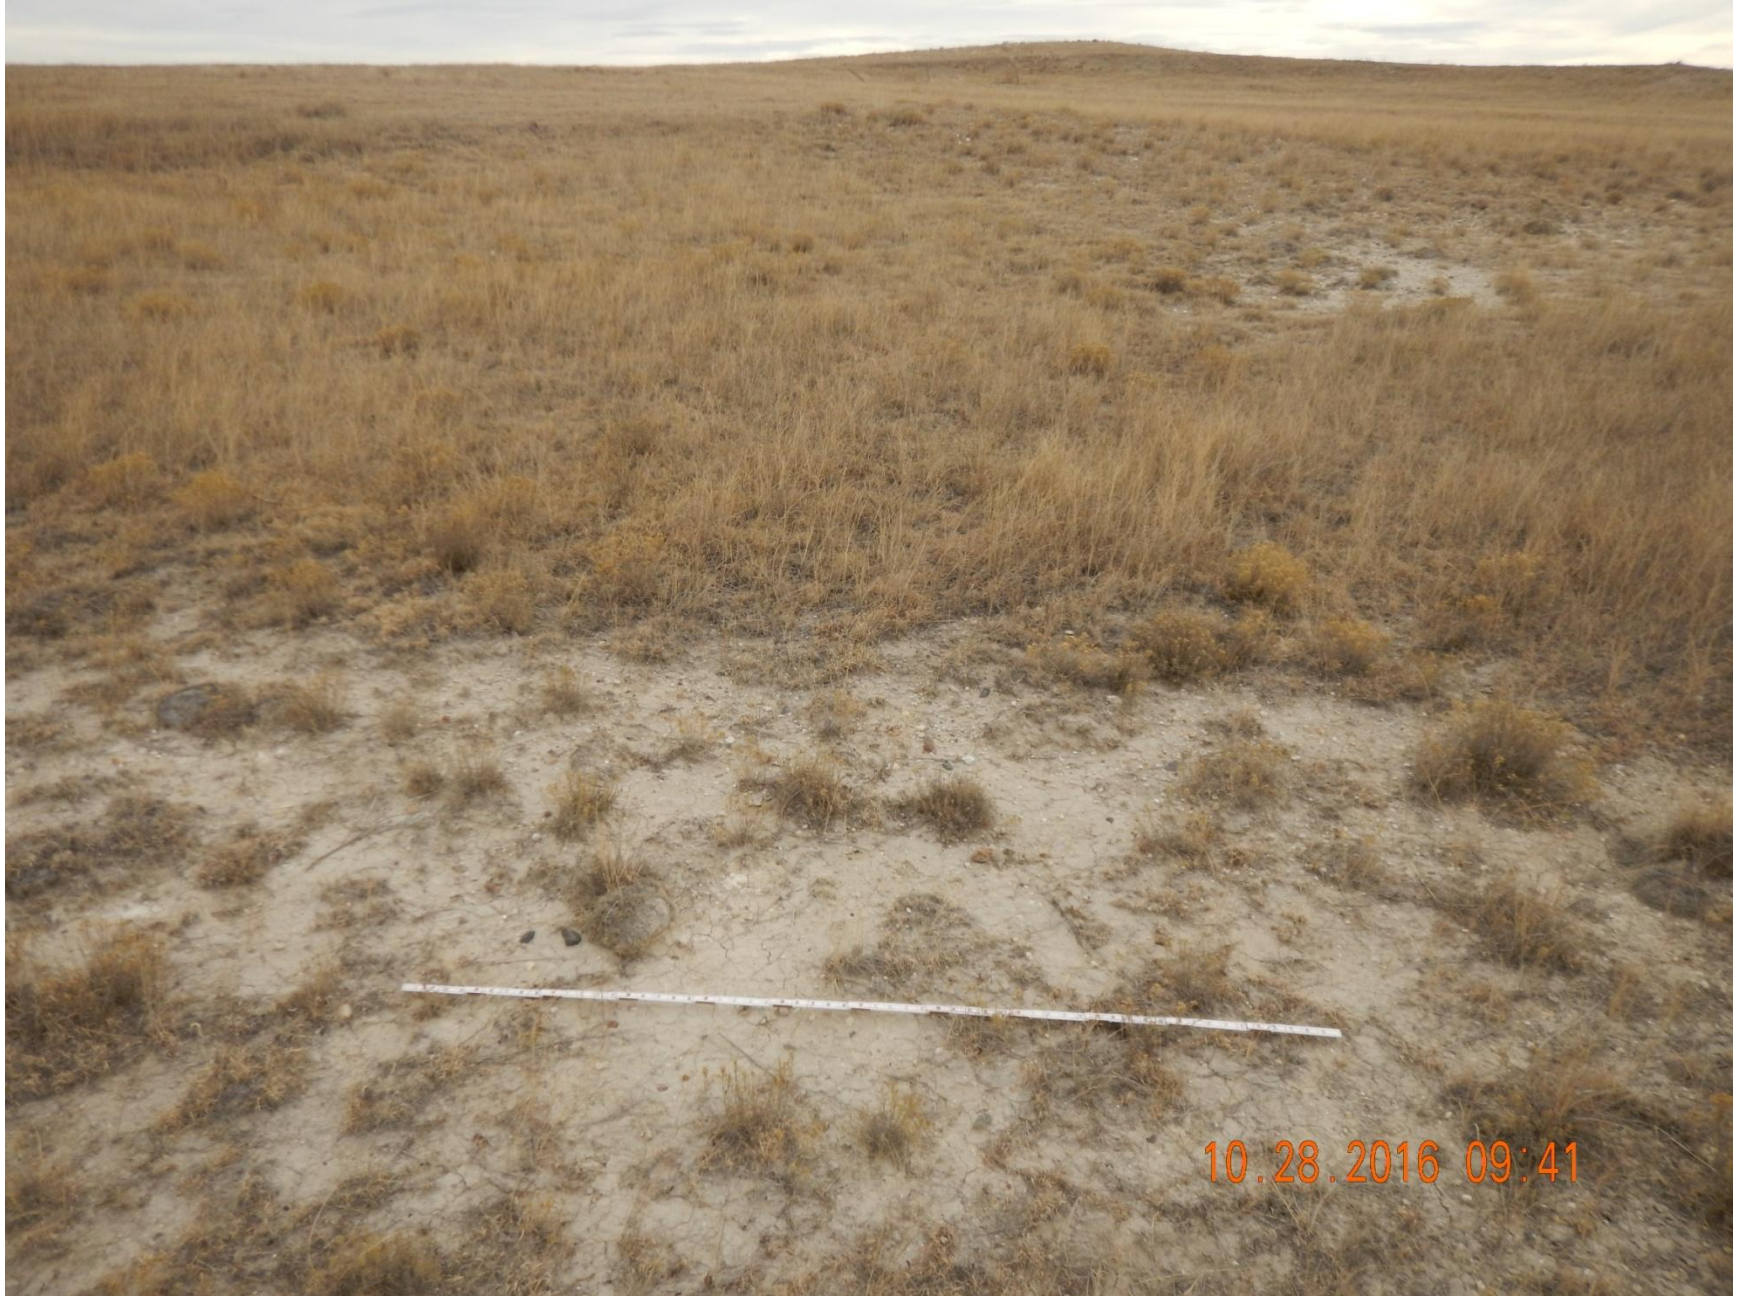
Figure 29: Photo taken from the access road, on the north end of the pit/battery location, facing northeast. Photo shows areas that remain unvegetated. 6' measuring stick for reference.

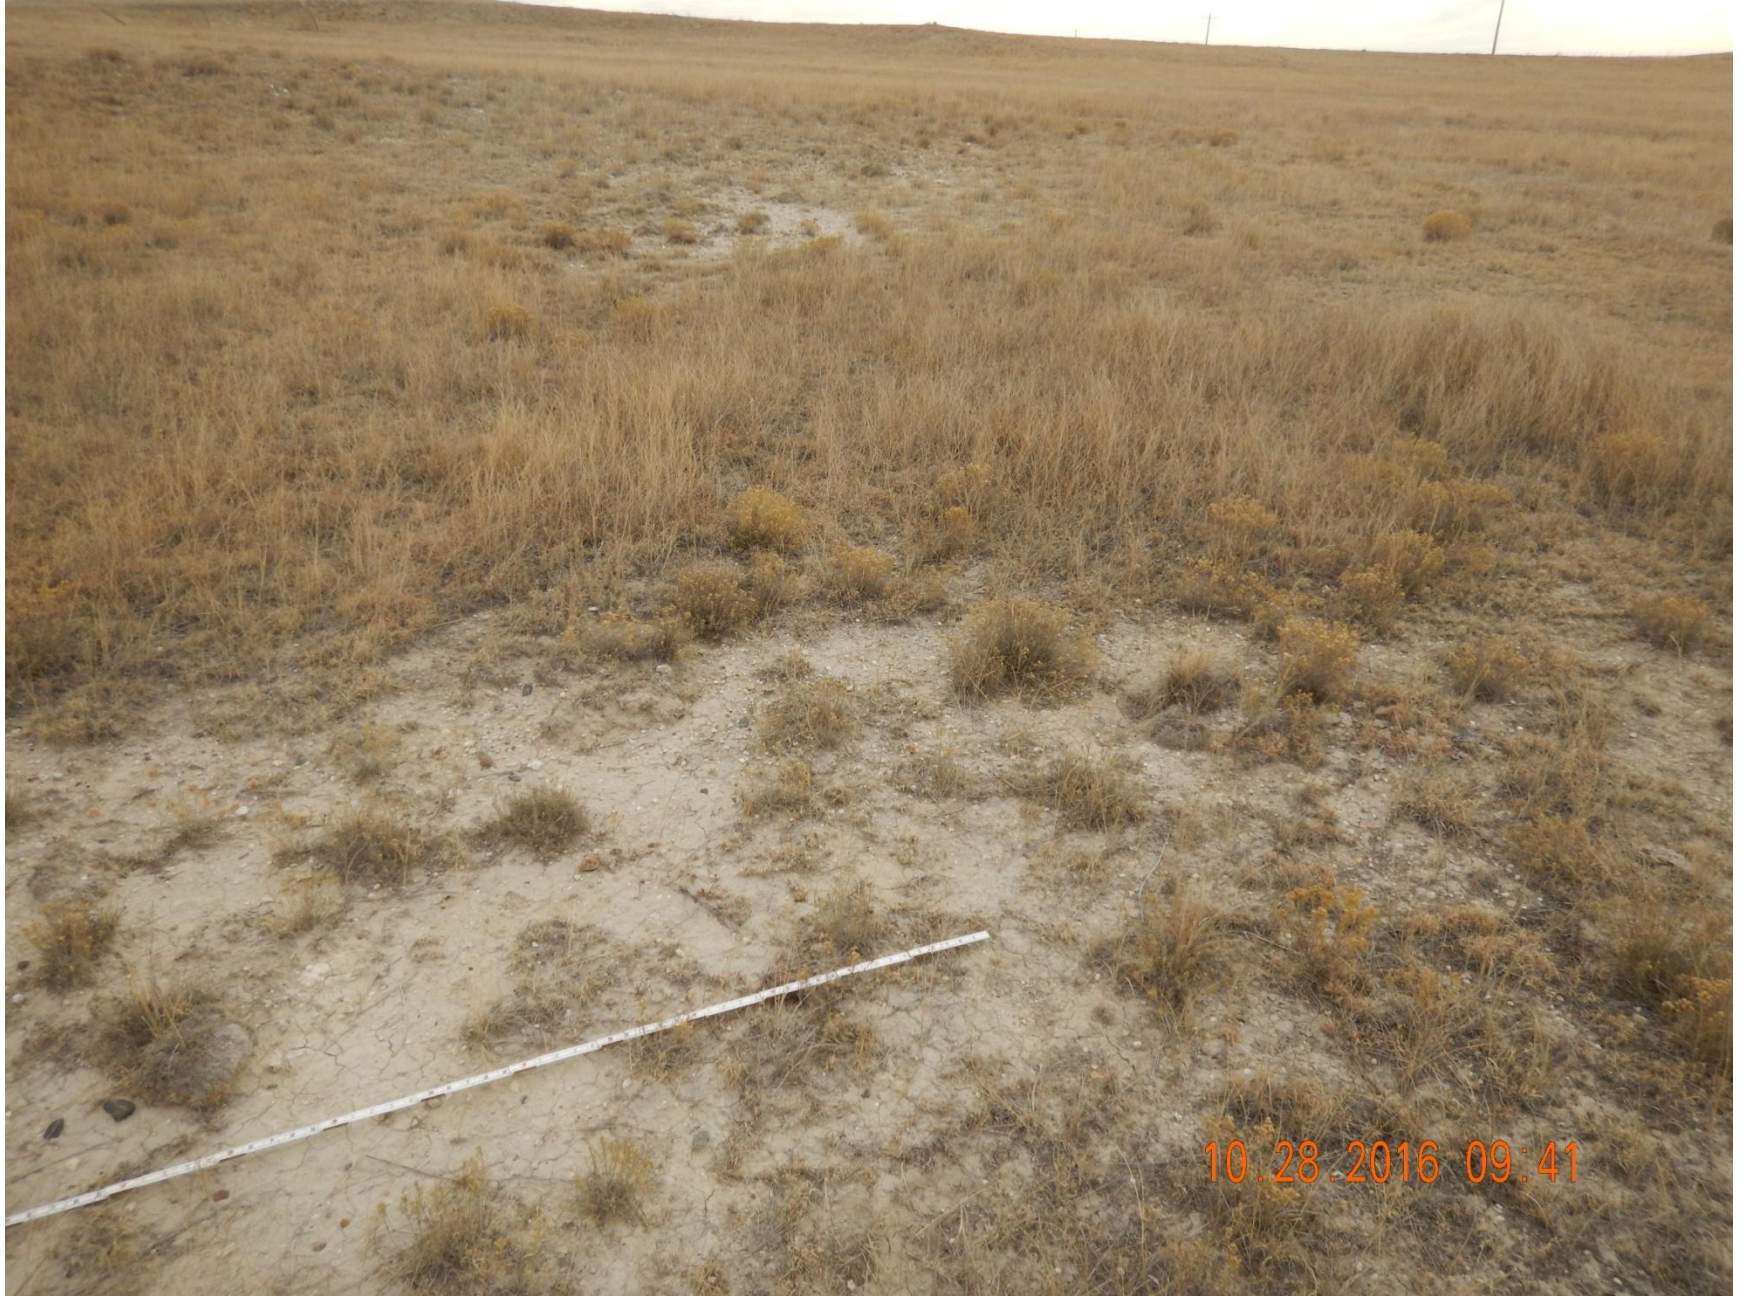
Figure 30: Photo taken from the access road, on the north end of the pit/battery location, facing northeast. Photo shows areas that remain unvegetated. 6' measuring stick for reference.

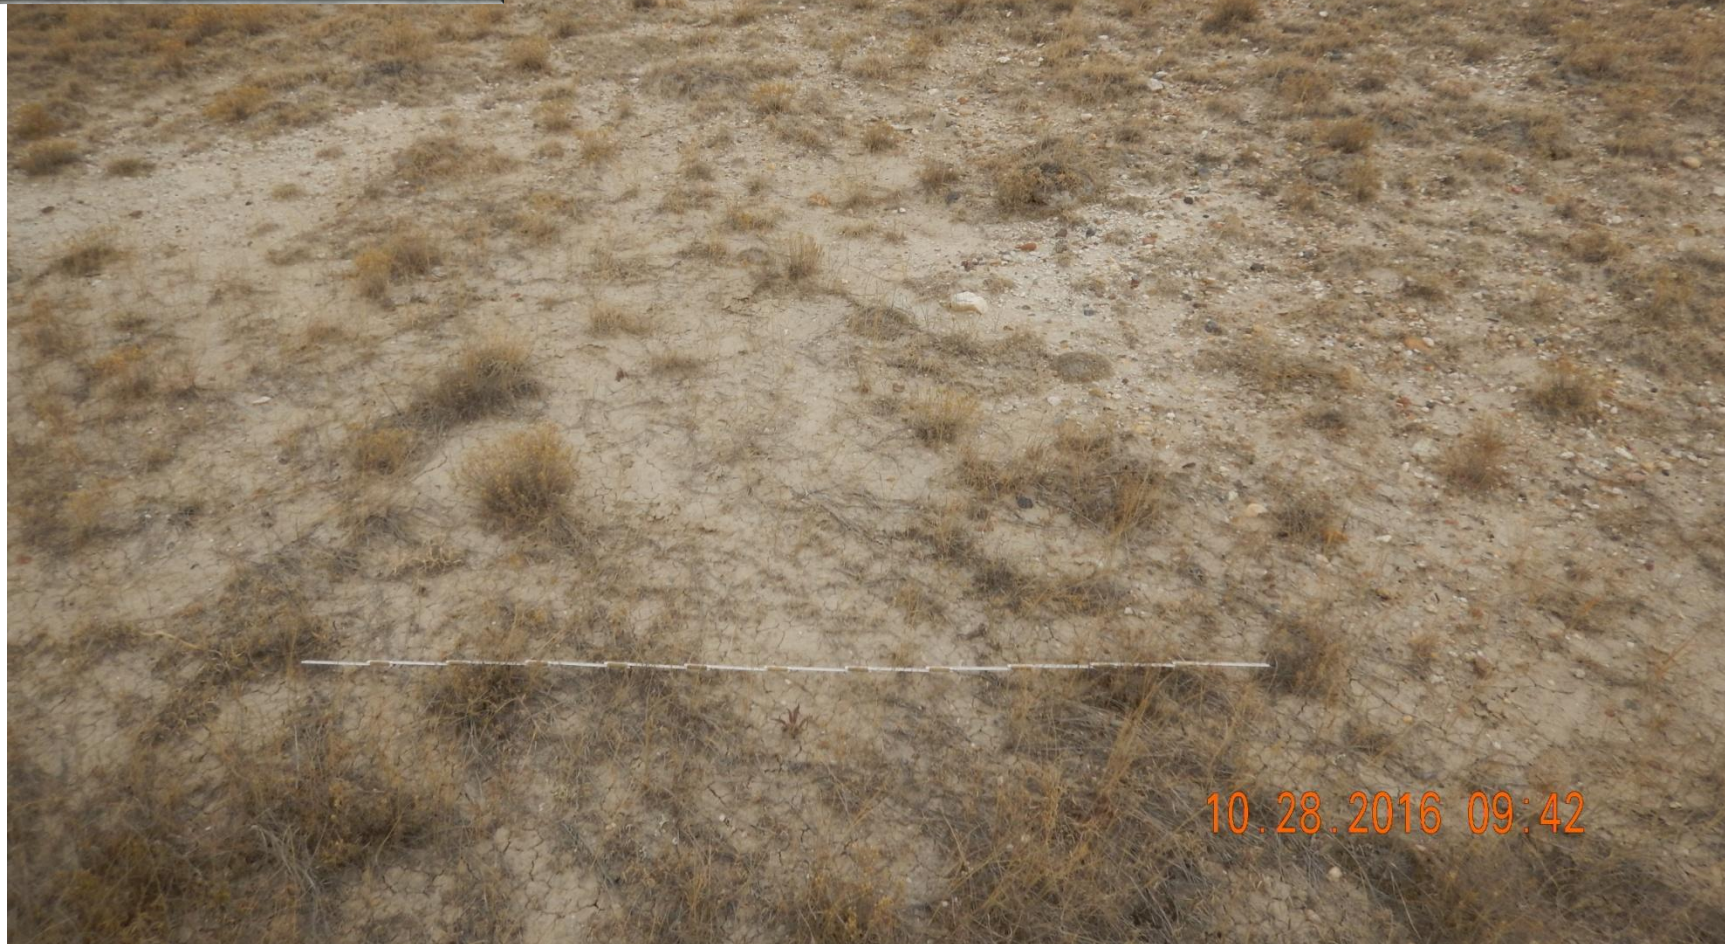
Figure 31: Photo taken from the access road, on the northeast end of the pit/battery location, facing north. Photo shows areas that remain unvegetated and experiencing degradation due to erosion. 6' measuring stick for reference.

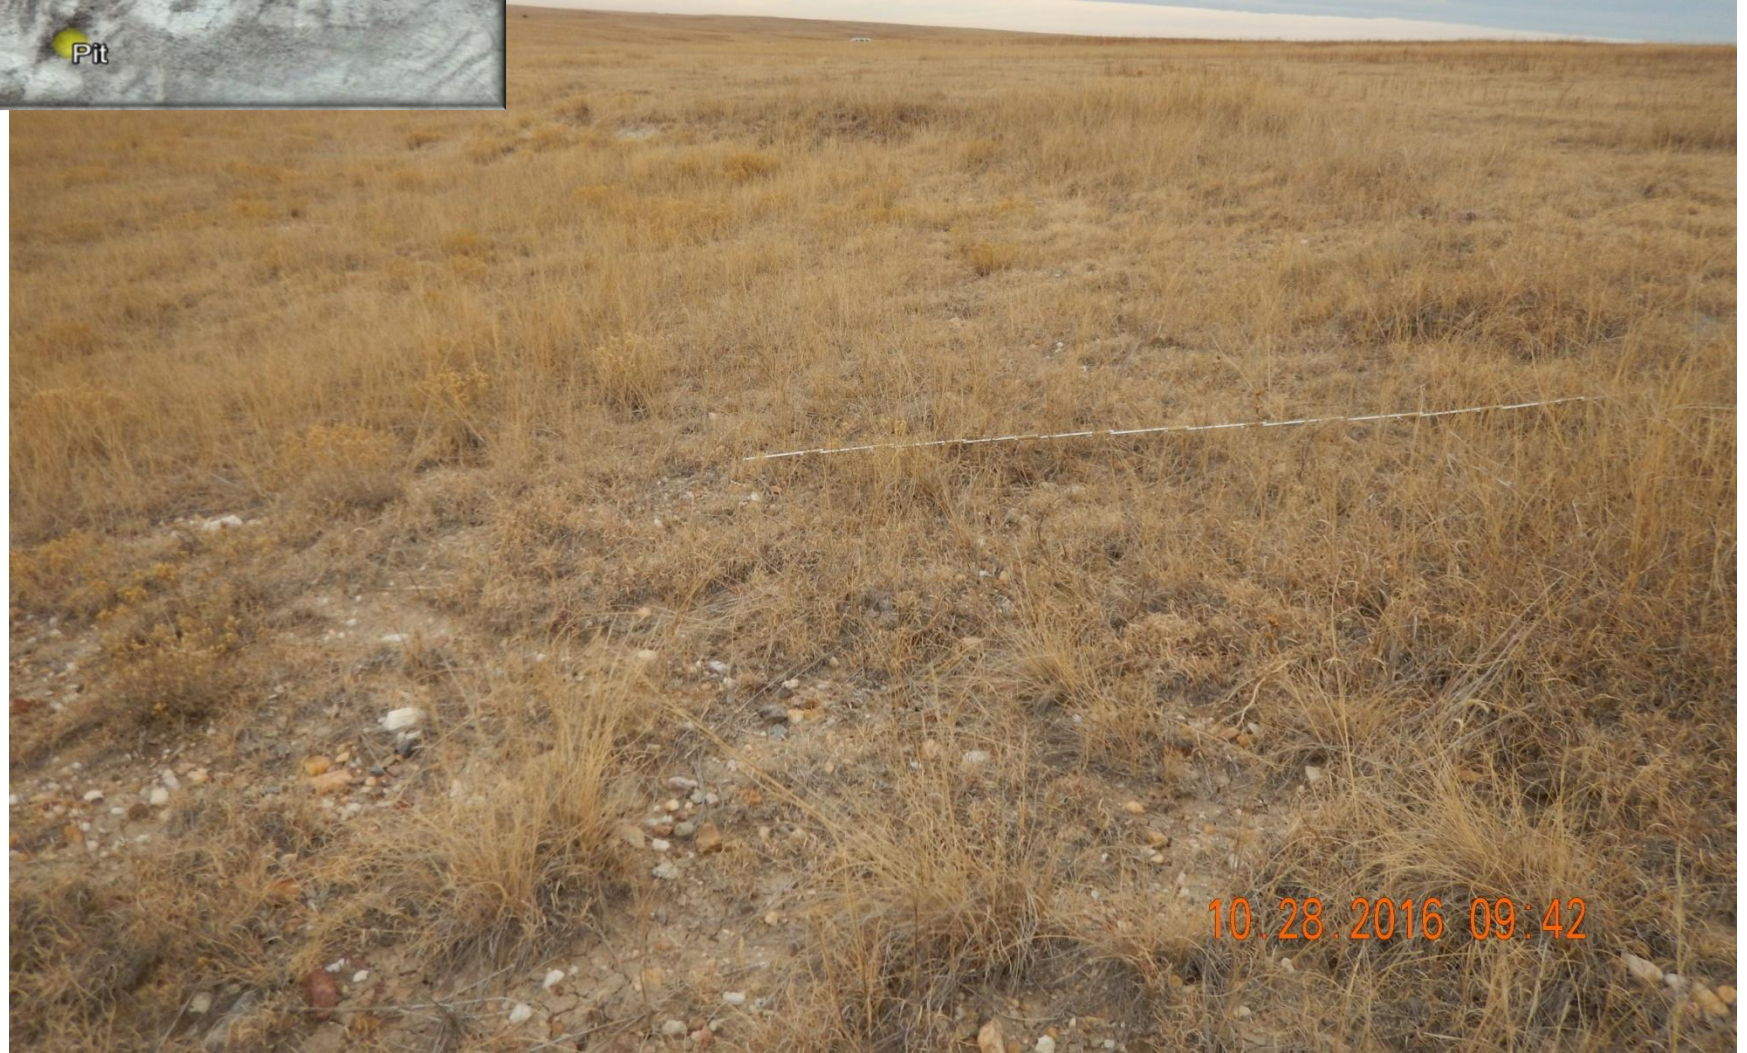
Figure 32: Photo taken from area north of the pit/battery location, facing west. Photo shows area that has either not been recontoured, or has experience erosion degradation.

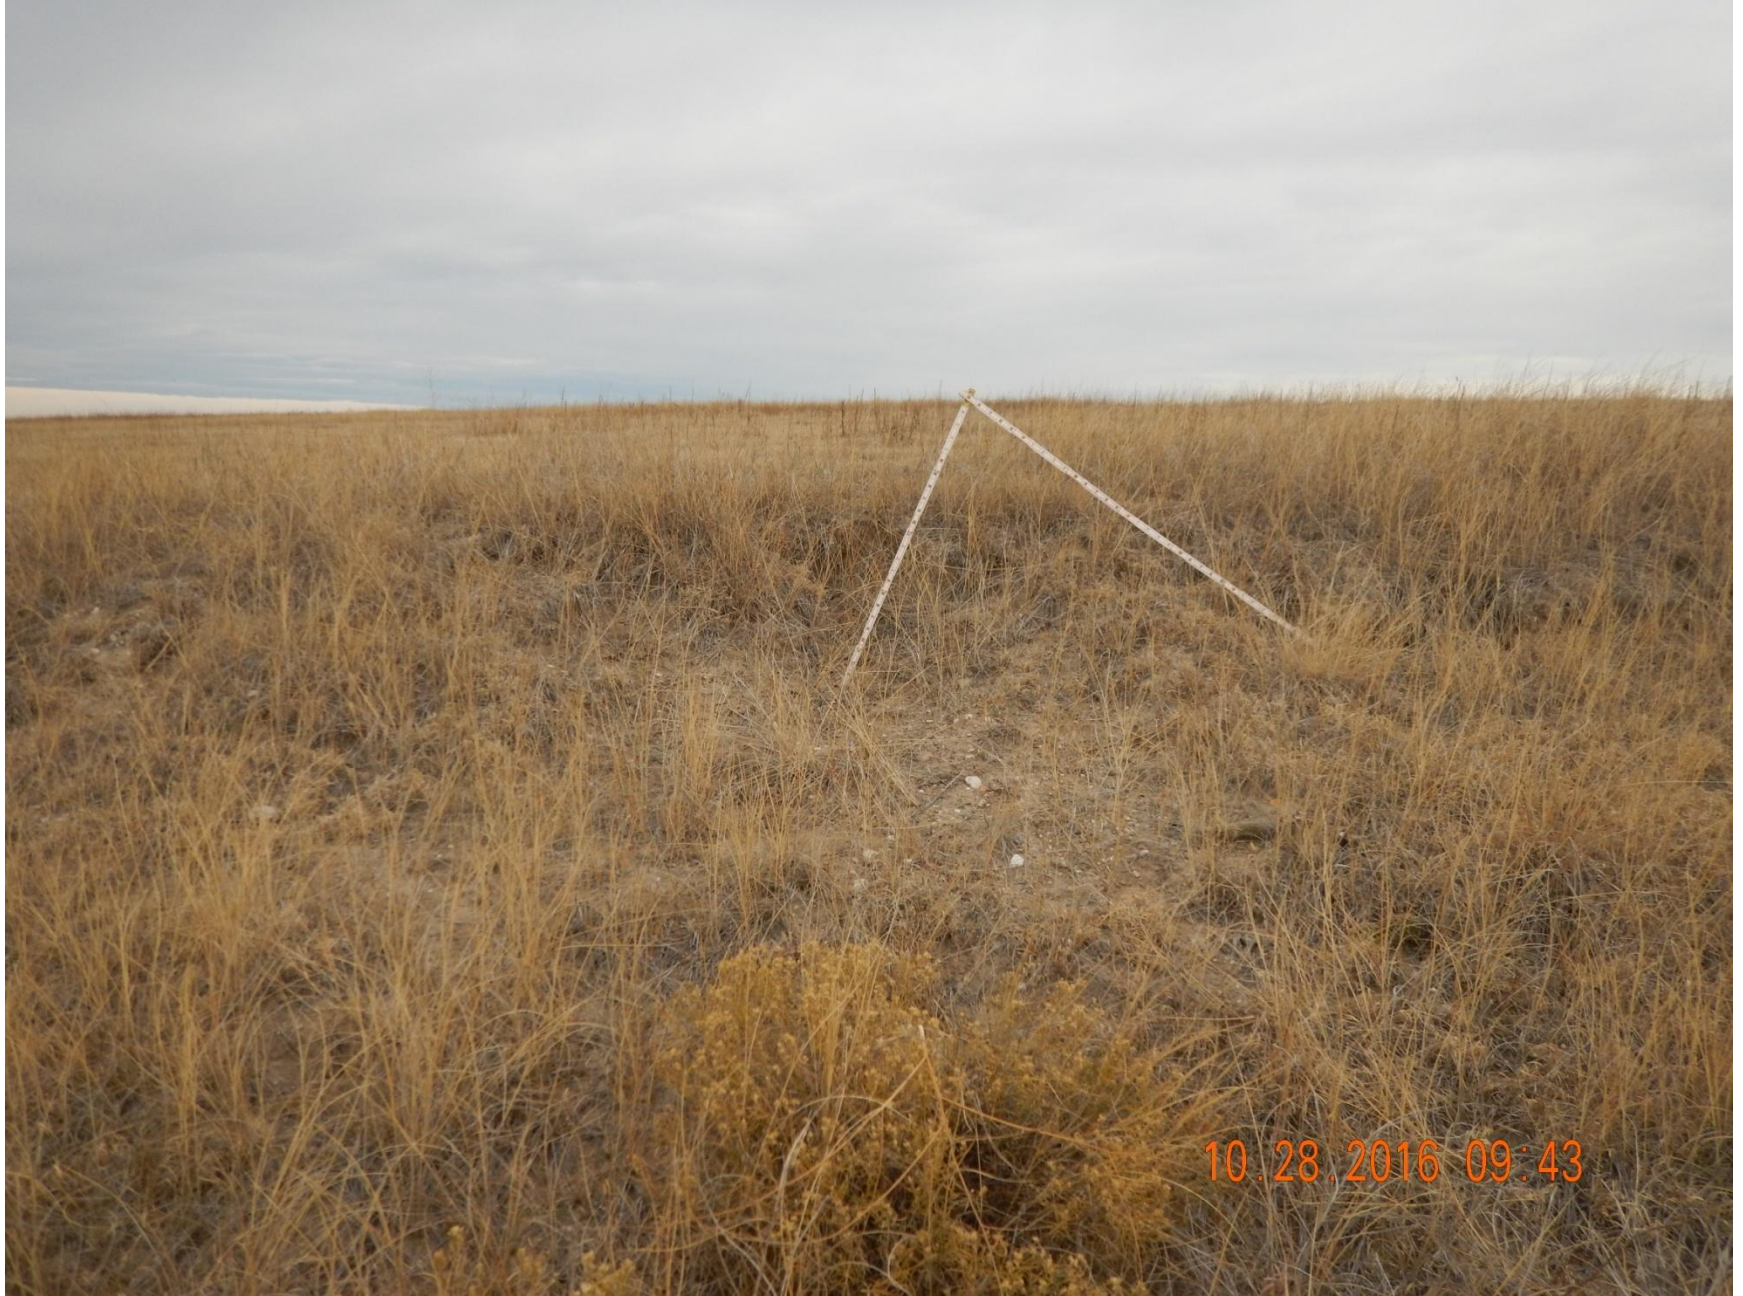
Figure 33: Photo taken from area north of the pit/battery location, facing north. Photo shows area that has either not been recontoured, or has experience erosion degradation.

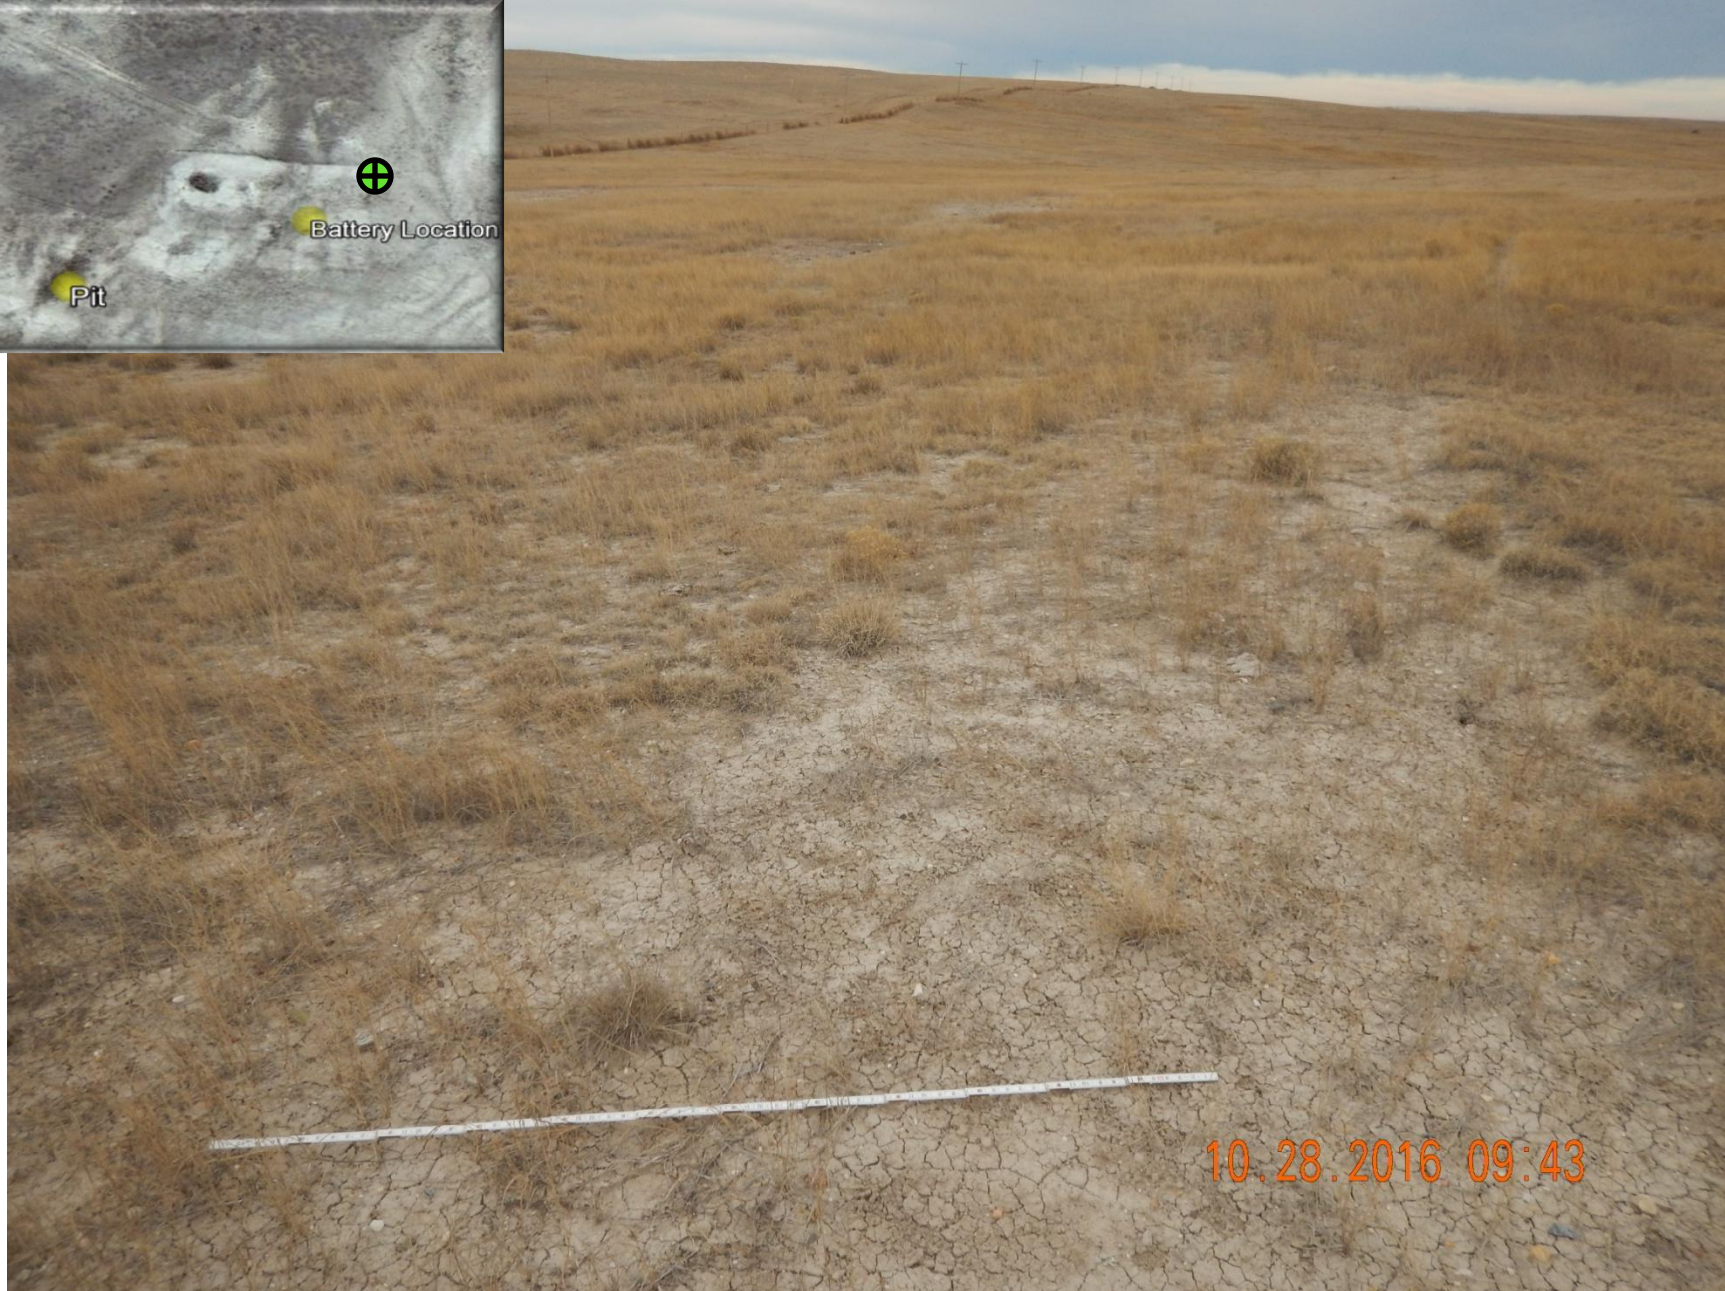
Figure 34: Photo taken from the northeast corner of the battery location, facing west. Photo shows areas pit/battery location has not achieved uniform vegetative cover and large areas remain unvegetated. 6' measuring stick for reference.
