Reclamation Inspection

10/28/2016

Operator: Markus Production Inc.

Location ID: 406198

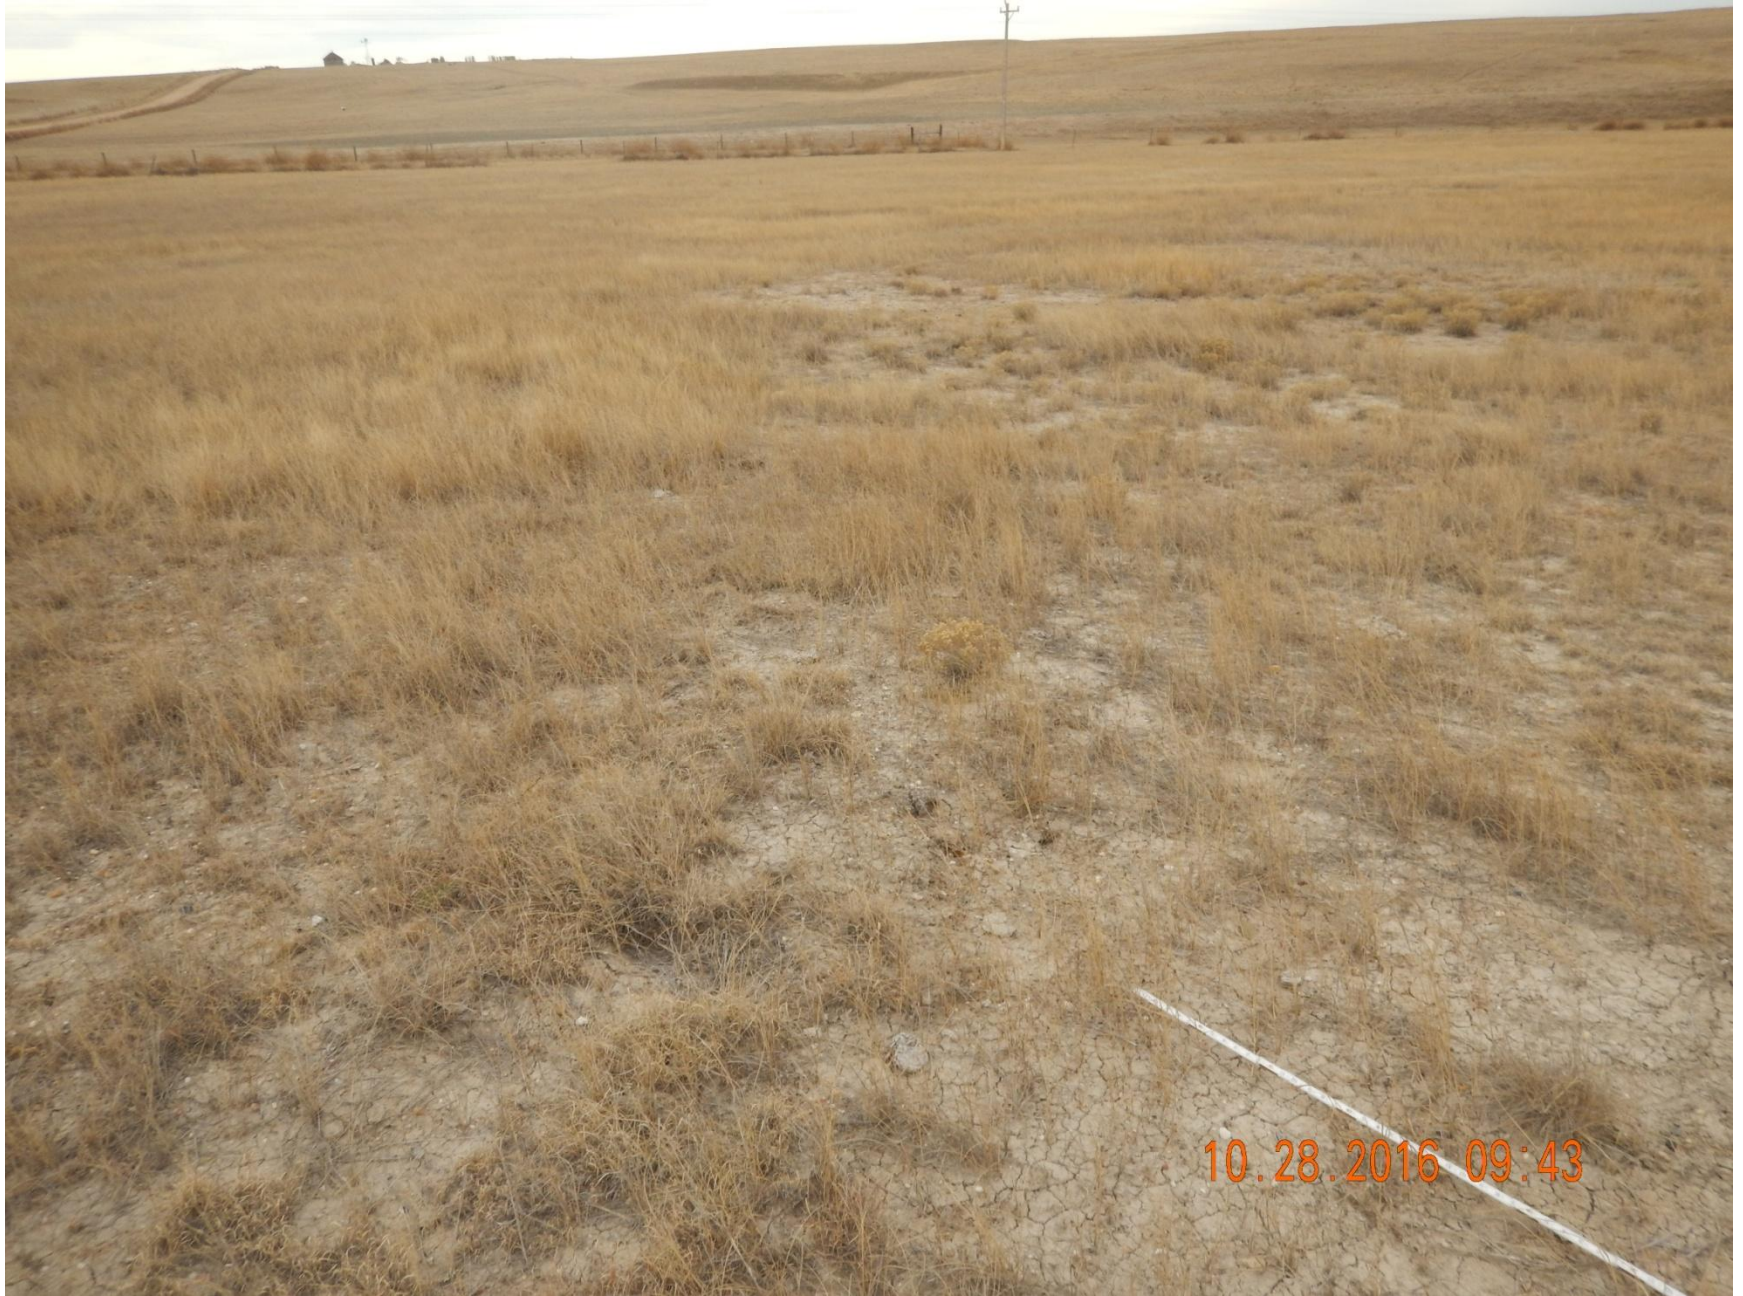
Figure 35: Photo taken from northeast corner of the battery location, facing south. Photo shows areas pit/battery location has not achieved uniform vegetative cover and large areas remain unvegetated. 6' measuring stick for reference.

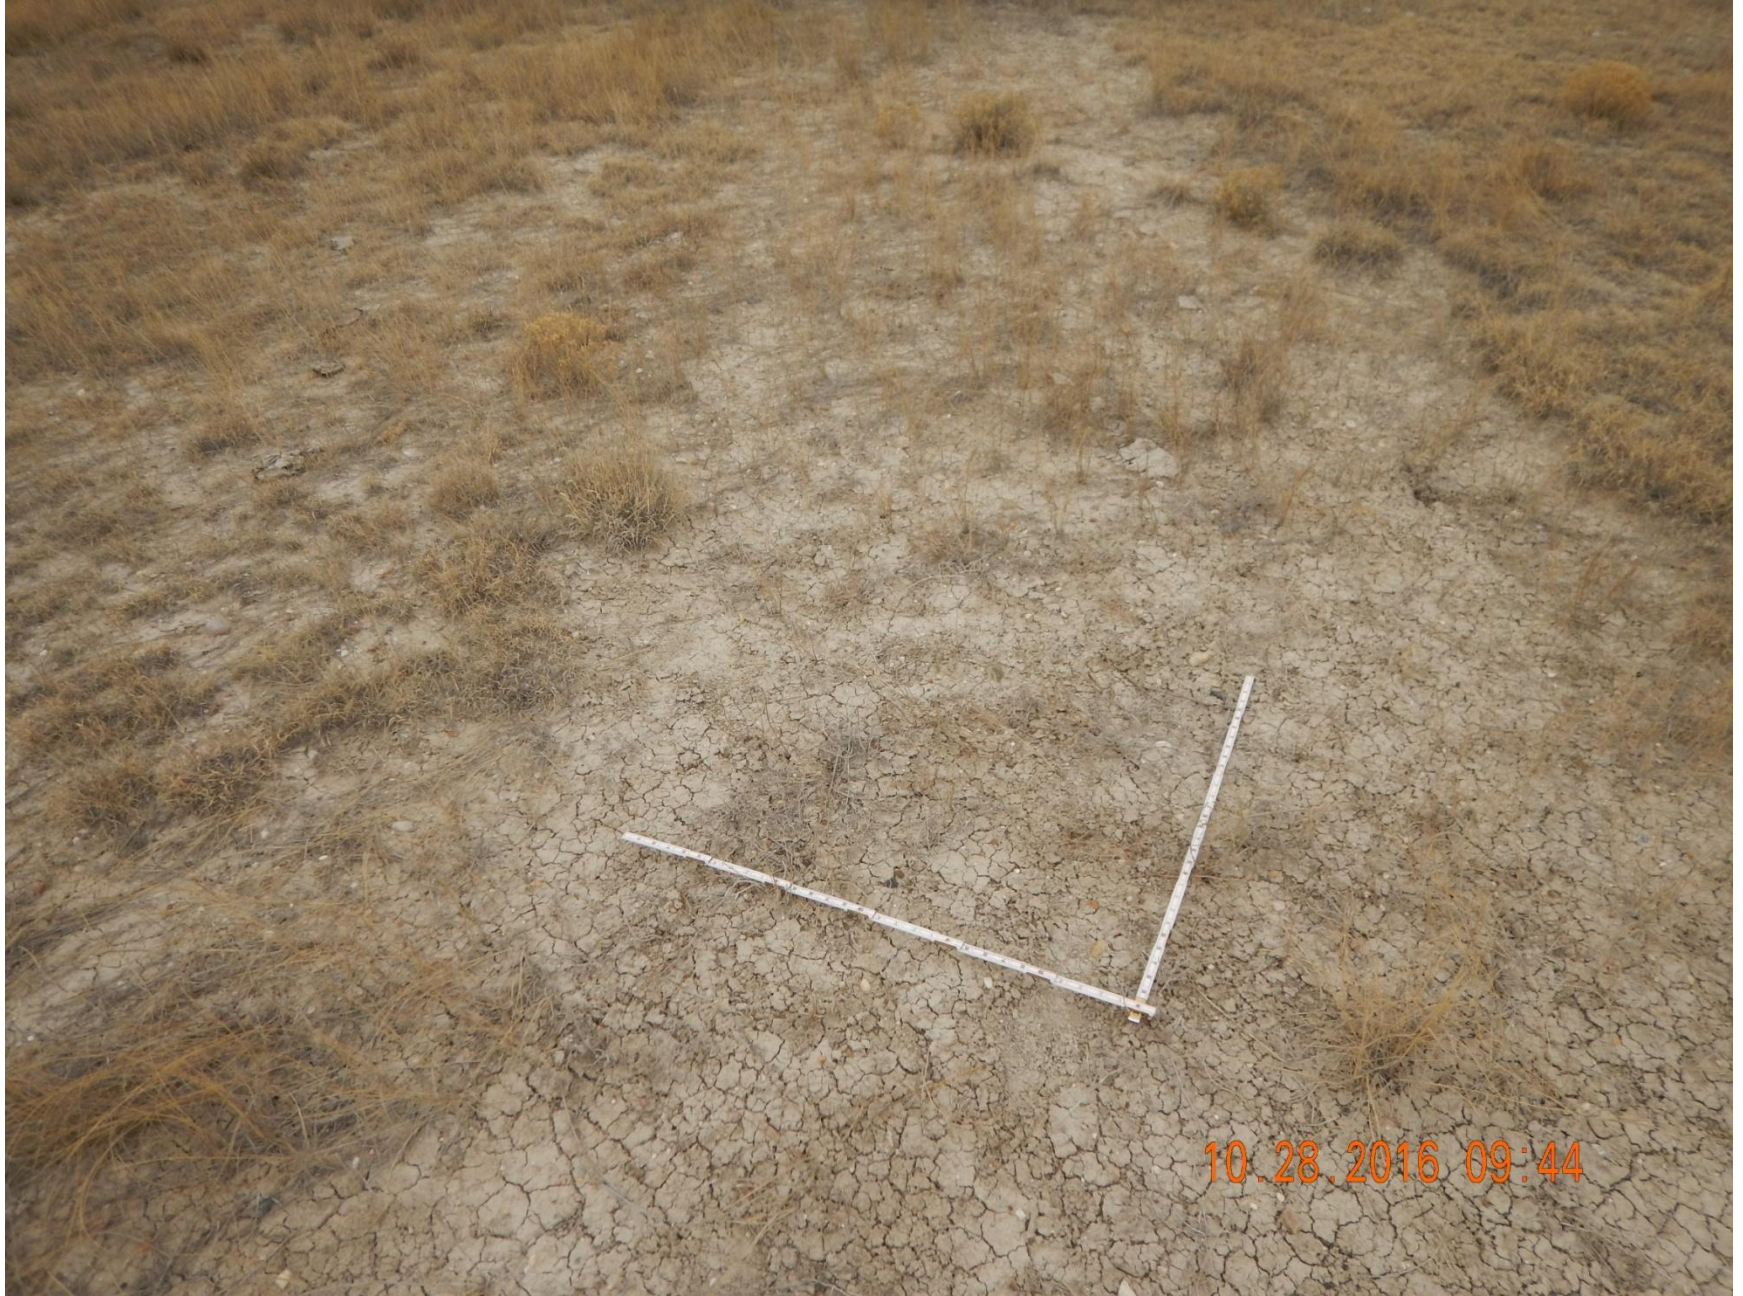
Figure 36: Photo taken from northeast corner of the battery location. Photo shows areas pit/battery location has not achieved uniform vegetative cover and large areas remain unvegetated. 3'x3' measuring stick for reference.

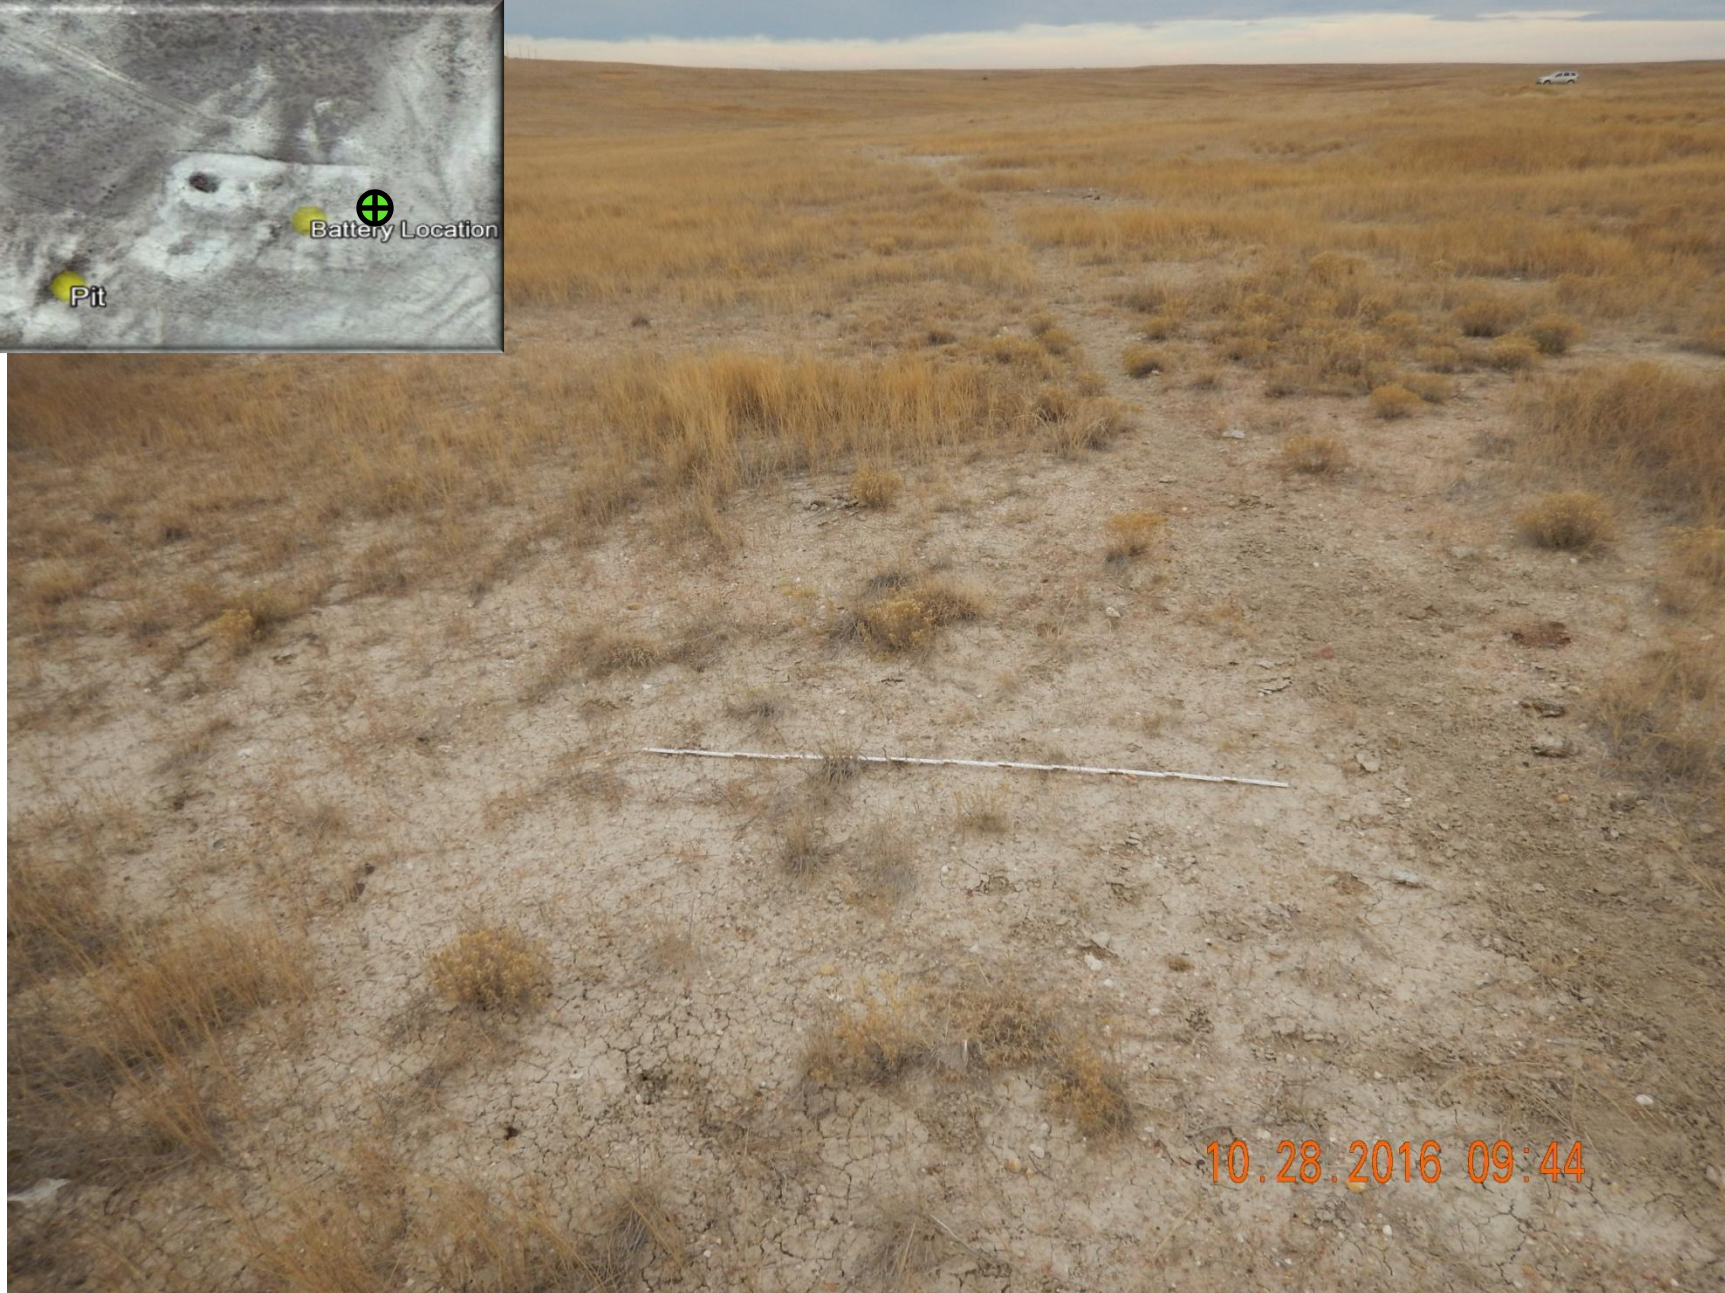
Figure 37: Photo taken from east end of the battery location, facing west. Photo shows areas pit/battery location has not achieved uniform vegetative cover and large areas remain unvegetated. 6' measuring stick for reference.

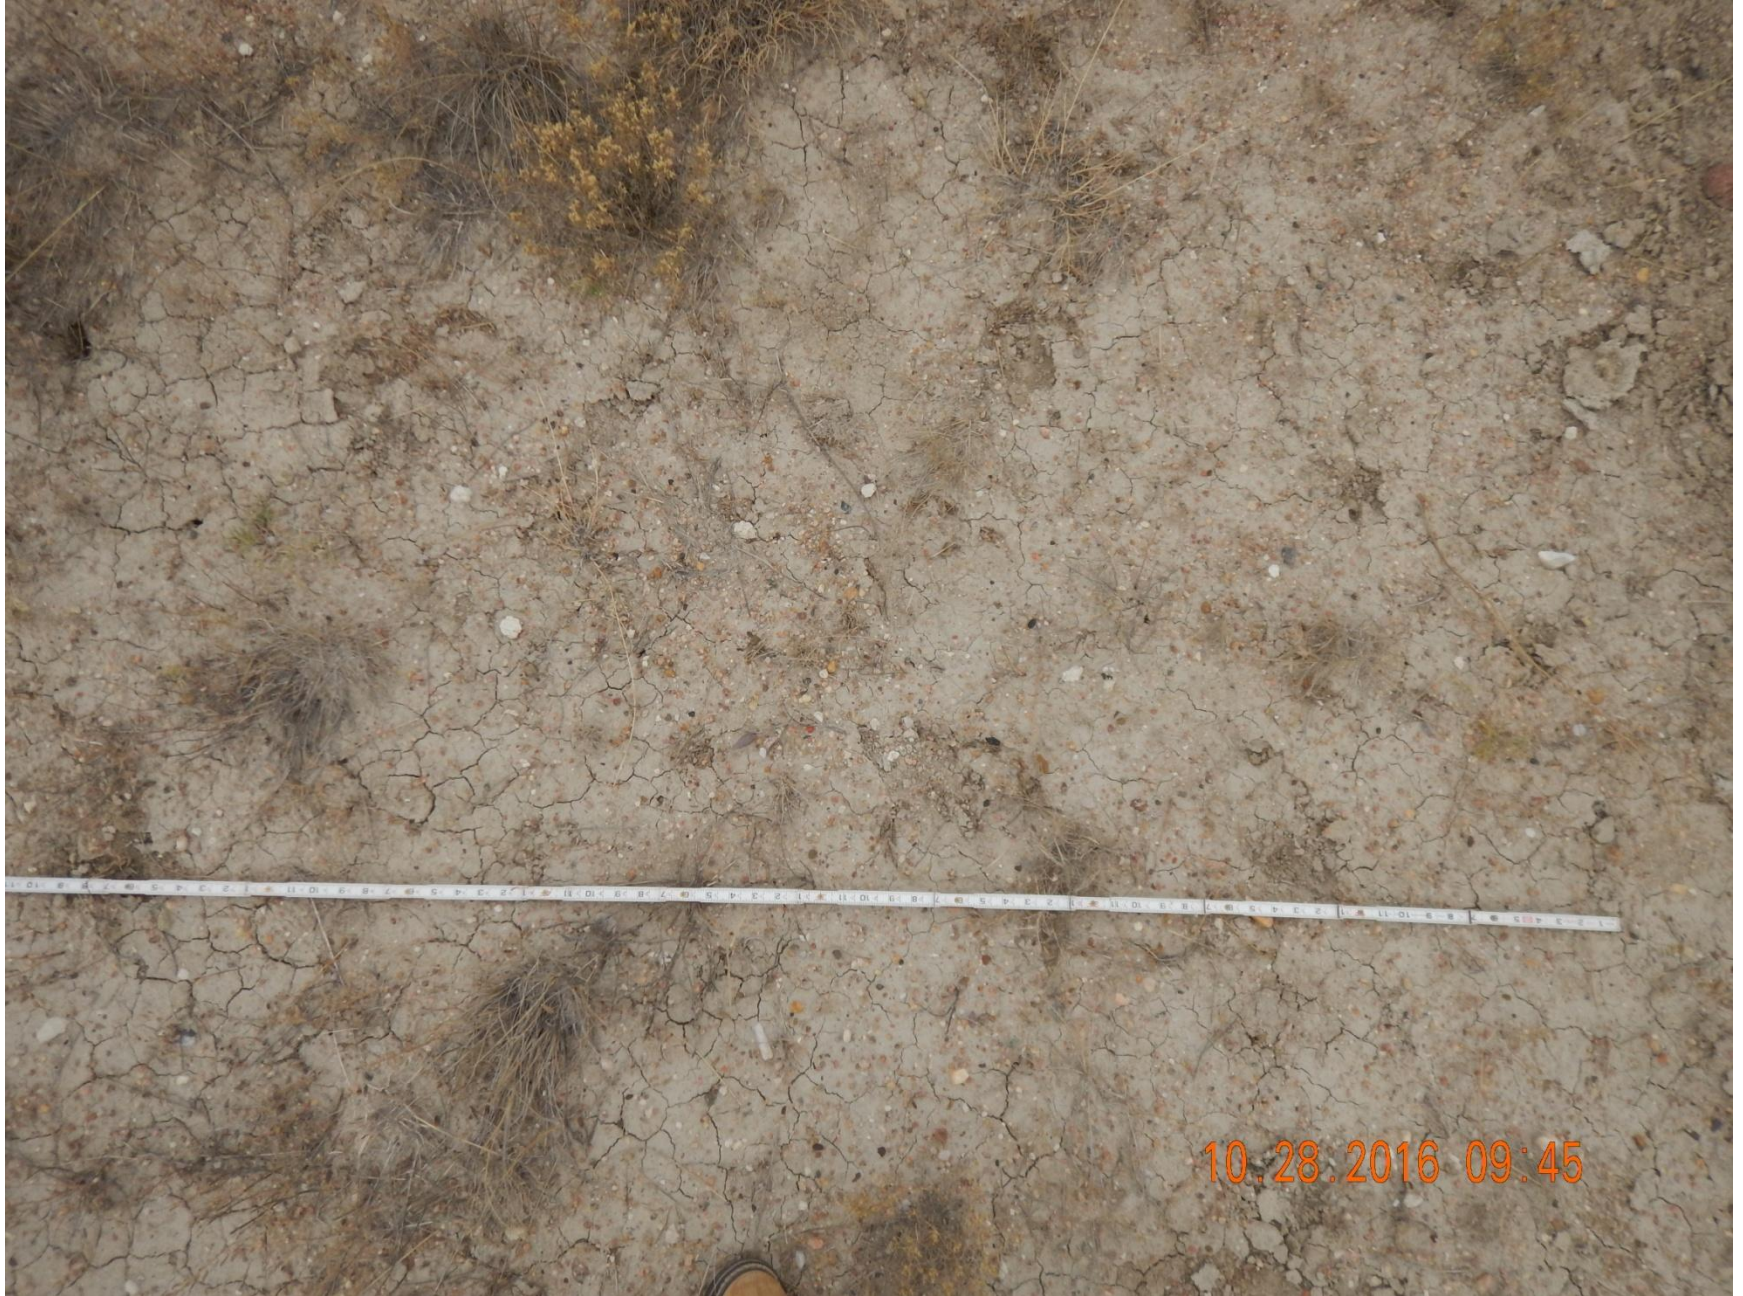
Figure 38: Photo taken from east end of the battery location, facing west. Photo shows areas pit/battery location has not achieved uniform vegetative cover and large areas remain unvegetated. 6' measuring stick for reference.

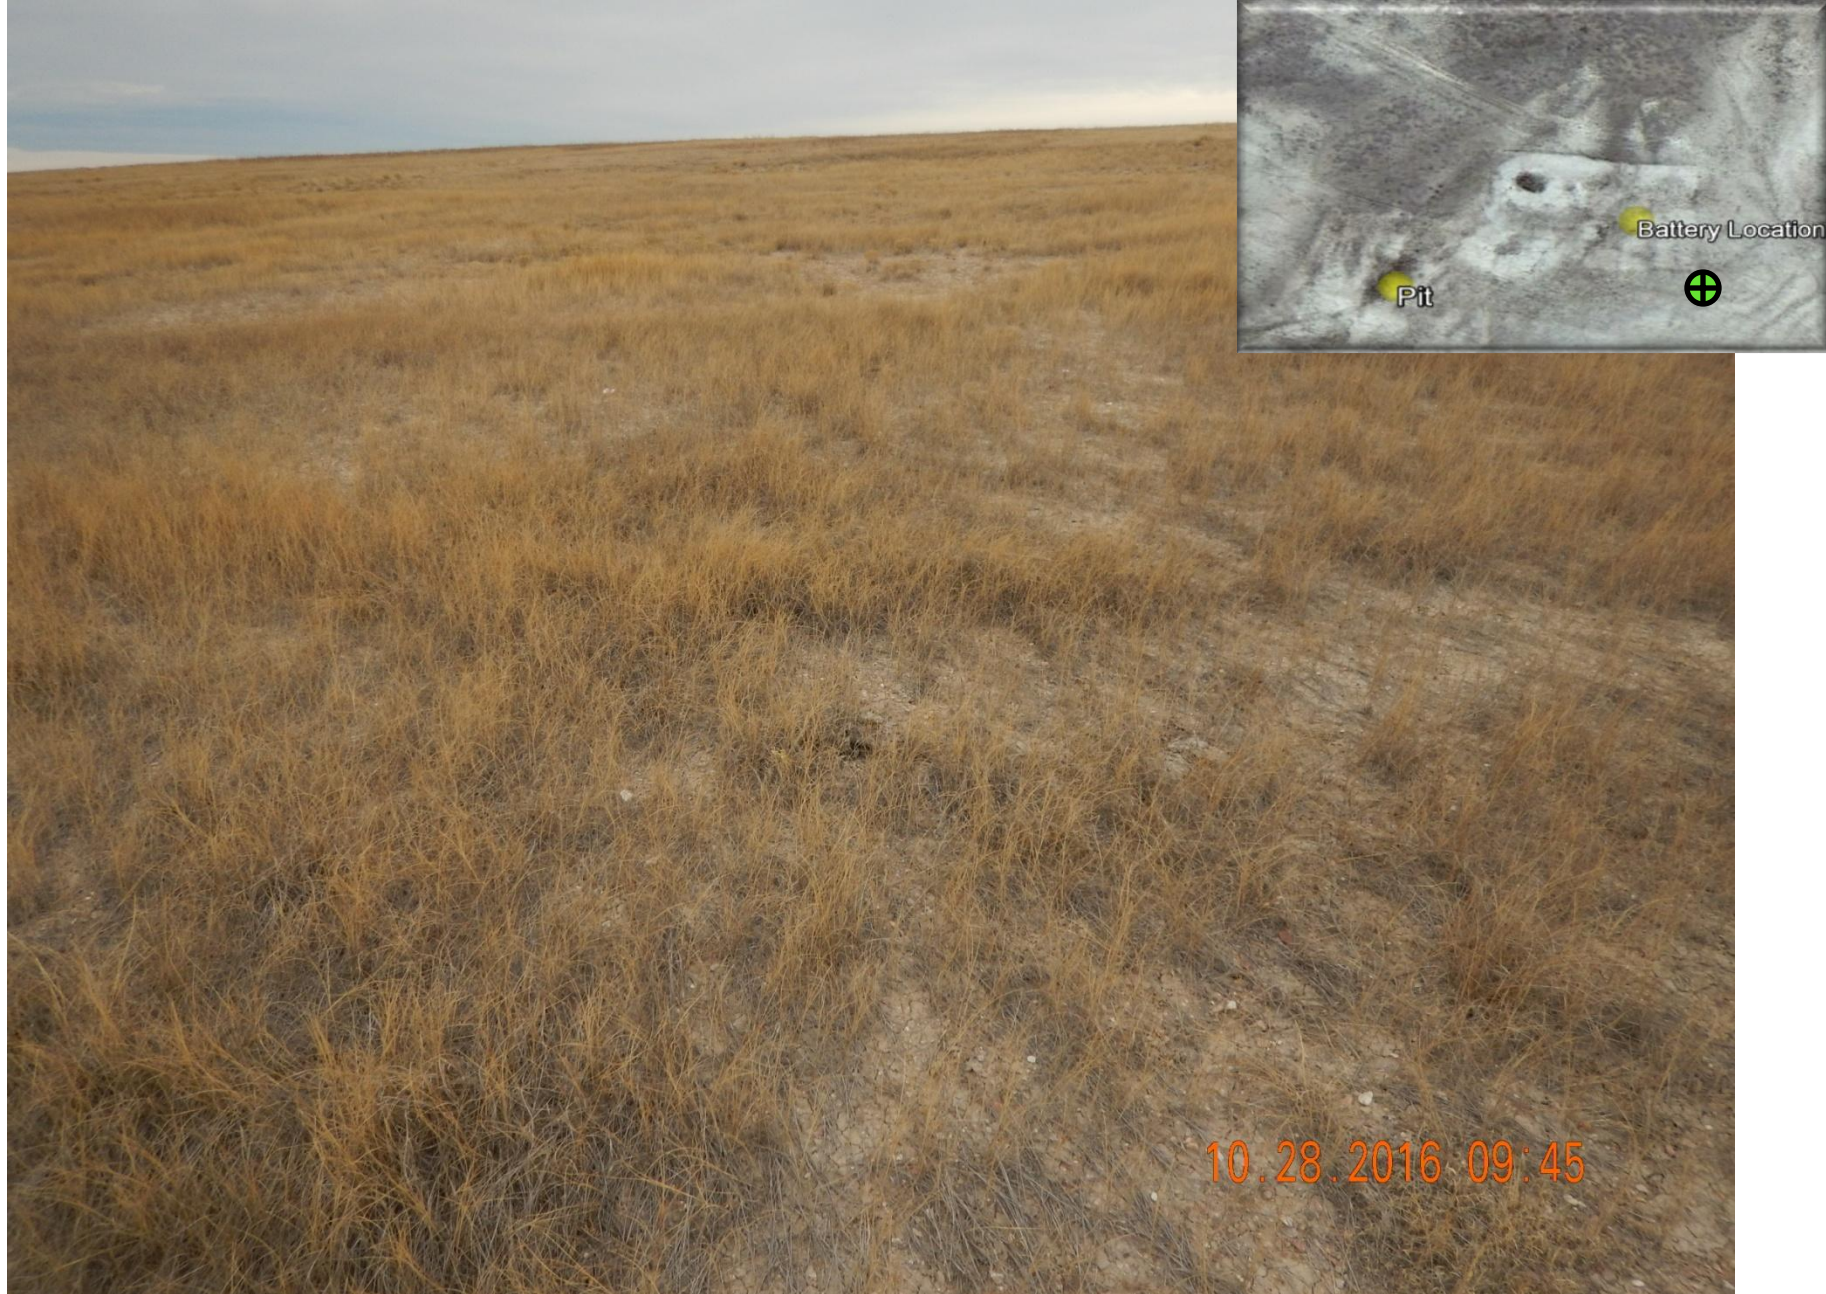
Figure 39: Photo taken from southeast end of the battery location, facing north. Photo shows areas pit/battery location has not achieved uniform vegetative cover and large areas remain unvegetated. 6' measuring stick for reference.

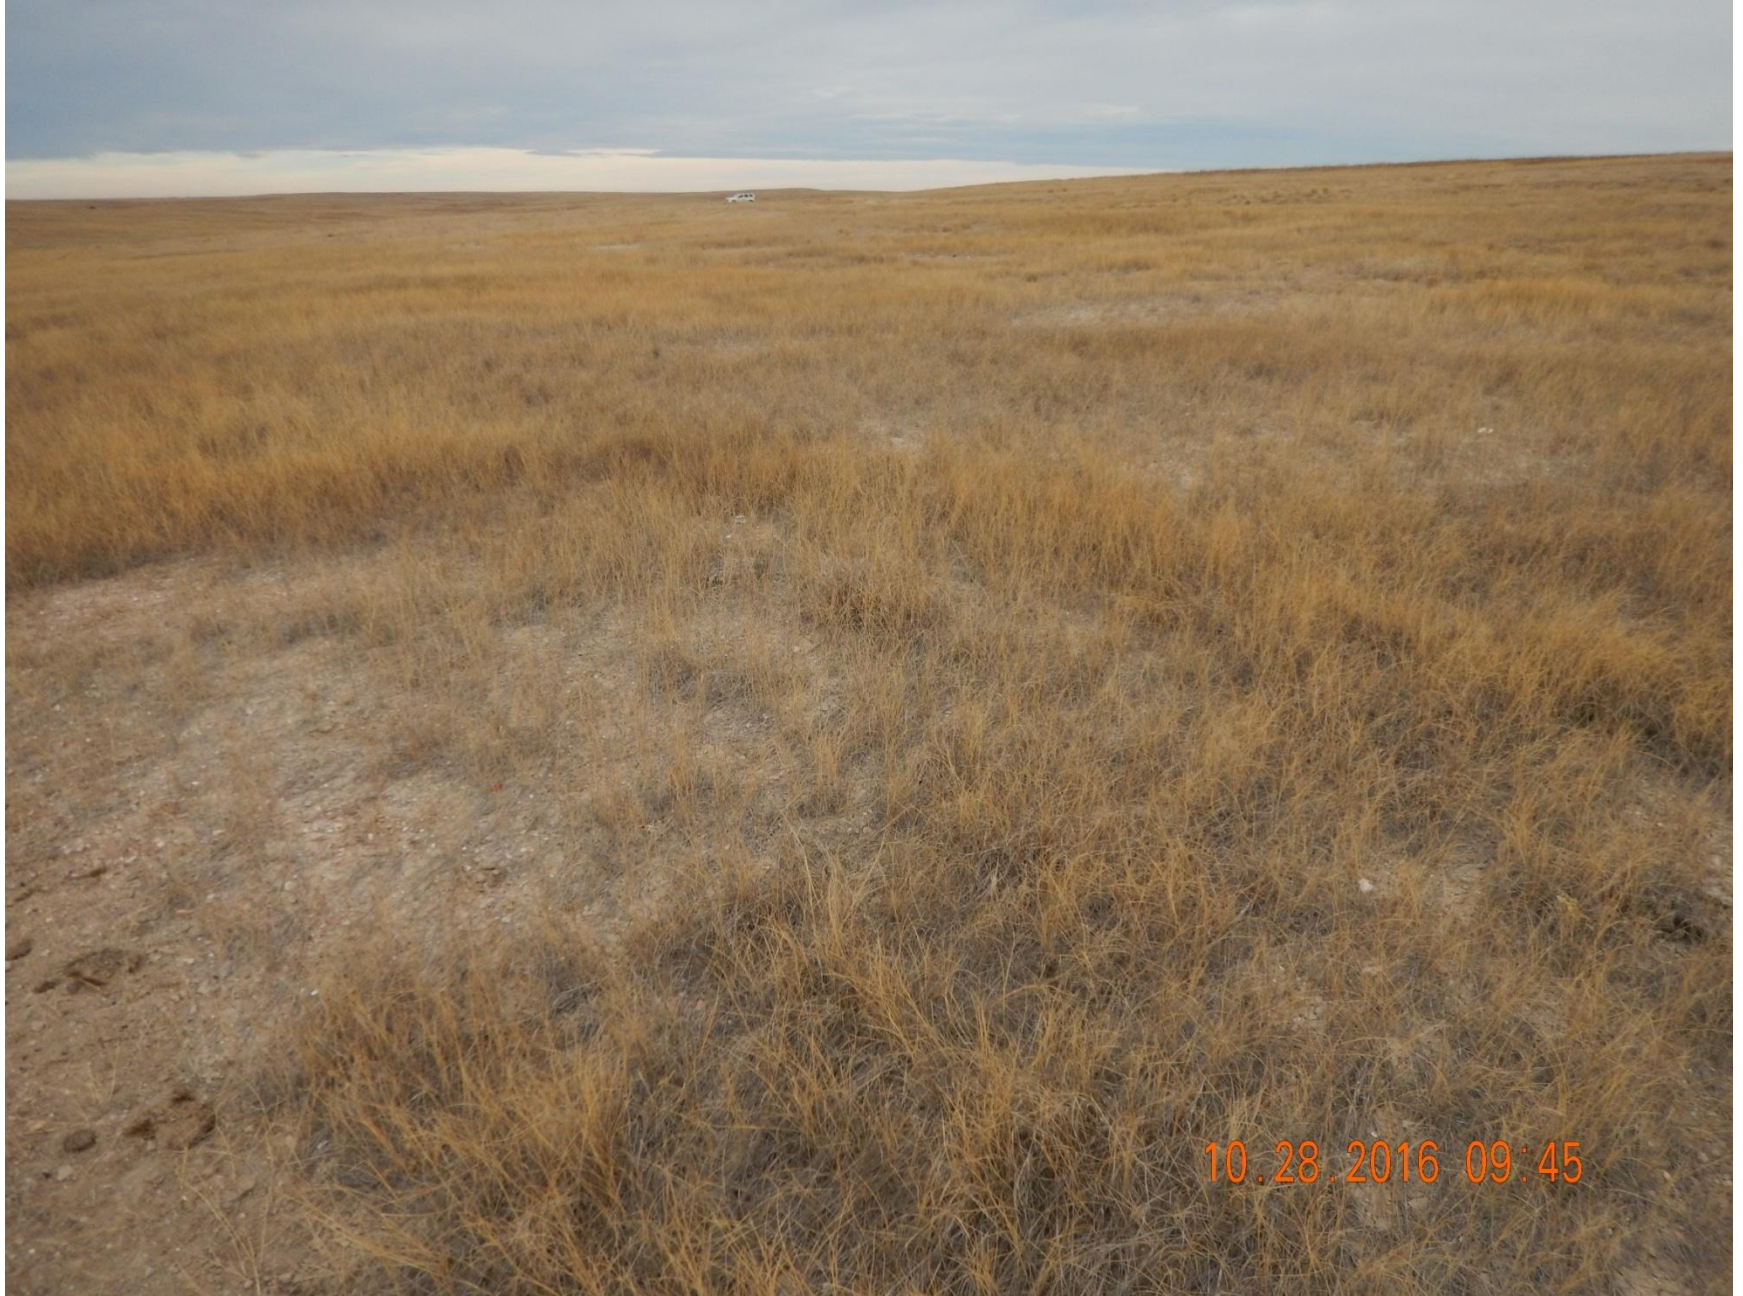
Figure 40: Photo taken from southeast end of the battery location, facing northwest. Photo shows areas pit/battery location has not achieved uniform vegetative cover and large areas remain unvegetated. 6' measuring stick for reference.

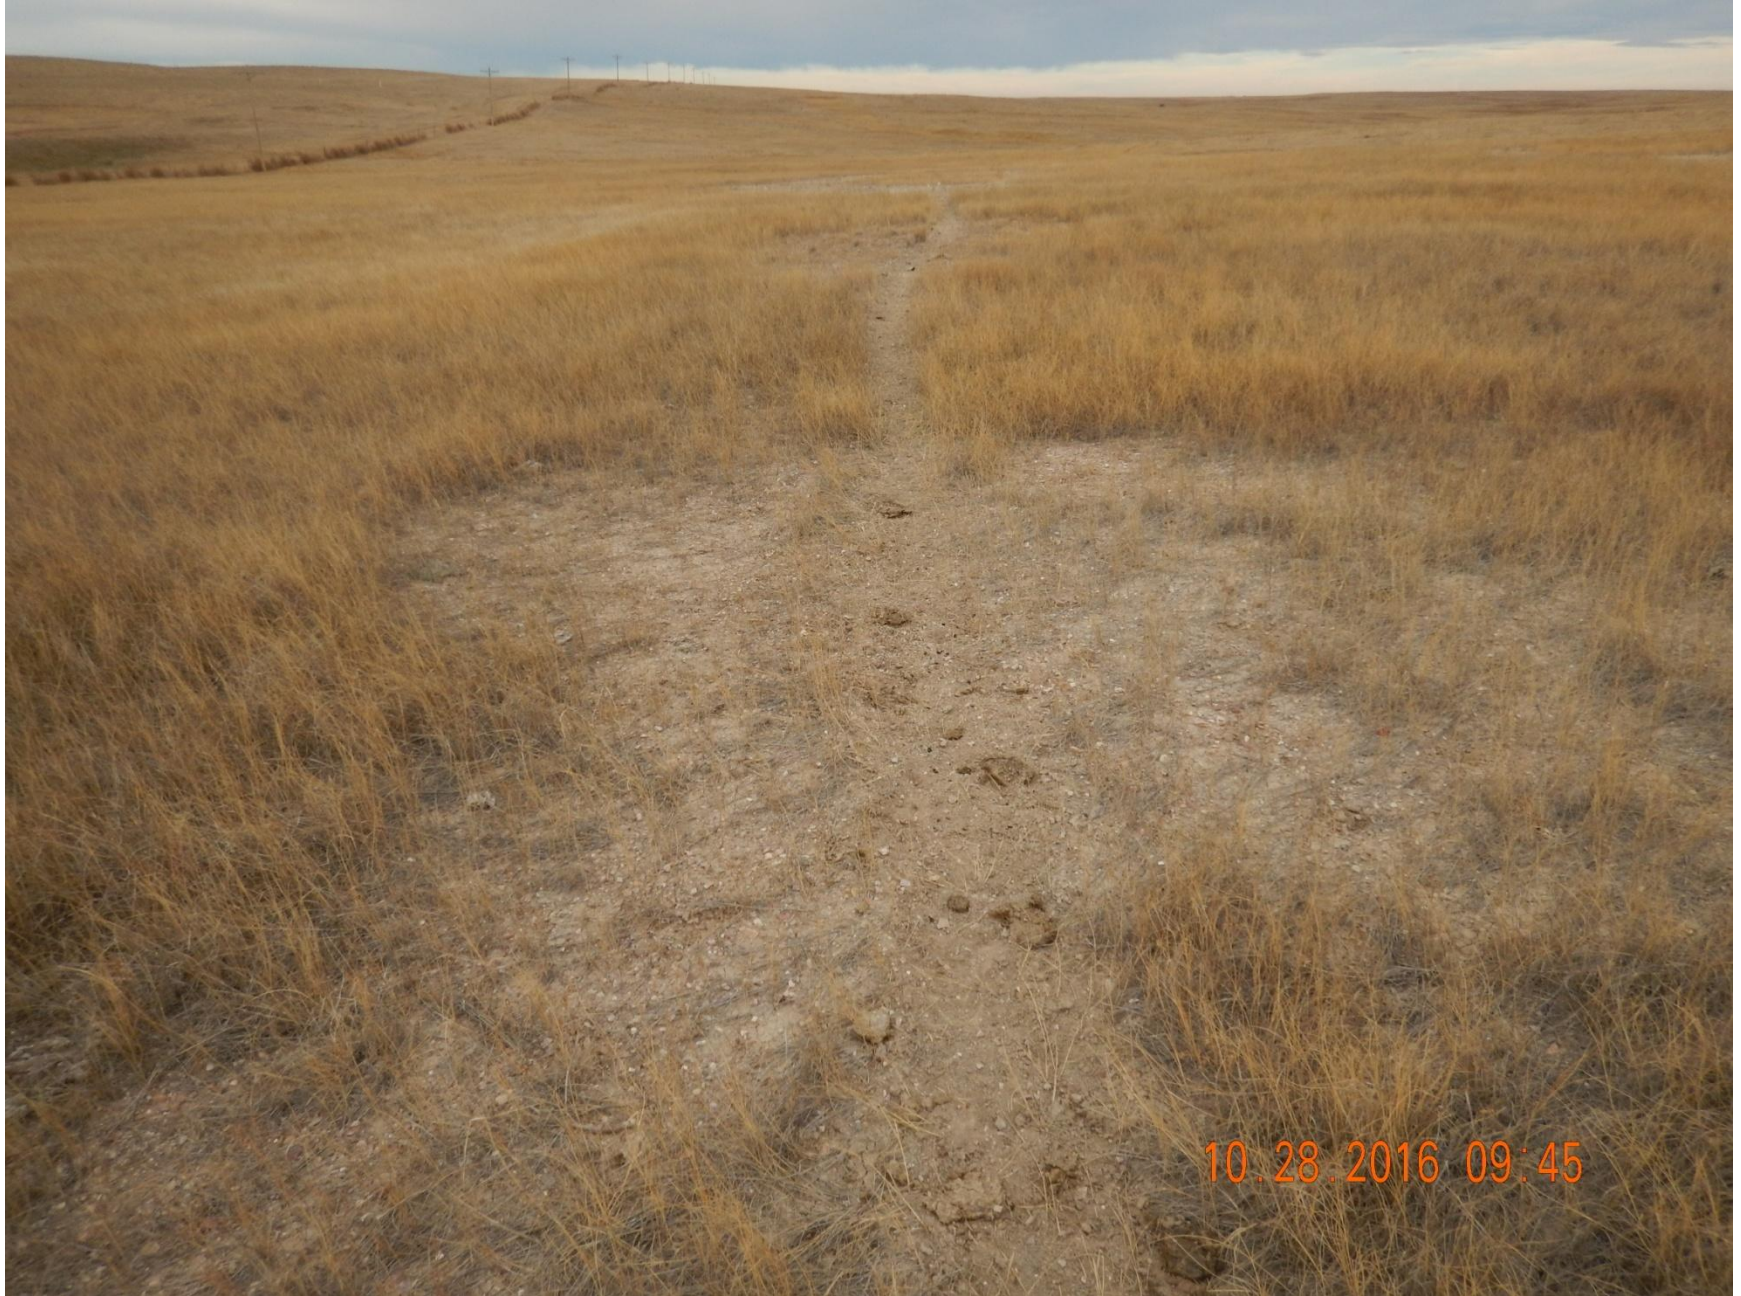
Figure 41: Photo taken from southeast end of the battery location, facing west. Photo shows areas pit/battery location has not achieved uniform vegetative cover and large areas remain unvegetated. 6' measuring stick for reference.

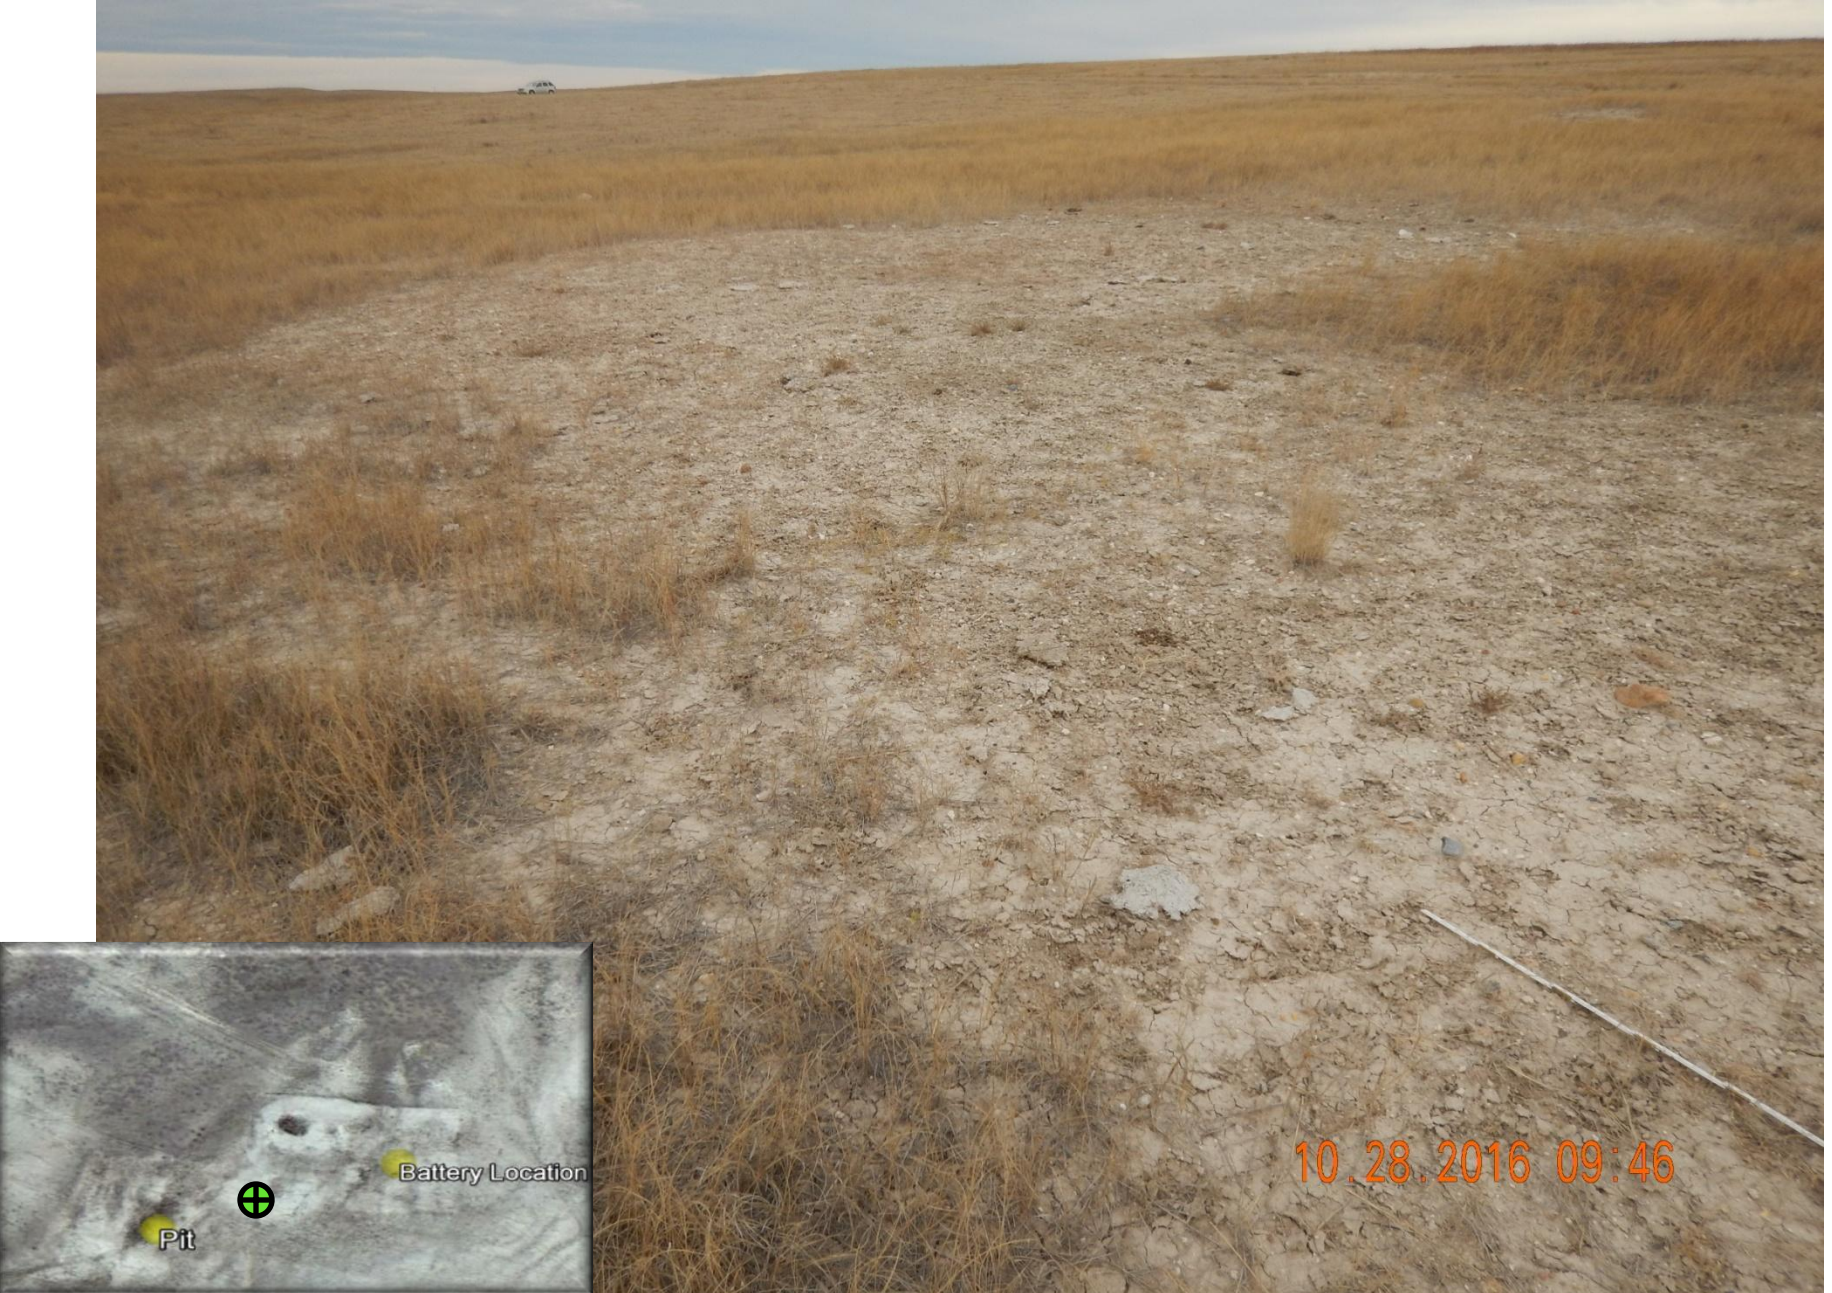
Figure 42: Photo taken from southeast end of the battery location, facing north. Photo shows areas pit/battery location has not achieved uniform vegetative cover and large areas remain unvegetated. 6' measuring stick for reference.

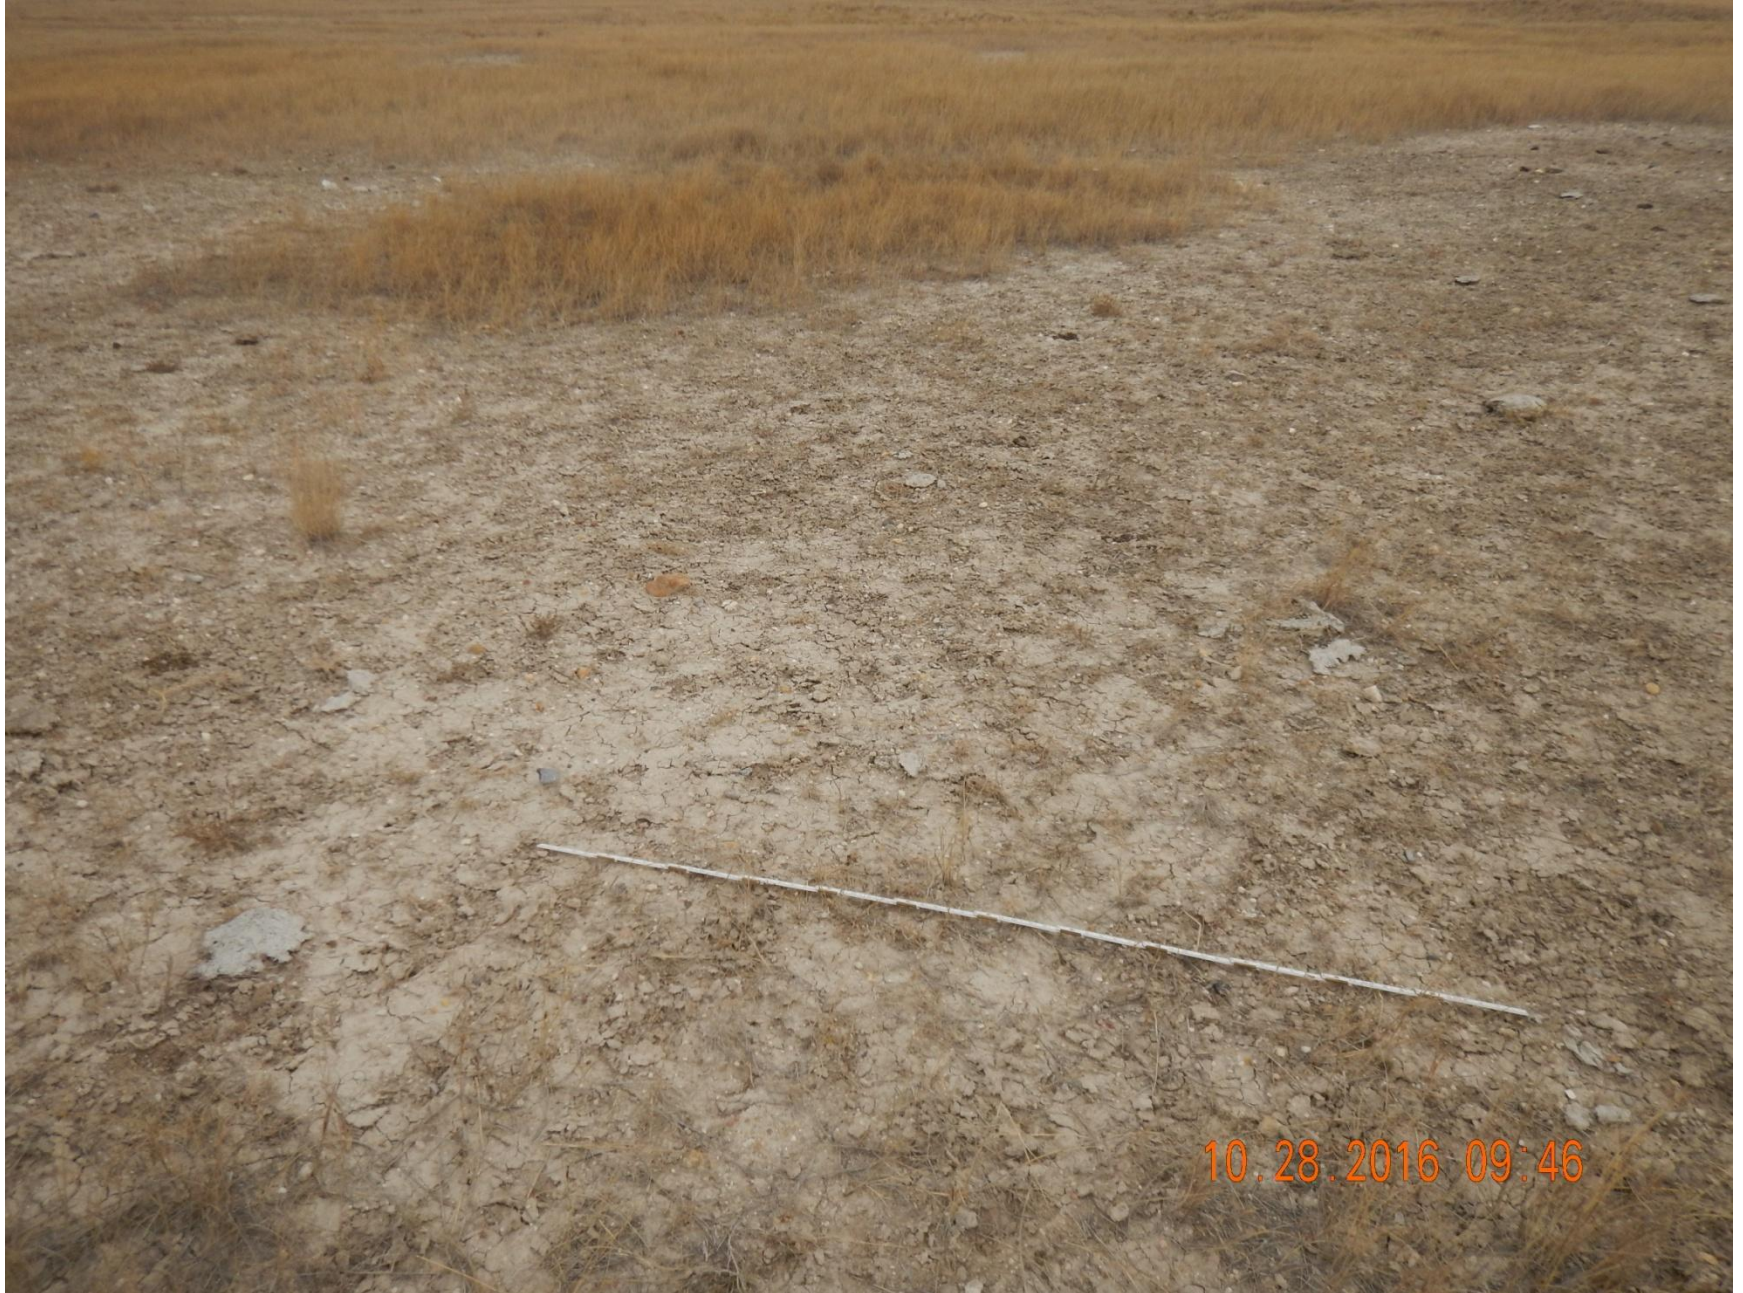
Figure 43: Photo taken from southeast end of the battery location, facing northeast. Photo shows areas pit/battery location has not achieved uniform vegetative cover and large areas remain unvegetated. 6' measuring stick for reference.
