Reclamation Inspection

10/28/2016

Operator: Markus Production Inc.

Location ID: 406198

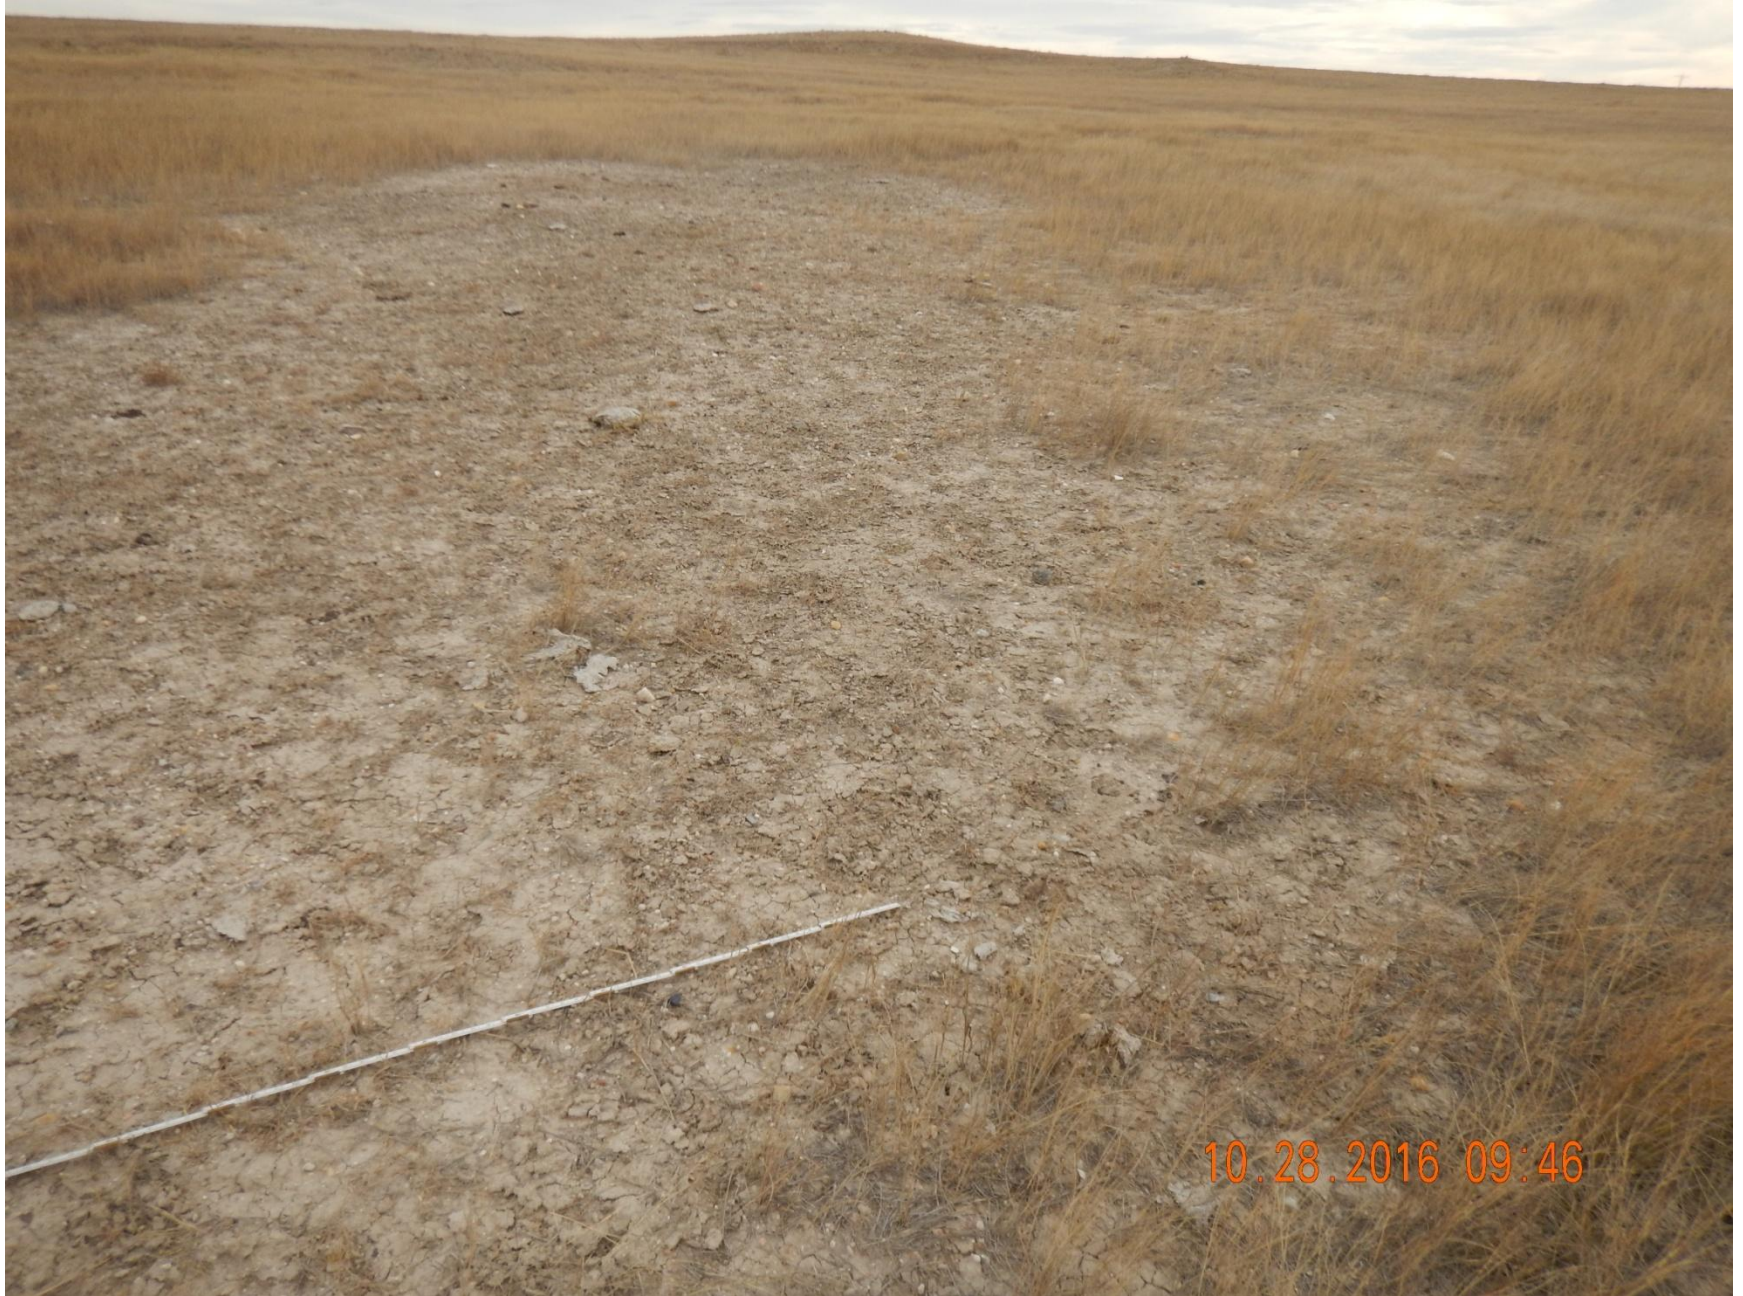
Figure 44: Photo taken from southeast end of the battery location, facing east. Photo shows areas pit/battery location has not achieved uniform vegetative cover and large areas remain unvegetated. 6' measuring stick for reference.

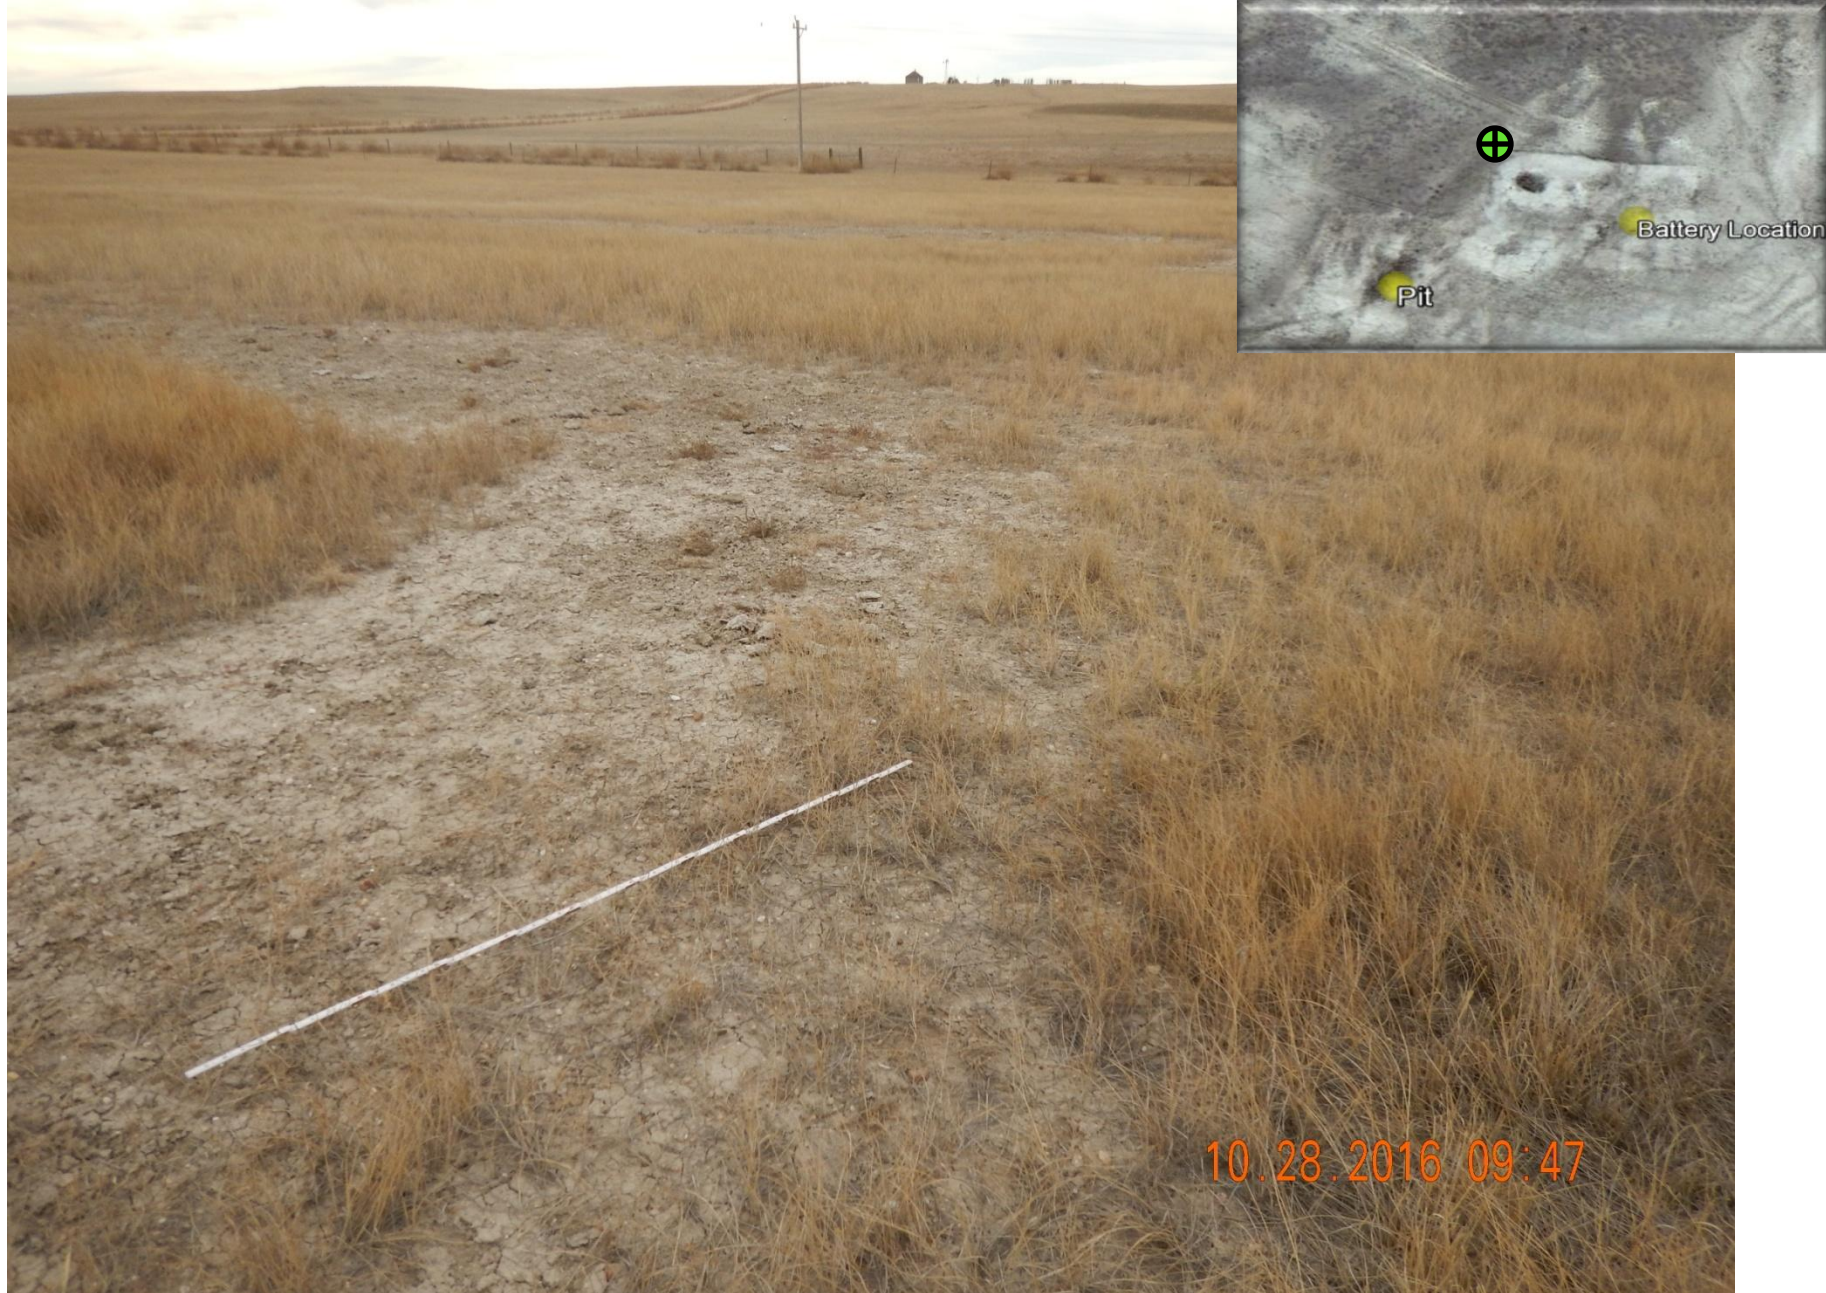
Figure 45: Photo taken from northwest end of the battery location, facing south. Photo shows areas pit/battery location has not achieved uniform vegetative cover and large areas remain unvegetated. 6' measuring stick for reference.

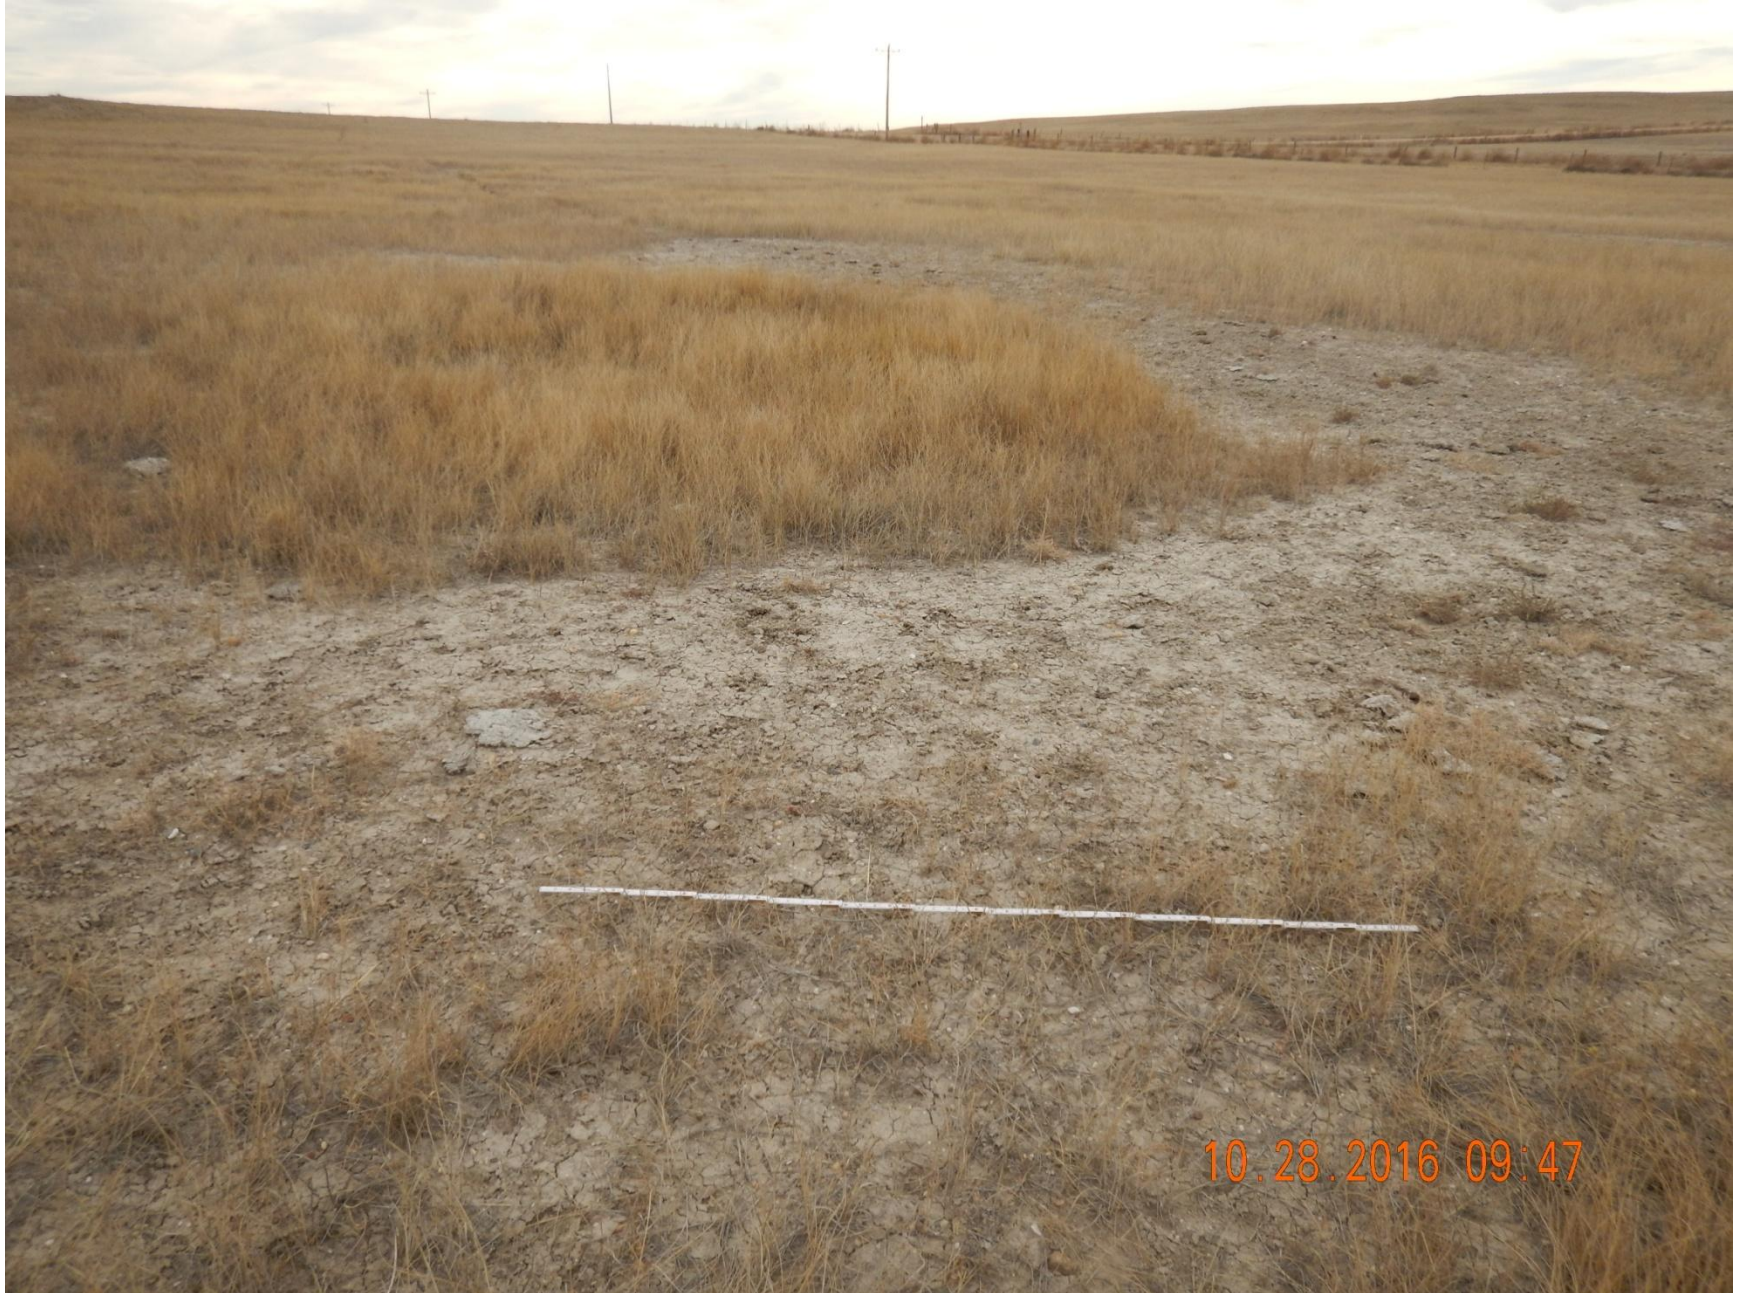
Figure 46: Photo taken from northwest end of the battery location, facing southeast. Photo shows areas pit/battery location has not achieved uniform vegetative cover and large areas remain unvegetated. 6' measuring stick for reference.

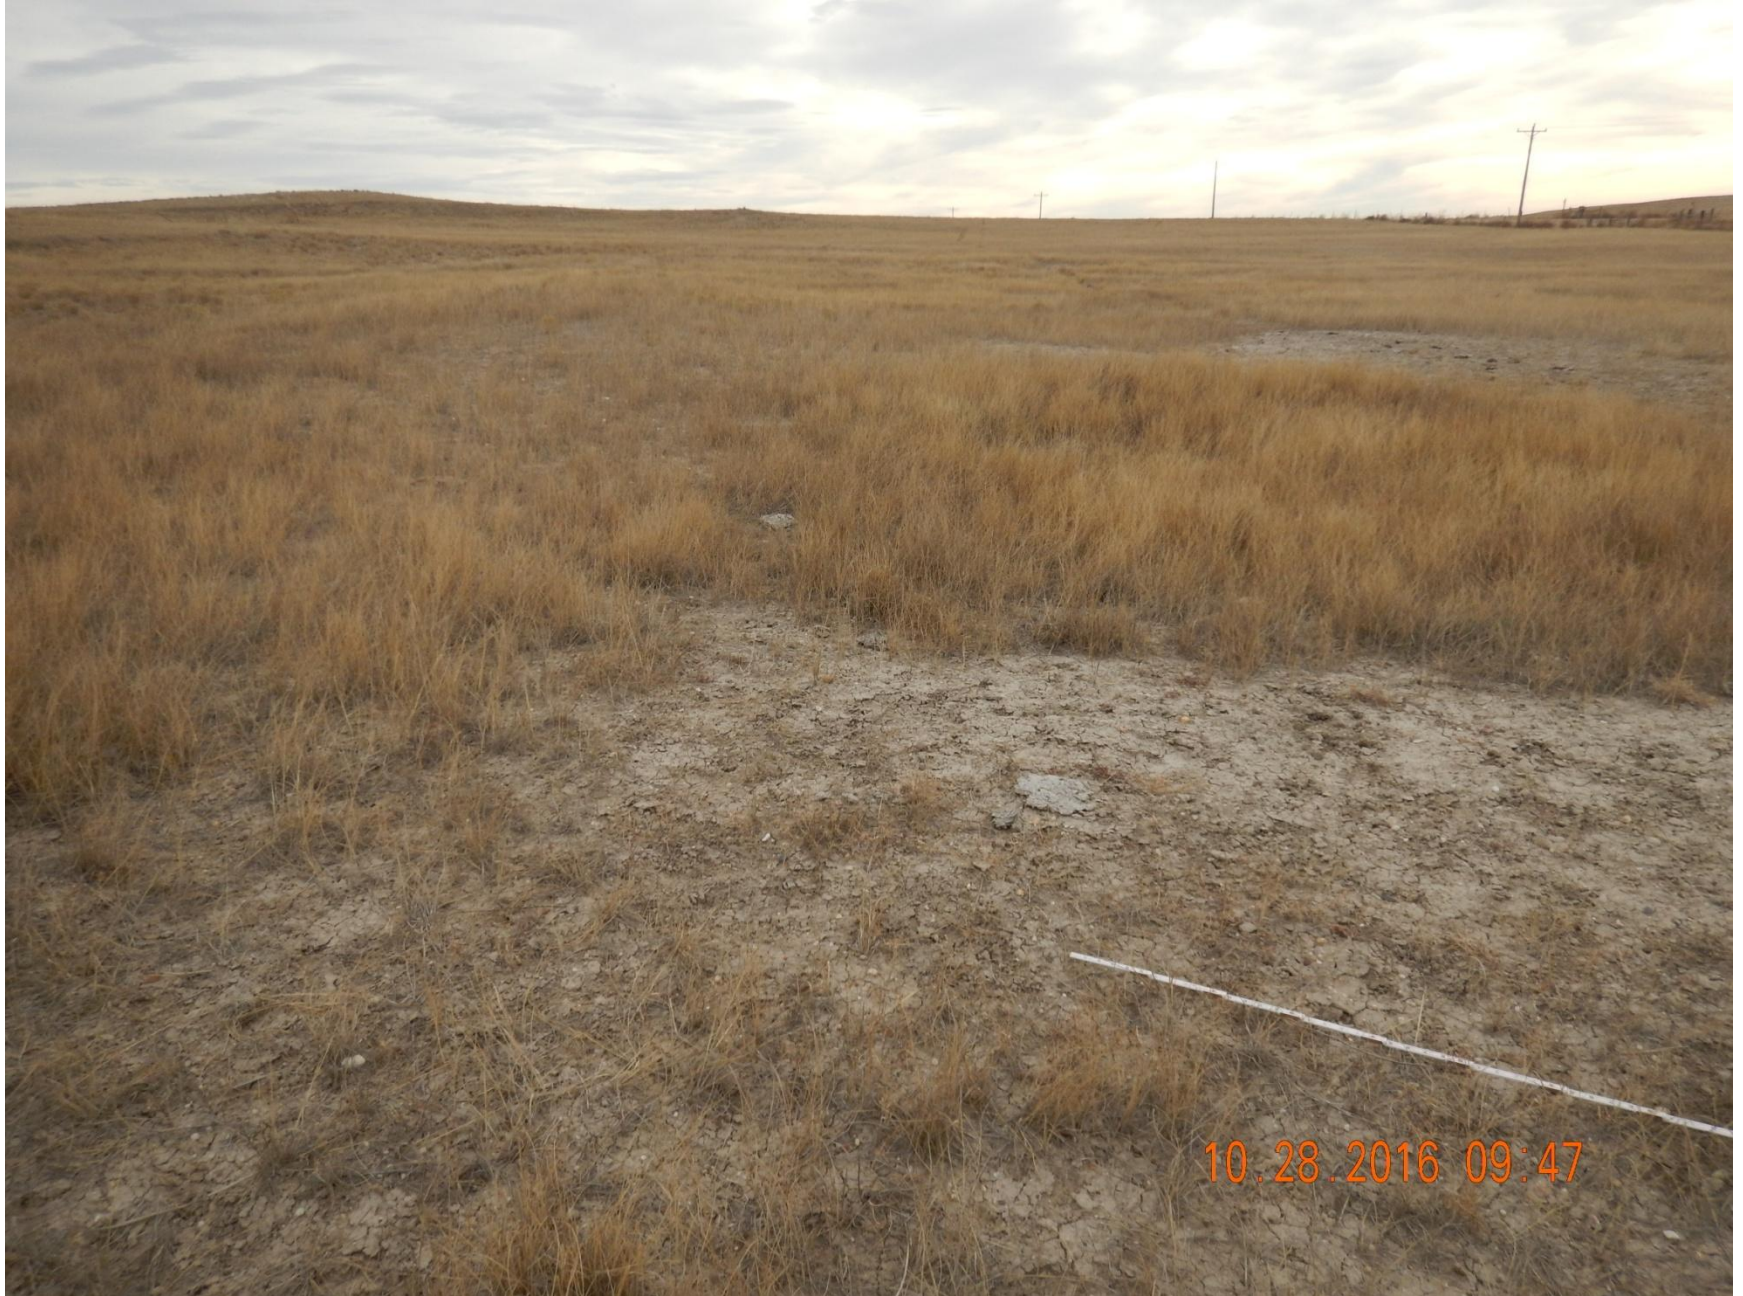
Figure 47: Photo taken from northwest end of the battery location, facing east. Photo shows areas pit/battery location has not achieved uniform vegetative cover and large areas remain unvegetated. 6' measuring stick for reference.

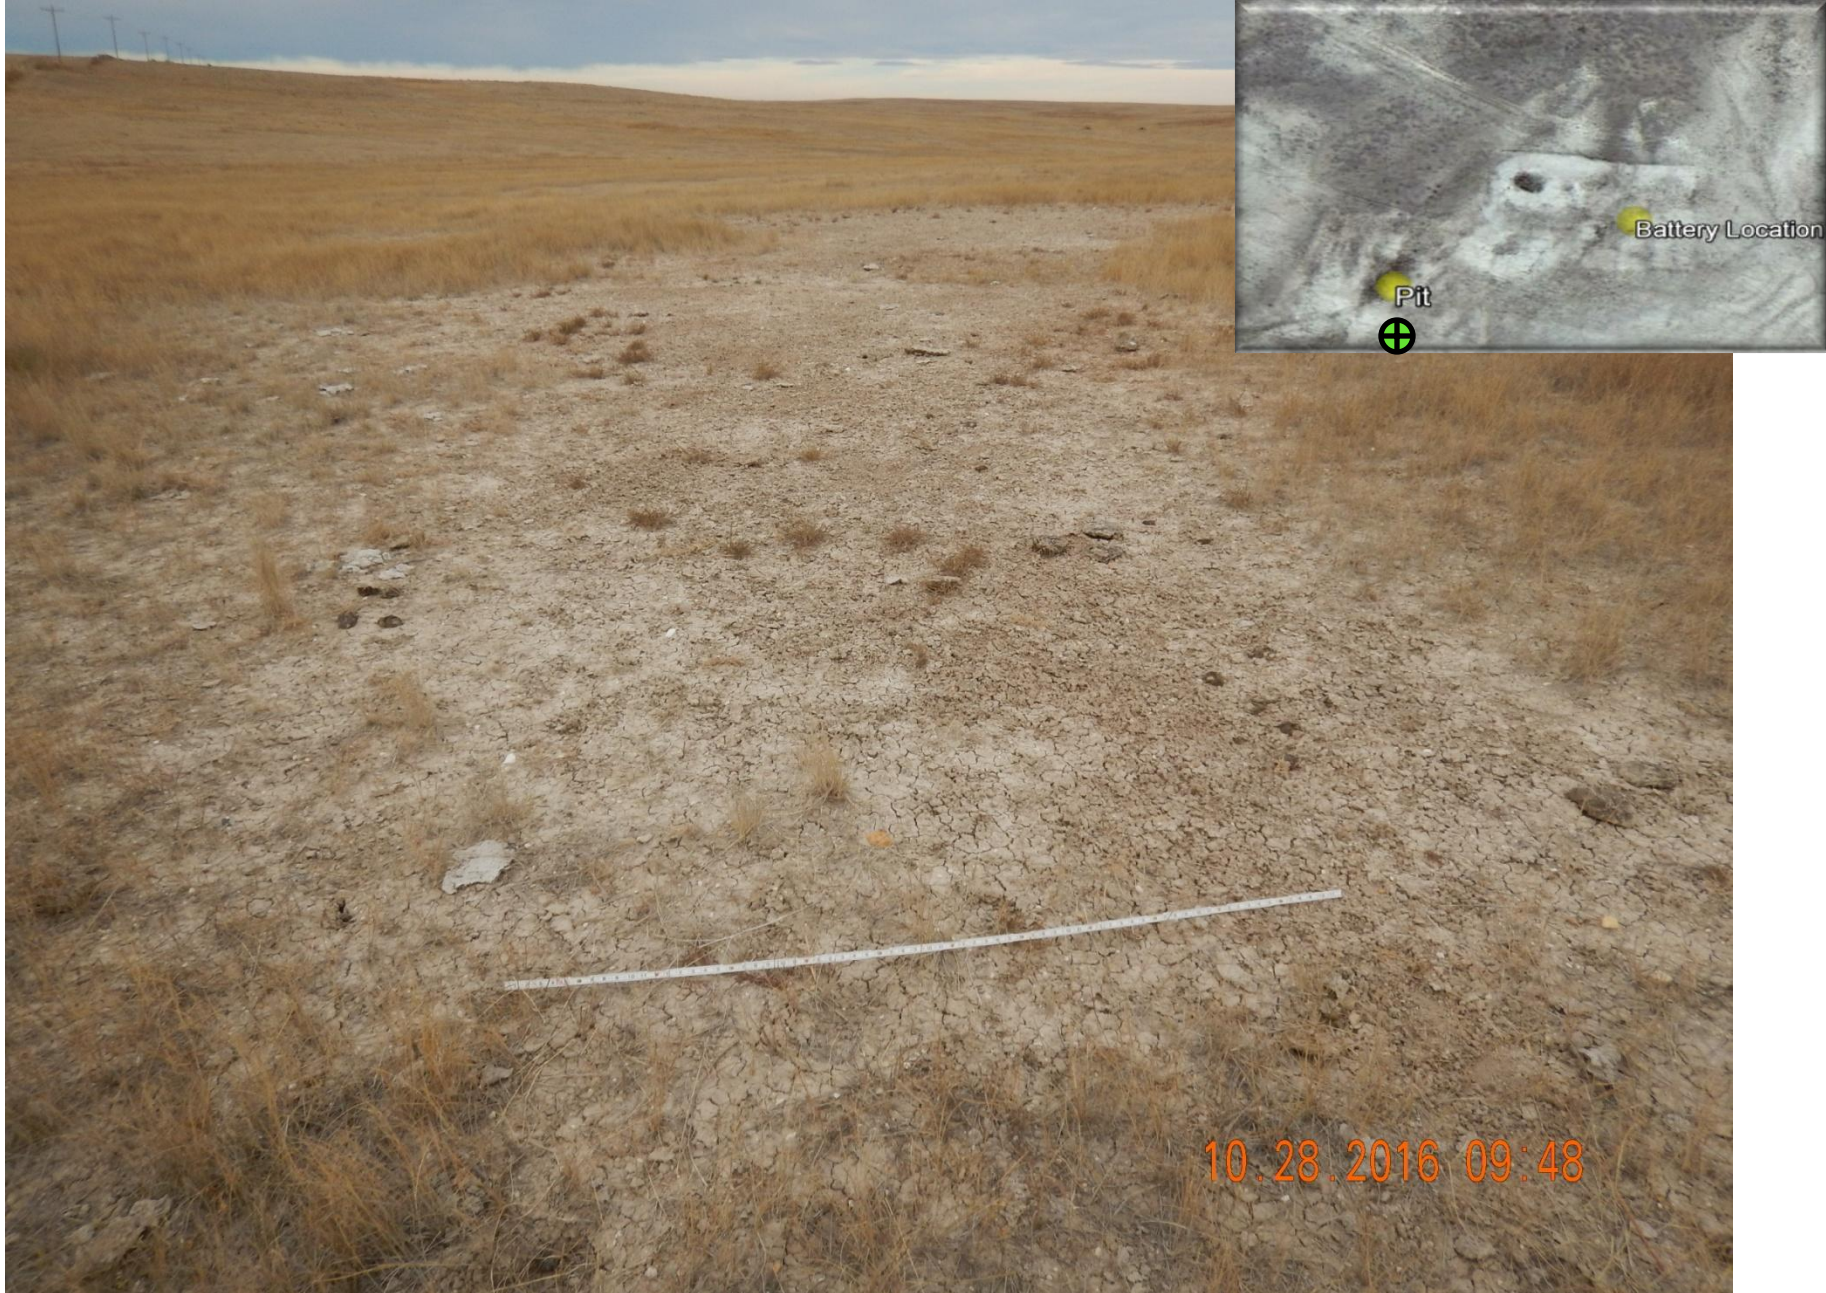
Figure 48: Photo taken from southeast end of the pit location, facing west. Photo shows areas pit/battery location has not achieved uniform vegetative cover and large areas remain unvegetated. 6' measuring stick for reference.

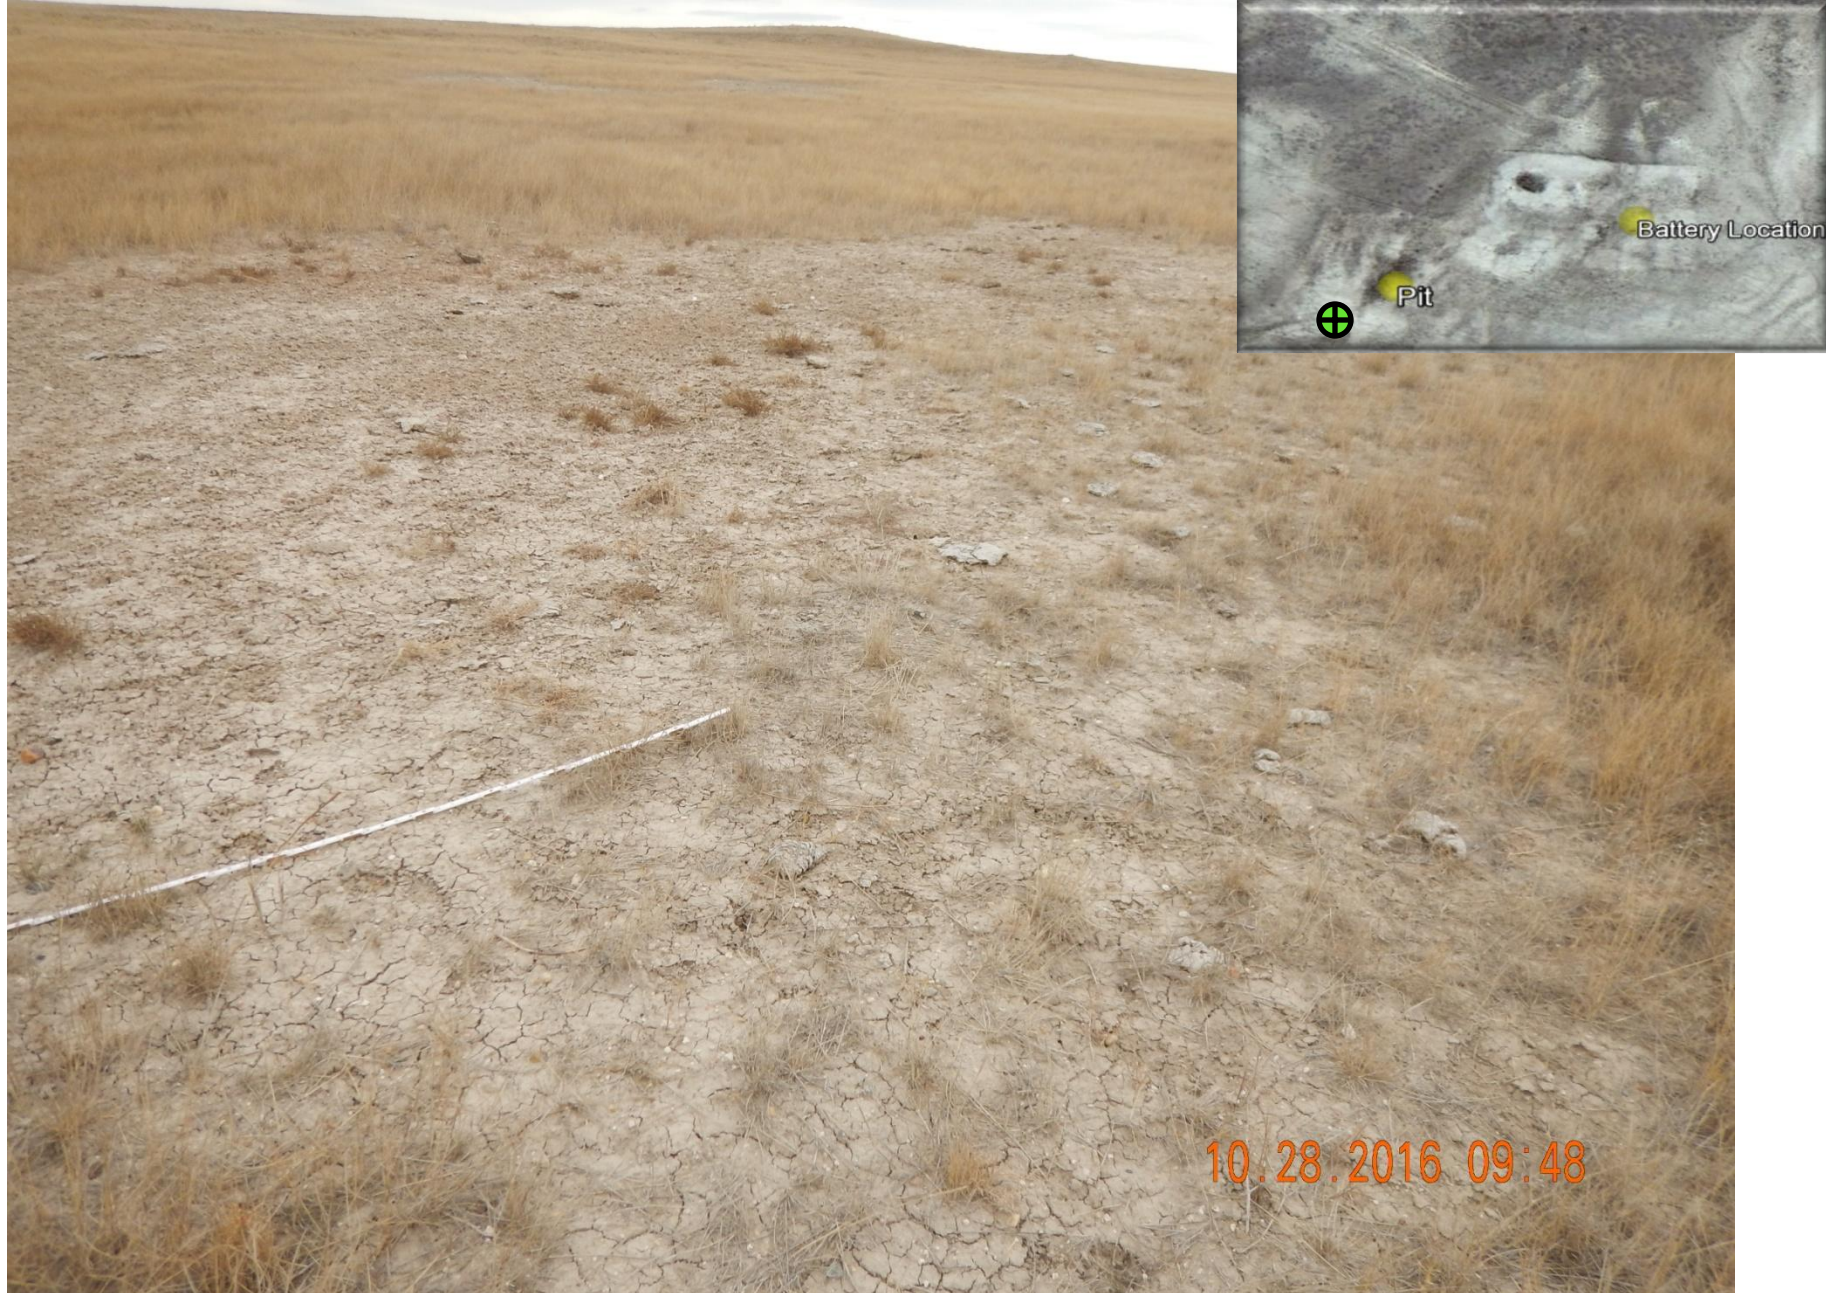
Figure 49: Photo taken from south end of the pit location, facing east. Photo shows areas pit/battery location has not achieved uniform vegetative cover and large areas remain unvegetated. 6' measuring stick for reference.

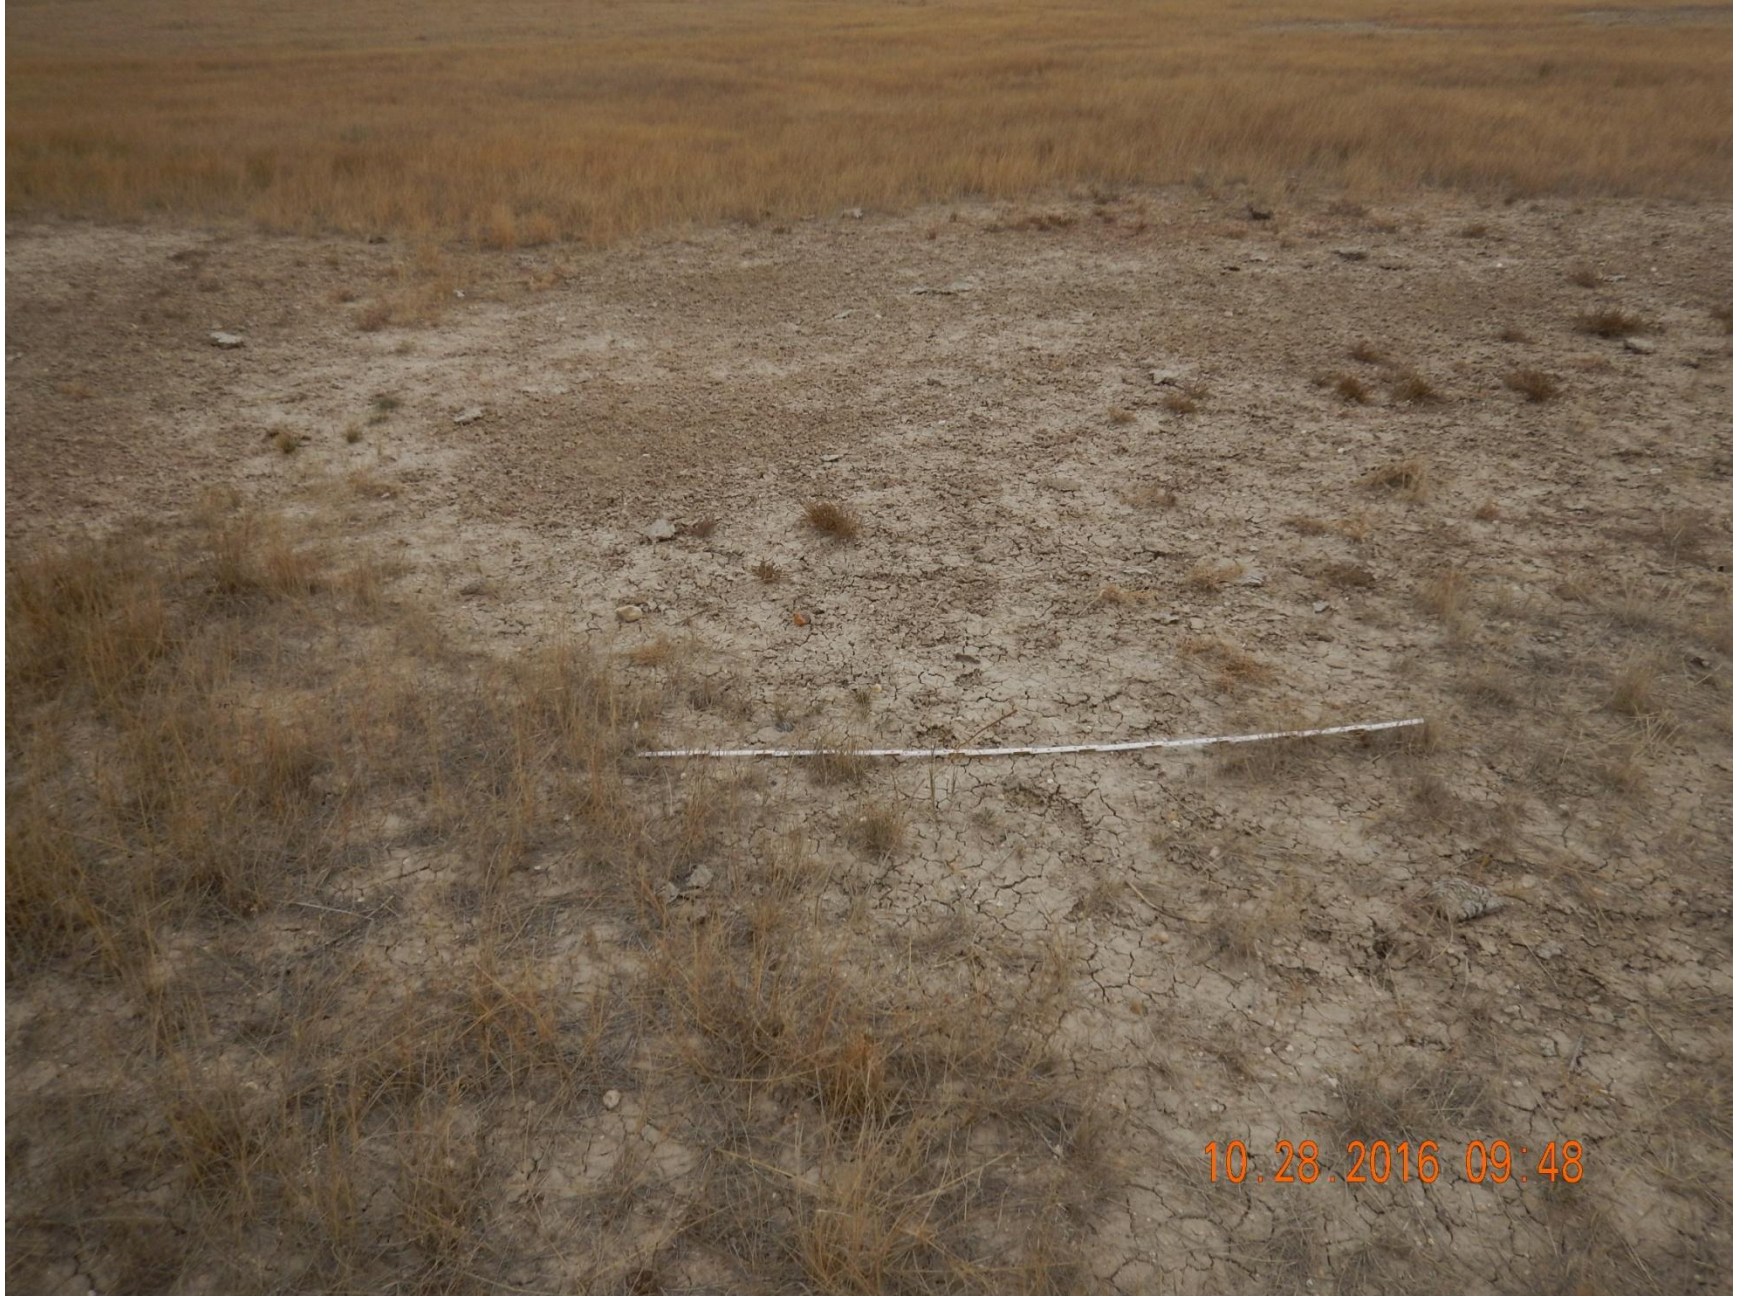
Figure 50: Photo taken from south end of the pit location, facing north. Photo shows areas pit/battery location has not achieved uniform vegetative cover and large areas remain unvegetated. 6' measuring stick for reference.

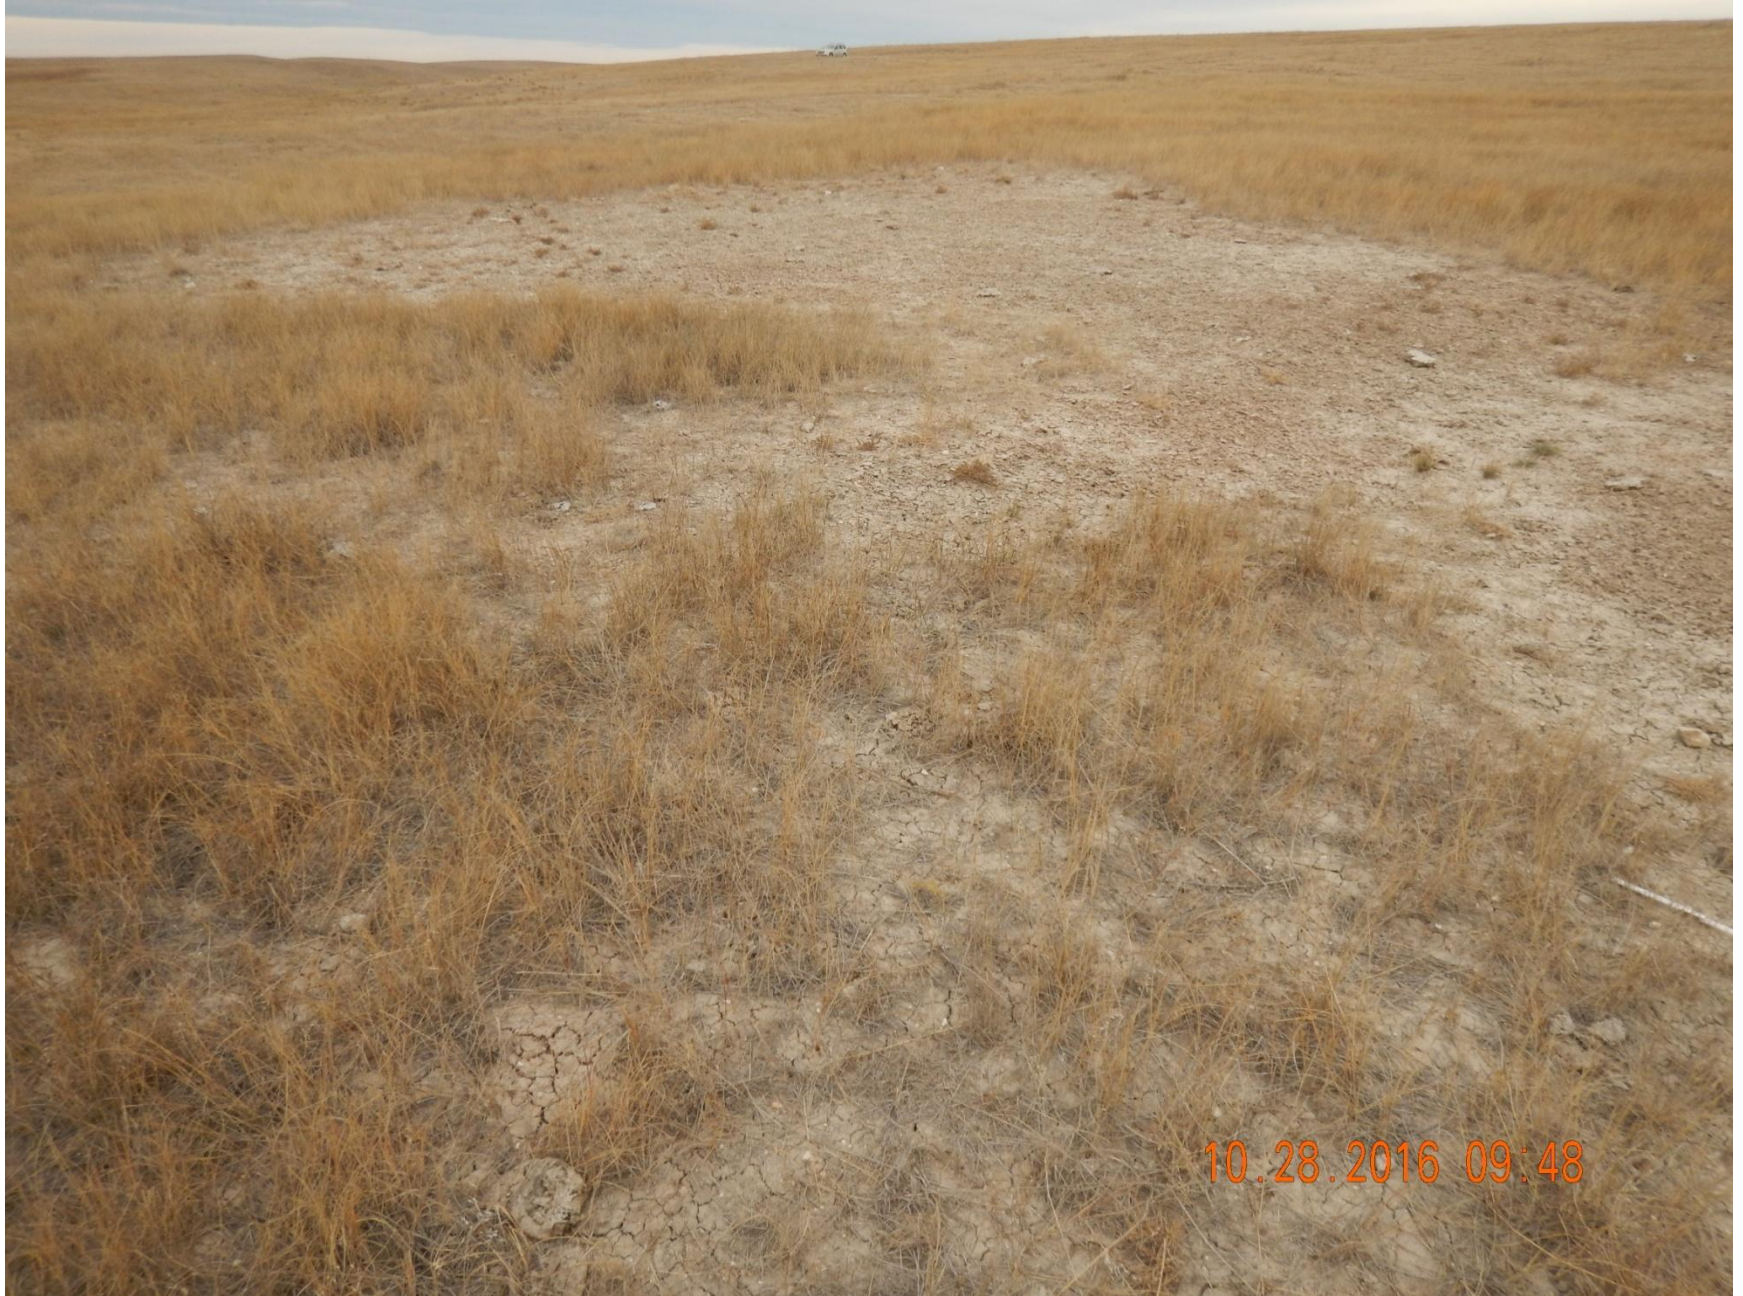
Figure 51: Photo taken from south end of the pit location, facing northwest. Photo shows areas pit/battery location has not achieved uniform vegetative cover and large areas remain unvegetated. 6' measuring stick for reference.

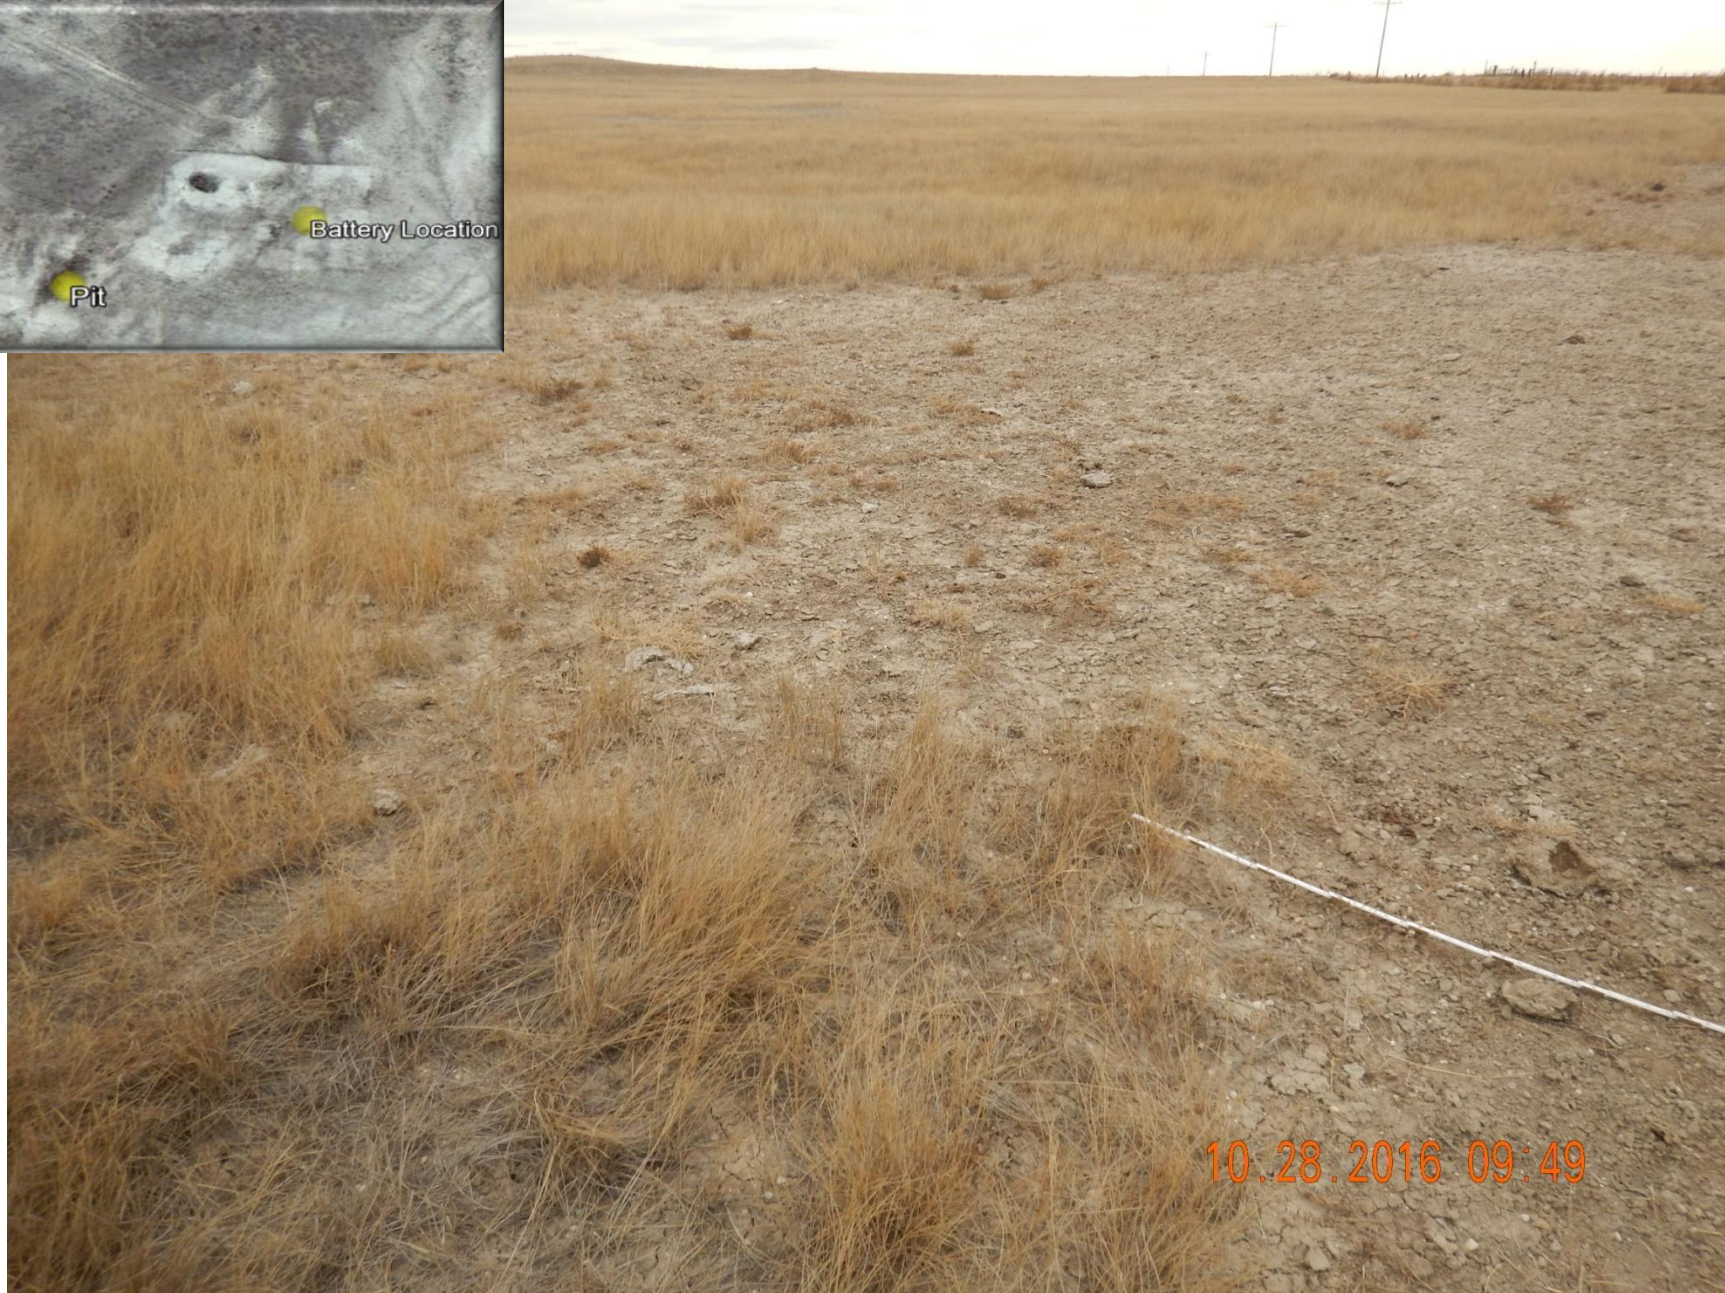
Figure 52: Photo taken from southwest end of the pit location, facing northeast. Photo shows areas pit/battery location has not achieved uniform vegetative cover and large areas remain unvegetated. 6' measuring stick for reference.
