Reclamation Inspection

10/28/2016

Operator: Markus Production Inc.

Location ID: 406198

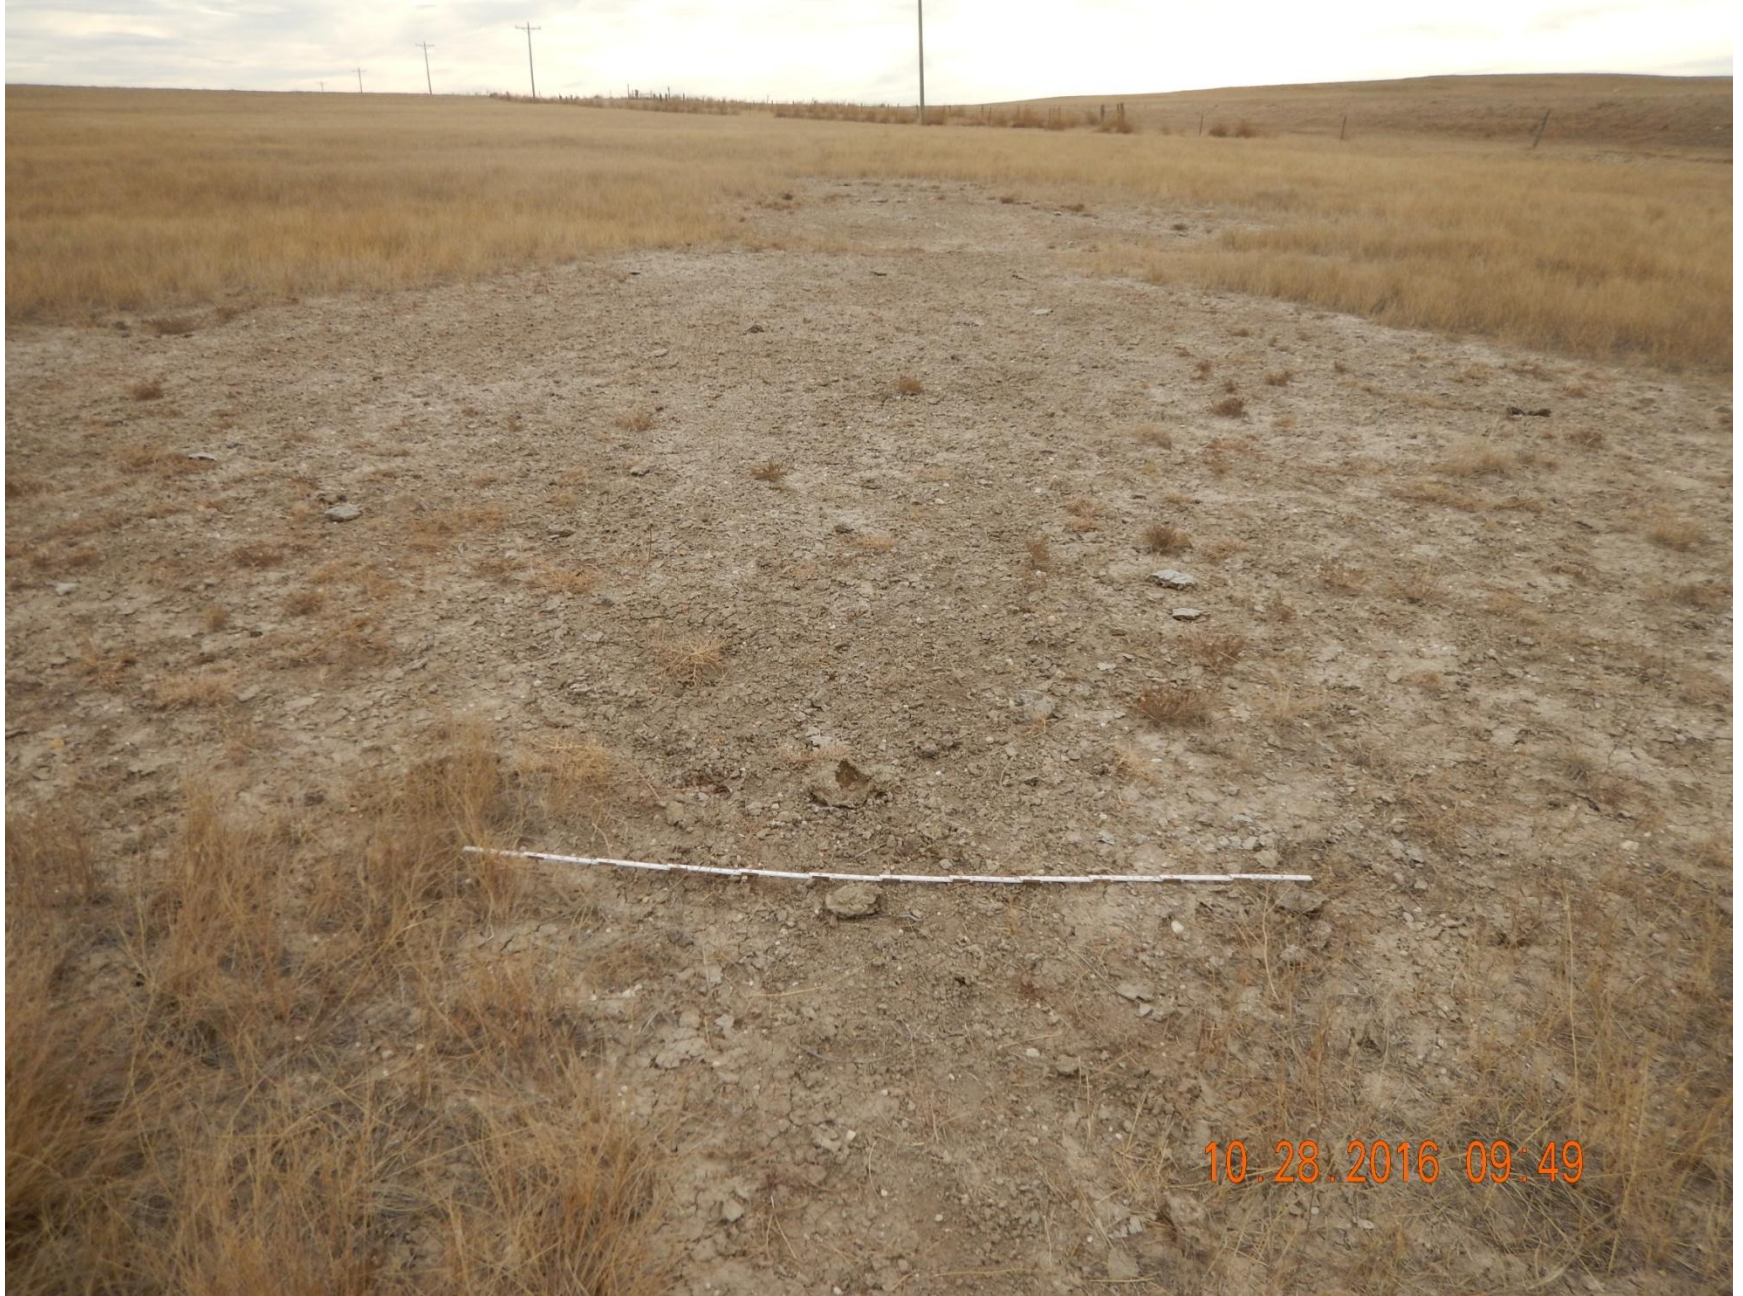
Figure 53: Photo taken from south end of the pit location, facing east. Photo shows areas pit/battery location has not achieved uniform vegetative cover and large areas remain unvegetated. 6' measuring stick for reference.

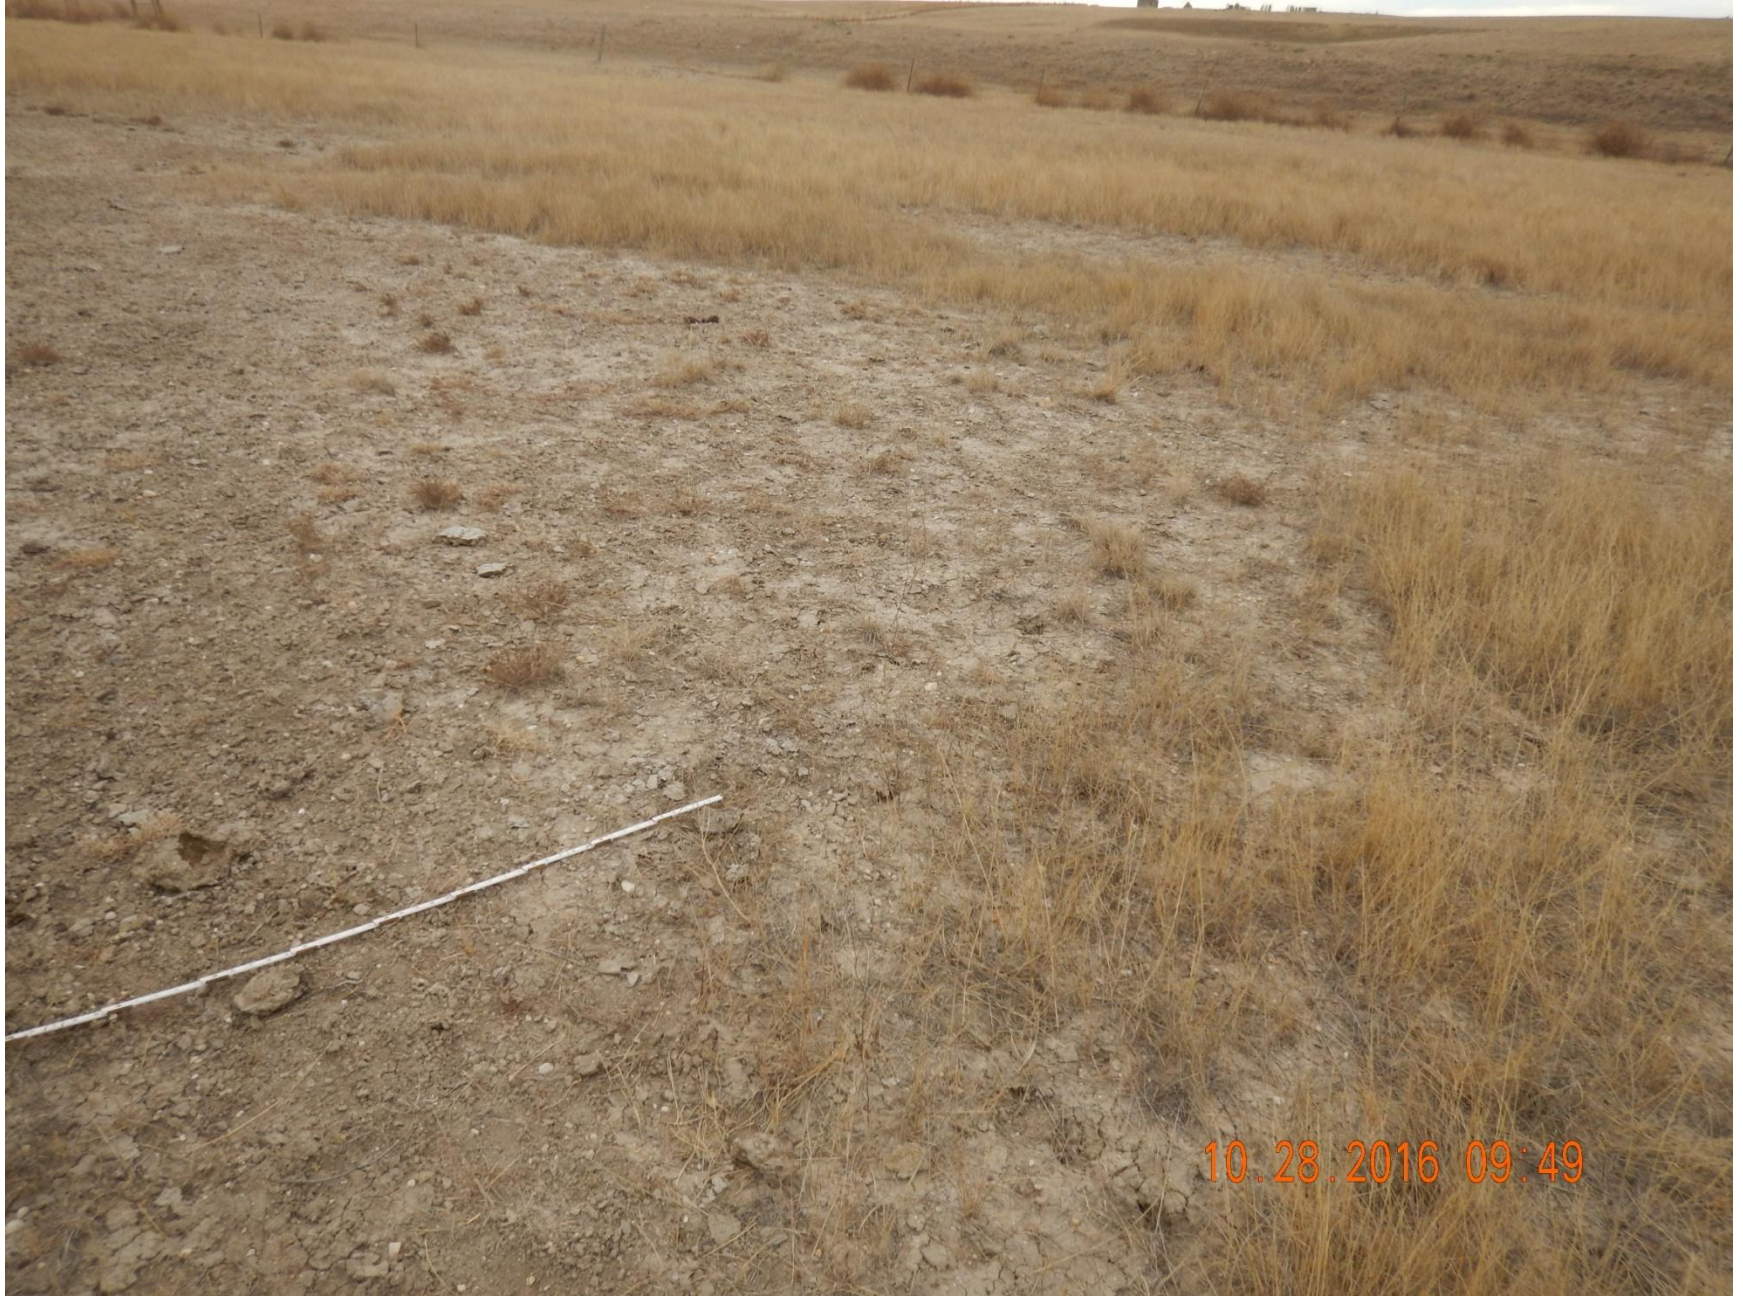
Figure 54: Photo taken from south end of the pit location, facing southeast. Photo shows areas pit/battery location has not achieved uniform vegetative cover and large areas remain unvegetated. 6' measuring stick for reference.
