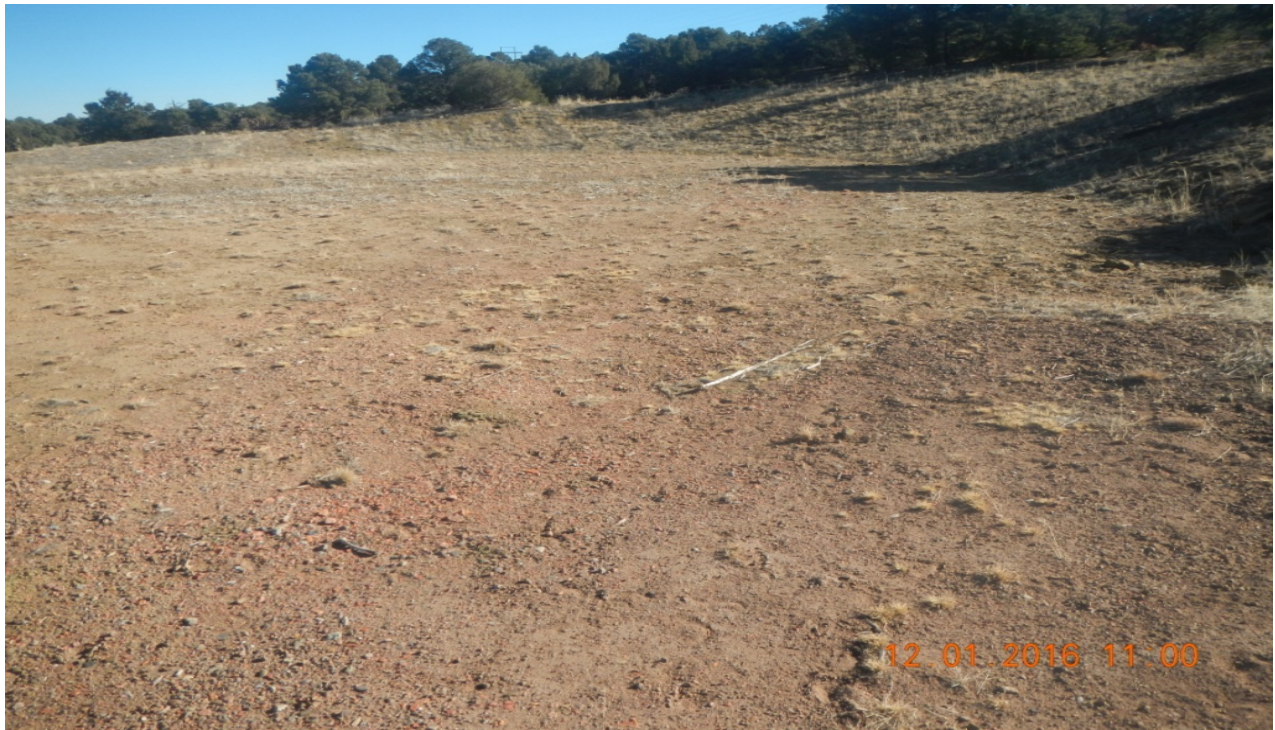
photo 1: Facing east toward the location.

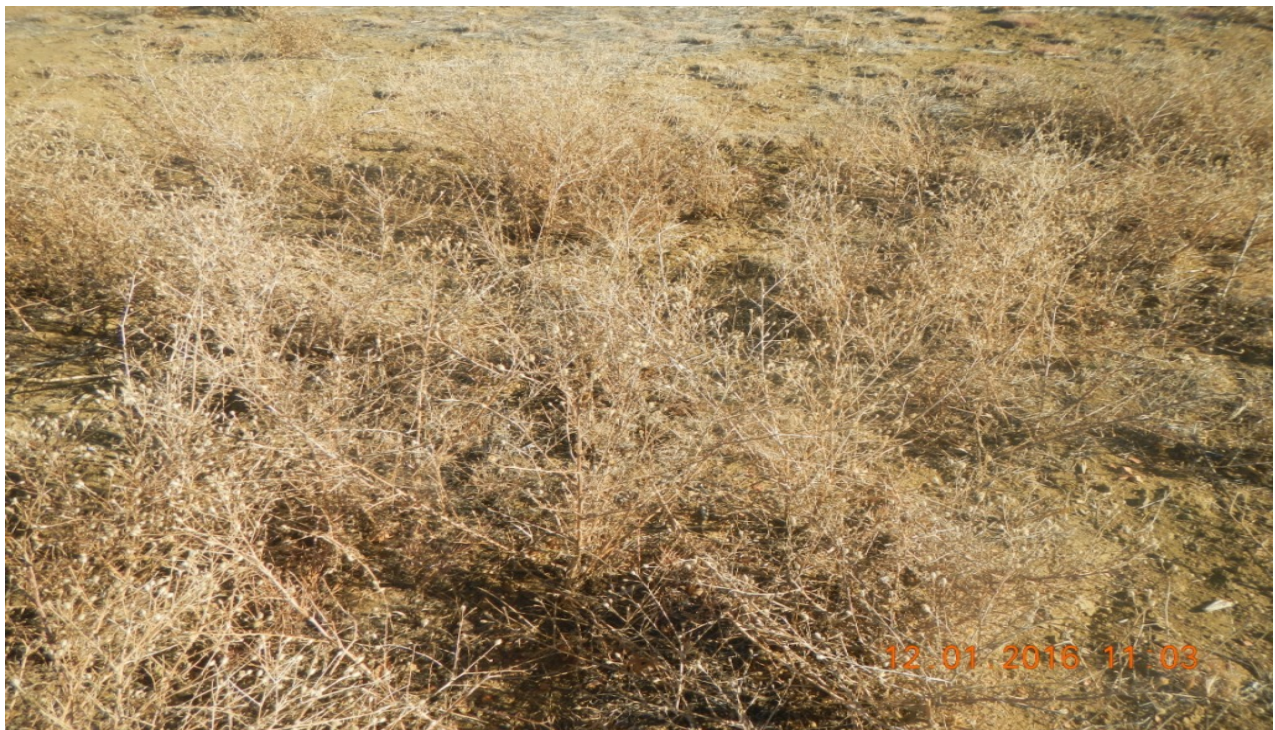
photo 2: There is List B noxious weeds (Diffuse knapweed) found growing throughout the location.

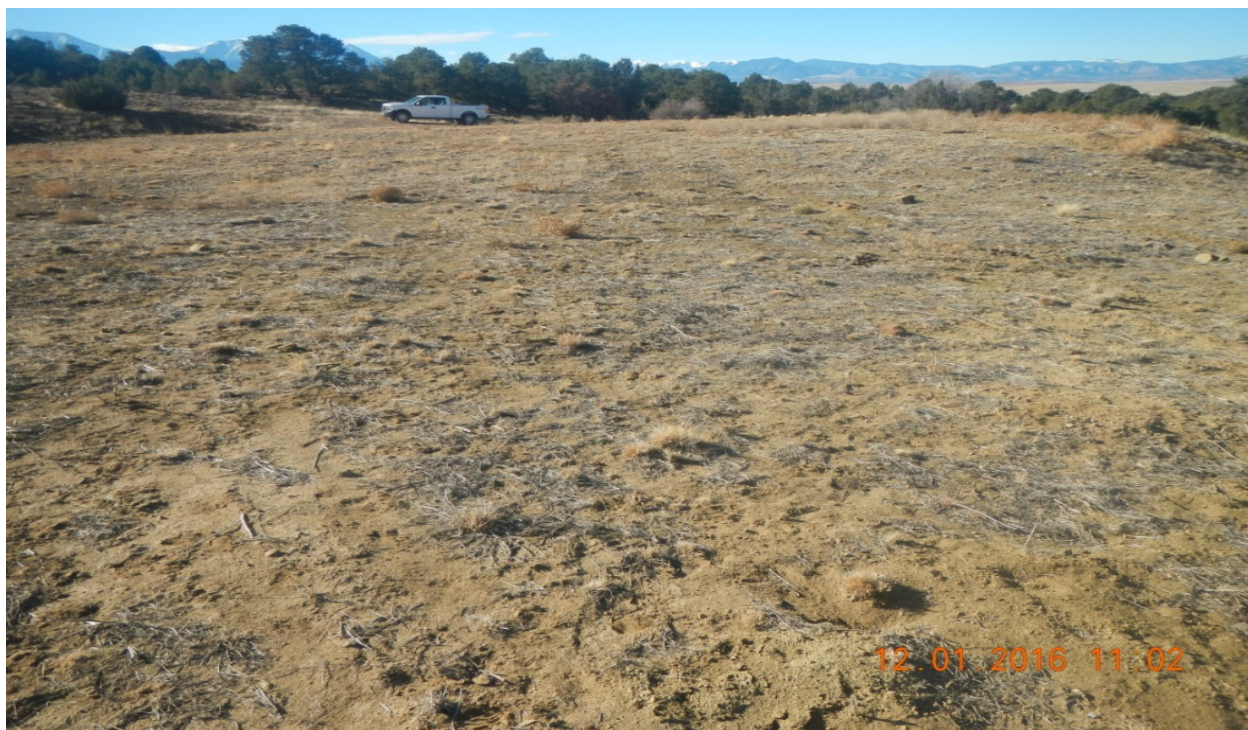
photo 3: East side of the location facing west.

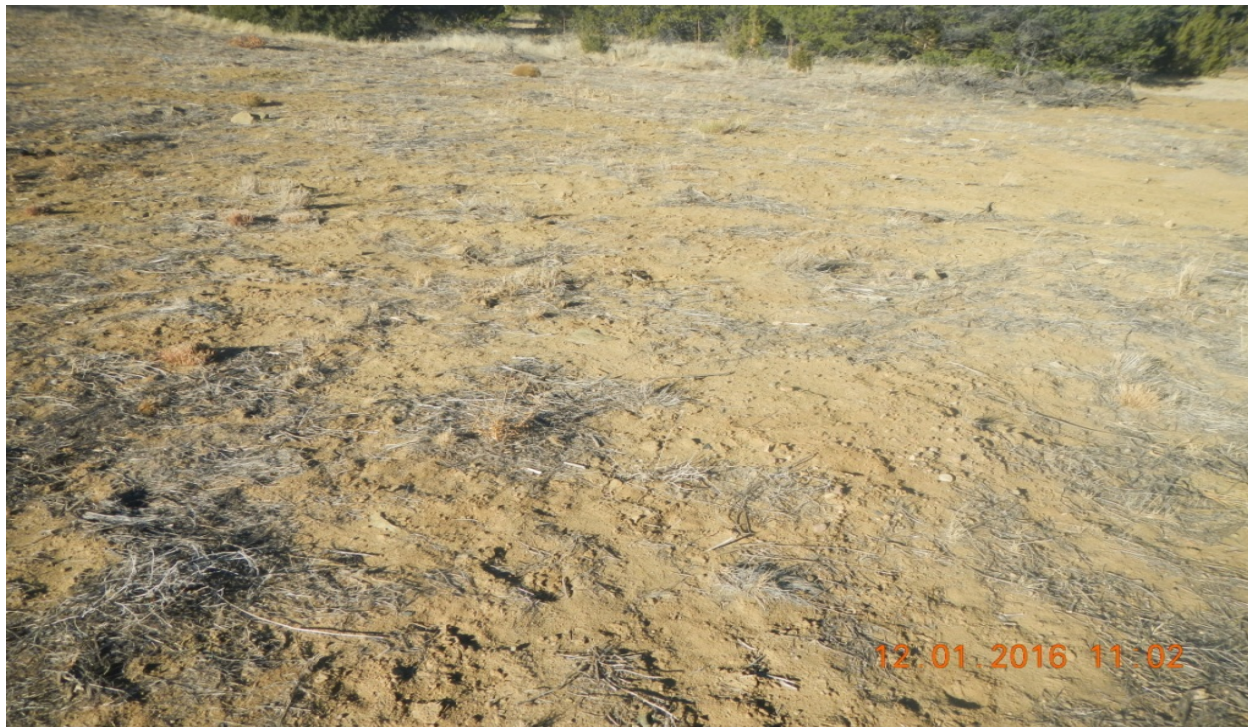
photo 4: View of groundcover at the east side of the location. The vegetation has not adequately established in this area.

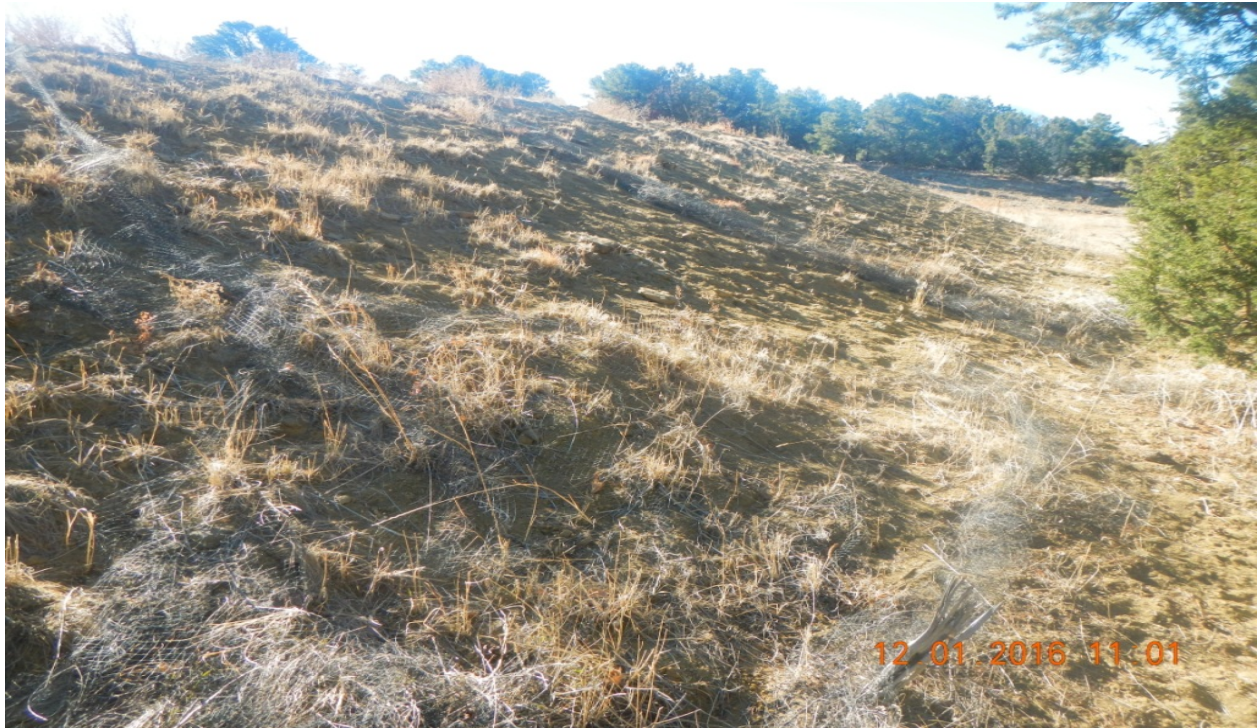
photo 5: Facing west along the fill slope.

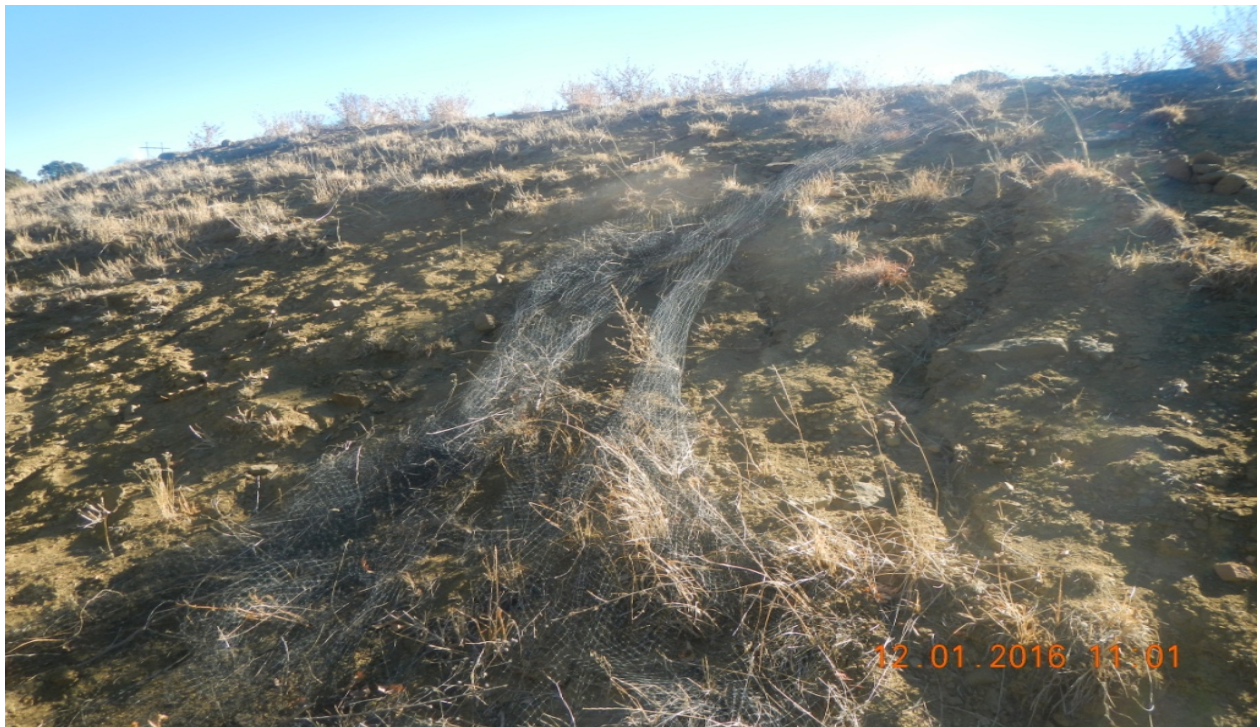
photo 6: The fill slope is not adequately stabilized with vegetation and there are signs of erosion. The plastic netting debris remains.

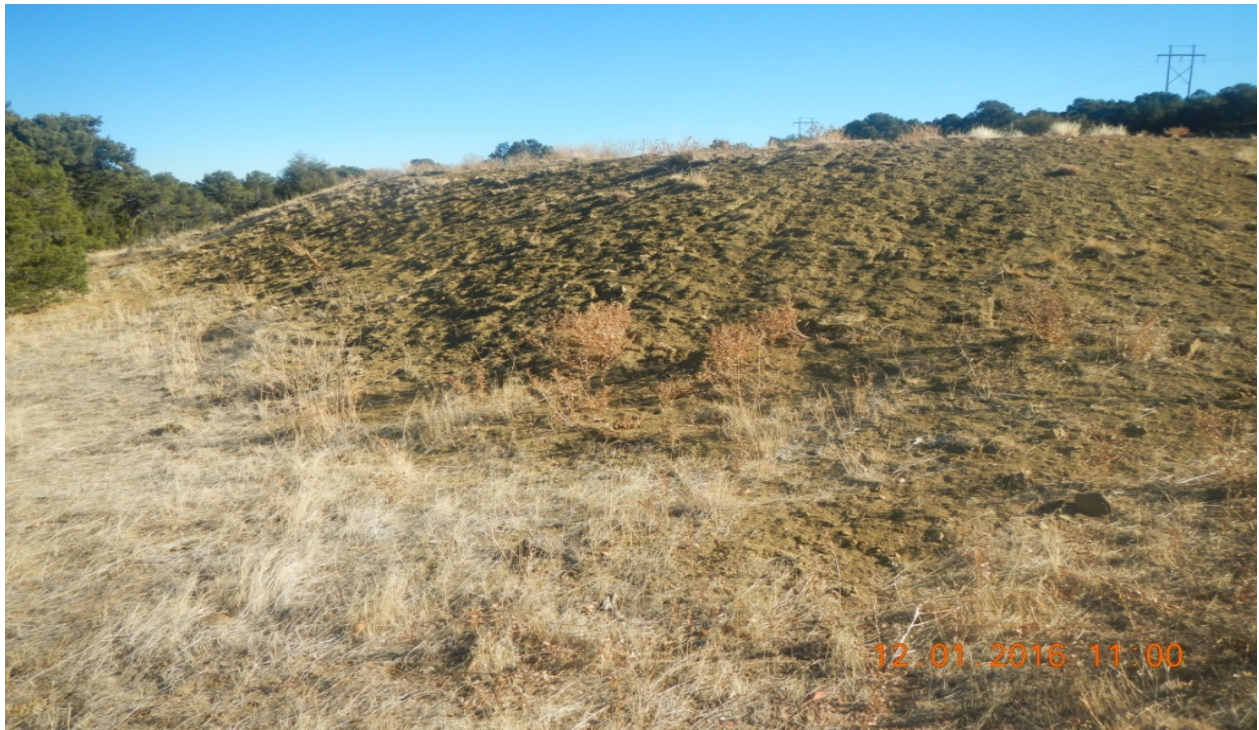
photo 7: Northwest side of the location facing northeast toward the fill slope.

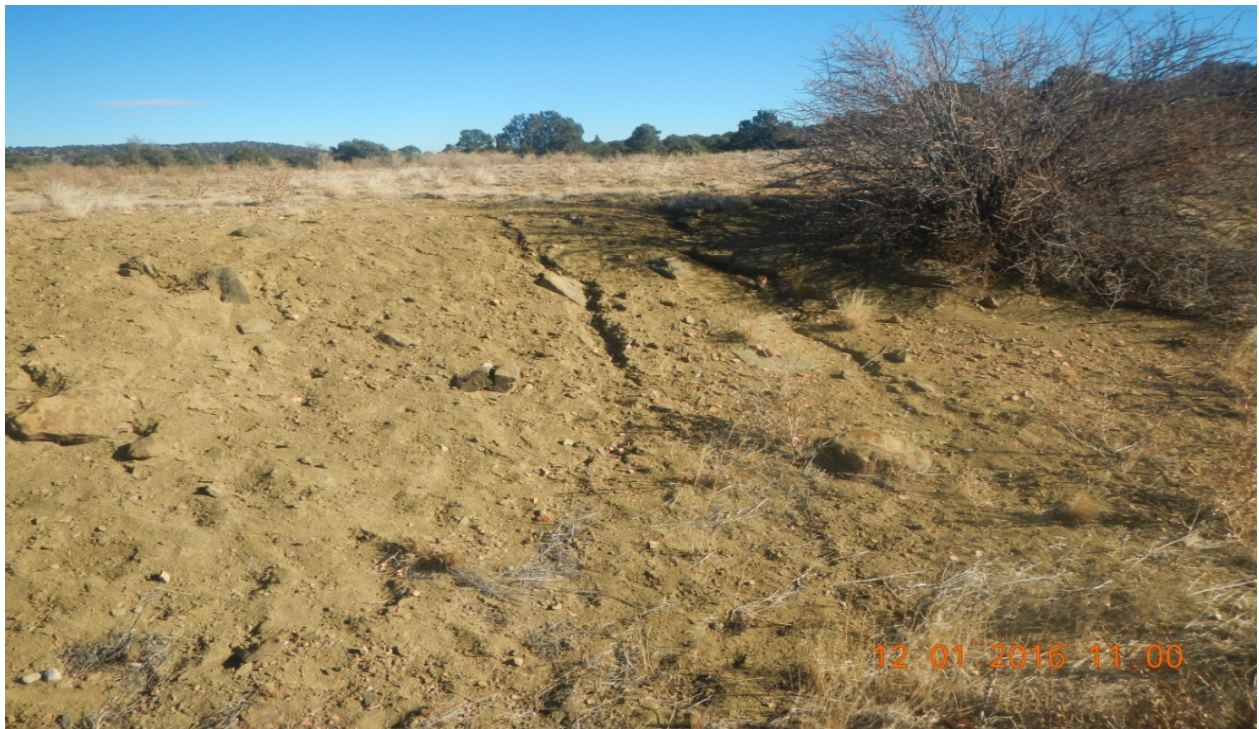
photo 8: There are signs of erosion along west side of the pad.
