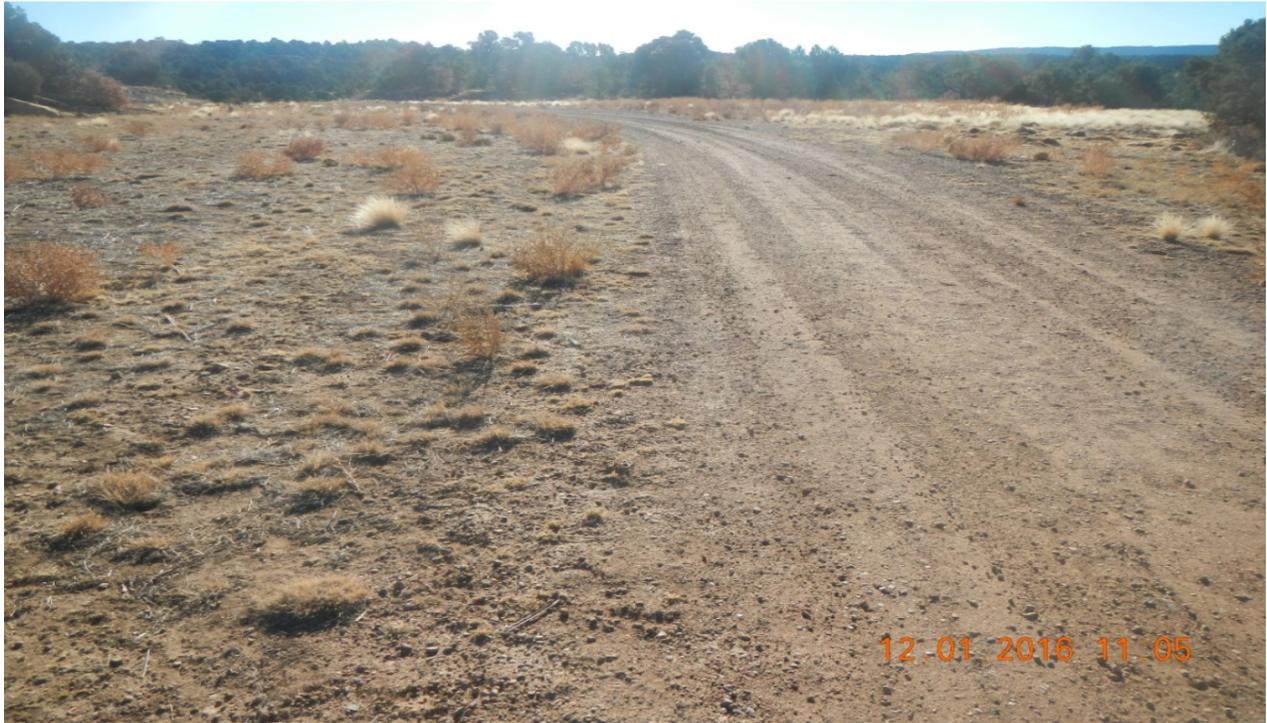
photo 1: Facing southeast toward the location. The access road passes thru the location.

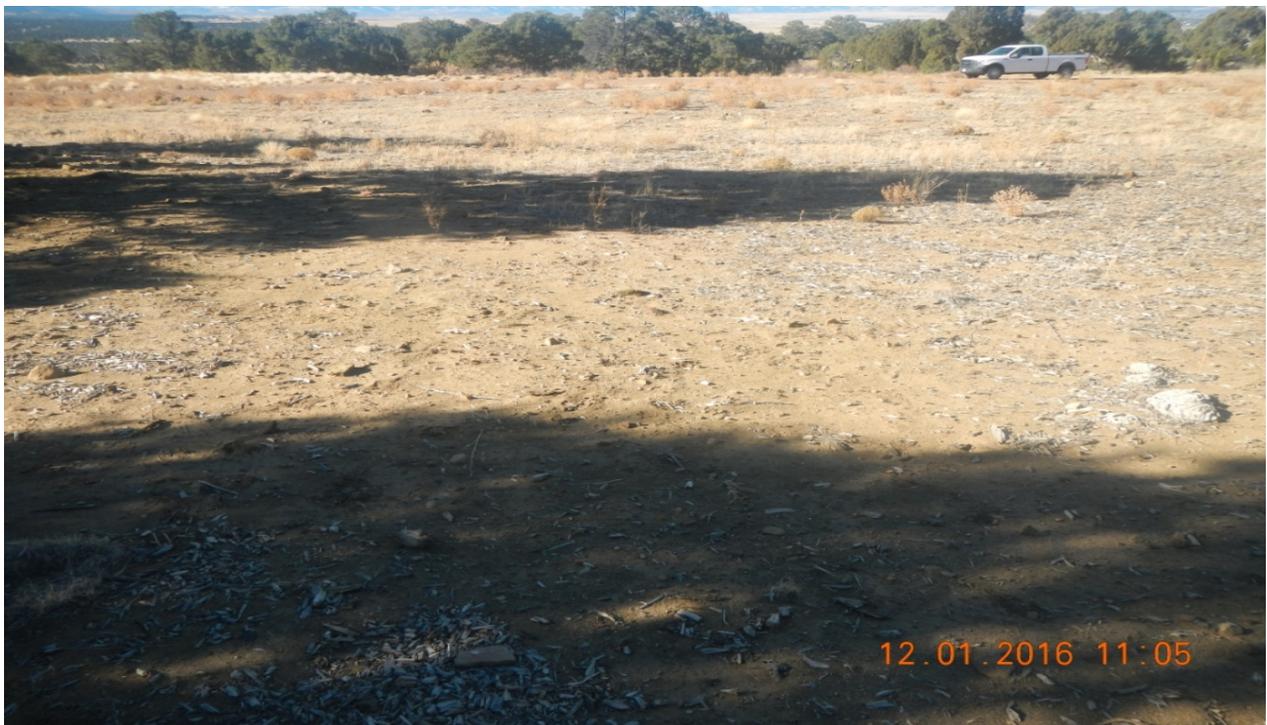
photo 2: East side of the location facing west. Vegetation has not adequately established.

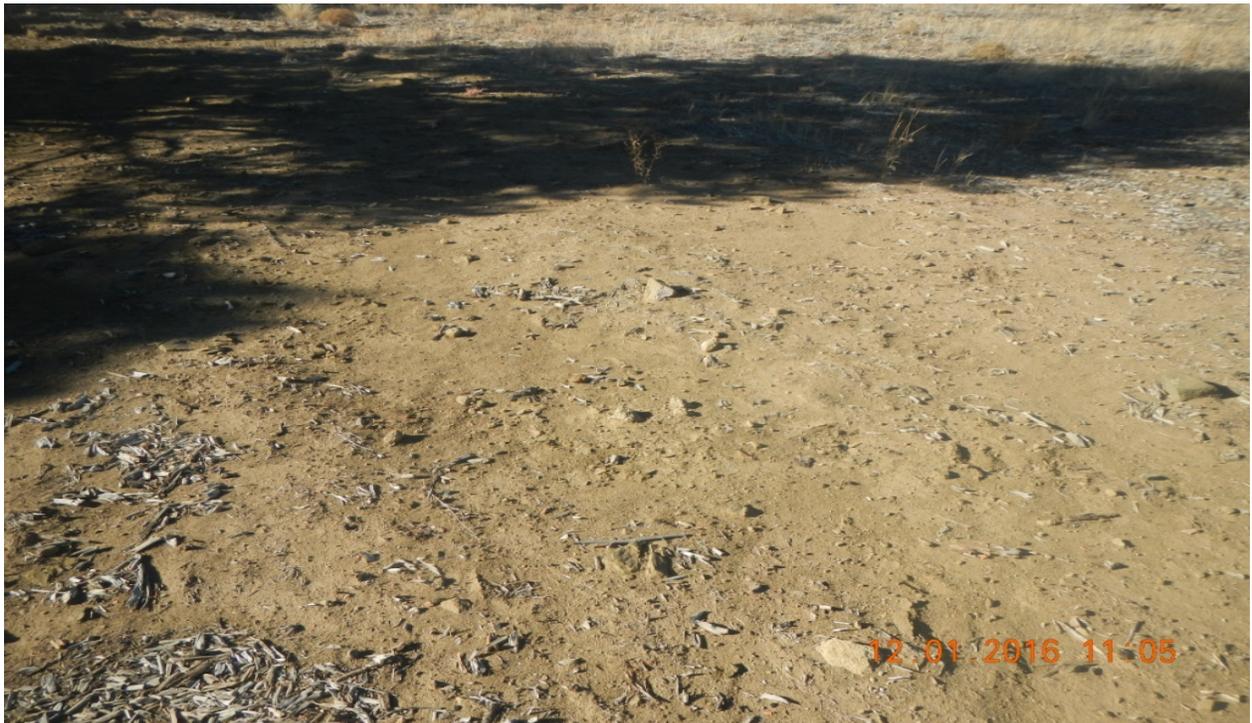
photo 3: View of groundcover at the east side of the location. The vegetation has not established in this area.

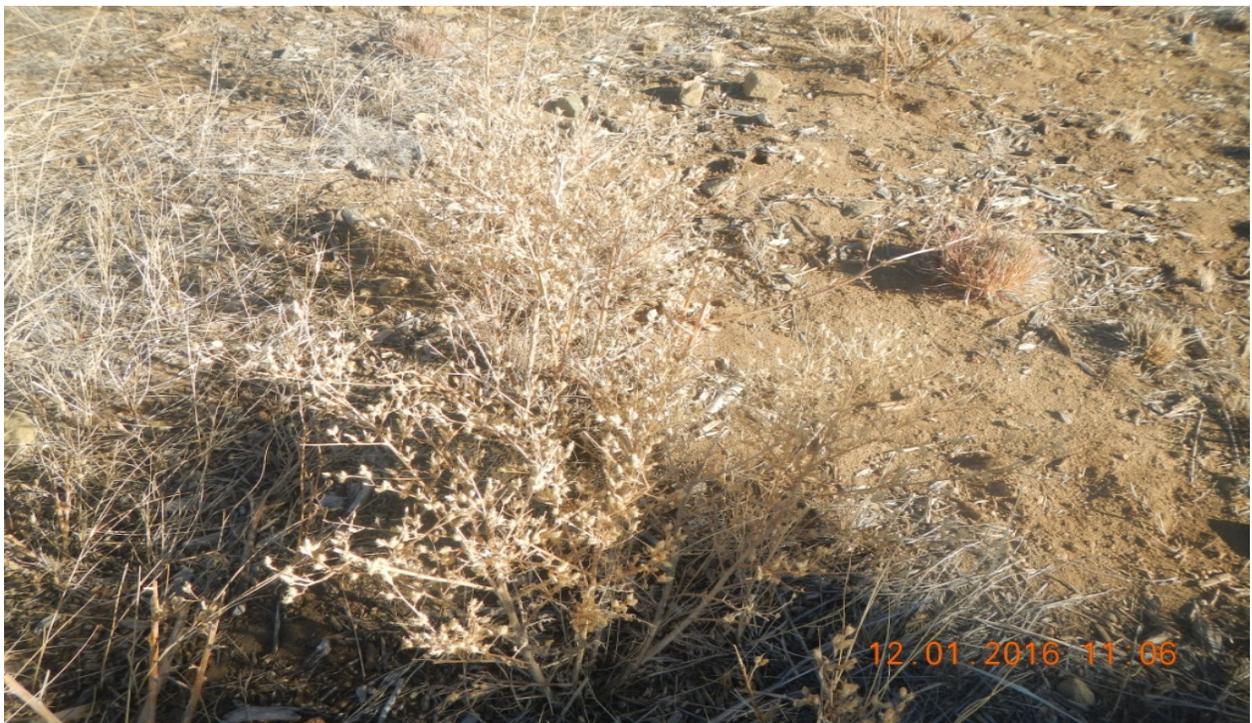
photo 4: There is List B noxious weeds (Diffuse knapweed) found growing throughout the location.

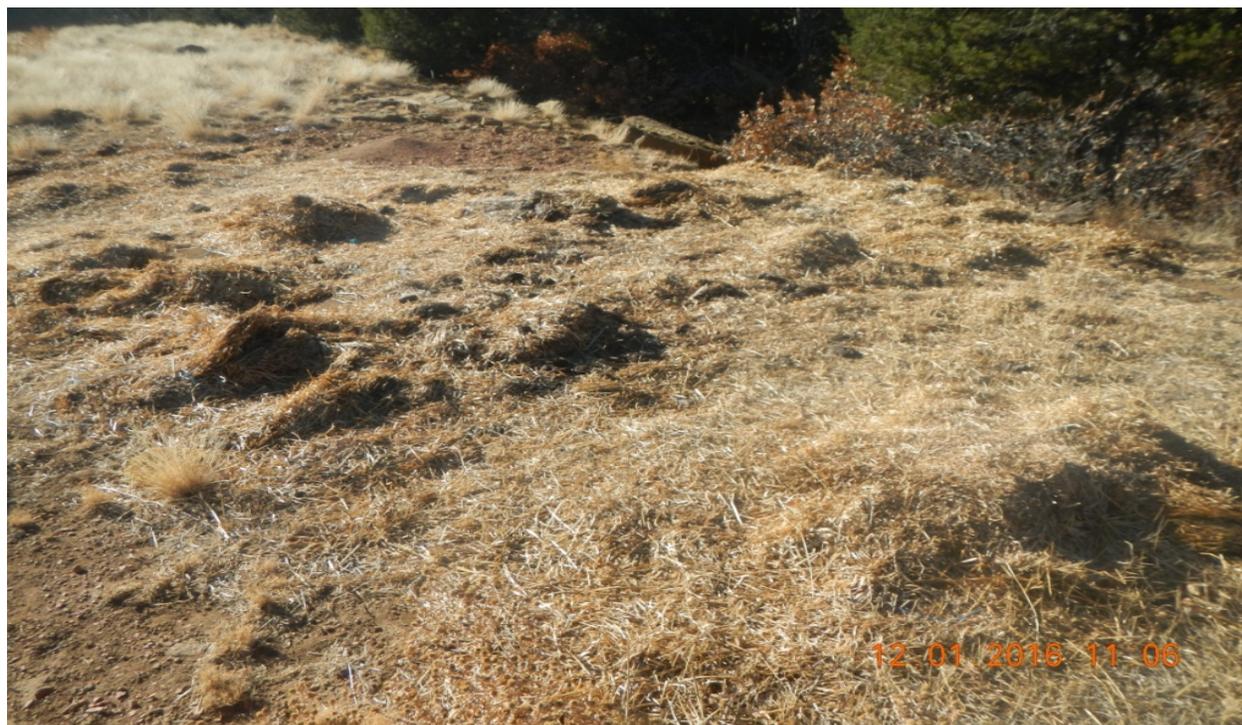
photo 5: There is straw debris left in piles at the west side of the location.

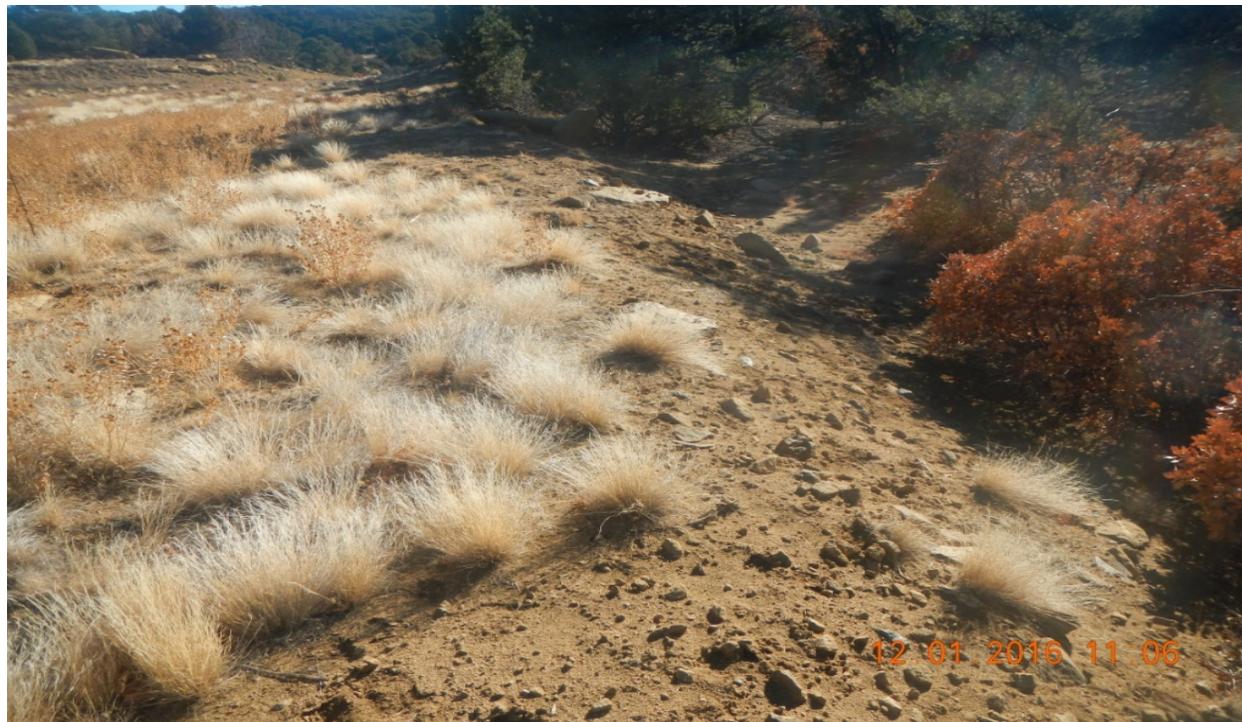
photo 6: Facing east along the south side of the location.

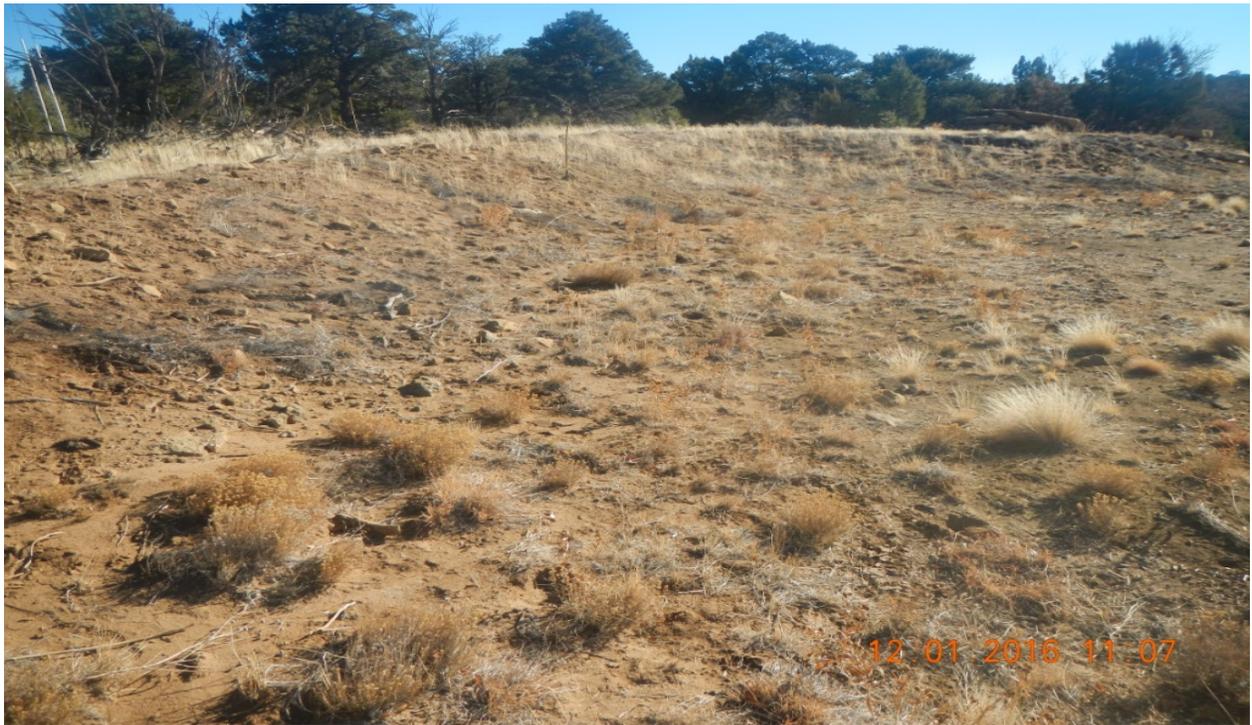
photo 7: Facing along the cut slope at the southeast side of the location.

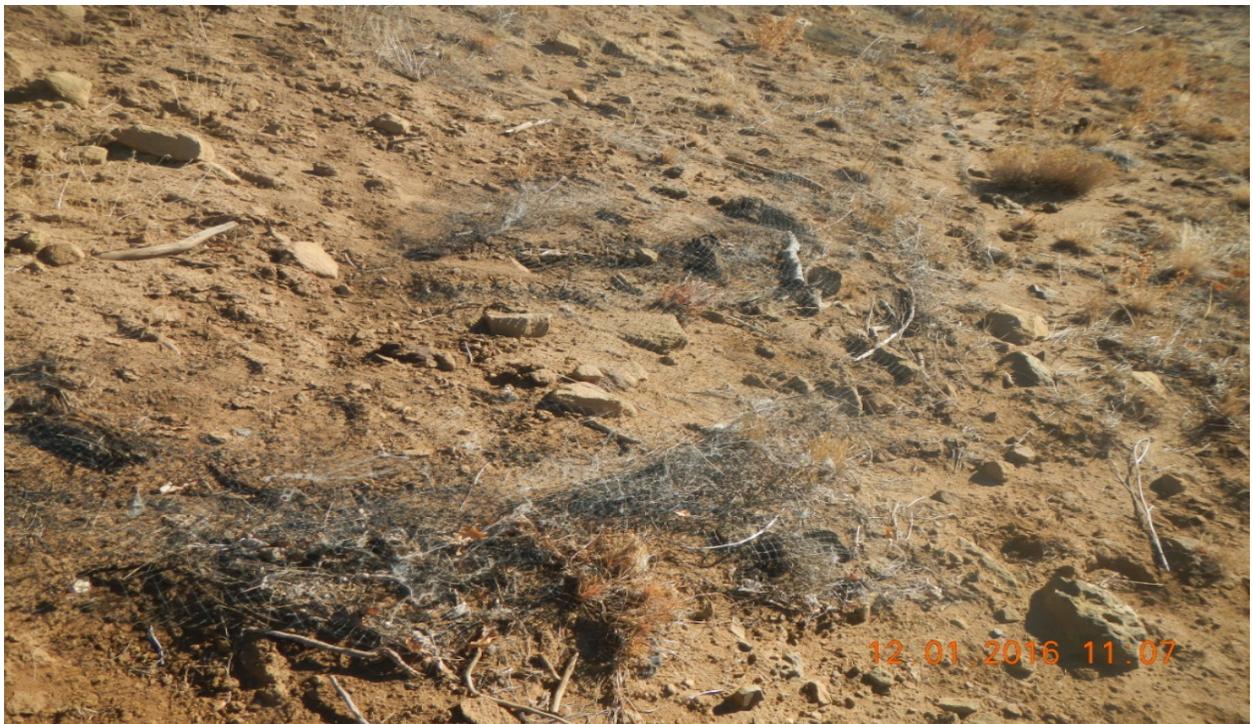
photo 8: There is plastic debris along areas of the southeast cut slope.
