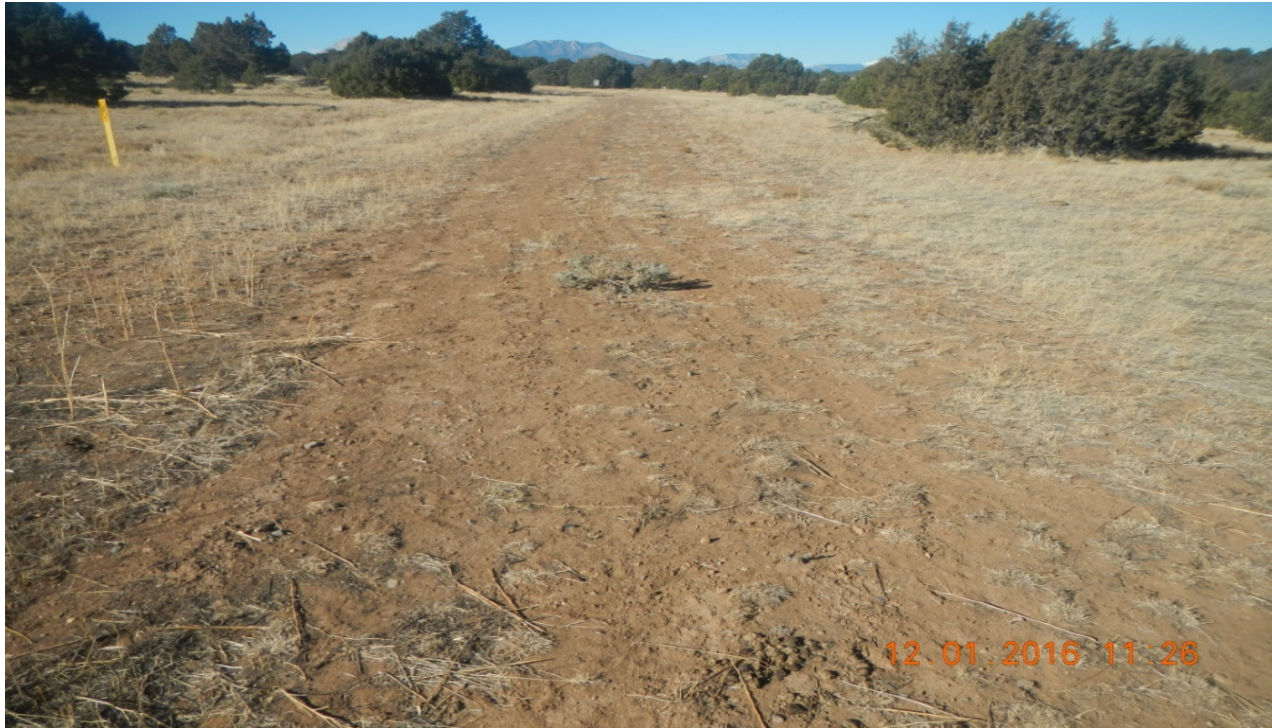
**photo 1:** Facing west along the former access road. The vegetation has not adequately established.

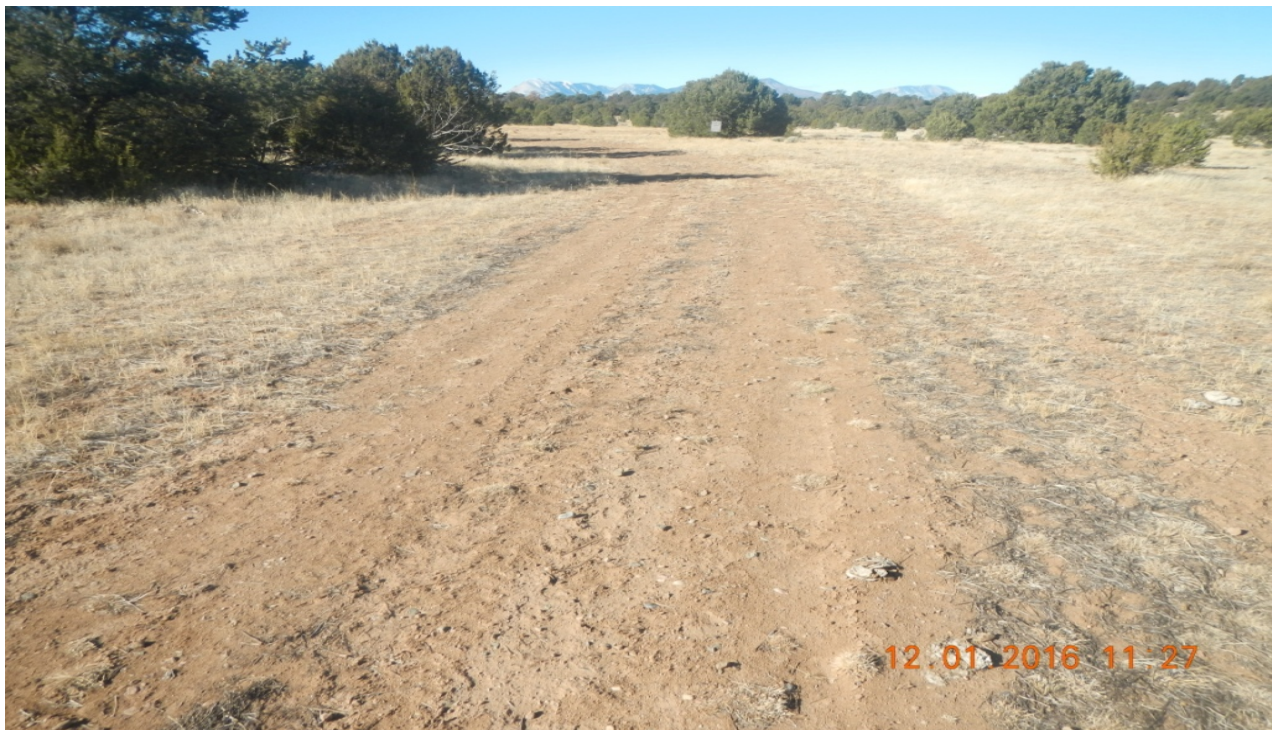
**photo 2:** Facing west along the former access road. The vegetation has not adequately established.

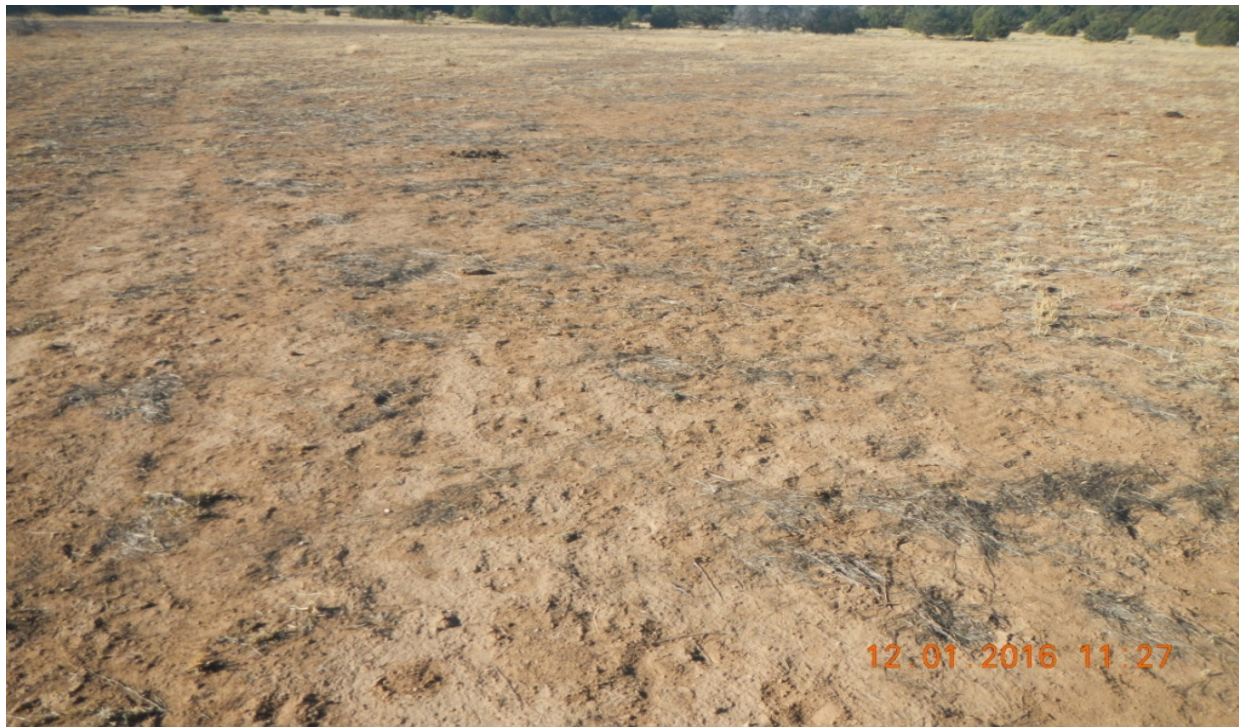
**photo 4:** There areas at the location which do not have adequate vegetation cover.
