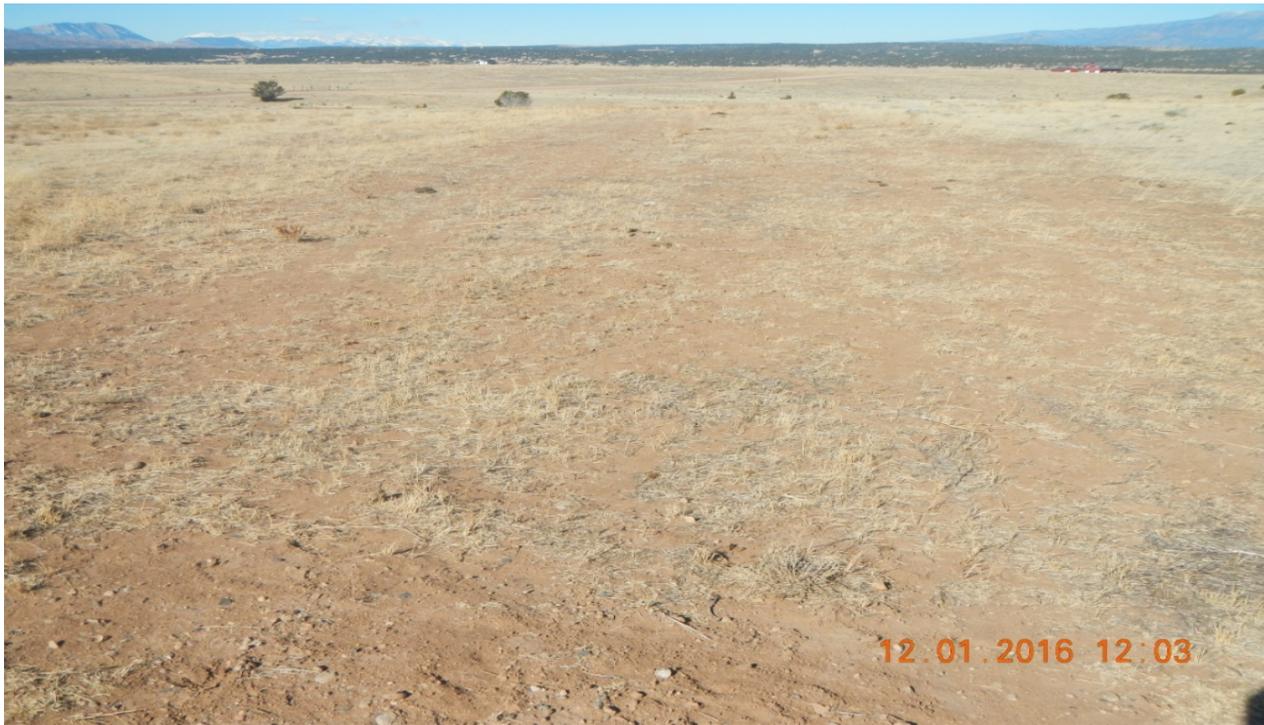
photo 1: Facing northwest along the former access road. The vegetation has not adequately established.

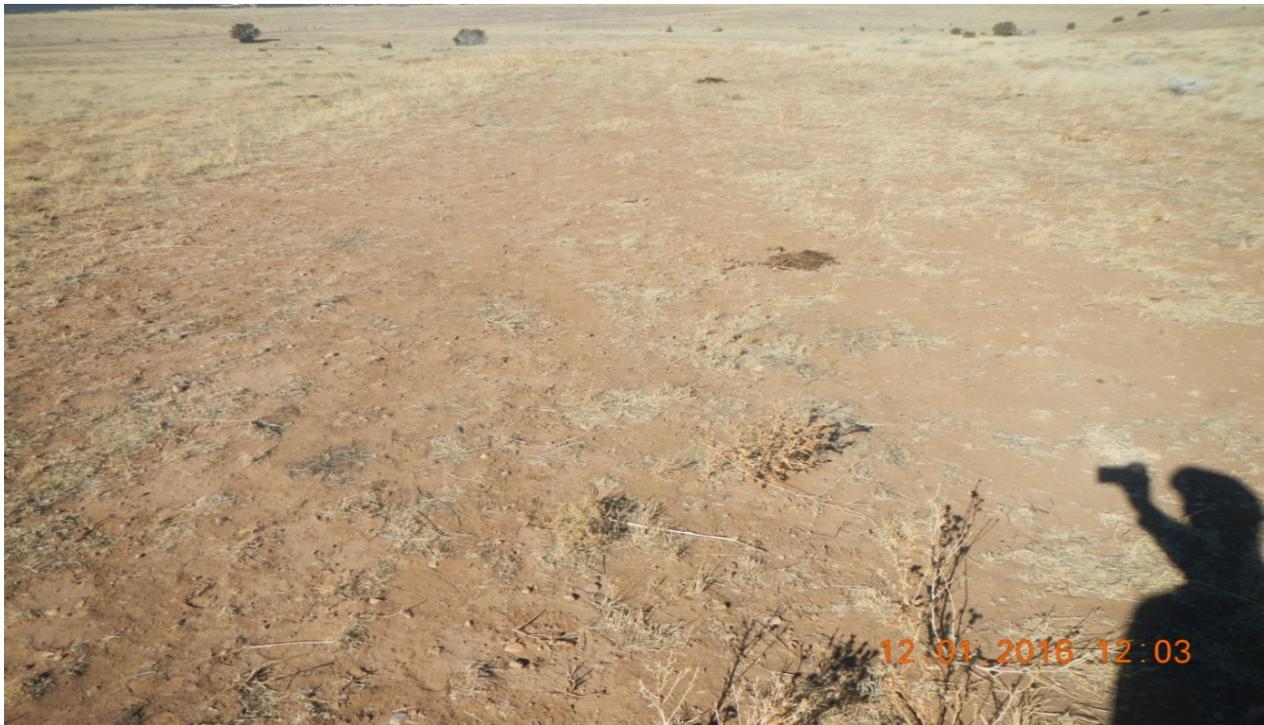
photo 2: Facing northwest along the former access road. The vegetation has not adequately established.

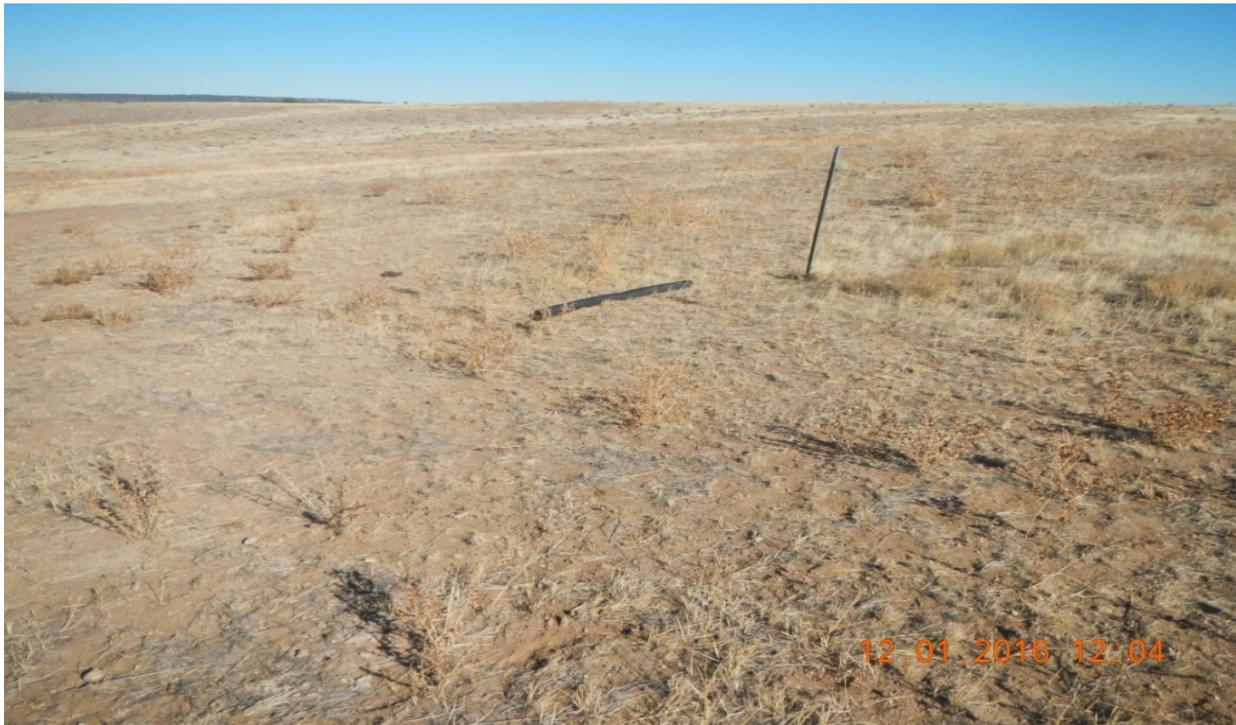
photo 3: Facing north toward the location.

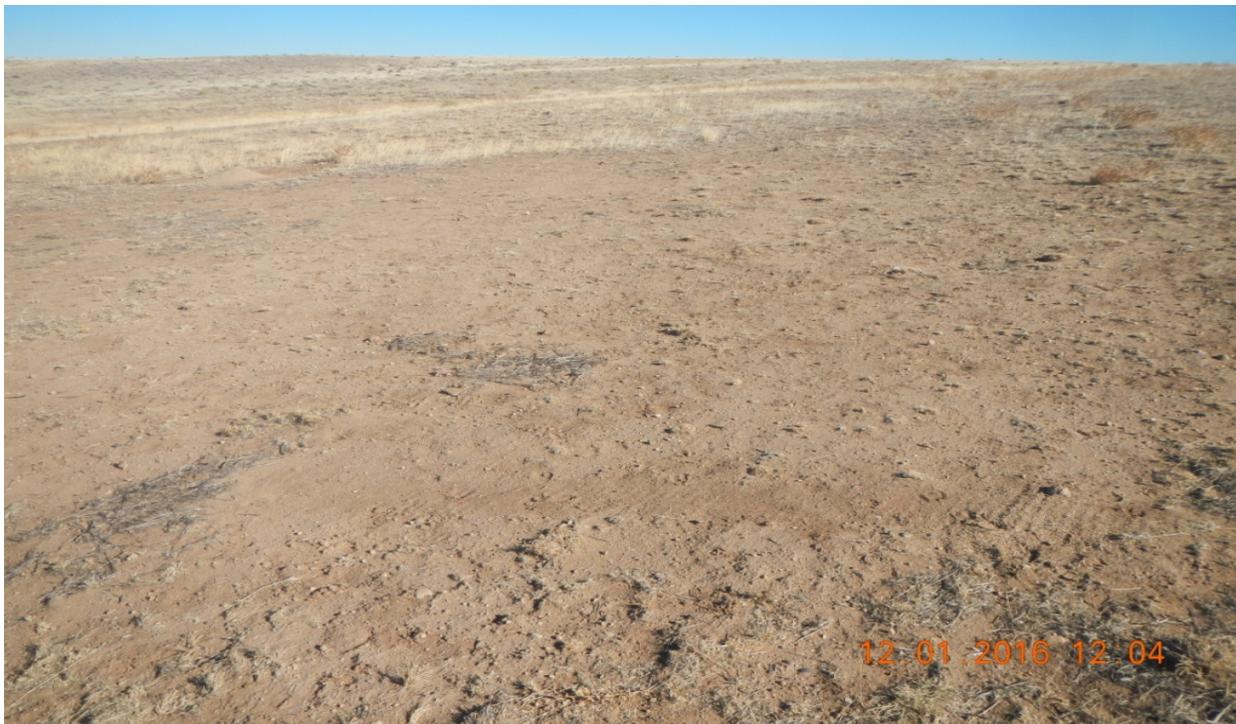
photo 4: West side of the location facing east. Vegetation has not adequately established in this area.

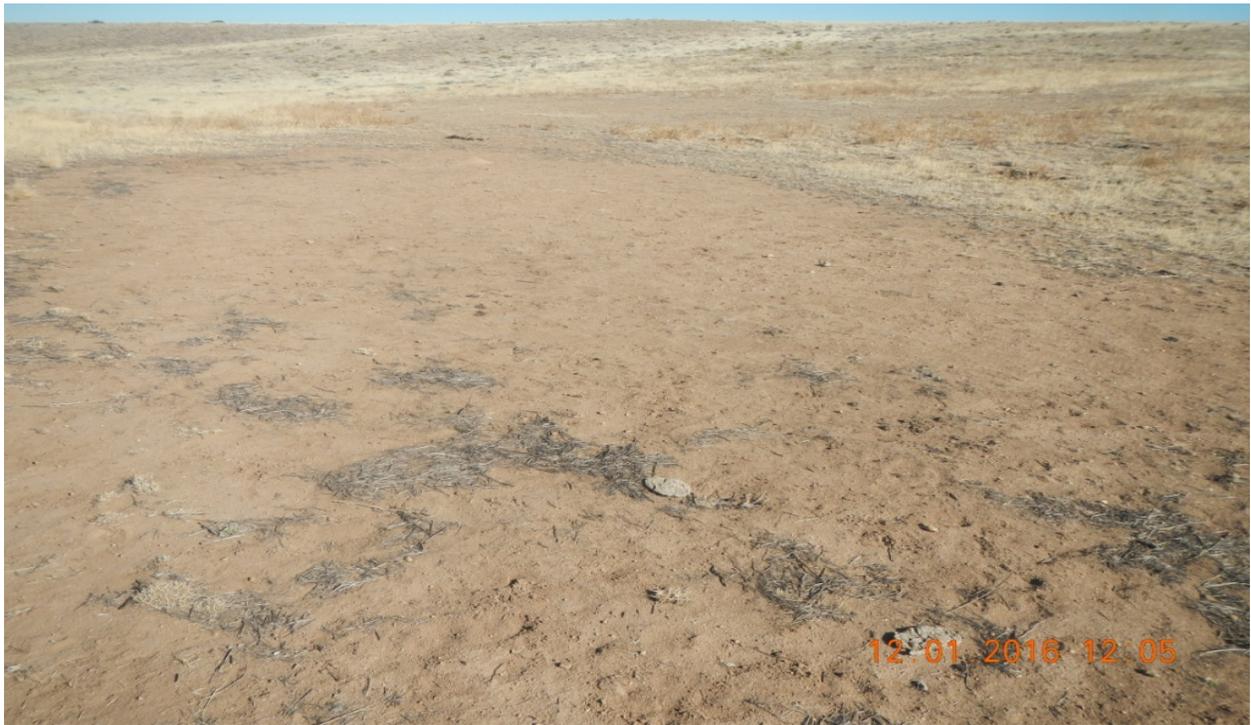
photo 5: Facing toward the north side of the location. Vegetation has not adequately established in this area.

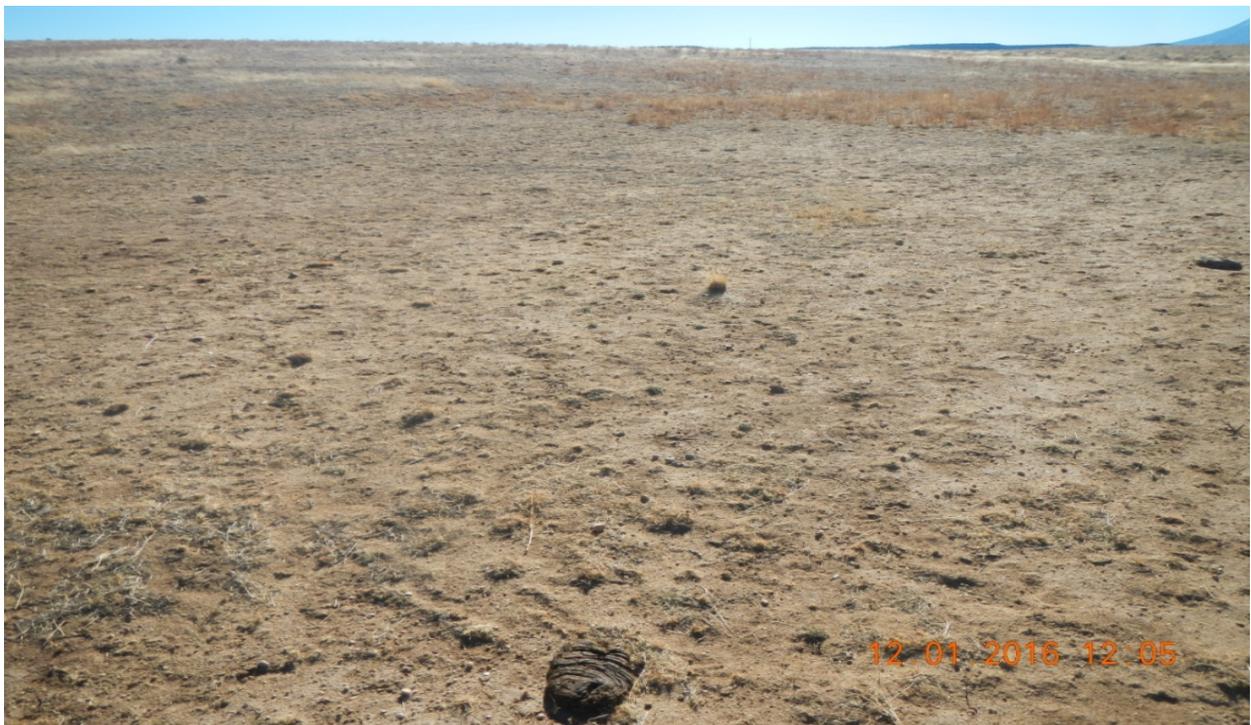
photo 6: North side of the location facing south.

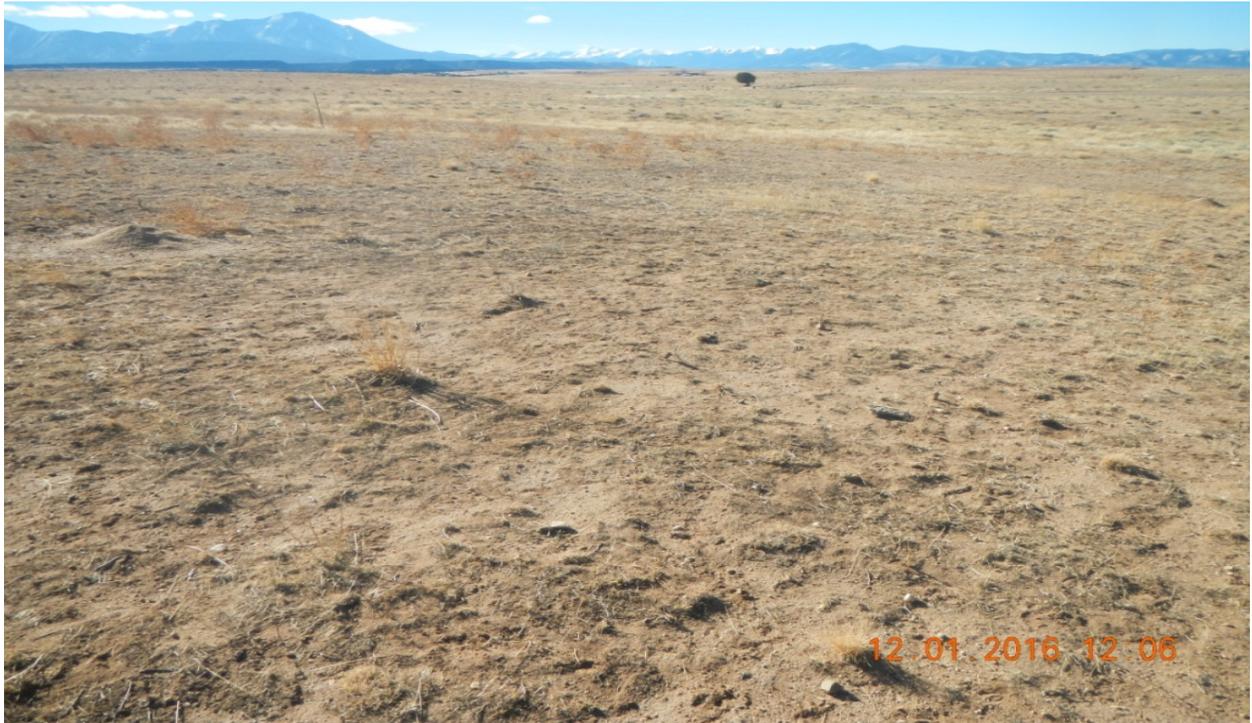
photo 7: Facing southwest toward the location.

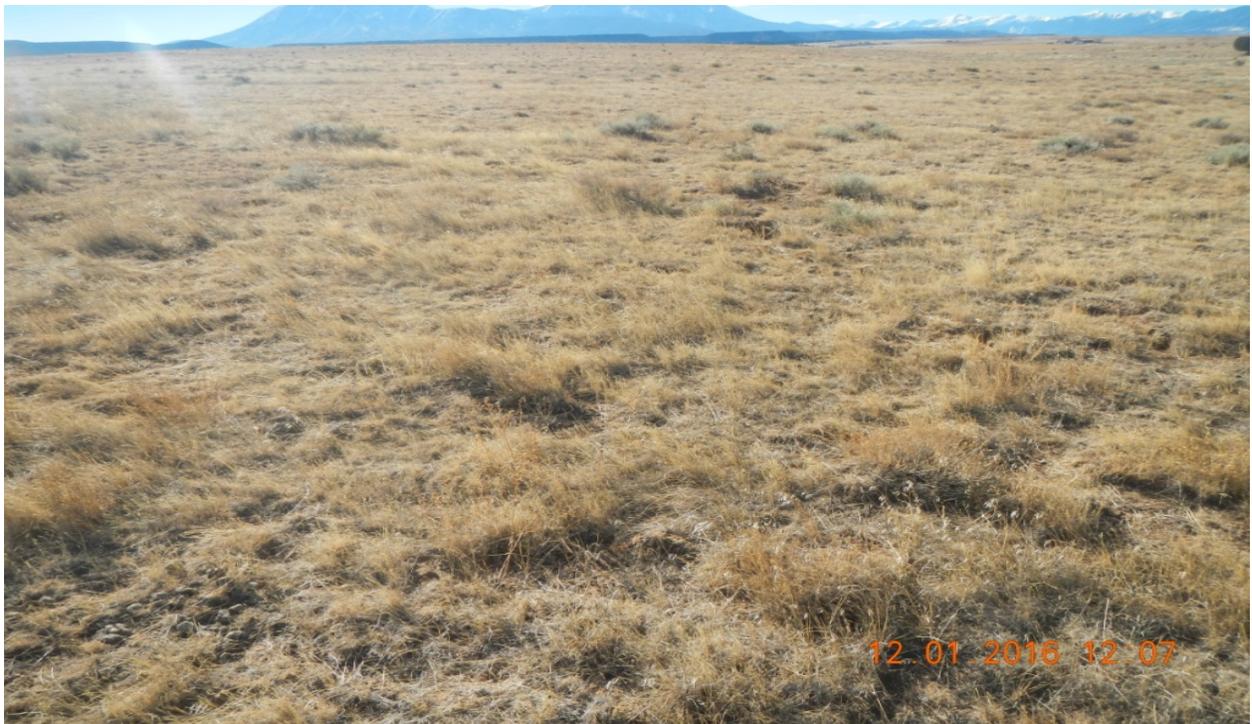
photo 8: Facing southwest toward the surrounding undisturbed reference area.
