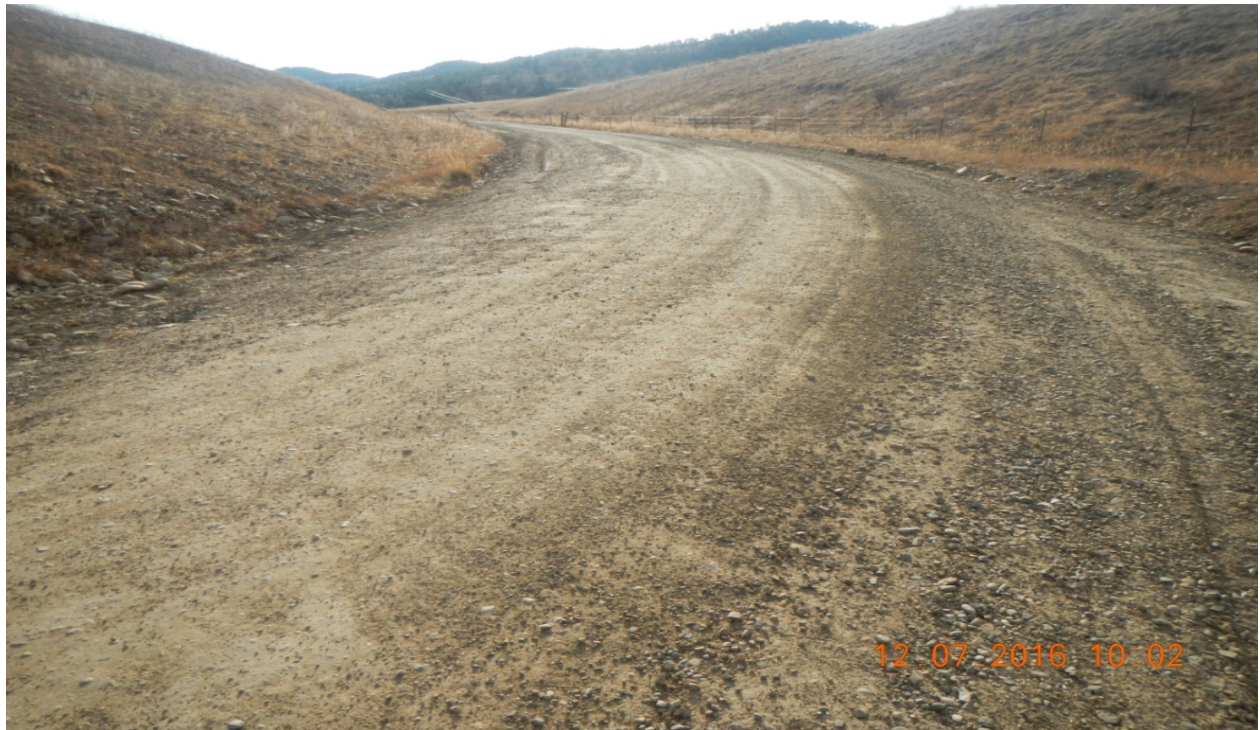
photo 1: Facing southeast along the access road toward the location.

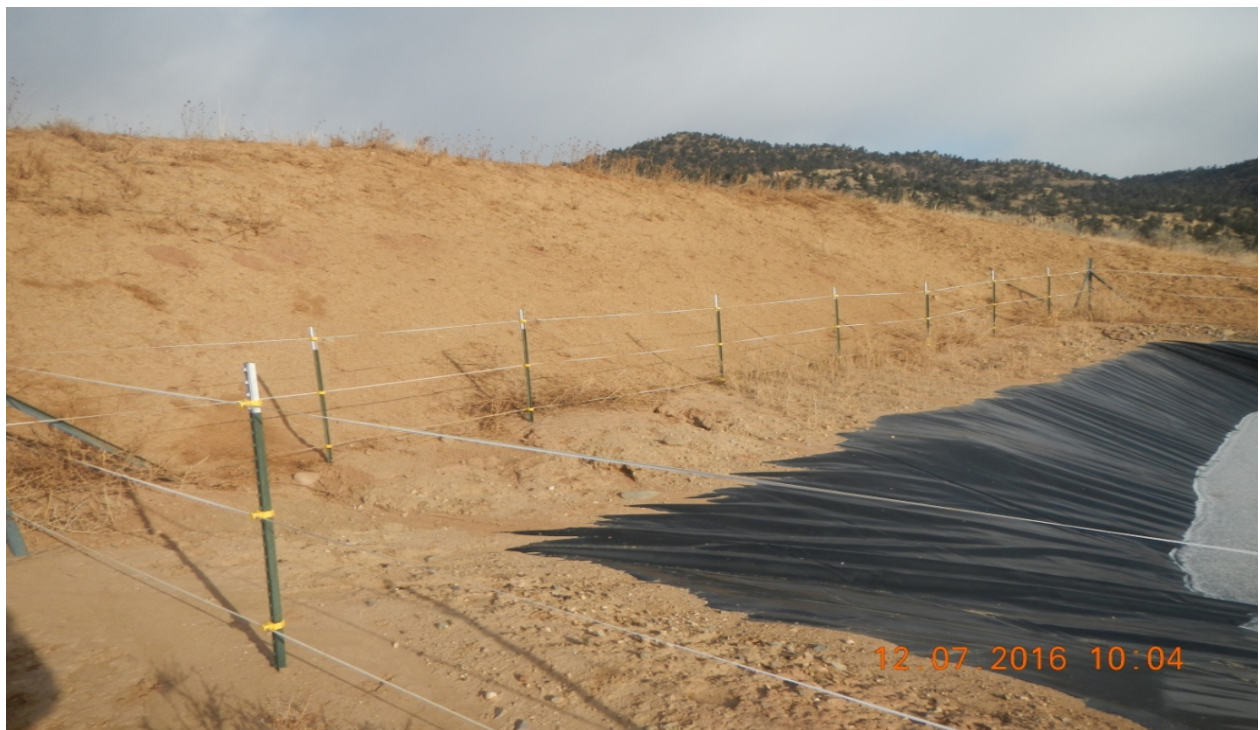
photo 2: Facing toward the west cut slope which has been seeded and hydro mulched.
